**Massachusetts State Laboratory**

**Facility Condition Assessment Study**

Project Number DPH 0702 ST1

January, 2014

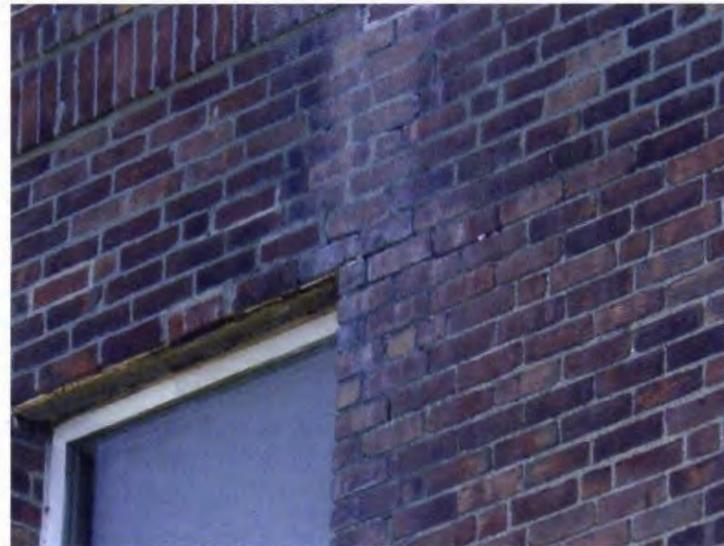
A.022 **Biologics Building** Exterior Detail, masonry degradation

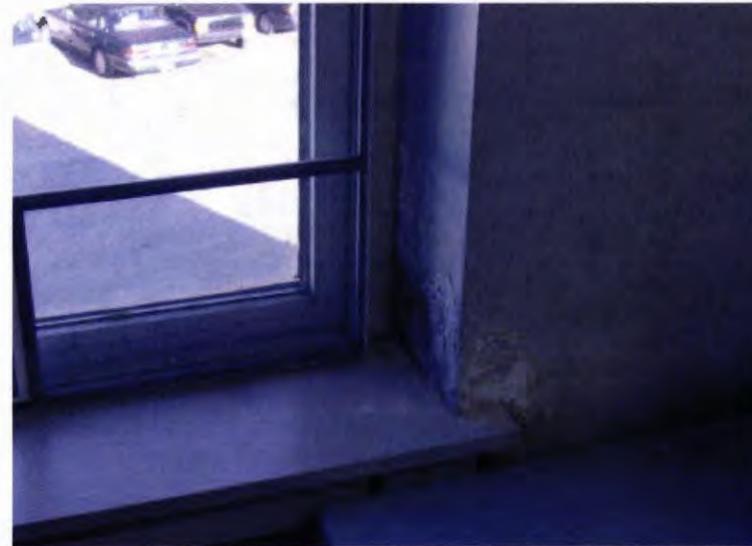
A.023 **Biologics Building** Interior moisture damage

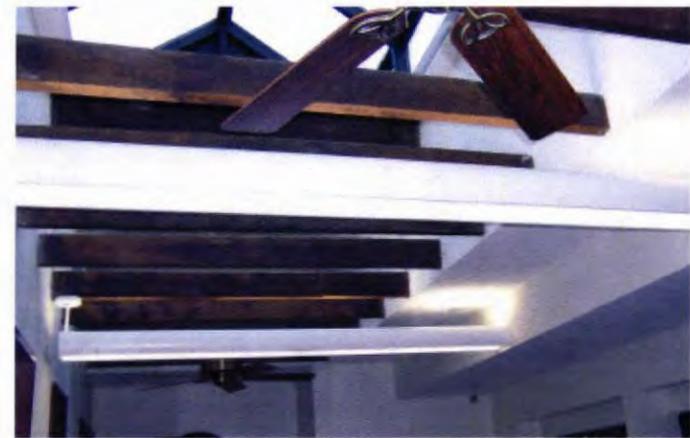
A.030 **Stable Building** Conference Room Skylight

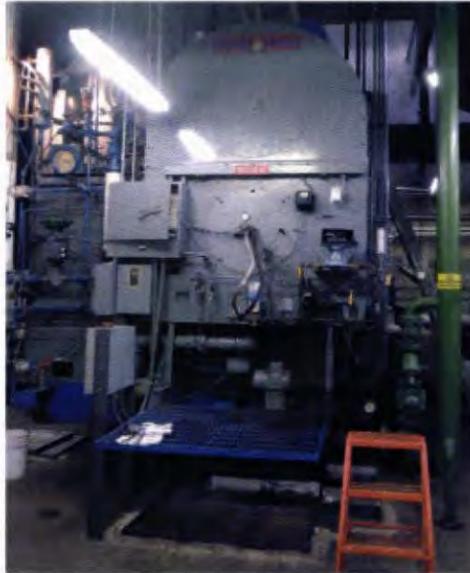
- Steam Boilers: 3 high pressure steam boilers located in the power plant, are original since the building was constructed and run off no.2 fuel oil. The boilers serve the Tower, Stable and Biologics buildings for both lab use and heating purposes. The main steam load on campus came from the Biologics building, which is not operational anymore, hence removing the majority of steam requirements on campus. The boilers are past their useful life and oversized for the steam requirements and should be replaced with more appropriately sized boilers.
- Air Handling Units (AHUs): Most AHUs serving the lower 3 floors of the Tower building are original and past their useful life, except for AHU-13 which was replaced in 2010 and AHU-12 which has been removed. The remaining 11 AHUs have dampers that are non-operational, coils and piping that are leaking and ductwork that is in fair condition.

M.001 Tower – Power Plant: Steam boiler.

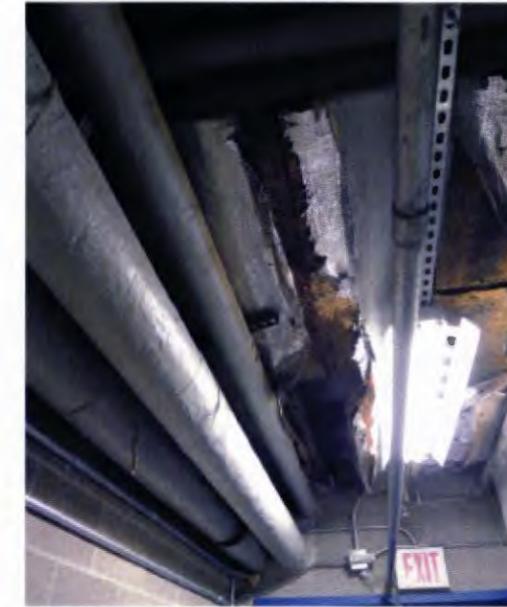
M.003 Tower – Ductwork insulation.

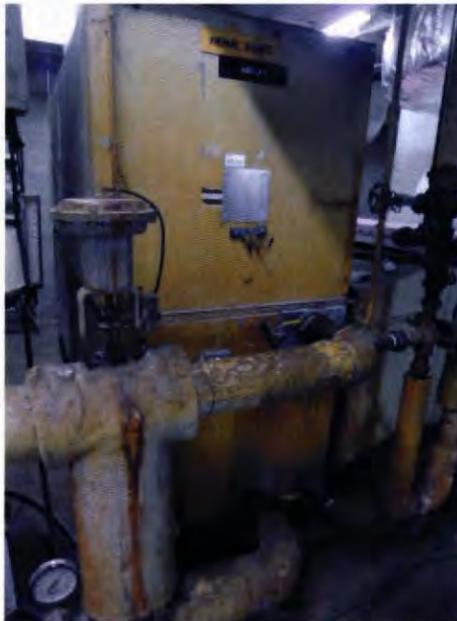
M.004 Tower – Lower floor AHU: Bad condition.

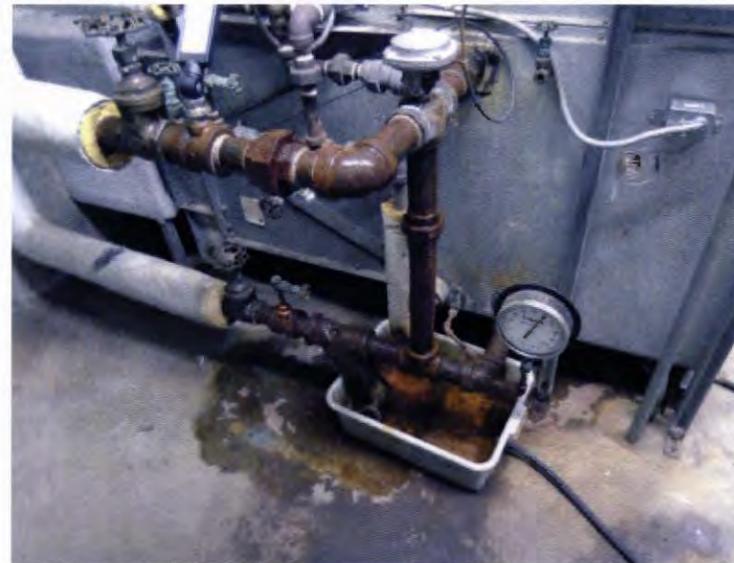
M.005 Tower – Lower floor AHU: Leaking pipes. Container used to capture leaking water.

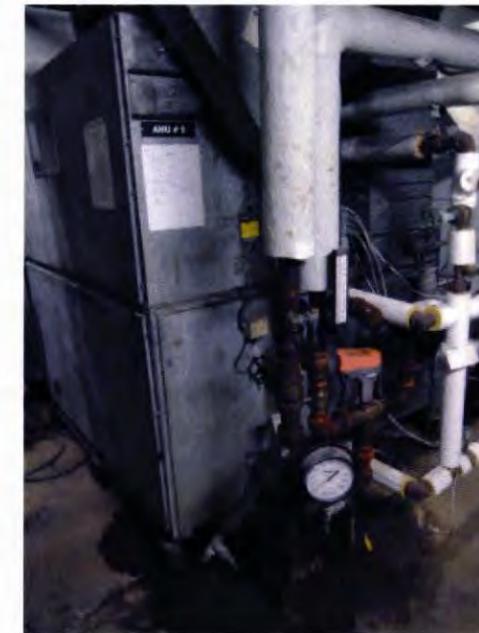
M.006 Tower – Lower floor AHU: Leaking pipes.

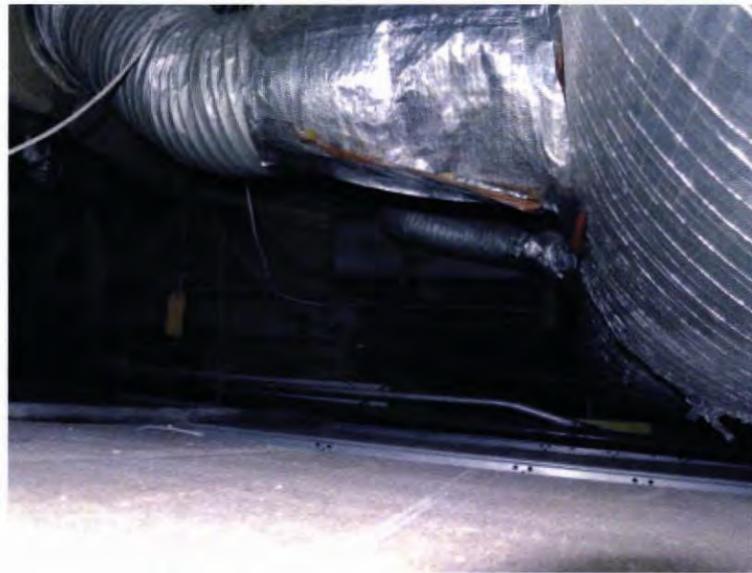
M.007 - Tower – Damaged ductwork.

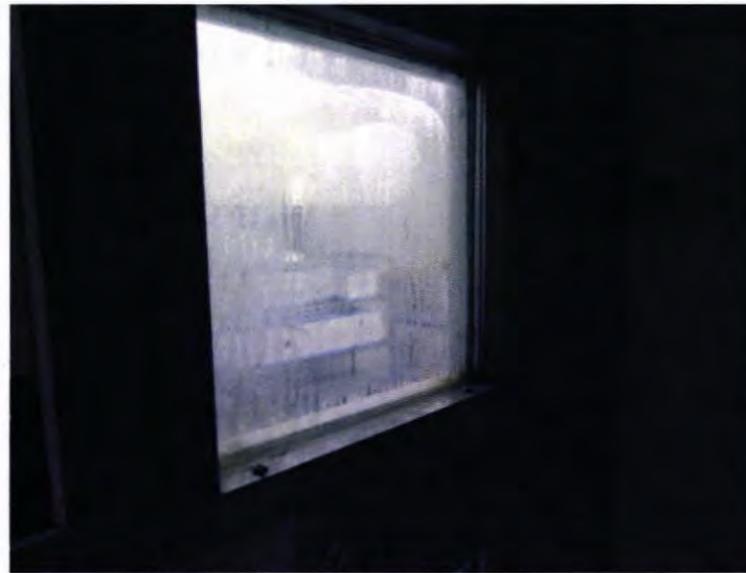
- Pipes: A lot of pipes in various areas are deteriorating and have damaged insulation. Piping in power plant is in poor condition.
- Refrigeration systems: A few of the walk-in refrigeration units were found to be non-operational and have failed doors/door seals.

M.008 Tower – Walk-in refrigeration unit: Condensation on door.

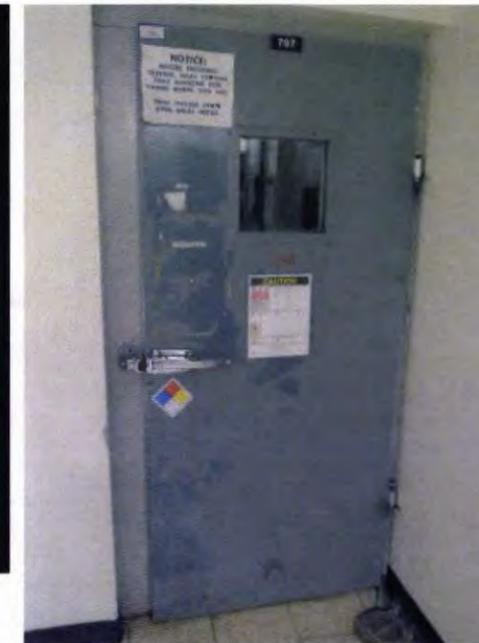
M.009 Tower – Walk-in refrigeration unit: Door is dented and has paint peeling.

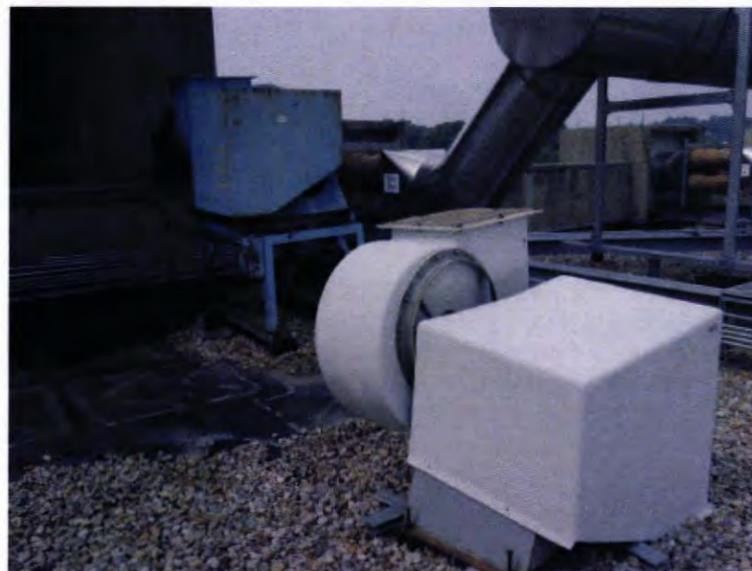
M.010 Tower – Roof exhaust: Blue unit is old, white replacement unit not connected.

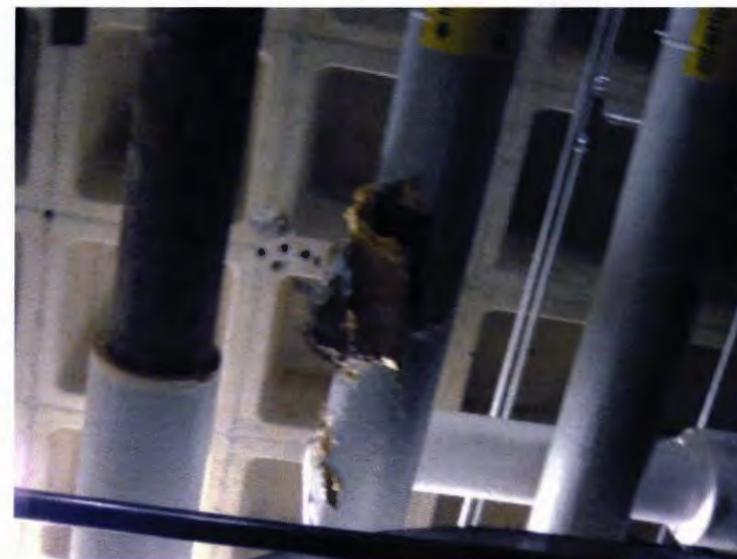
M.011 Biologics – Damaged piping and pipe insulation.

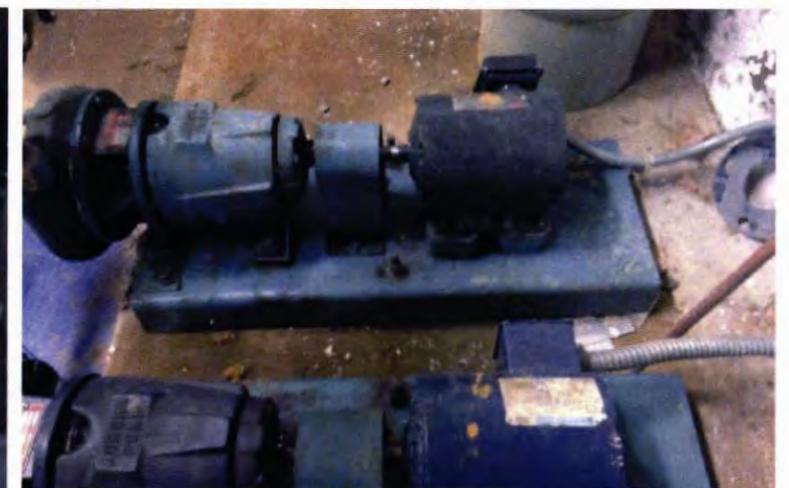
M.012 Stable – Hot water pumps: Old and worn.

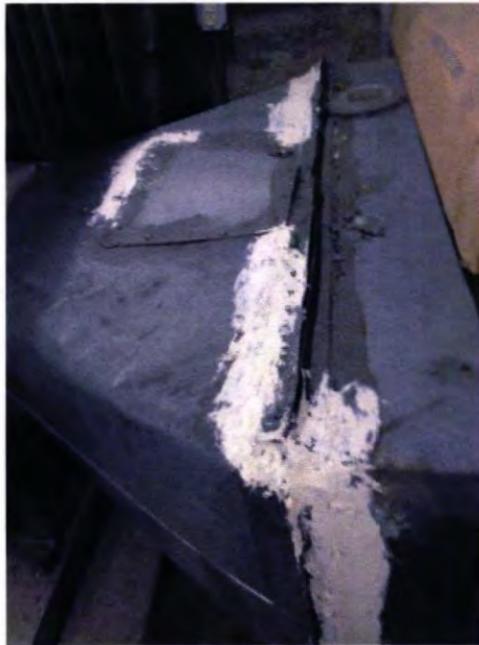
M.013 Stable – Ductwork has been patched and sealed.

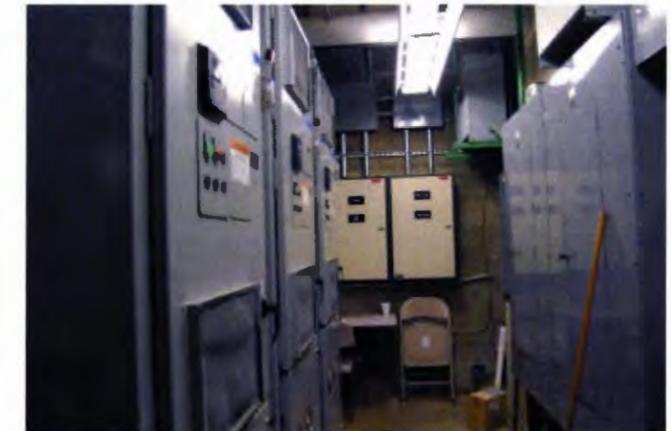
E.006 Tower – Typical VFD and Panelboard at power plant.

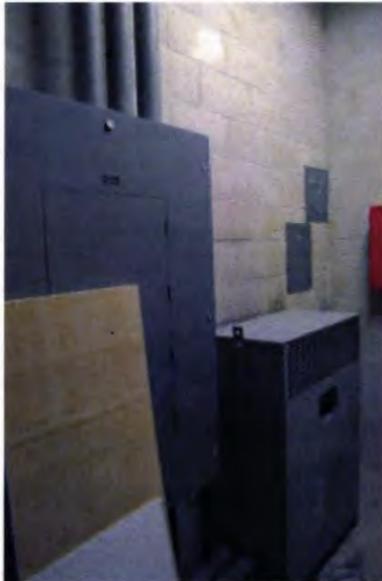
E.007 - Tower – Electrical room and space use for storage.

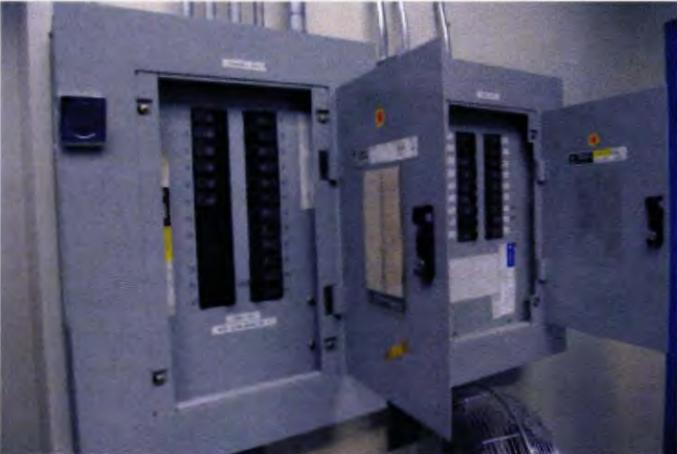
E.011 Tower –.Panelboards serving IT equipment – reach maximum capacity

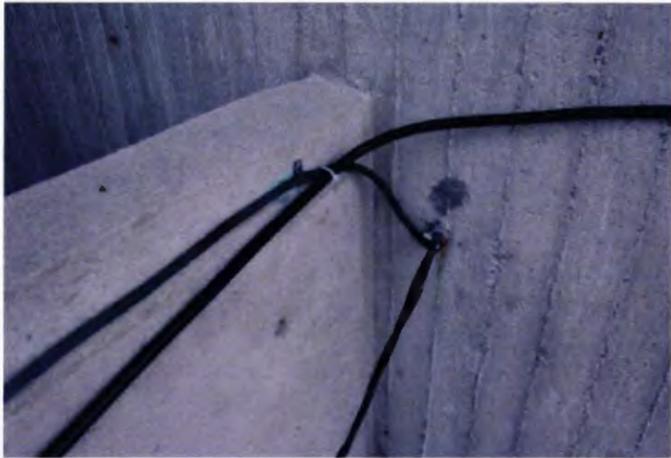
E.012 Tower – Lightning protection conductor tied to other cables

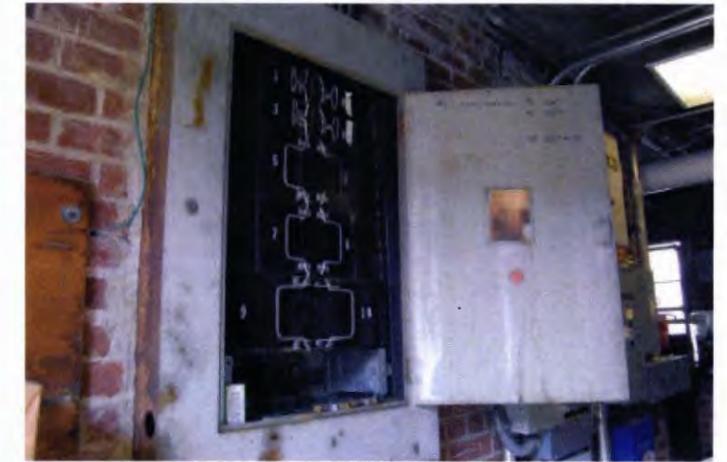
E.027 Biologics – Outdated panelboard on roof mechanical room

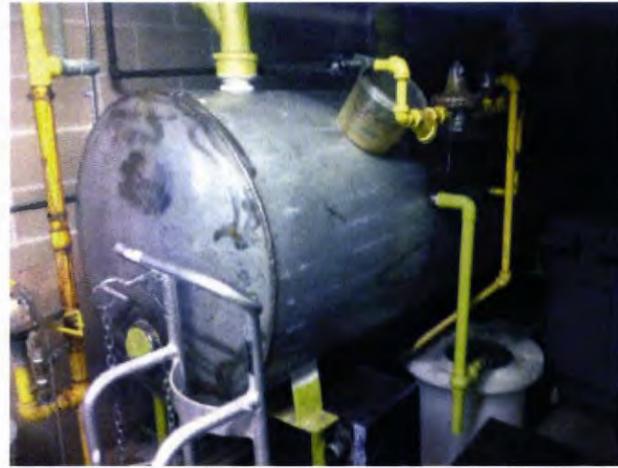
P.001 Tower Building- Existing grease waste holding tank
