4 October 2016

Project 111409.71 – Structural Conditions Assessment, McCormack Building Garage, One Ashburton Place, Boston, MA

**ICCP OVERLAY EVALUATION REPORT  
MCCORMACK BUILDING GARAGE,  
1 ASHBURTON PLACE, BOSTON, MA 02108**

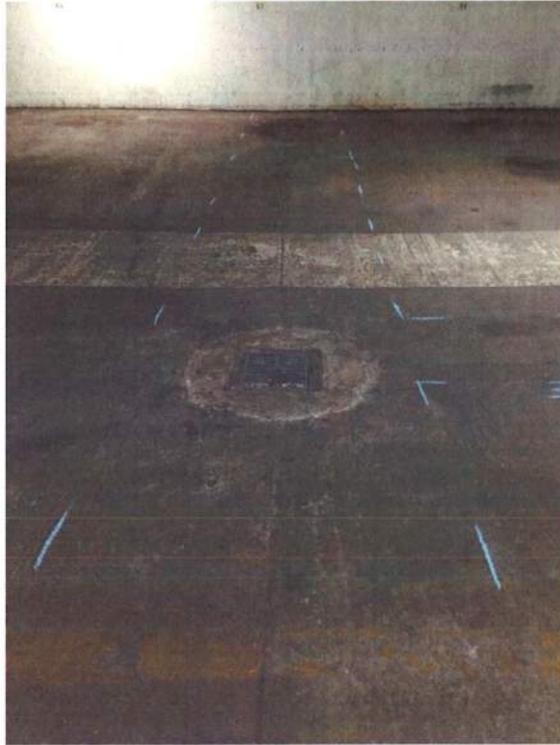
**Photo 1**

- There is unsound concrete topping at many locations on the topsides of the parking garage floor slabs where the topping is debonded from the structural slab. Some areas are significant in size ranging from 1 sq ft to 900 sq ft (Photos 1 and 2). Refer to Figures 1 through 3 for locations.

Area of debonded topping slab.

- Repair deteriorated/delaminated concrete on the topsides and undersides of concrete slabs. At some locations where the topside and underside damage overlaps, full slab thickness repairs are likely. Install sacrificial galvanic anodes within some of the repair underside repair areas.
- Remove and replace areas with debonded topping. Repair MMO in areas with debonded topping.
- Repair deteriorated concrete at concrete walls, columns, and stair landings. Install sacrificial galvanic anodes within the repair area.
- Rout and seal the cracks at the topside of the parking deck.
- Install a VTBW system at all areas of Levels 1, 2, 3 and ramps
- Install a penetrating sealer on Level 4.
- Repair or replace the ICCP system at each of the parking garage slabs. Repair ICCP system at certain zones where chloride contamination is low and corrosion potential is high.

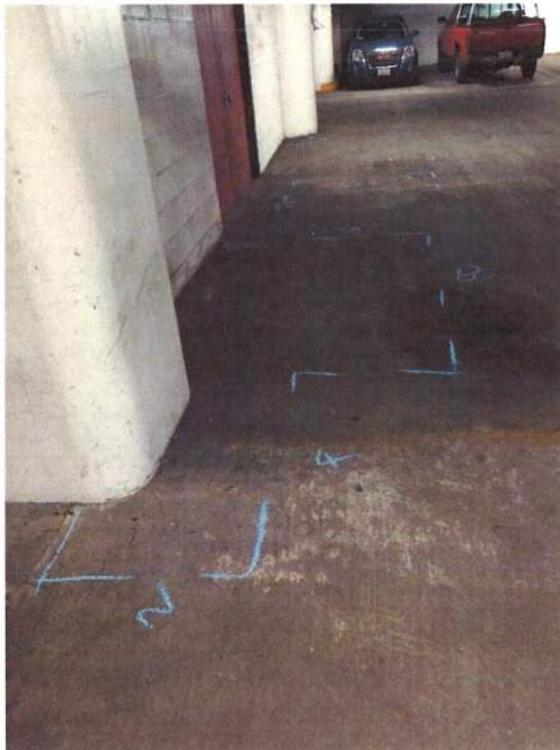
**Photo 2**

Area of debonded topping slab.

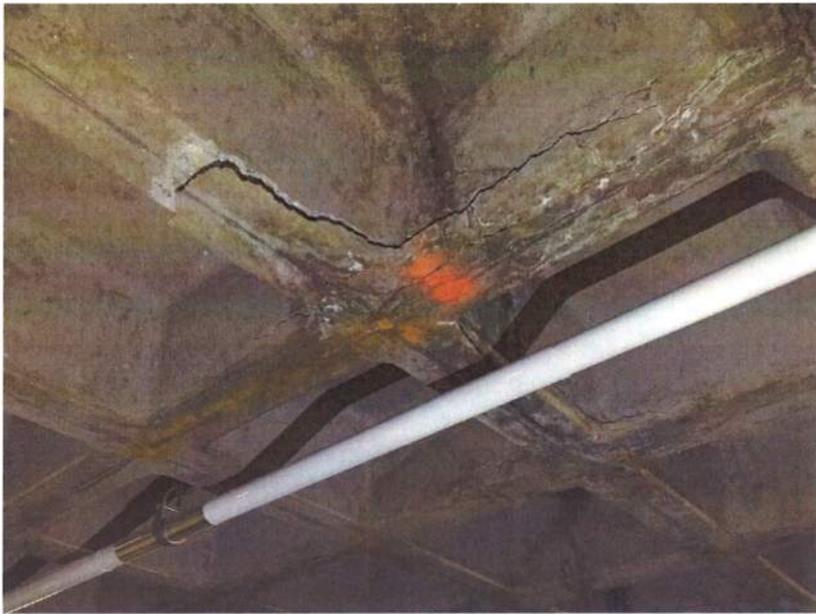
**Photo 3**

- There are many locations on the underside of the slabs where the concrete ribs are delaminated or spalled, with exposed steel reinforcement ranging from 1 sq ft to 25 sq ft (Photos 3 and 4). Refer to Figures 1 through 3 for locations.

Underside deterioration at rib.

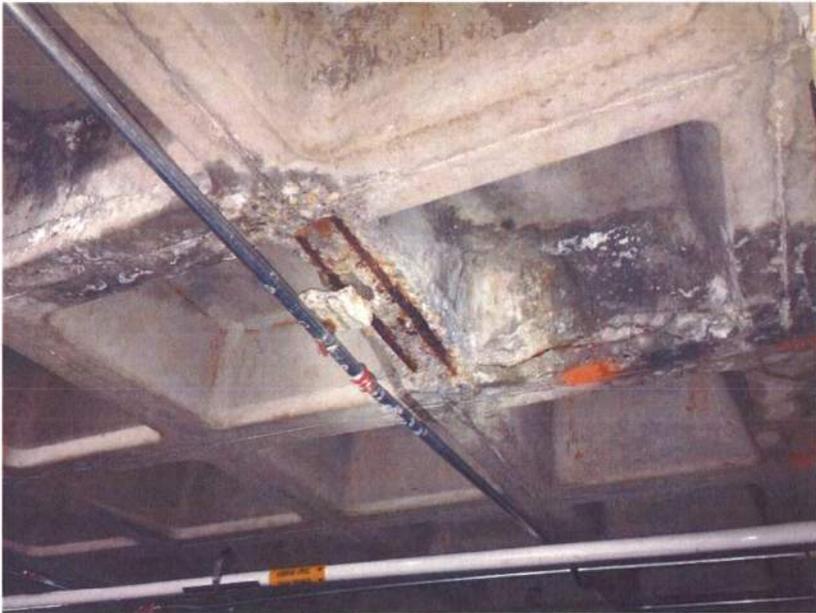
**Photo 4**

Underside deterioration with exposed steel reinforcement.

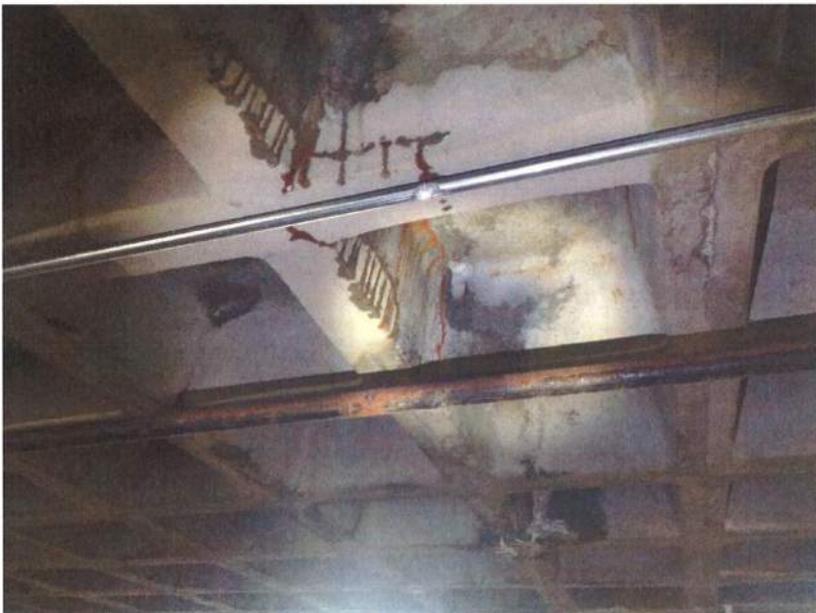
**Photo 5**

- Many previous concrete repairs are failed on the undersides of the slabs. At some locations, the concrete deterioration extends beyond the edge of the previous repair (Photo 5).

Underside concrete deterioration at previous repair.

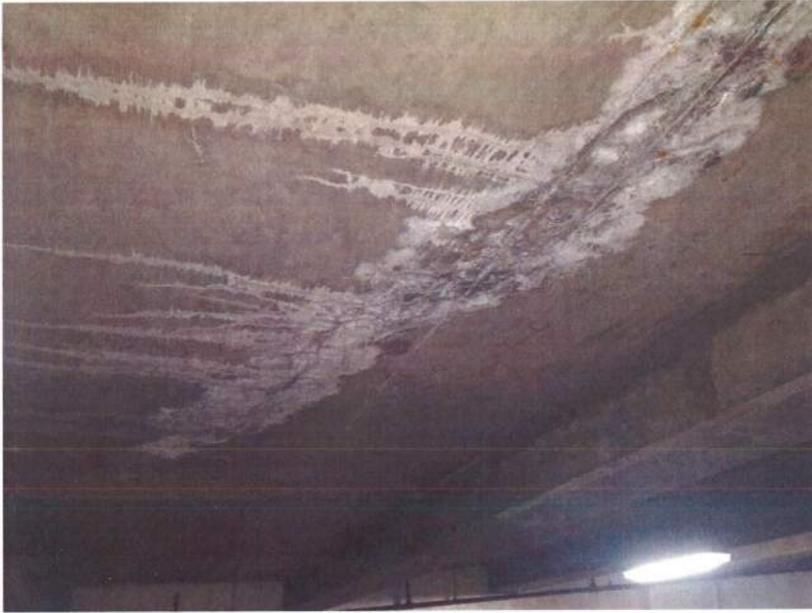
**Photo 6**

- There are cracks with efflorescence on the undersides of the concrete slabs (Photo 6).
- There are locations where the walls and columns are deteriorated (Photo 7).

Crack on underside of slab  
with efflorescence.

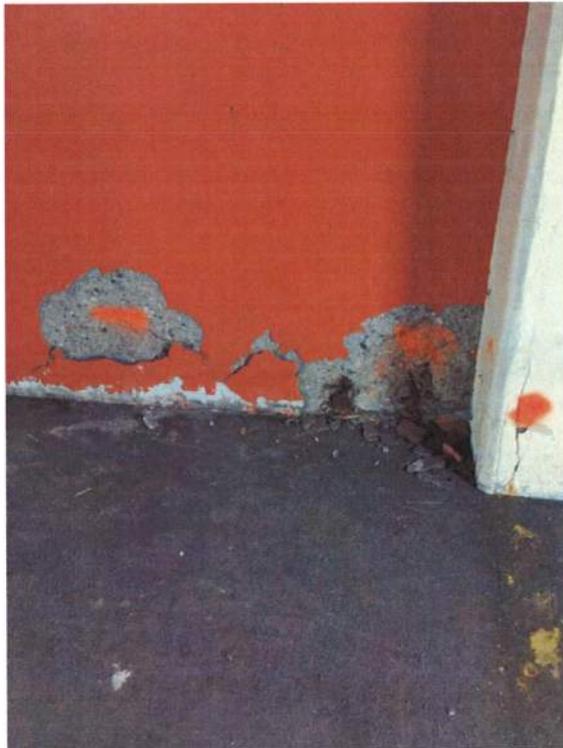
**Photo 7**

Deterioration at base of  
concrete wall and column.

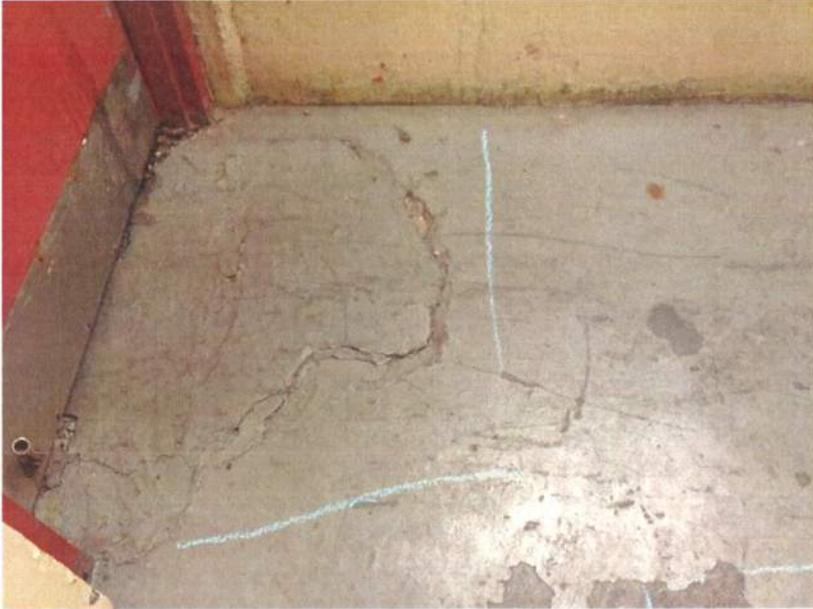
**Photo 8**

- There is concrete deterioration in the stairwells at topside and underside of landings, at walls (Photos 8 and 9).
- There is no vehicular-traffic-bearing waterproofing (VTBW) on the slabs.

Deteriorated concrete at  
topside of stair landing.

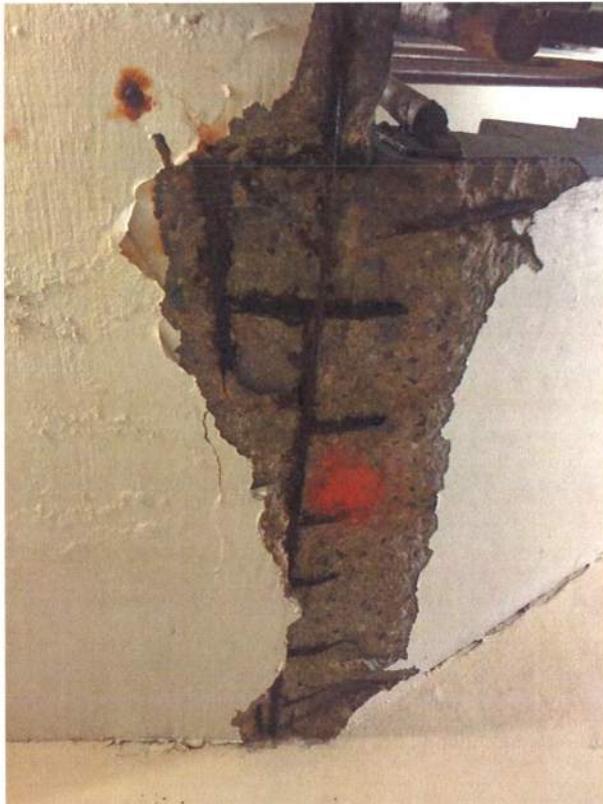
**Photo 9**

Deteriorated concrete at  
underside of stair landing.

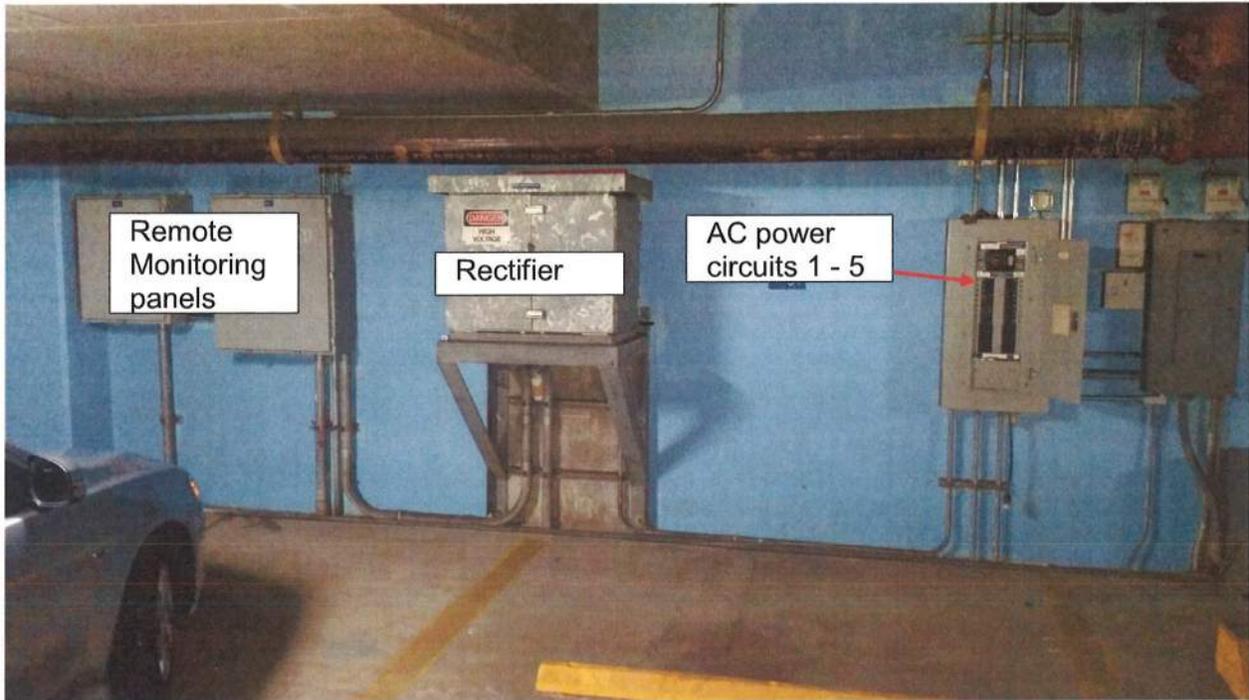
Figure 1: Level 1 Rectifier

Level 1 - The rectifier was operating, but neither the DC voltage nor DC current supplied could be adjusted.

2. All three rectifiers need to be replaced. Internal parts for the rectifier may be available, but even if the parts could be located, other parts would be near the end of their functional life and would likely fail in short order.

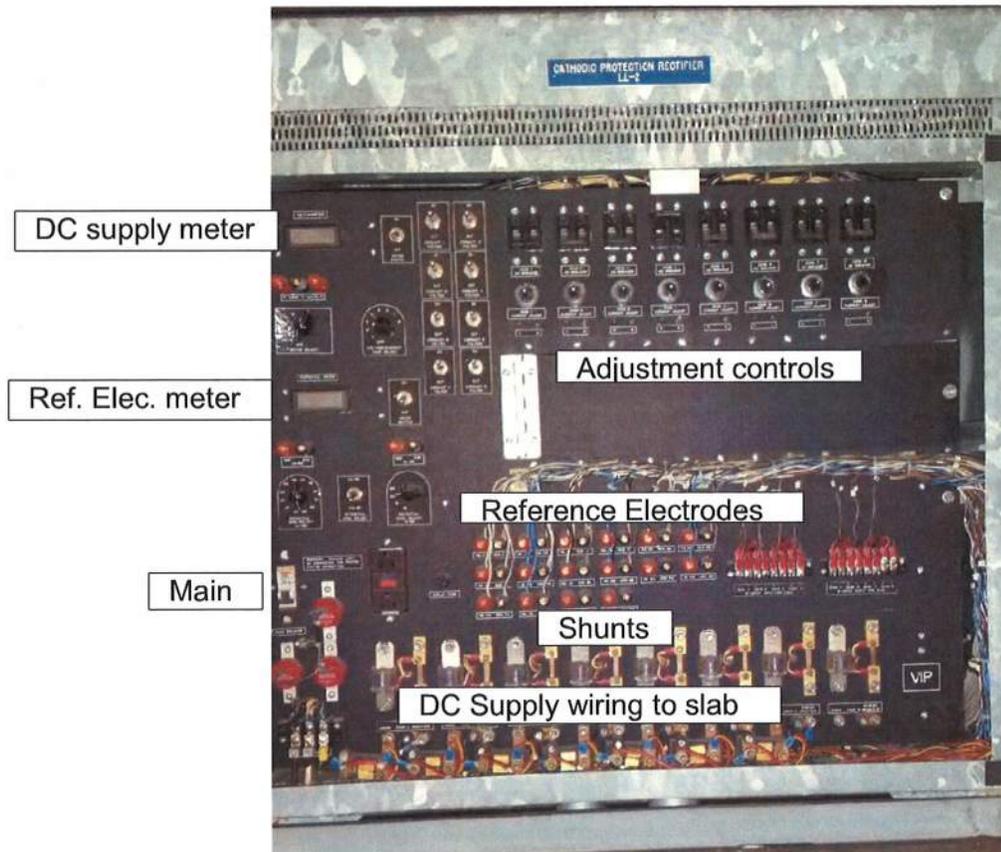
Figure 2: Rectifier controls

- Rectifier control circuits were not operable. The adjustment is conducted using a multi-turn potentiometer with the control circuits housed on a circuit board. This circuit board has a remote dial up functionality, that appears to be operable, but no one knew of any data or how to communicate with the unit. During testing, the switch was in the "Manual" position, and no channel on any rectifier responded to manual adjustment. The rectifier is rated at 24V, but the maximum voltage measured at any time was 3.3V.

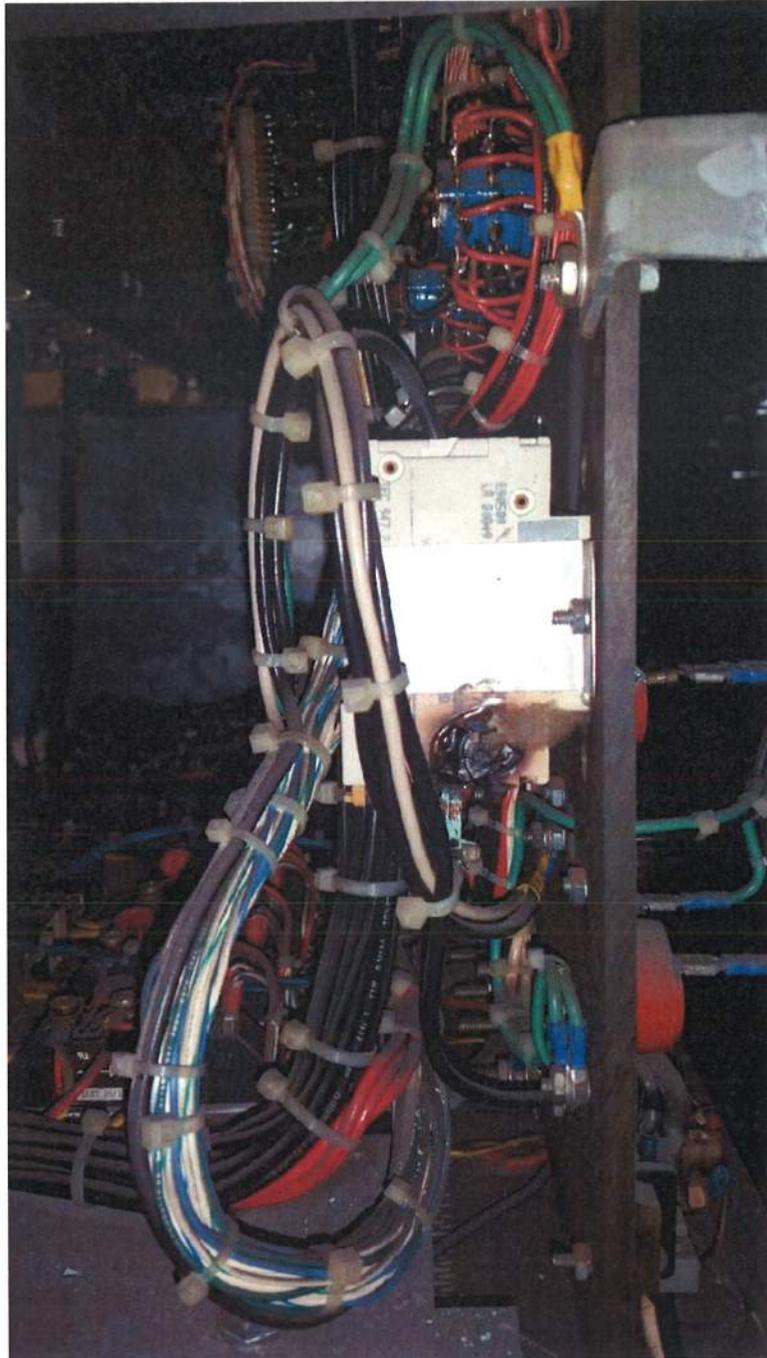
Figure 3: Level 2 Rectifier main breaker melted

Level 2 - The rectifier was not operating. AC power was turned on, but the main breaker had melted and the AC wiring was severely corroded.
