# OCEAN AVENUE WEST PUMP STATION FLOOD MITIGATION – CONDITIONS ASSESSMENT

Municipal Vulnerability  
Preparedness Grant  
Program

0232827.00  
**City of Salem, MA**  
June 2020

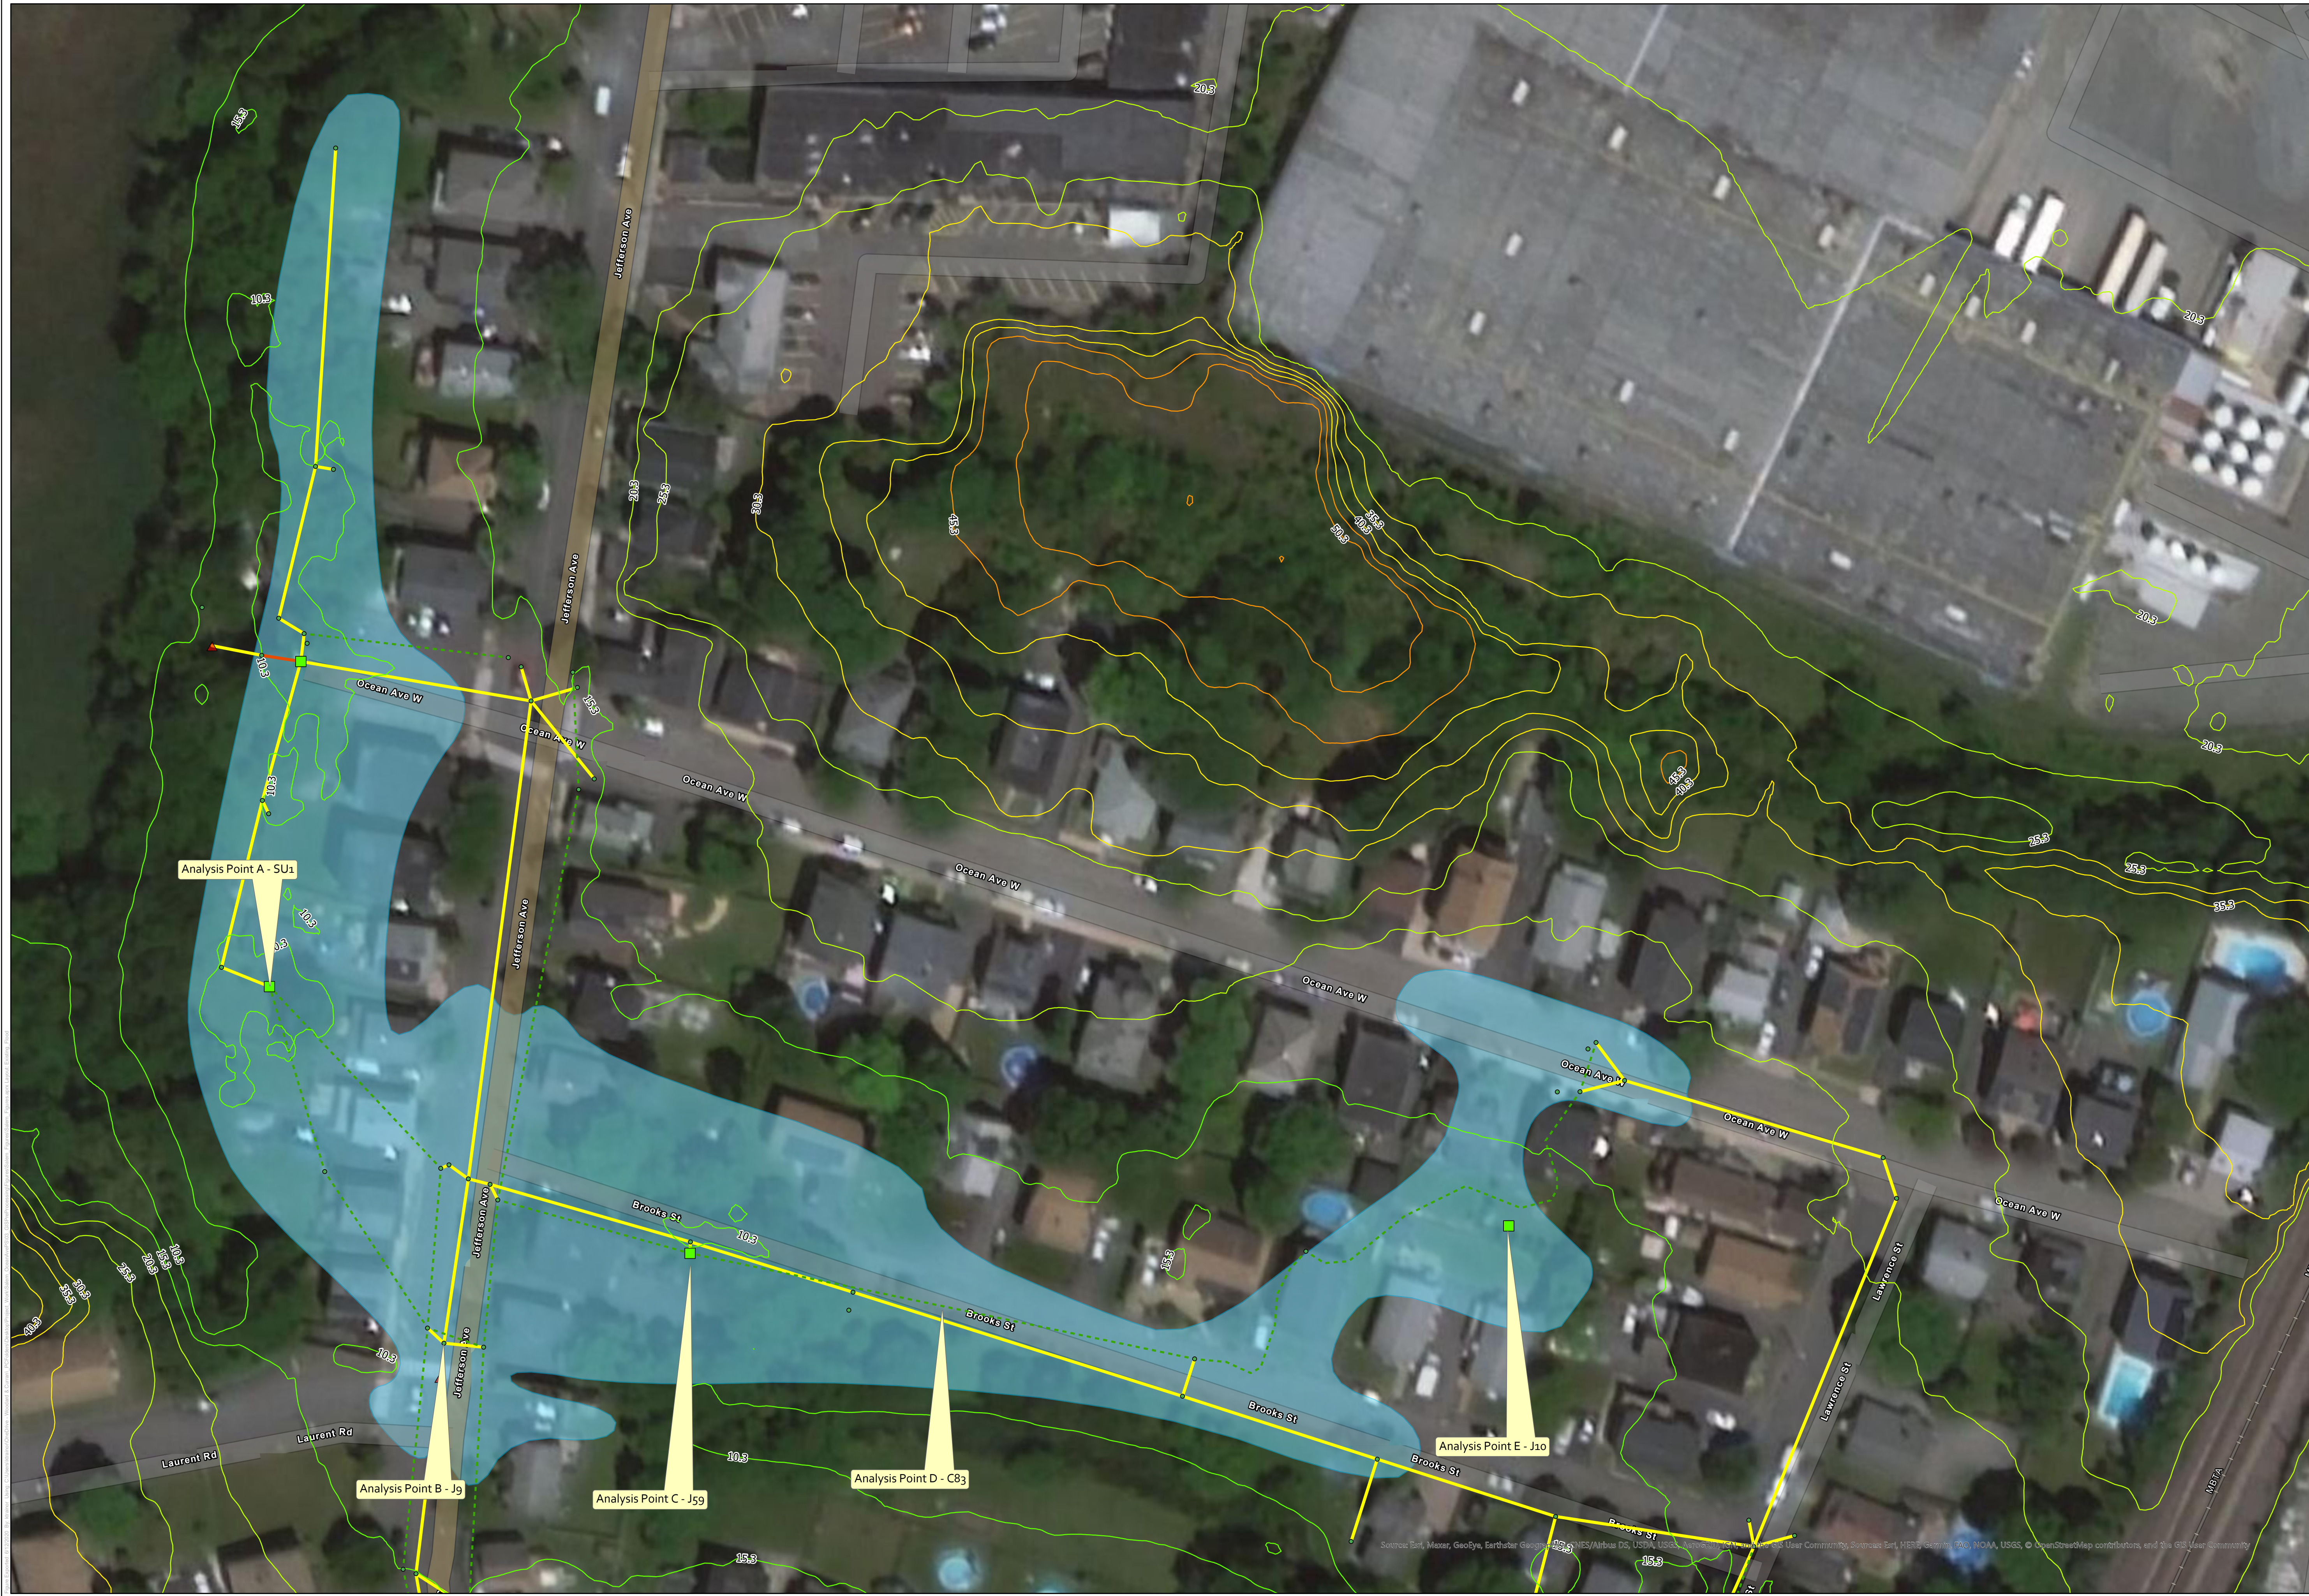
Figure 3-3:  
Existing Conditions  
Flood Extent

The existing conditions were modeled to establish design flowrates, quantify restrictions, and provide a means of evaluating proposed improvement alternatives. The 100-year storm event was simulated on the existing system model. Results from this model indicate that all existing components of the system, including roadway flow paths, inlets, conveyance piping, and pumps are undersized for the 100-year storm event. The collection system is limited by the inlet and conveyance capacity. Figure 3-3 shows the approximate extent of flooding in the existing condition, assuming that the Rosie's Pond Flood Mitigation Project, as currently designed, is constructed. The following subsections describe the limitations of each component of the collection system. Table 3-2 below indicates the peak inundation depth at each analysis point labelled on Figure 3-3.

Description	Location	Peak depth of water (ft)
Analysis Point A	Low point behind 208 Jefferson Ave	2
Analysis Point B	Jefferson Ave vertical sag	2
Analysis Point C	West end of Brooks St	3.5
Analysis Point D	Brooks Street	2.25
Analysis Point E	Behind 169 Ocean Ave W	2.5

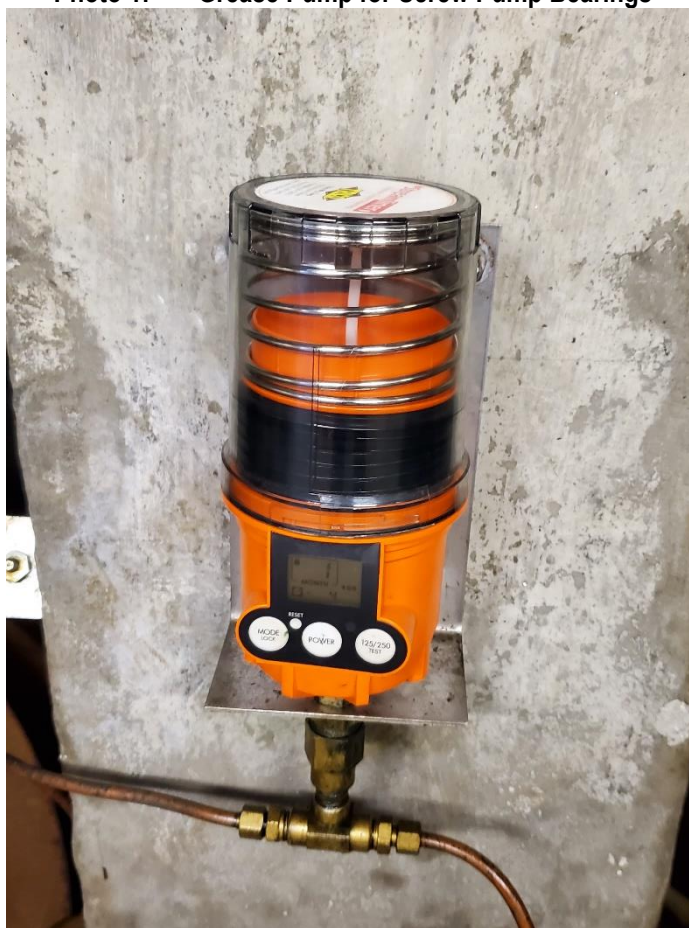
**Photo 1: Grease Pump for Screw Pump Bearings**

A new Trico Streamliner bearing grease pump was observed to have been installed since the previous assessment. The original grease pump is still mounted near Pump 1 below the main distribution panel; however, it was disconnected.

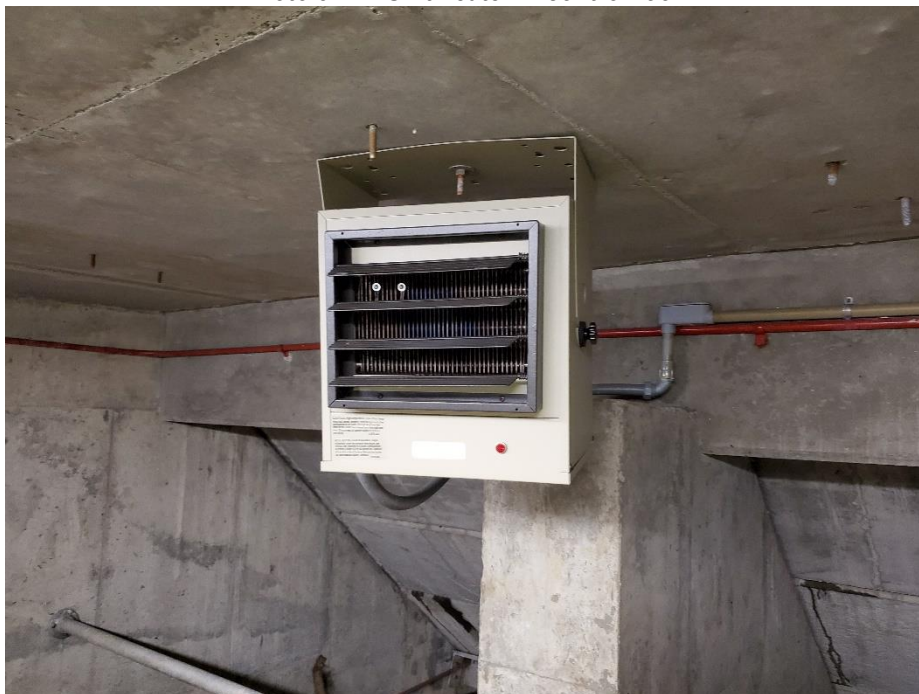
As noted in the 2009 Assessment, no means of mechanical ventilation is provided for the station other than manual opening of the upper and lower access doors to the station. An electric heater on the upper level of the station is installed to provide heat in the building and maintain a minimum temperature for the electrical and control equipment. The building has no air conditioning. The discharge chute from each pump is accessible from the building via aluminum floor grating. Operations staff has placed sheet plywood over these grates to both limit heat loss and prevent animal intrusion. It appears that no improvements to the heating, ventilation and air conditioning components of the Pump Station have been made since the 2009 Assessment based on observations during the field visit.

**Photo 5: Unit heater in control room**

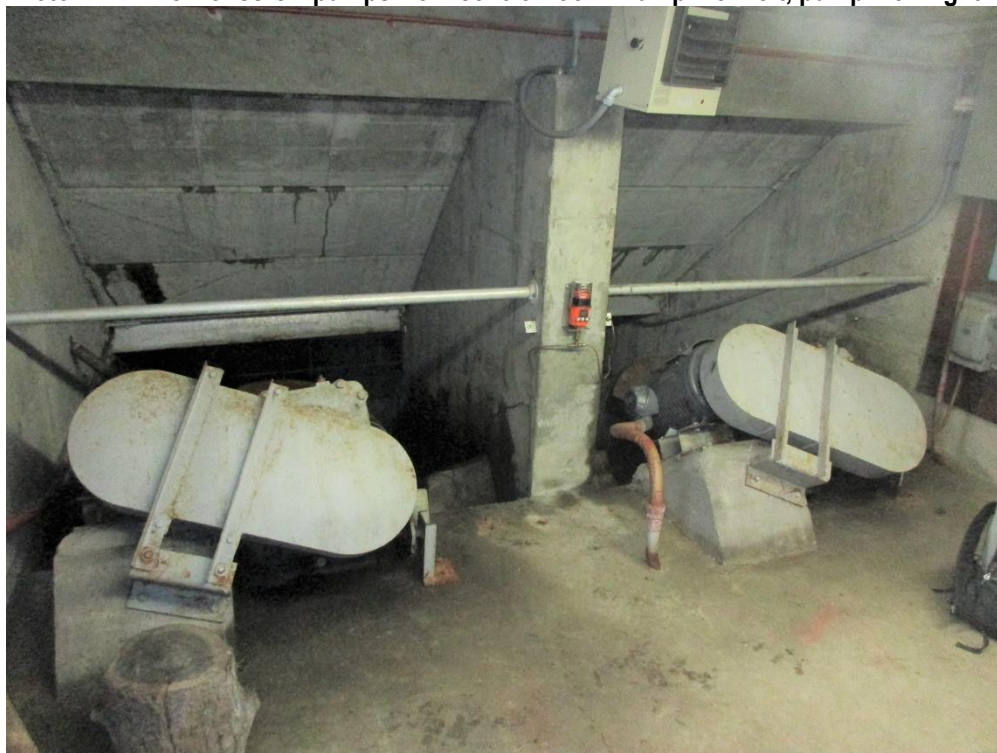
The flights of the screw pumps showed edge deterioration on both pumps. The painted steel screw pump flights were in poor condition with visible corrosion, pitting, and some material loss.

Pump 1 screw flights were generally intact at the upper and lower ends, but significantly reduced in the center of the pump. As a result, flow slippage is likely encountered when operating. Rusted leading edges of the flights indicated that Pump 1 has not been run recently. Peeling paint and bare metal with areas of rust were prevalent on the torque tube and flights.

Similar to Pump 1, Pump 2 exhibited degradation at the center of the pump, likely resulting in flow slippage when operating. Pump 2 did not have rusting leading edges as the pump has continued operating since 2009.

**Photo 7: View of screw pumps from control room. Pump 1 on left, pump 2 on right.**

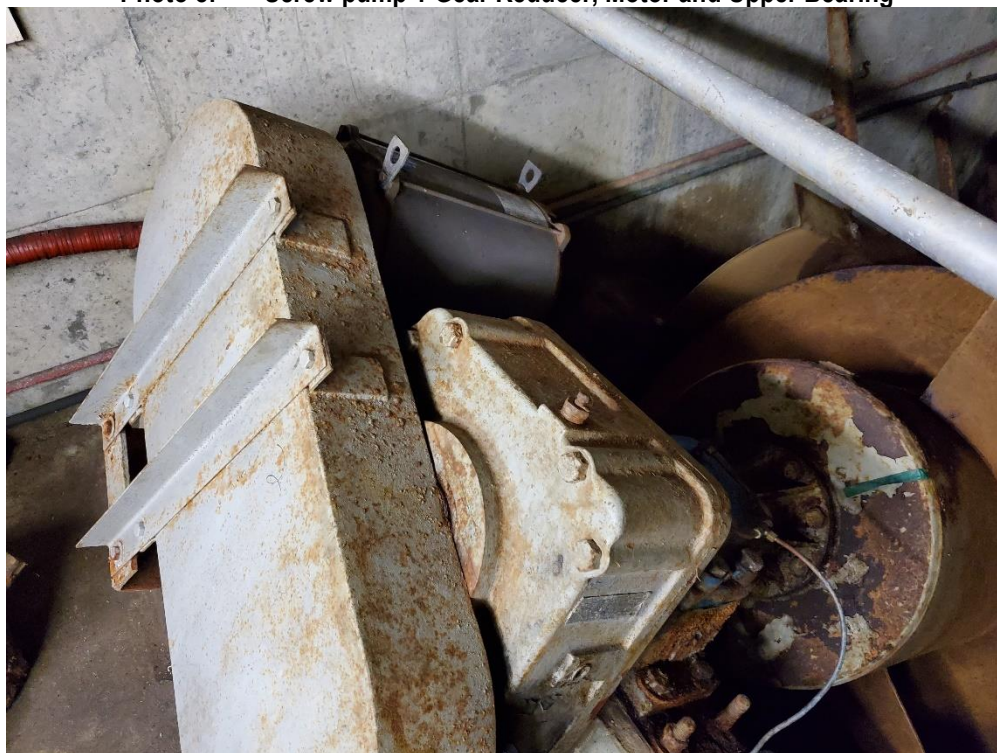
The motor housing and belt guards on each of the pumps showed rust and general deterioration consistent with the age of the pumps but were intact on both pumps.

**Photo 8: Screw pump 1 Gear Reducer, Motor and Upper Bearing**

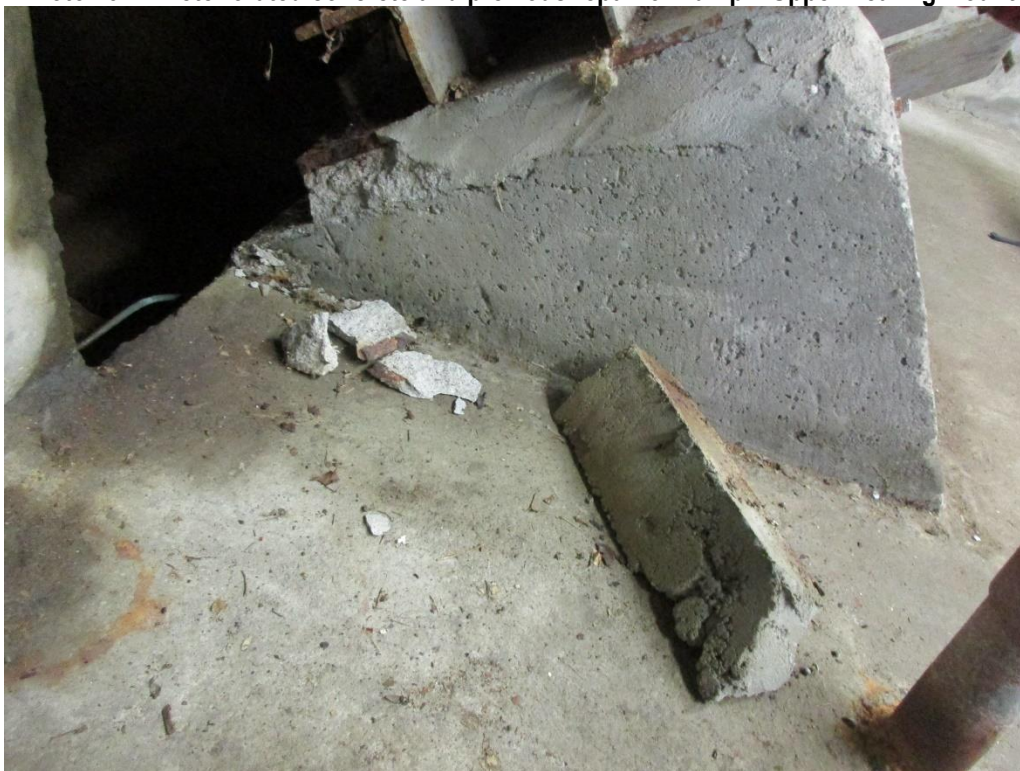
The upper pump mounts were visible and inspected. The upper mount for Pump 1 did not display any severe deterioration. The mount for Pump 2 had dislodged, with broken concrete observed on the side of the mount facing the pump station center wall. There appeared to be only 2 inches of concrete cover between the edge of the mounting pad and the anchor bolts. While the anchor bolts were intact, this deterioration may have contributed to the vibration observed in the gearbox. Additional discussion of concrete condition is included in the Building and Grounds Section of this assessment.

**Photo 13: Deteriorated concrete and previous repair of Pump 1 Upper Bearing Mount**

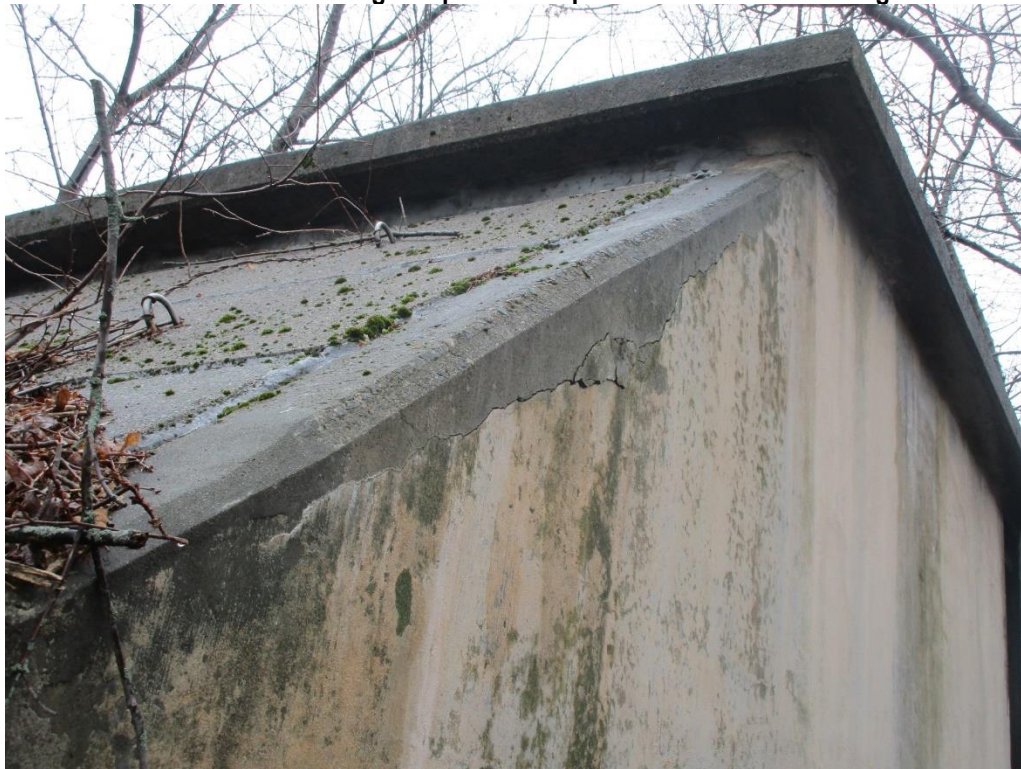
Exterior concrete walls and the concrete stair slab had several areas with localized cracking, spalling, and hollow concrete in need of repair. The sloped and flat sections of the precast roof were not accessed but a build-up of debris, moss growth, and algae indicating trapped moisture problems and poor drainage was observed. Some localized areas of leakage into the structure due to failing sealant of the removable concrete roof planks were identified. The concrete discharge chute slab has areas of hollow, delaminated concrete in need of repair along the west edge. The slab was undermined due to erosion, but this is a structural slab cantilevered off the building wall and is not dependent on the underlying soil for support.

**Photo 16: Cracking and previous repairs on exterior of building.**

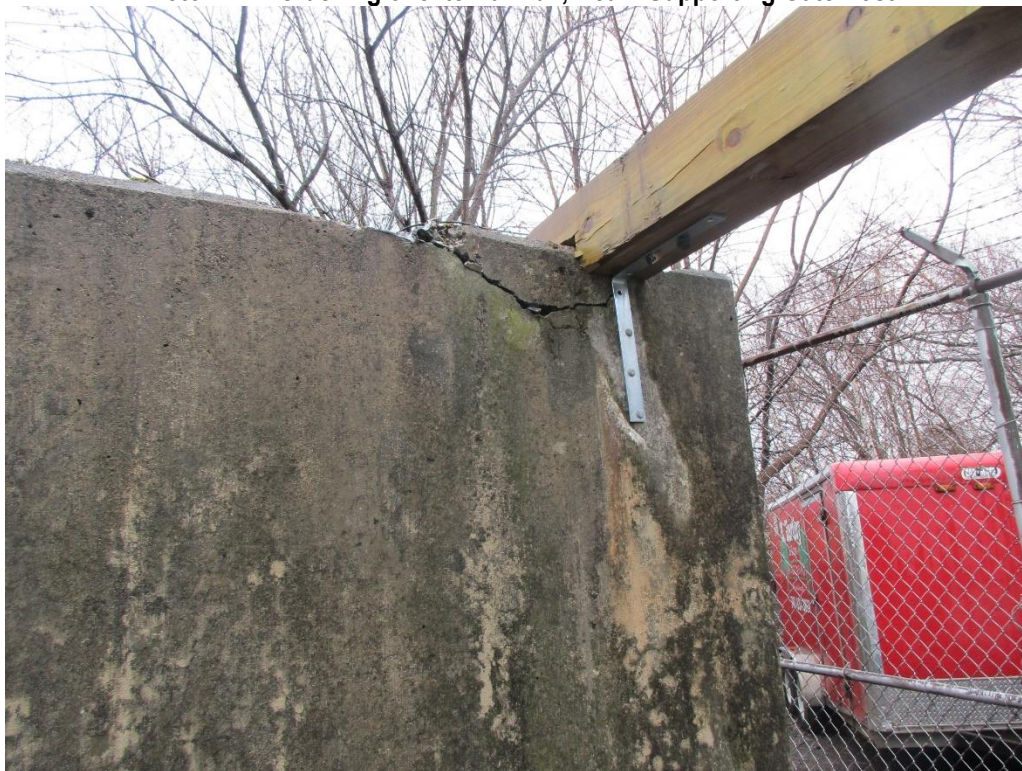
**Photo 17: Cracking of external wall, Beam Supporting Gate Post.**

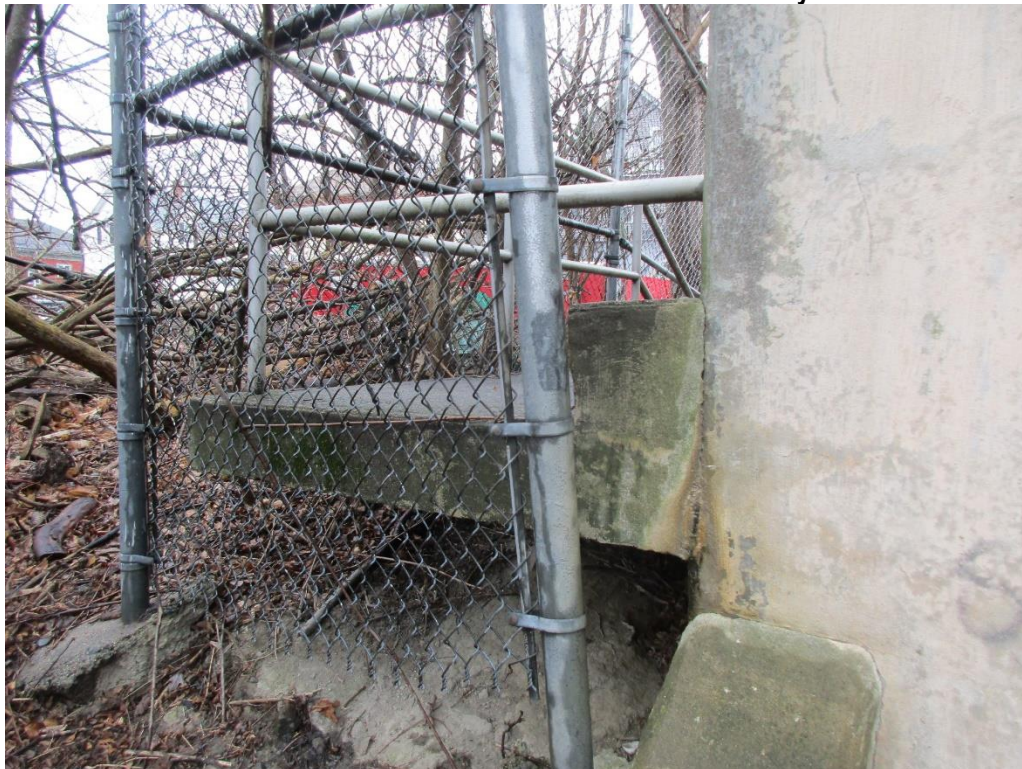
The Pump Station is surrounded by a 6-foot chain link fence topped with barbed wire. The City's Operations contractor has maintained the grounds within the fence. There was evidence that stormwater has eroded the earth around the Pump Station with debris being collected along the outside of the fence and at the back corners of the building. In addition, erosion of soil below the upper level access stairs was observed. Signs of undermining and erosion of subbase soils under the slab of the discharge chute leading edges and joints along with movement of rip rap from its original position was observed during the field visit.

**Photo 18: Soil Erosion under entrance slab and security Fence.**

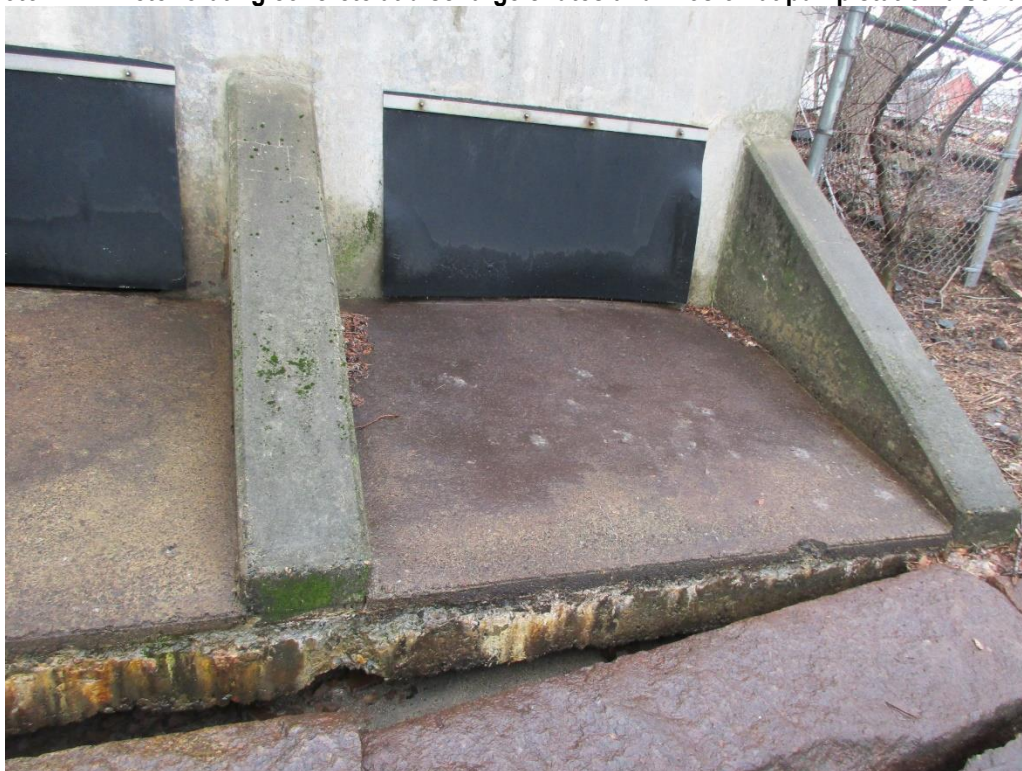
**Photo 21: Deteriorating concrete at discharge chutes and Erosion at pump station discharge.**

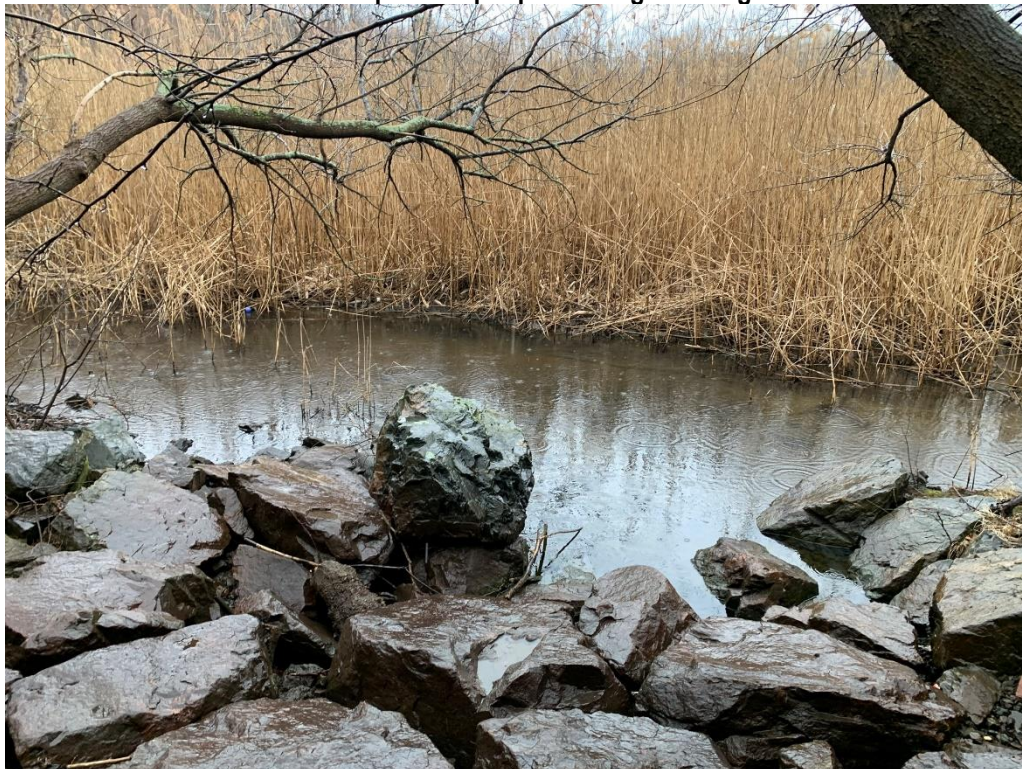
**Photo 22: Displaced rip rap following discharge chute.**

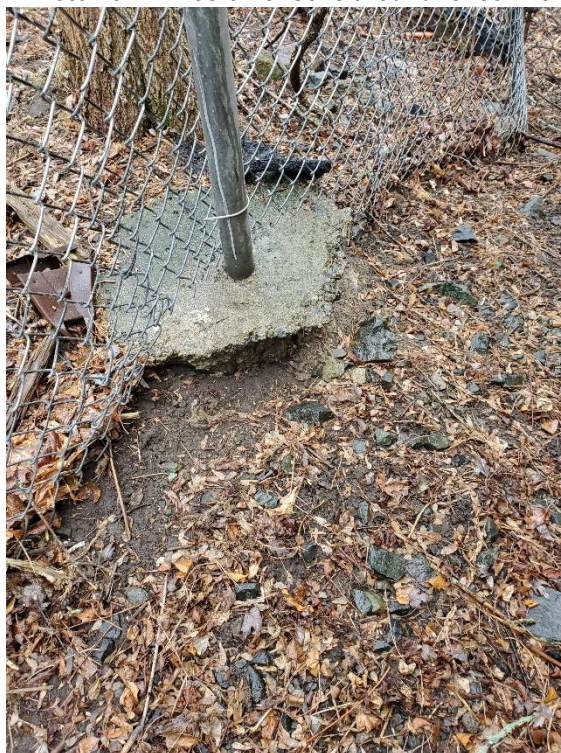
**Photo 23: Erosion of soils around fence line**

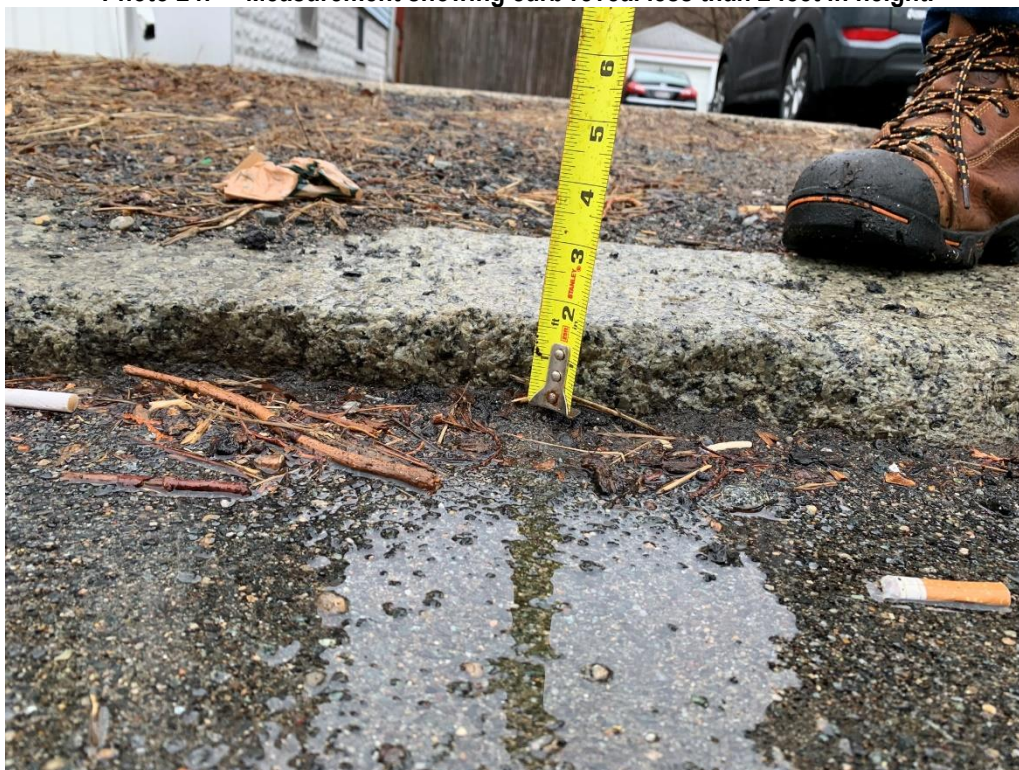
During the field visit, Woodard & Curran engineers walked the neighborhood surrounding the Pump Station to observe the existing drainage infrastructure. Woodard & Curran measured a number of curb reveals throughout the neighborhood and noted several locations in which the curb reveal was less than the typical 6-inches, likely due to overlaying new pavement in the roadway over time. In several locations there was no curb reveal, and Woodard & Curran observed catch basins constructed at a high point, rather than a low point in the road. In addition, Woodard & Curran noted that several catch basins were full of debris and areas in the neighborhood roadways showed signs of ponding. These factors can cause stormwater to bypass the drainage system and pond in the roadway, limiting travel to residents and emergency vehicles, or flow into private property. These conditions will be considered in the Preliminary Design section of this report.

**Photo 24: Measurement showing curb reveal less than 2 feet in height.**

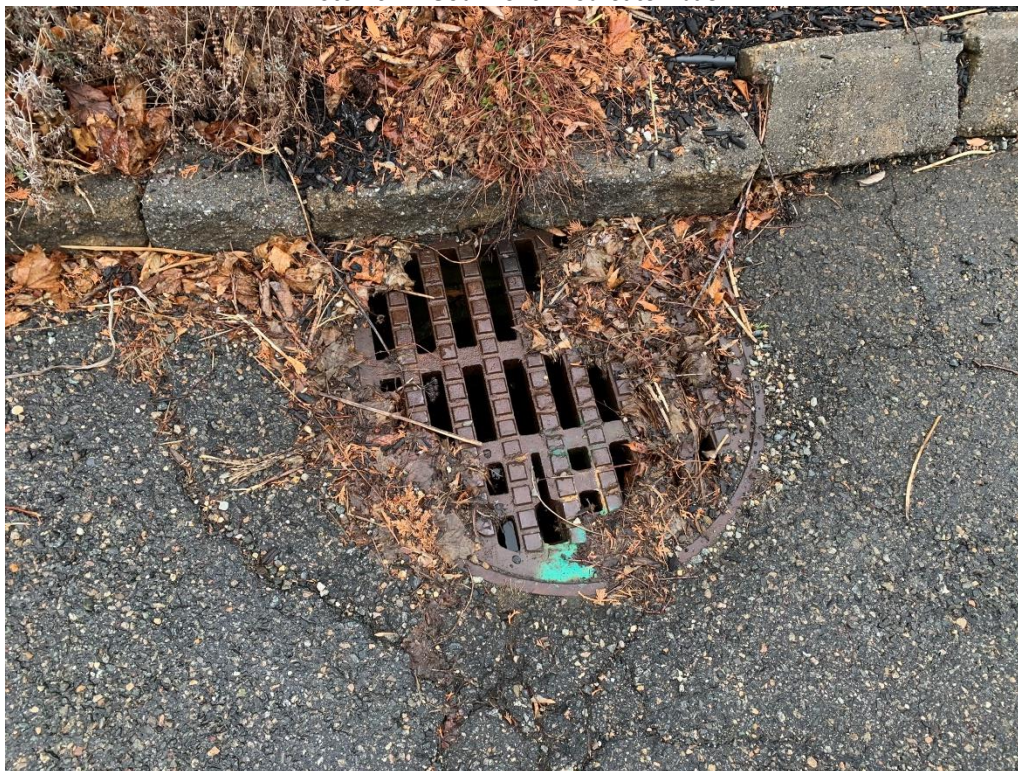
As documented in the 2009 Assessment, inlet capacity is frequently a limiting factor for stormwater conveyance systems due to clogging. Based on field observations and operator reports, clogging and general lack of inlet capacity is an issue for the collection system flowing to the Pump Station. In addition, the inlet capacity is limited by the type of inlet and curb reveal. A standard grate inlet has a capacity of approximately 3.5 cfs with six inches of driving head (water depth, generally provided by curb reveal); however, there is no curb reveal present at the inlet grates at the end of Ocean Avenue West, and the curb reveal along Jefferson Ave is less than three inches in most locations. This lack of curb reveal allows water to leave the road and flow into private property or buildings before being captured and conveyed to the Pump Station. Given the limited flow capacity of existing inlets, the number of inlets is also insufficient for accommodating larger events. The model confirmed that both inlet capacity and curb reveal conditions influenced the 100-year storm analysis results as well.

**Photo 25: Sediment filled catch basin.**

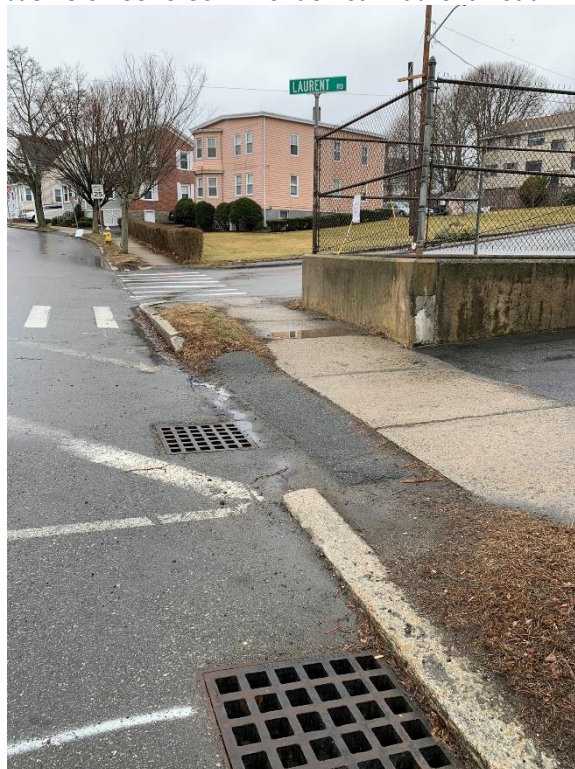
**Photo 26: Catch basins on Jefferson Avenue near Laurent Road with small curb reveal.**
