# Integrated Water Infrastructure Vulnerability Assessment and Climate Resiliency Plan

## TOWN OF CHARLTON & TOWN OF SPENCER, MASSACHUSETTS

JUNE 2019

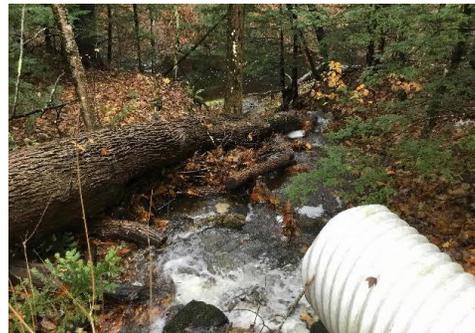
Image 1: View of outlet freefall condition looking downstream from crossing outlet during field assessment on November 6, 2018.

- Replace the existing undersized culvert with a 17-foot span bridge to accommodate the 1.2 times bankfull width design standard of the Massachusetts River and Stream Crossing Standards. Reconstruct the stream channel and banks through the crossing to match the existing channel and banks, including stream substrate and slope.
- The proposed culvert replacement design concept will:
  - Provide increased hydraulic capacity to reduce risks from flooding and road overtopping
  - Reduce geomorphic risk associated with freefall conditions and the fact that the crossing slope is significantly less than that of the natural channel
  - Eliminate a significant barrier to aquatic passage in a high-value habitat area

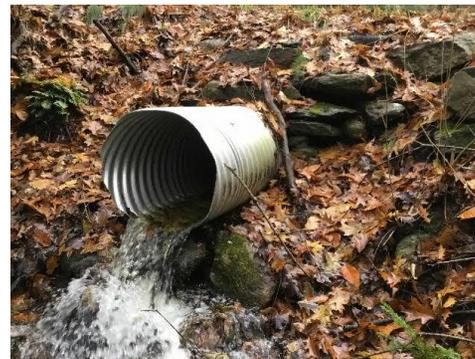
Image 2: View of outlet freefall condition at crossing during field assessment on November 6, 2018.

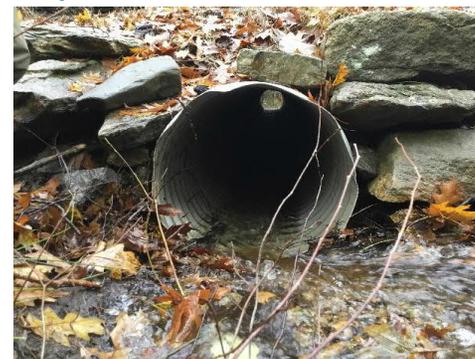
Image 3: View of crossing inlet during field assessment on November 6, 2018.

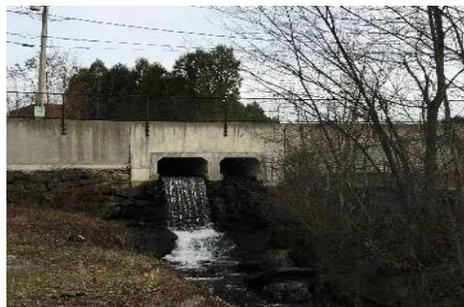
Image 1: View of freefall condition at Elm Street crossing outlet during field assessment on November 12, 2018.

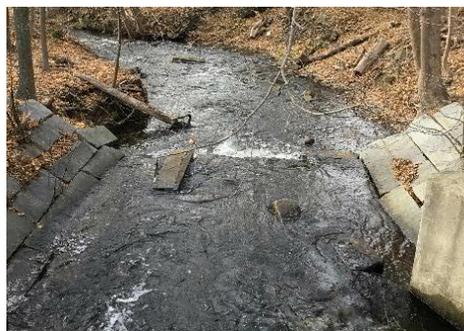
Image 3: View of bank armoring below the Valley Street crossing outlet.

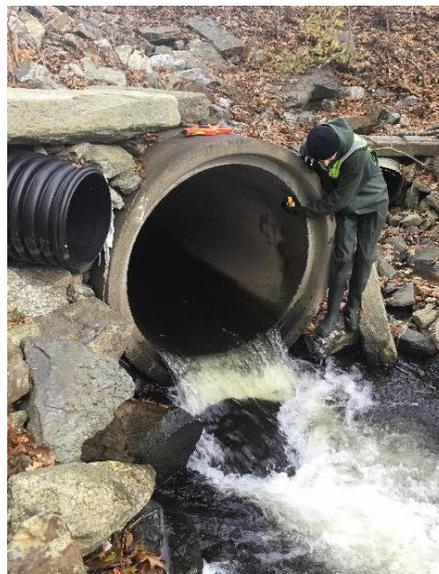
Image 1: View of freefall condition at crossing outlet during field assessment on November 15, 2018.

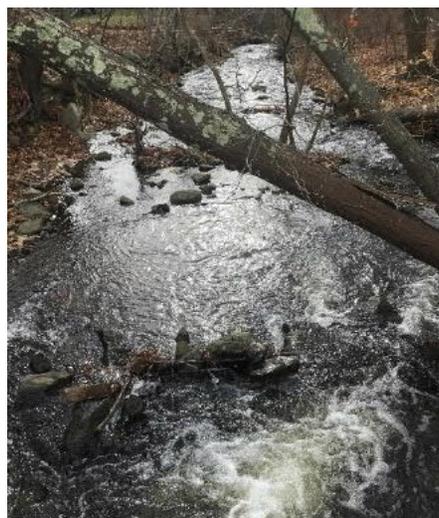
Image 2: Downstream channel on November 15, 2018.

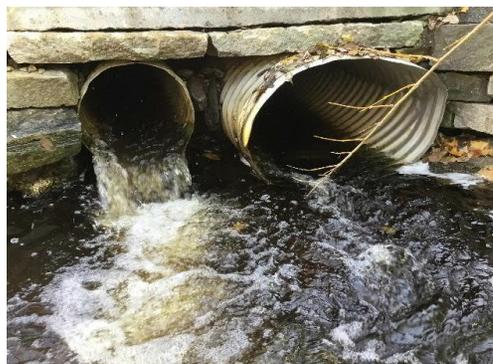
Image 1: View of crossing outlet during field assessment on November 8, 2018.

- Replace the existing undersized culvert with a 10-foot wide embedded box culvert to accommodate the 1.2 times bankfull width design standard of the Massachusetts River and Stream Crossing Standards.
- Reconstruct stream channel and banks through the crossing to match the existing channel and banks, including stream substrate and slope.
- Determine contributing drainage area for the drainage pipe that empties into the smaller of the two stream culverts and investigate green infrastructure opportunities to infiltrate or retain this water upstream.
- The proposed culvert replacement design concept will:
  - Provide increased hydraulic capacity
  - Reduce the potential for scour and erosion by reducing constriction
  - Reduce additional pressure on the crossing capacity from contributing drainage flows

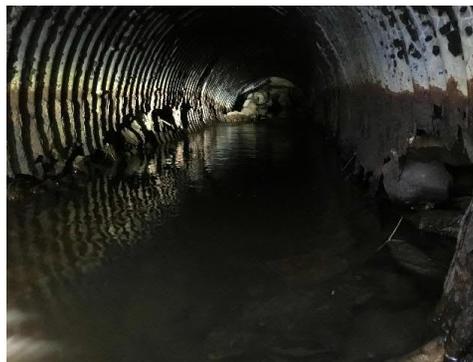
Image 2: View of critical barrel and seam condition of the crossing outlet pipe on October 16, 2018.

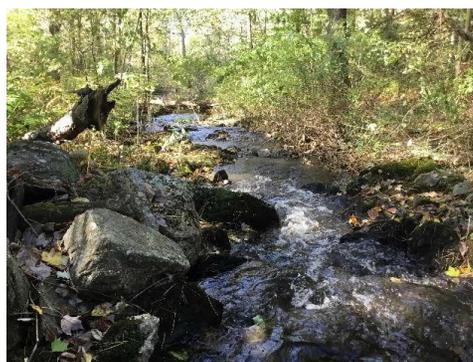
Image 3: View of downstream channel, October 16, 2018.

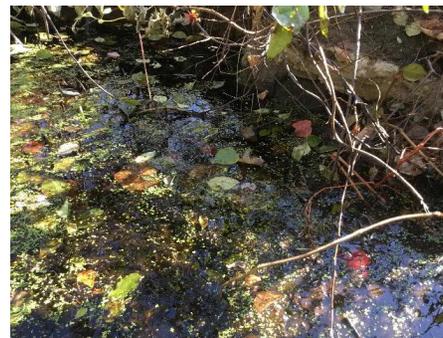
Image 3: View of backwater condition at the submerged inlet of the Center Depot Road crossing on October 31, 2018.

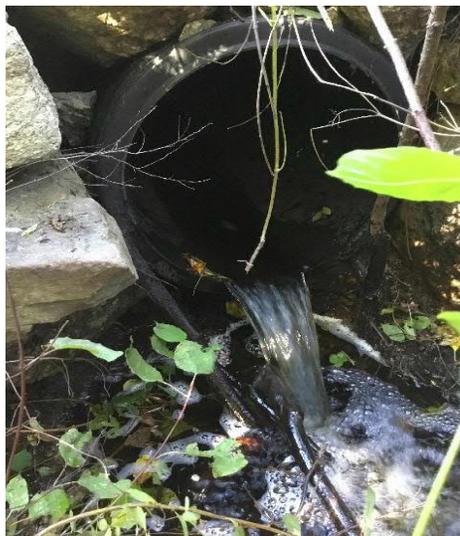
Image 1: View of crossing outlet taken during field assessment on October 16, 2018. Note the freefall condition which contributes to geomorphic risk.

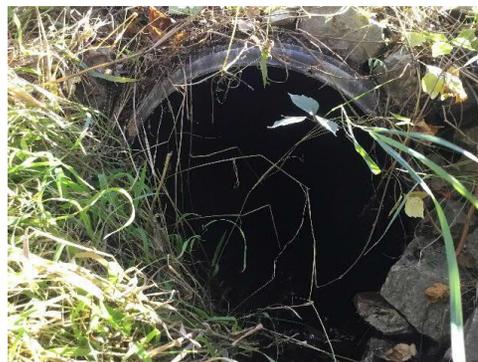
Image 2: View of structure inlet taken during field assessment on October 16, 2018.

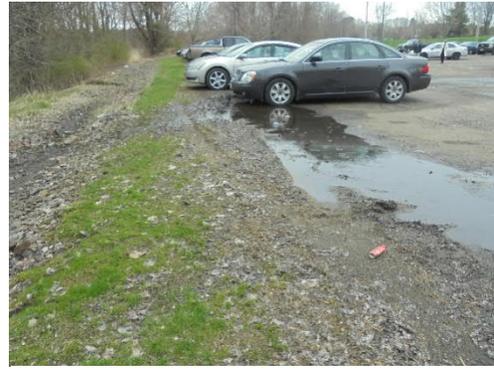
Image 1: Existing swale and runoff forming concentrated flow over the embankment into the swale.

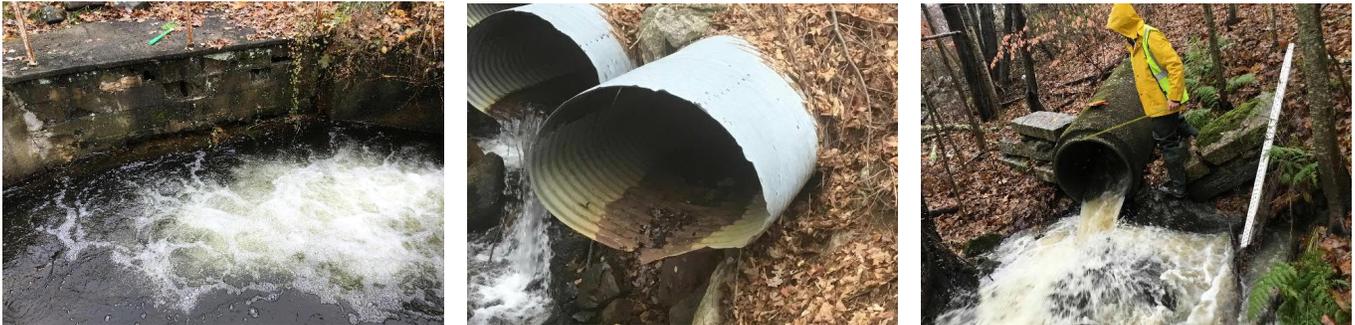
Figure 3. Examples of crossing structures in poor structural condition observed at various locations during field assessments. Left: Degraded concrete armoring; Center: rusted out pipe inverts; Right: collapsed headwall at outlet.

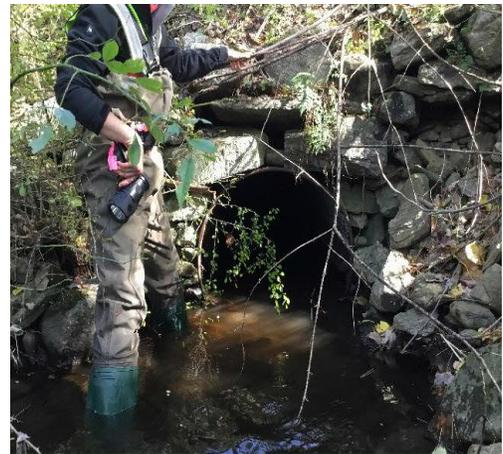
Figure 13. View of existing crossing outlet taken during field assessment on October 16, 2018.

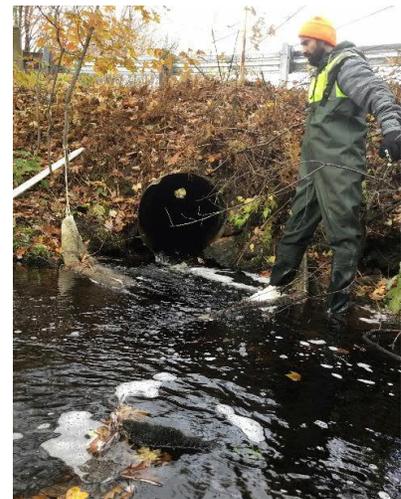
Figure 14. View of existing crossing outlet taken during field assessment on October 29, 2018.
