## MODEL REFINEMENT AND CALIBRATION REPORT

### Appendix A

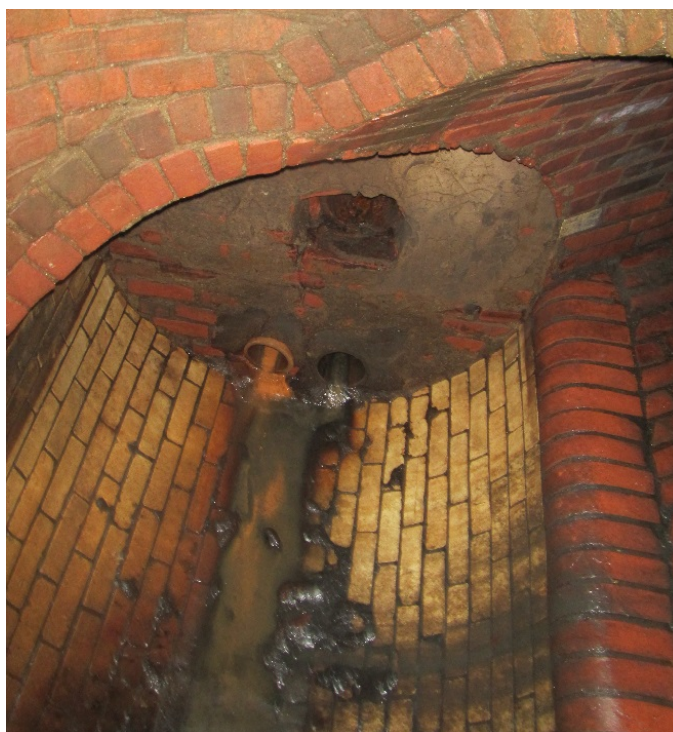
During the field investigations a confined space entry was attempted within the drain manhole at the intersection of Medford Street and School Street. This structure is not listed within the City's GIS and was therefore given a manhole ID of 30-5112A, since it is located downstream from manhole 30-5112 on School Street. A confined space entry was not conducted within 30-5112A due to the gas meter alarm Lower Explosive Limit (LEL) readings that were above allowable limits. A petroleum odor along with an orange stain was observed from an inlet coming from the northwest side of Medford Street (See **Figure A.9**). The orange stain can be a sign of petroleum infiltrating through groundwater. A gas station is located at the intersection of Medford Street and School Street.

**Figure A.9 – MH 30-5112A observed petroleum odors and orange discoloration**

The structures identified with flap gates, debris, corrosion, or fractures should be evaluated to determine if maintenance or repairs are needed. The source of the petroleum odors and orange discoloration within drain manhole 30-5112A at School Street and Medford Street should be mitigated. In addition, it is recommended the structures that are shown in the City's GIS, but not found in the field, should be investigated with a metal detector and raised to grade for access if they exist.

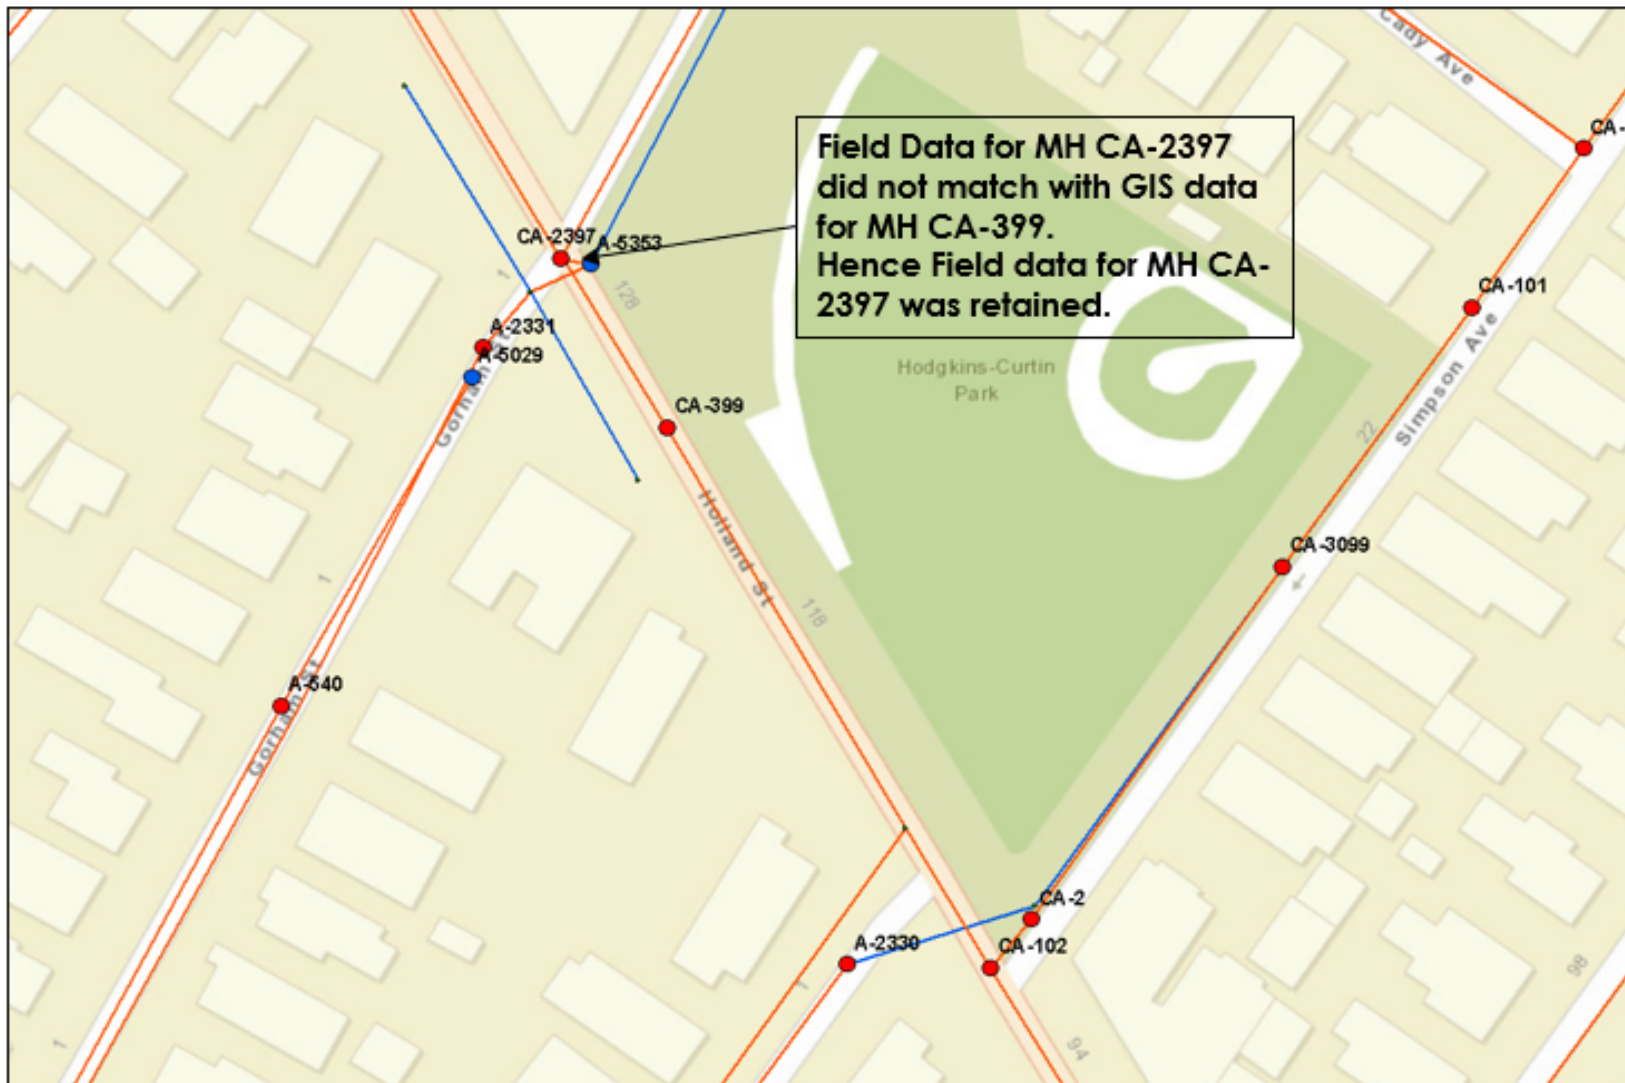
Figure B1. Discrepancy between City's GIS data and Field data at Holland Street

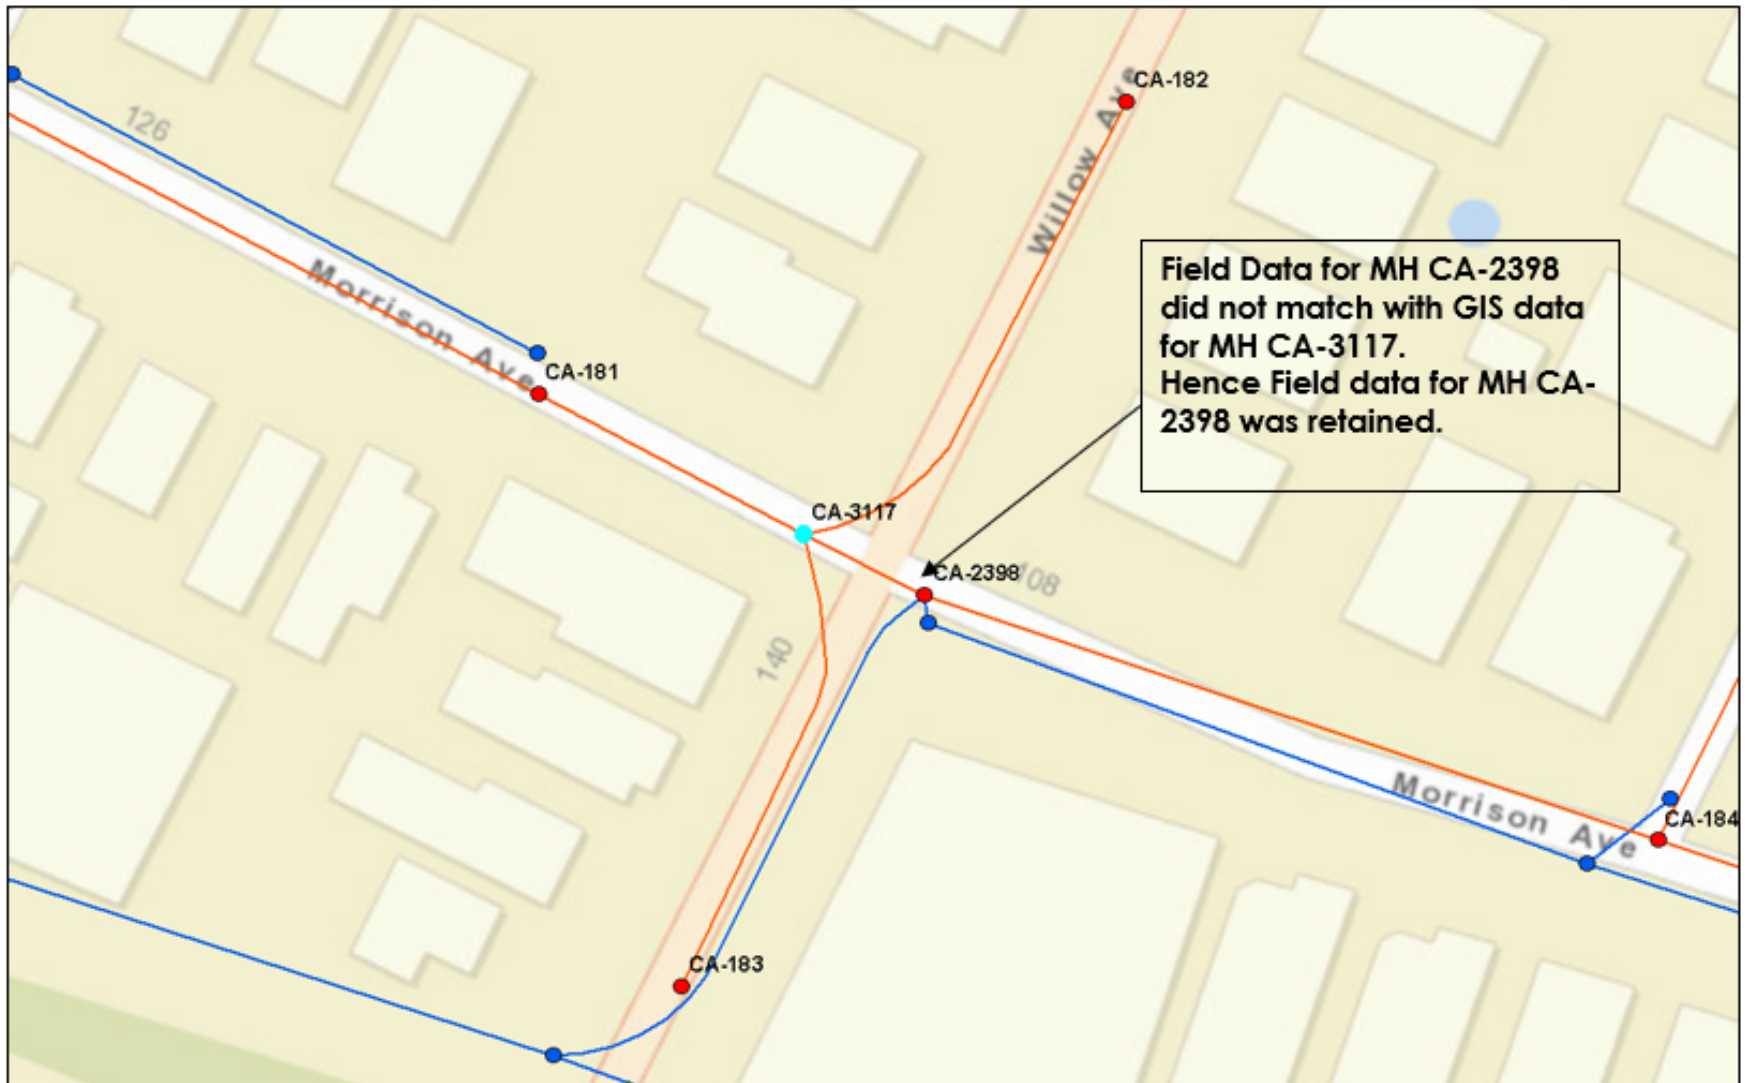
Figure B2. Discrepancy between City's GIS data and Field data at Morrison Avenue

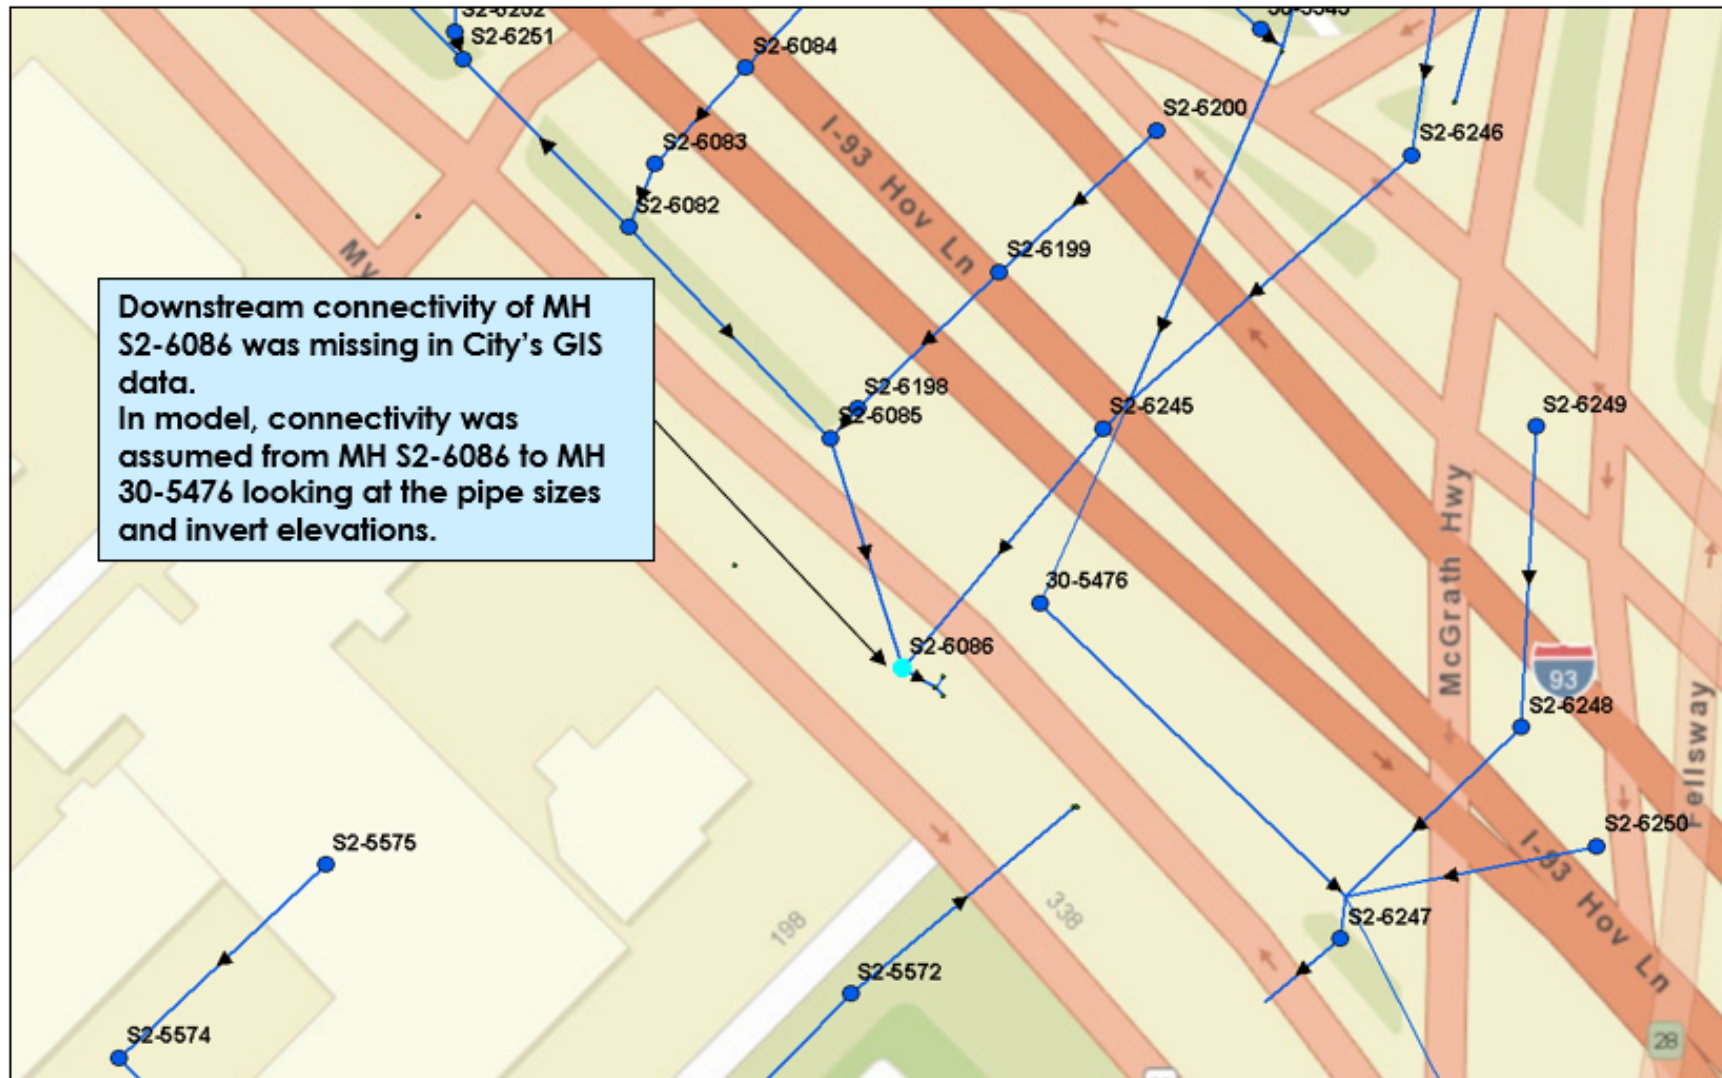
- At Mystic Ave, downstream connectivity of manhole S2-6086 was missing in the City's GIS data. In the model, connectivity is assumed to MH 30-5476 looking at the pipe sizes and invert elevations.

Figure B3. Connectivity Issues in City's GIS data at Mystic Avenue
