*Massachusetts Coastal Infrastructure
Inventory and Assessment Project
Coastal Hazards Commission*

South Coastal

Fairhaven
Mattapoissett
Marion
Wareham

July 6, 2009

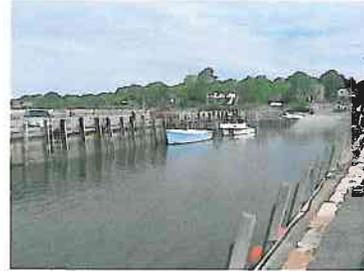
A filled wharf that has a concrete wall constructed that is in good condition. The concrete wall is 18 inches to 24 inches wide were constructed as a facing to original stone wall. Filling with concrete behind the structures was observed.

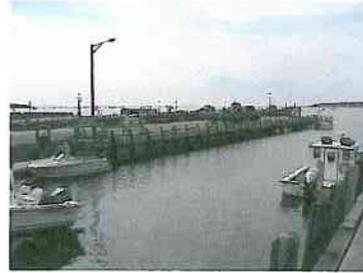
A filled wharf that has a concrete wall constructed that is in good condition. Concrete wall is 18 inches to 24 inches wide were constructed as a facing to original stone wall. Filling behind structures with concrete observed.

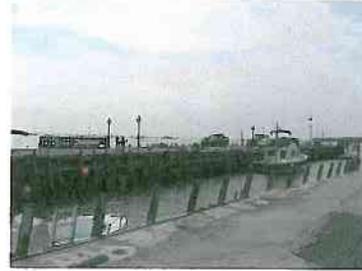
A filled wharf in fair condition. Mortar filled joints above mean high water. No mortar observed below mean high water mark. Signs of minor stone movement.

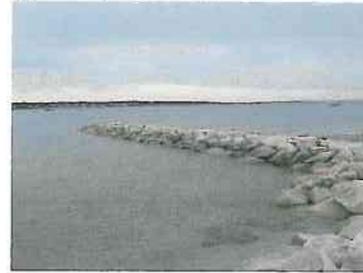
Structure Summary :
 Stone groin on the beach is in good condition. The stones are approximately 3 feet by 2 feet by 4 feet in size. The top width of the groin is 4 feet. There are no signs of erosion or stone movement. The groin protects a boat ramp and beach.

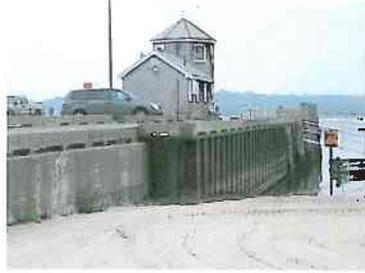
Structure Summary :
The sheet pile bulkhead with a cast in place concrete wall behind it. There is minor corrosion on the steel at the tidal zone. There is a parking lot and the harbor masters office on top of the structure. There are beaches adjacent to it.

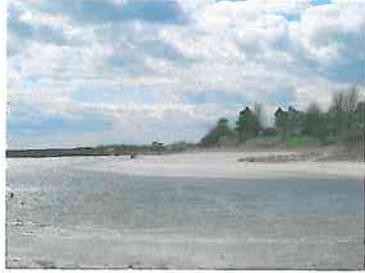
Structure Summary :
Sandy beach that shows signs of recent beach nourishment. Behind is houses and a hotel. Beach is well maintained.

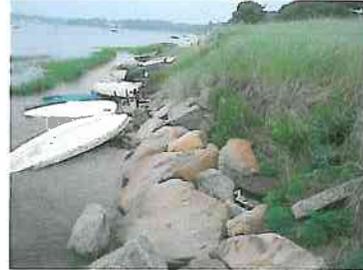
Structure Summary :
 The placed stone revetment has stones that are approximately 5 feet by 3 feet by 2 feet in size. The stones have been placed tightly together. There is no sign of movement or scour. There is a sandy beach in front of the stones and a parking lot behind the structure.

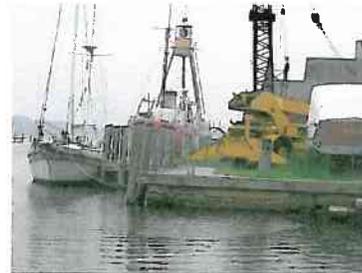
Structure Summary :
The stone mortared seawall has a cast in place walkway on top of it. The stones are approximately 2 feet by 1 foot by 1 foot in size. There are signs of mortar loss, and stone movement and rotation.
