## HISTORIC STRUCTURE REPORT

# MAGAZINE BEACH POWDER MAGAZINE

CHARLES RIVER RESERVATION  
CAMBRIDGE, MASSACHUSETTS

JANUARY 20, 2016

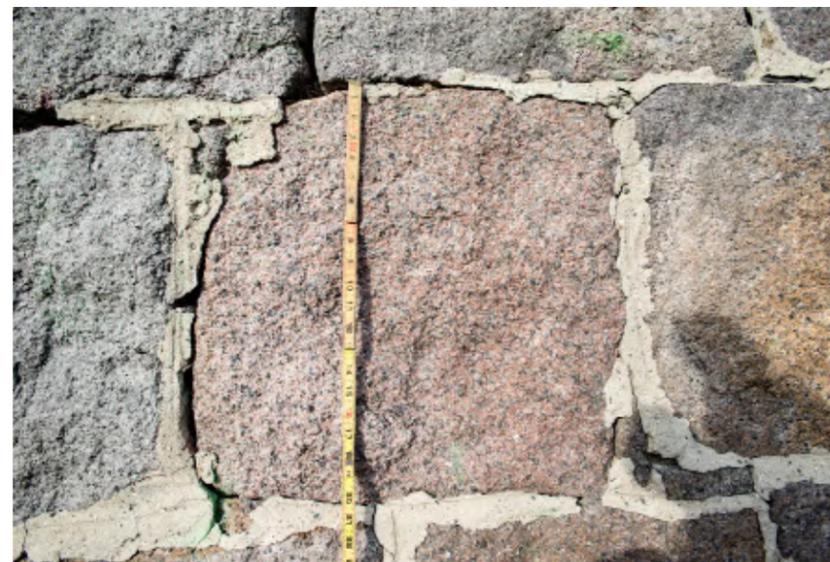
14.5: Detail of south facade showing the typical size of the stones along with the poor condition of the 1900 pointing. Despite the poor condition of the mortar, the stones show little evidence of movement except for the one crack noted in the engineer's report.

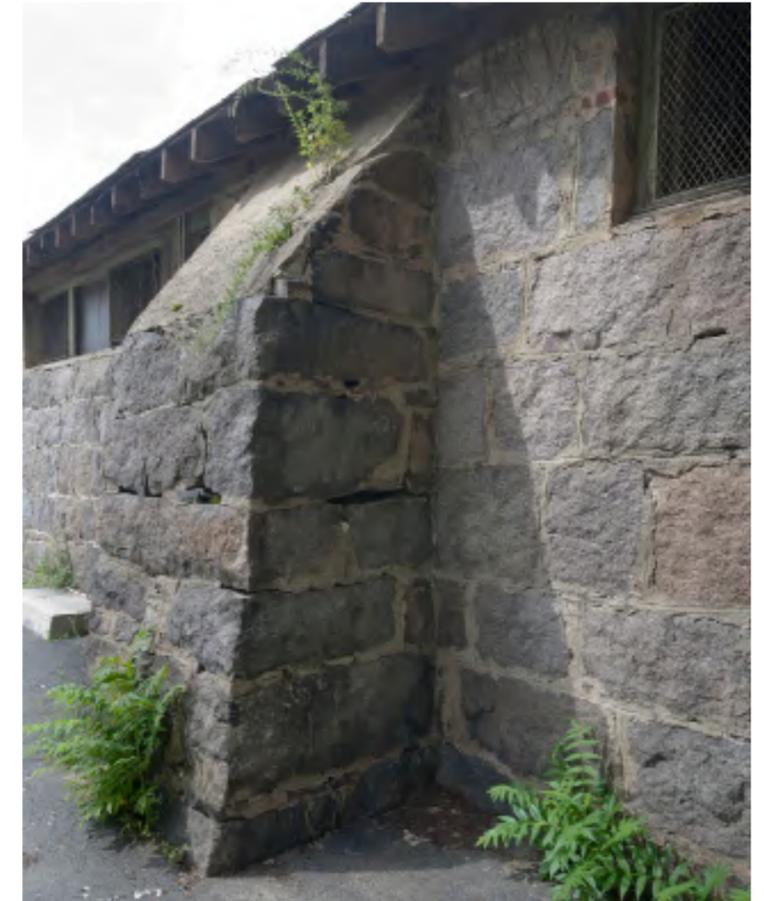
14.3: Overview of buttress at south facade showing substantial mortar defects with plants growing out of some joints. Some rebuilding of this buttress may be needed.

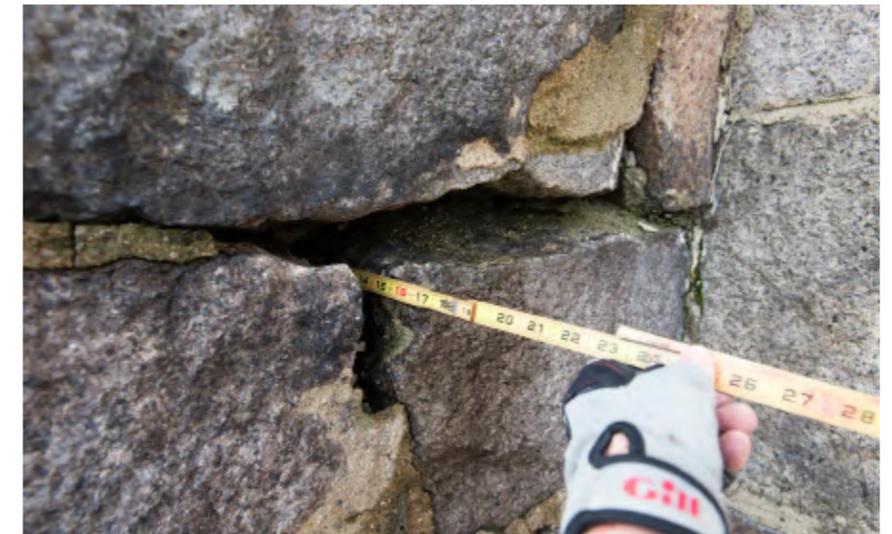
14.6: Detail of severely defective joint in buttress that is void of mortar 16" into the joint. The interior mortar may be very deteriorated. Rebuilding the buttress using the existing stones and coursing may prove necessary.

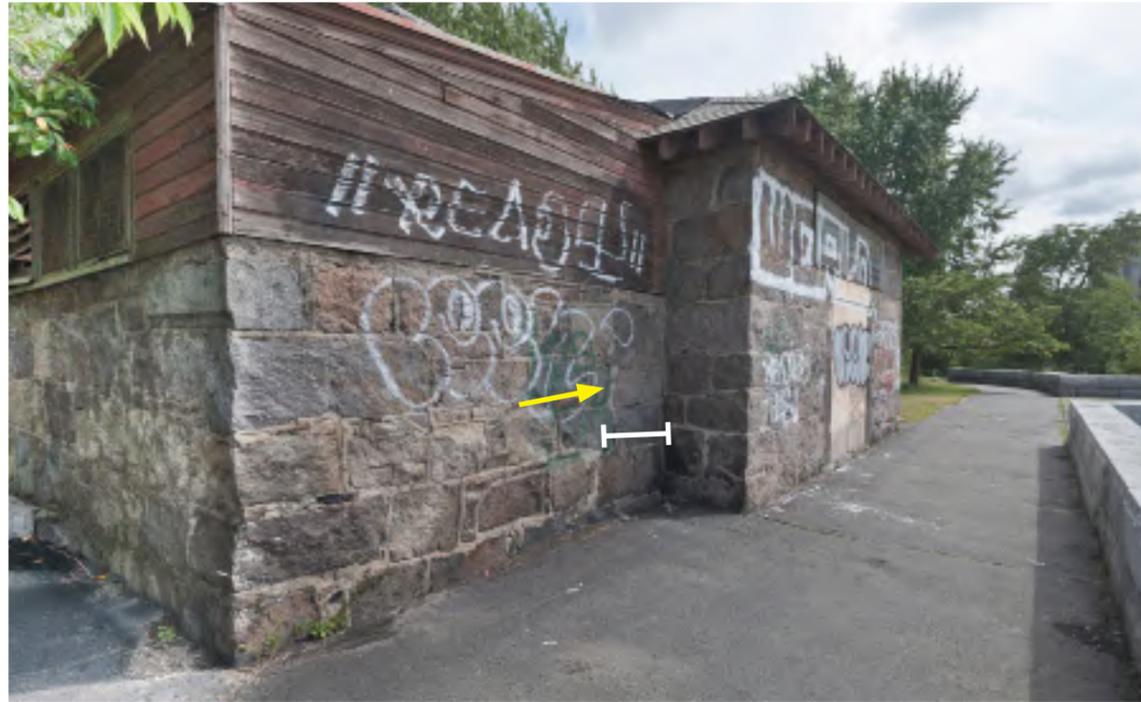
15.1: Overview of the west end of the 1899 addition and its junction with the magazine. The terrace wall in front of the building dates to 1975. The arrow points to the crack shown in 15.2. The white line indicates the position of the 1899 opening that led into the open yard defined by the addition.

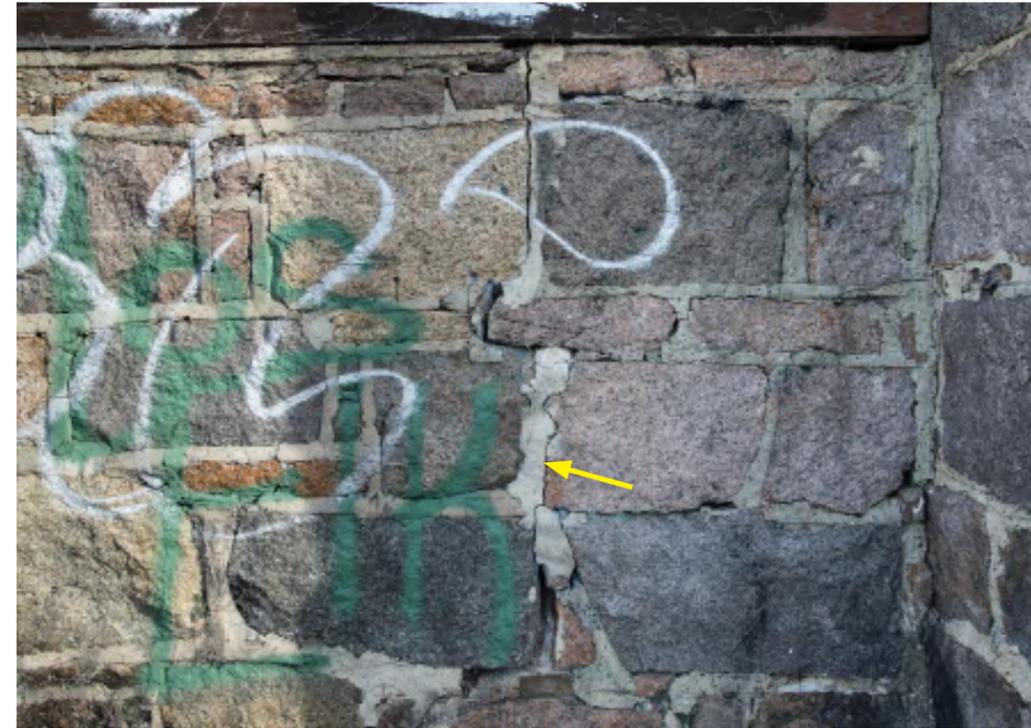
15.2: Detail of west wall of 1899 addition showing vertical crack through mortar joints (arrow) that corresponds to the edge of the masonry installed in 1918 to fill in the 1899 entry to the open yard. The color of the mortar in the 1918 joints to the right of the crack is slightly greyer than the 1899 mortar to the left of the crack. The crack extends clear through the 2' thick wall. Most of the mortar joints have hairline cracks at their junction with the stone, and in some places the mortar has fallen out.

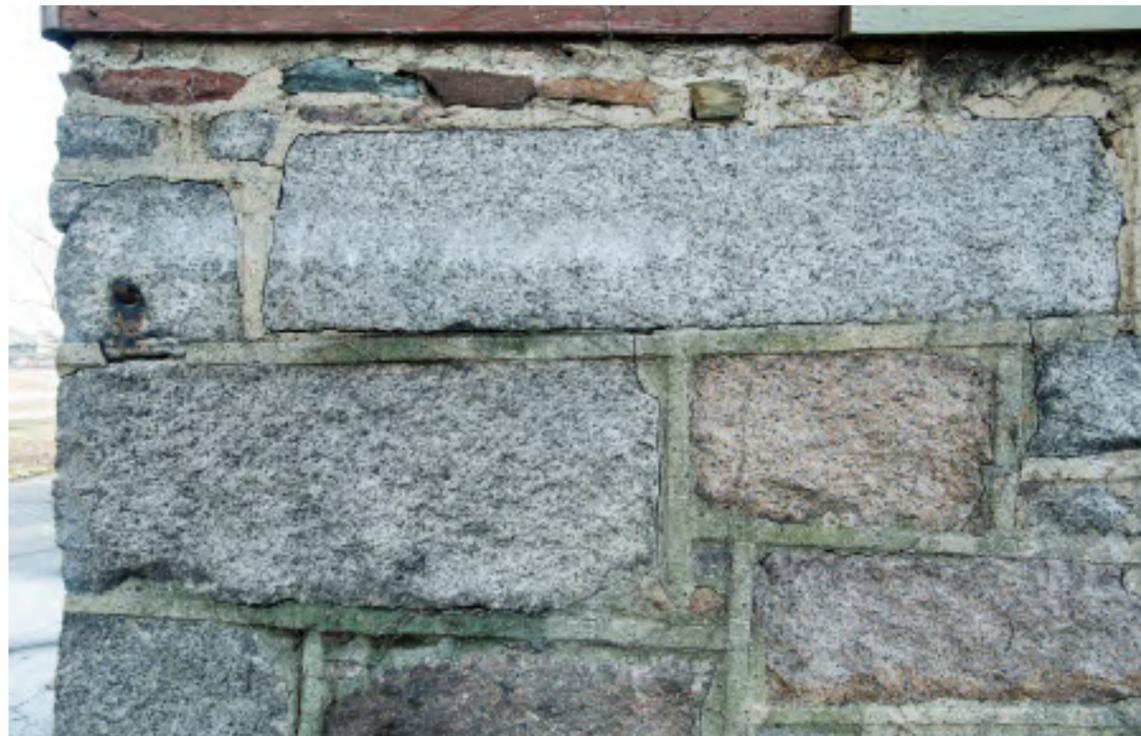
15.3: Detail at east end of north wall of 1899 addition showing the original mortar joints finished with a raised rectangular profile. Repointing on the addition should duplicate this profile. The small stones at the top are probably 1918 work to provide a level bed for the wood wall and windows.

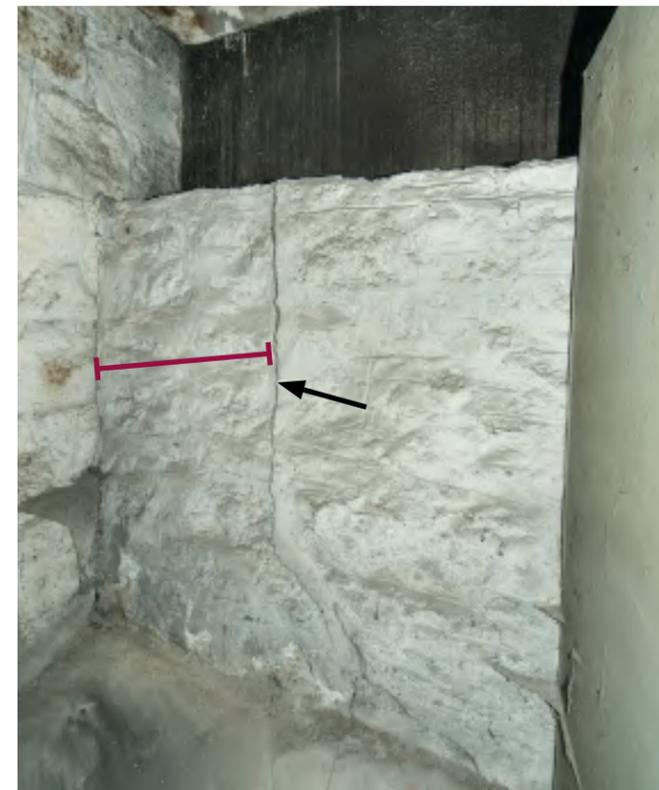
15.4: Detail of interior at west end of 1899 addition. The arrow points to the same crack that is shown on the exterior in 13.2. The red line marks the former entry to the 1899 open yard.

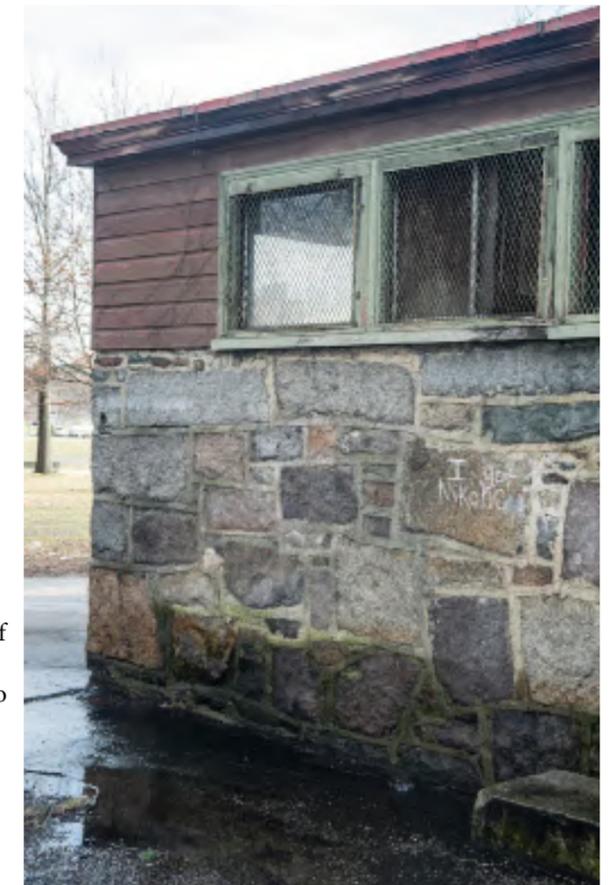
15.4: West end of north wall showing green algae staining and dark color of stone at the base of the wall due to chronic wetting from the roof drainage above and splashback from the paved surface below.

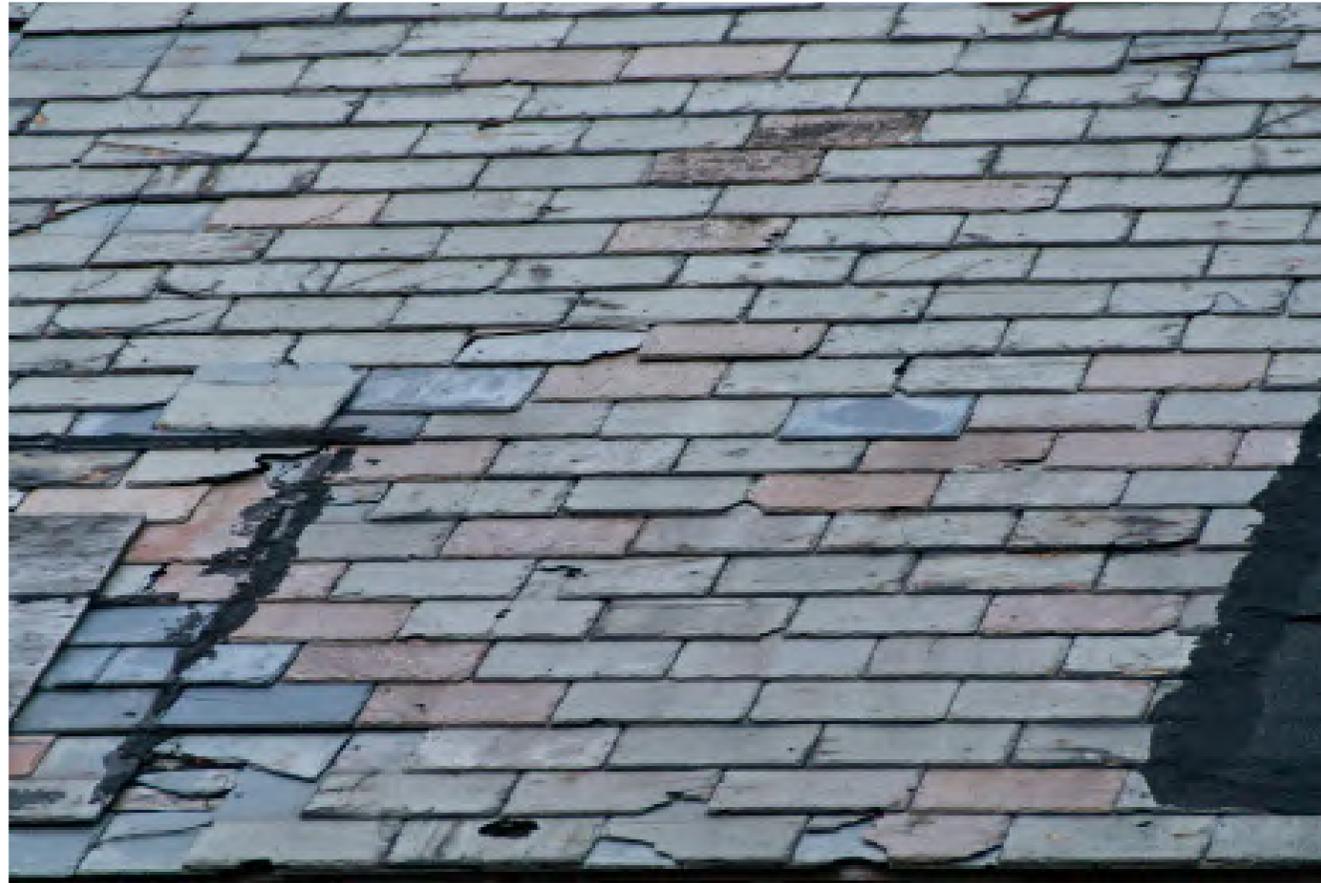
**16.1:** Section of the south pitch of the magazine roof showing the variegated color of the slates from grey-green to light tan. This is typical of the “sea green” slate specified in the 1918 drawings. They are a type also known as “weathering green” because they change color as they weather. They were less expensive than “unfading green” slates which do not change color and last substantially longer than weathering slates.

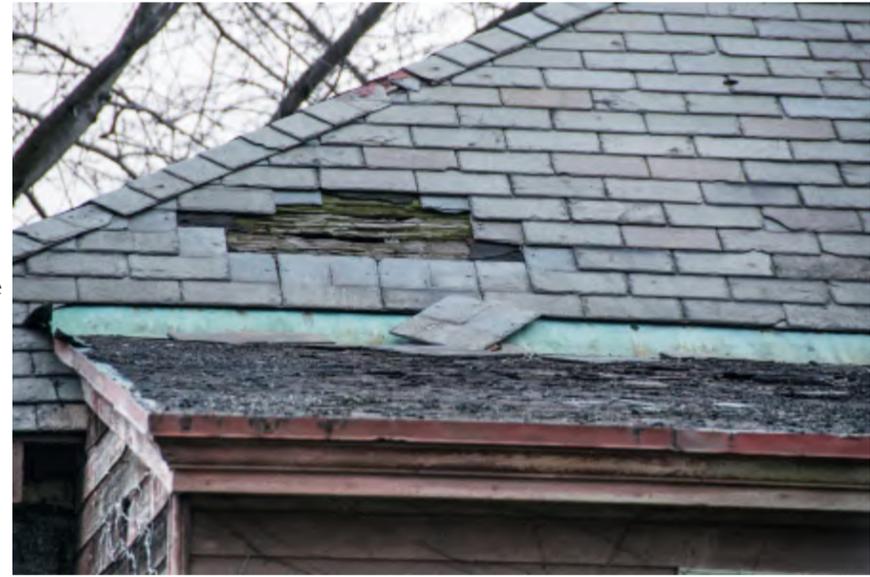
**16.2:** Section of the north pitch of the slate on the magazine, and the tar and gravel roof on the 1899 addition with a copper flashing apron between the two. Although most of the slates appear sound at this end, the sheathing boards where the slates are missing have rotted clear through. The tar and gravel roof is of unknown age (perhaps 1954) and is assumed to be well past its service life.

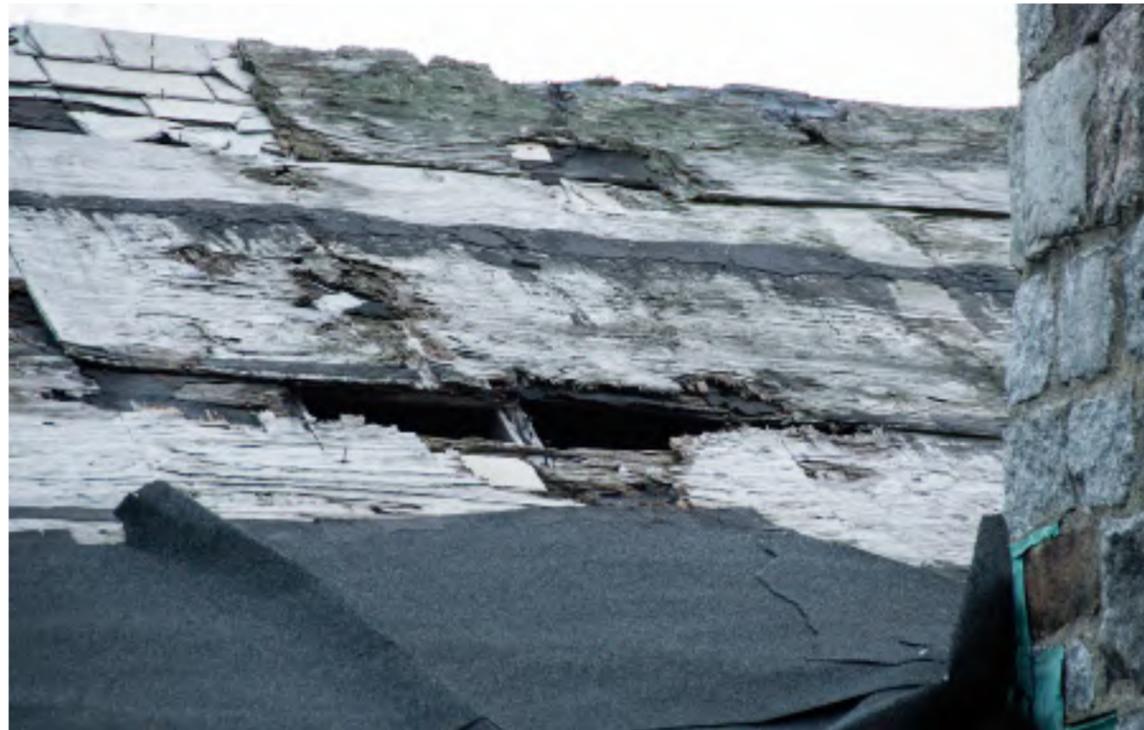
**16.3:** Detail of the south pitch of the magazine roof above the chimney showing that not only is the slate gone, but the plywood put on to patch the roof and sheathing below it is now severely rotted. The copper flashing for the chimney is also in poor condition and needs to be replaced if the chimney is retained (the chimney was added in 1954).

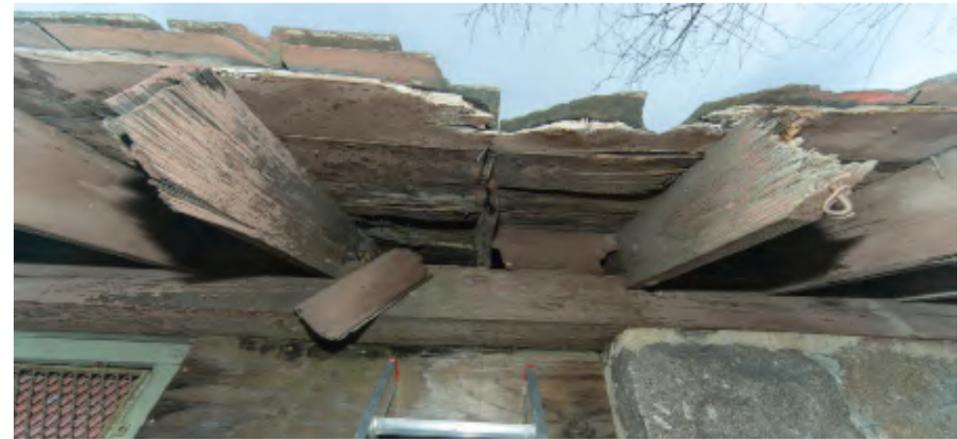
**16.4:** Detail of the roof edge at the south facade where the projecting rafter tails and roof sheathing are severely rotted due to uncontrolled drainage off the roof edge and broken slates. This is the most severe damage observed at the rafter tails, but many have minor damage as shown in 14.5 below.

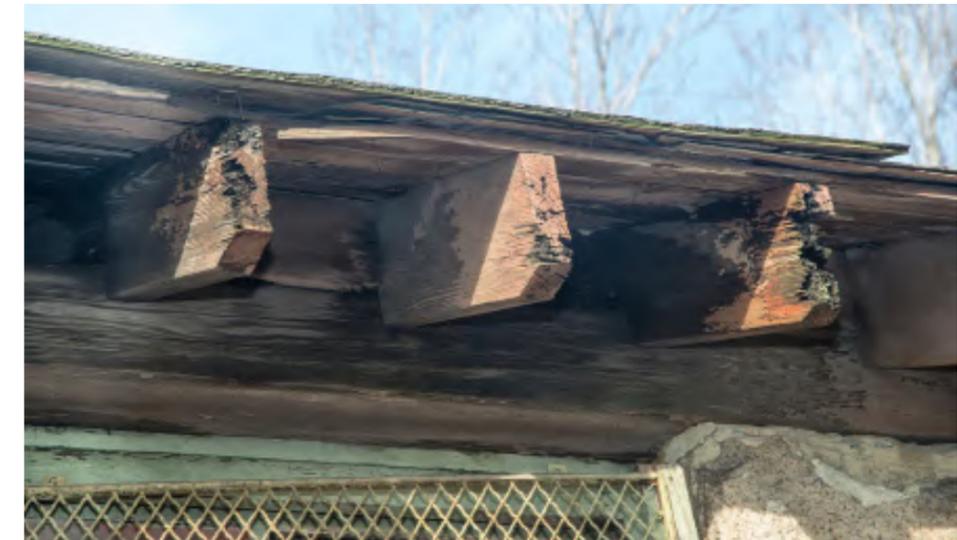
**16.5:** Detail of the roof edge at the south facade showing more typical rot in the rafter tails than in 16.4. At least 20% of the rafter tails show this level of deterioration due to uncontrolled drainage off the roof edge. In the 1899 construction a gutter was placed over the rafter tails, but was removed in the 1918 alterations. Exposed end grain is particularly vulnerable to deterioration when water drains over it.

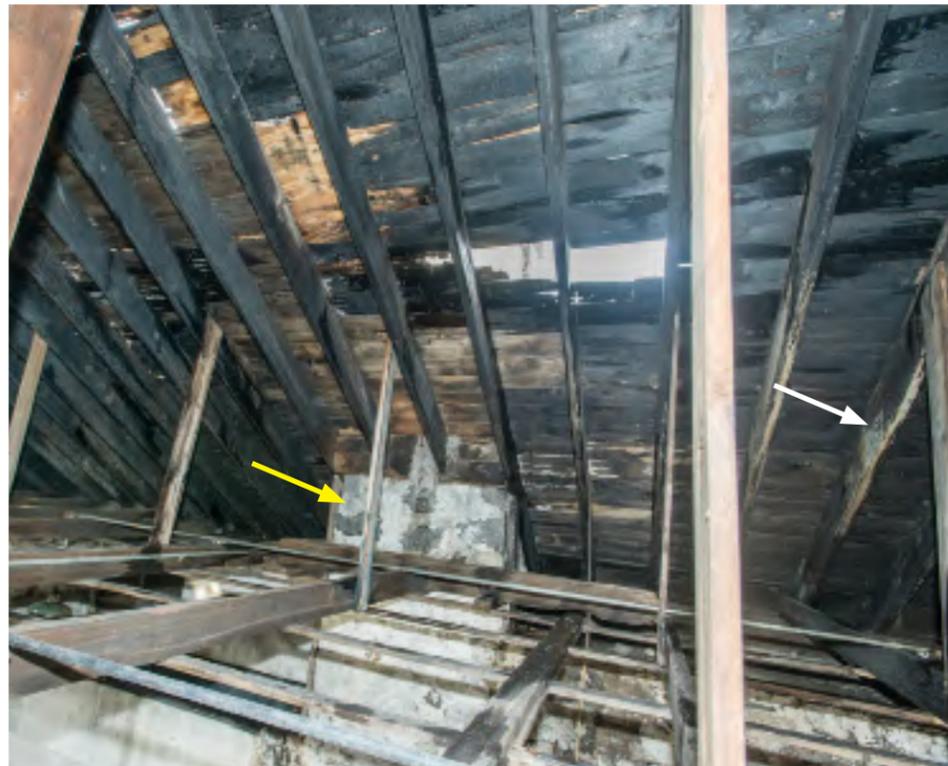
17.4: Interior of north pitch above chimney (yellow arrow points to chimney) showing sheathing severely damaged from rot due to missing slates, and charred from past fire. Some of the rafters have fungus growth from chronic dampness (white arrow). The roof exterior in this area is shown in 17.3. At minimum all sheathing in this area will have to be replaced as will some of the rafters.

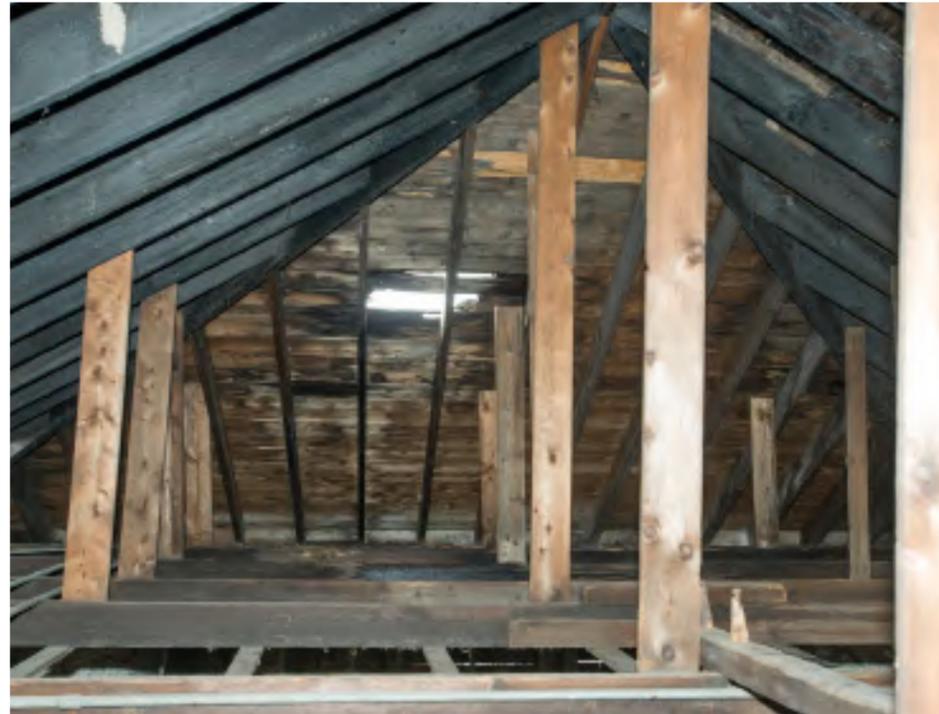
17.2: Interior of west pitch where rafters and sheathing were all replaced in 1954 due to fire damage. The vertical 1 x 6 struts were likely installed in 1954 or later as some are located on the section replaced in 1954. They were probably installed to support the framing for the fiberboard ceiling (i.e., tie beams and furring).

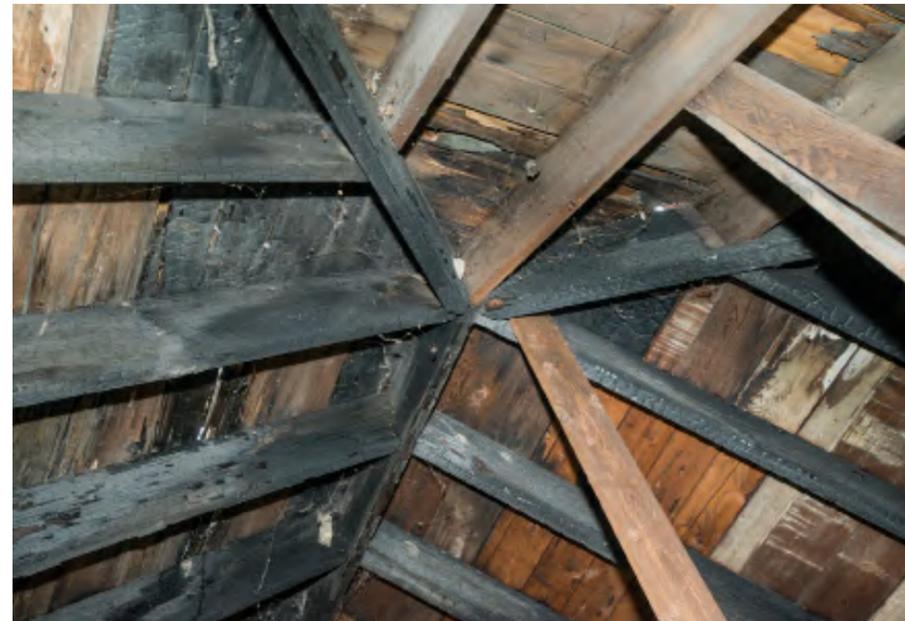
17.5: Detail of junction of main ridge with west hip. The sheathing and rafters of the west hip (upper center right corner) are obviously newer wood. The original rafters show surface char as do the few remaining boards of original sheathing.

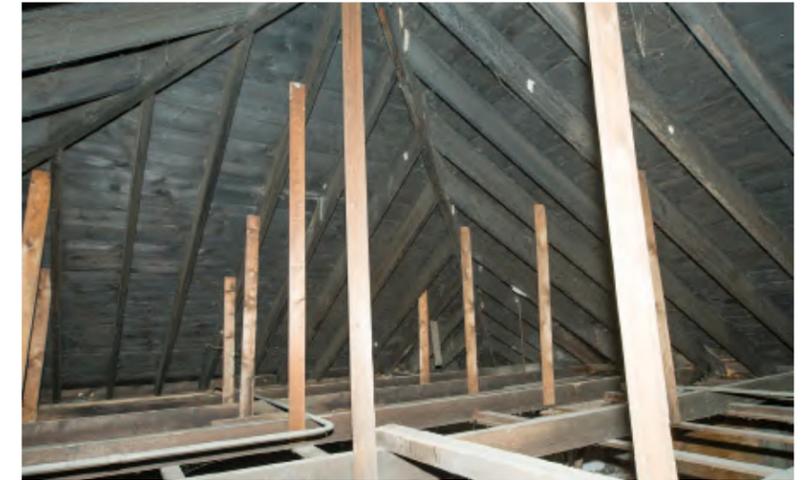
17.3: Interior of east hip at junction with south pitch (right). The rafters and sheathing in this section are mostly in serviceable condition and retain their original dark brown stain finish.

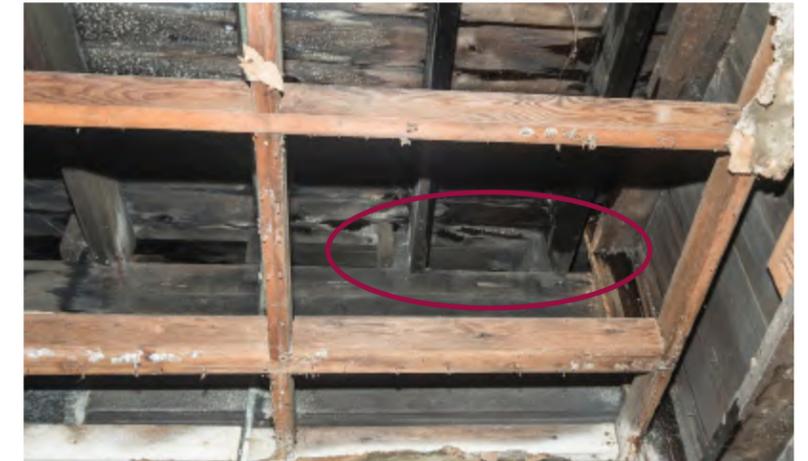
17.6: Interior of 1899 addition looking towards its junction with magazine north wall. The lower light colored framing was installed with the fiberboard ceiling. White spots on the ceiling are probably fungus from dampness.

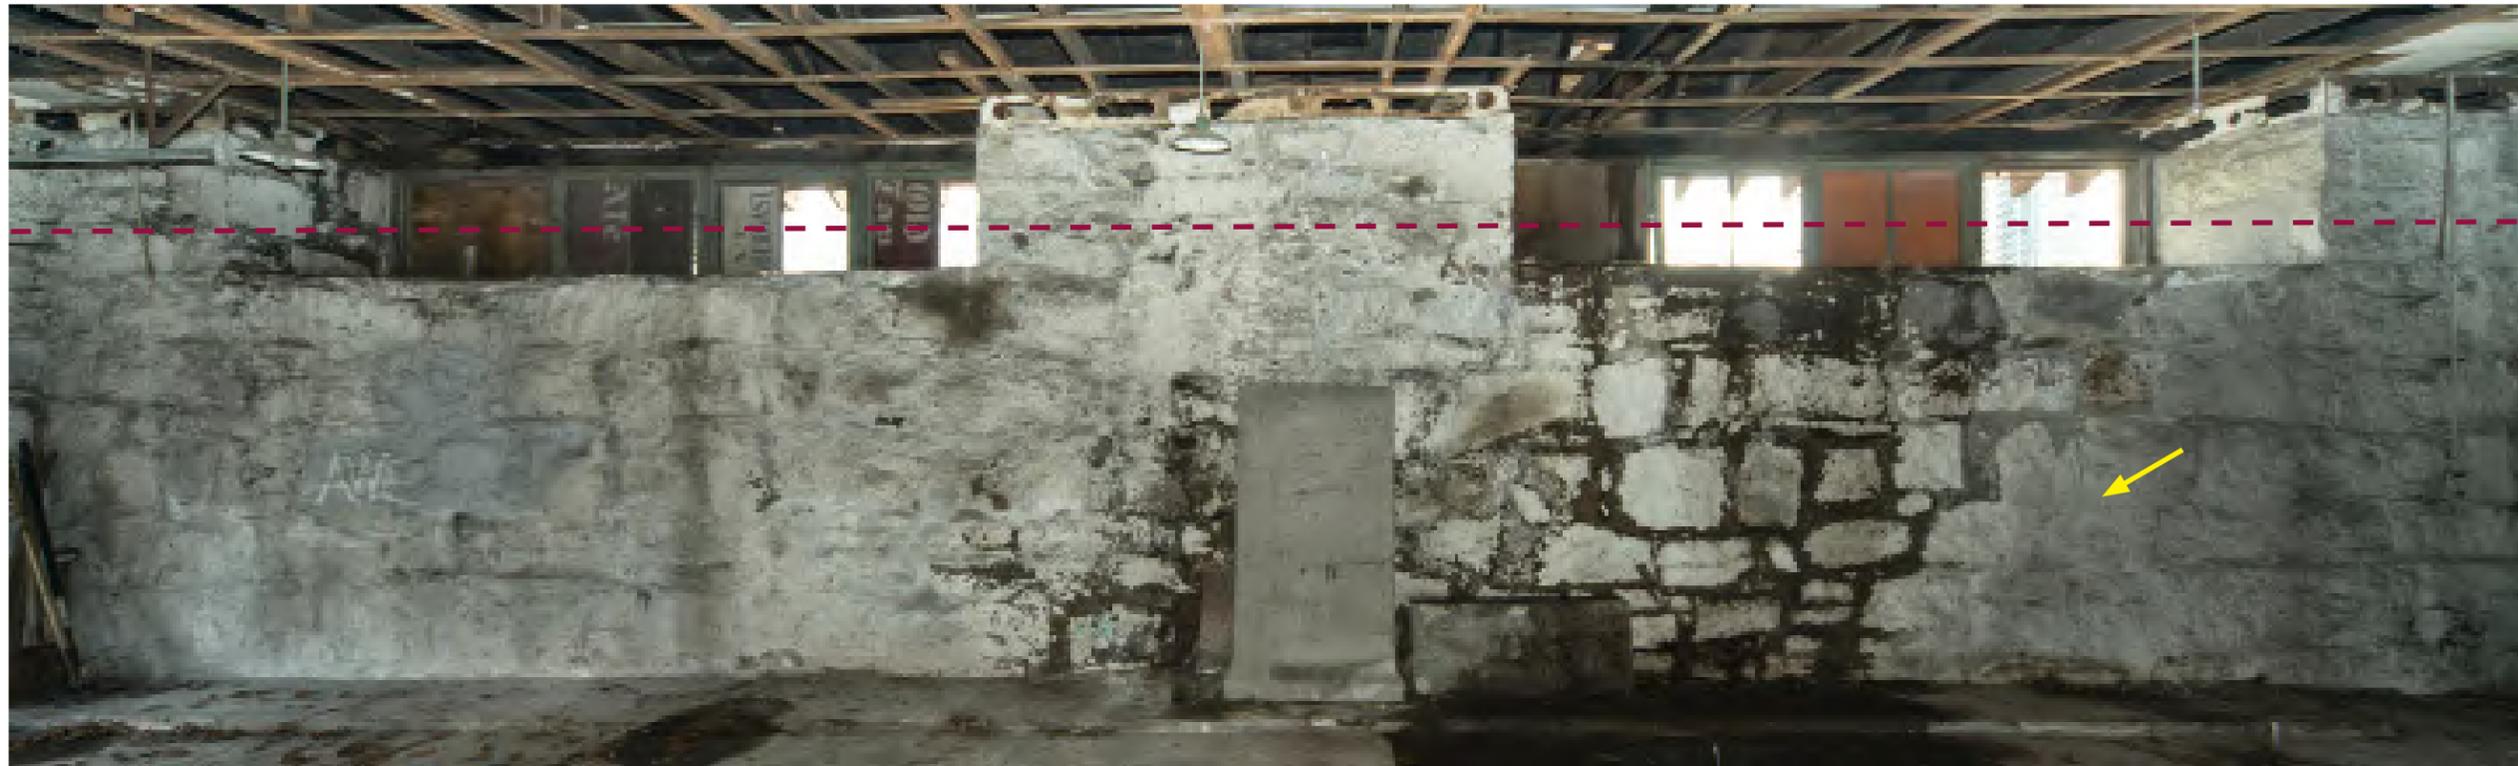
**18.1:** Overview of south wall in magazine. Dark joints are sloppily repointed using an inappropriately dark colored mortar. The crack discussed in the engineers's report is barely visible and is marked with the arrow (see 19.6 for a close up). The red line marks the approximate position for the spring of the 16" thick brick arch in the magazine as built in 1818. The stones above this line would have been missing for the 16" depth of the arch and would have been rebuilt in 1899.

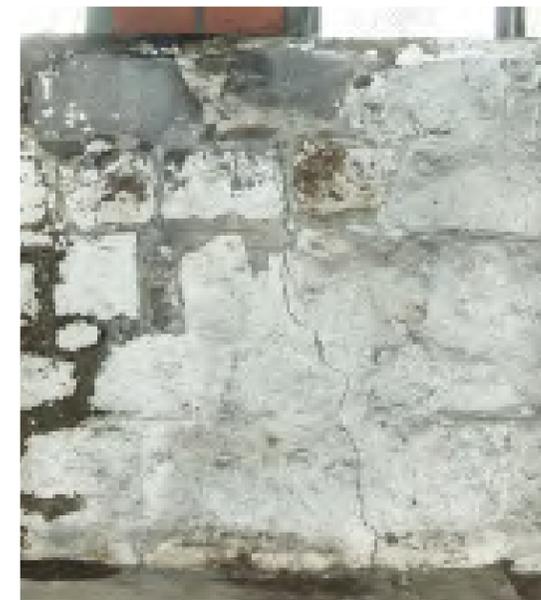
**19.6:** Detail of south wall (18.1) showing the crack discussed in the engineers's report that extends through the full thickness of the wall.

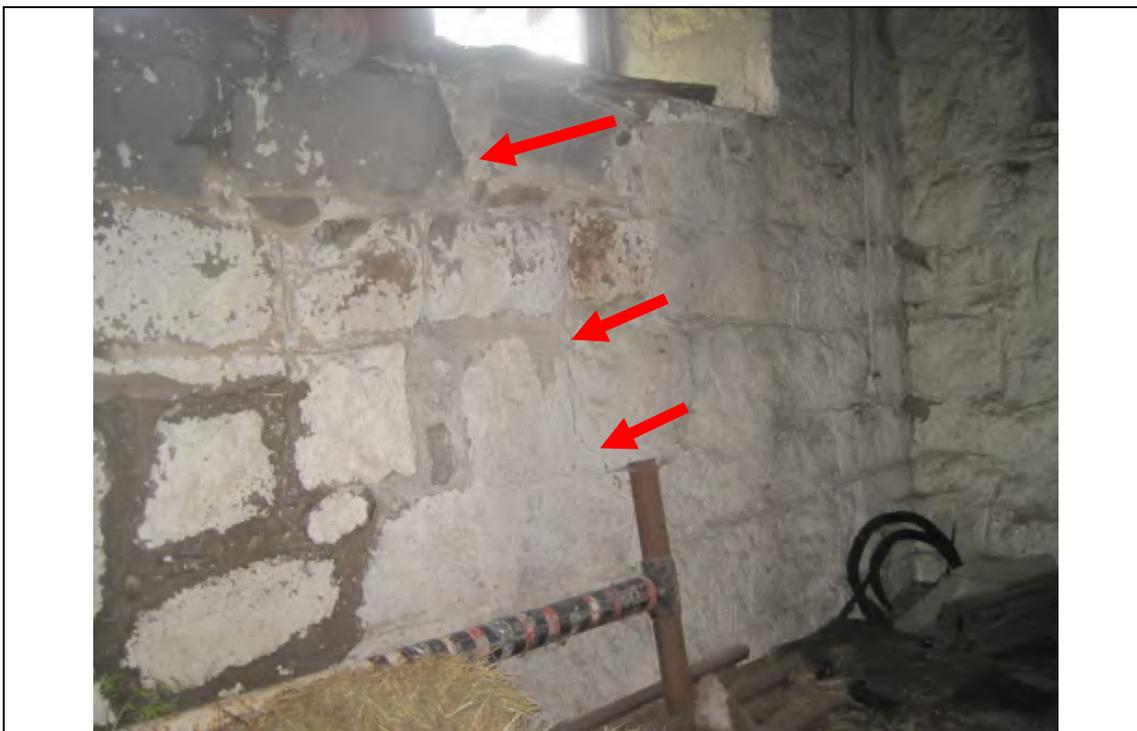
**Photo 1:** Diagonal Crack in interior face of main building's south wall at west end.

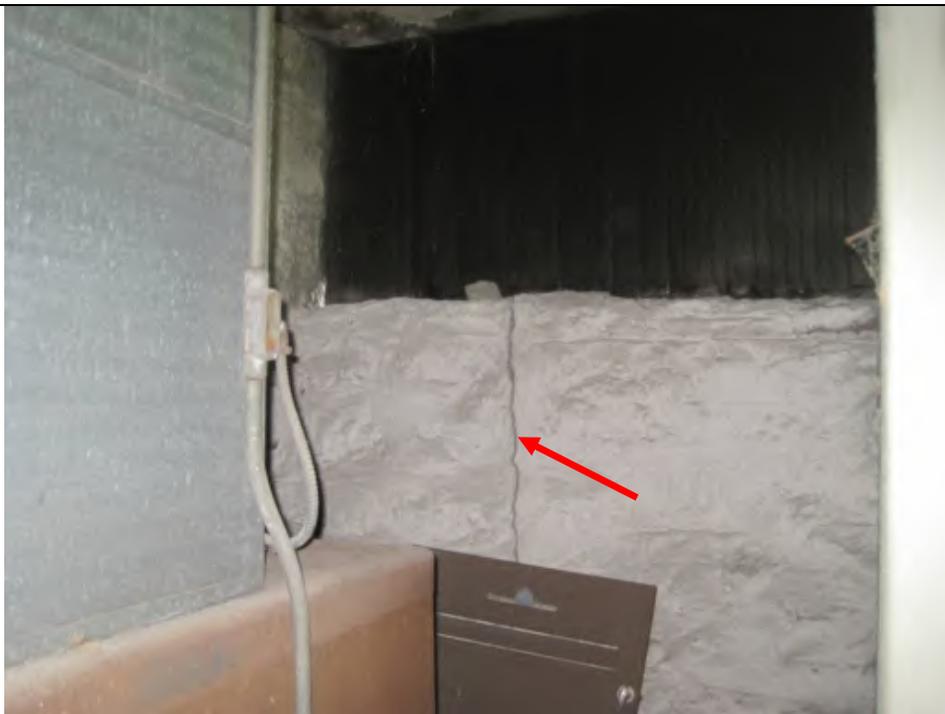
**Photo 3:** Crack in interior face of addition's west wall at south end.

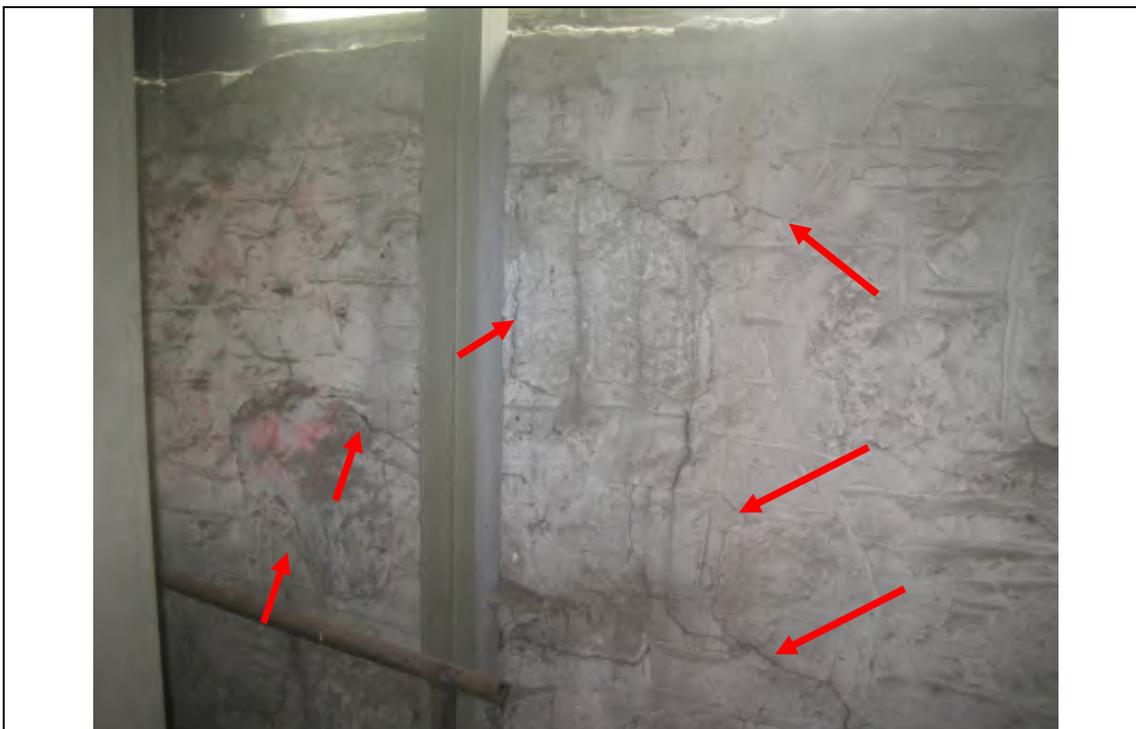
**Photo 5:** Spider cracking in the mortar joints at the interior face at the west end of the addition's north wall.
