CASE STUDIES

SITE SPECIFIC ISSUES AND RECOMMENDATIONS

FIRST BURIAL GROUND

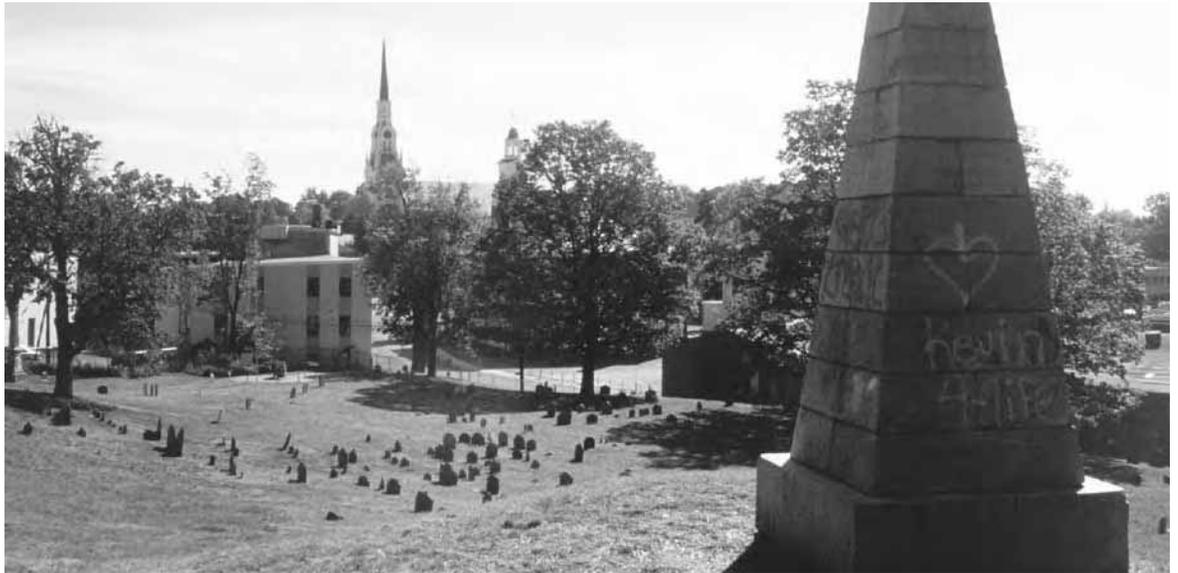
View from top of hill toward town center. Baldwin Family Tomb at right.

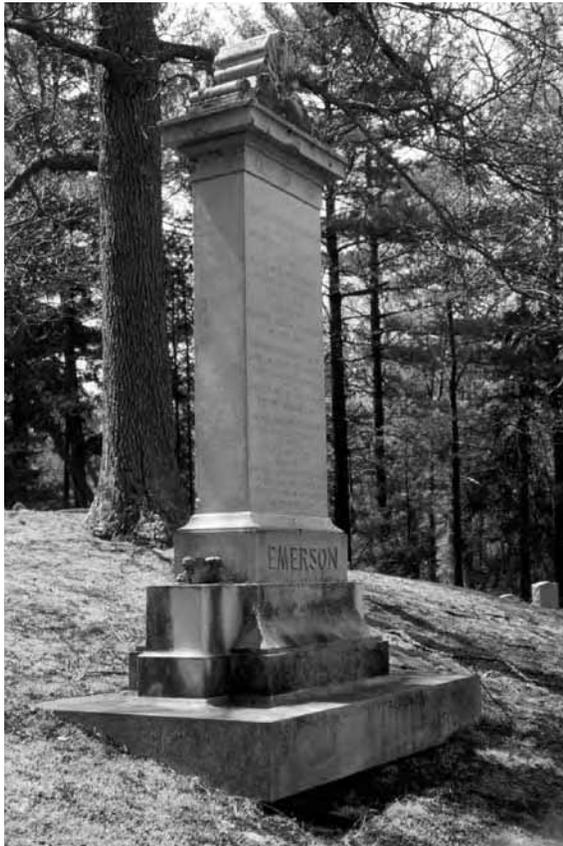
Exposed foundation of Emerson monument

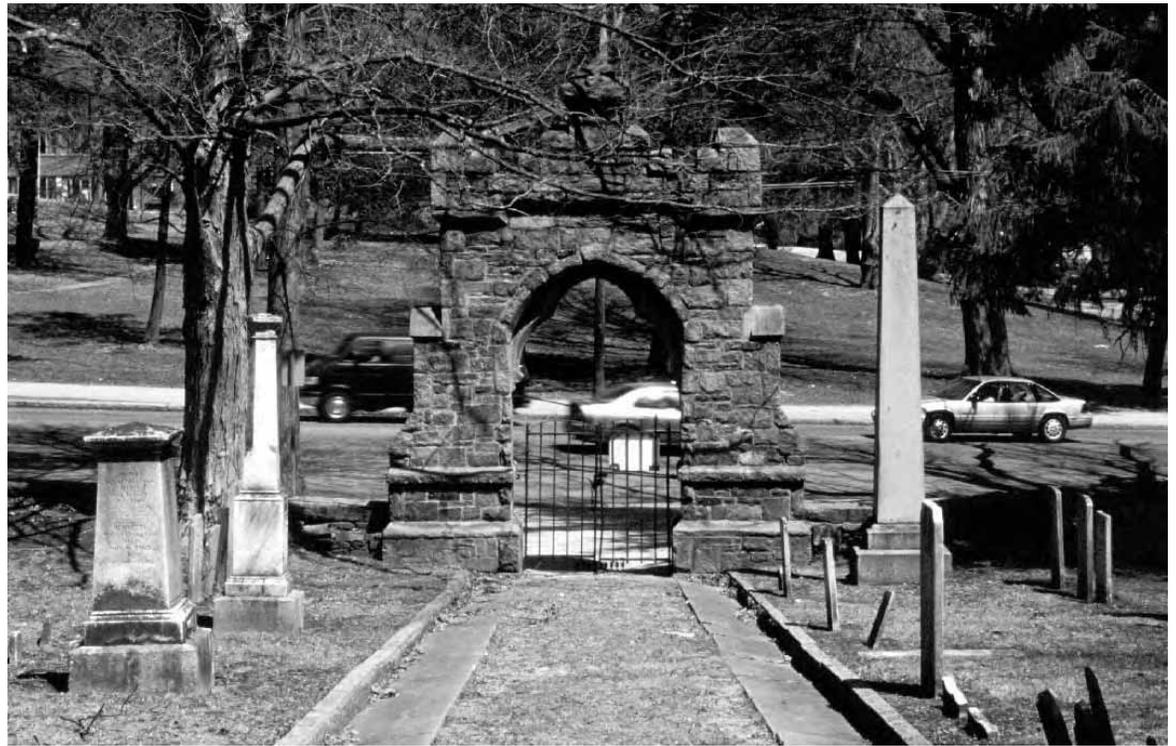
The 1878 Main Street entrance consists of a passage through a monumental stone arch made up of relatively small, mortared granite units, probably quarried in nearby Monson. The cut stone is coursed. The arch is in fair condition. Although there has been little, if any, shifting and displacement of the stonework, there is evidence of extensive water infiltration into the joints and behind the stones.

Main Street entrance arch

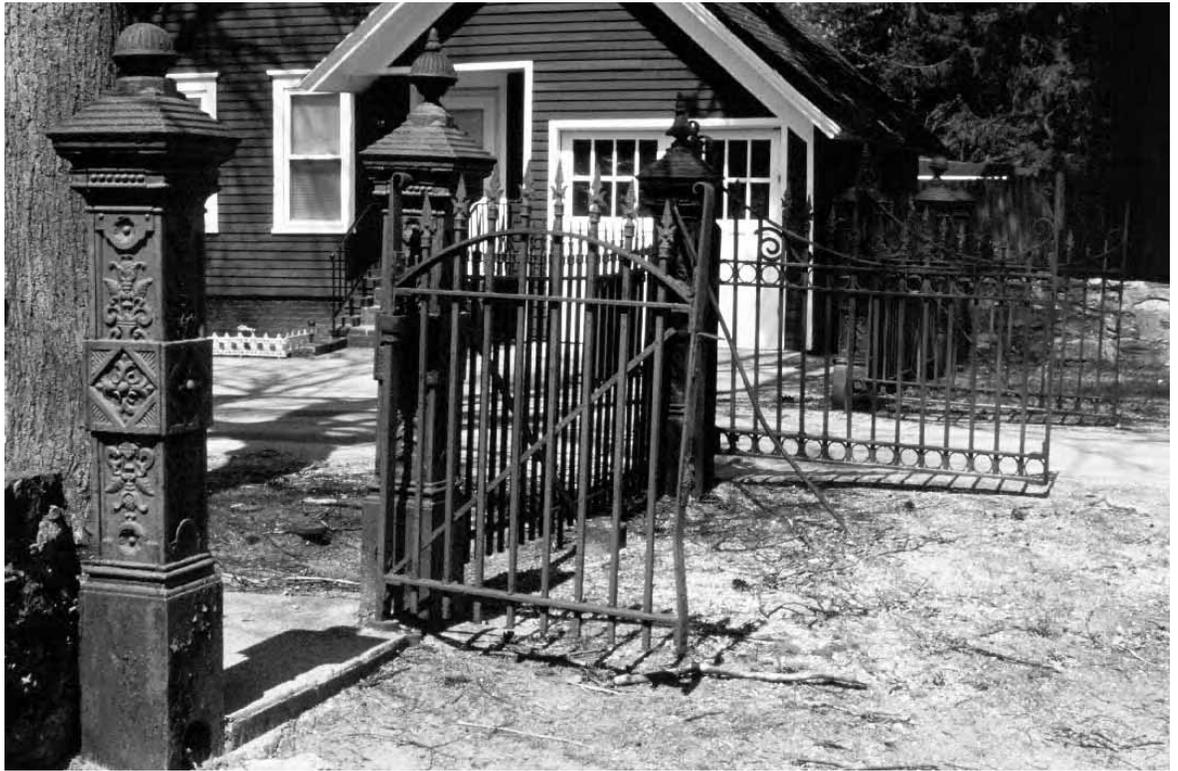
Oak Ridge Avenue Entrance Gate and Fence: This assembly consists of a green painted central double swing vehicular gate with single leaf pedestrian gates at the ends separated with an 8'-11.5" long section of fence. The north pedestrian gate is chained and welded closed. The overall assembly has 6 cast iron posts and spear headed picket fences and gates. Overall it is in poor to fair condition. The posts are made up of several cast iron pieces that snap or seat together to make up each decorative square post, base, tapering cap and finial. Damage from vehicle impact and general wear and tear have caused some of iron pieces to break or separate, such that the south vehicular gate post has been damaged and has welded repairs. It is also diagonally braced with a steel channel and bolts. The north pedestrian gate post is askew and the top is missing allowing water infiltration. Other post tops are loose or damaged. The fences are in generally good condition although a few of the spearheads are missing and some of the pickets are bent. There is also extensive corrosion and rust jacking where decorative bent bars on the gates scroll together and overlap at the bottom of the gate leaves and at the top center.

Oak Ridge Avenue entrance gate and fence
