Re: NEWBURYPORT - Solid Wastes/COR
Crow Lane
Crow Lane Landfill
Revised Closure Plan
Notice of Deficiency
File No. W046210
FMF No. 39545

Preliminary Shaw Review Comments relative to the SITEC Engineering Drawings Perimeter Berm and the MSE Wall

Shaw review of GeoComp's "REPORT ON ADDITIONAL GEOTECHNICAL ANALYSIS"

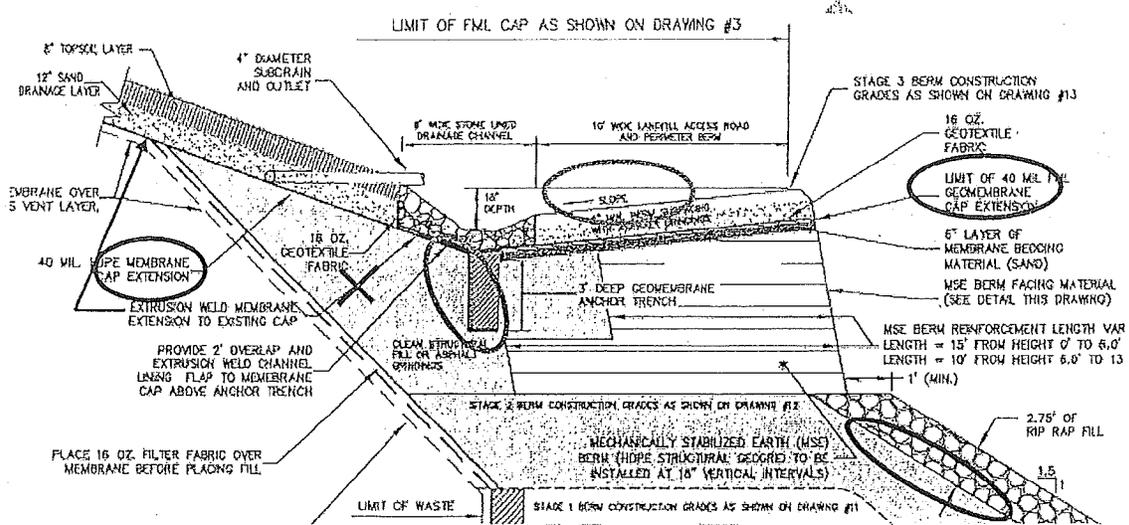
Drawing 5 – Westerly Perimeter Berm detail:

1. The callouts identifying extrusion welds between membrane appear are confusing. Should the call out "Extrusion weld membrane extension to existing cap be at the top of the existing cap steep slope? It appears that the

Geomembrane cap extension is continuous under the swale, so the purpose of the anchor trench is not clear, and how the weld to it would occur. If an additional swale liner is desired, then it could be just layered on top of the cap extension: (Unless the lines are miss-labeled and then these should be corrected).

2. What is the slope of the road to the channel, or the height of the channel adjacent to the road?
3. What will prevent the existing berm material under the riprap from eroding? Either a geotextile or graded stone is needed between the riprap and the existing berm.

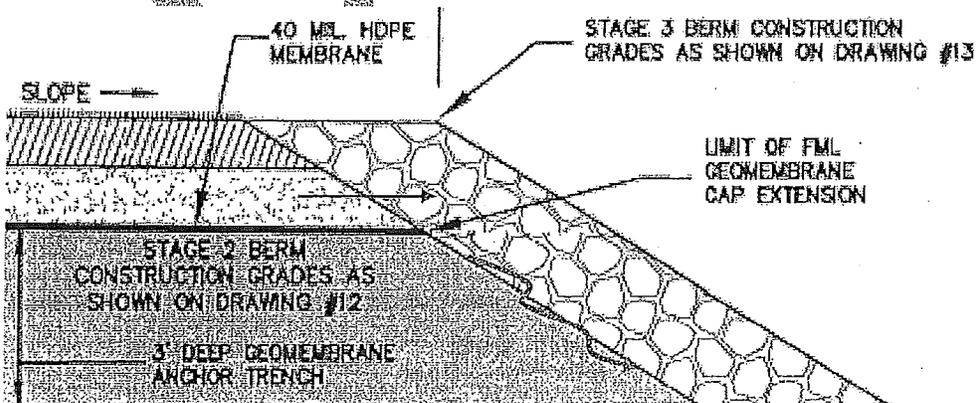
Drawing 6 – Detail Southern Perimeter Berm Detail Structural Fill.

1. What will prevent the drainage layer sand above the 40 mil HDPE membrane from washing out at the FML limit into the riprap?
2. What will prevent the existing berm material under the riprap from eroding? Either a geotextile or graded stone is needed between the riprap and the existing berm.

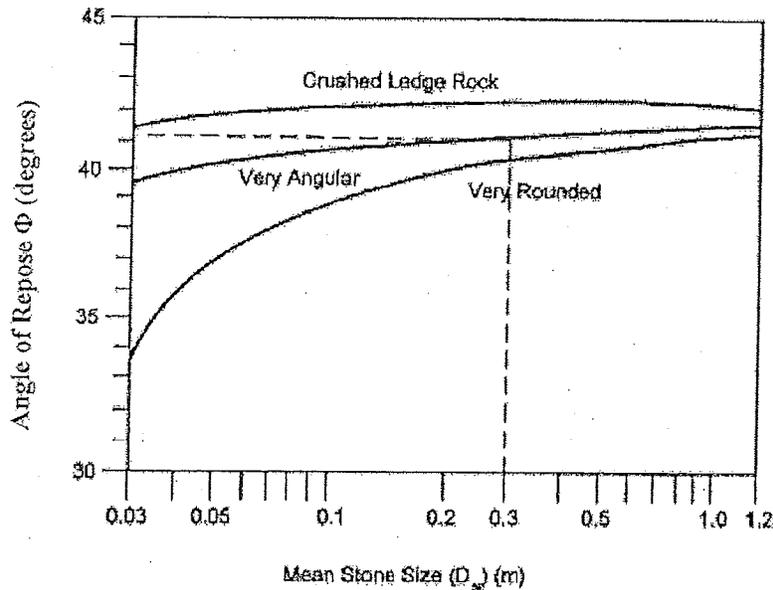
Figure 7-27 Angle Of Repose Of Riprap In Terms Of Mean Size And Shape Of Stone (metric units)

An internal friction angle of 45 degrees for riprap and buttress wall material was used in the February 2007 GeoComp calculation. In the May 2007 GeoComp calculation, this value increased to 50 degrees. A justification for using the higher value should be provided. Otherwise, the slope stability runs should be repeated with the previous value (45°) to determine if it changes the factor of safety (FS).

As noted in the figures below from the Connecticut DOT Drainage Manual, the maximum angle of repose for stone sizes similar to the sizes proposed for the buttresses is less than 43 degrees.

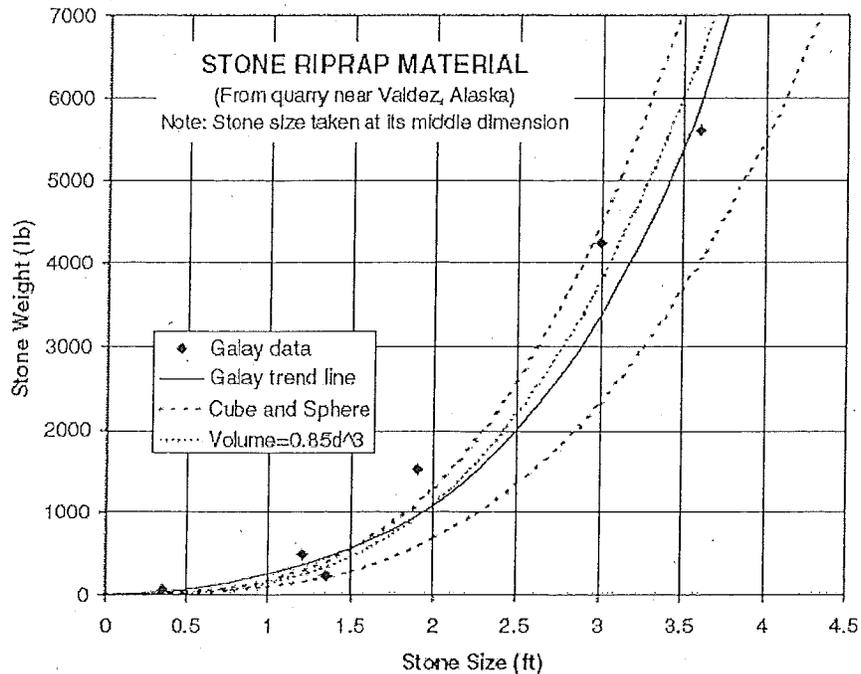
Figure 3.24. Stone weight versus stone size for riprap.

In addition, unless the rock placement is such that there is less than 20% voids, the required buttress's overall density used in the stability analysis cannot be achieved. As demonstrated in Figure 3.24 from the National Cooperative Highway Research Program (NCHRP) Report 568, the size and shape of the rock significantly affect the bulk density of the embankment. For instance, due to voids, a fill with 3.15 ft cubic rocks neatly stacked will have a bulk density of 160 lbs/cf but a fill with 3.15 ft round rocks will have a bulk density of approximately 80 lbs/cf. So achieving the necessary 130 lbs/cf bulk density used in the stability calculations is not assured based upon the design presented so far.

In the construction specification for rip rap, allowable range of sizes and/or weights of the individual particles, allowable range of particle shape, minimum allowable density (or Gs), and the minimum allowable durability requirements should be addressed.
