VISUAL AND SCANNING ELECTRON MICROSCOPY INVESTIGATION AND TENSILE TESTING TO ESTIMATE RESIDUAL TENSILE STRENGTH OF A SELECTION OF LOBSTER LINES

**The Division of Marine Fisheries,
Commonwealth of Massachusetts**

Ref: TTI-JN-410-2007

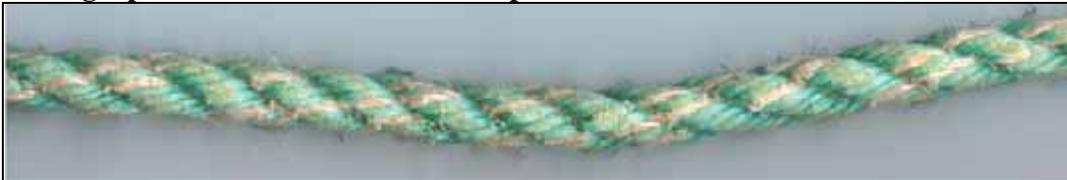
Photograph 1 Anacko Field rope 55 hauls

The field Anacko rope is seen to have broken filament material protruding from its surface. The field Polysteel Ester Pro has lost much of its surface appearance due to abrasion of the yarns at the surface. However, all the field ropes have suffered external abrasion, this being evenly distributed along the length and around the circumference of each of the ropes samples. The ropes did not show any signs of localized enhanced damage and no other unusual features were seen.

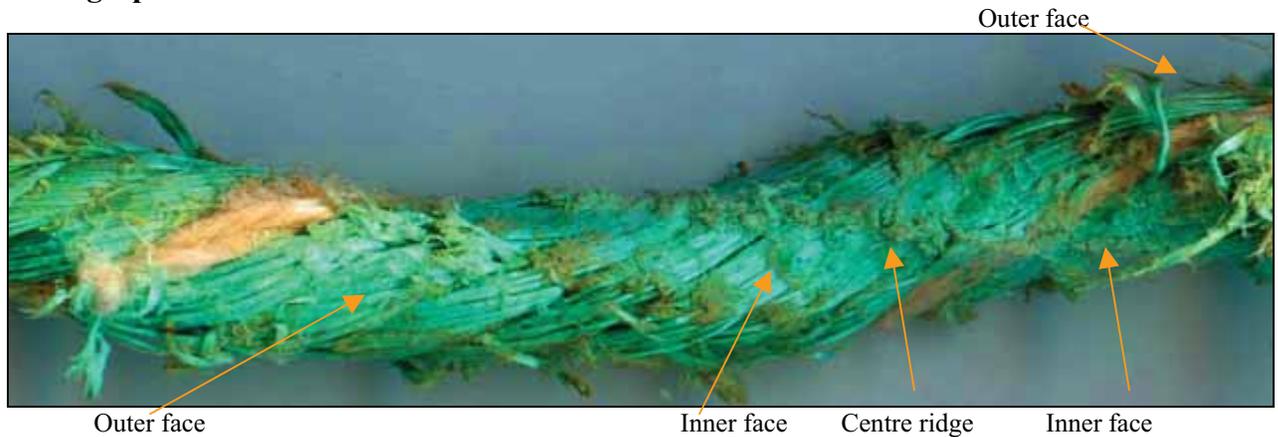
Photograph 6 Anacko Close view of strand

The outer layer of the strand is composed of rope yarns made from PP filaments. A polyester rope yarn also appears on the surface. The core rope yarns are from polyester filaments. Much abrasion damage is seen to the outer face of the strand, it being a combination of broken PP filaments and fibrillated PP debris. Some damage is also seen to the polyester rope yarn. The inner face has a more polished appearance but with fibrillated material at the centre ridge. This ridge lies in the space between the two partner strands of the rope construction.

Clearly, from the broken filaments and fibrillated debris seen on the outer face, external abrasion damage is the dominant wear mechanism. This rope has had the greatest number of hauls of the five types inspected, at 55.

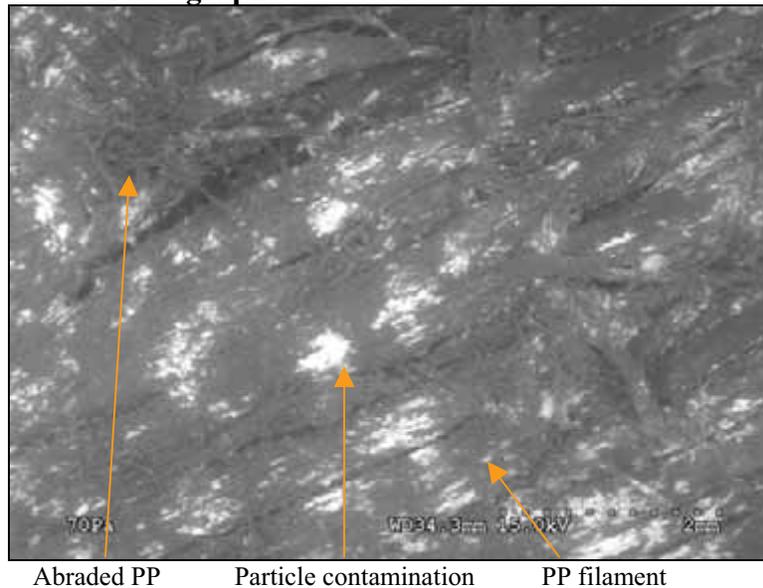
Photograph 7 General view outer face

The outer face has much fibrillated polypropylene debris, the result of external abrasion. Particle contamination is seen as the white areas in the image.

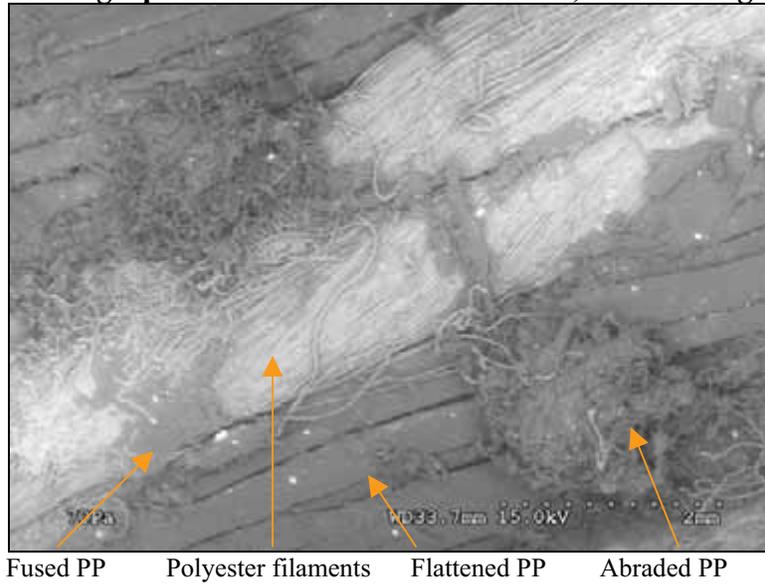
Photograph 8 General view inner face, close to ridge

The inner face shows evidence of the polypropylene having been subjected to pressure as well as internal abrasion, the evidence of pressure being seen as a flattening of the surfaces of the filaments. Also, there are patches of the [darker] abraded polypropylene material that have been fused together, further evidence of the effect of pressure on the polypropylene component of the rope.

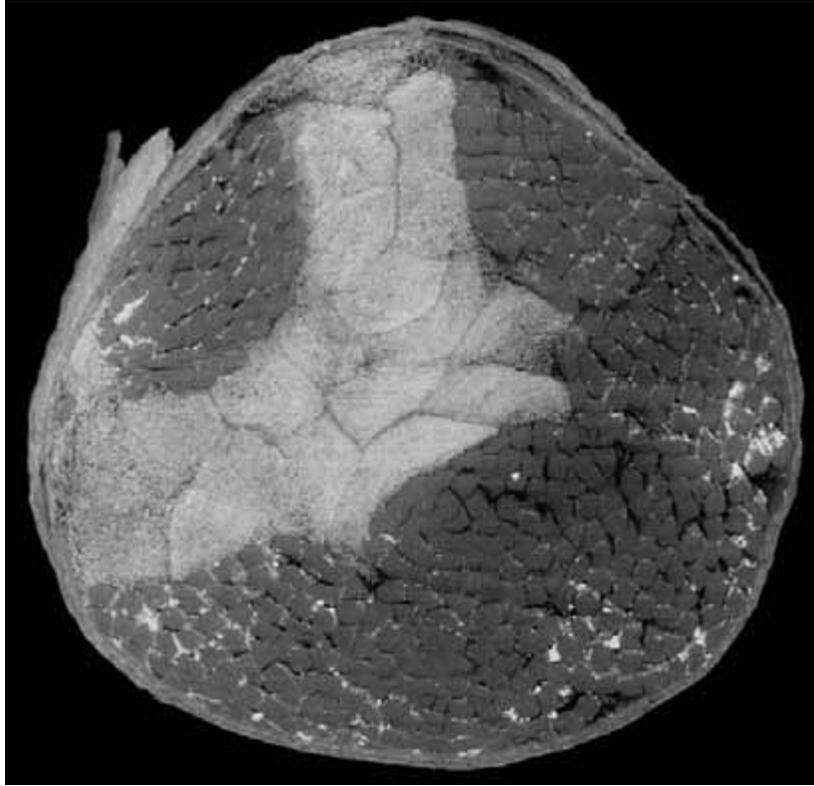
Photograph 9
General view of a cross-section of the strand

Both the polypropylene and polyester components of the strand are clearly seen. The outer surface of the rope strand is seen to be mostly of polypropylene rope yarns/filaments, with the polyester yarns lying mainly in the inner part of the strand. The polyester filaments are seen to be closely packed with no gaps, whereas the PP yarns have larger gaps between them. These gaps will make it easier for particles to migrate through the strand.

Particle contamination is seen in white. Particle contamination is seen to track through the polyester filaments where polyester yarn has appeared on the surface. However, the polypropylene yarns/filaments have suffered the majority of the contamination. The contamination is dispersed around the cross-section but with higher concentrations being seen in the lower half of the cross-section.

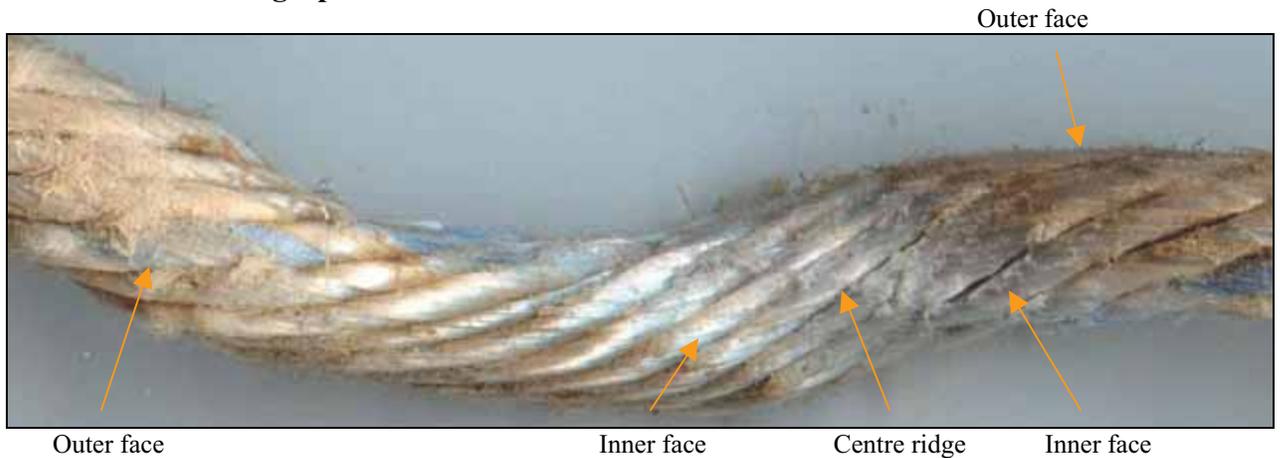
Photograph 10 Everson 3-strand close view of strand

The rope strands of this rope consist of an outer layer of rope yarns that are blends of polyester and PP filaments. The core textile yarns are made from PP filaments. External and internal abrasion and particle contamination is seen. The [blue] polypropylene filaments are not showing the same degree of actual failure when compared to the Anacko rope and in general the overall wear is less than that of the Anacko rope.

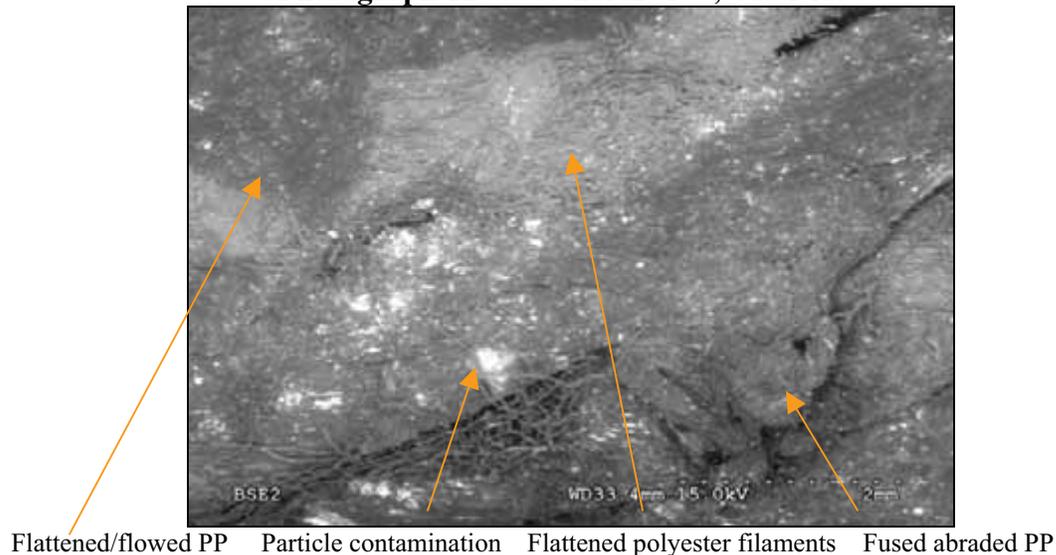
Photograph 11 General view, outer face

The outer surface is showing clear evidence of pressure damage where polypropylene material is seen to have flattened/flowed around polyester filaments, these in turn also displaying pressure induced flattening.

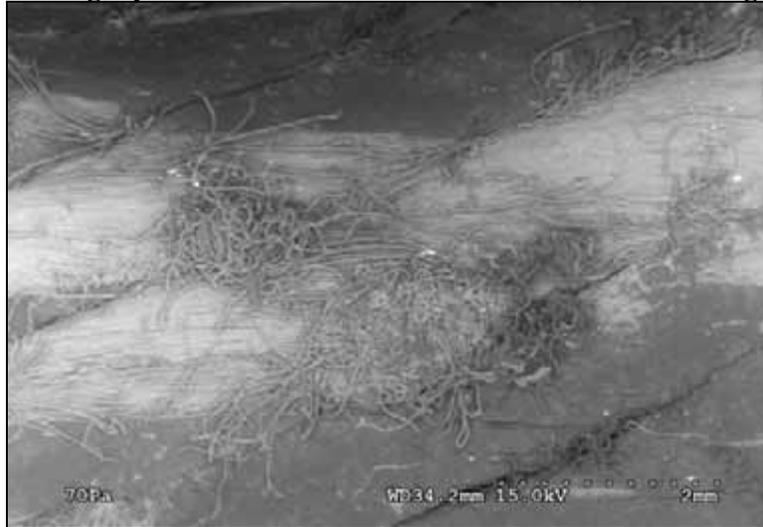
Photograph 12 General view inner face, close to ridge

This image shows both polypropylene and polyester material. Evidence of pressure flattening/flowing is seen, as is some internal abrasion damage.

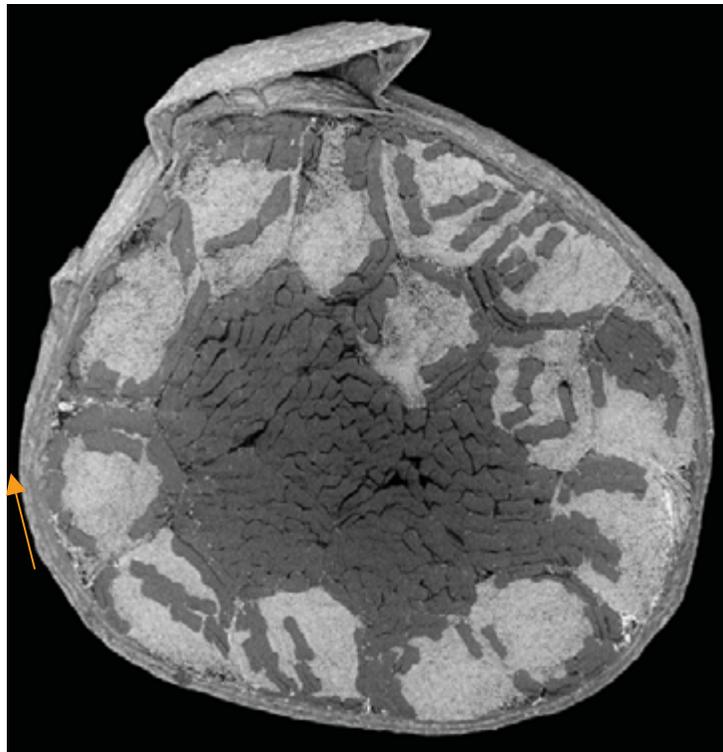
Photograph 13
General view of cross-section of strand

The structure of the strand is seen, where the rope yarns of the outer layer are made up of a blend of polypropylene and polyester filaments. The general arrangement of these rope

yarns appears to be that the polypropylene filaments surround the polyester filaments, though inevitably there is migration of the two materials. There is a core of inner rope yarns are made up exclusively of polypropylene yarns/filaments, but some polyester/PP blended rope yarns also appear in the inner structure of the strand.

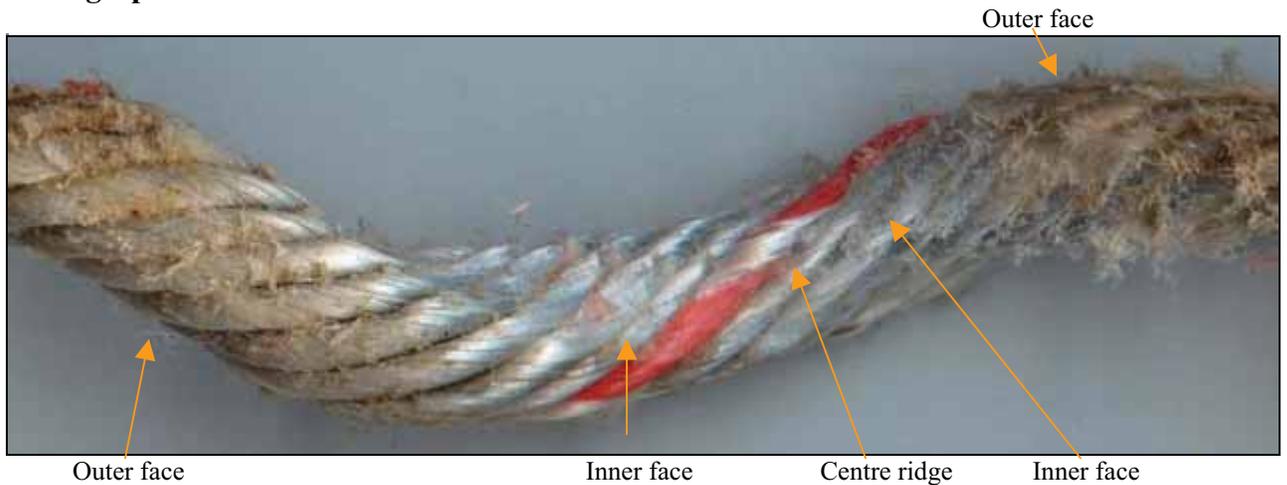
Photograph 14 Everson 4-strand close view

The rope strands of this rope consist of an outer layer of yarns that are blends of polyester and PP filaments. This is the same as for the Everson 3-strand construction. There are also 100% PP yarns in the core of the strand, though the strand assembly does not appear to be as regular as that seen in the 3-strand rope.

The strand in this view shows external abrasion at a higher level than for Everson 3-strand and is probably related to an increased number of hauls. The centre ridge is less prominent than for the 3-strand construction, the cause of this being most likely due to loading being distributed over 4 strands rather than 3.

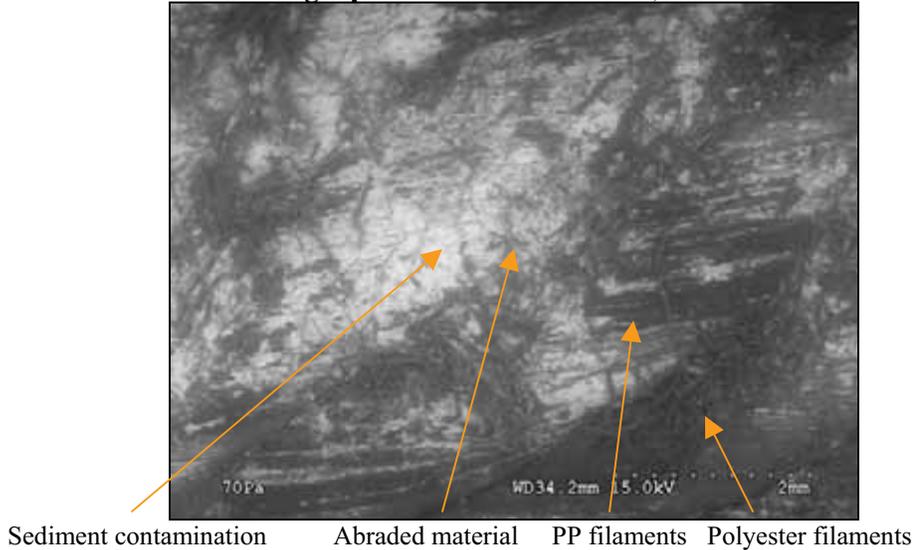
Photograph 15 General view, outer face

In this view, the outer surface is seen to be heavily contaminated with sediment, with abraded material protruding through it. The underlying structure of polypropylene filaments can be seen as well as disturbed polyester filaments.

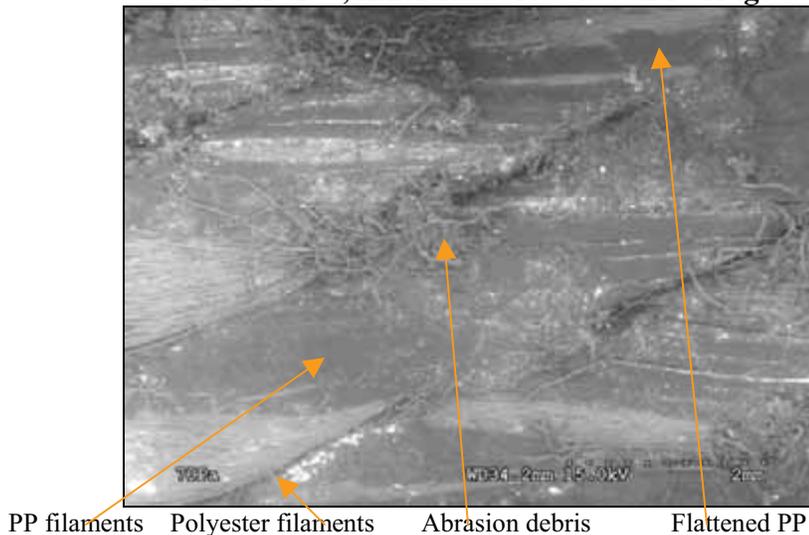
Photograph 16 General view, inner face close to centre ridge

Contamination is much reduced compared to the outer face, but debris from internal abrasion is seen. Some evidence of pressure-induced flow of polypropylene is also seen.

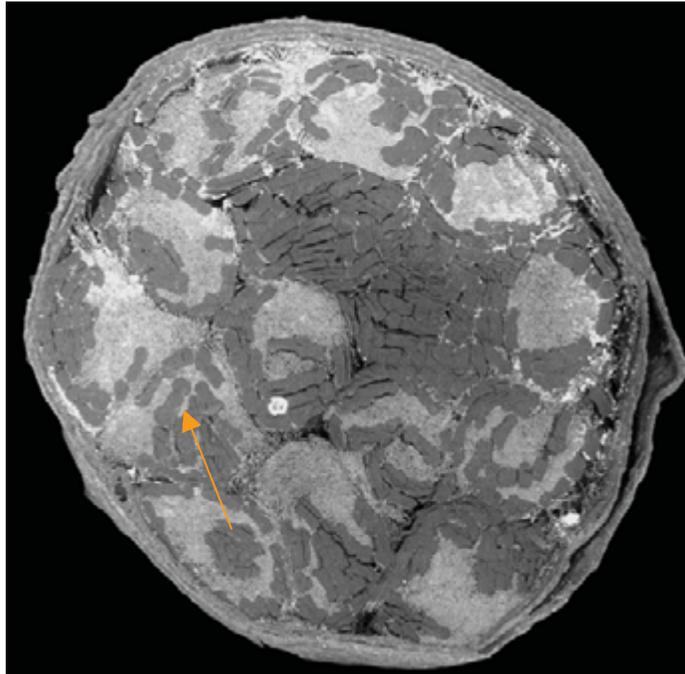
Photograph 17
General view of cross-section

The structure of the rope yarns in the outer layer is the same as for the 3-strand construction, with a general arrangement of polypropylene filaments wrapped around polyester filaments. This type of rope yarn is also seen in the inner structure of the strand. There is also an inner assembly exclusively of polypropylene filaments.

Significant particle contamination is seen in the upper half of the cross-section and, in general, the level of contamination and penetration is higher than for the 3-strand construction. However, this may well be due to a greater number of hauls rather than due to differences in construction. Particle contamination appears to follow the boundaries between adjacent rope yarns

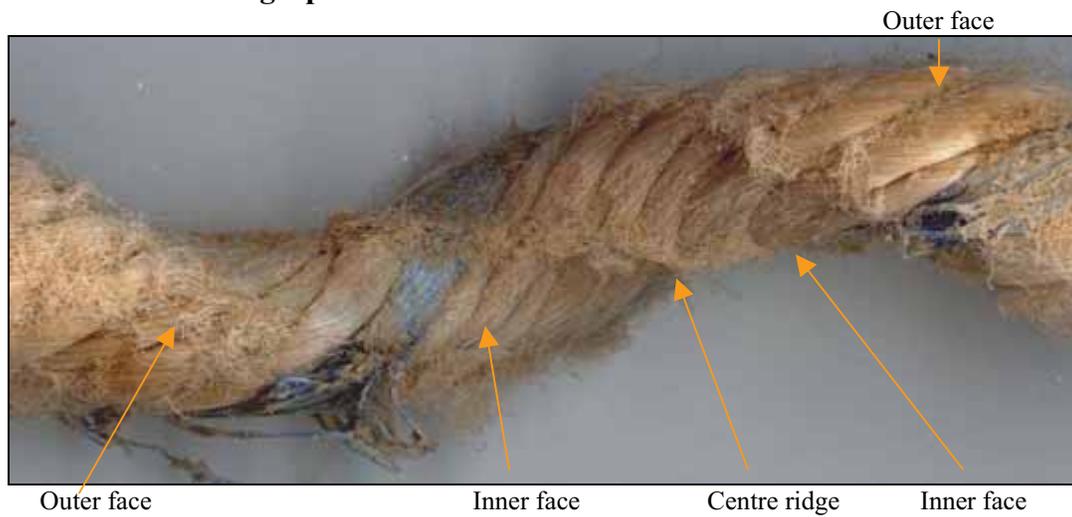
Photograph 18 Orion Orco Close view of strand

The strands of this rope is an assembly of yarns that have outer polyester filaments around a core of PP filaments. Both internal and external abrasion damage is clearly seen and is severe given the low number of hauls. One rope yarn appears to have suffered excessive external abrasion, resulting in severe loss of polyester filaments and the consequent exposure of blue PP filaments.

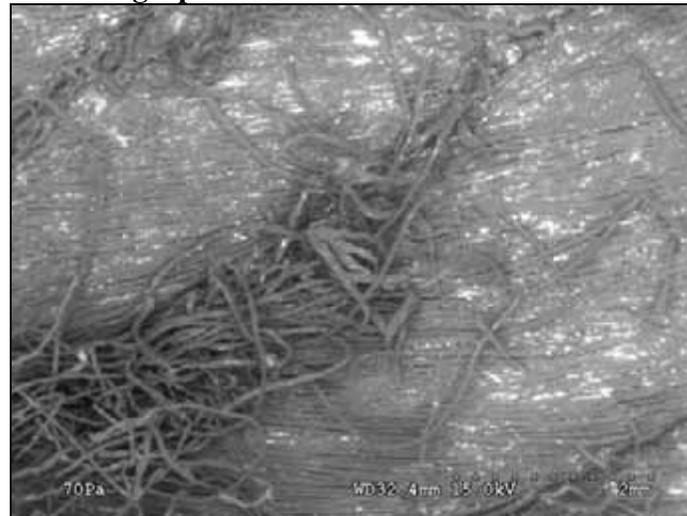
Photograph 19 General view outer face

Only the polyester yarns/filaments are seen. Abrasion damage and flattening of filaments is seen, as well particle contamination.

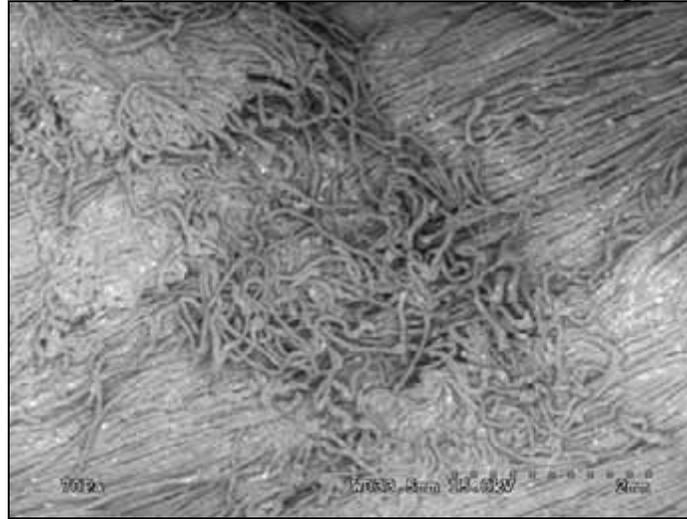
Photograph 21 General view of inner face, ridge area

Whilst pressure flattening is seen, it is at a reduced level when compared to the outer face. Contamination is seen, but also at a reduced level when compared to the outer face.

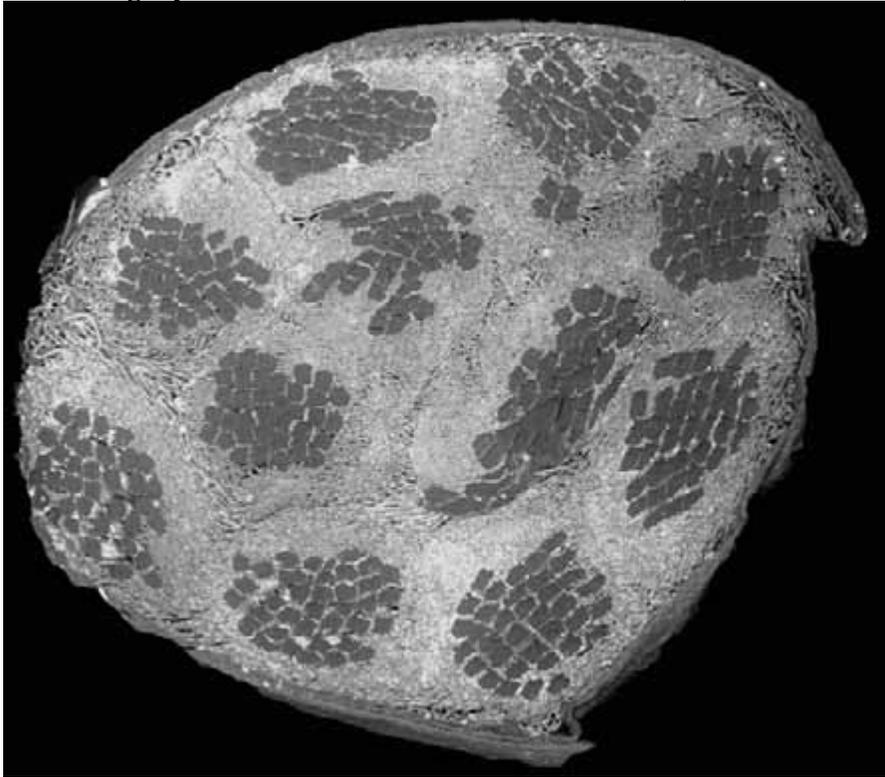
Photograph 23 General view of cross-section, field tested

It may be seen that the two cross-sections appear to be different in that the field sample has more polyester filaments of [probably] thicker cross-section than does the machine tested sample.

From inspection of Photograph 23, it can be seen that the rope yarns are an outer assembly of polyester yarns surrounding an inner assembly of polypropylene yarns. Particle penetration is high when the relatively low number of hauls [28] is taken into account.

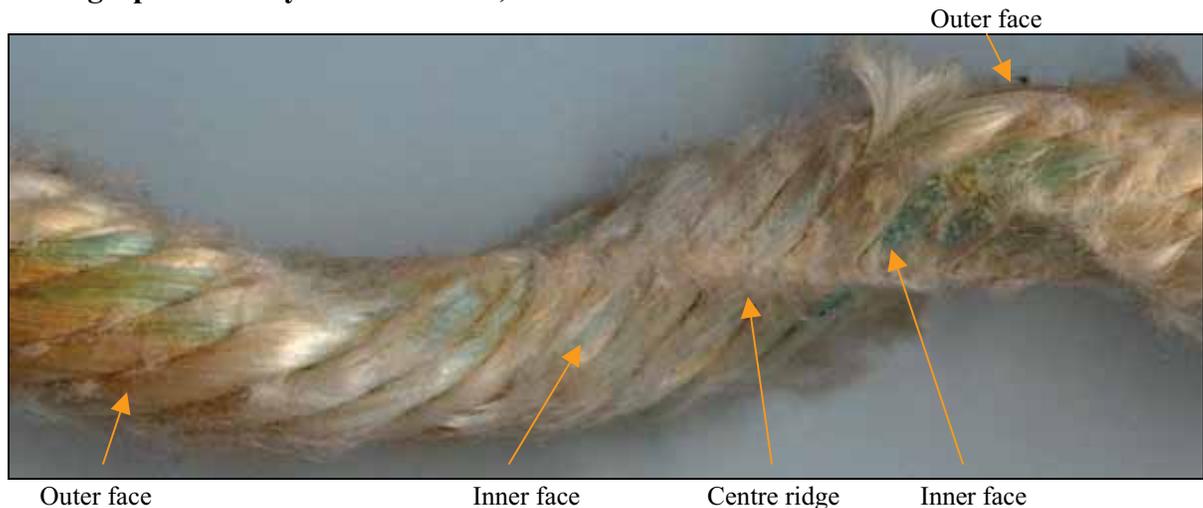
Photograph 25 Polysteel Ester Pro, close view of strand

The outer surface of this rope is primarily polyester yarns/filaments, with the [green] polypropylene yarns/filaments being exposed by a combination of migration and abrasion.

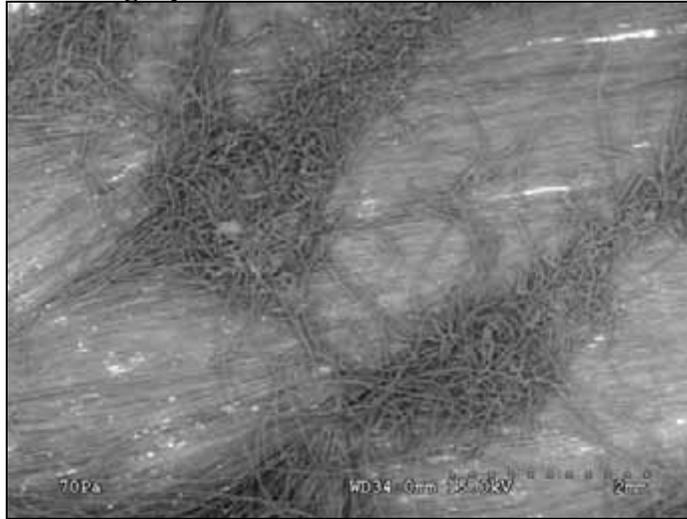
Photograph 26 General view of outer face

Whilst external abrasion damage is seen, pressure flattening is relatively mild.

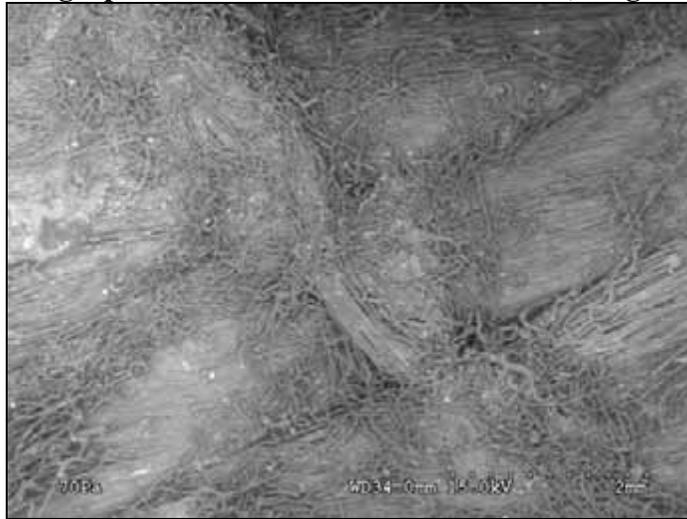
Photograph 27 General view of inner face, ridge area

Internal abrasion damage is seen, as is a higher degree of pressure flattening when compared to the outer face.

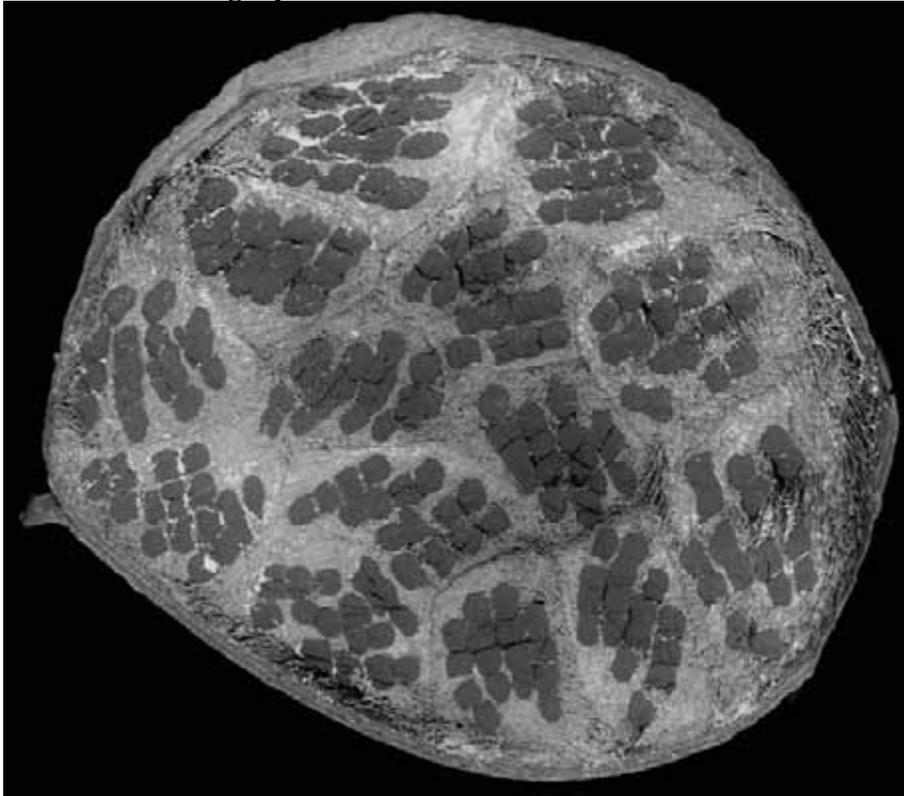
Photograph 28 General view of cross-section

As with the Orion Orco rope, all the rope yarns are blends of PP and polyester filaments, with the PP filaments arranged as a core. However, the PP filaments are more loosely arranged than the Orco rope yarns, with a greater tendency for the polyester filaments to intermingle with them.

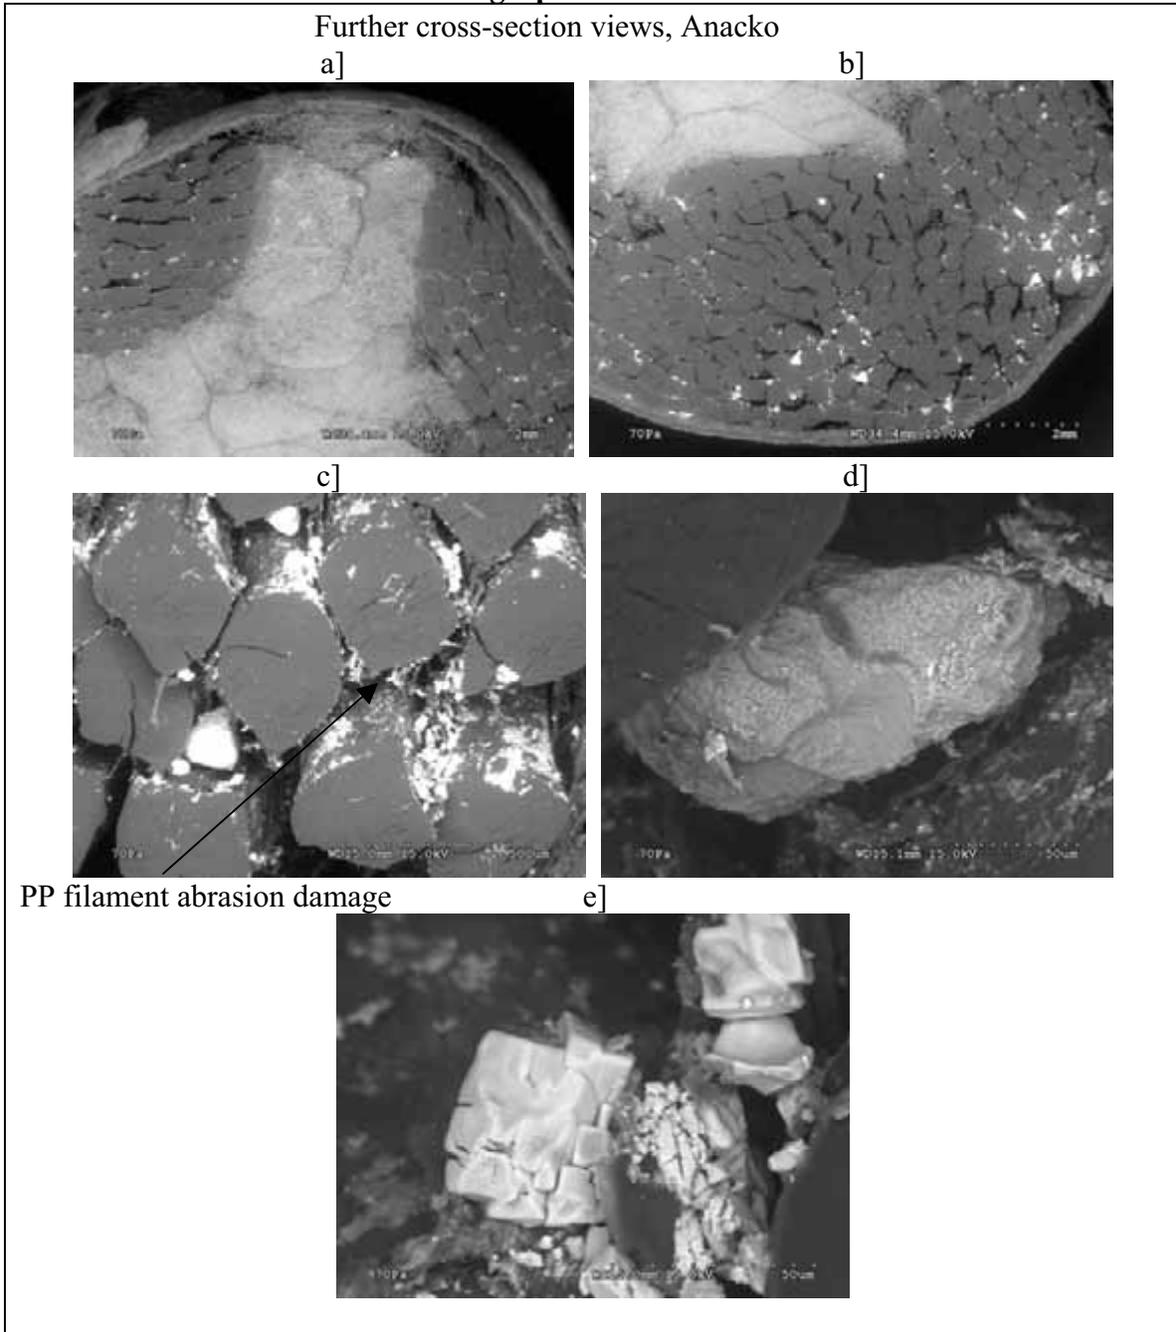
Photograph 29

Photographs 29, a-c, show close views of part of the cross-section with particle contamination and some filament damage due to this contamination is seen. Photographs d and e give examples of particles trapped within the filaments.

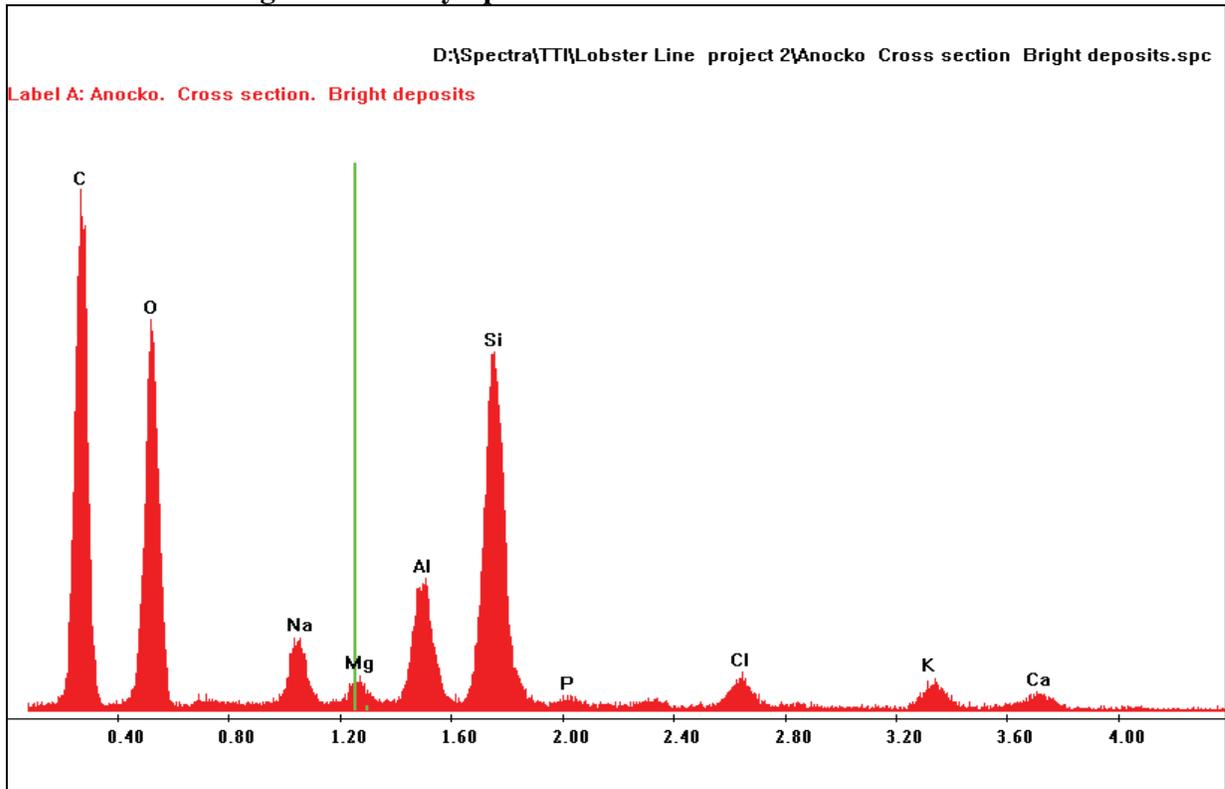
Figure 1 X-ray Spectrum of Anacko cross-section

It must be remembered this is only from one cross-section and from one small part of that cross-section. However, in this spectrum, the C and O peaks represent the polypropylene and polyester materials and the other major peak is for silicone, Si. This suggests that silica in the form of sand is the dominant particle contaminant.

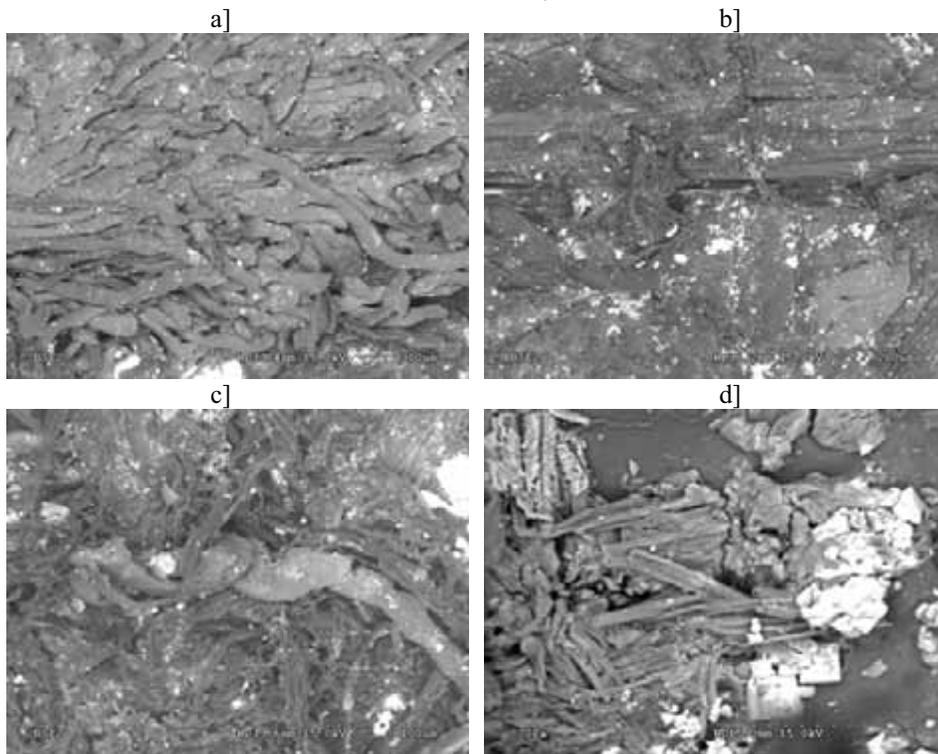
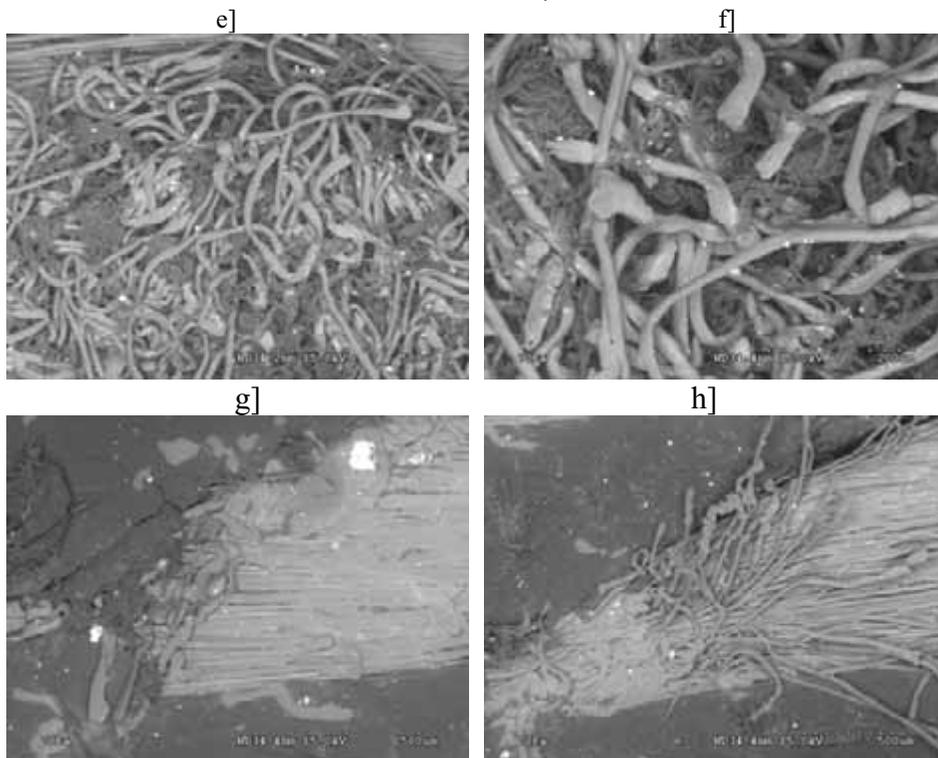
Flattened polyester filaments are seen in photograph 30a, whilst photographs 30b and c show abraded PP. Photograph 30d shows what appears to be the remains of small organisms with salt crystals adjacent, both being partially embedded in flowed PP.

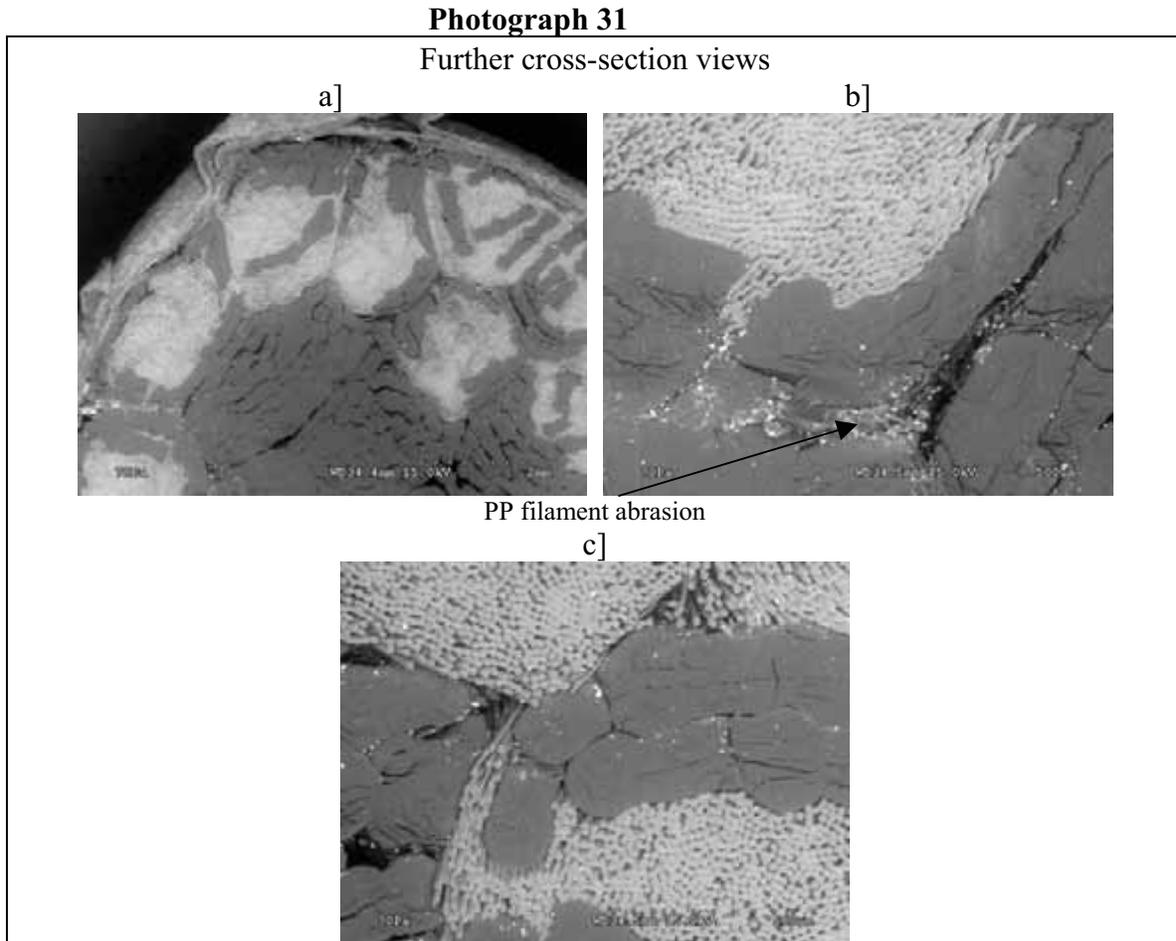
Photograph 31 shows close views of a cross-section of a strand.

Particle penetration is mild but there is some evidence of PP filament abrasion caused by this. Although external abrasion and pressure effects are seen in the surface views, the cross-sections show that these effects do not extend into the interior of the strand. Some abrasion due to particle penetration is also seen.

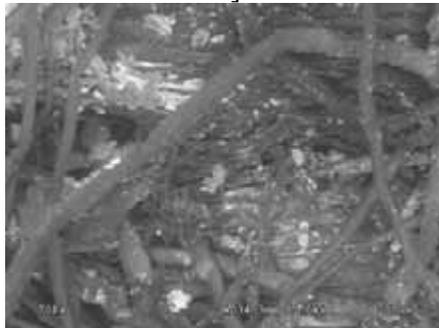
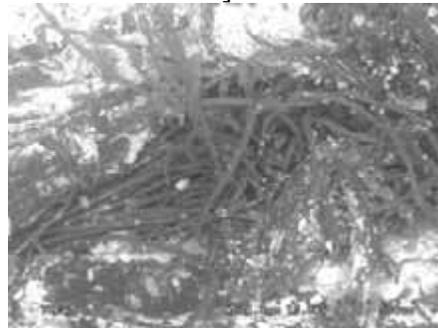
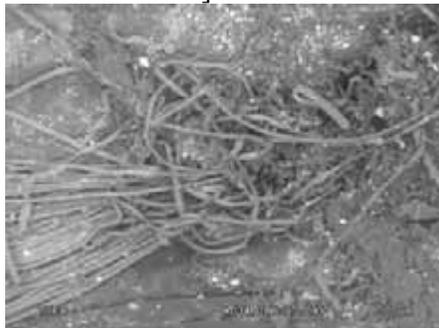
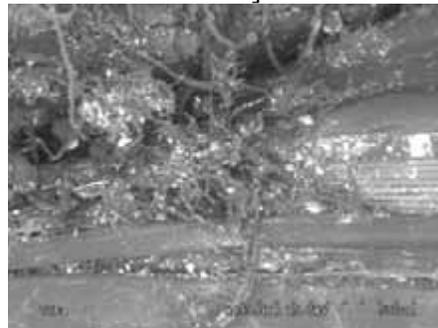
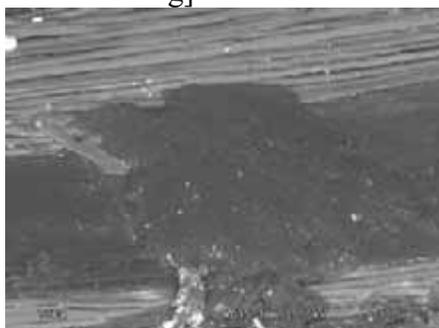
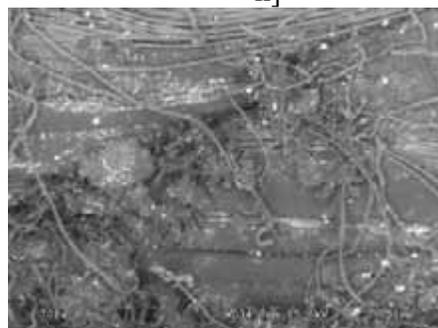
Embedded sediment is much in evidence on the outer face of this rope. Polypropylene abrasion debris and flattened polyester filaments are also seen. Very much reduced sediment is found on the inner face. Flattened PP and PP abrasion debris is seen on the inner face as well as abraded polyester filaments.

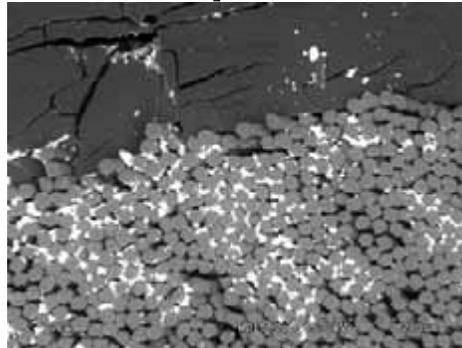
c]

Photograph 33c shows little filament surface abrasion damage with either the PP or the polyester filaments, despite a reasonably high level of particle penetration.

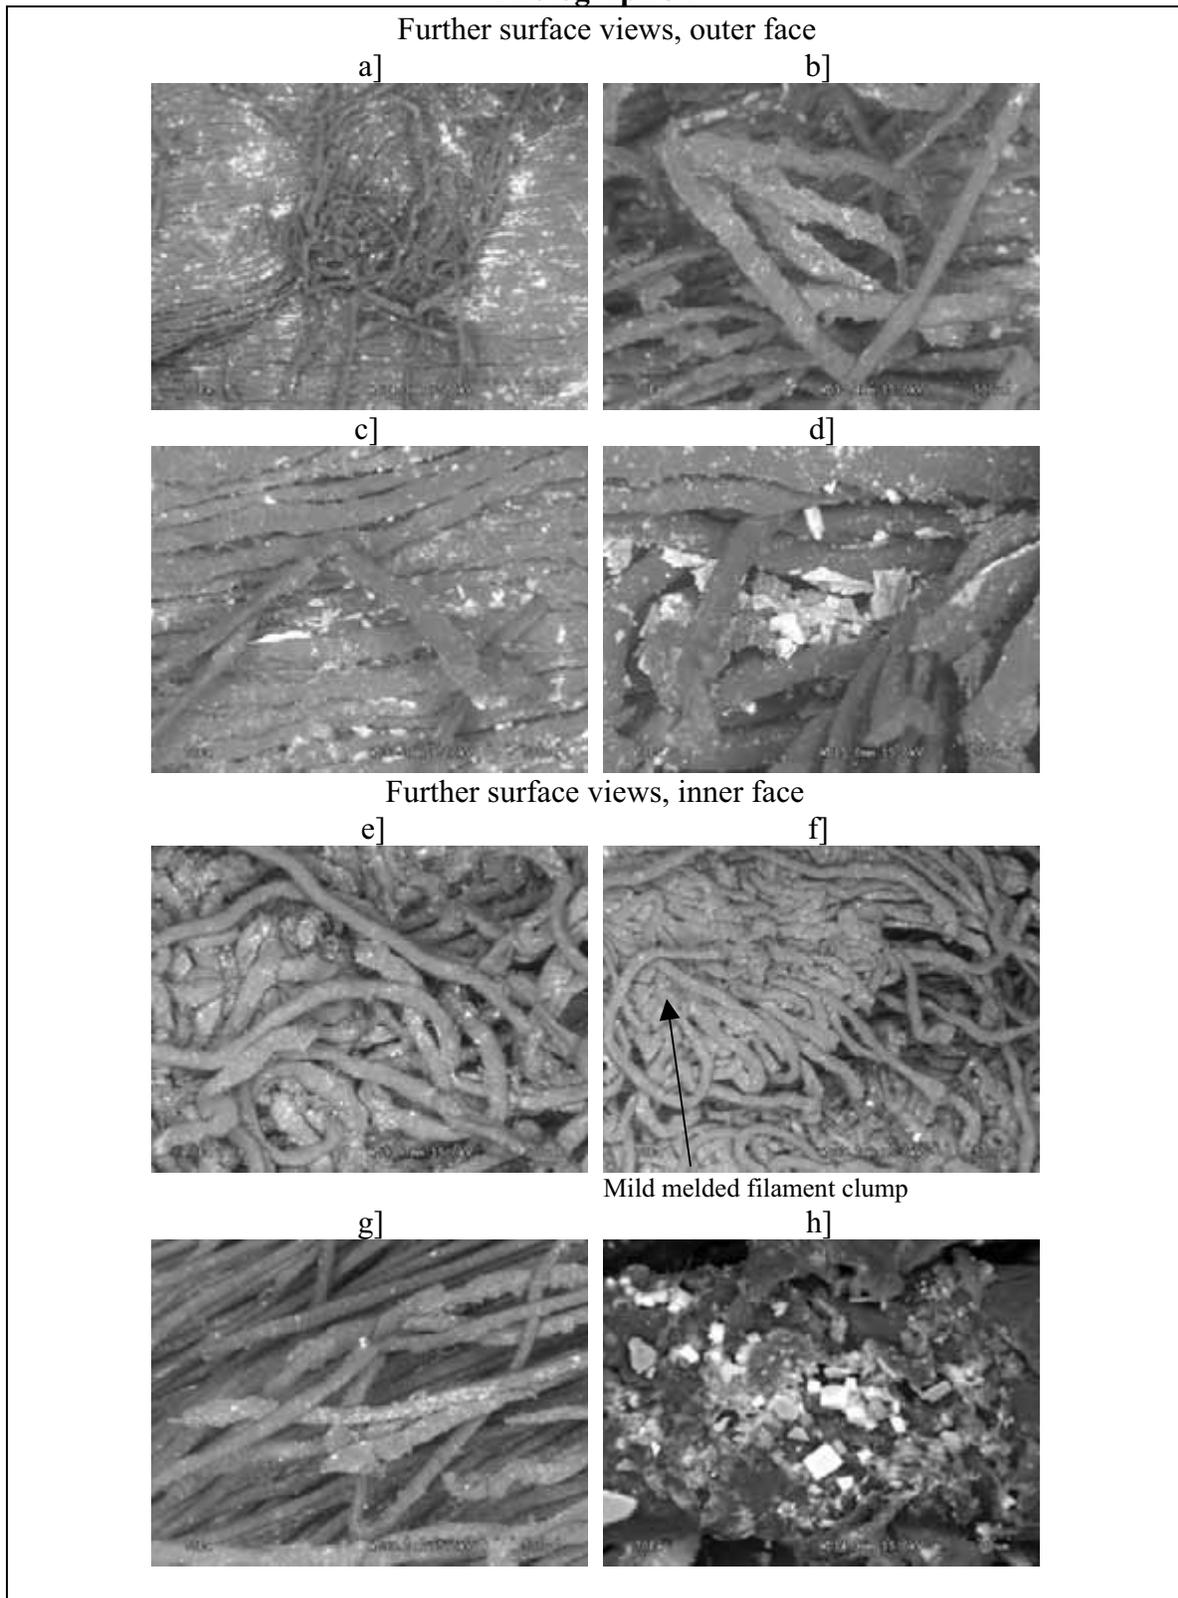
Photograph 34

Pressure-induced flattening and abrasion damage is seen to the polyester filaments on the outer face. Less abrasion damage is seen on the inner face, whilst pressure flattening is still seen. Photograph 33h shows a clump of particle contamination.

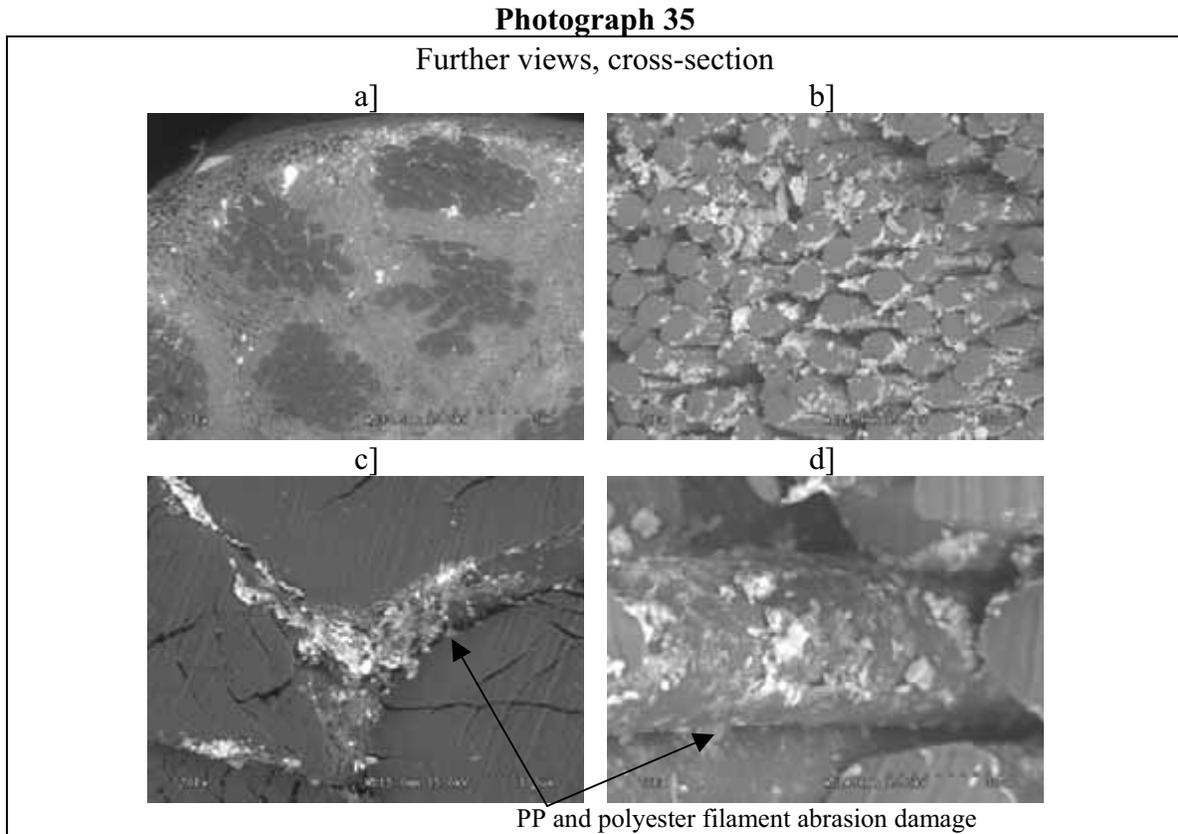
Photographs 35c and d show particle penetration within the PP and polyester filaments, respectively. Some surface damage to both types of filament is seen.
