VISUAL AND SCANNING ELECTRON MICROSCOPY INVESTIGATION AND TENSILE TESTING TO ESTIMATE RESIDUAL TENSILE STRENGTH OF A SELECTION OF LOBSTER LINES

**The Division of Marine Fisheries,
Commonwealth of Massachusetts**

Ref: TTI-JN-410-2007

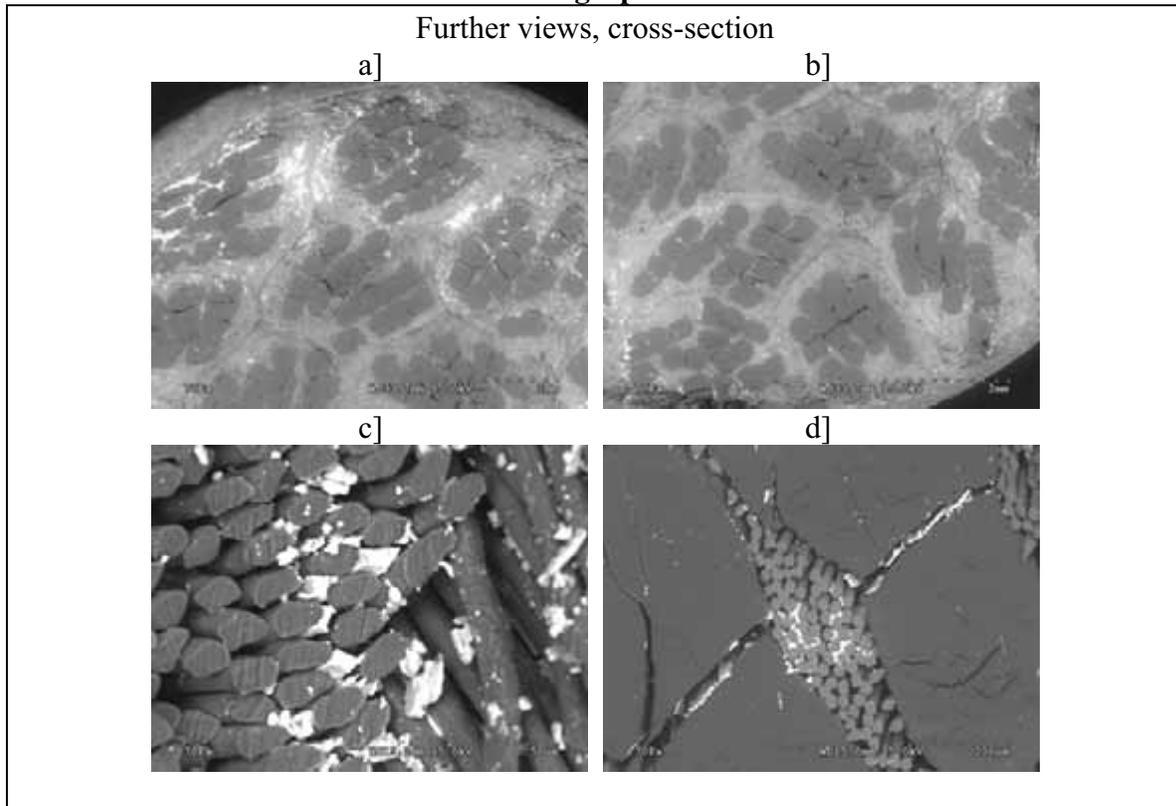
Photograph 37

In cross-section, the Orco specification does show evidence of filament surface damage to both filament types where sediment/particles are present whilst for the Ester Pro specification, this is much less obvious.
