INCIDENT REPORT

88 Waltham Street, Maynard, Massachusetts

January 3, 2008

Gas Company: NSTAR Gas Company

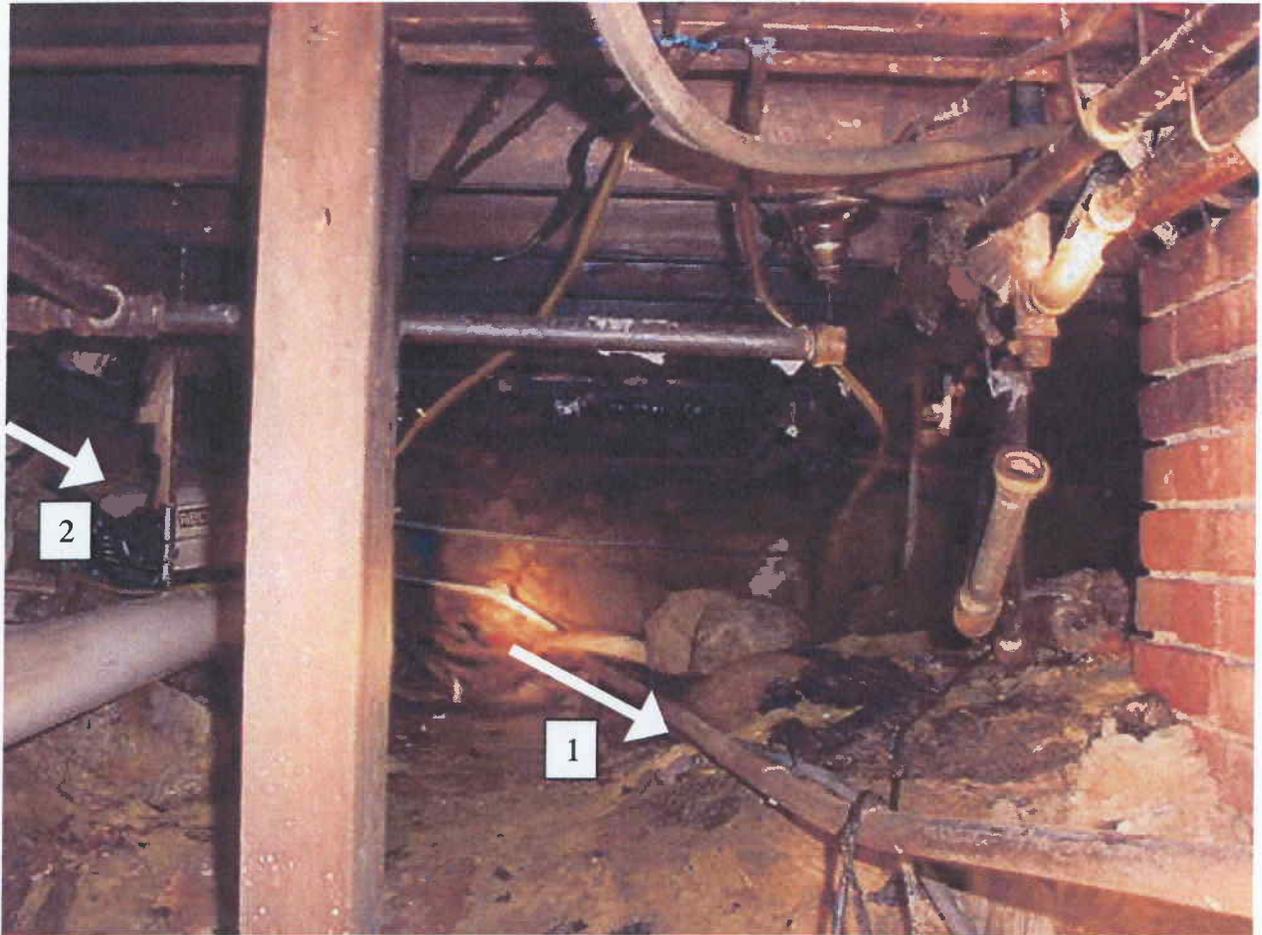
1. Steel service line with inserted plastic line looking from the inside meter set going through the crawl space.
2. Space heater positioned towards service line.

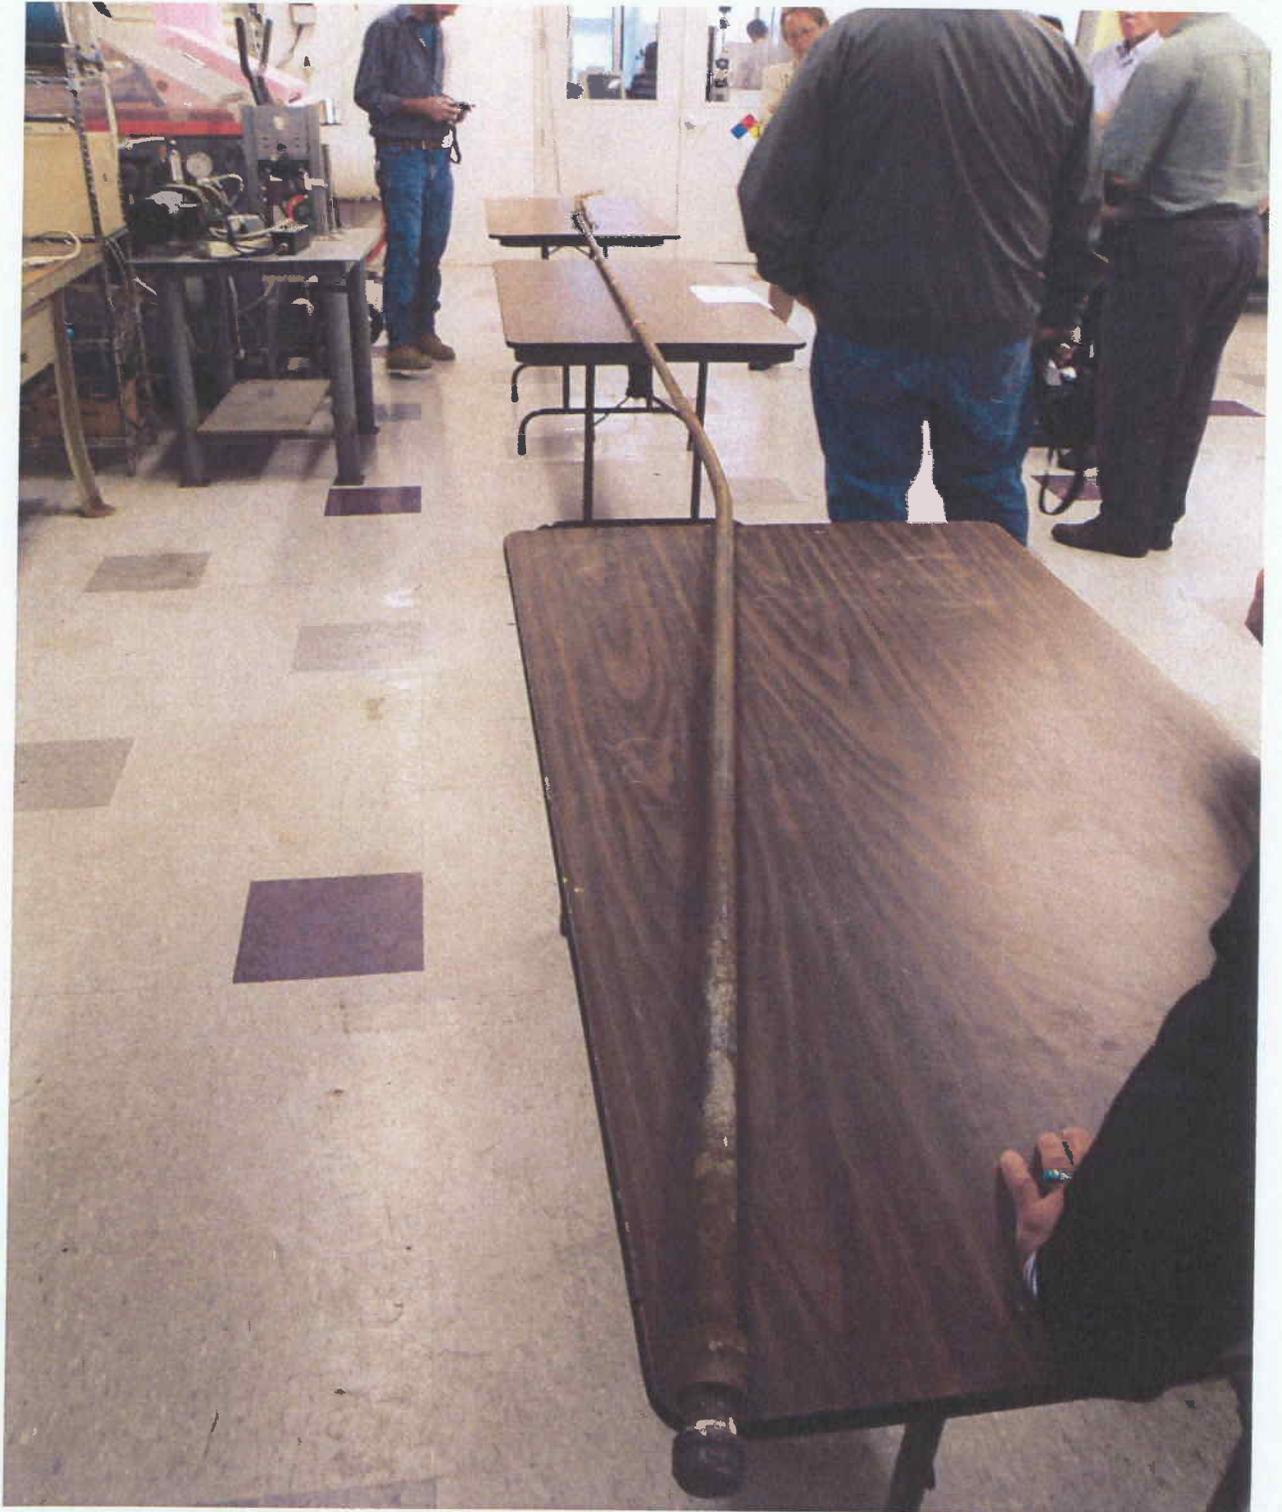
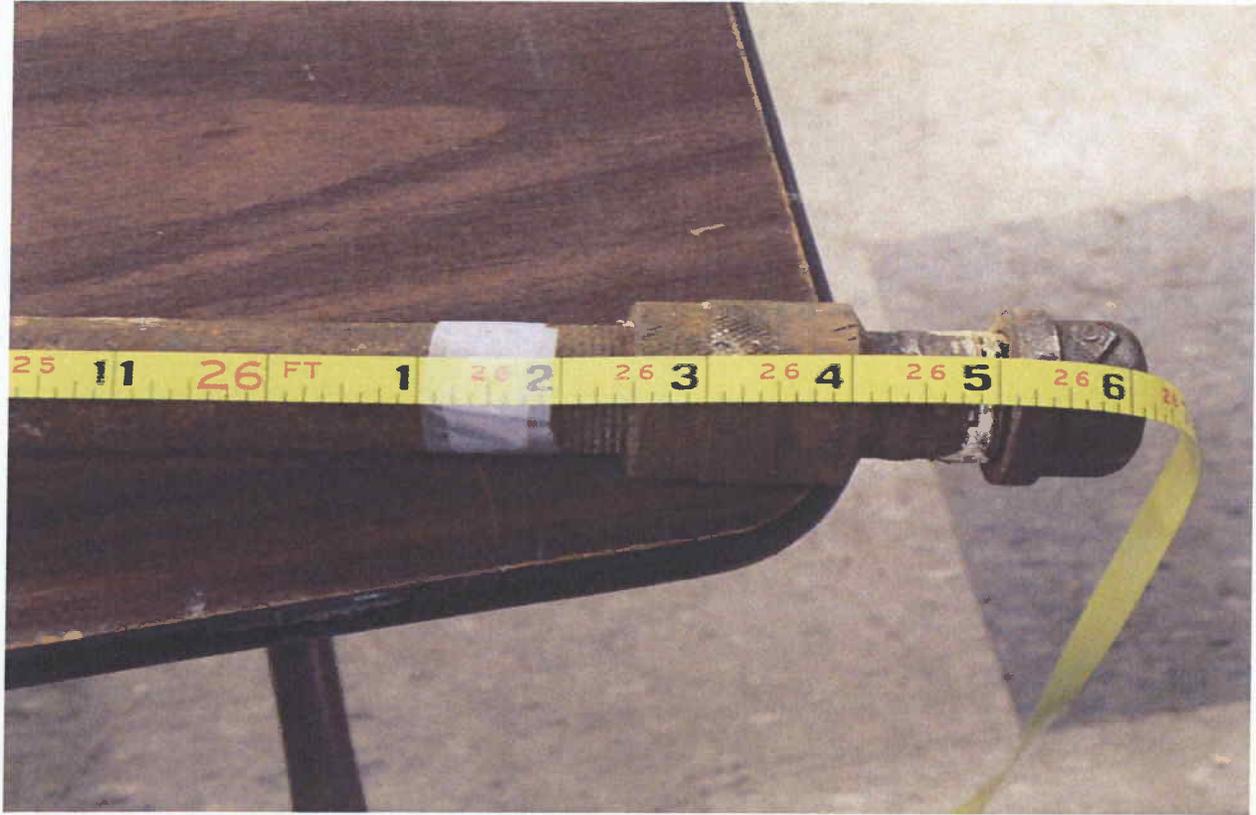
The results of the testing and evaluation indicate the leakage failure of the pipe was due to application of localized high temperature, resulting in polymer melting and material flow. Several thermal and chemical analyses were performed on polymeric material from the leak site and, for reference, from distant portions of the pipe. No evidence of contamination or manufacturing defects was found, and no burning (charring) was seen. The mechanical, analytical and

pressure tests suggest the material was not defective or measurably degraded from age. The noted deformation from twisting and bursting are consistent with softening of the material to the point where the internal gas pressure exceeded the lowered strength of the pipe wall causing the burst (*id.* at 12).

NSTAR Gas Company service line recovered from 88 Waltham Street, Maynard.

Portion of gas service line recovered from crawl space of 88 Waltham Street, Maynard.

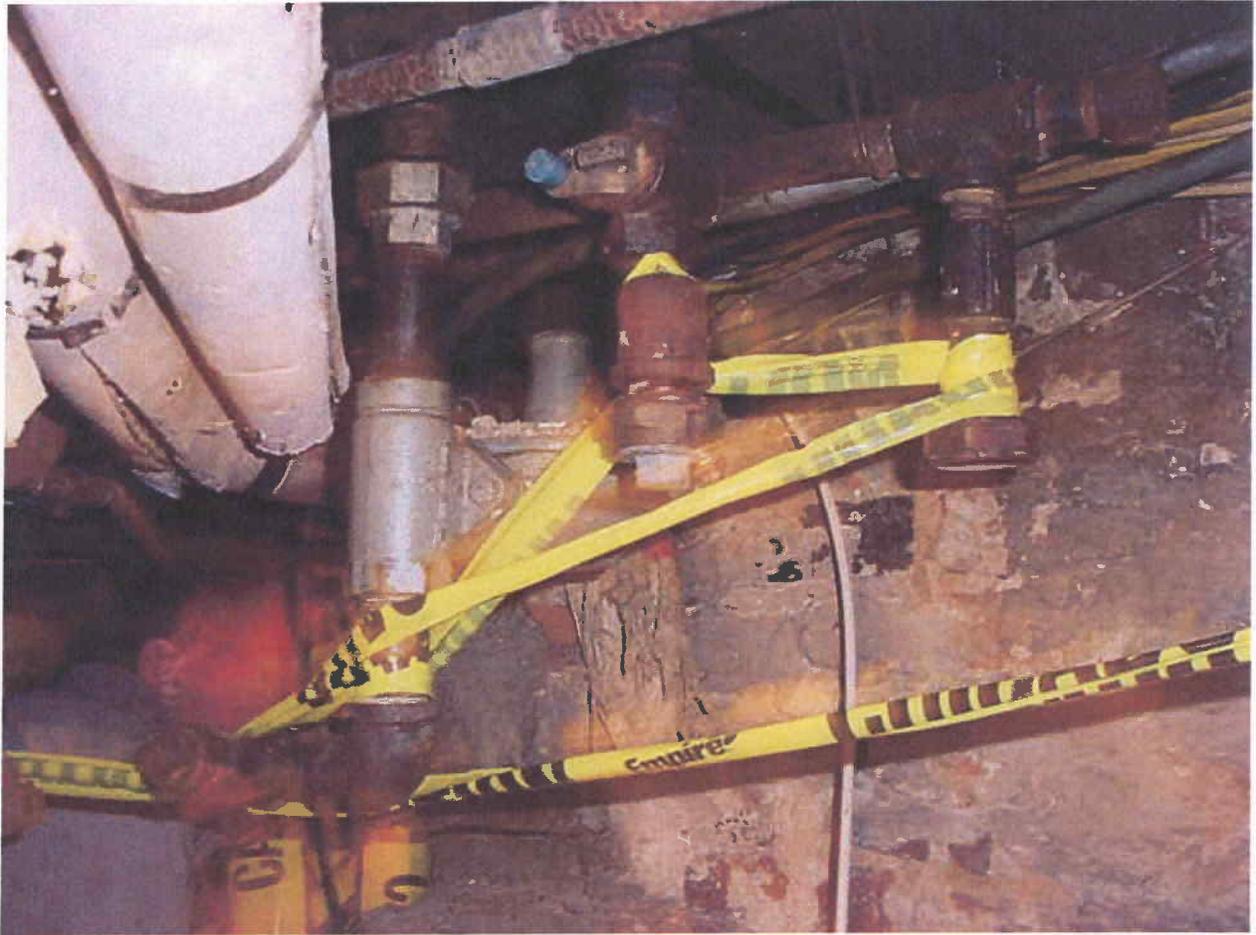
Location of Meter set in basement.

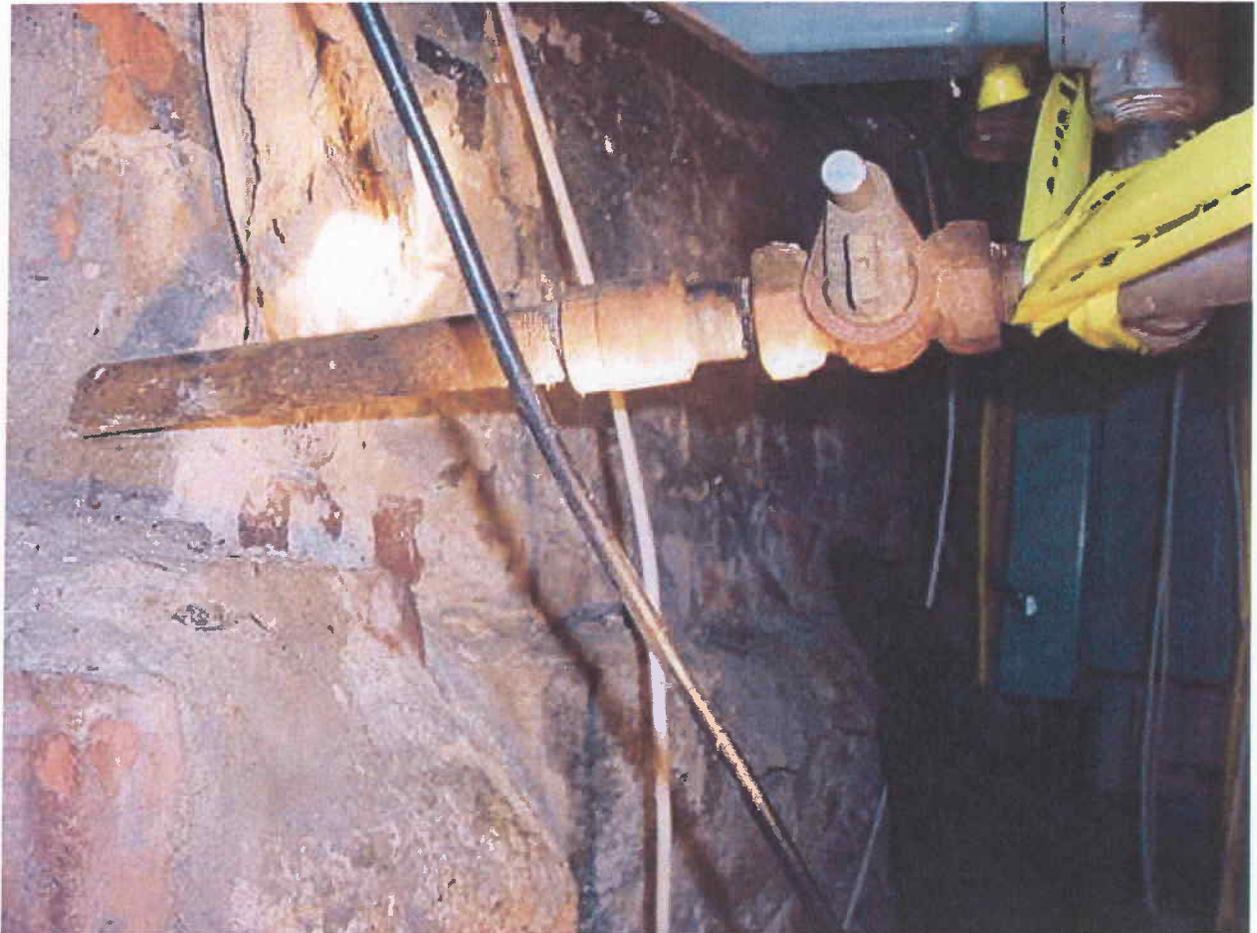
Service line and shutoff located in original basement entering from crawl space.

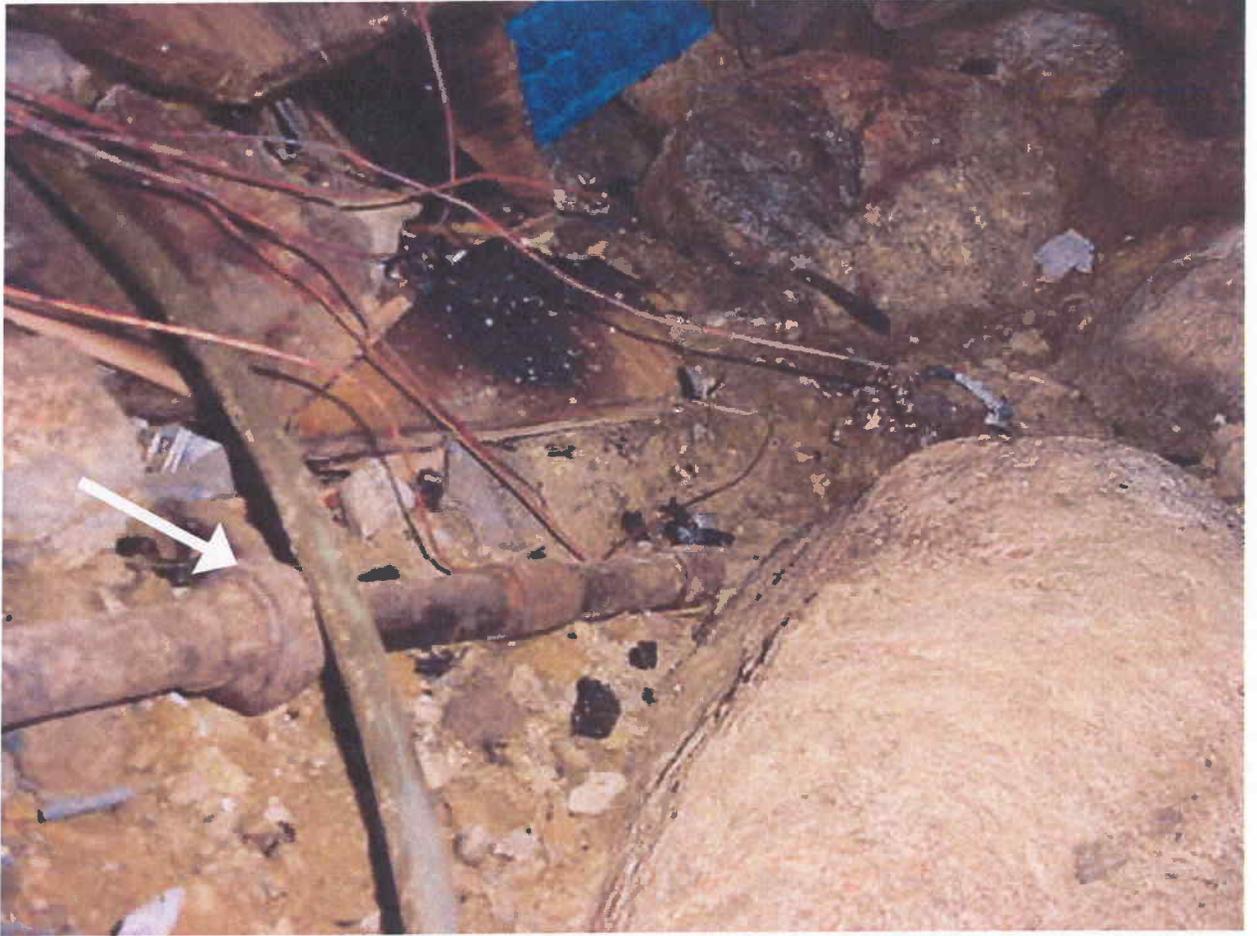
Threaded coupling where gas may have escaped

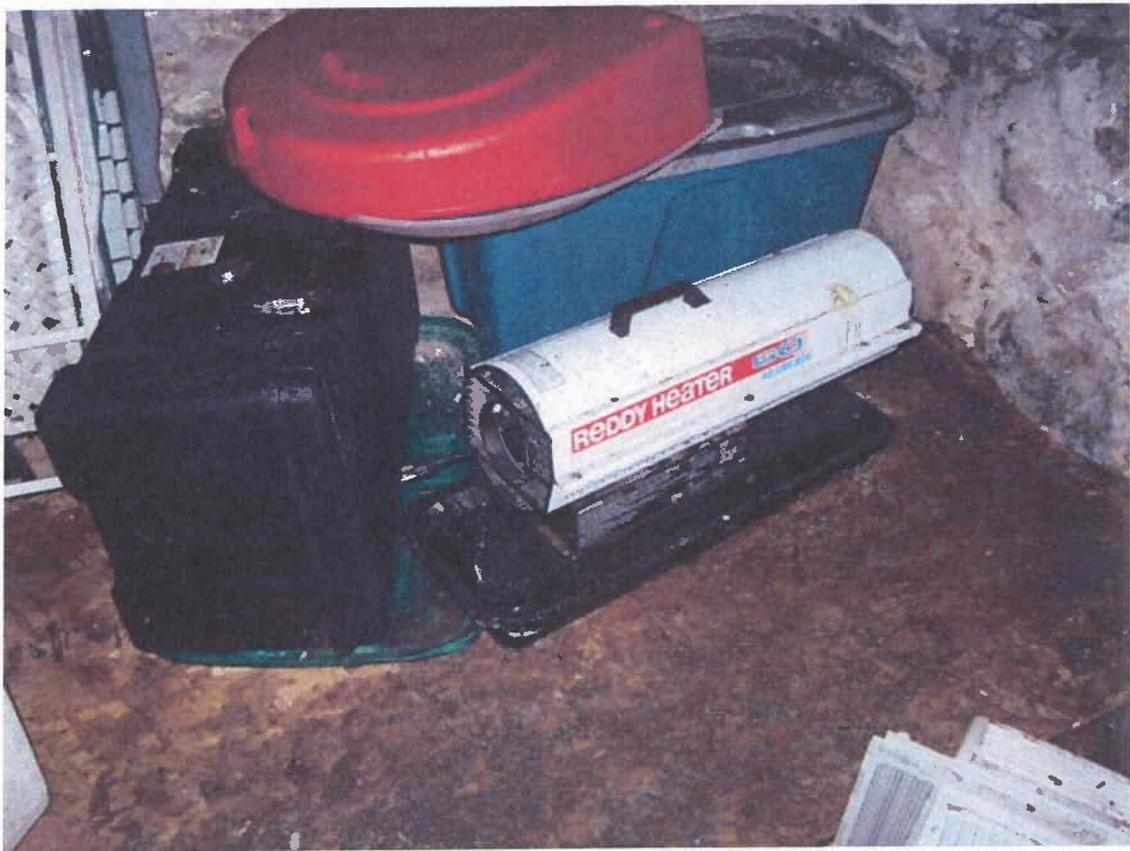
Space heater used in crawl space
