**DEPARTMENT OF
TELECOMMUNICATIONS & ENERGY**

PIPELINE ENGINEERING AND SAFETY DIVISION

INCIDENT REPORT

82 Marsh View Road, Chatham, Massachusetts
October 30, 2002

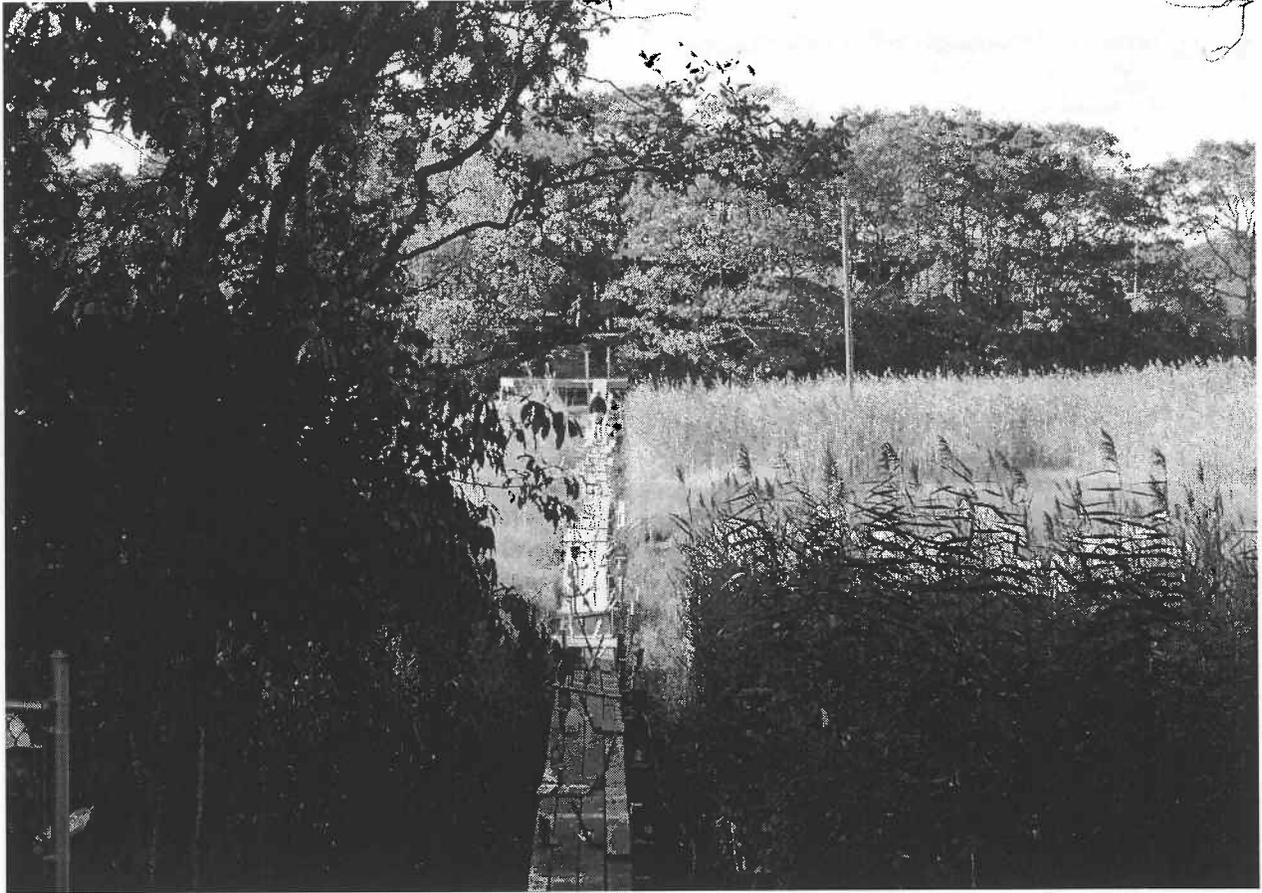
Exhibit 7: View of the marsh, the walkway to the island and the island.

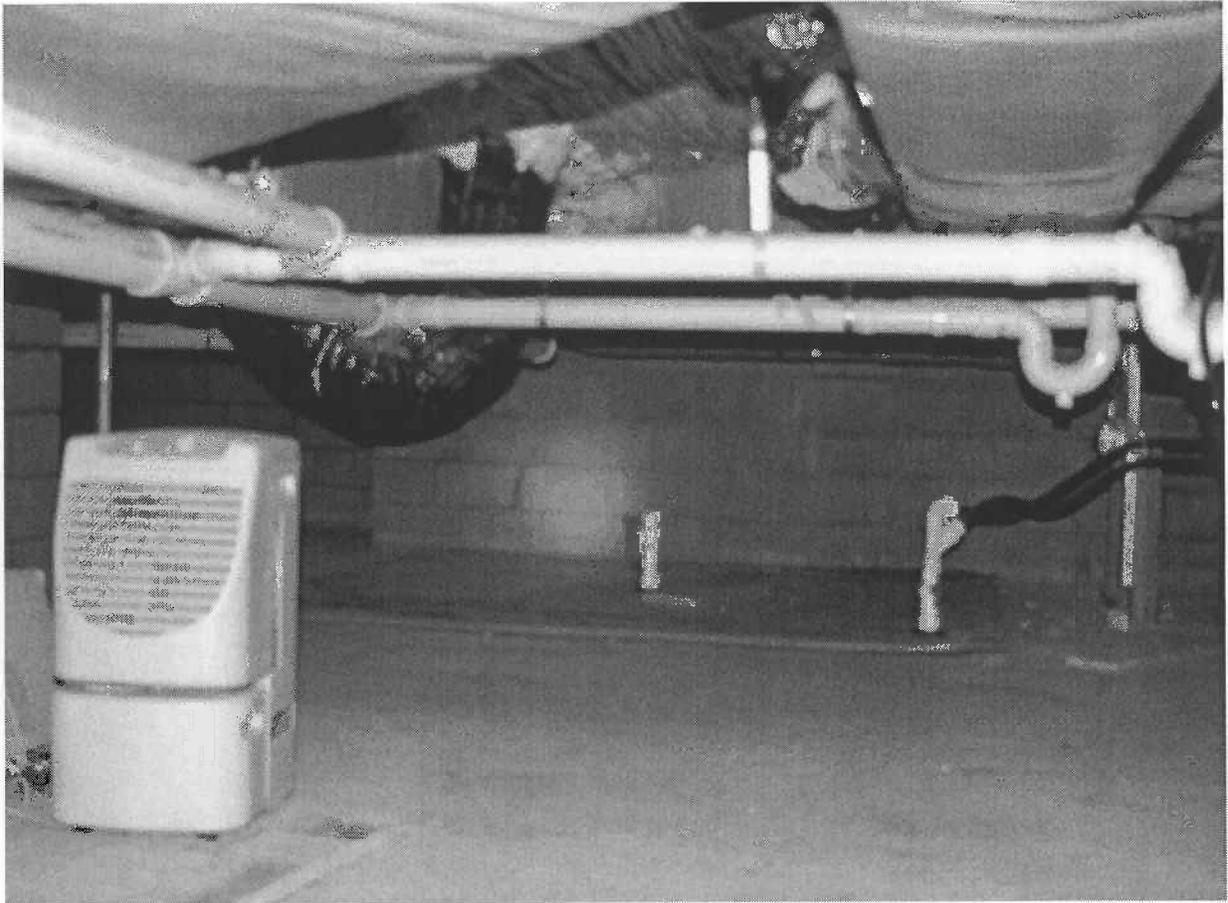
Exhibit 8: View of the half-basement.

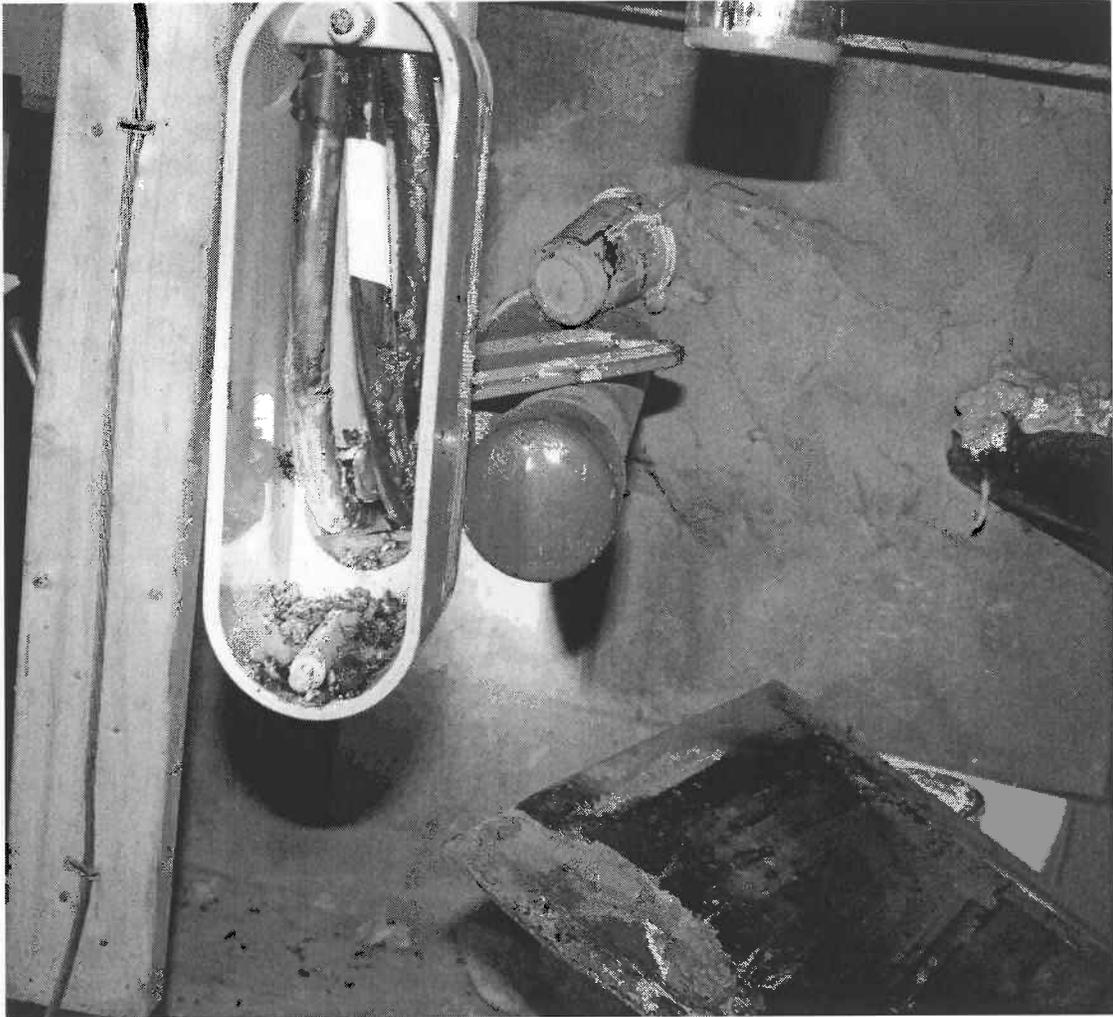
Exhibit 10a: View of electric conduit in the half-basement.

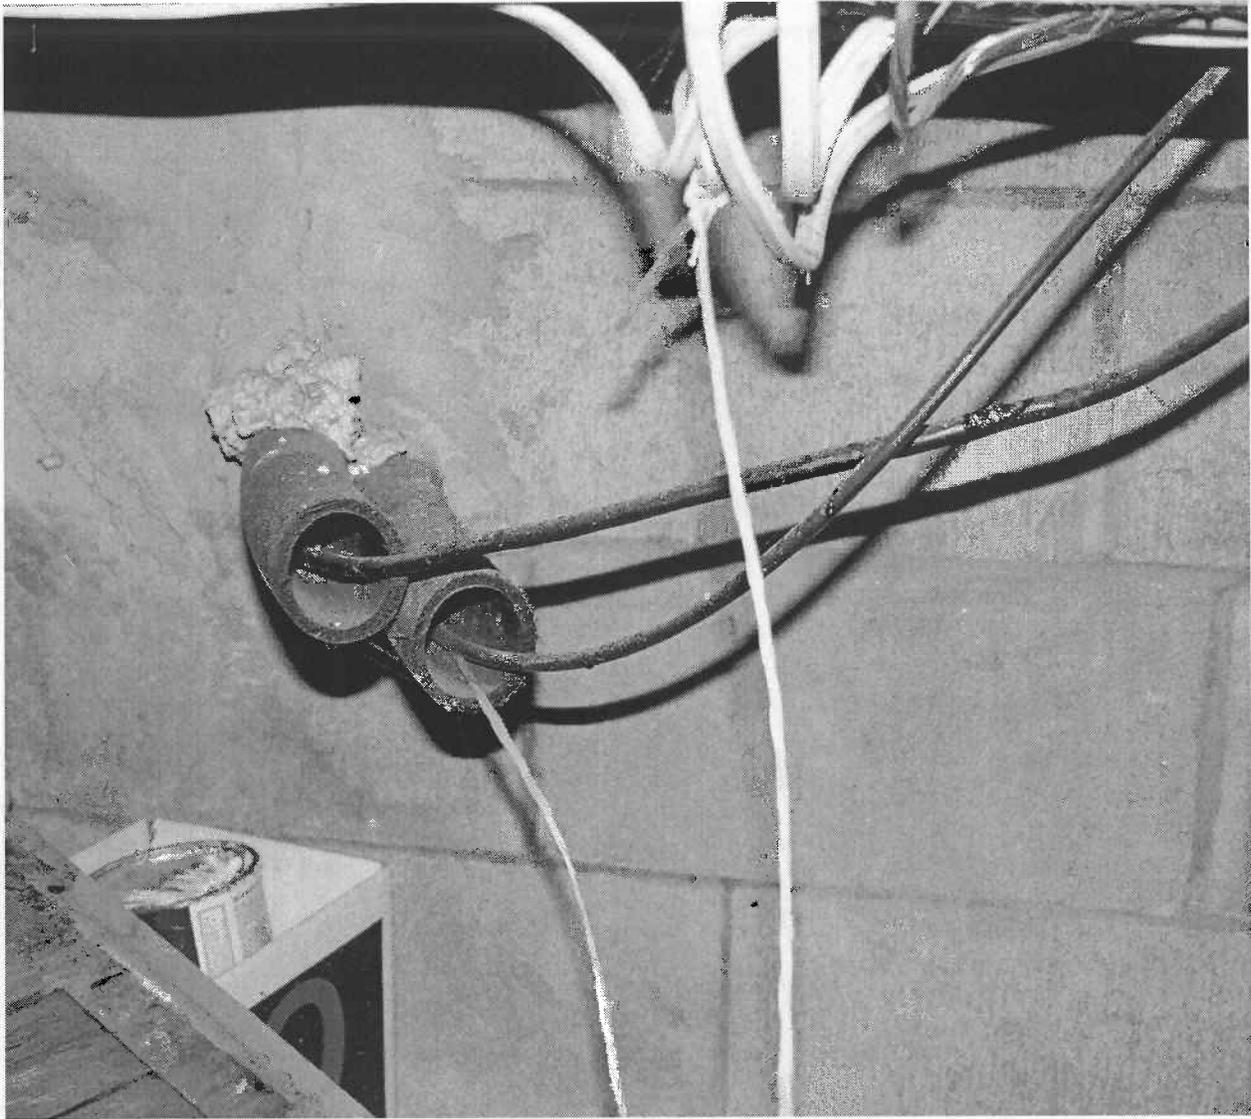
Exhibit 10b: View of the telephone conduit in the half-basement.

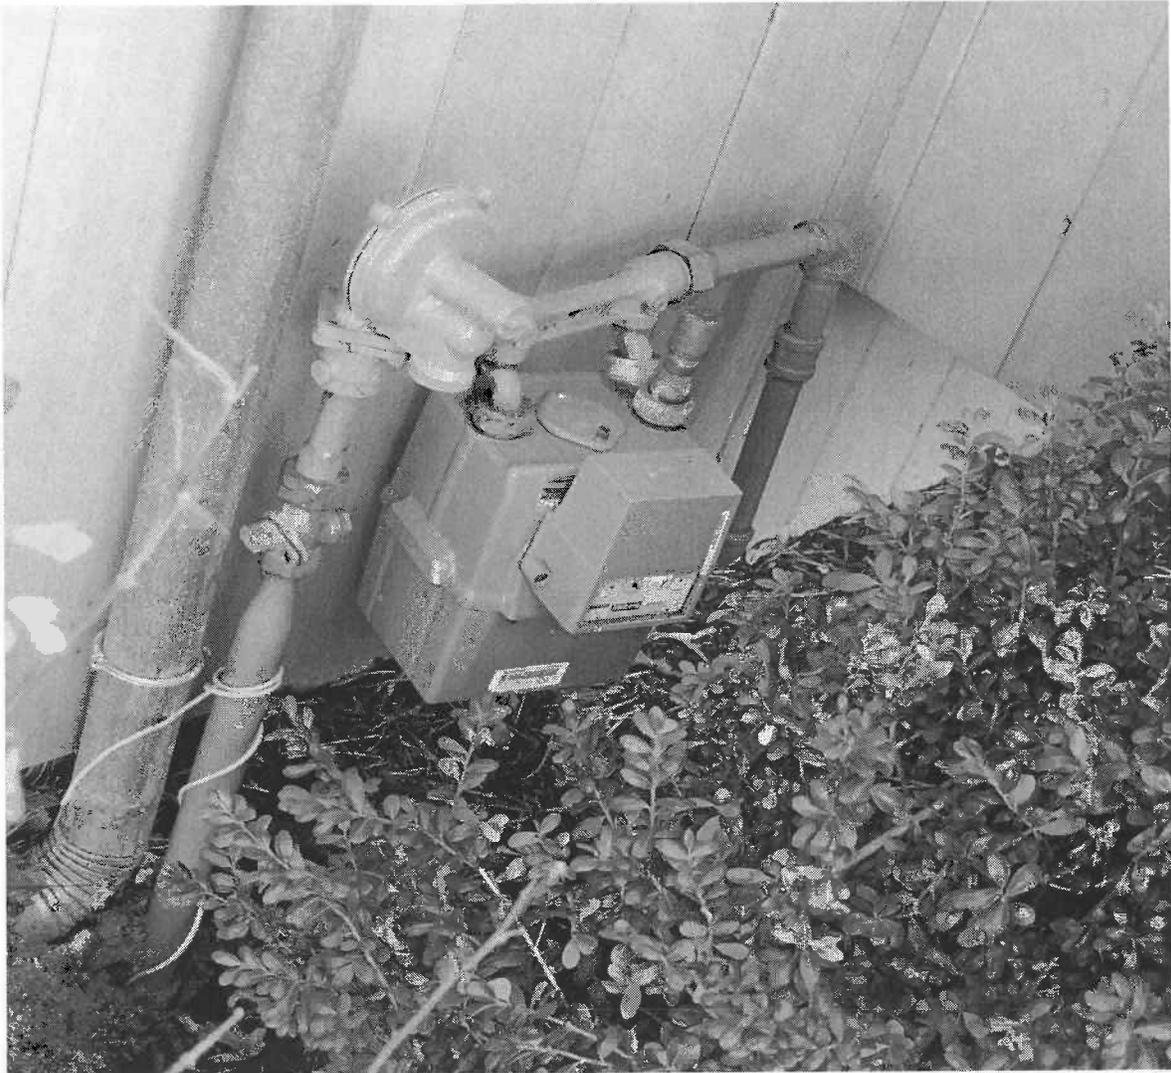
Exhibit 12: View of the gas meter and regulator located outside of the house.

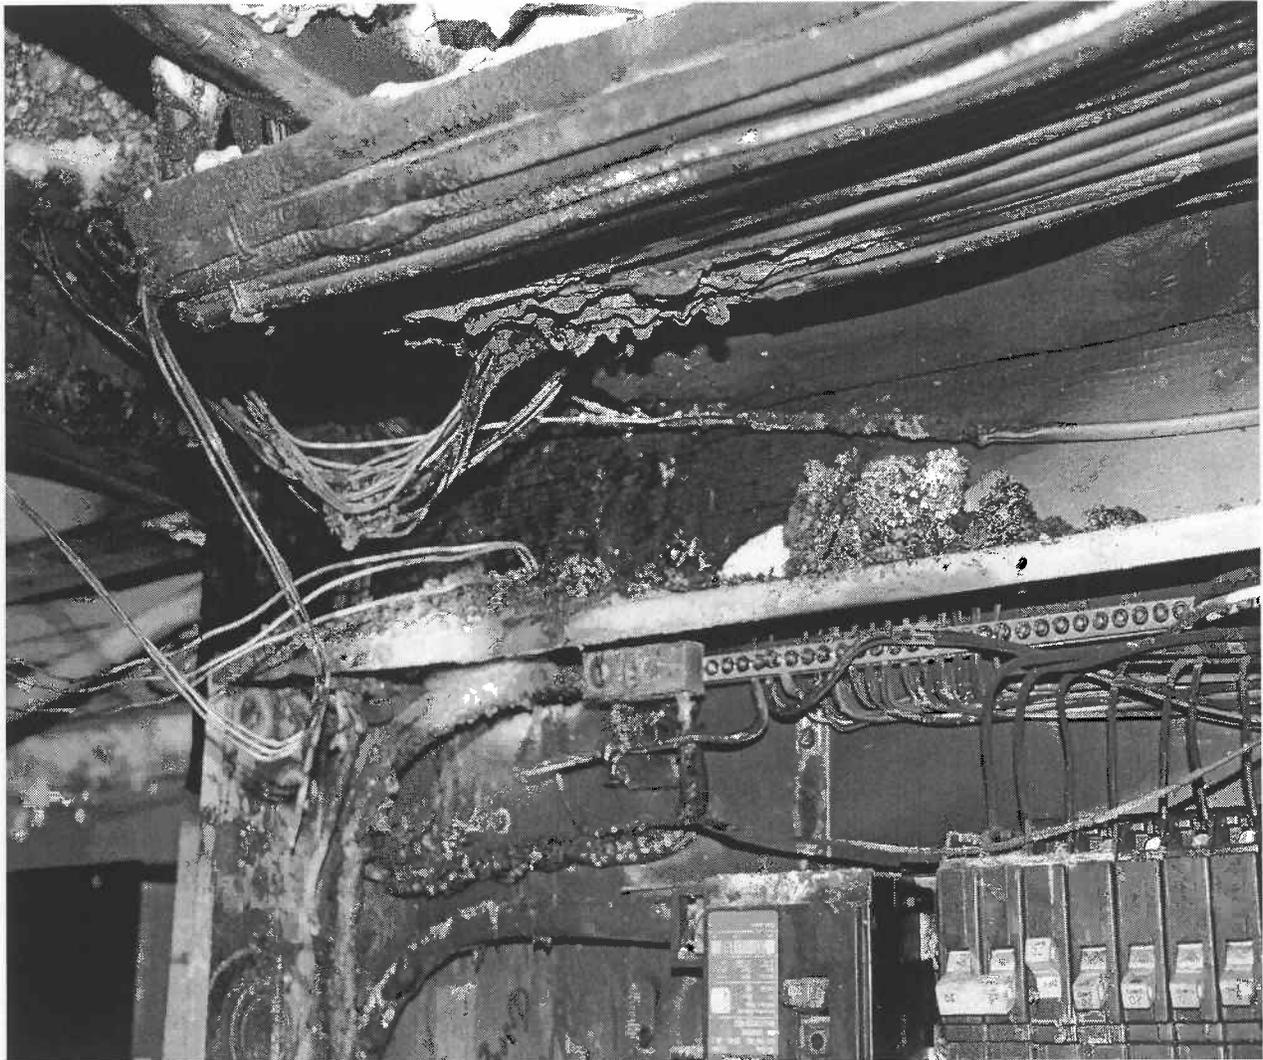
The Division investigator observed that there was some fire and smoke damage in the half-basement. There was fire damage to the wood structure, electrical wiring and insulation in the half-basement (Exhs. 13a, b). The upper level of the house displayed no visible damage (Exh. 14).

Exhibit 13a: View of some of the fire damage to the electrical wiring.

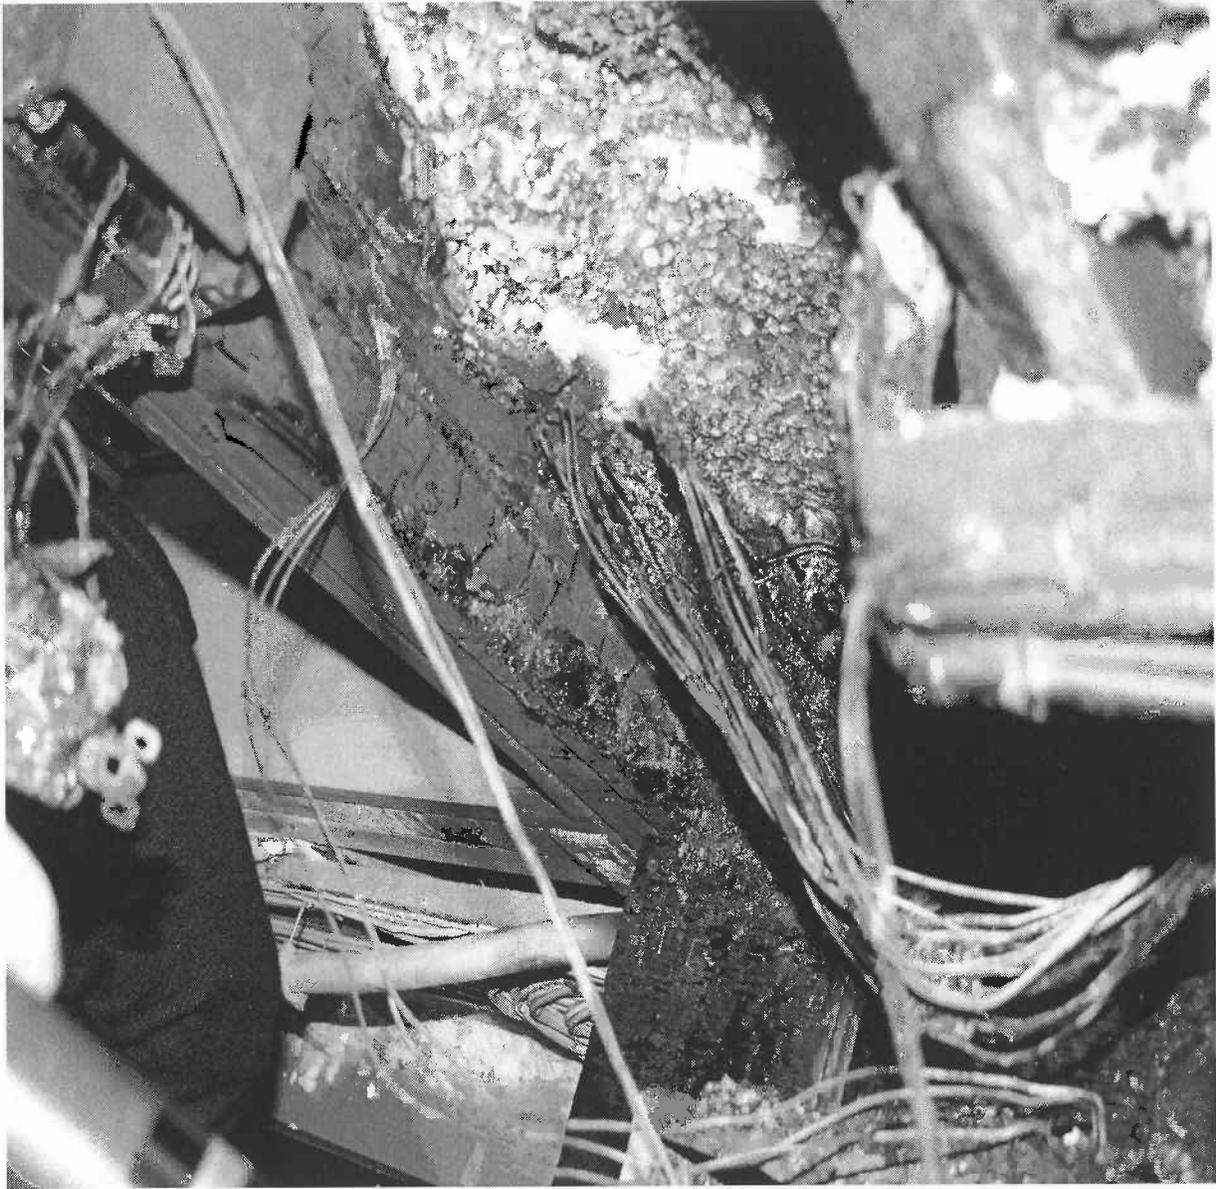
Exhibit 13b: View of fire damage to the wood structure, insulation and electrical wiring.

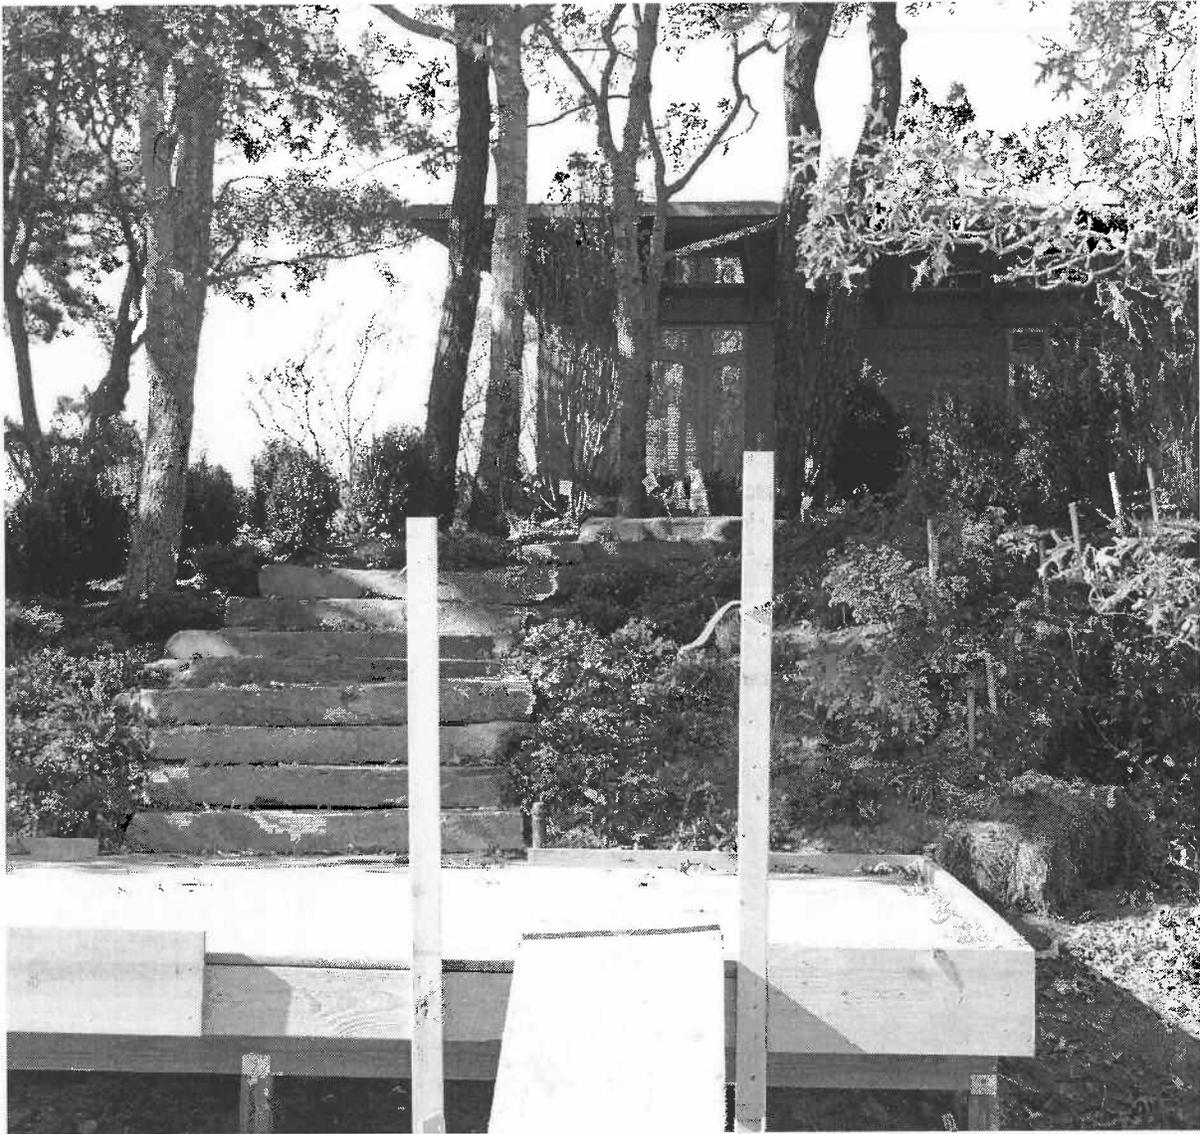
Exhibit 14: Close up view of the house. Orange cones show the location near the end of the sleeve where the service was cut and capped.

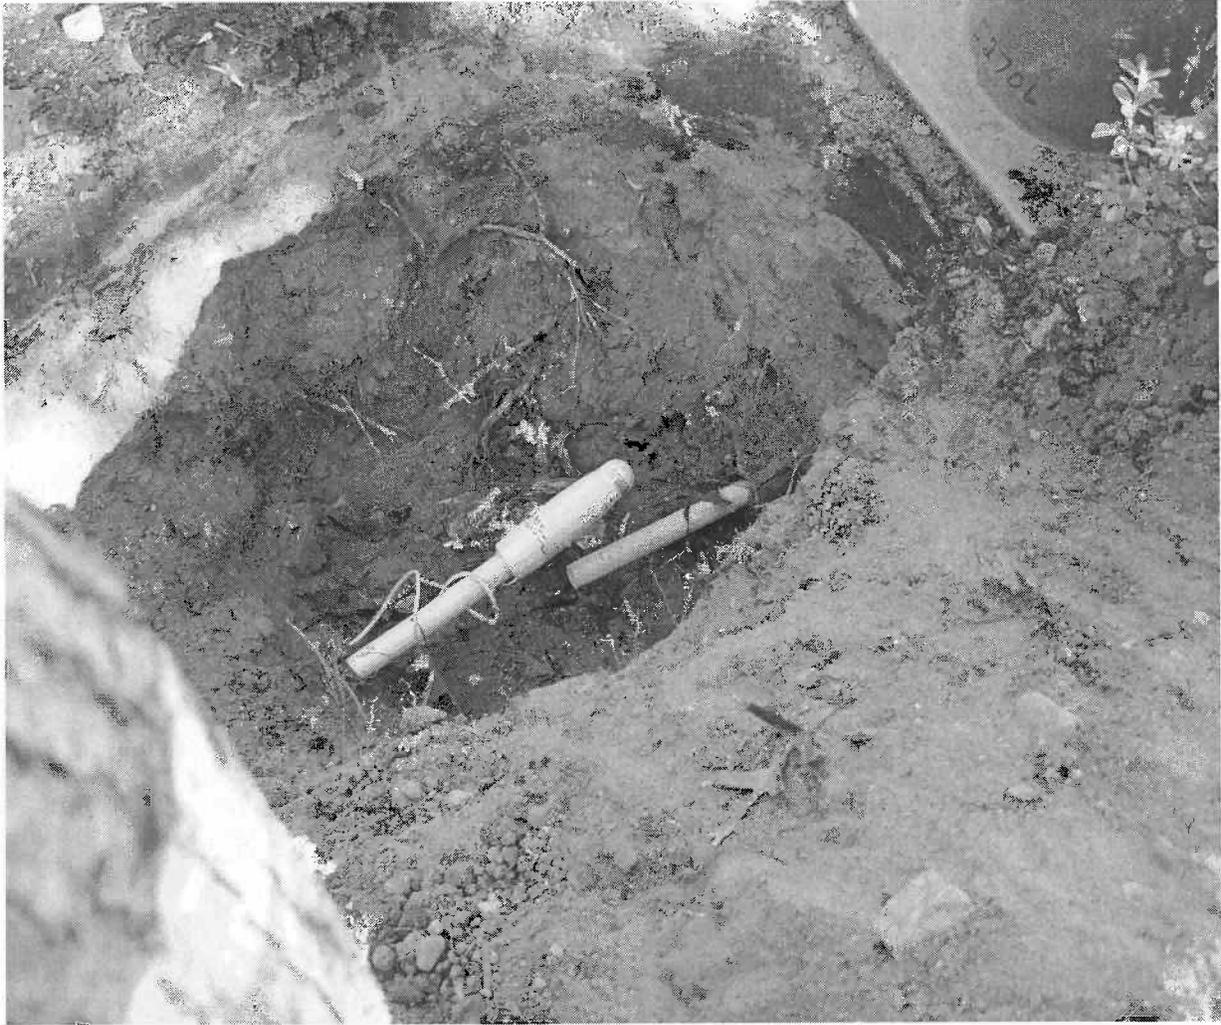
The Department inspector observed that the curb valve⁴ was closed and the service line had been cut and capped near the house (Exh. 15). On October 31, 2002, KeySpan excavated

Exhibit 15: View of the service where it was cut and capped on the island.

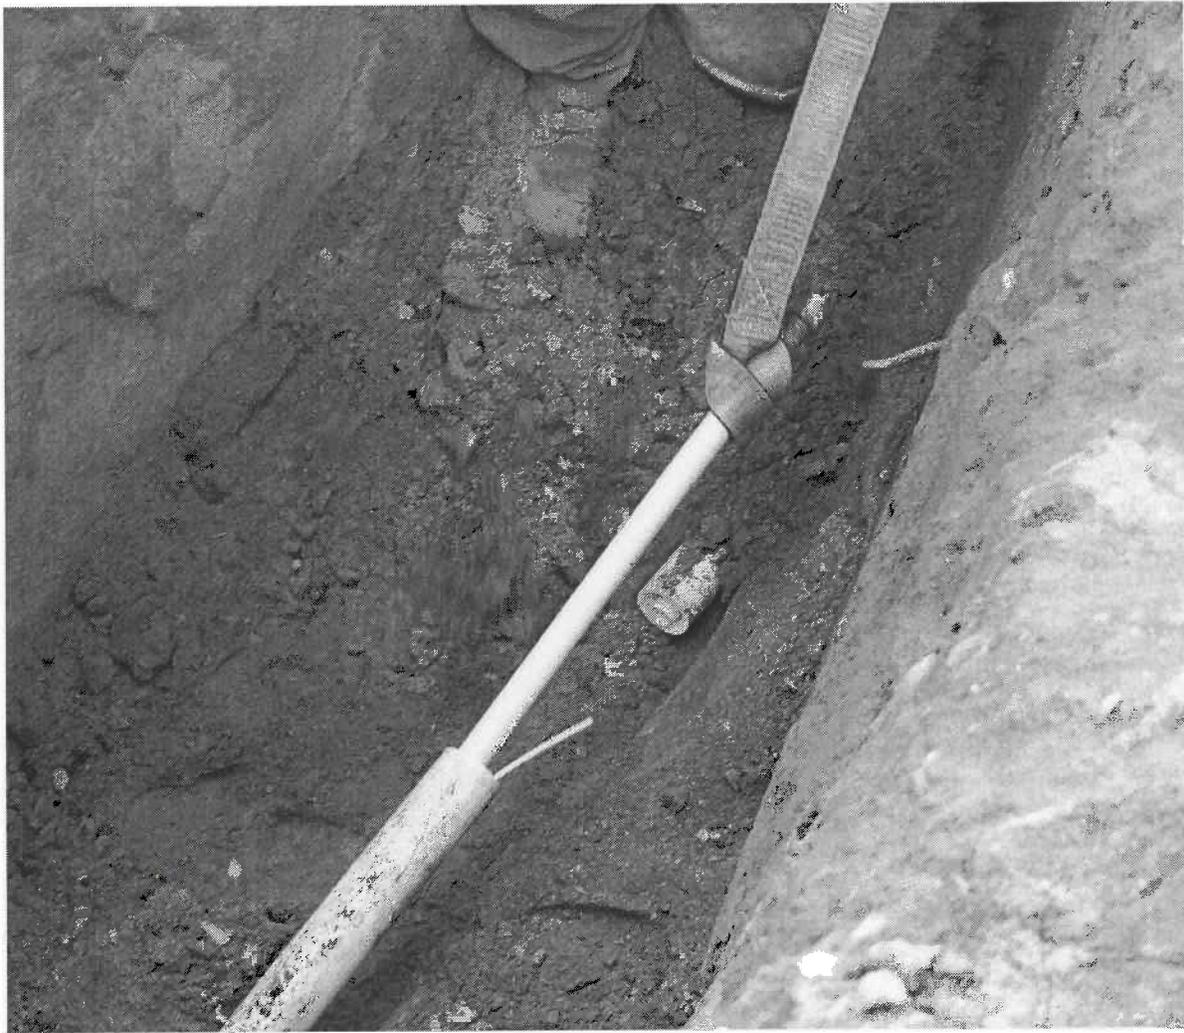
Exhibit 16: Service line being pulled out of the sleeve.

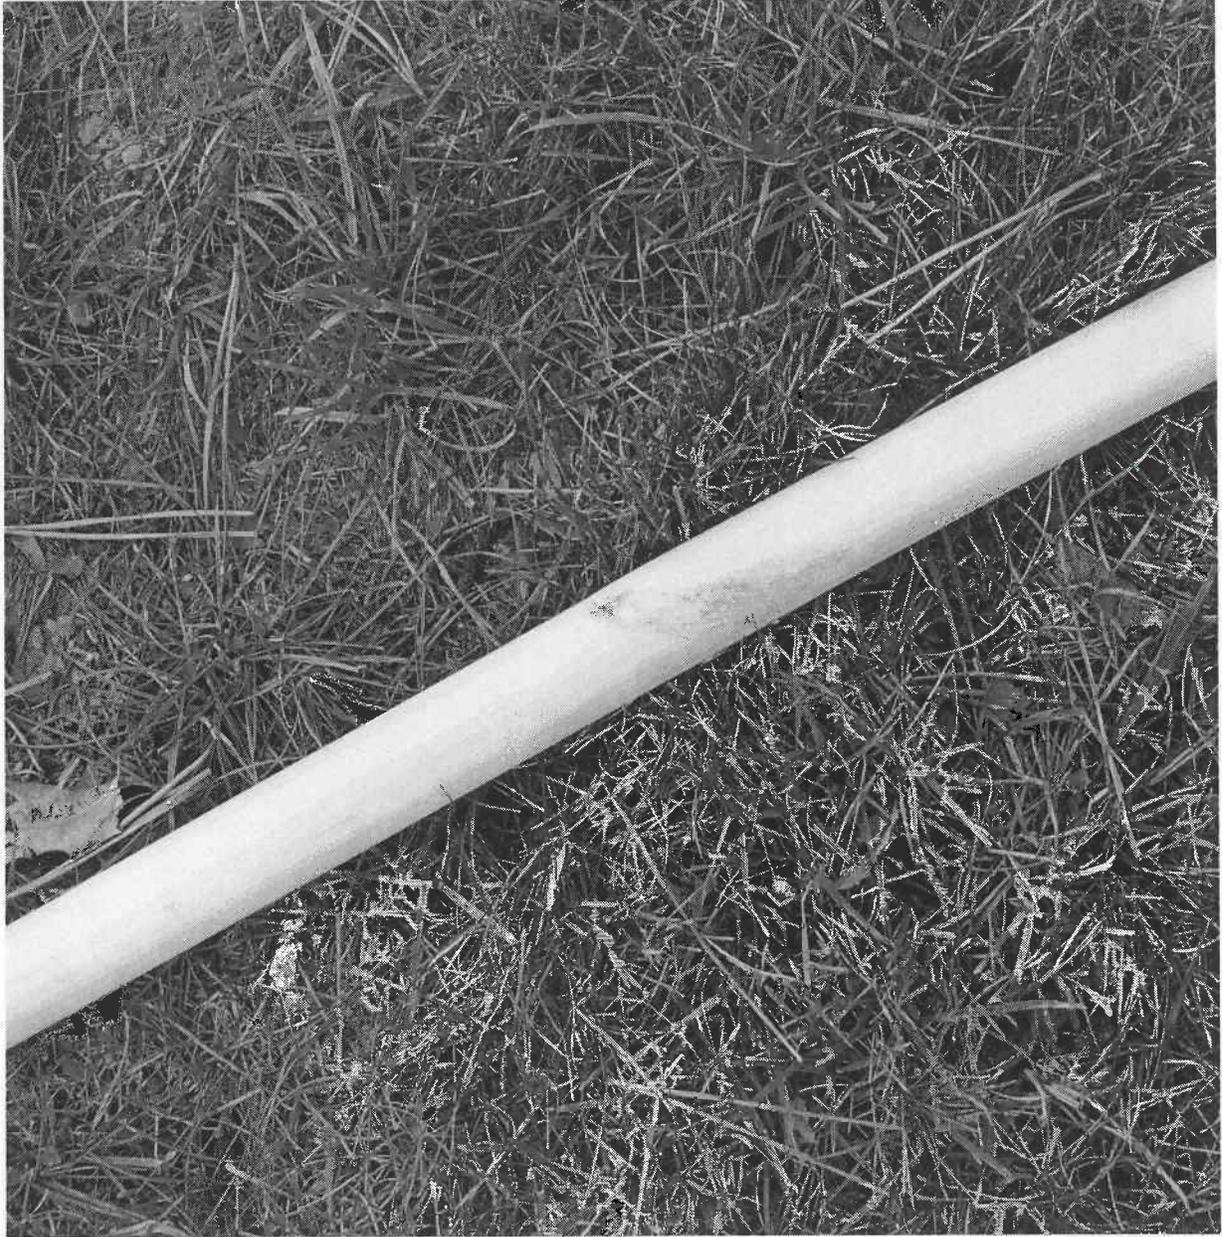
Once the street end of the service pipe and the conduit were exposed, the service pipe was extracted. There were scuff marks on the service pipe surface and there was also a hole in the service pipe (Exh. 17). The scuff marks and the hole were located 83 feet from service line cut made on the island (Exh. 21). On October 30, 2003, KeySpan excavated a small hole near the pier in question and a pool of water formed. KeySpan observed bubbles in the water. These were located in the marsh and were 83 feet from where the service line had been cut. (Exhs. 23a, b).

Exhibit 17: View of the service pipe showing the puncture and scratches.

Damage Repair
 PULLED 1" PL PIPE OUT OF SLEWING
 FOUND DAMAGED AREA, CUT OUT AND
 INSTALLED COP. CAPPED END AND
 TESTED AT 100 LBS FOR 25 MIN. *PIPE*
 TEST AT 2:20 PM - ALL OK - *ESTABLISH*
 CAP ON 1" FORMERLY ~~EXPOSED~~ *TOOK MEAS.*
 CAP ON BLUE TRUCK - ALSO CAPPED END
 HOUSE. GAS IS ON AT G.B. SOAP TESTED

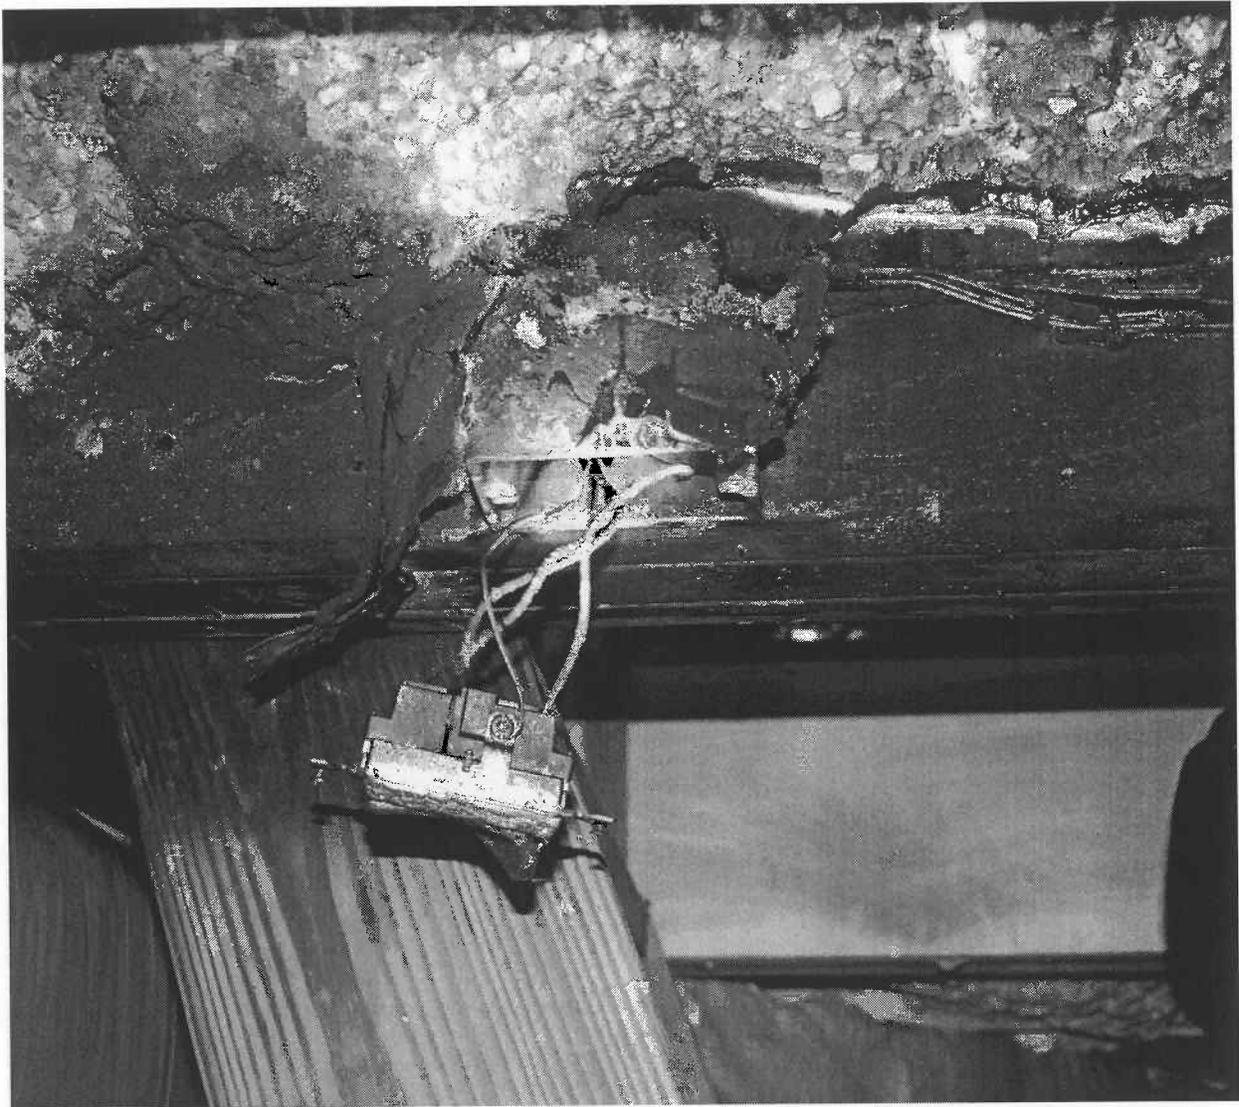
Exhibit 22: View of the light switch.

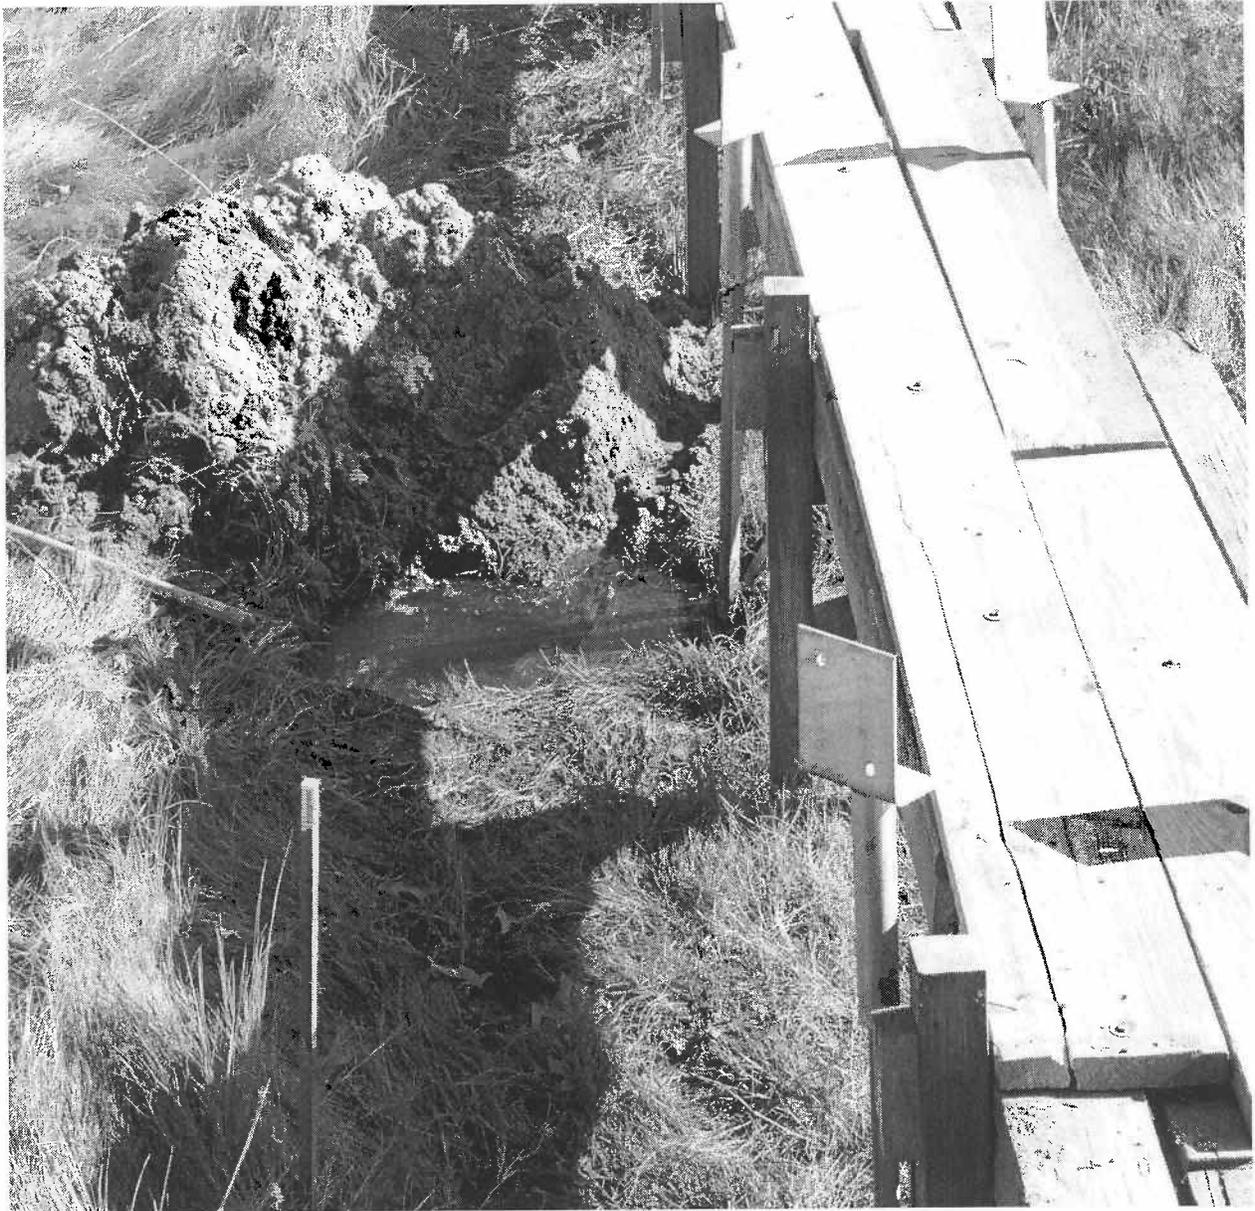
- (1) The contractor, Solid Earth Technology is found to be in violation of the notification provisions of G. L. c. 82, § 40.
- (2) A pier, drilled by the Contractor on October 28, 2002, punctured the service line and the conduit in which it was located..
- (3) The puncture allowed gas to escape into the conduit.
- (4) Some of the gas flowed through the conduit to the island and into the ground.
- (5) The gas flowed into the half-basement of the house through penetrations in the foundation wall.
- (5) The gas was ignited by the maintenance man turning off the light switch.
- (6) The flash fire was attributable to hazardous gas concentrations in the house.

Exhibit 23a: View of the pier at the location where the pipe was damaged.

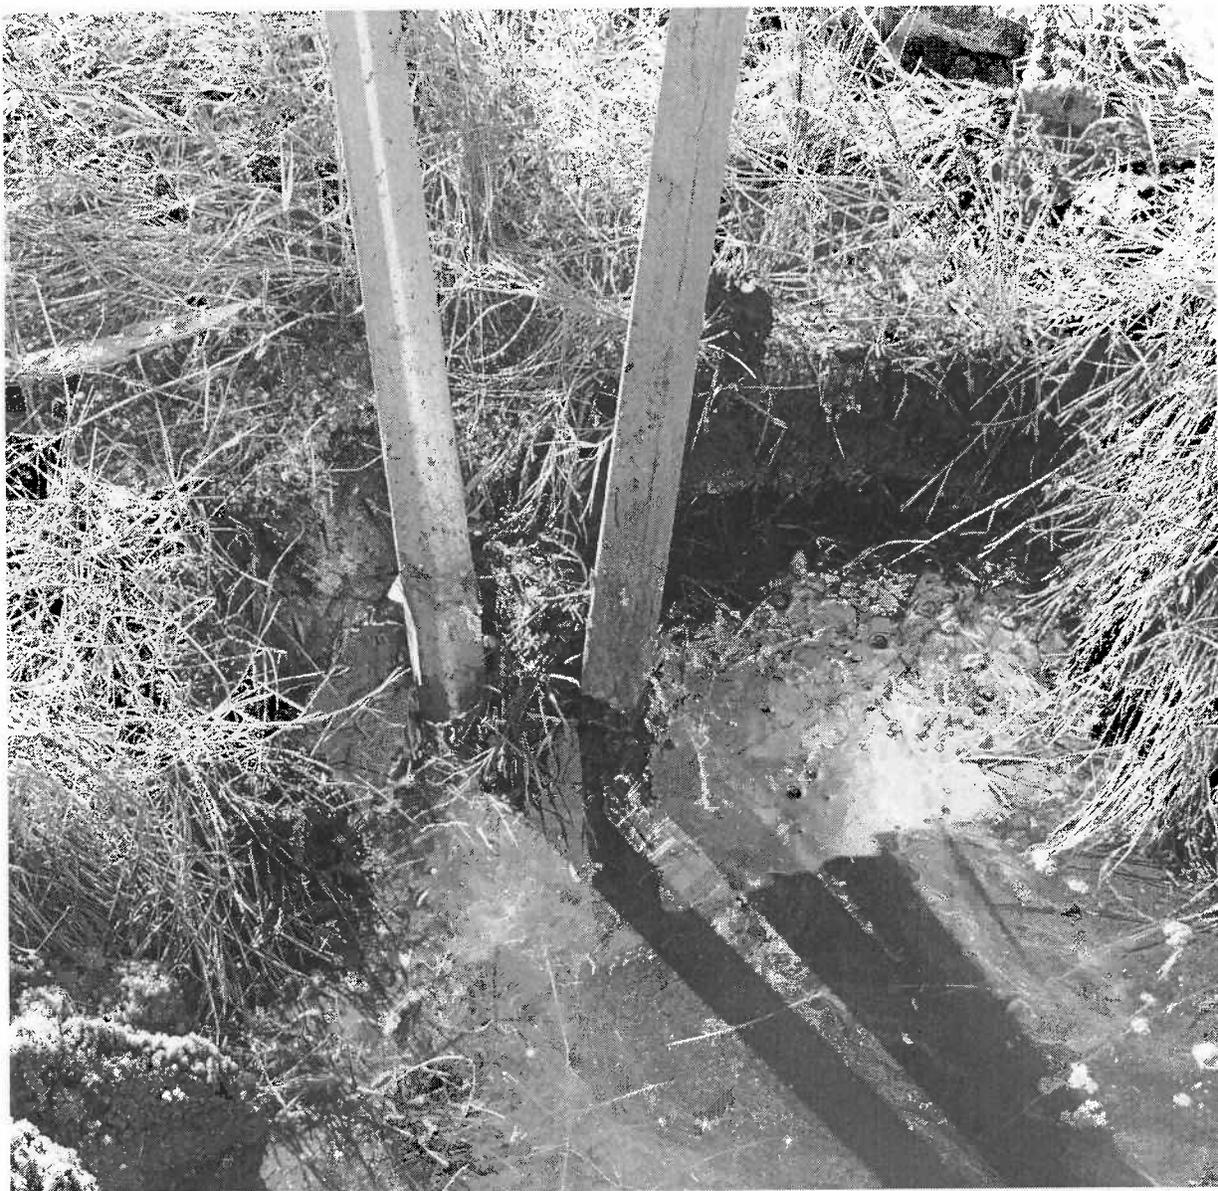
Exhibit 23b: Close-up view of the pier at the location where the pipe was damaged. Note the gas bubbles in the water.
