DEPARTMENT OF PUBLIC UTILITIES

INCIDENT REPORT

Overpressurization
3 Hancock Avenue, Lexington, Massachusetts
November 9, 2005

PIPELINE ENGINEERING AND SAFETY DIVISION

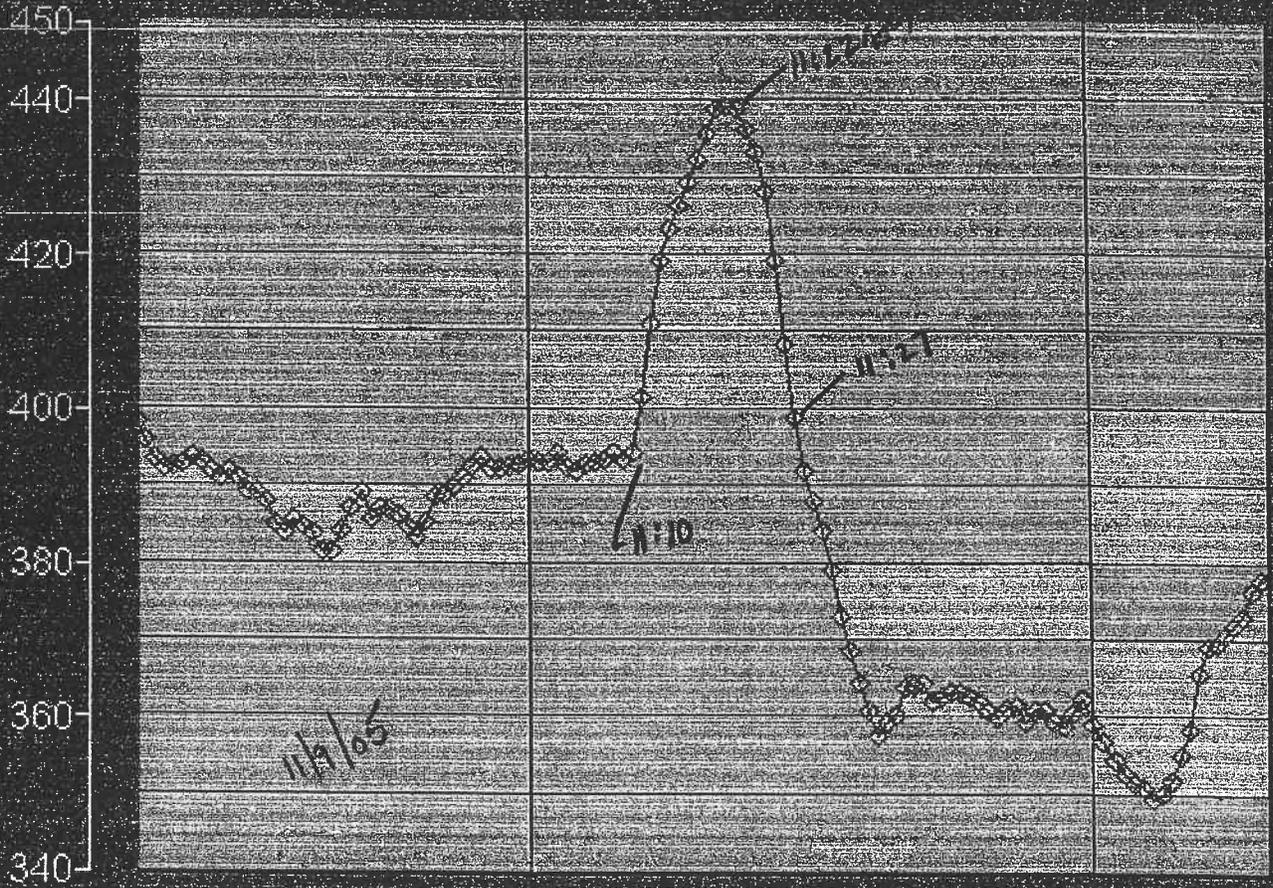
Lexington Take Station outlet

As a result of the over-pressurization, the home at 3 Hancock Avenue was destroyed and KeySpan reported leaks on company owned piping at 11 other addresses. Further, KeySpan found and replaced 165 service regulators that had been compromised (Exh. 3). In addition 317 gas meters were subsequently replaced (Exh. 6). KeySpan stated that the two psig system returned to normal operating pressure at 12:04 p.m. (Exh. 3,4).

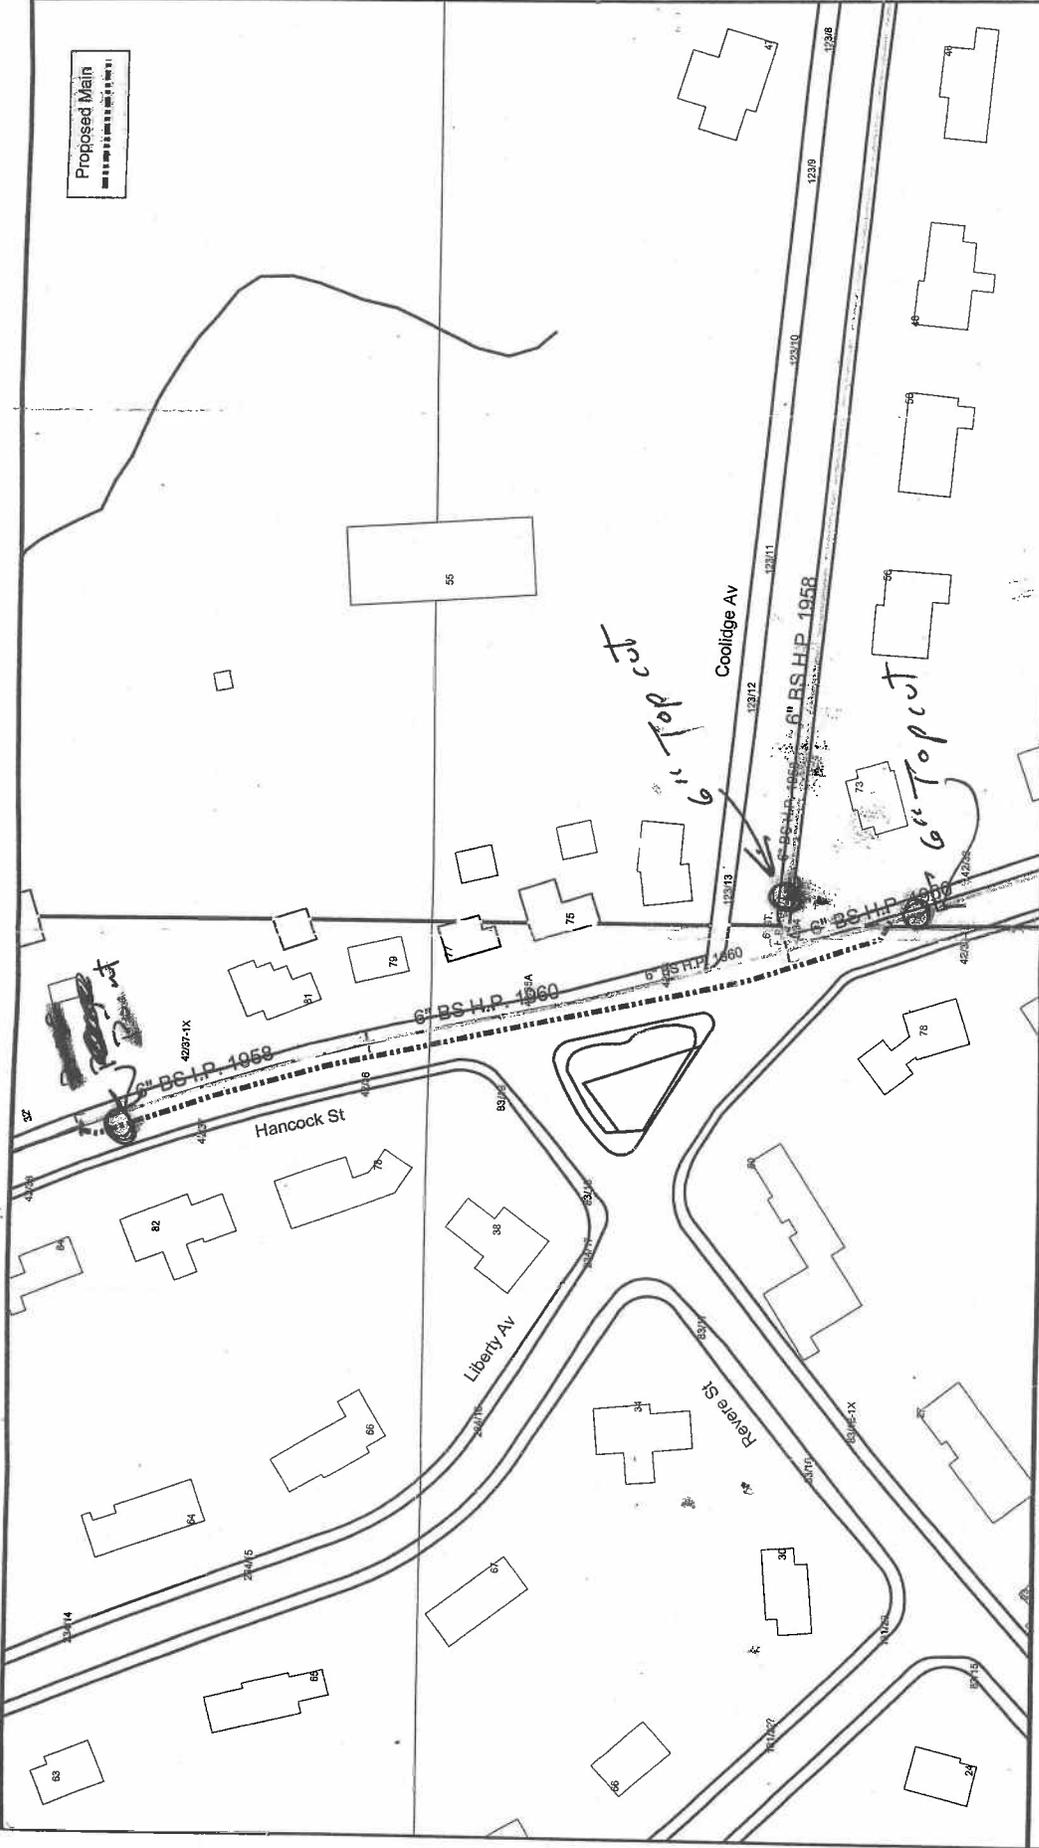
Distribution Systems Map Showing
Where the Hot Taps Were Made

1. The over-pressurization of the two psig system to 56 psig exceeded the maximum allowable operating pressure of the two psig system.
2. The map which the KeySpan supervisor and crew relied upon for the main replacement project in Lexington was not comprehensive and current.

As part of the 2005 Bare Steel/Wrought Iron Replacement Program Supplemental Budget, Corrosion Control recommends the relay of approx. 550 feet of 6 inch BS (1960) with 6 inch PL from the exst 6 inch PL at #84 to Coolidge Av.
