DEPARTMENT OF PUBLIC UTILITIES

INCIDENT REPORT

3 Hancock Avenue, Lexington, Massachusetts
November 9, 2005

PIPELINE ENGINEERING AND SAFETY DIVISION

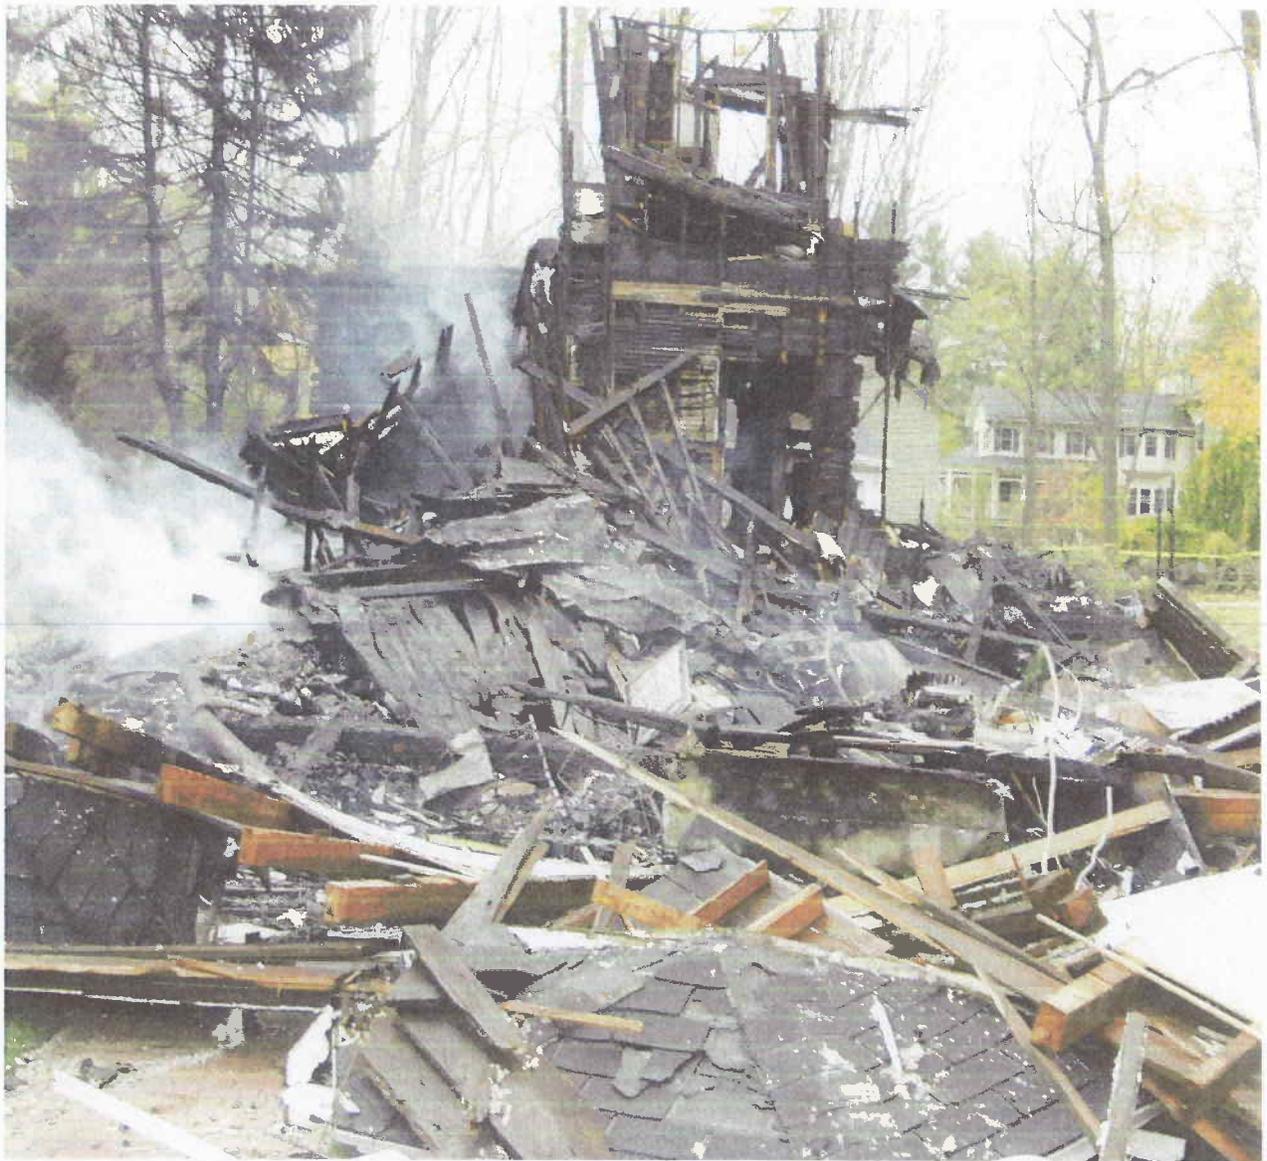
EXHIBIT 8

Photograph - 3 Hancock Avenue, Lexington,
following explosion and ensuing fire

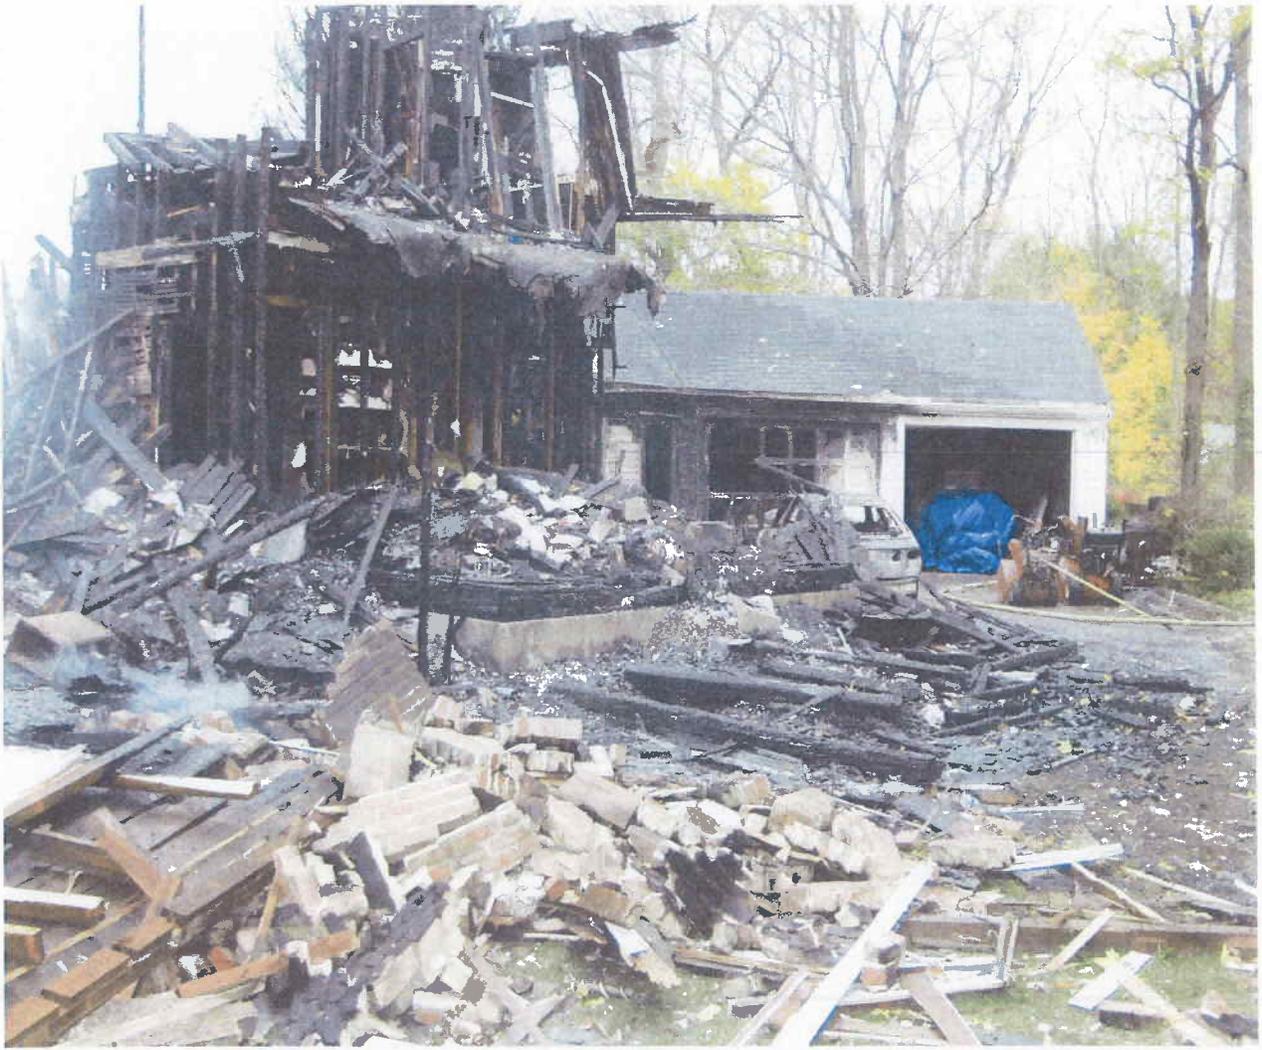
EXHIBIT 9

Photograph - 3 Hancock Avenue, Lexington, collapsed into basement. Adjacent two car garage was partially destroyed

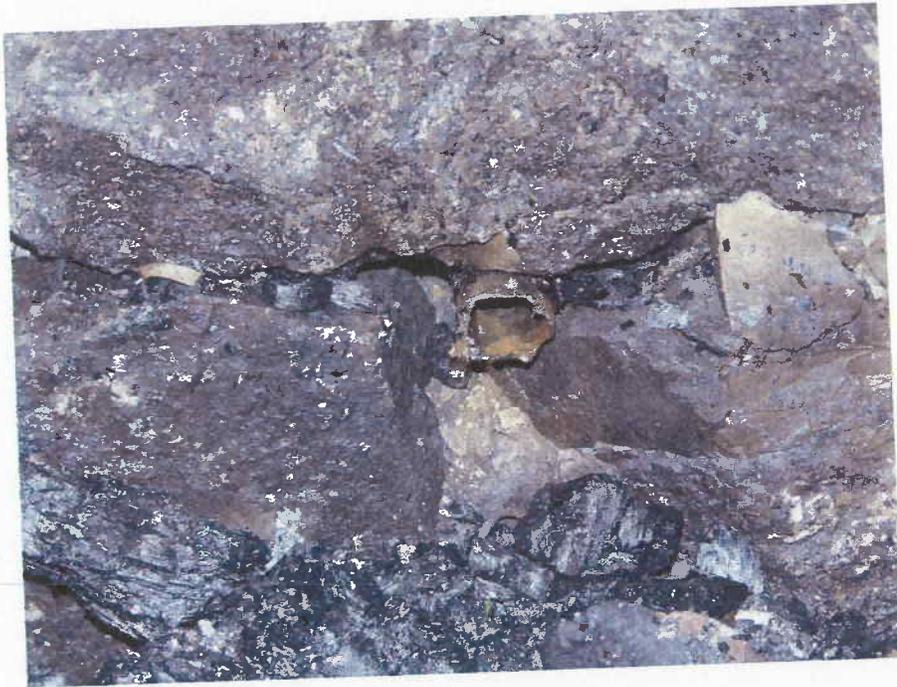
This incident was caused by the over-pressure event on the two psig gas main resulting in a blown out section of corroded inlet pipe on the service line to 3 Hancock Avenue. The corroded region of pipe surrounding the missing blown-out material revealed regions where the pipe wall was corroded through. This indicates that portions of the pipe retaining pressure consisted solely of corrosion products. The corroded portion of pipe was visible to inspection outside the inner foundation wall surface in the cellar of 3 Hancock Avenue.

Figure 26: Inlet pipe prior to dismantling incident location foundation wall. Note fracture and blowout location are visible. Photo courtesy of DTE.

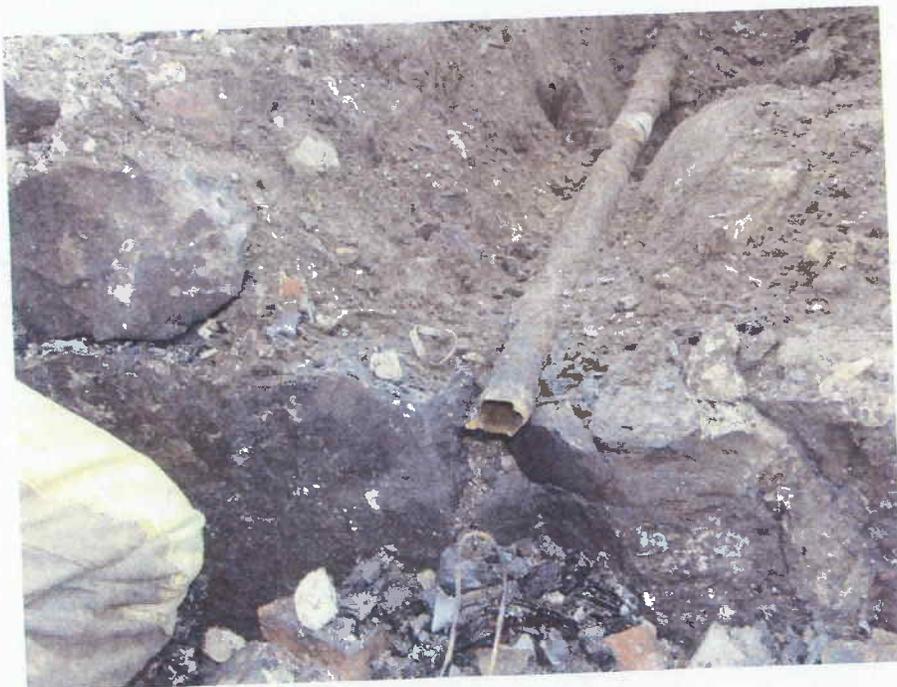
Figure 27: Cut end of inlet pipe exposed. Photo courtesy of DTE.

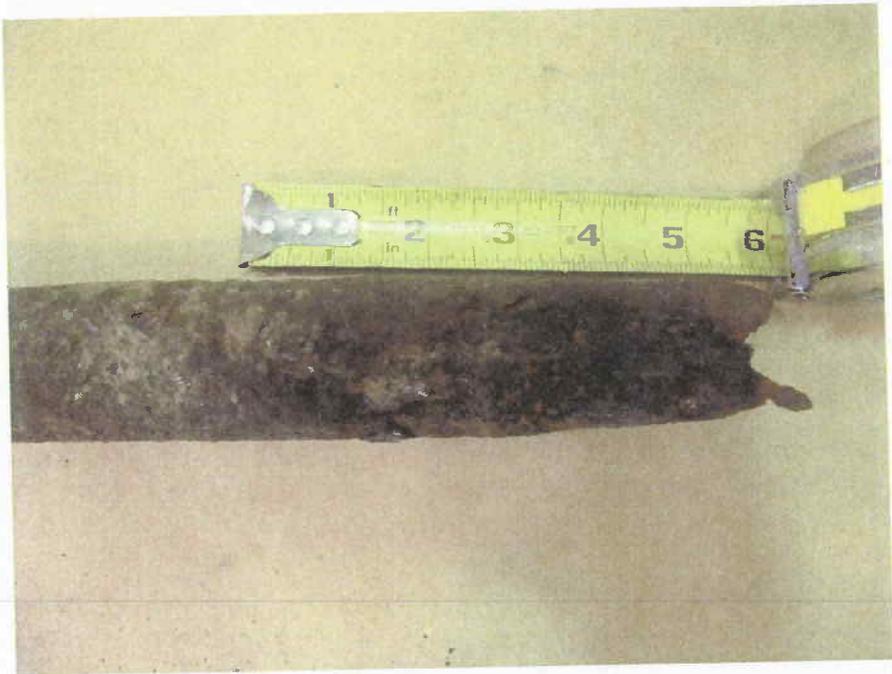
Figure 24: Approximate extent of sooty debris on pipe OD.

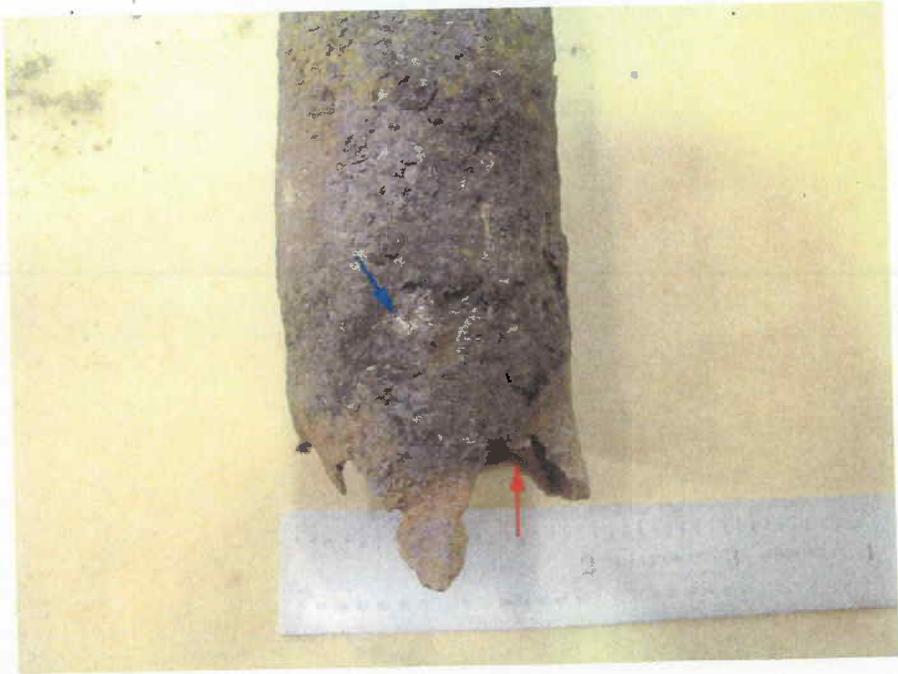
1. The fractured end was corroded to a knife-edged appearance and the corrosion appeared to be from the outer surface to the inner surface.
2. On-site photographs taken after the incident during the dismantling of the foundation to excavate this pipe revealed that the fracture surface was visible at the cellar wall.
3. Examination of the fracture origin region revealed extensive corrosion at the knife-edged region rimming the blown-out section.
4. The inlet pipe examination revealed that the metal at the fracture origin had been completely consumed by corrosion products by the time of the incident.

Figure 25: Blown-out material and fracture origin location, red arrow. White debris at blue arrow.

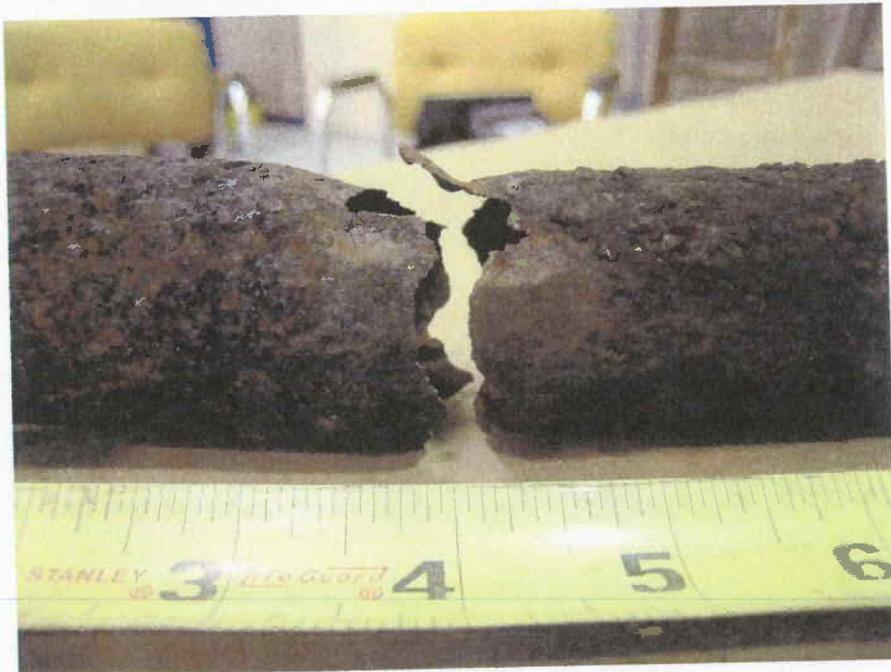
Figure 30: Inlet pipe (foundation side), right, and inlet pipe assembly, left, mating fractures aligned and viewing 12 o'clock position at front.

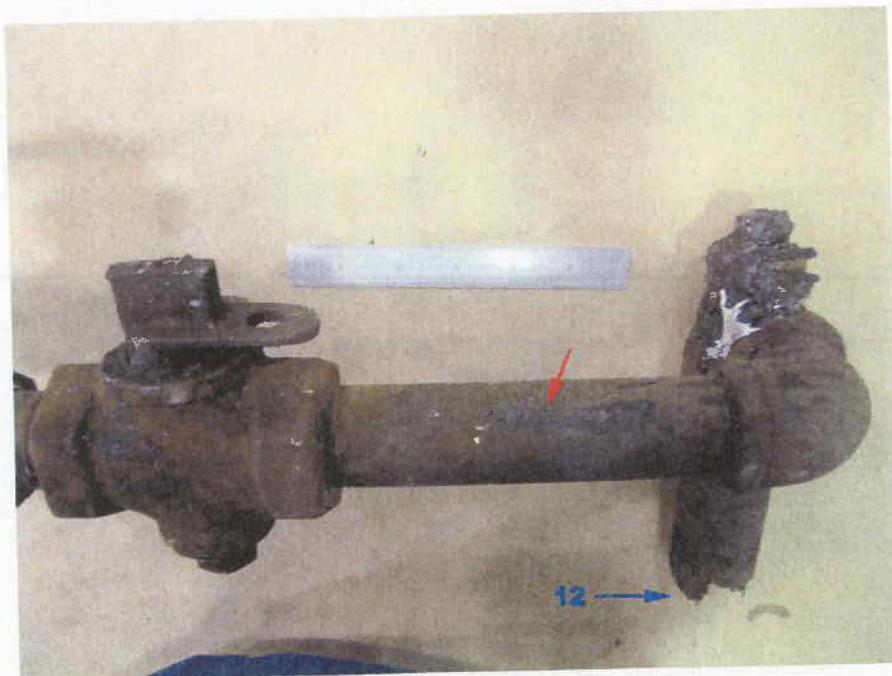
Figure 31: Inlet pipe assembly showing drip marks upstream of shutoff valve, arrow. In-service 12 o'clock position on inlet pipe fracture marked.
