INCIDENT REPORT

1415 Osterville Road, West Barnstable, Massachusetts
Cape Cod Animal Hospital
March 9, 2009

PIPELINE ENGINEERING AND SAFETY DIVISION

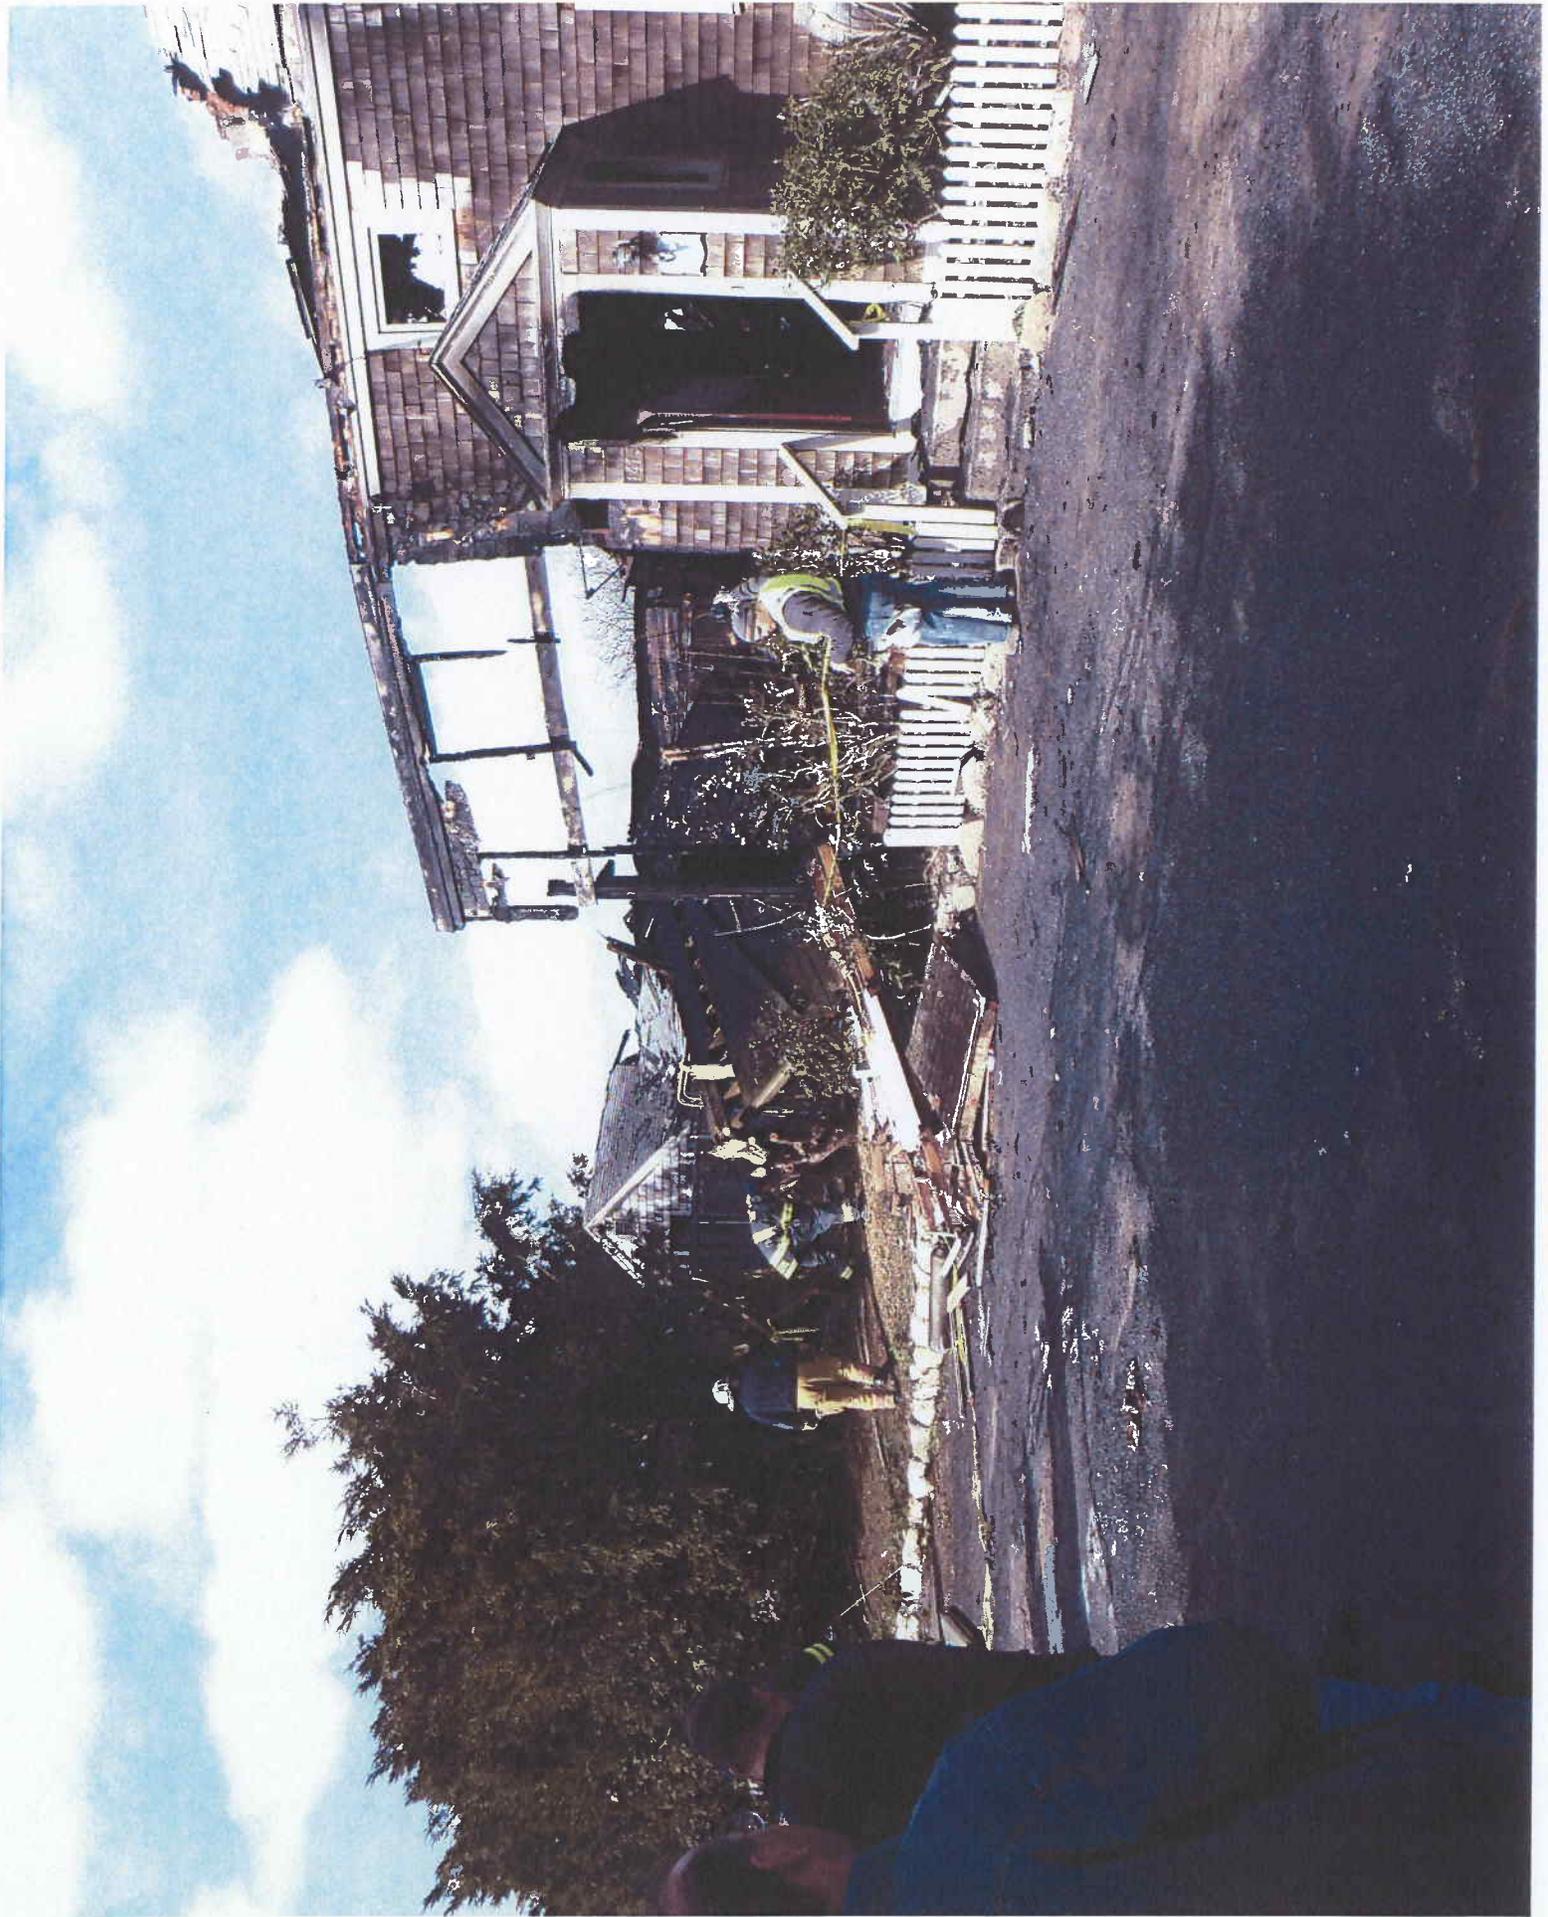
EXHIBIT 4

The Division investigators observed that the main portion of the building had been completely destroyed. The roof, the second and first floors had collapsed in the front left portion of the main building. Windows had been blown out and were approximately 75 feet from the building (Exh. 9). National Grid estimated the damage to be \$350,000 (Exh. 10).

Damage to 1415 Osterville Road

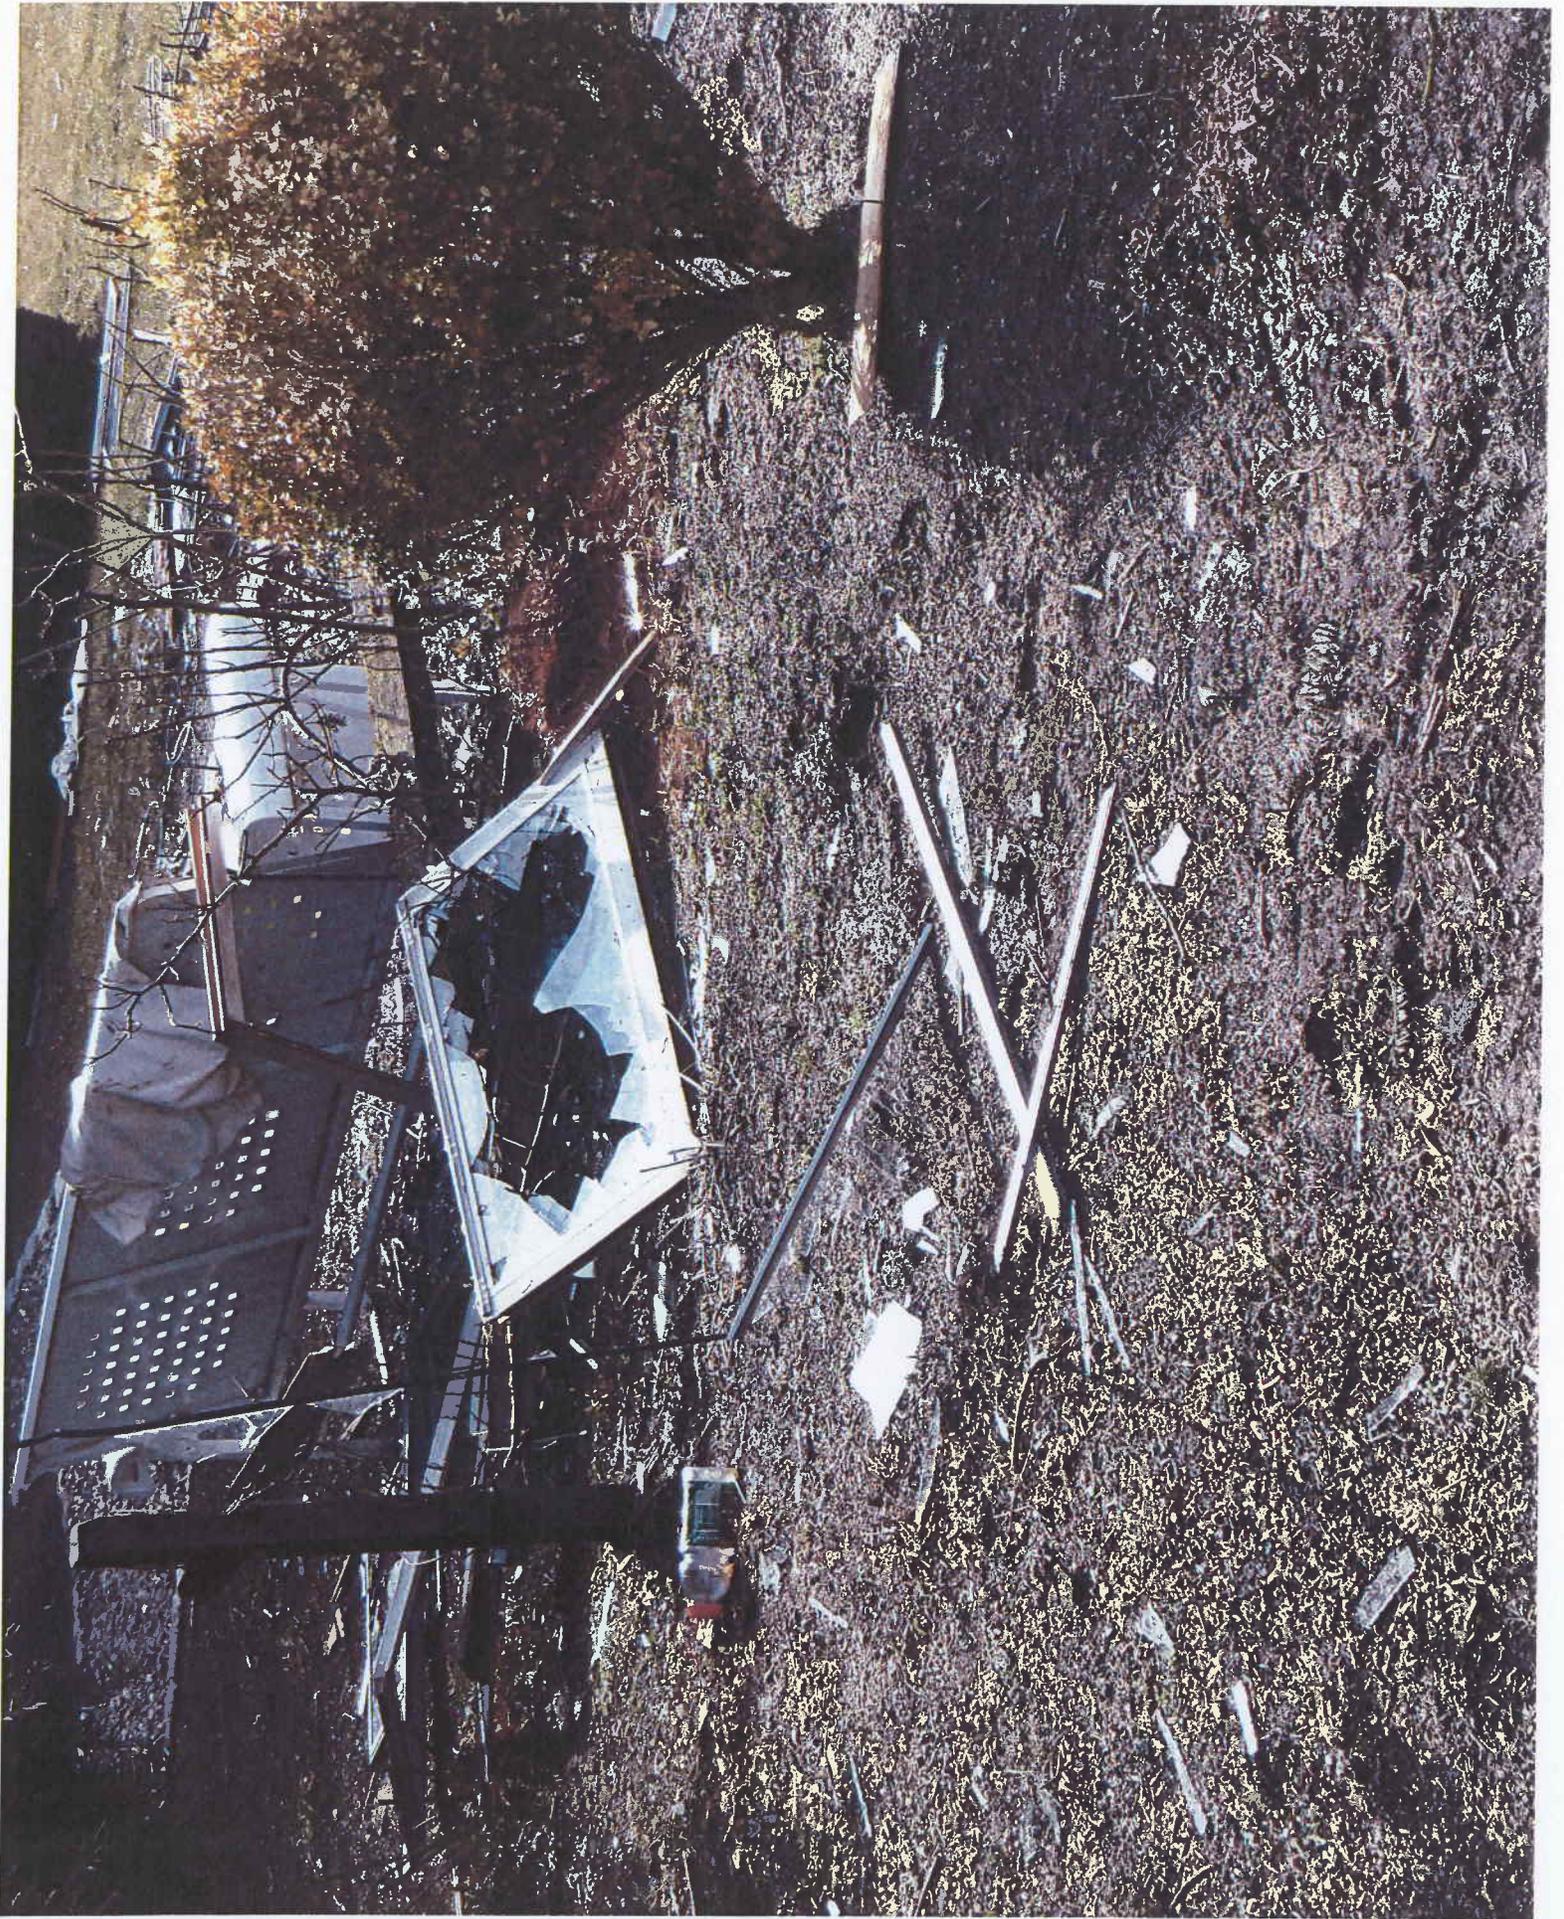
EXHIBIT 9

Photo of Debris Blown From 1415 Osterville Road

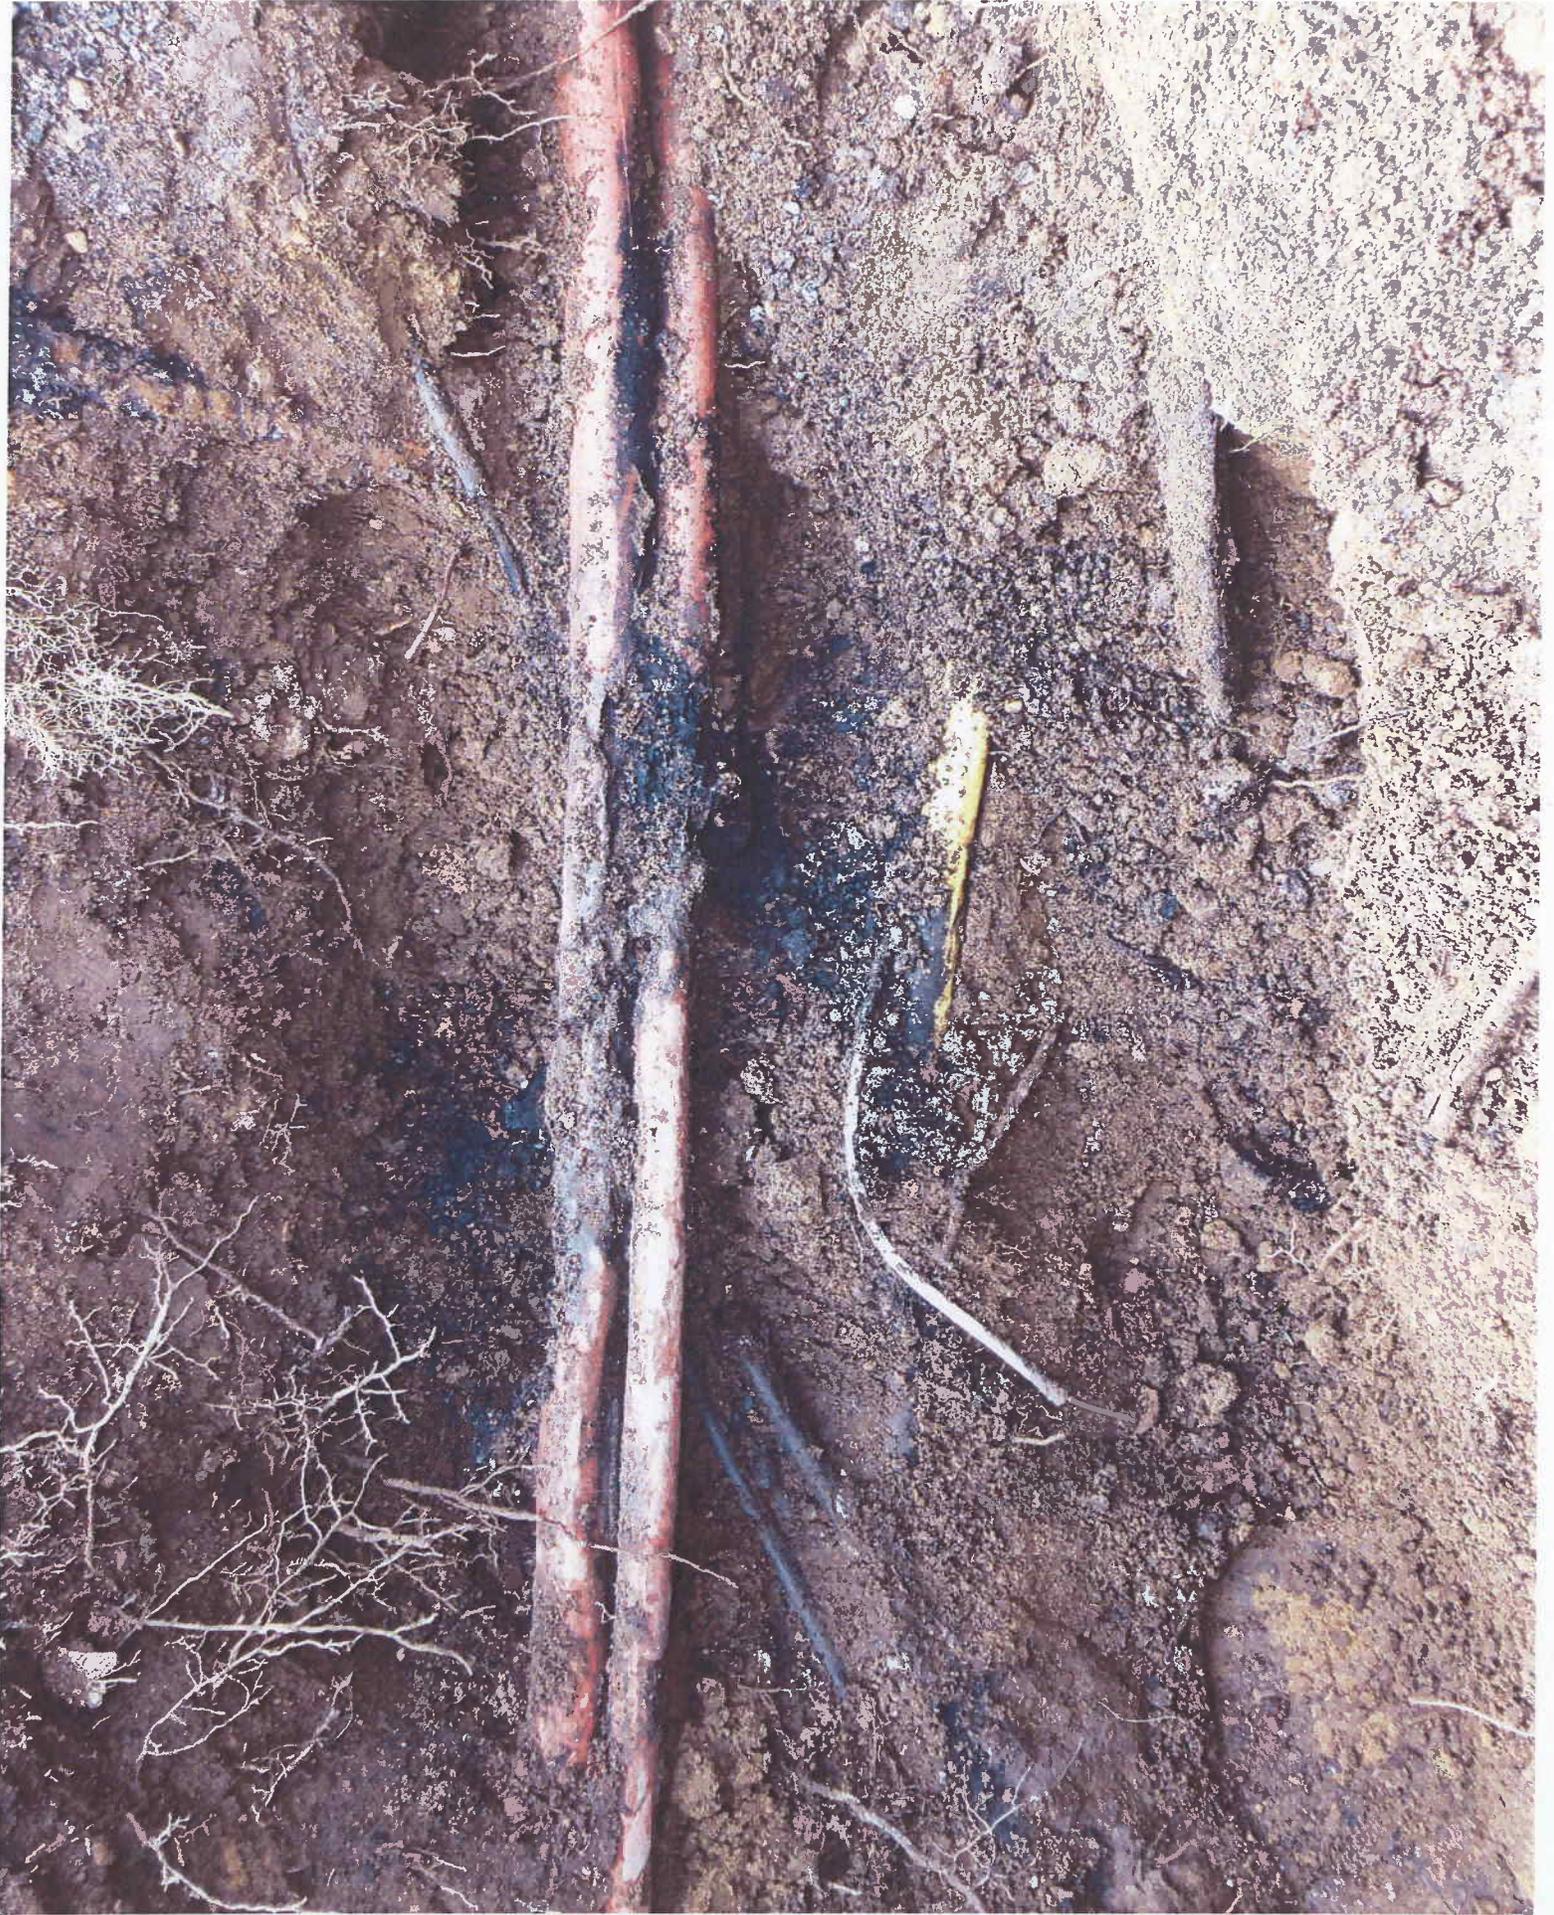
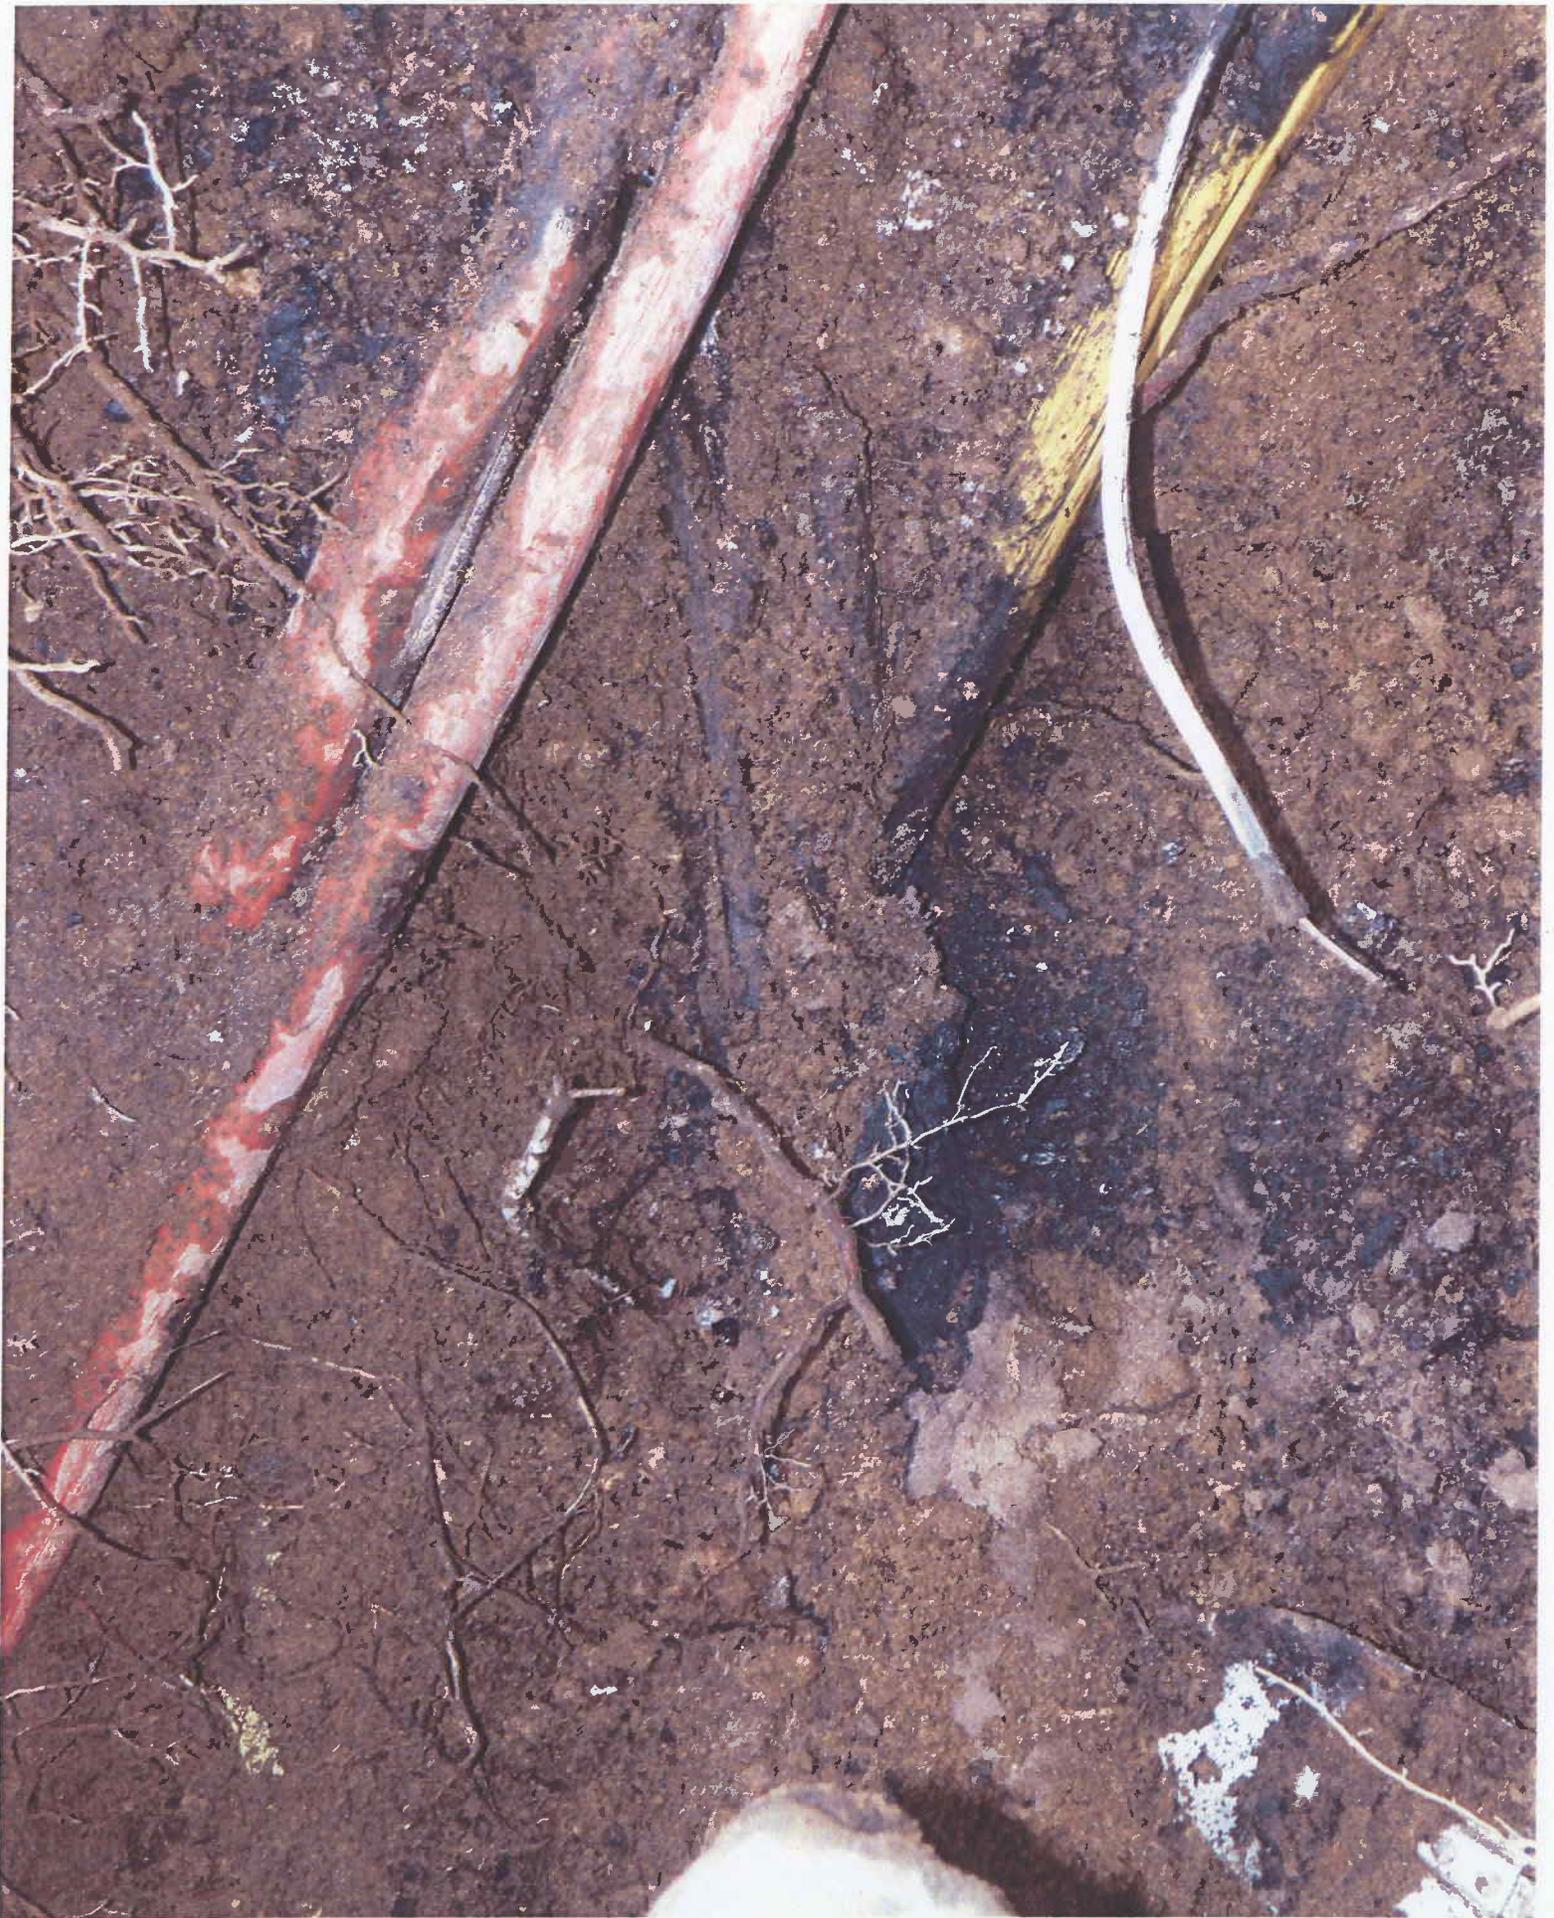
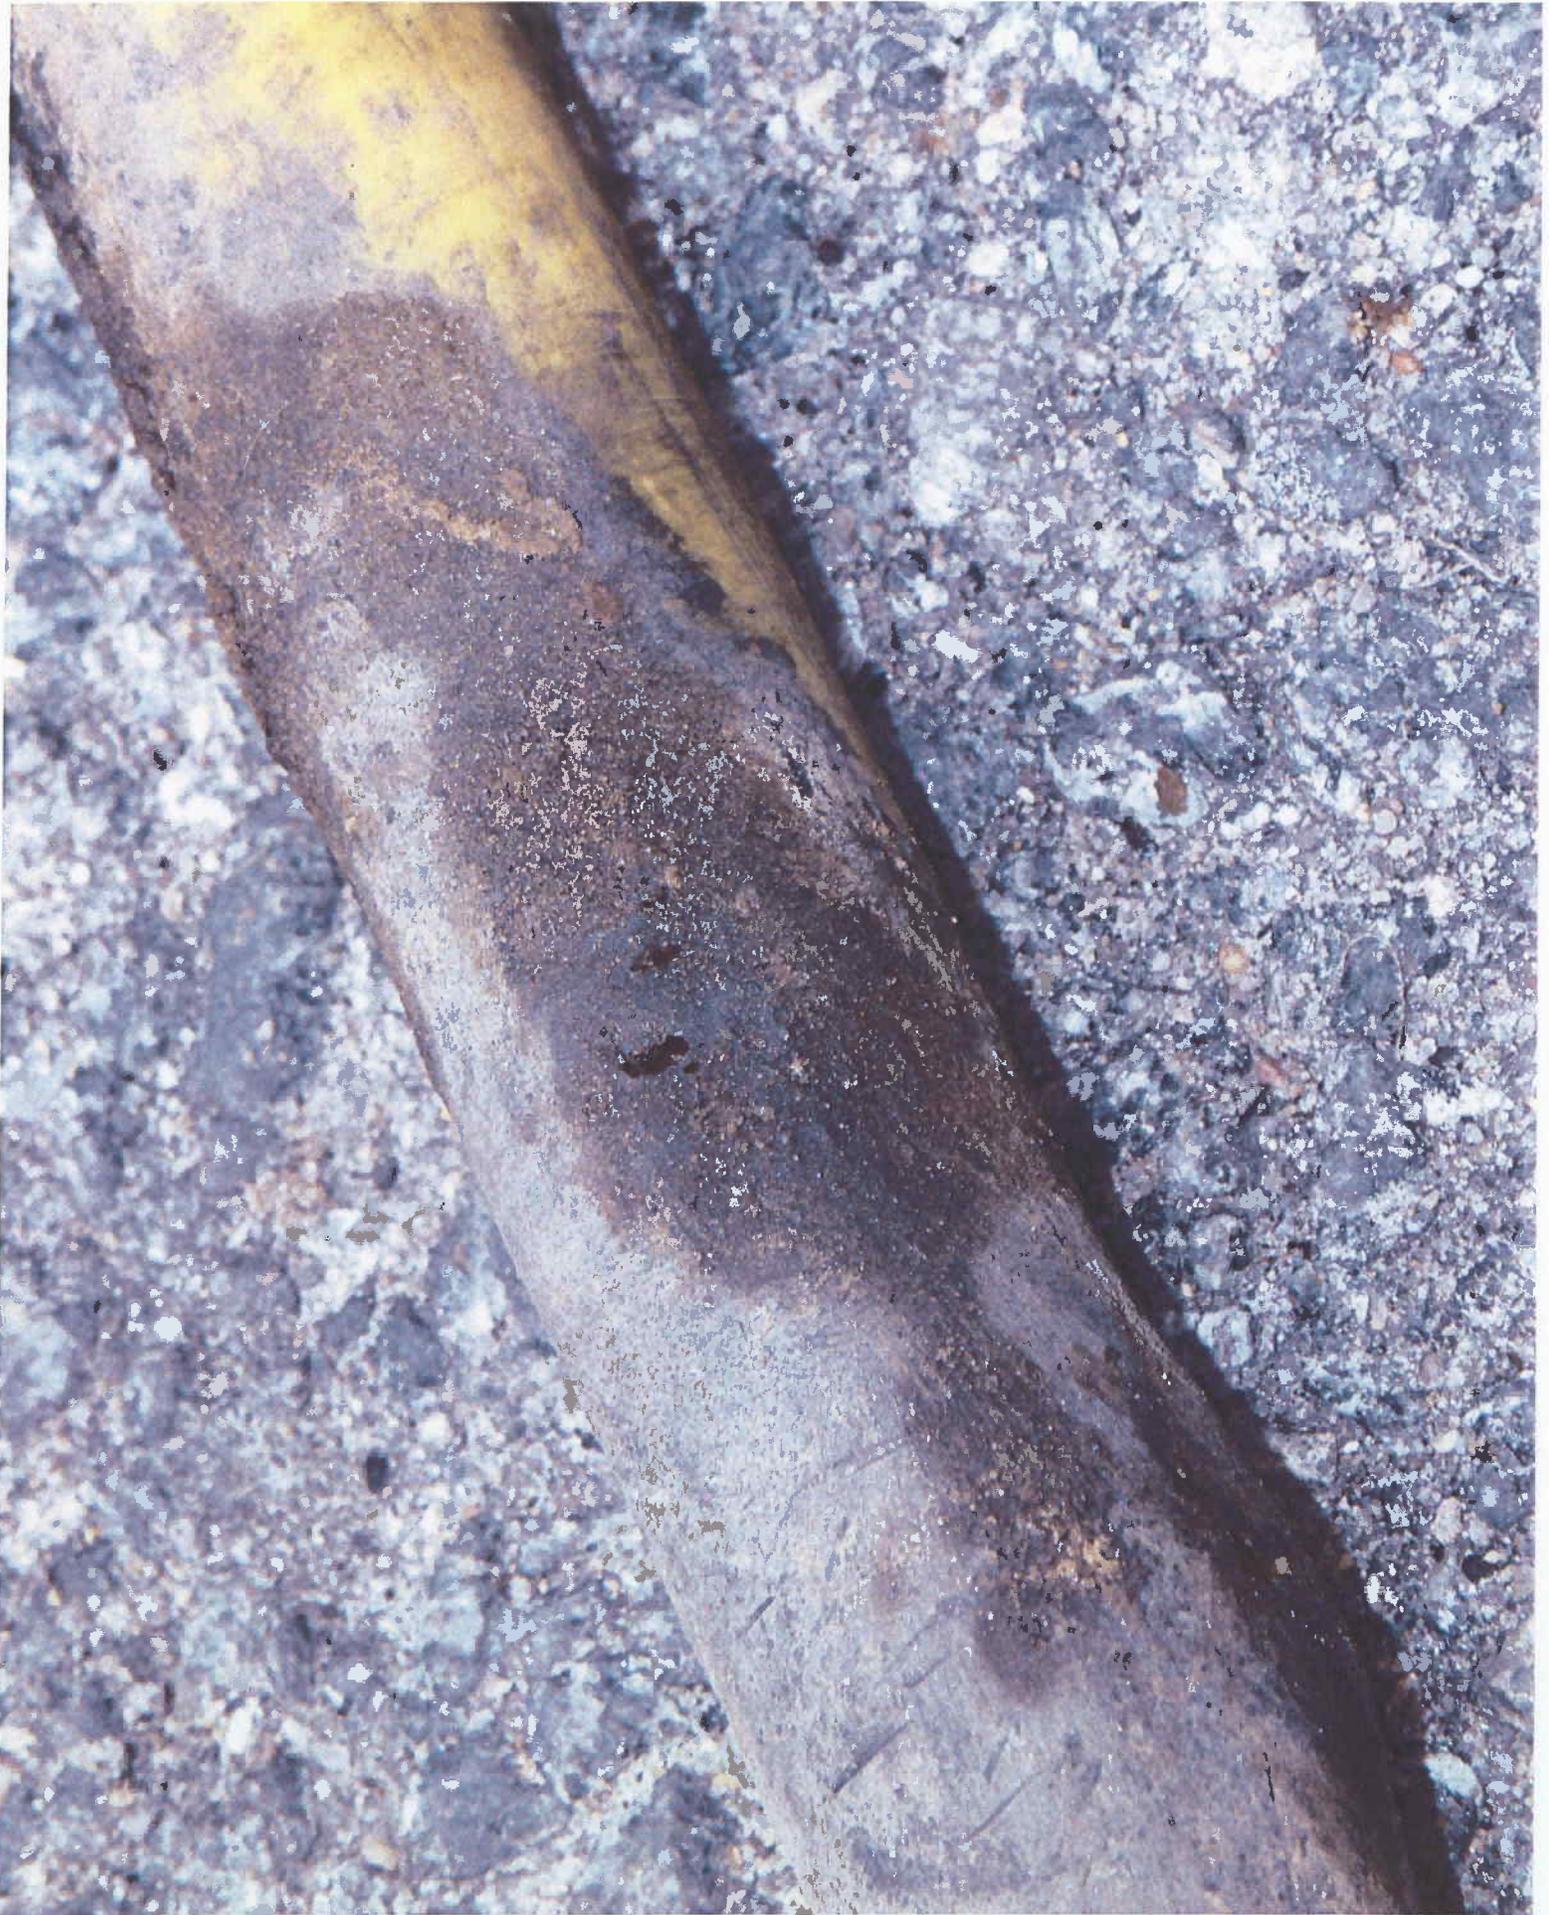
EXHIBIT 18

The Fire and Explosion Investigation Section of the State Fire Marshal's Office ("SFM") excavated where the Operator found the leakage (Exh. 17). The excavation revealed that a number of utilities entered the building in the same area (id.). The telecommunication conduits, the electrical service line, and the gas service line intersected in this area (Exh. 18). The telecommunication conduits, which were located above the electric line, were burned through on the bottom (id.). The gas service line, which was located in close proximity and below the electric line, was burnt through on the top (id.).

The service line was then excavated in the area of the leakage. The service line was found burned and melted with holes. In the excavation were a number of other cables conduits and wires. The underground direct buried electric service (2 services for 2 meters, 6 cables) was also burned and completely severed. Some of the other cables and conduits were also burned or showed heat damage. There was also an electric ground close to the electric service and the gas service. There were areas of burned or heat affected earth (see picture). The SFM determined that the electric service had a malfunction and melted the gas service causing a leak.

Photos of Electric, Gas, Comcast Conduit and
Damage to Gas Pipe
