DEPARTMENT OF PUBLIC UTILITIES

PIPELINE ENGINEERING AND SAFETY DIVISION

INCIDENT REPORT

96 The Fenway, Boston, Massachusetts

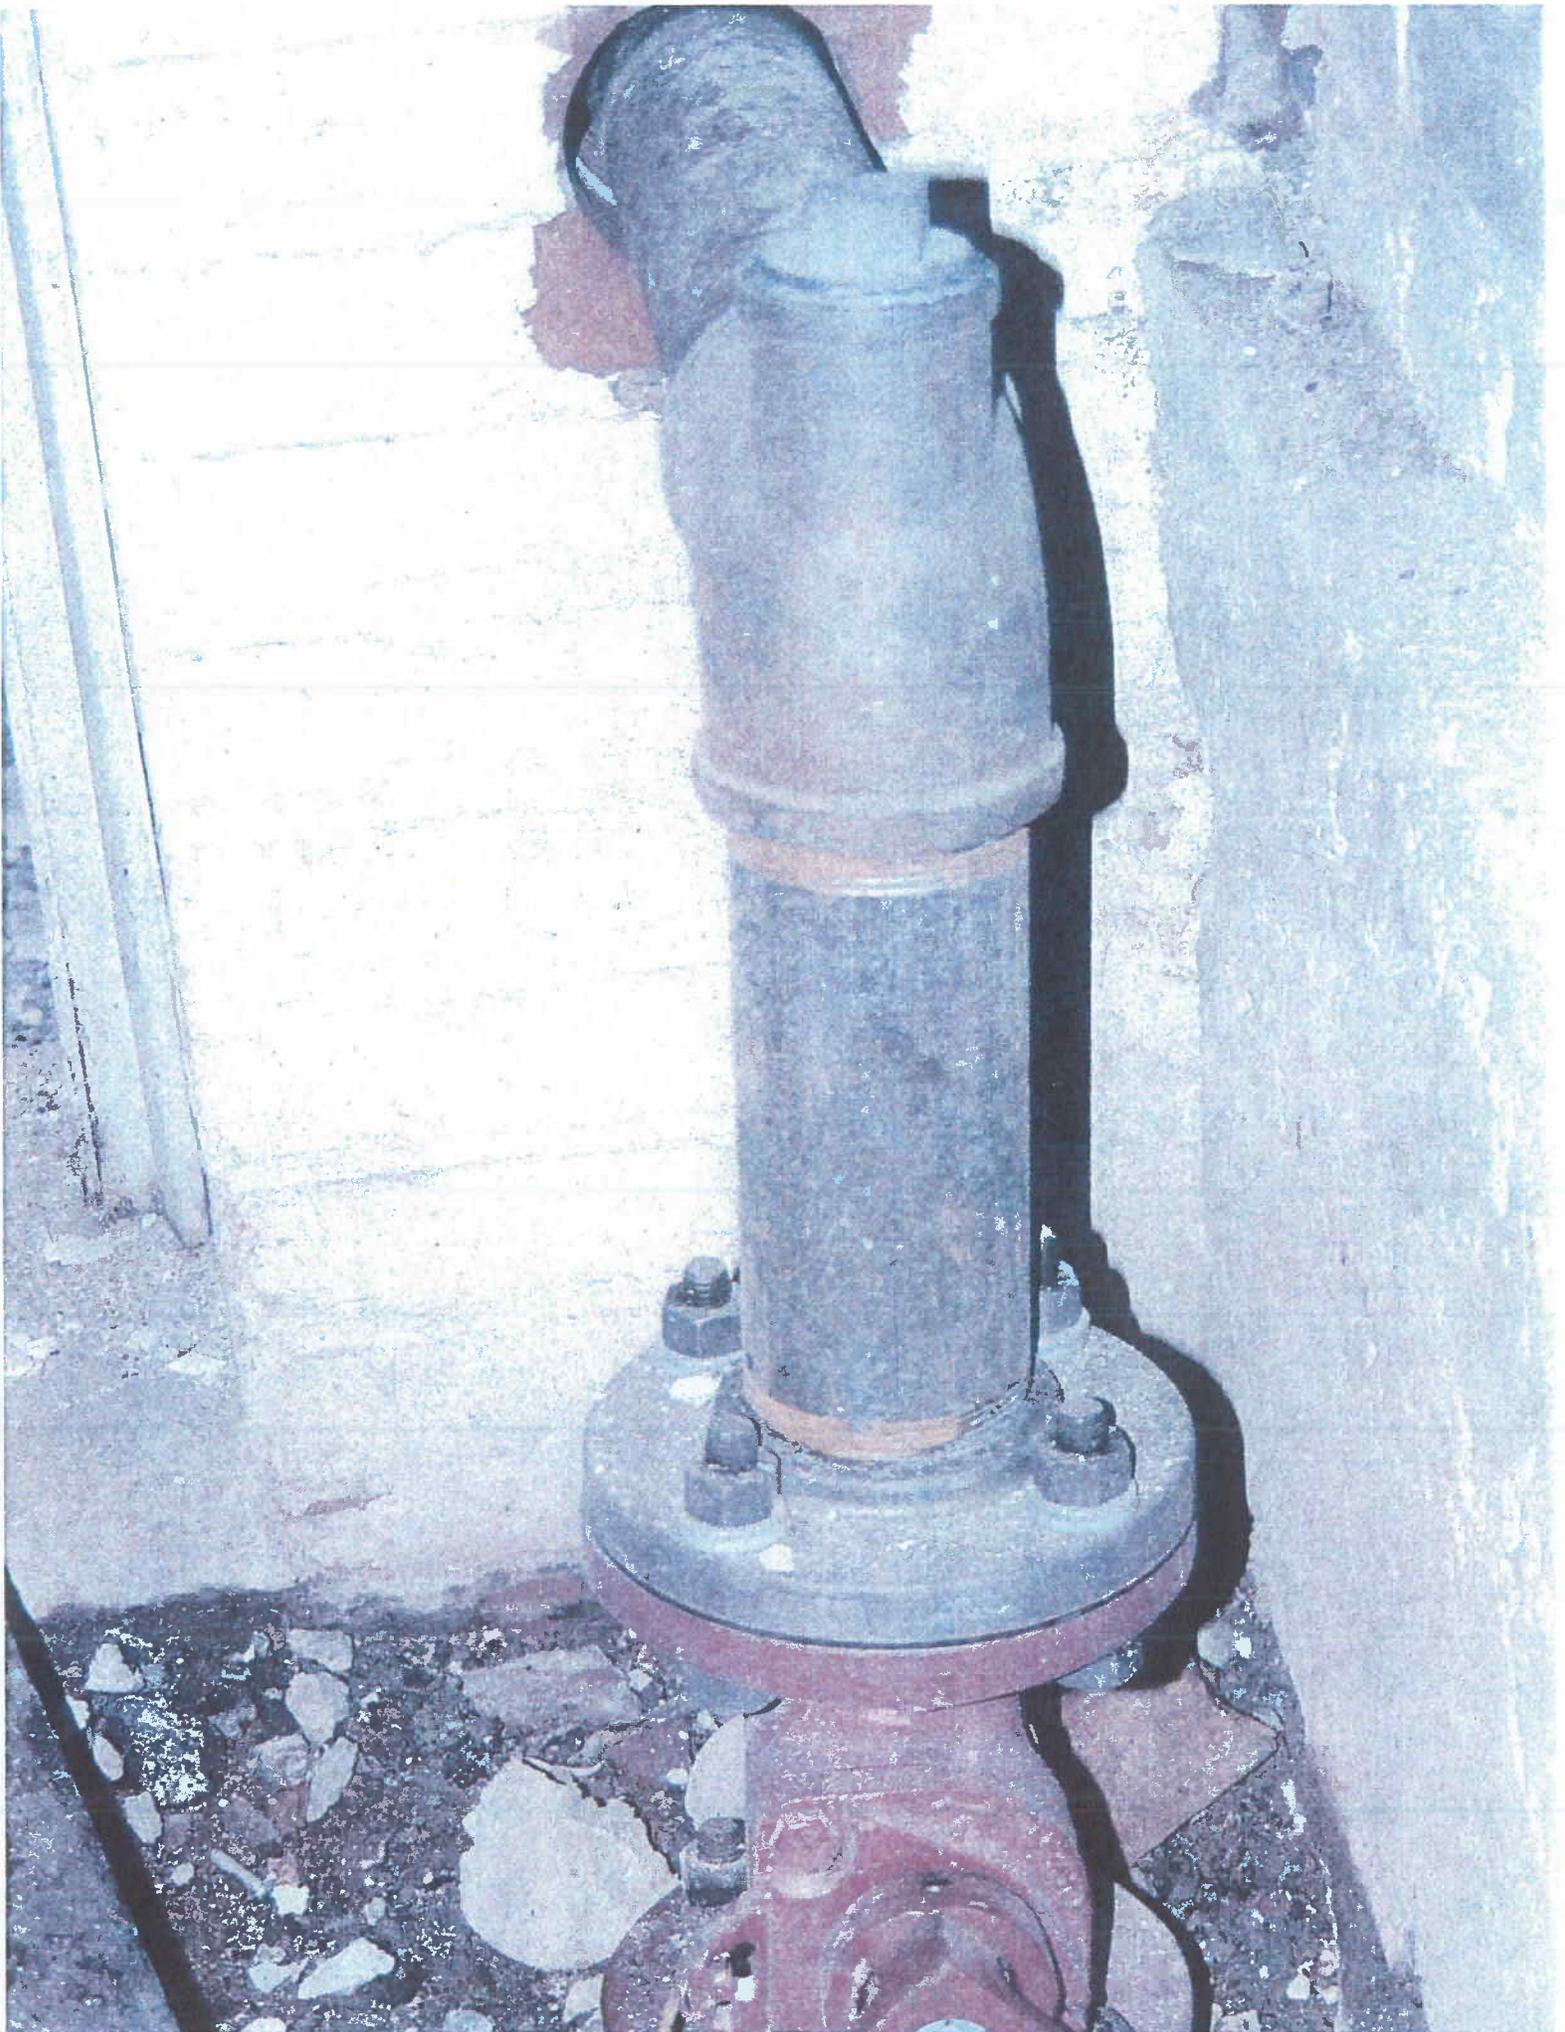
EXHIBIT 10

19. One of the fitters removed the blank flange from the service valve. They failed to close the service valve.
20. The fitters extended the service pipe from the service valve through a concrete wall into the meter room and installed an open-ended elbow in the service.

25. The source of the gas leak was through the service valve, which had been inadvertently left in the open position and the open-ended pipe in the service.

**Photograph of Service Valve and New Service Pipe Inside
96 The Fenway**

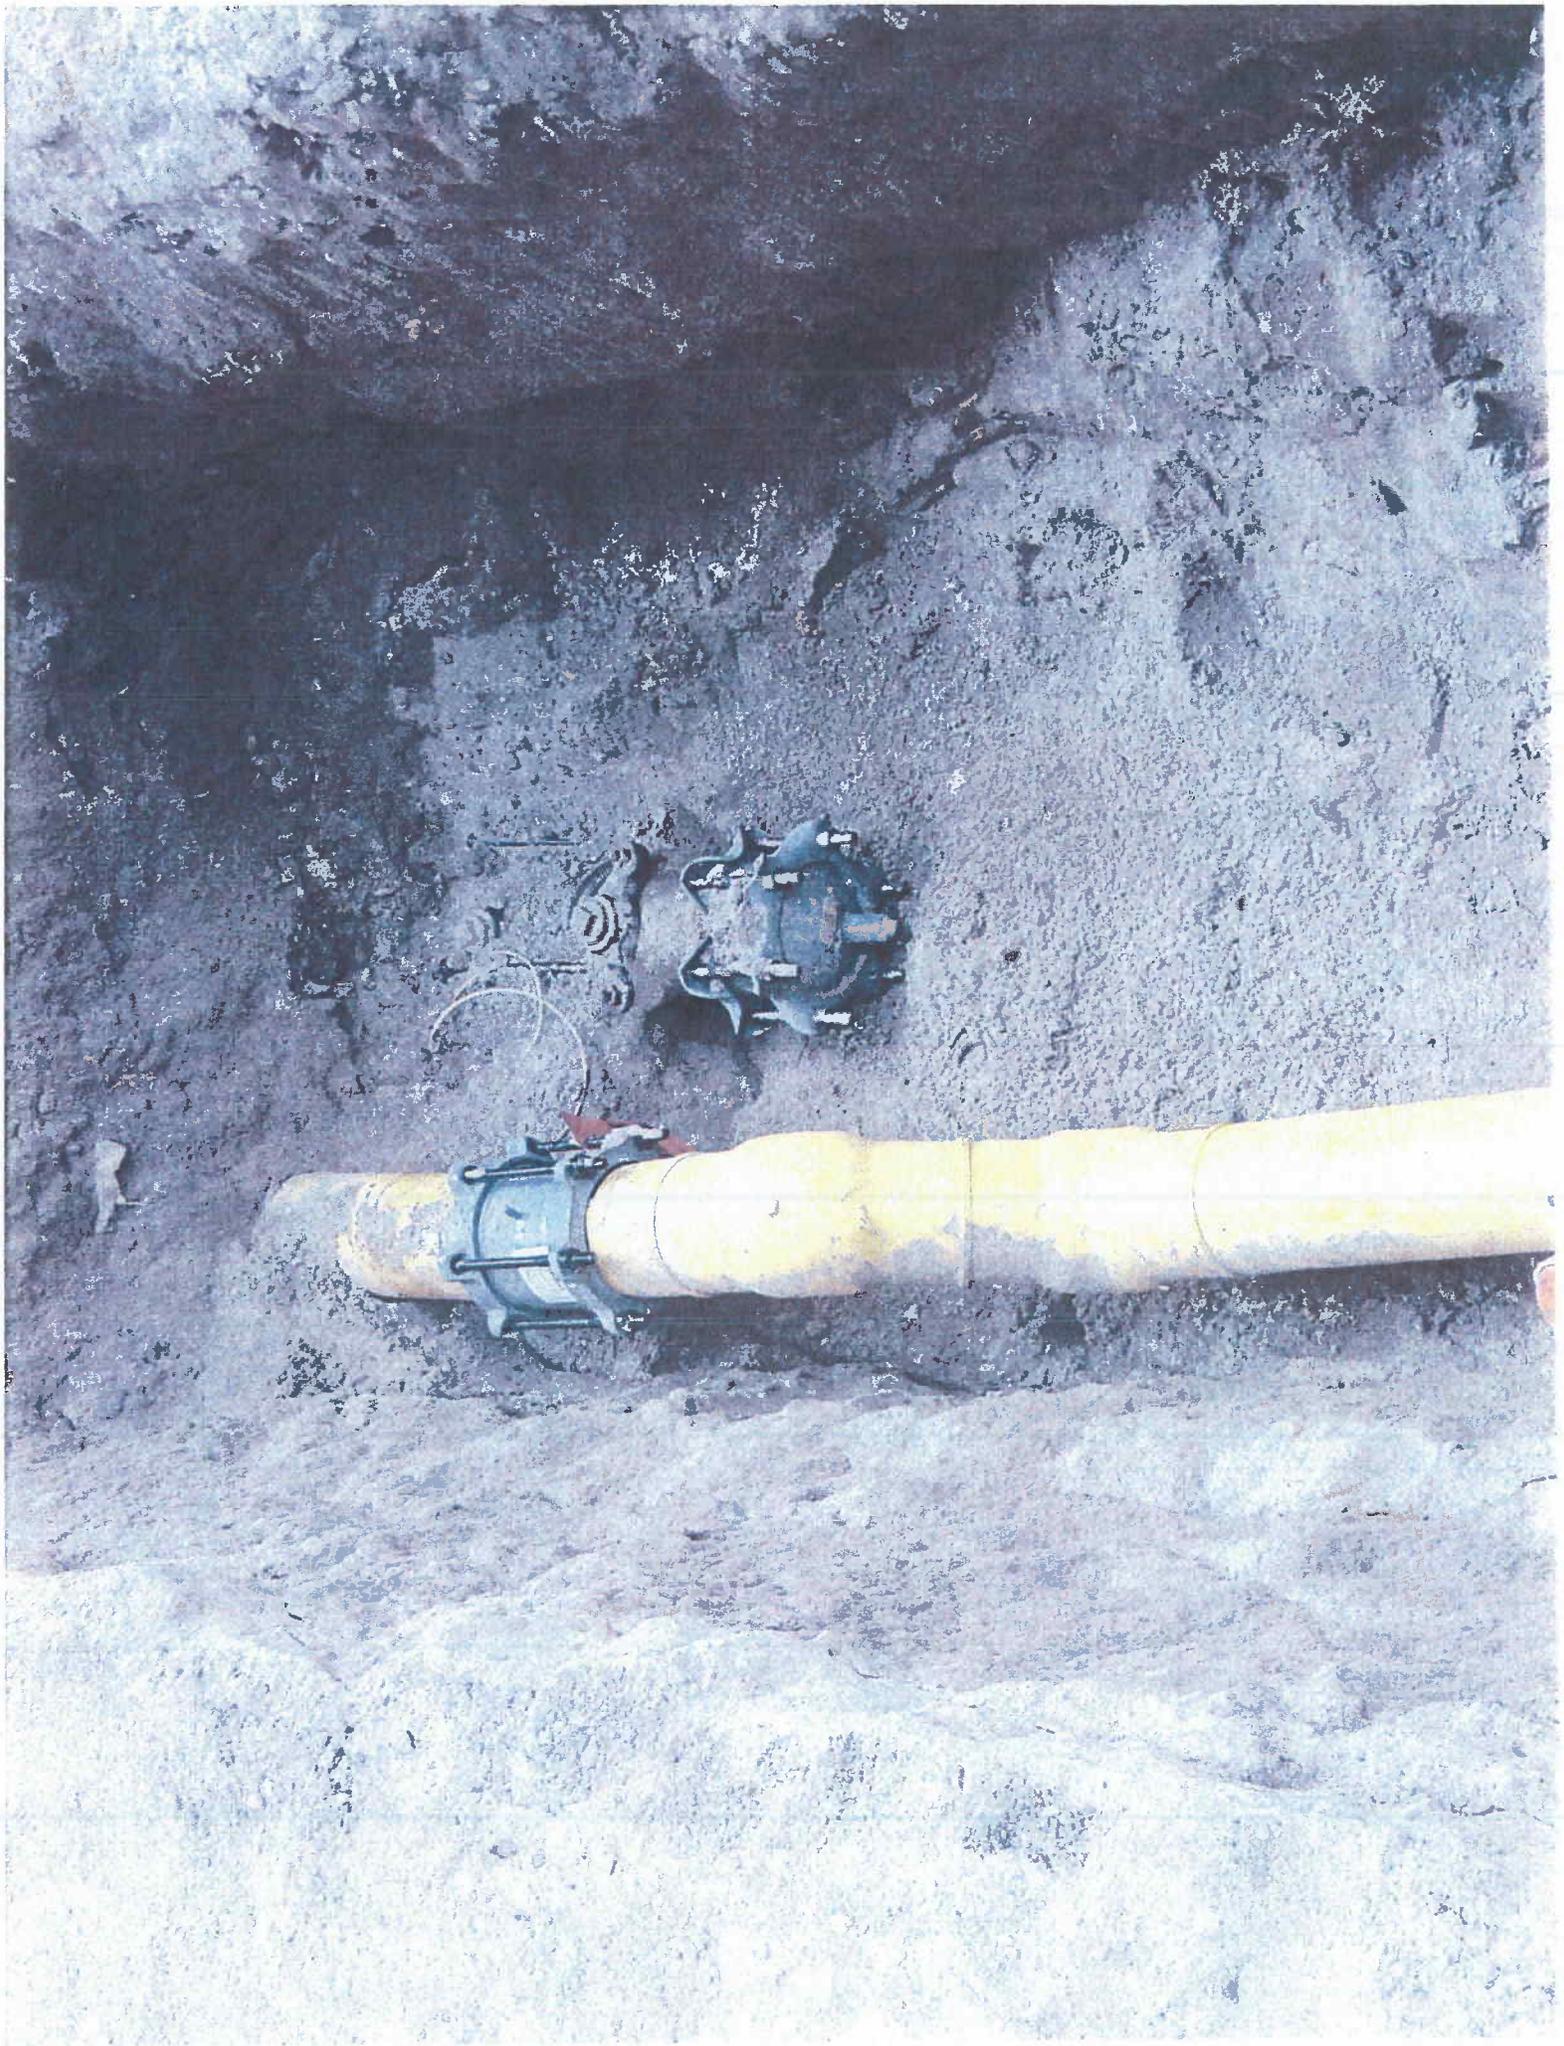
EXHIBIT 12

**North Excavation Site and New 6-Inch
Plastic Main**

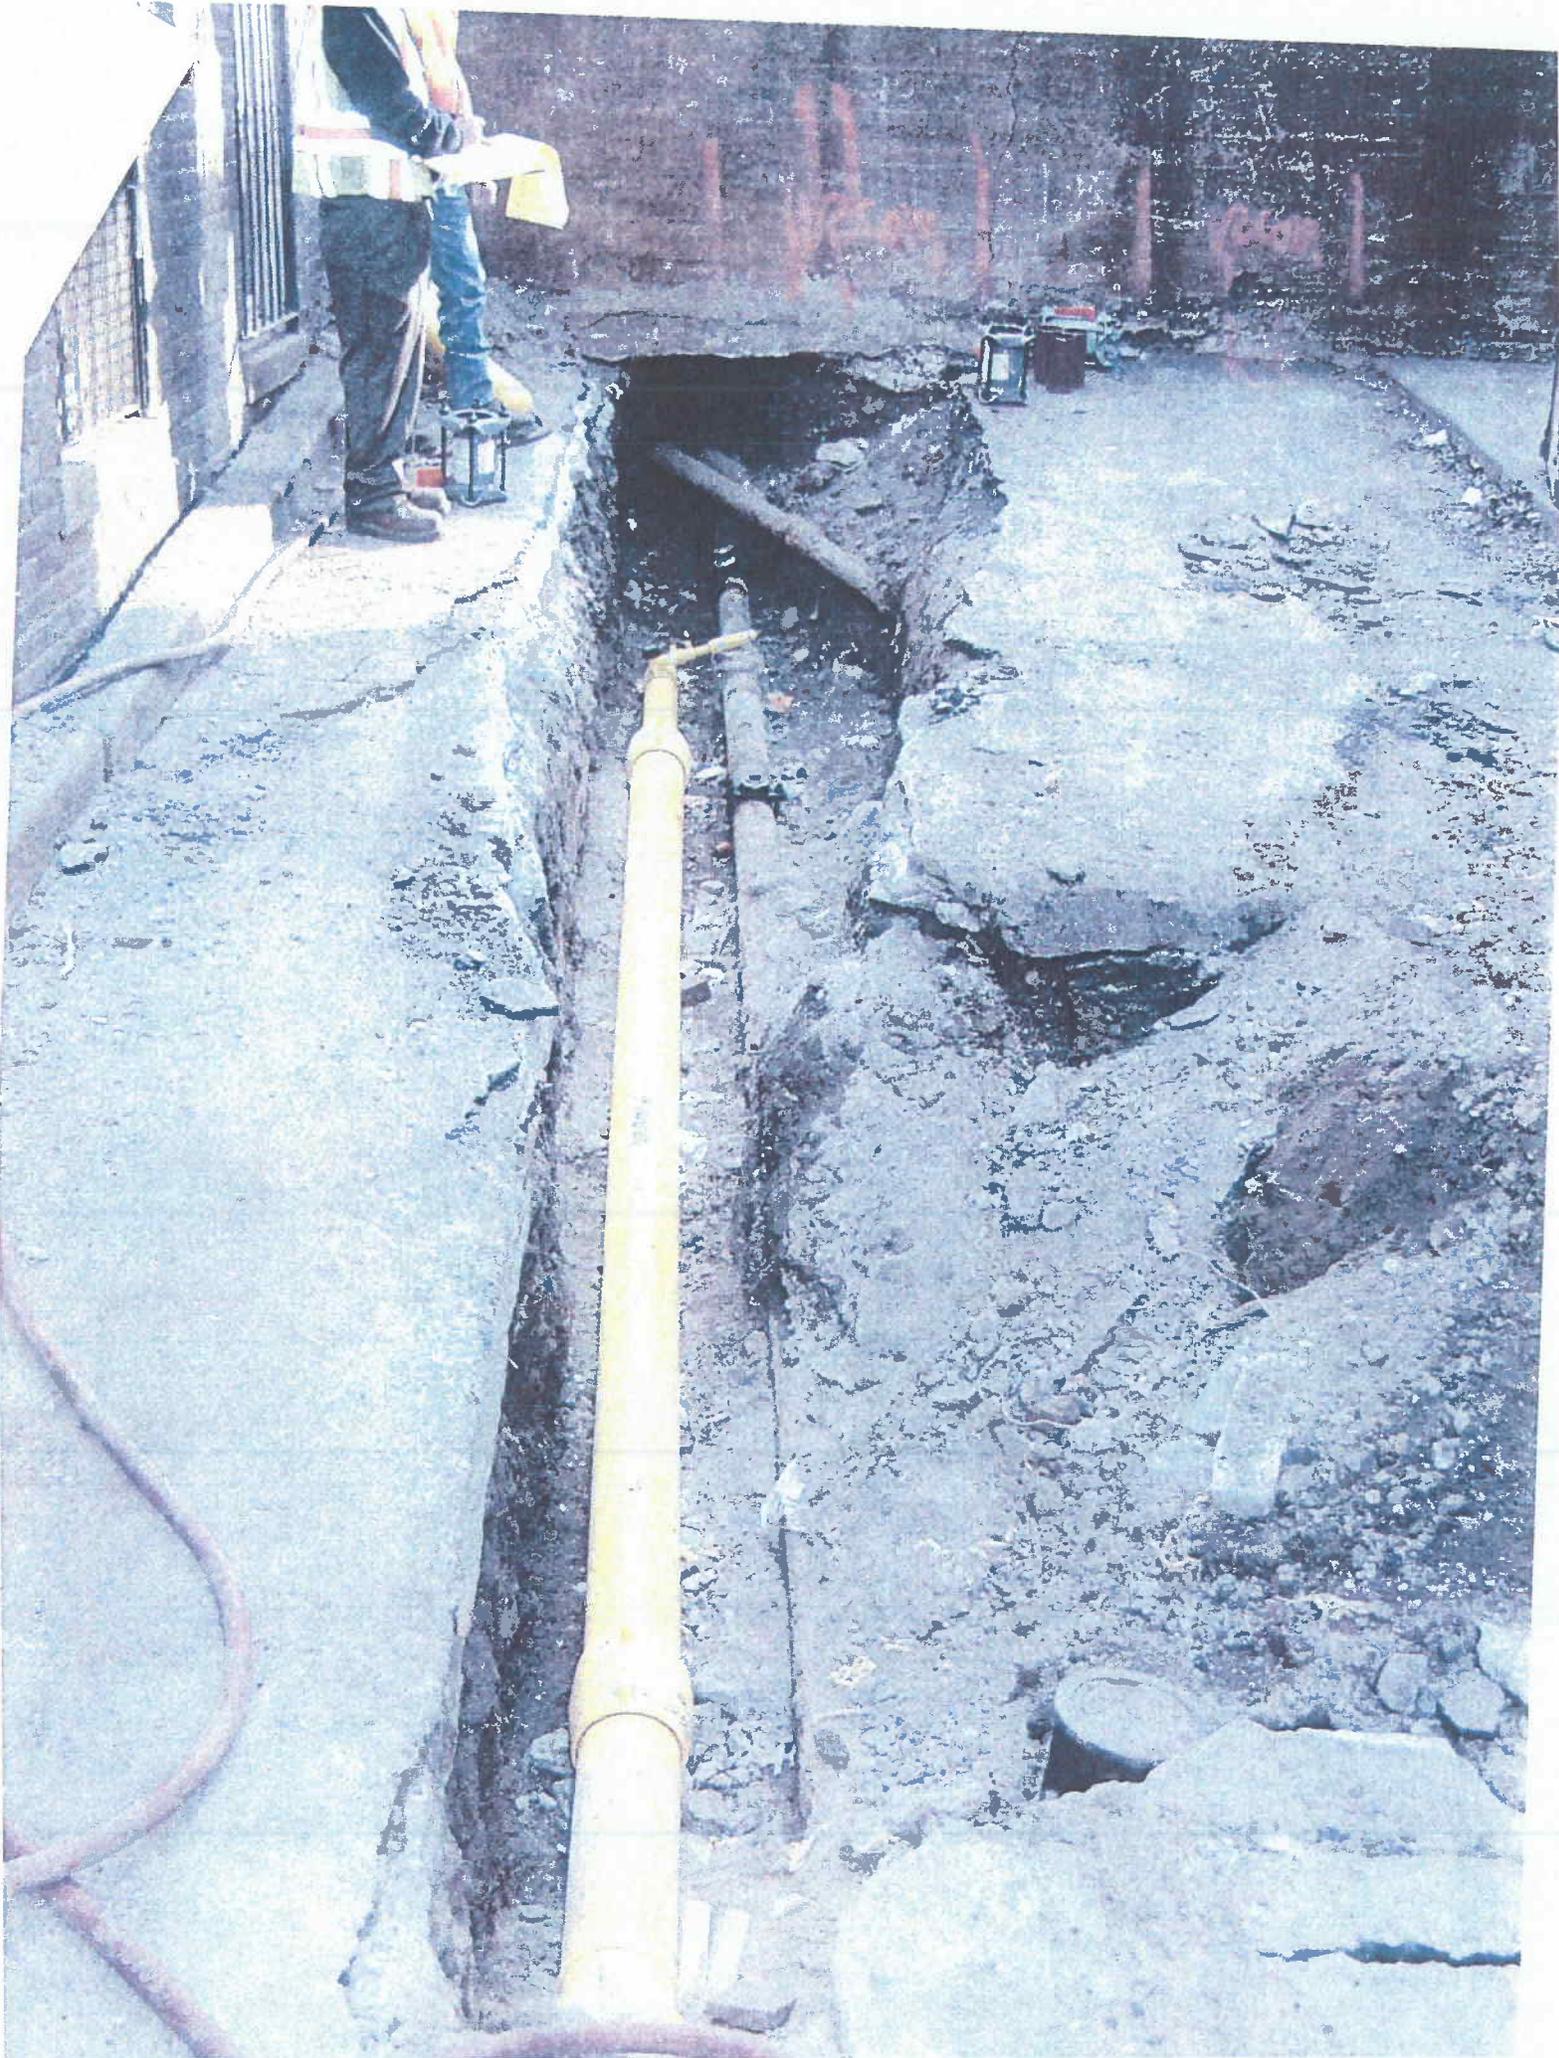
EXHIBIT 13

**South Excavation Site and End
Of New Plastic Main**
