# **INDOOR AIR QUALITY ASSESSMENT**

**Amherst Center for Extended Care  
150 University Drive  
Amherst, Massachusetts**

Prepared by:  
Massachusetts Department of Public Health  
Center for Environmental Health  
Emergency Response/Indoor Air Quality Program  
April 2007

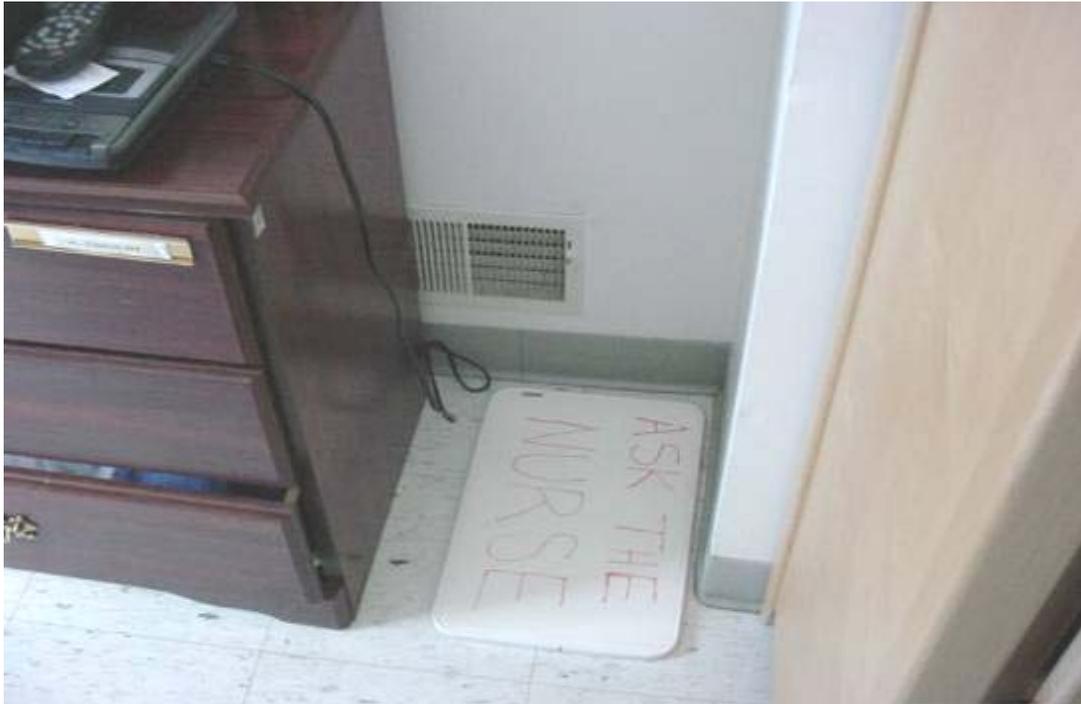
**Picture 1**

**Fresh Air Supply Vent, 1992/1997 Wing**

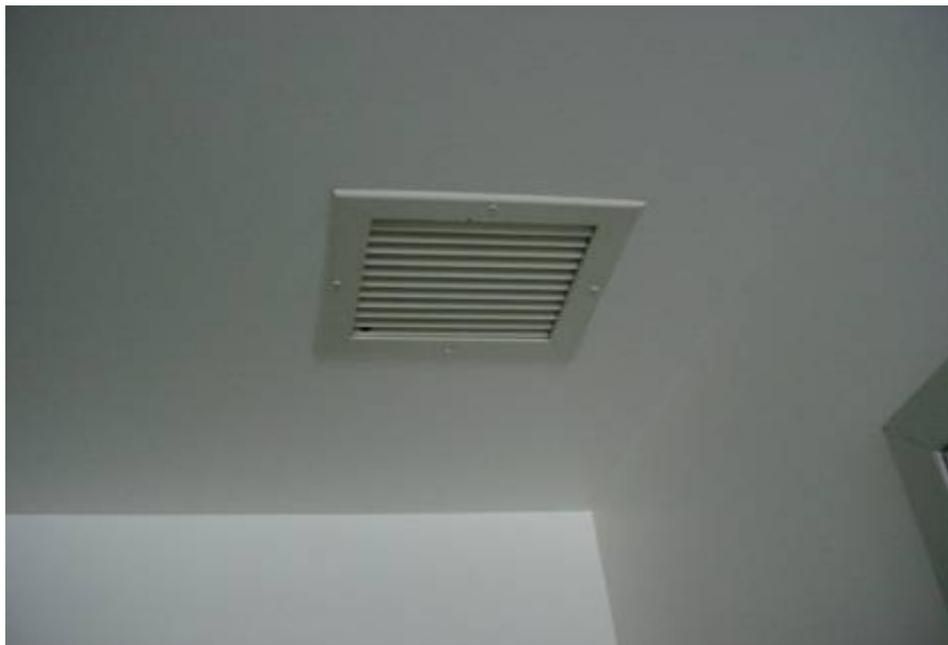
**Picture 2**

**Return Air Vent, 1992/1997 Wing**

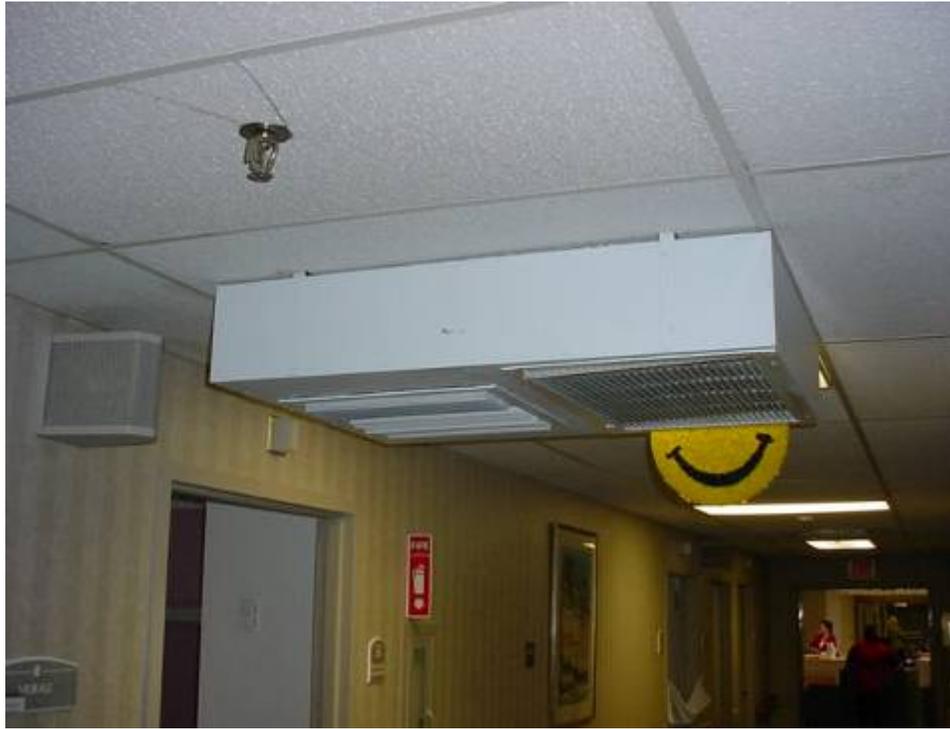
**Picture 3**

The HVAC system for the 1967 wing is configured in a manner that differs from that of the 1992/1997 wing. The 1967 wing is outfitted with ceiling-mounted unit ventilators (univents) (Figure 3, Picture 3). A univent draws air from outdoors through a fresh air intake located on the roof (Picture 4) and returns air through an air intake located at the base of each unit. Fresh air and return air are mixed, filtered, heated and provided to the interior of the building through fresh air diffusers located in the top of the units. The wing layout is the shape of an inverted “t” (Figure 2), and ceiling-mounted univents are stationed near the terminus of each corridor. The univent in the Dharma A hallway of the 1967 wing was deactivated, which may indicate a broken fan belt or motor malfunction. The univent in the Dharma C hallway of the 1967 wing was producing a warmer air stream (note temperature measurements in Table 1), than the other

functioning univents, which likely indicates a closed/frozen fresh air supply louver. Subsequent correspondence indicated that malfunctioning relays to these units were replaced (CEC, 2007).

**Ceiling Mounted Univent, 1967 Wing**

Based on the observations made, it appears that the CEC contains all of the HVAC system components necessary to provide adequate fresh air during the heating season. At the time of the assessment, CEC staff committed to contact their HVAC contractor to examine and repair the malfunctioning univents in the 1967 wing as needed. CEH staff agree with the HVAC contractor's recommendation regarding closing of windows, particularly during hot, humid weather as a method to preventing mold growth within the building. If windows are opened during heat wave conditions, hot moist air enters the building, which can result in condensation subsequently moistening building components, resulting in mold growth. The prevention of mold growth inside of a medical facility is needed to protect the health and safety of the facility patients. These types of conditions conducive to mold growth may result in an indoor environment that could adversely affect the health of patient's with respiratory disease, asthma, immuno-suppression and/or sensitivity to fungal microorganisms. Therefore, based on the air measurements conducted in the 1993/1997 wing, it is advised that these windows remain closed to maintain the integrity of function of the HVAC system.

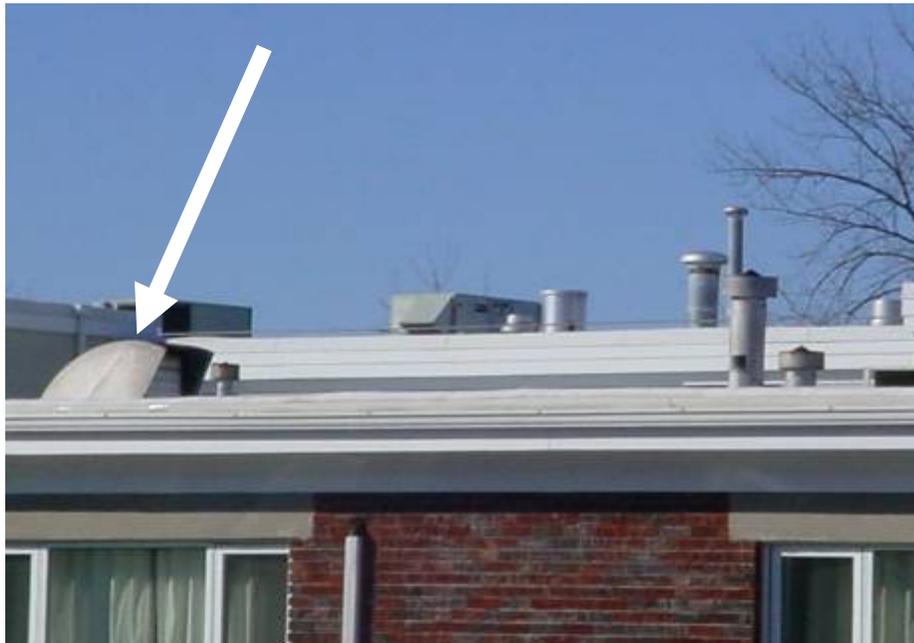
**Picture 4**

**Likely Rooftop Univent Fresh Air Supply Vent, 1967 Wing**

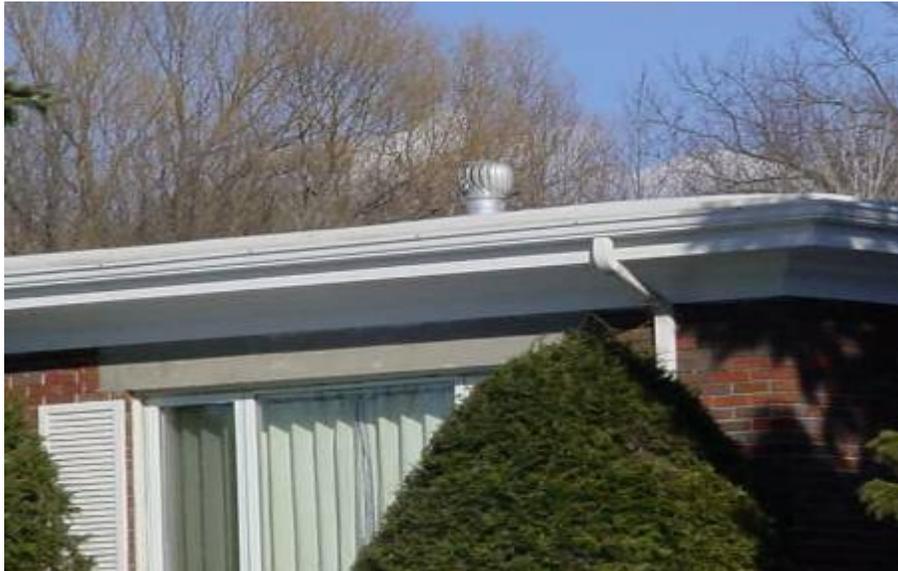
**Picture 5**

**Wind Driven Turbine Vent, 1967 Wing**

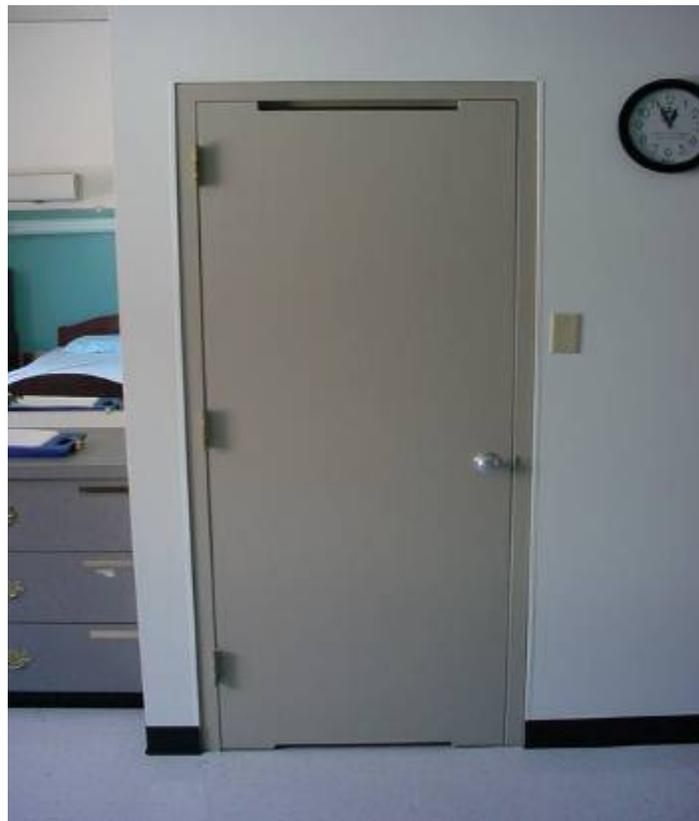
**Picture 6**

## **Example of Bathroom Door, 1967 Wing**
