INDOOR AIR QUALITY ASSESSMENT

**Massachusetts Department of Labor
Department of Industrial Accidents
30 Third Street
Fall River, Massachusetts**

Prepared by:
Massachusetts Department of Public Health
Center for Environmental Health
Emergency Response/Indoor Air Quality Program
May 2007

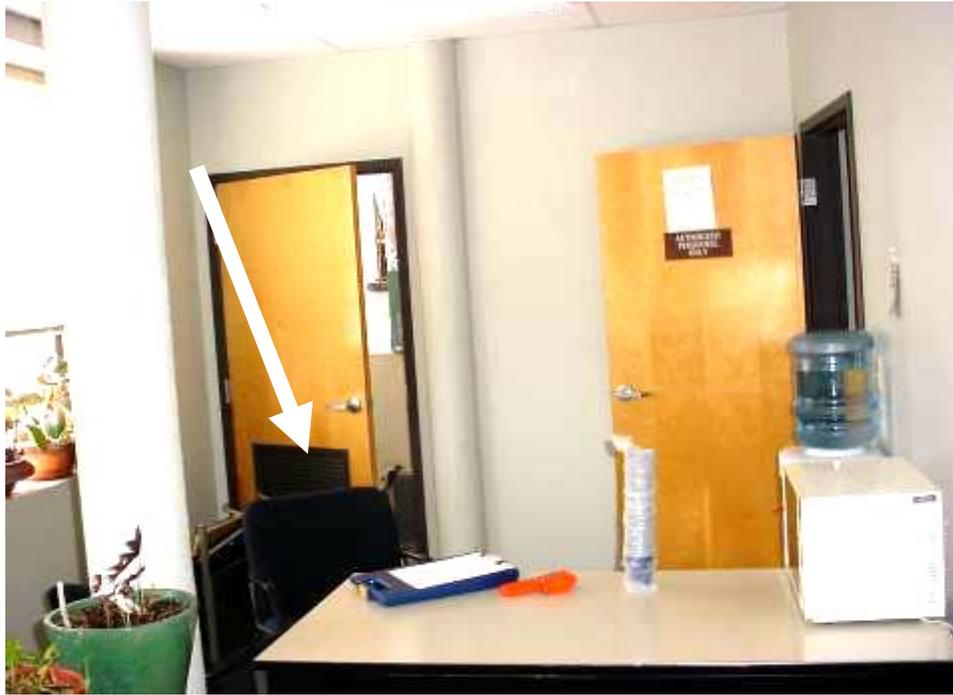
Picture 1

Return air is drawn to the AHUs by a passive vent that is located on the wall of the mechanical rooms (Picture 1). The system is designed to use hallways to draw return air from office areas. To facilitate airflow, office doors are often undercut approximately one-inch to provide a space through which air can be drawn into the hallways. Office doors did not appear to be undercut, thus limiting the amount of transfer air from offices to the hallway when office doors are closed. Some rooms have a plastic grill installed in the suspended ceiling, with a second plastic grill installed in a wall on the opposite side of the room adjacent to the hallway. It appears that air is intended to be drawn *through* the ceiling plenum and into the hallways. Picture 2 shows the top of the ceiling plenum, which seems to be the original floor boards of the second story offices.

Return Air is Drawn to the AHU Return Vent

4. Install appropriate filter racks on the AHUs to provide proper filtration.
5. Install return vents to draw air from hearing rooms directly to the appropriate AHU room.

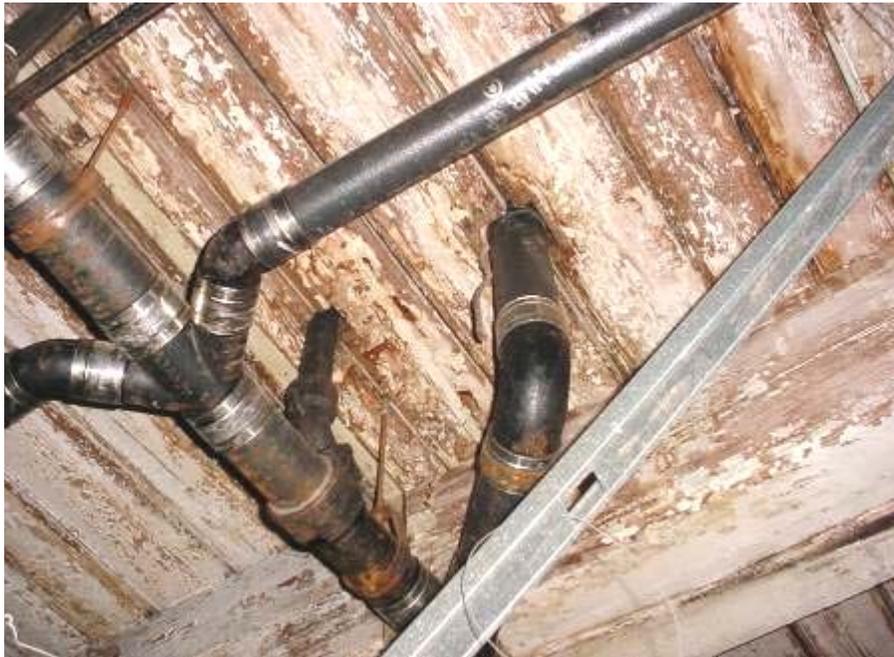
Picture 2

**Underside of Floor the Serves as the Top of the Ceiling Plenum,
Note Heavy Water Staining**

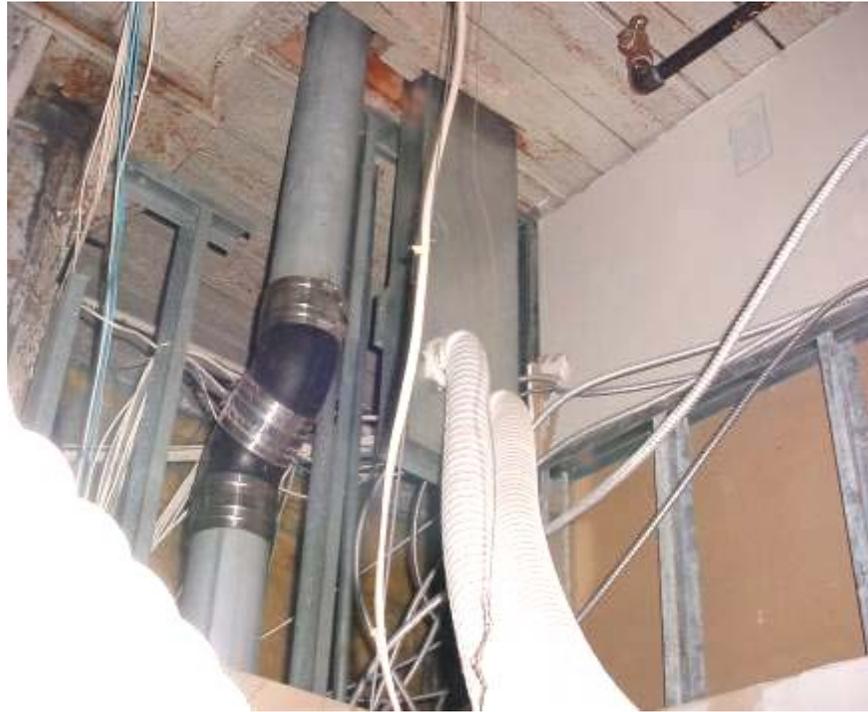
Picture 3

Restrooms were found to have non-functioning exhaust vents or lacked them. Exhaust fans in restrooms appear to be connected to a duct by a flexible dryer hose (Picture 3). The flexible hose was disconnected in places, which can allow odors and moisture to vent into the ceiling plenum.

Restroom exhaust vents connected to duct with flexible dryer hose

- 12. Provide appropriate restroom exhaust ventilation and operate during business hours.
- 13. Insulate the components of the AHU condensation drainage system.

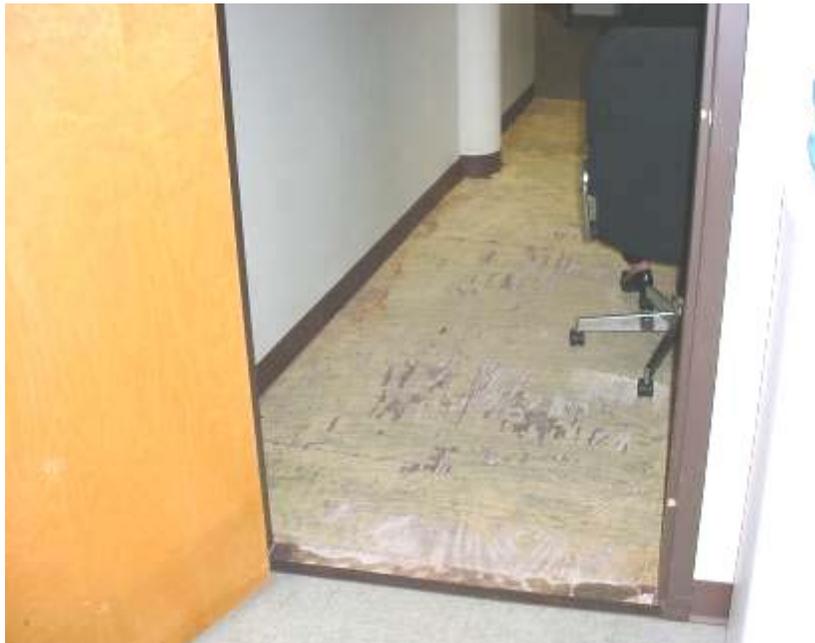
Picture 4

In order for building materials to support mold growth, a source of water exposure is necessary. No active leaks were observed, however, water damage was noted on gypsum wallboard (GW) in a hallway (Picture 4). The hallway reportedly had its carpet removed prior to the MDPH assessment due to water damage. GW was found to be wet 12 days after the April 14, 2007 nor'easter (Picture 5). GW was used to form the sills of windows in the building. The location of the water staining indicates that leaks around window frames are the most likely source of moisture penetration. The floors of the AHU rooms also appear to be heavily stained with moisture (Picture 6), likely due to condensation generated from uninsulated components of the condensation drainage system for each AHU.

Water Damaged GW and Floor

1. Remove and replace any mold contaminated/water damaged GW and insulation along exterior walls and around affected windowsills. This measure will remove actively growing mold colonies that may be present. Remove mold contaminated materials in a manner consistent with recommendations found in “Mold Remediation in Schools and Commercial Buildings” published by the US Environmental Protection Agency (US EPA, 2001). This document can be downloaded from the following EPA website:
http://www.epa.gov/iaq/molds/mold_remediation.html
2. Establish communications between all parties involved with remediation efforts (including building occupants) to prevent potential IAQ problems. Develop a

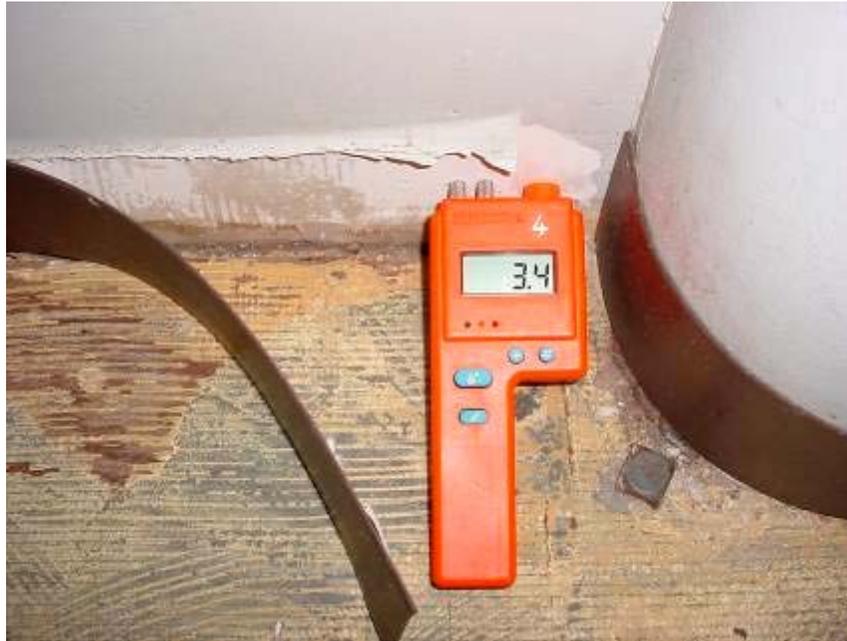
Picture 5

Moisture Meter Measure Moisture in Water Damaged GW 10 Days after Rainstorm

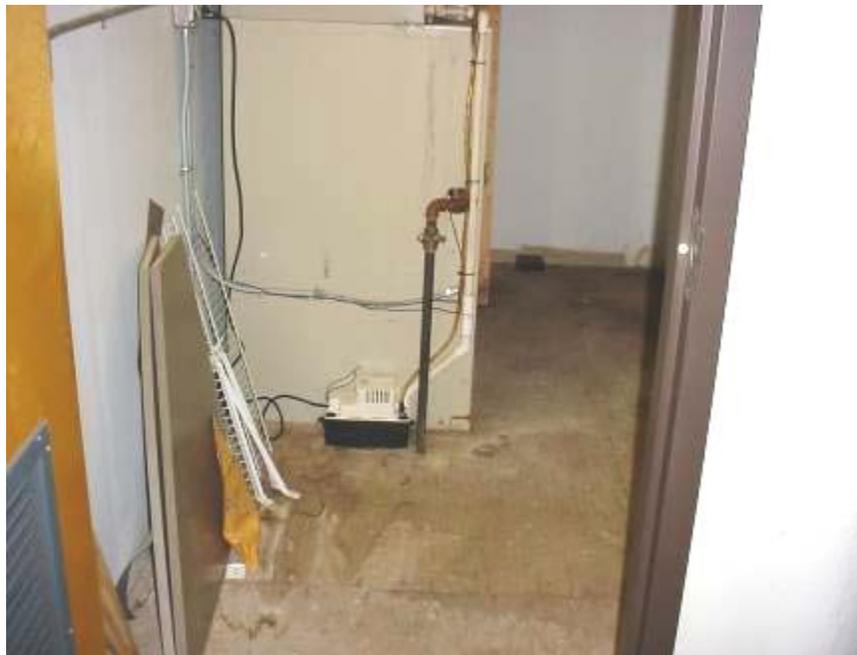
Picture 6

AHU Rooms Appear to be Heavily Stained with Moisture

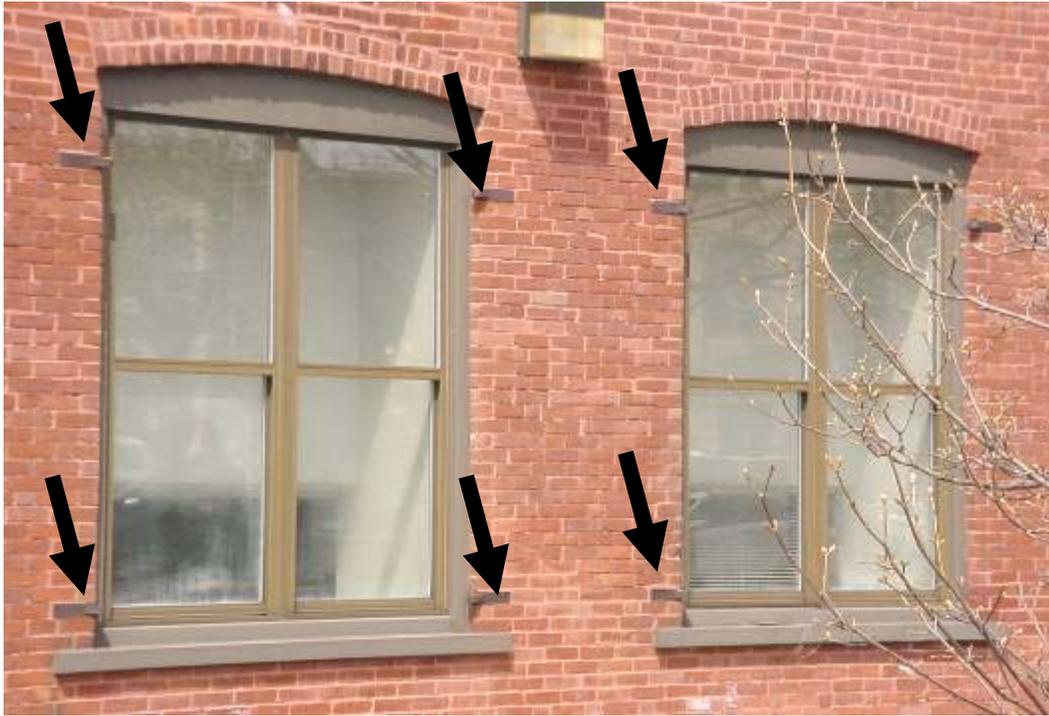
Picture 7

- It appears that the building was originally equipped with heavy shutters, which were held in place by large steel hangers (Picture 7). Over time,

Steel Shutter Hanger

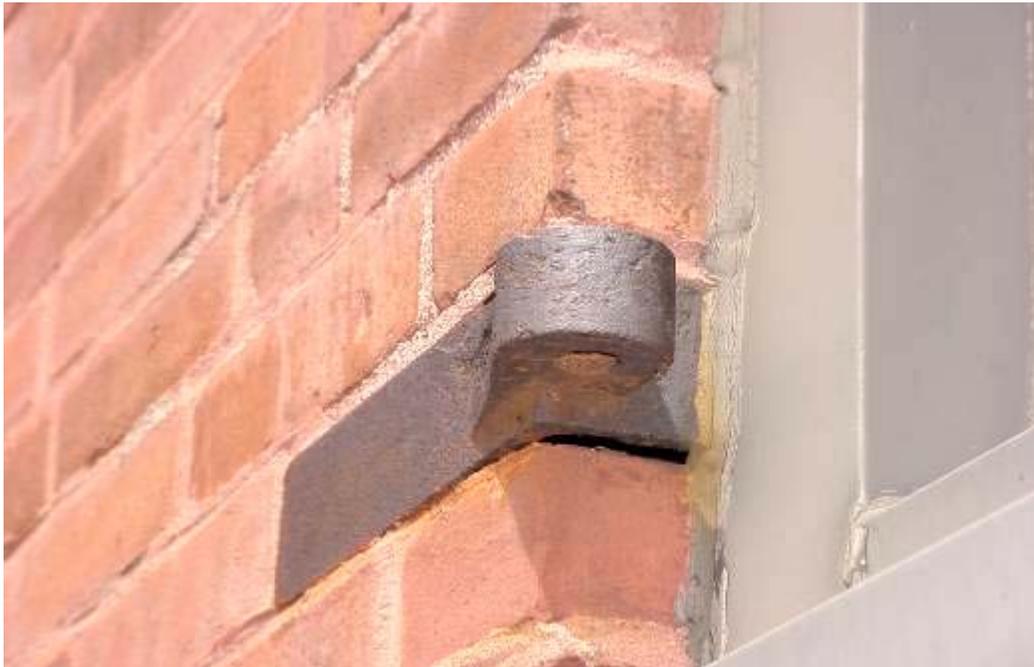
Picture 8

spaces have opened around the hangers, resulting in a pathway for wind-driven rain to access the exterior brick face (Picture 8).

Space under Hanger

- e. sealing the doorframe of the mechanical room door.
- 8. Seal breaches in brick façade as well as any other routes of water penetration into the building.

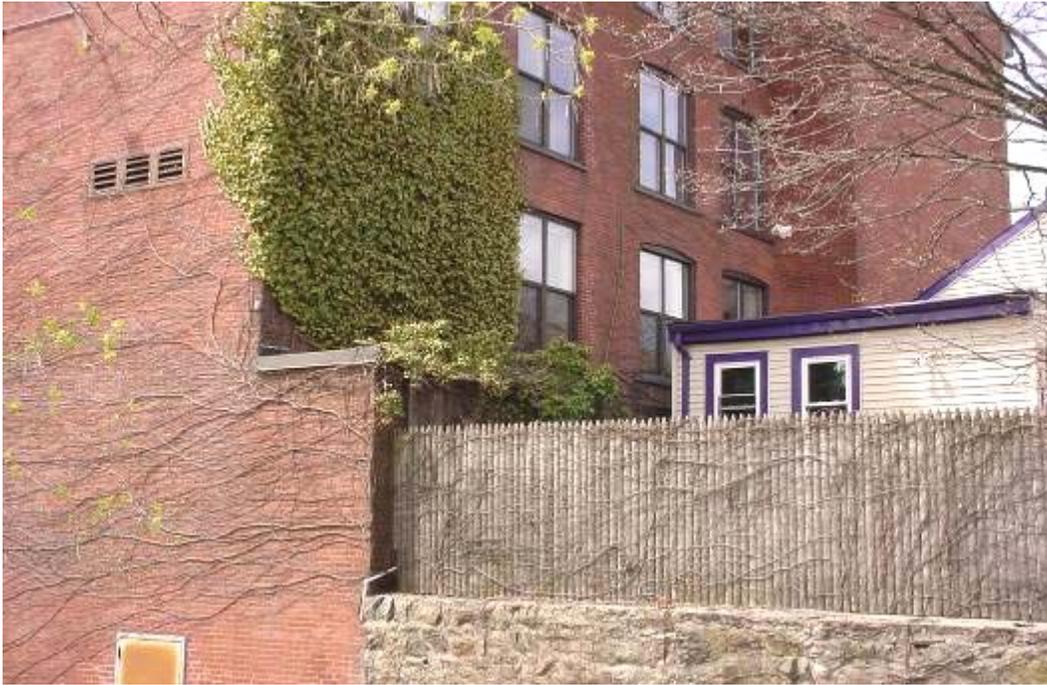
Picture 9

Ivy on Exterior of Building

- 9. Seal all window frames and seams in a proper manner.
- 10. Remove ivy from the building exterior.
- 11. Examine the short roof along the north wall to ensure that rubber membrane is intact, properly flashed and draining appropriately.

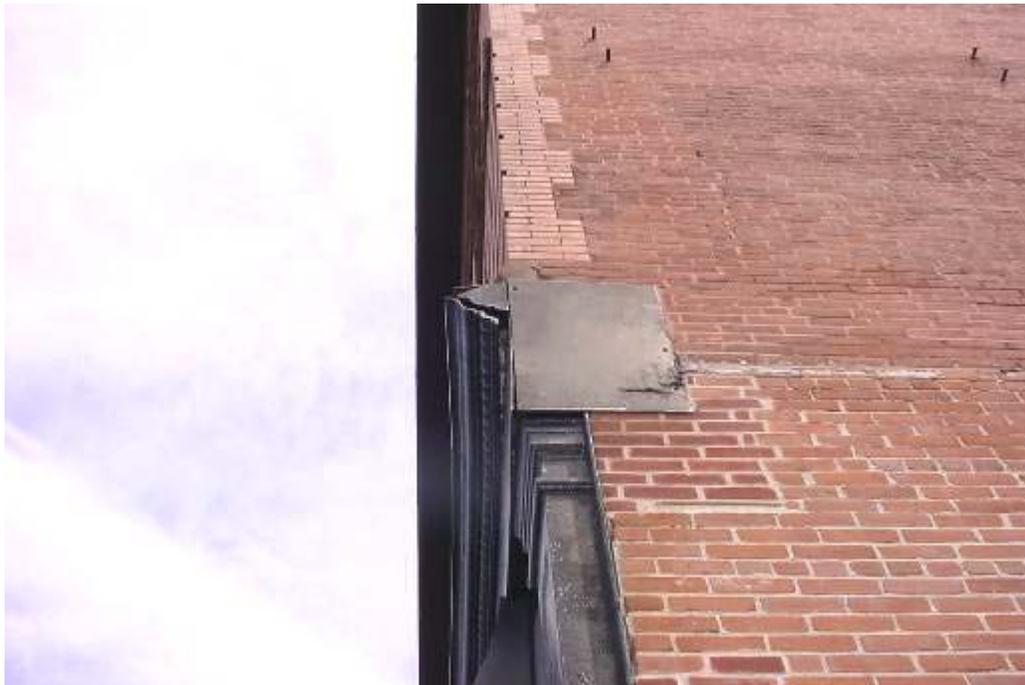
Picture 10

Damage to the Building Façade

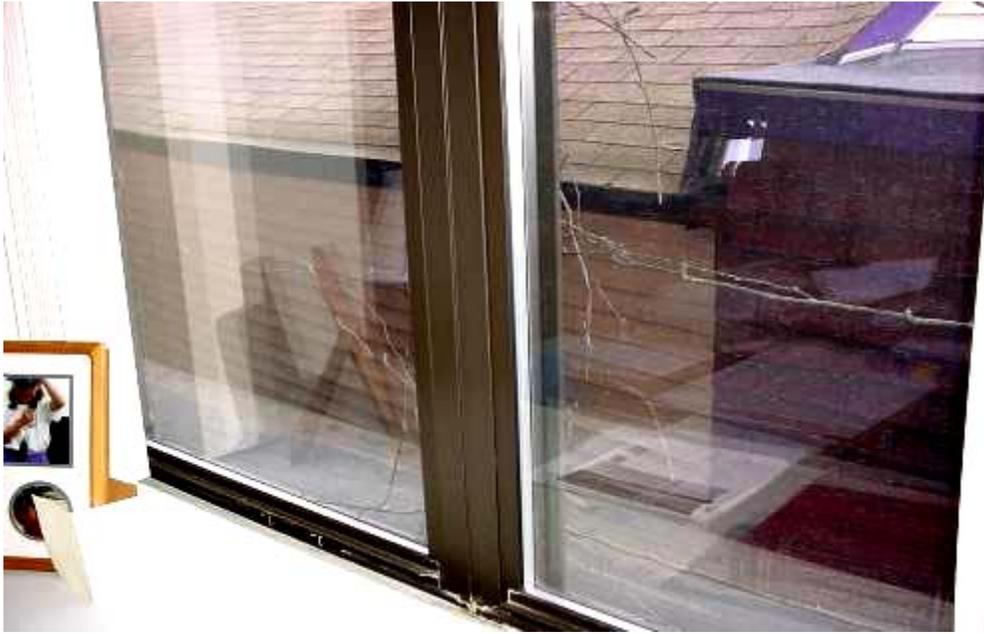
Picture 11

Short Roof, North Side of Building, Note Location of Roof Edge of Adjacent Building Which Lacks a Gutter/Downspout System

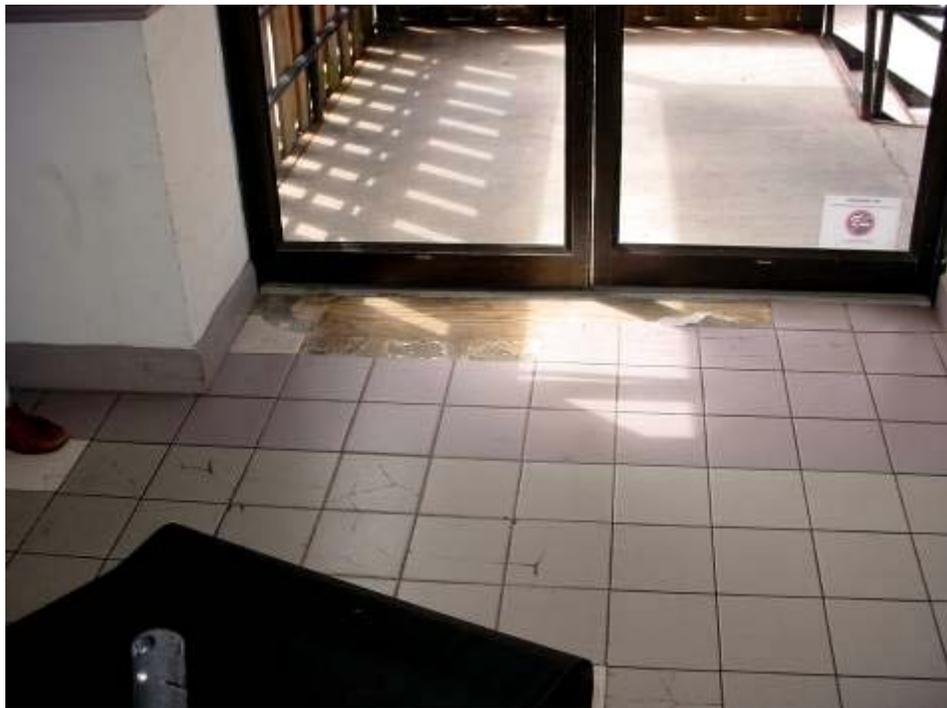
Picture 12

Damage to Tile at Door Threshold

- 14. Seal the threshold of the exterior door entrance to the DIA offices to prevent water penetration. Repair tile in the front entrance lobby.
- 15. Consider reducing the number of plants in work areas. Avoid over-watering and examine drip pans periodically for mold growth. Disinfect with an appropriate antimicrobial where necessary.

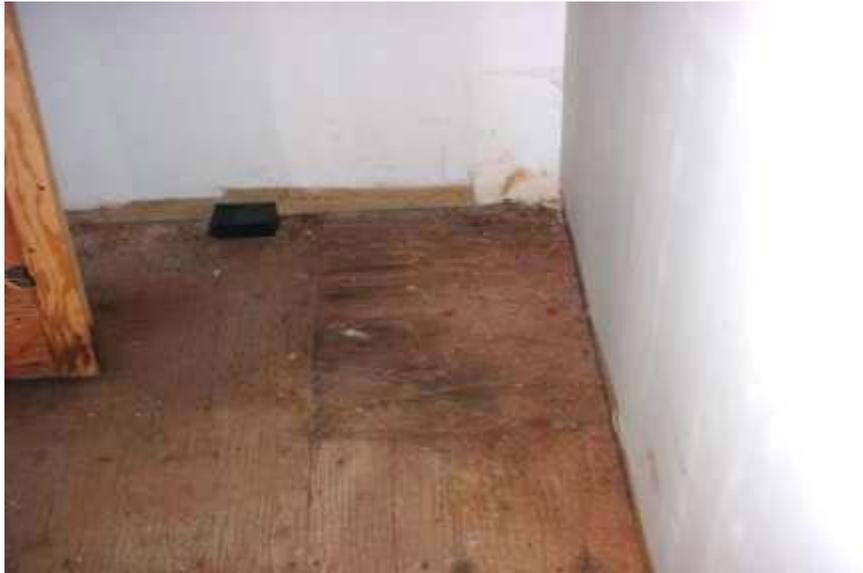
Picture 13

Several other conditions that can affect indoor air quality were noted during the assessment. Of note was the heavy accumulation of mouse droppings inside the rear AHU room on the first floor (Picture 13). Under current Massachusetts law (effective November 1, 2001) the principles of integrated pest management (IPM) must be used to remove pests in state buildings (Mass Act, 2000). Pesticide use indoors can introduce chemicals into the indoor environment that can be sources of eye, nose and throat irritation. The reduction/elimination of pathways/food sources that are attracting these insects should be the first step taken to prevent or eliminate this infestation.

Mouse Droppings on AHU Floor, Note Bait Trap

3. Clean mouse droppings in the AHU rooms in a proper manner to prevent the aerosolization of rodent-related allergens. Thoroughly clean and disinfect floors of the AHU rooms to reduce mouse-related allergens.

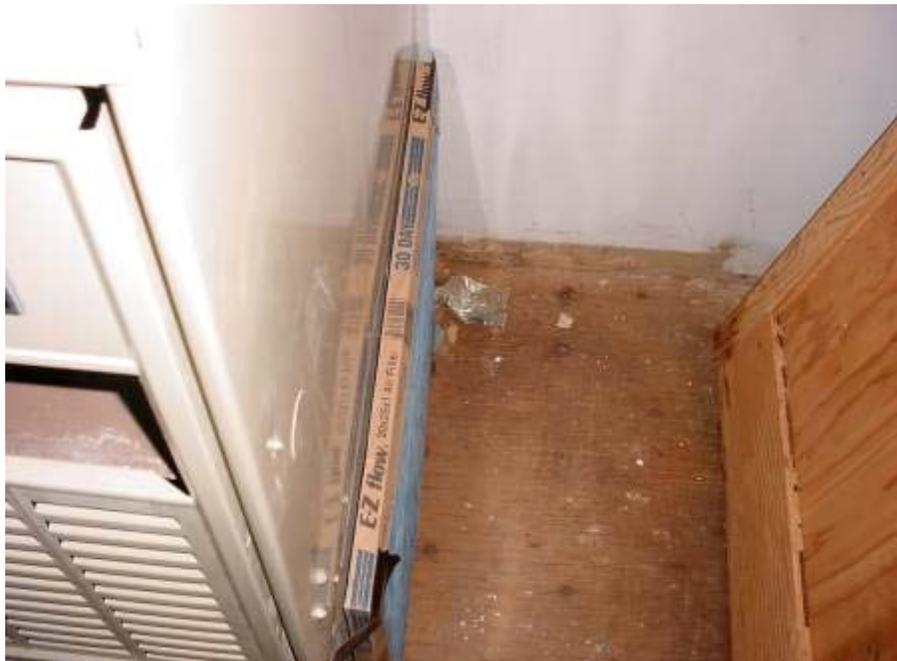
Picture 14

AHUs are normally equipped with filters that strain particulates from airflow. The AHUs for the DIA office have filters duct taped to air intake openings (Picture 14). In this condition, any airborne particles drawn into the hallway, the floor, wall cavities or other locations can be distributed via the ventilation system. Particle sources can include the AHUs, photocopiers and materials stored in the mechanical rooms. In order to decrease aerosolized particulates, filters should be properly installed. The amount of airborne particles prevented from entering the air stream is determined by the dust spot efficiency. Dust spot efficiency is the ability of a filter to remove particulates of a certain diameter from air passing through the filter. Filters that have been determined by ASHRAE to meet its standard for a dust spot efficiency of a minimum of 40 percent would be sufficient to reduce airborne particulates (Thornburg, 2000; MEHRC, 1997; ASHRAE, 1992). Note that increased filtration can reduce airflow produced by the AHUs by increased resistance (called pressure drop). Prior to any increase of filtration, the AHUs should be evaluated by a ventilation engineer to ascertain whether they can maintain function with more efficient filters installed.

AHU Air Filter Held in Place by Tape, Note Spaces between Filter and Cabinet

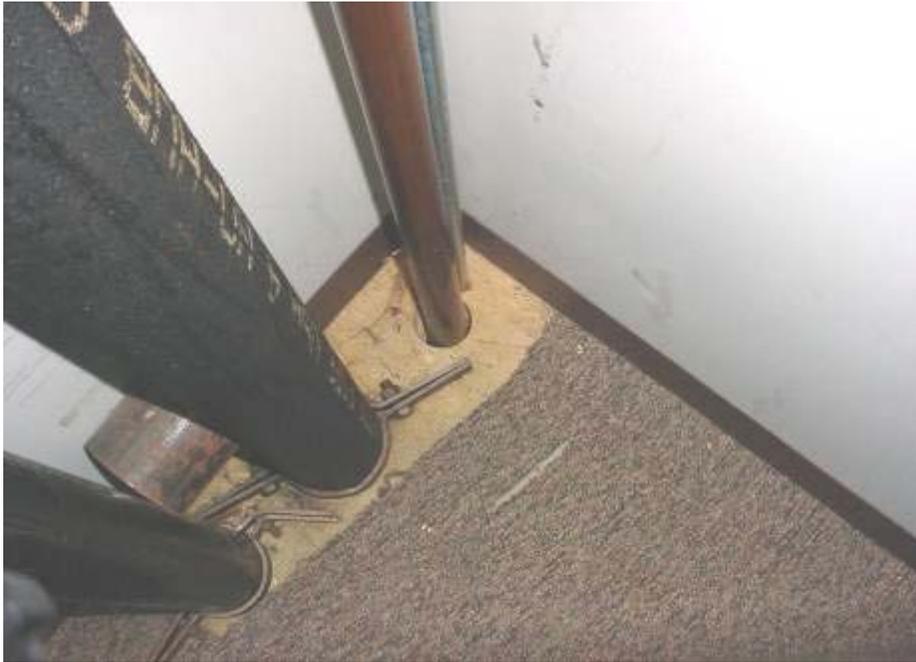
Picture 15

Finally, a pipe in an office appears to have an opening in the floor that allows for basement air to migrate into this office (Picture 15). This condition can allow for moisture and basement odors to enter this office space.

**Pipe Hole in Floor of Office, Cold Air Was Found Flowing
upwards Through This Space**

17. Seal all pipe penetrations through the floor of the first story to prevent basement air migration into office space.
