INDOOR AIR QUALITY ASSESSMENT

**Department of Social Services
Dowling Building
22 Pleasant Street
Malden, Massachusetts**

Prepared by:
Massachusetts Department of Public Health
Bureau of Environmental Health
Emergency Response/Indoor Air Quality Program
August, 2007

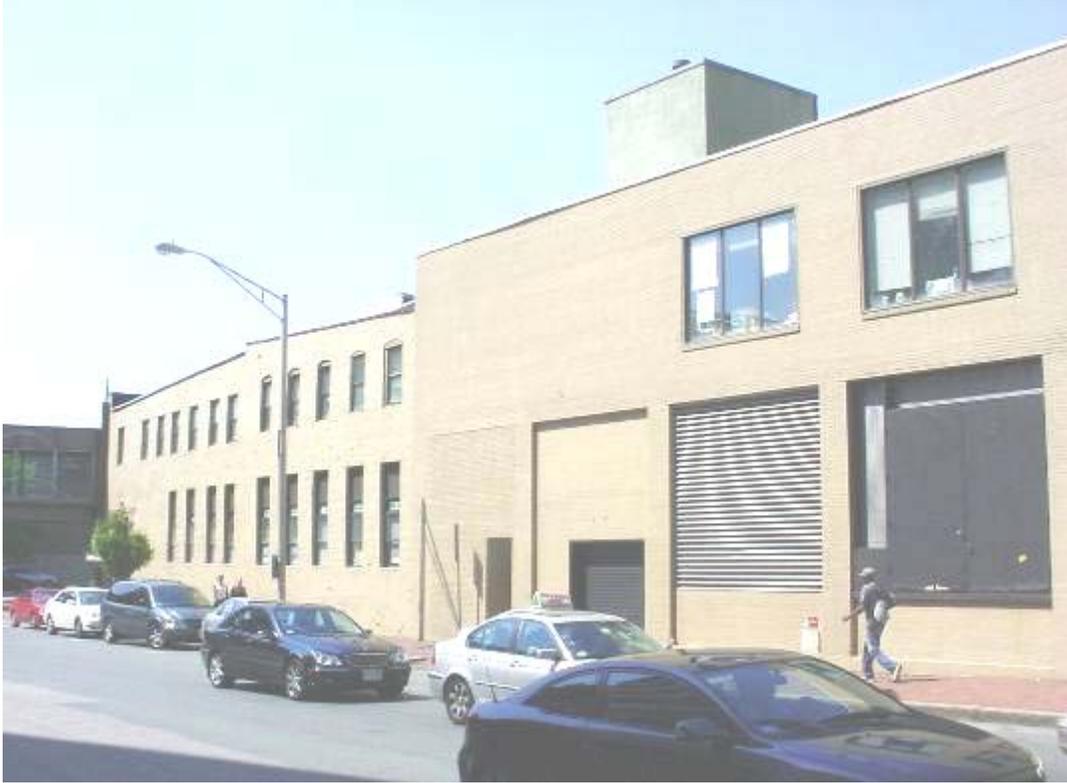
Picture 1

The DSS is located on the second floor of an early 1900's office building that appears to have an addition that was built in the mid-1900's (Picture 1).

Rear of 22 Pleasant Street, DSS Office is Located on the Second Floor

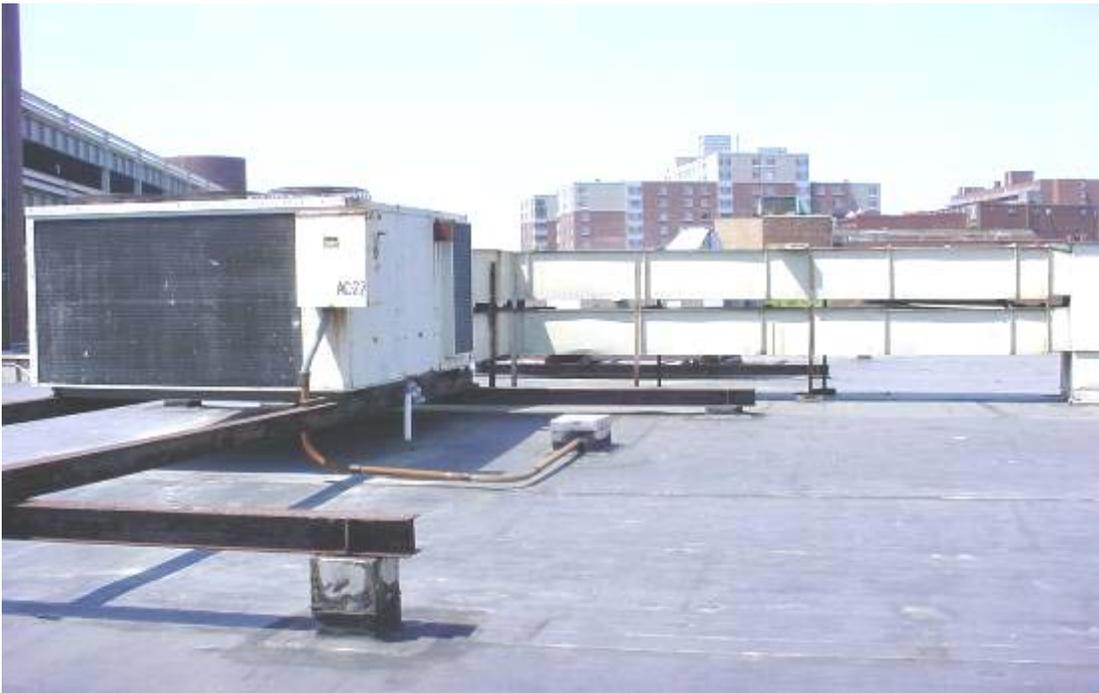
Picture 2

Rooftop AHU

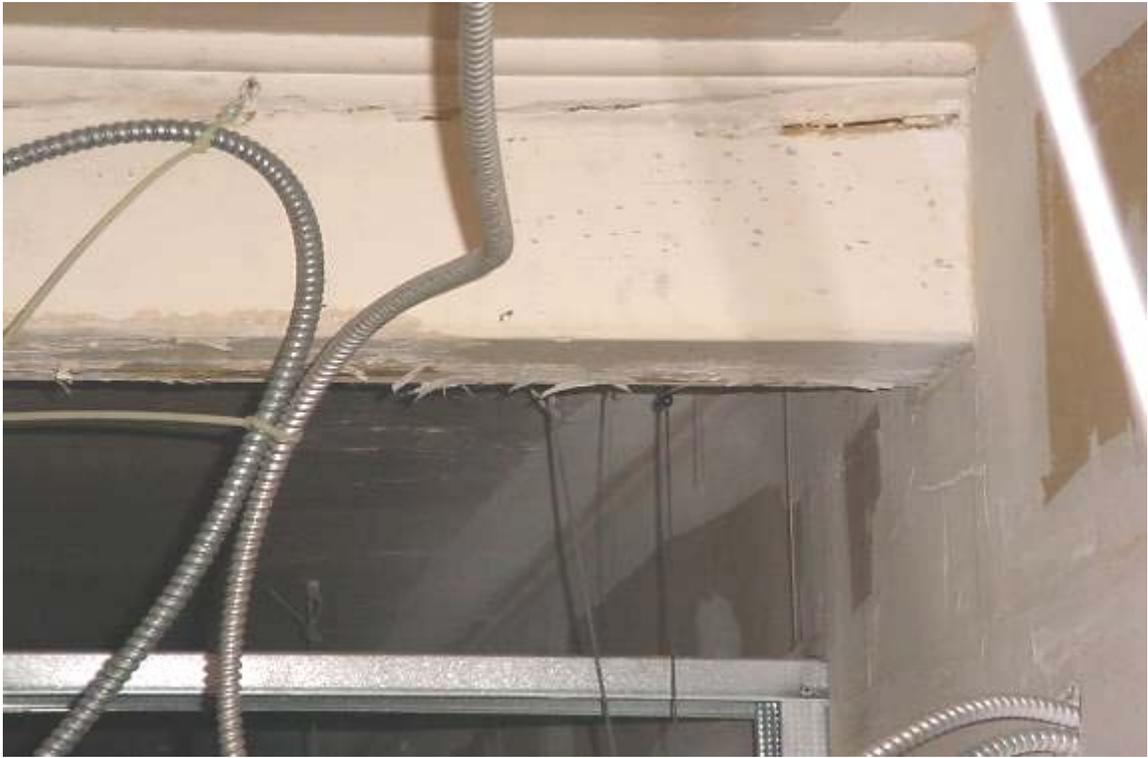
Picture 3

Water damaged ceiling plaster (above the ceiling plenum) and stained ceiling tiles were observed (Picture 3) at the time of assessment, which are evidence of roof leaks. In one location, the source of water wetting ceiling tiles appeared to be a duct connected to a rooftop AHU (Picture 4). The AHU cabinet had a space along a corner, through which rainwater could leak under certain weather conditions (Picture 5).

Water Damaged Materials in Ceiling Plenum

8. Repair water leaks and replace any remaining water-stained ceiling tiles. Examine the areas above these tiles for mold growth. Disinfect areas of water leaks with an appropriate antimicrobial as needed.
9. Report any roof leaks or other signs of water penetration to the building owner/manager for prompt remediation.
10. Ensure all plants are equipped with drip pans. Examine drip pans periodically for mold growth and disinfect with an appropriate antimicrobial where necessary.
11. Clean/vacuum upholstered furniture regularly to prevent dust build-up. If not possible/practical, remove upholstered furniture from building.
12. Ensure photocopiers are located in a well-ventilated area.
13. For further building-wide evaluations, advice on maintaining public buildings and other related indoor air quality documents see the MDPH's website at <http://www.state.ma.us/dph/MDPH/iaq/iaqhome.htm>.

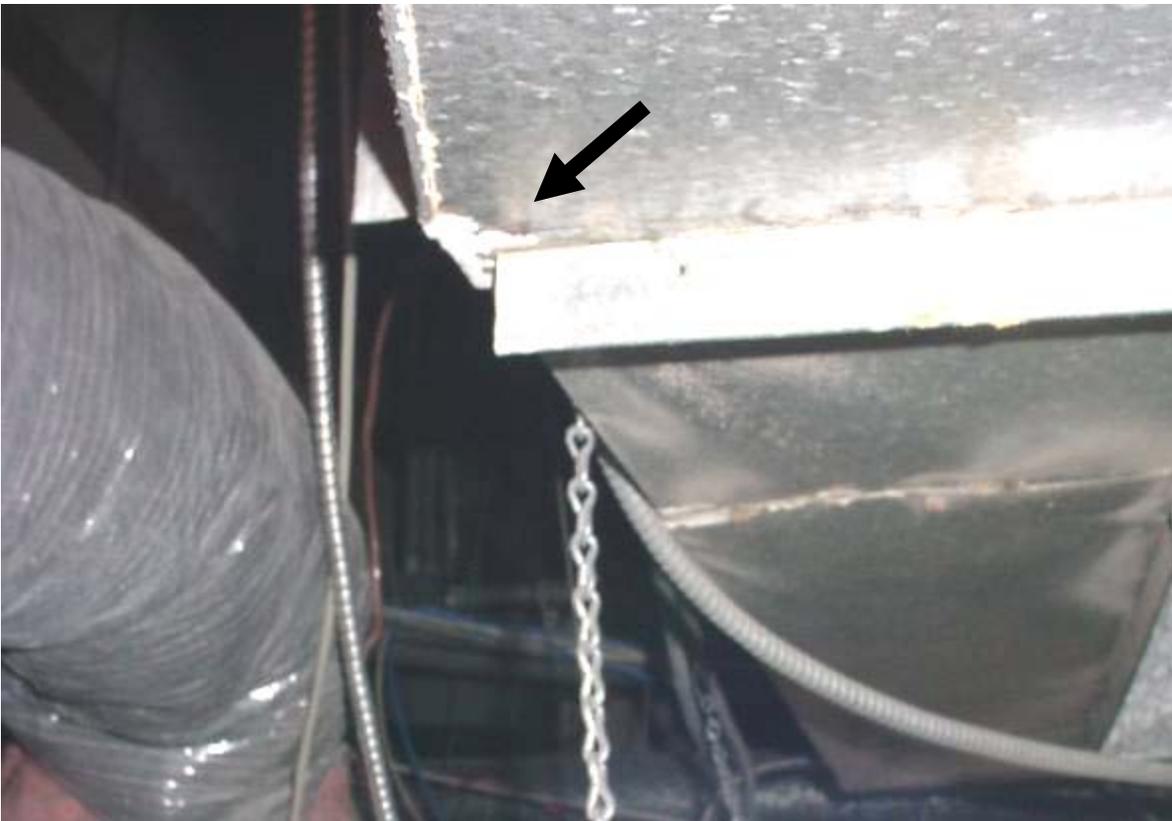
Picture 4

Duct Leaking Water, Note Stain at Seam of Duct (Arrow)

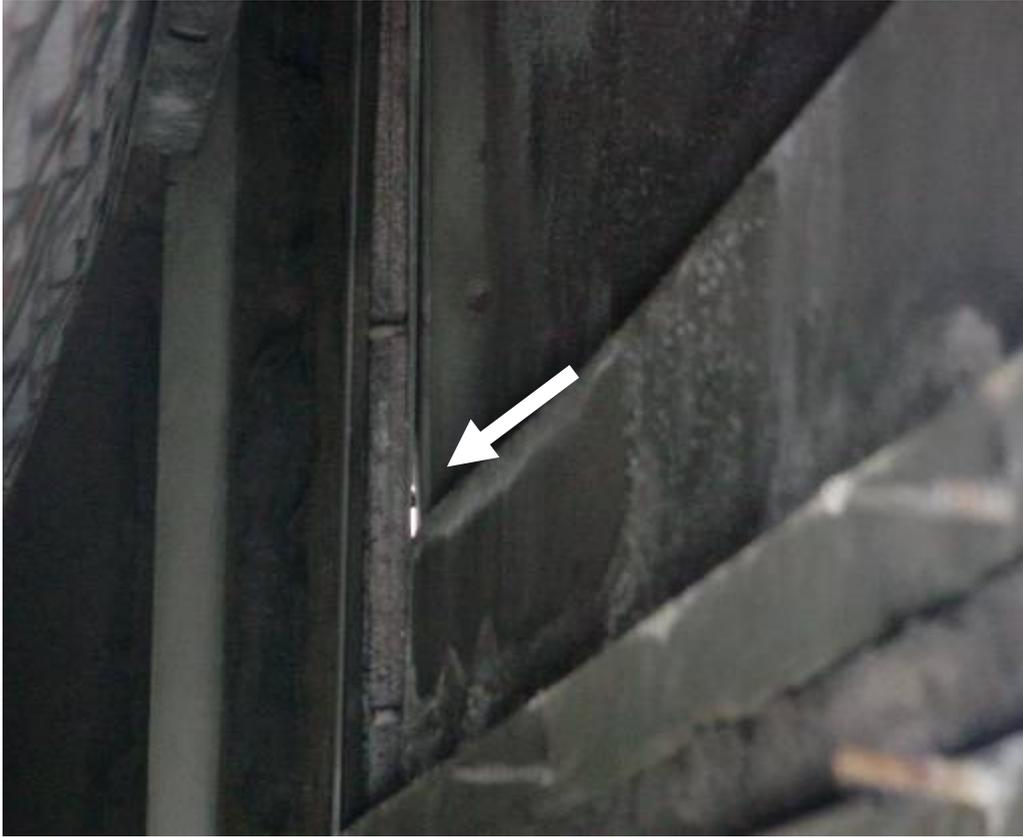
Light at Seam Inside AHU, Indicating Opening (Arrow)

1. Seal the seam in the rooftop AHU shown in Picture 5 with an appropriate caulking material. Inspect rooftop AHUs for similar spaces and repair as needed.
2. Remove accumulated soda cans from storage closet.
3. Remove furniture and discarded boxes that can serve a pest harborages.
4. Reduce/remove toaster ovens, microwave ovens and refrigerators from all areas with the exception of the kitchen.
5. It highly recommended that the principles of integrated pest management (IPM) be used to rid the building of pest. A copy of the IPM recommendations can be obtained from the Massachusetts Department of Food and Agriculture (MDFA) website at the following website:

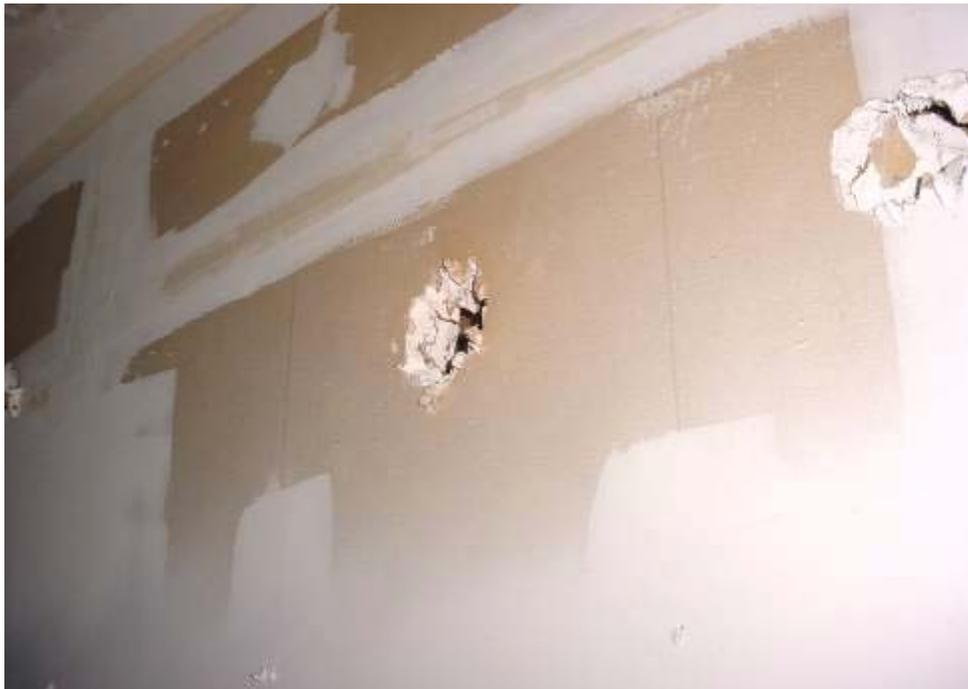
Picture 6

The ceiling plenum was created by installing a suspended ceiling tile system below the original plaster ceiling. It appears that large holes were made in the plaster ceiling in order to install chains from which the suspended ceiling would hang (Picture 6). These holes create breaches through which unconditioned air above the original plaster ceiling can be drawn.

Holes in Wall above Ceiling, Allowing for Rodent Access

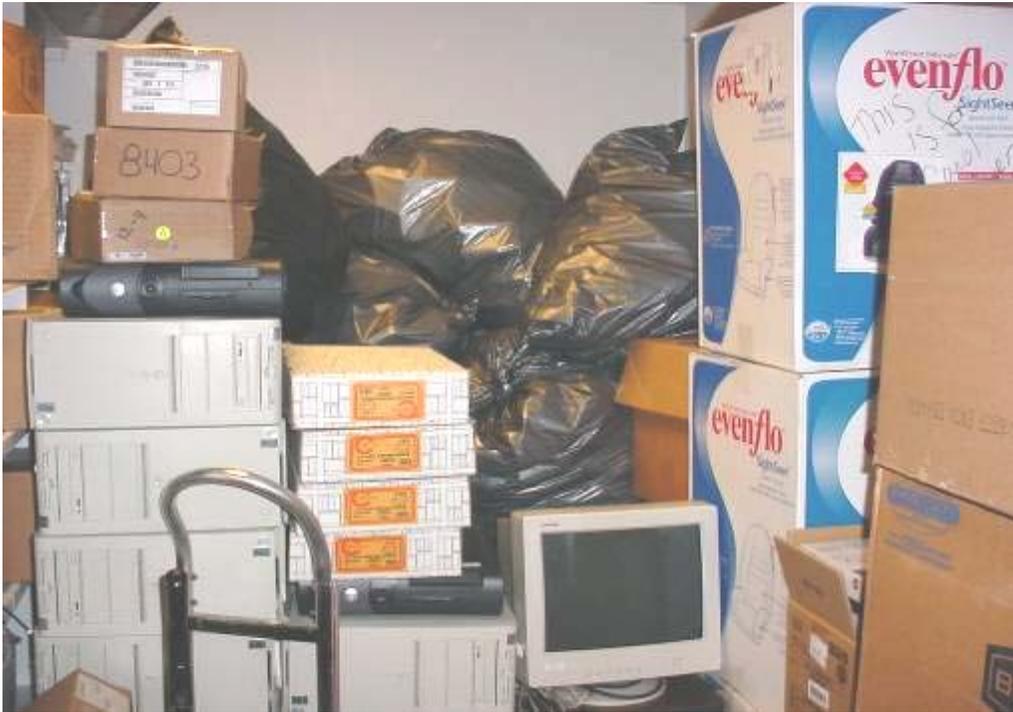
Picture 7

A number of conditions that may attract rodents were observed in work areas. A large collection of soda cans in plastic bags was found in a storeroom (Picture 7). Stored food containers were noted in some rooms. Food preparation equipment (e.g., toasters, microwave ovens and refrigerators) were also found in a number of offices (Picture 8). Food preparation equipment did not appear to be cleaned of food residues, which can serve as a rodent attractant. Numerous means for pests to enter the DSS were identified in the ceiling plenum as well as the electrical closet (Pictures 6 and 9). Under current Massachusetts law (effective November 1, 2001) the principles of integrated pest management (IPM) must be used to remove pests in state buildings (Mass Act, 2000).

Soda Cans in Plastic Bags

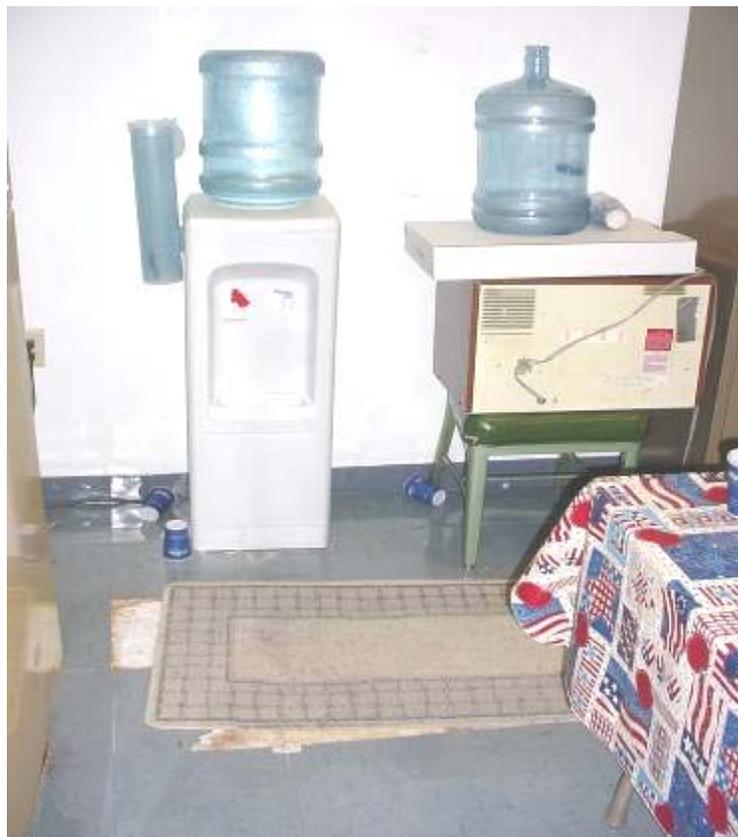
Picture 8

Unused Microwave Oven

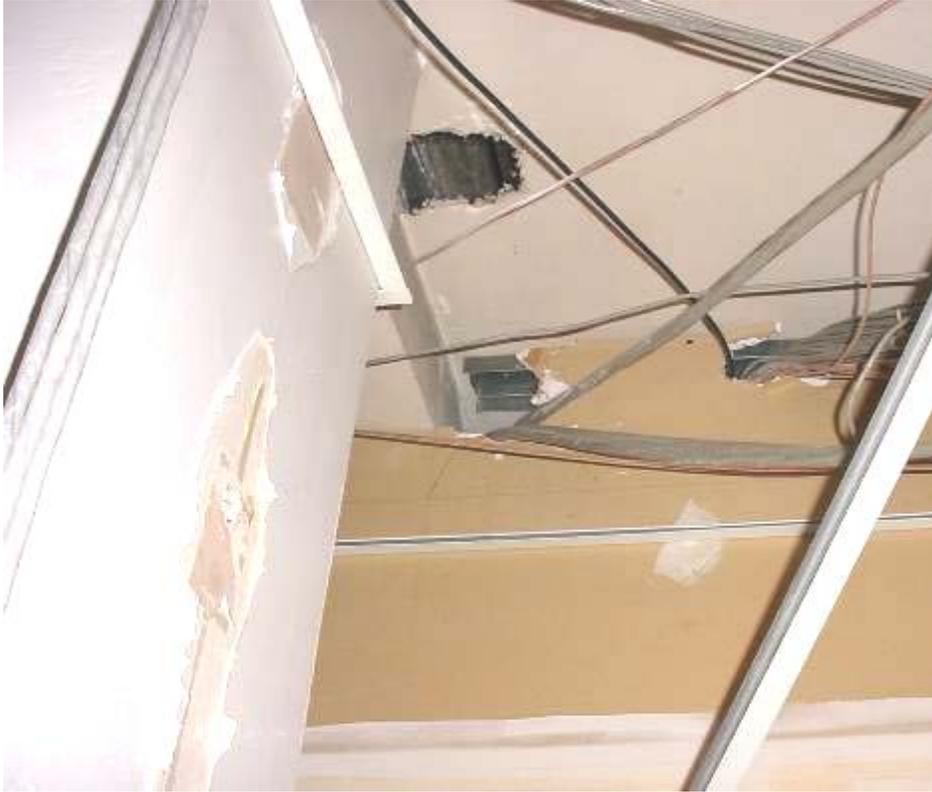
Picture 9

Holes in Wall of Electrical Room

Examine each room and the exterior walls of the DSS office for means of rodent egress and seal. If doors do not seal at the bottom, install a weather strip as a barrier to rodents. Reduce harborages (e.g. discarded equipment and cardboard boxes) where rodents may reside (MDFA, 1996).
