INDOOR AIR QUALITY ASSESSMENT

**Merrimac Town Hall
2 School Street
Merrimac, Massachusetts**

Prepared by:
Massachusetts Department of Public Health
Center for Environmental Health
Emergency Response/Indoor Air Quality Program
March, 2007

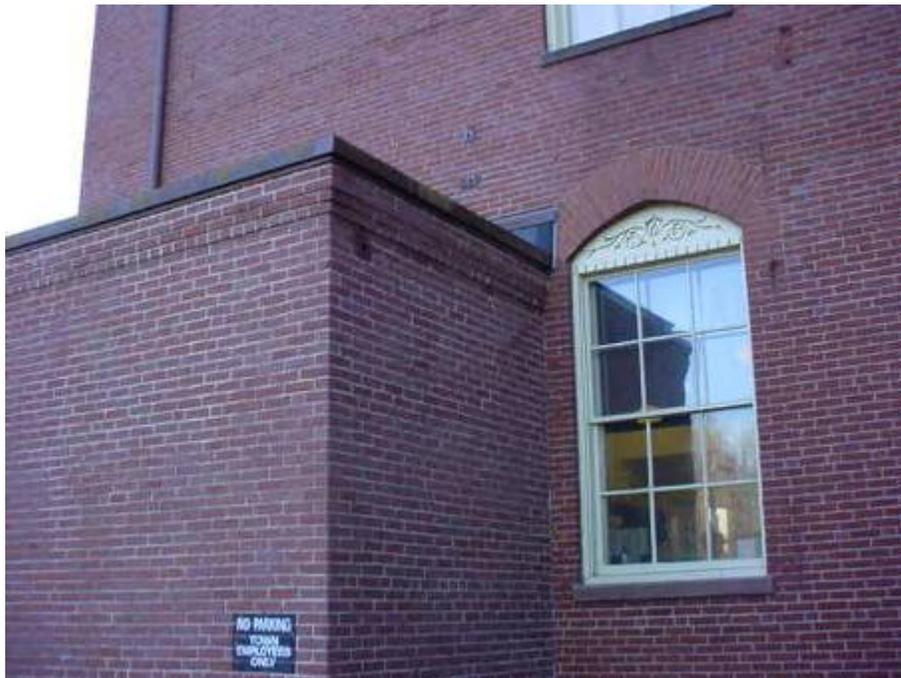
Picture 2

Temperature measurements ranged from 66° F to 75° F, which were below the lower end of the MDPH recommended comfort guidelines in several areas the day of the assessment. The MDPH recommends that indoor air temperatures be maintained in a range of 70° F to 78° F in order to provide for the comfort of building occupants. There were two areas in the building that had reported problems with temperature control, the vault and a storage closet that once served as an entrance into the basement. The vault (Picture 2) is a structure attached to the building with no discernable heat source. Temperature inside the vault during the assessment was 66° F.

The Vault

12. Consideration should be given to installing a heating system in the vault and closet shown in Picture 3.
13. The plywood plug in Picture 4 should have all seams sealed and be appropriately insulated to prevent cold air penetration in the winter and hot, moist air in summer months.

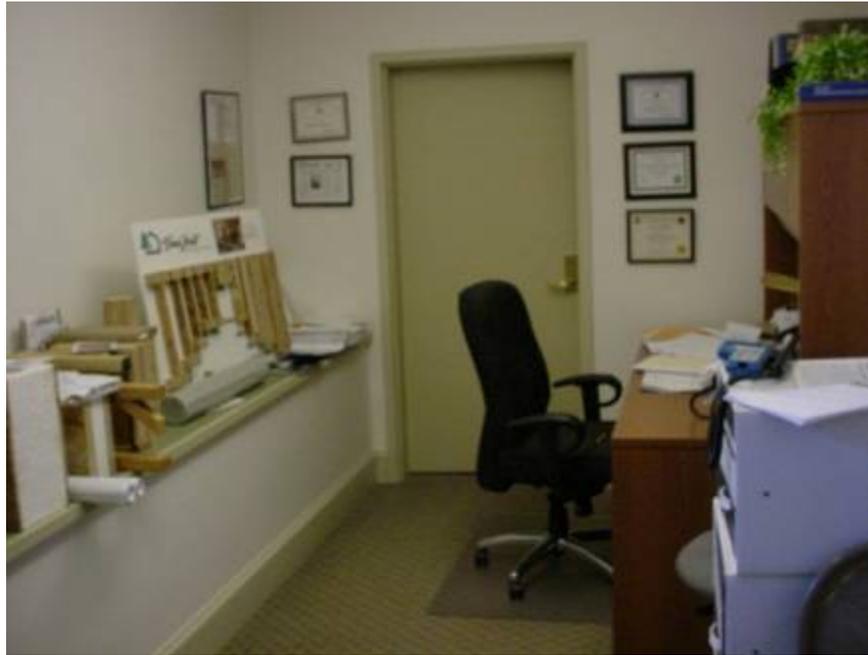
Picture 3

Reports of cold drafts through the closet door (Picture 3) of the room adjacent to the former basement entrance were voiced. Inside the closet is a plywood plug, which did not appear to be sealed or insulated (Picture 4), allowing cold air to penetrate into the closet. Of note was the presence of a sprinkler head in the closet, which could be subject to freezing in extremely cold temperature. In many cases concerning indoor air quality, fluctuations of temperature in occupied spaces are typically experienced, even in a building with an adequate fresh air supply.

Closet Door Leading To Former Basement Entrance

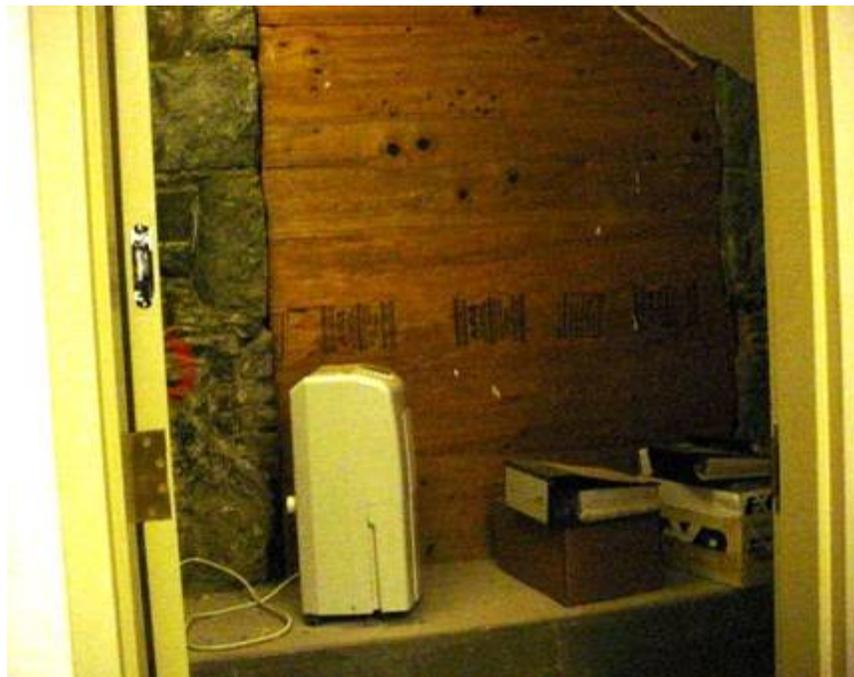
Picture 4

Plywood Plug over Former Basement Entrance

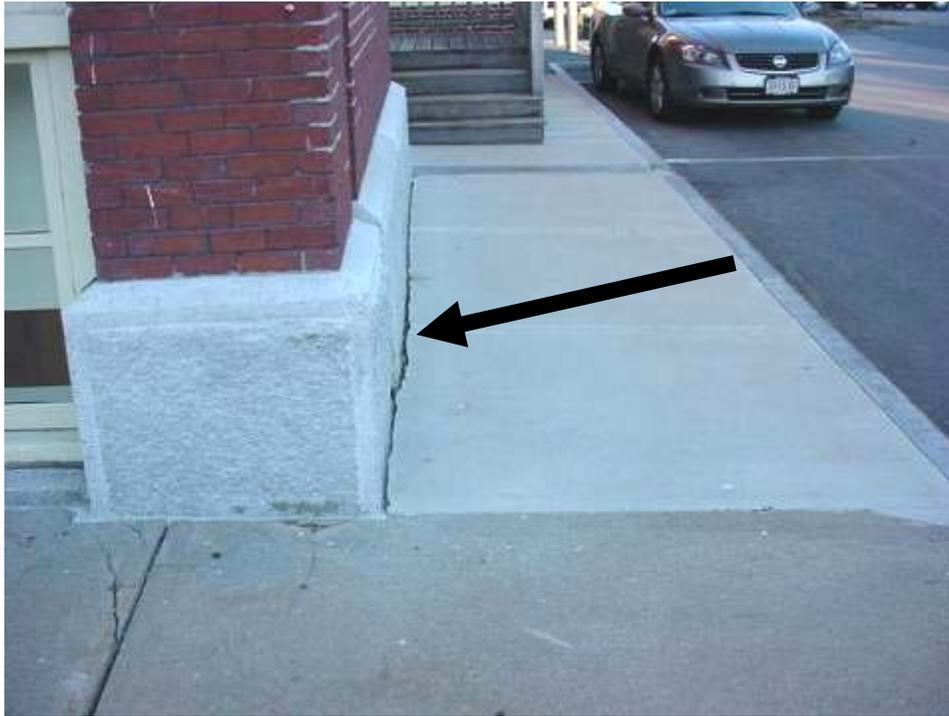
Picture 5

- Cracks were observed between the sidewalk along the south wall (Picture 5) and in a number of areas along the front exterior wall (Pictures 6 and 7). Unsealed seams between the exterior wall and sidewalk can allow driving rain and runoff to accumulate in the seam and eventually migrate into the building through the foundation.
- Cement conduits were installed beneath downspouts to direct water away from the building. The height of the downspouts above the cement conduits would tend to create splashing, spilling water into the seams around the conduit (Picture 8).
- A mailbox cement base was placed against the foundation (Picture 9), which can allow water to accumulate against the building.
- An unsealed seam was observed between the building sill and the wooden window system (Picture 10). Under driving rain in certain wind conditions, water may penetrate through this seam.

South Wall, Sidewalk/Exterior Wall Seam

6. Examine the exterior of the building and seal all seams between the sidewalk and foundation with an appropriate sealing compound.
7. Seal all seams around the cement conduits with an appropriate sealing compound.

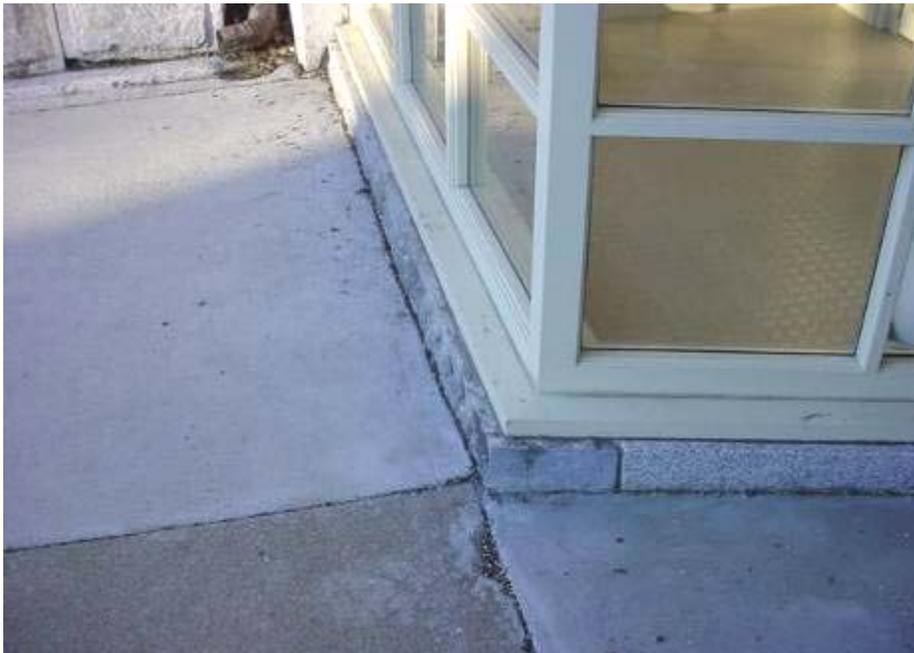
Picture 6

Front Wall, Sidewalk/Exterior Wall Seam

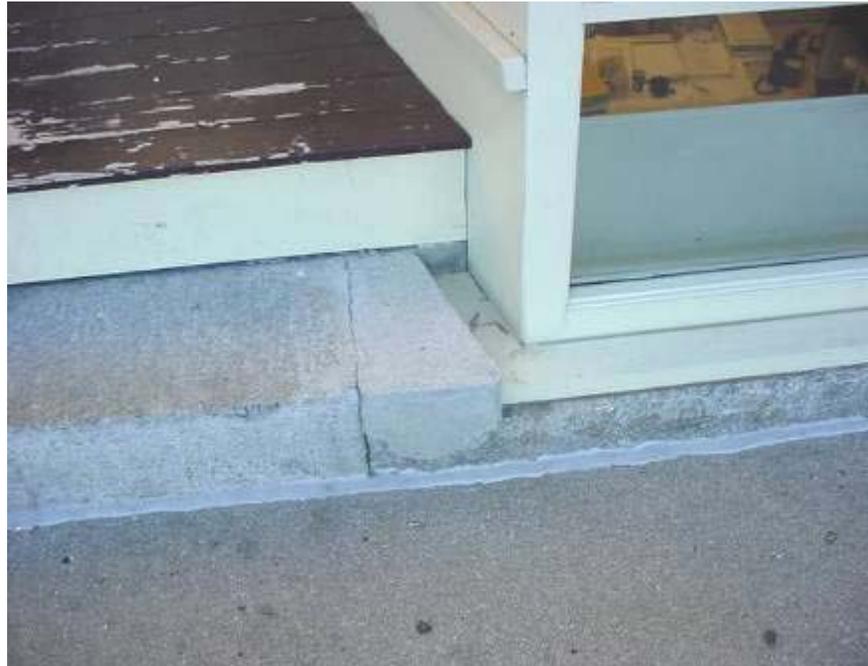
Picture 7

Front Wall, Sidewalk/Exterior Wall Sealed Seam, Note Crack in Step

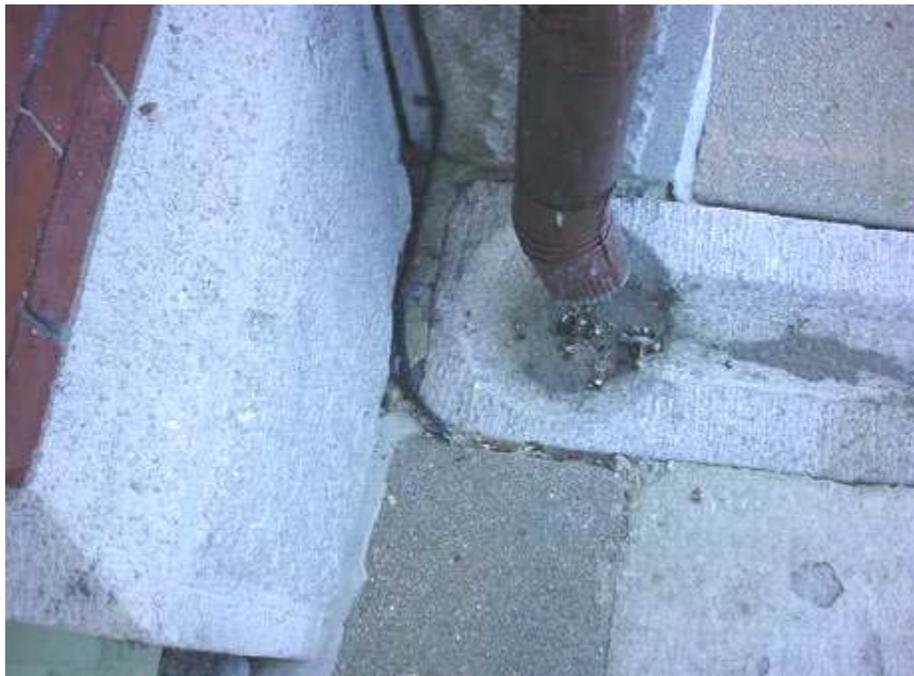
Picture 8

Downspout and Cement Conduit, Note Seams

8. Lower the height of the downspouts to reduce back-splashing.

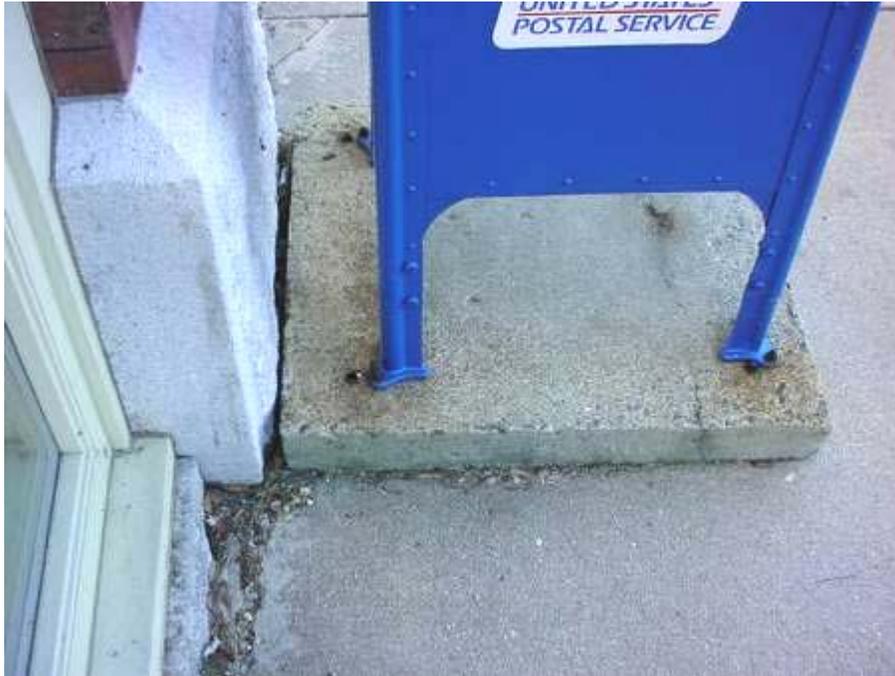
Picture 9

Mail Box Base

9. Seal the space behind the mailbox base or move mailbox to decrease water accumulation.
10. Examine the seam between the window frames and building sills outside the Assessor's office (and other areas) and seal with an appropriate material where necessary. Consider altering the slope of the drip sill above this area to prevent water from contact with the window frame. Once done, repair water damage to the window frame.

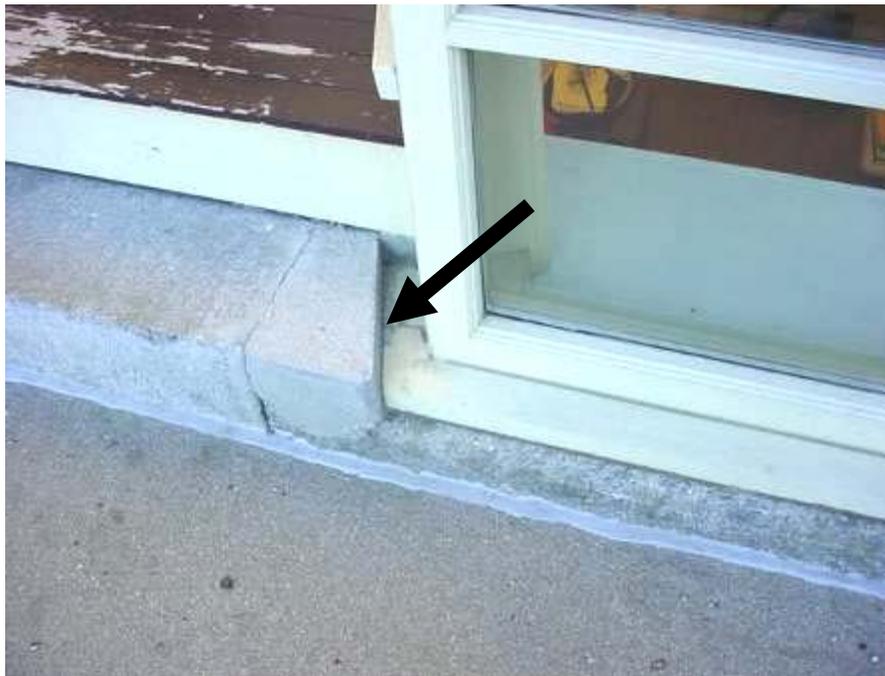
Picture 10

Open Seam between Building Sill and Window System

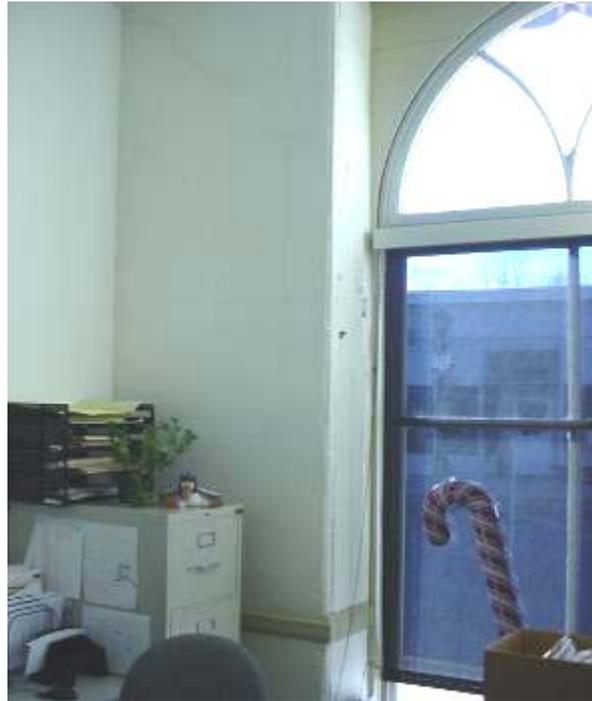
Picture 11

A water damaged widow frame was seen in the Assessor's office (Pictures 11 and 12). The damage appeared to be located directly beneath a drip sill on the building's exterior (Picture 13). It is likely that an open seam exists between the window frame and exterior wall in this location allowing for water penetration.

Window Assessor's Office

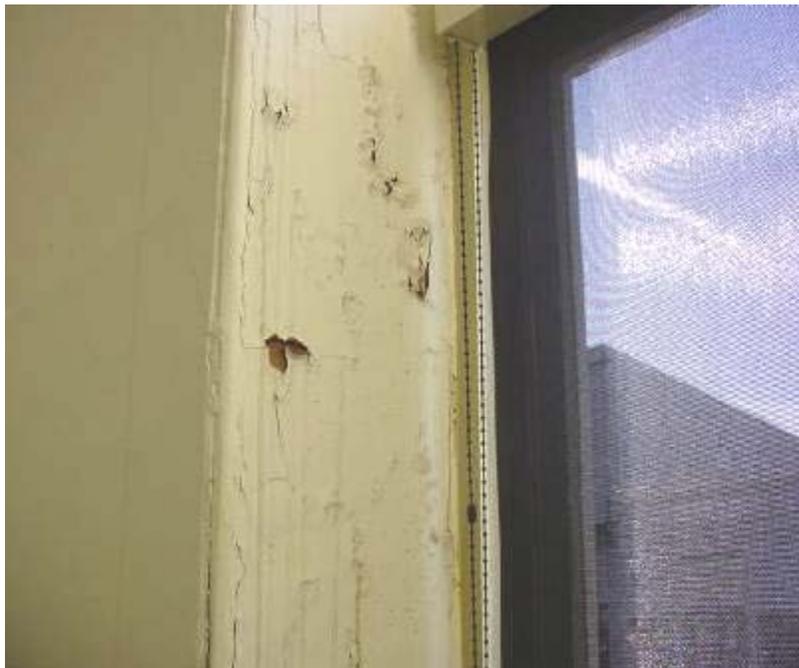
Picture 12

Close Up Of Water Damage in Picture 11

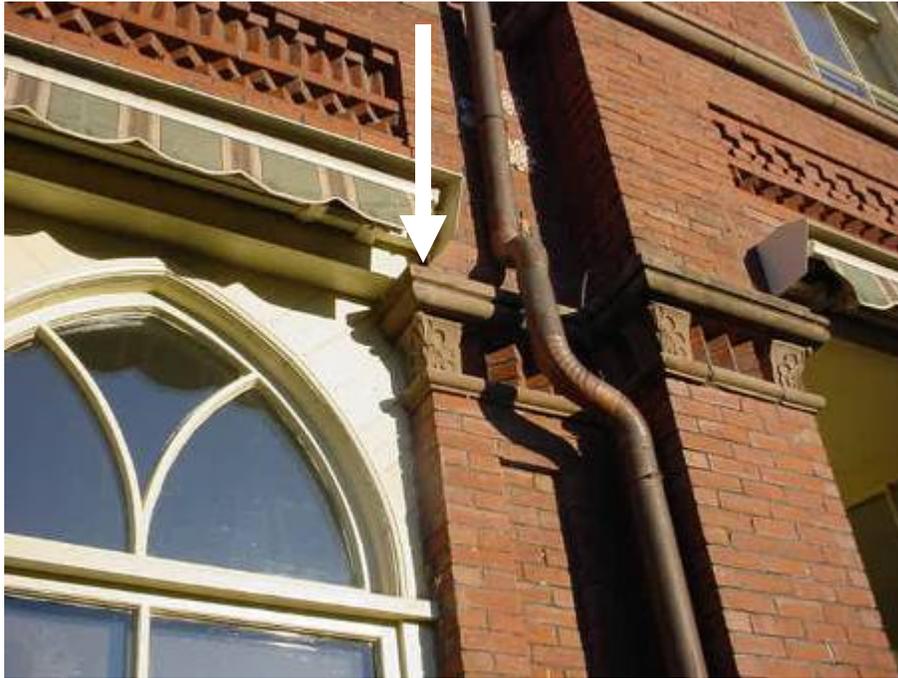
Picture 13

Drip Sill and Window Frame above Water Damage in Assessor's Office

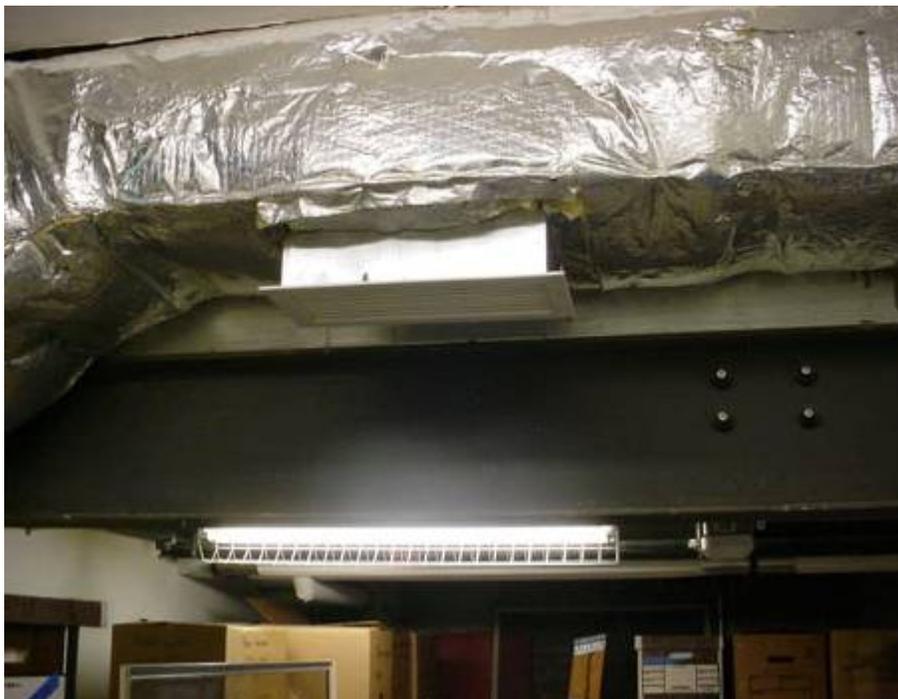
Picture 14

Respiratory irritation was reported by occupants in basement offices. Of note is a room that is used for storage. This room contains a supply vent (Picture 14) connected to the AHU which appears to pressurize the room, forcing storeroom pollutants (e.g., settled dust, odors) into the hallway through seams around the storeroom door. While an exhaust/return vent exists in this room, the vent was not drawing air (Picture 15). Storerooms in general should have exhaust ventilation to remove pollutants from stored materials.

Fresh Air Supply, Basement Storeroom

3. Seal the fresh air supply vent in the storeroom to depressurize the storeroom.
4. Seal all holes in walls of the storeroom to prevent the movement of pollutants from the building wall cavity into the storeroom.

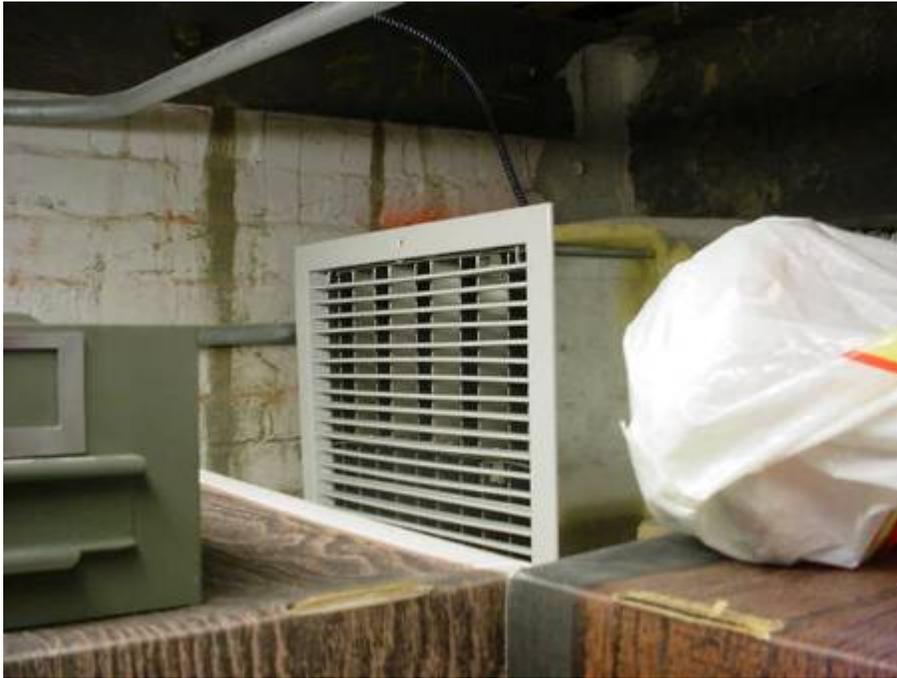
Picture 15

Return Vent, Basement Storeroom

1. Identify if fresh air supply and exhaust exist for the HVAC system.
Consideration should be given to retrofitting these vents if none exist.
2. Install weather-stripping and a door sweep on the basement storeroom door. Keep the door closed during business hours.
