INDOOR AIR QUALITY ASSESSMENT

**Massachusetts Rehabilitation Commission
85 Main Street
North Adams, Massachusetts**

Prepared by:
Massachusetts Department of Public Health
Center for Environmental Health
Emergency Response/Indoor Air Quality Program
January 2007

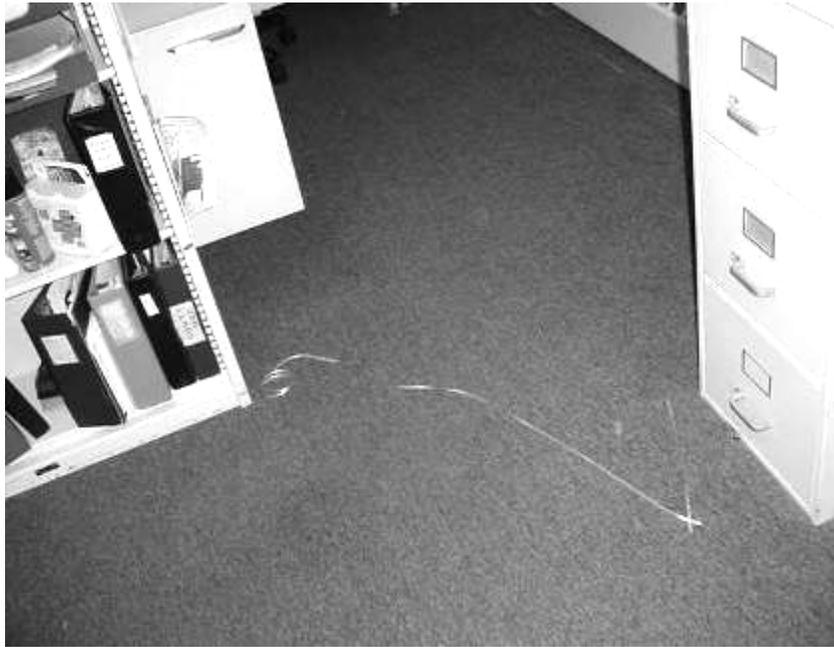
Picture 1

As discussed, the assessment was prompted by flooding from a restroom above the MRC space. Water damage to building materials in the MRC appeared to be isolated to a particular cubicle (Lamarre/Table 1). A distinct musty odor was detected in this area. CEH staff conducted moisture testing on the carpeting in this cubicle as well as other (non-affected) carpeting in these offices (Picture 1).

Cubicle with Water Damaged Carpet, (Area of Wet Carpet Marked With Ribbon)

1. Remove water-damaged materials (e.g., carpeting, and ceiling tiles) in a manner consistent with recommendations found in “Mold Remediation in Schools and Commercial Buildings” published by the US Environmental Protection Agency

(US EPA, 2001). Consider replacing carpeting with a non-slip, nonporous material (e.g., rubber matting, tile).

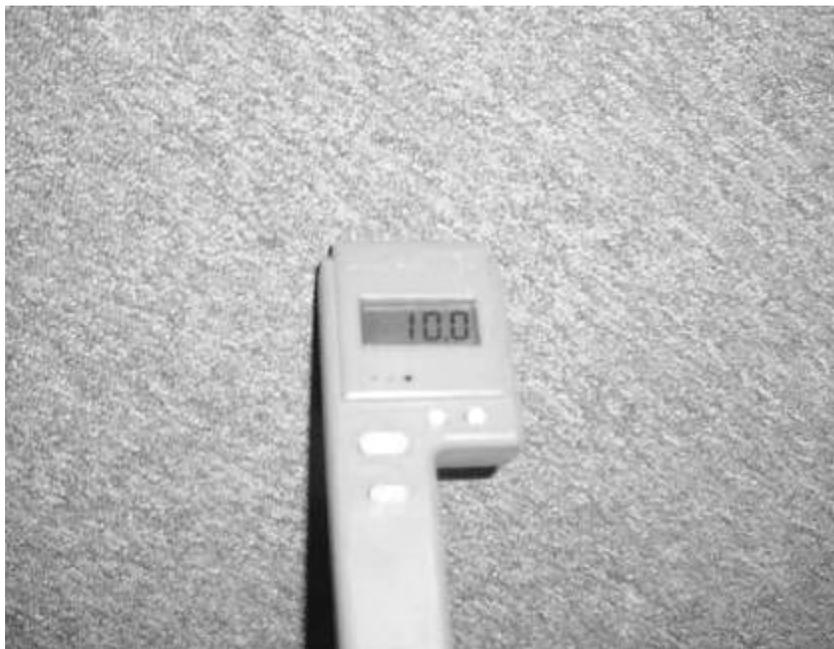
Picture 2

Elevated moisture levels (8-15.2 percent) were measured in carpet/flooring in the water damaged cubicle (Picture 2). These measurements were taken at least one week after the flooding incident, indicating that the carpet and the flooring were wet for well over 48 hours. In comparison, moisture measurements in all other carpeted areas measured at the MRC were non-detectable/normal (Table 1, Picture 3).

The type of flooding (i.e. toilets) that occurred in the restroom above the MRC space should be considered to be sewage contamination for the purpose of clean up (IICRC, 1999). In general, it is recommended that absorbent materials (gypsum wallboard, wall insulation, carpeting, fabrics, books, cardboard, etc.) be discarded once in contact with sewage (IICRC, 1999). Flooring and sub flooring (such as wood and tile) should be evaluated, cleaned, disinfected, dried and sealed when appropriate (IICRC, 1999). These measures should be implemented.

Carpet with Elevated Moisture Measurement

2. Once carpet is removed, use ventilation and dehumidifiers to draw moisture from the cement floor that exists above the slab vapor barrier.
3. During removal of building materials use local exhaust ventilation and isolation techniques to control remediation pollutants. Precautions should be taken to avoid the re-entrainment of these materials into the building's HVAC system. The design of each system must be assessed to determine how it may be impacted by renovation activities. Specific HVAC protection requirements pertain to the return, central filtration and supply components of the ventilation system. This may entail shutting down systems (when possible) during periods of heavy construction and demolition, ensuring systems are isolated from contaminated environments, sealing ventilation openings with plastic and utilizing filters with a higher dust spot efficiency where needed (SMACNA, 1995).

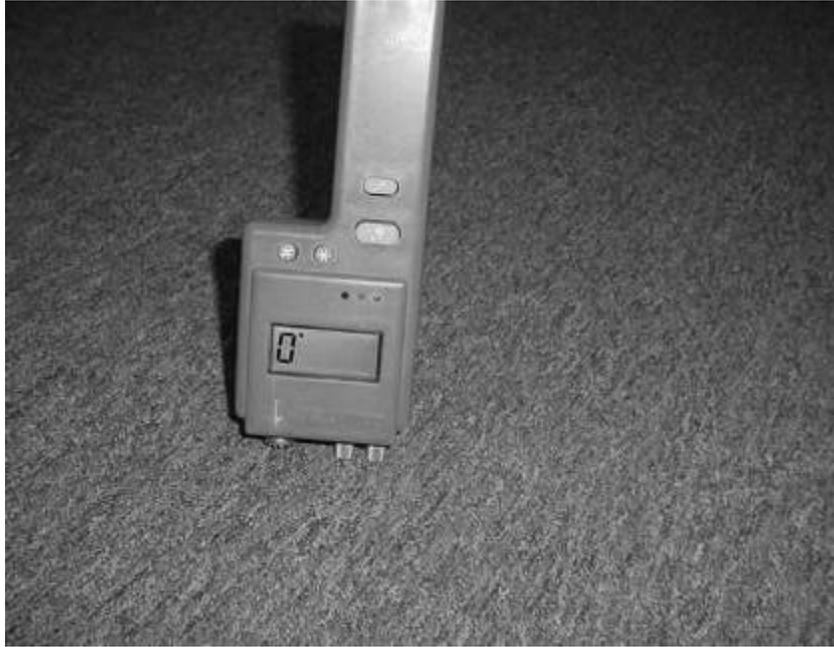
Picture 3

Carpet with Non-Detectable/Normal Moisture Measurement

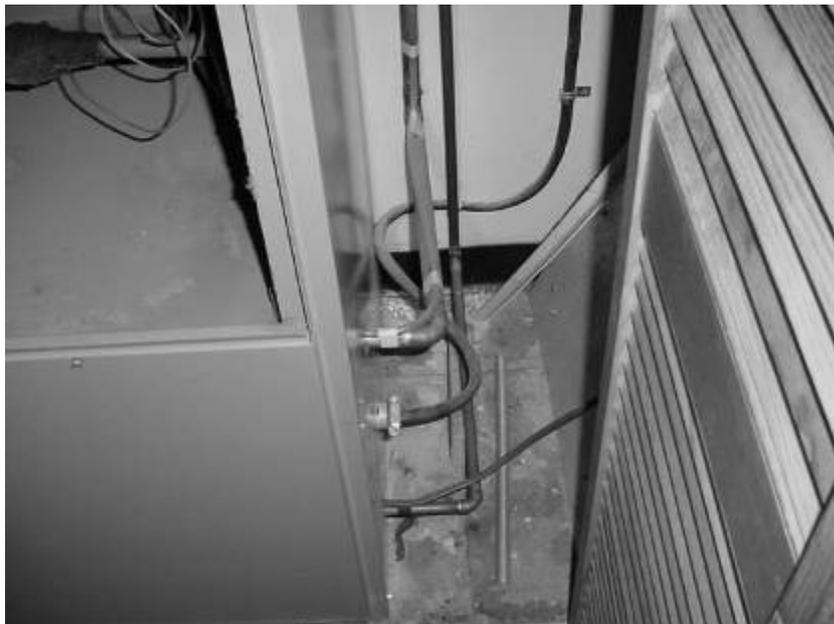
Picture 4

Also of note were the AC units. The areas outside the AC cabinets appeared to be water damaged (Picture 4). Cooling pipes, cooling coils and other uninsulated surfaces can be subjected to condensation¹. The AC cabinet in the hallway of the MCR has wall-to-wall carpet installed in contact with its outer surface (Picture 5), which may moisten the carpet.

Water Damaged Floor of Air Conditioning Closet

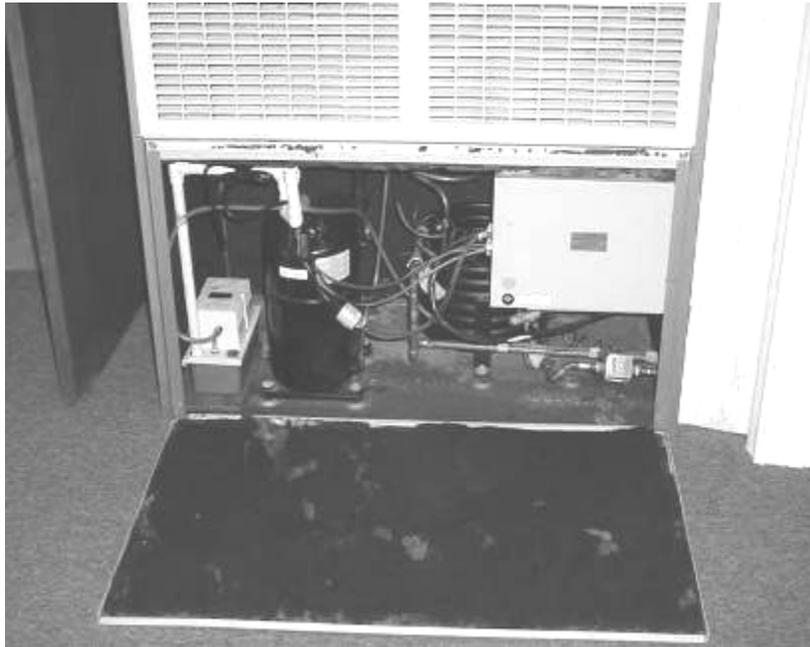
Picture 5

Carpet Adjacent To Air Conditioning Unit

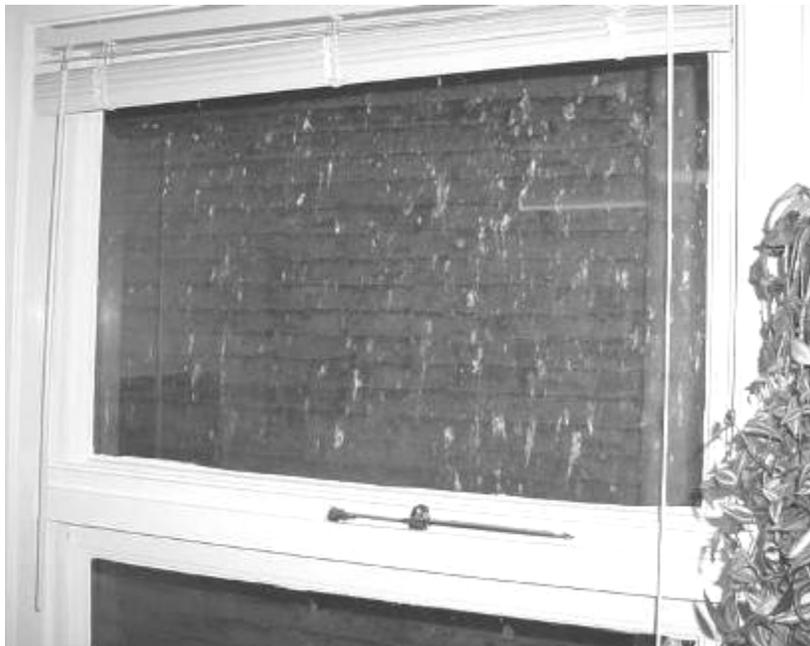
Picture 6

Examination of the windows of the MRC offices found sills and windows panes coated with pigeon waste (Picture 6). While the bird wastes are on the exterior of the building, windows are used to introduce fresh air from outdoors. Bird wastes in a building raise three concerns: 1) diseases that may be caused by exposure to bird wastes, 2) the need for clean up of bird waste and 3) appropriate disinfection. MDPH guidelines concerning the remediation of bird wastes are included as [Appendix B](#).

Window Pane Coated With Bird Waster

13. Clean bird waste from windows and sills in accordance with MDPH guidelines (Appendix B).
14. Install anti-roosting spikes on the top surface of all air conditioners as well as on window ledges.
15. Replace wire mesh screens with appropriate air filters in AC units. Prior to any increase of filtration, each piece of air handling equipment should be evaluated by a ventilation engineer as to whether it can maintain function with more efficient filters.
16. Seal all holes around the AC units. (i.e., floors, ceilings and walls) to eliminate draw of air from building cavities.

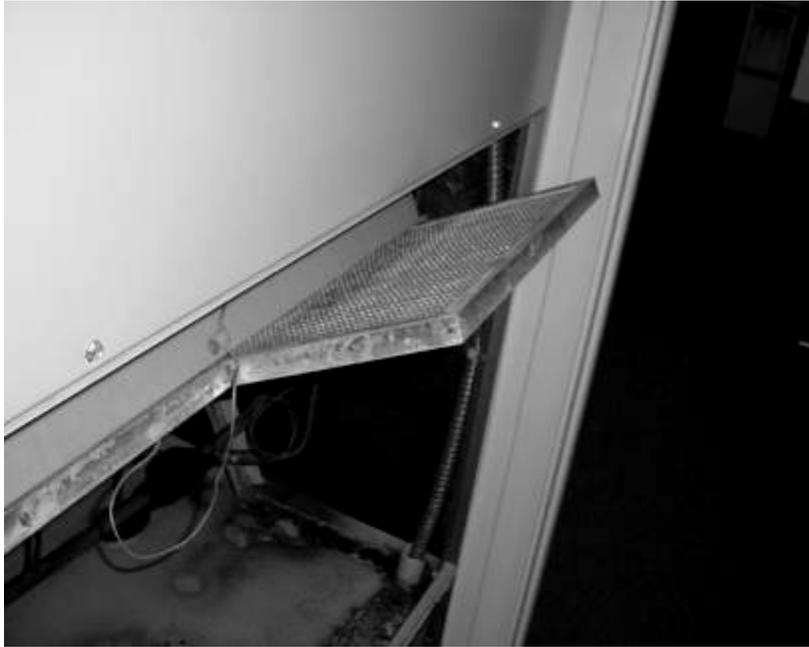
Picture 7

Air filters in the AC units consist of metal screens that provide minimal filtration of respirable dust (Picture 7). This can result in dust, dirt and other debris being distributed

by the AC system. Filters are designed to strain particulates from airflow. In order to decrease aerosolized particulates, disposable filters with an increased dust spot efficiency can be installed. The dust spot efficiency is the ability of a filter to remove particulates of a certain diameter from air passing through the filter. Filters that have been determined by ASHRAE to meet its standard for a dust spot efficiency of a minimum of 40 percent would be sufficient to reduce airborne particulates (Thornburg, D., 2000; MEHRC, 1997; ASHRAE, 1992). Note that increased filtration can reduce airflow produced by increased resistance (called pressure drop). Prior to any increase of filtration, each piece of air handling equipment should be evaluated by a ventilation engineer to ascertain whether it can maintain function with more efficient filters.

Wire Screen Used As Filter

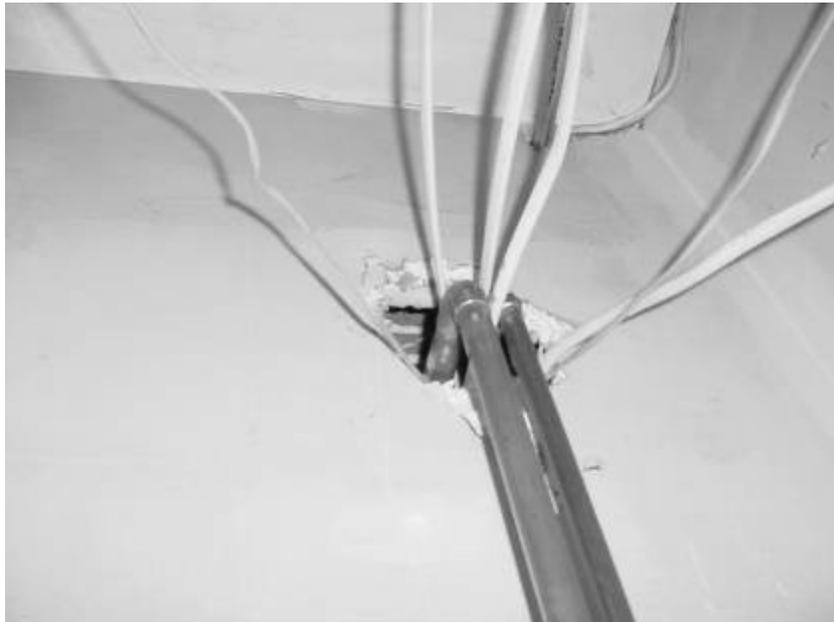
Picture 8

Finally, holes for utilities were observed in walls around the AC units (Picture 8). Breaches in walls can serve as pathways for odors and particulates in wall cavities to migrate into occupied areas.

Hole for Utility Pipe
