INDOOR AIR QUALITY ASSESSMENT

**Hampshire Family and Probate Court
33 King Street
Northampton, Massachusetts**

Prepared by:
Massachusetts Department of Public Health
Center for Environmental Health
Emergency Response/Indoor Air Quality Program
January 2007

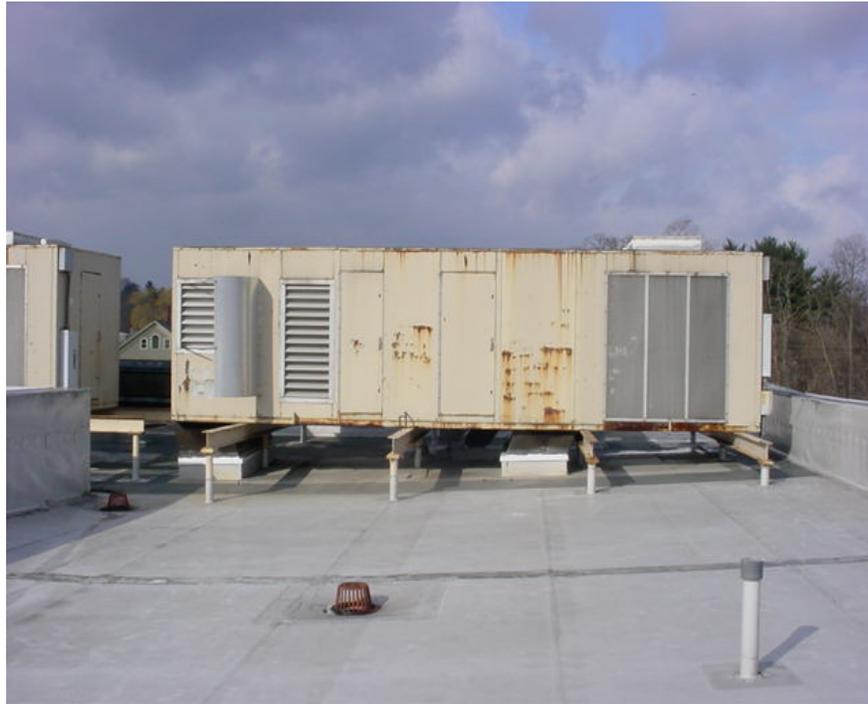
Picture 1

It can be seen from Table 1 that carbon dioxide levels were below 800 parts per million (ppm) in all areas surveyed, which generally indicates adequate fresh air supply in a building. Fresh air is supplied by ceiling or wall mounted fresh air supply vents connected to a rooftop air-handling unit (Picture 1). Exhaust ventilation is provided by ceiling mounted exhaust vents.

Rooftop Air Handling Unit

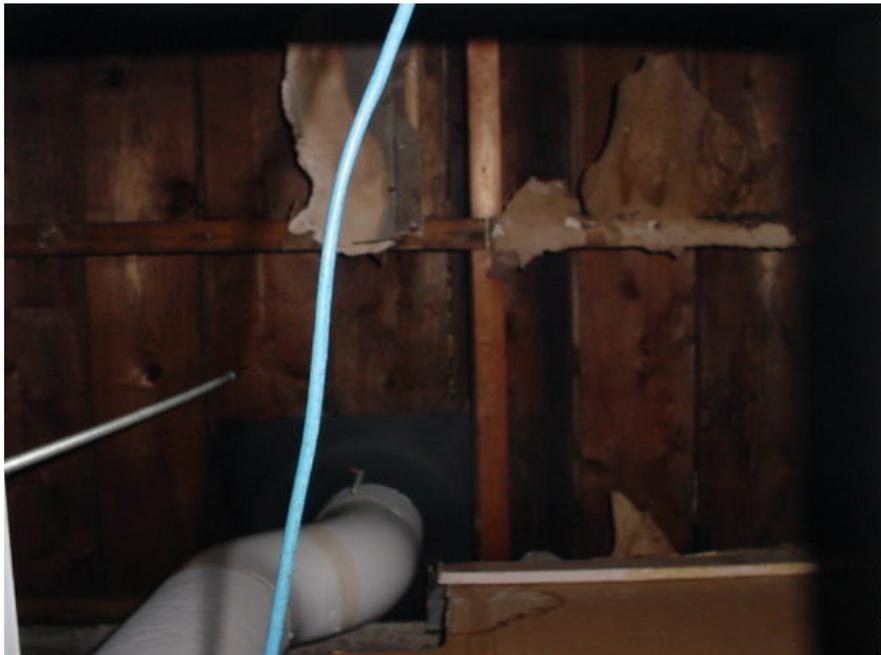
Picture 2

- The roof does not appear to be designed as an insulated roof. The decking appears to be comprised of wood with no apparent insulation (Picture 2). Without insulation, heat from the sun would heat the decking of the fourth floor, which would subsequently heat the ceiling plenum and the office space below the suspended ceiling.

Wooden Roof Decking

1. Consult with a building engineer to examine the roof and make recommendations to establish a functional, insulated roof to eliminate water leaks and improve temperature control.

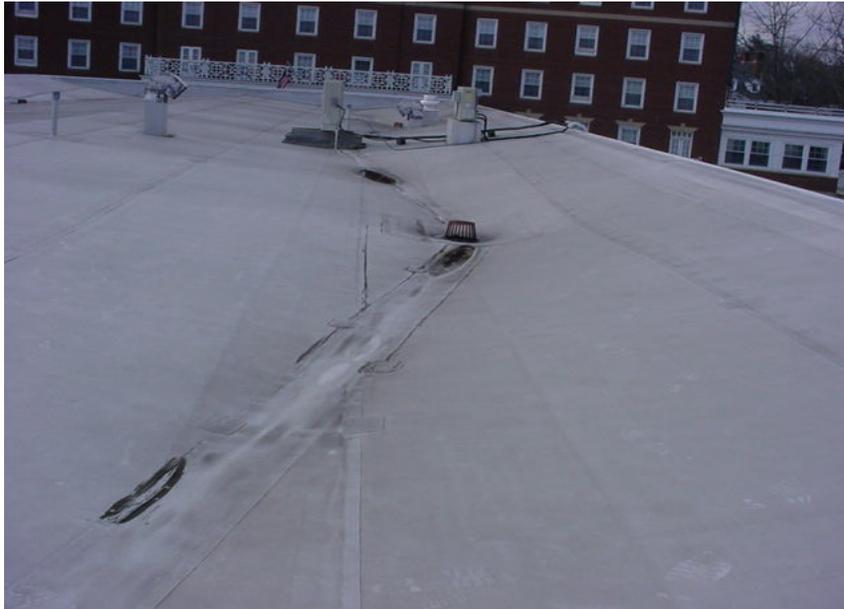
Picture 3

The roof is sloped inward from the exterior walls to enhance water drainage (Picture 3). Water damage ceiling tiles were seen in areas that roughly correspond to locations below roof drains (Table 1). In addition, debris was noted on the roof, which may clog drains. The freezing and thawing of water during winter months can lead to damage of the roof membrane and subsequent water penetration into the building. The American Conference of Governmental Industrial Hygienists (ACGIH) and the United States Environmental Protection Agency (US EPA) recommend that porous materials be dried with fans and heating within 24 to 48 hours of becoming wet (ACGIH, 1989; US EPA, 2001). If porous materials are not dried within this time frame, mold growth may occur. Water-damaged porous materials cannot be adequately cleaned to remove mold growth. The application of a mildewcide to moldy porous materials is not recommended.

The Roof of the Building is Sloped Inward from the Exterior Walls

1. Ensure leaks are repaired and replace any remaining water-damaged ceiling tiles. Examine the space above and around these areas for mold growth. Disinfect areas of water leaks with an appropriate antimicrobial.

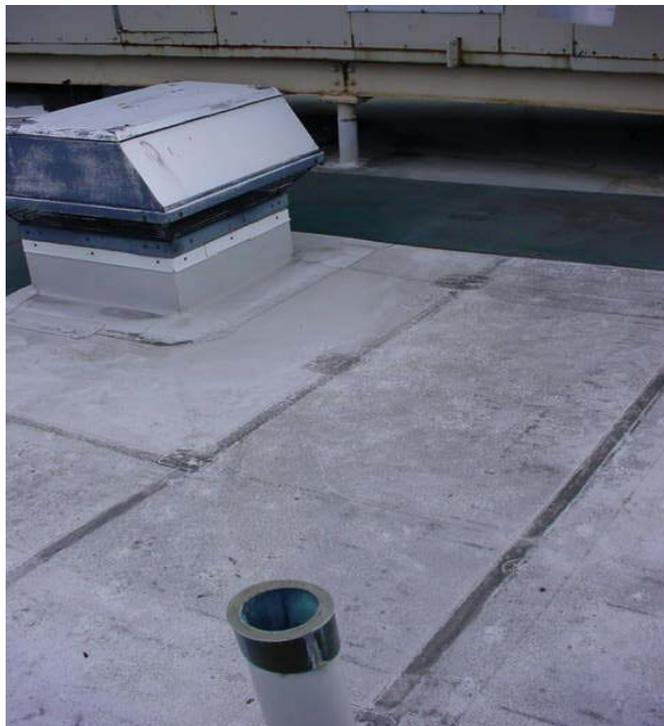
Picture 4

A number of other conditions were noted during the assessment, which can affect indoor air quality. Of note is the location of the exhaust vents for the restrooms (Picture 4). These exhaust vents are located in close proximity to the fresh air intake for the rooftop AHU (Picture 5). Under certain wind conditions, air from these exhaust vents may be directed toward the fresh air intake hood of the AHU and distributed to office space.

Exhaust Vent and Sewer Vent Pipe for the Restrooms

5. Consider either raising the exhaust vent and vent pipe for restroom (approximately 6-10 feet from the AHU air intake), or extending ductwork for AHU air intake away from exhaust and vent pipe to reduce/prevent entrainment of exhaust odors into the mechanical ventilation system.

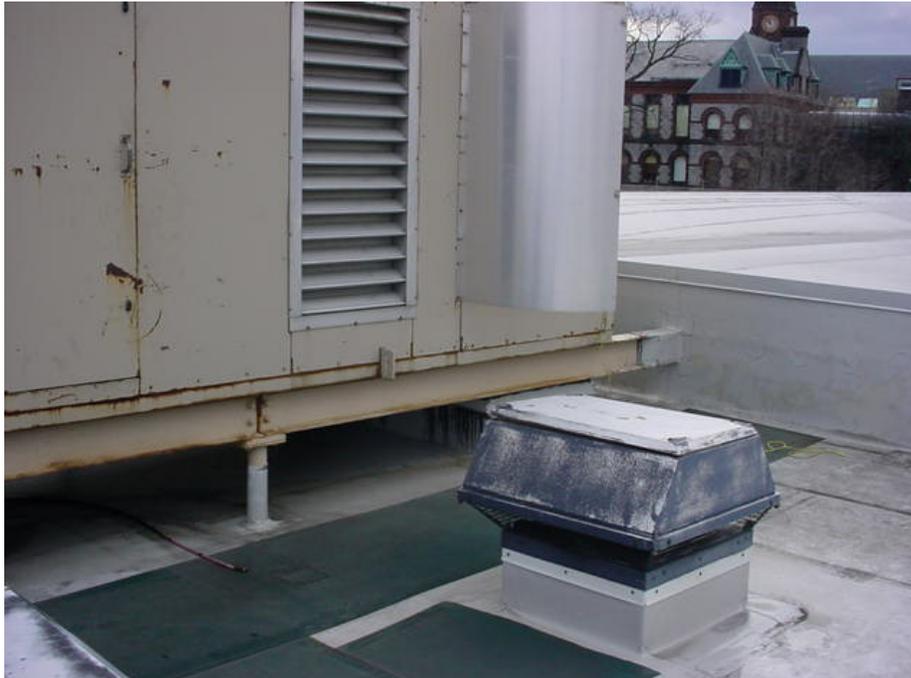
Picture 5

Exhaust Vents Are Located in Close Proximity to Fresh Air Intake for the Rooftop AHU

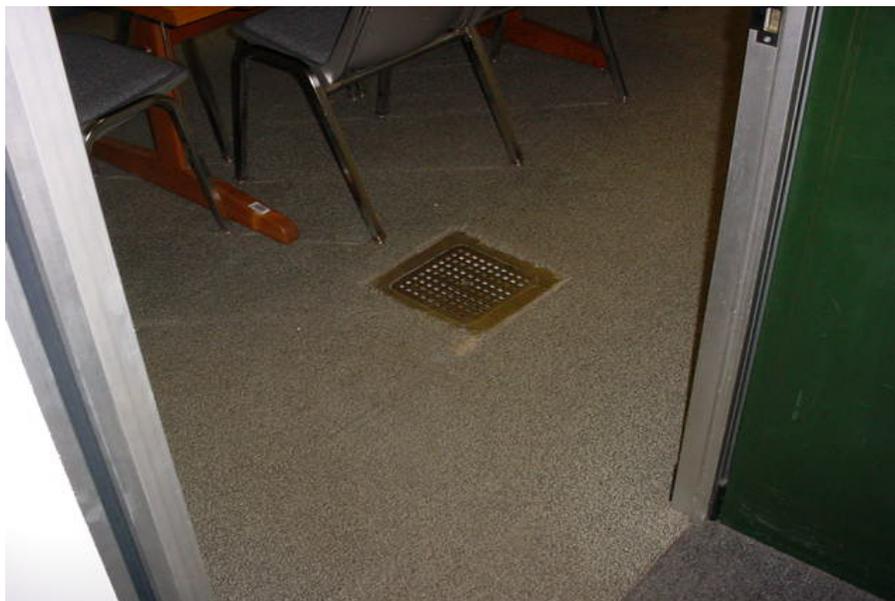
An unused floor drain was found in the Registry of Deeds Annex (Picture 6). The drain likely has a dry trap, which can allow sewer gases/odors to migrate from the drain system into occupied space. The drain should be filled regularly with water or sealed to prevent this contingency.

Unused Drain Was Found in the Floor of a Room in the Registry of Deeds Annex

2. Use window shades/blinds as much as practical to reduce heat/cold transmission into offices.
3. Remove debris from the roof, inspect regularly.
4. Seal the drain shown in Picture 6 or pour water down on a regular basis.
