INDOOR AIR QUALITY ASSESSMENT

**Westport Senior Center
75 Reed Road
Westport, Massachusetts**

Prepared by:
Massachusetts Department of Public Health
Bureau of Environmental Health
Emergency Response/Indoor Air Quality Program
August 2007

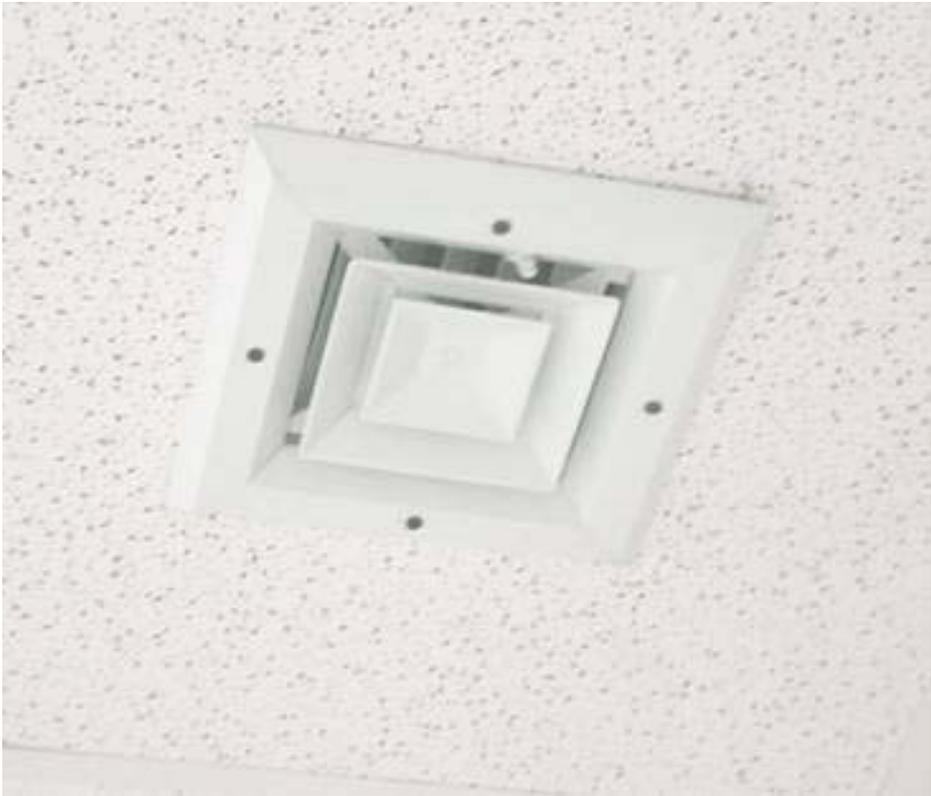
Picture 2

It can be seen from Table 1 that carbon dioxide levels were below 800 parts per million (ppm) in all areas surveyed, indicating adequate ventilation in the building. The heating, ventilation and air conditioning (HVAC) system does not have the ability to introduce fresh outside air and rather *recirculates* only. It appears that the building was originally designed to provide fresh air to interior spaces solely by openable windows. Mechanical ventilation is provided by an air-handling unit (AHU) located in the attic or mechanical closets. Heated or cooled air is supplied to occupied areas via ceiling-mounted air diffusers and drawn back to the AHU by ceiling or wall-mounted return vents (Pictures 1 through 4).

Ceiling-Mounted Air Diffuser in Basement

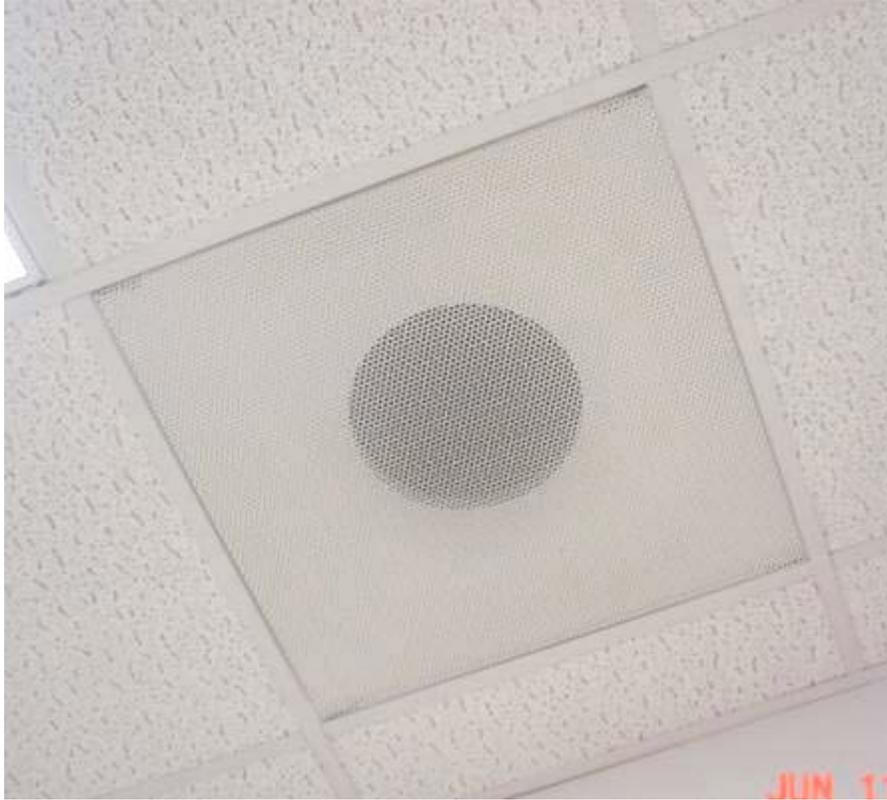
Picture 3

Ceiling-Mounted Return Vents

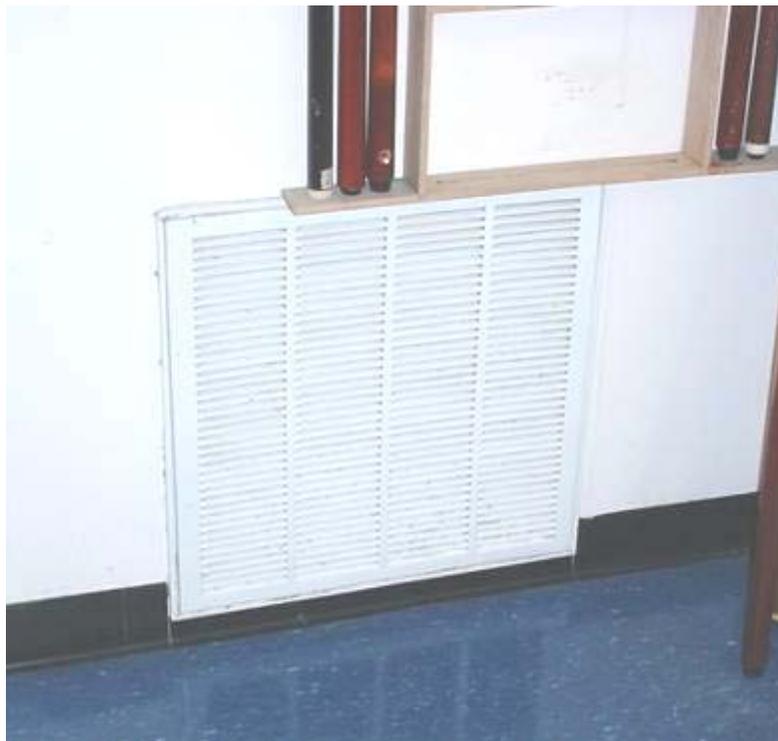
Picture 4

Wall-Mounted Return Vent in Basement

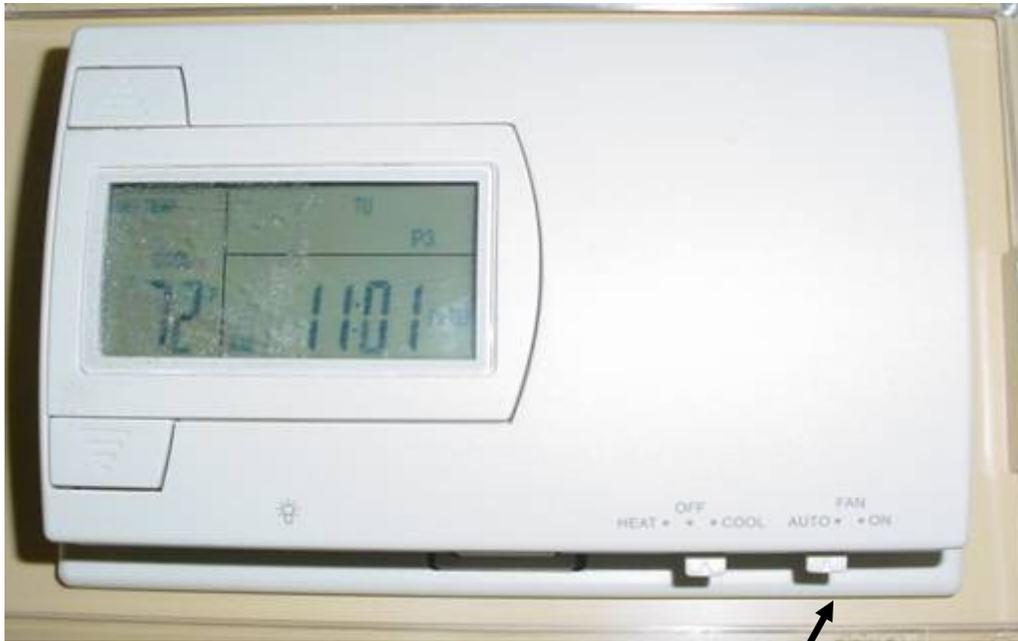
Picture 5

Digital wall-mounted thermostats control the heating, ventilating and air-conditioning (HVAC) system and have fan settings of “on” and “automatic”. Thermostats were set to the “automatic” setting (Picture 5) during the assessment. The automatic setting on the thermostat activates the HVAC system at a preset temperature. Once the preset temperature is reached, the HVAC system is deactivated. Therefore, no mechanical ventilation is provided until the thermostat re-activates the system. Without a continuous source of fresh outside air

Digital Wall-Mounted Thermostat with Fan in “Auto” Position

1. Contact an HVAC engineering firm to ensure ductwork is properly secured to the AHU and working as designed (e.g., airtight).
2. Consider operating the air-handling unit in the basement in the fan “on” mode (as opposed to the fan “auto” setting) to provide continuous air circulation.
3. Consider adopting a balancing schedule of every 5 years for mechanical ventilation systems, as recommended by ventilation industrial standards (SMACNA, 1994).
4. For buildings in New England, periods of low relative humidity during the winter are often unavoidable. Therefore, implementation of scrupulous cleaning practices should be

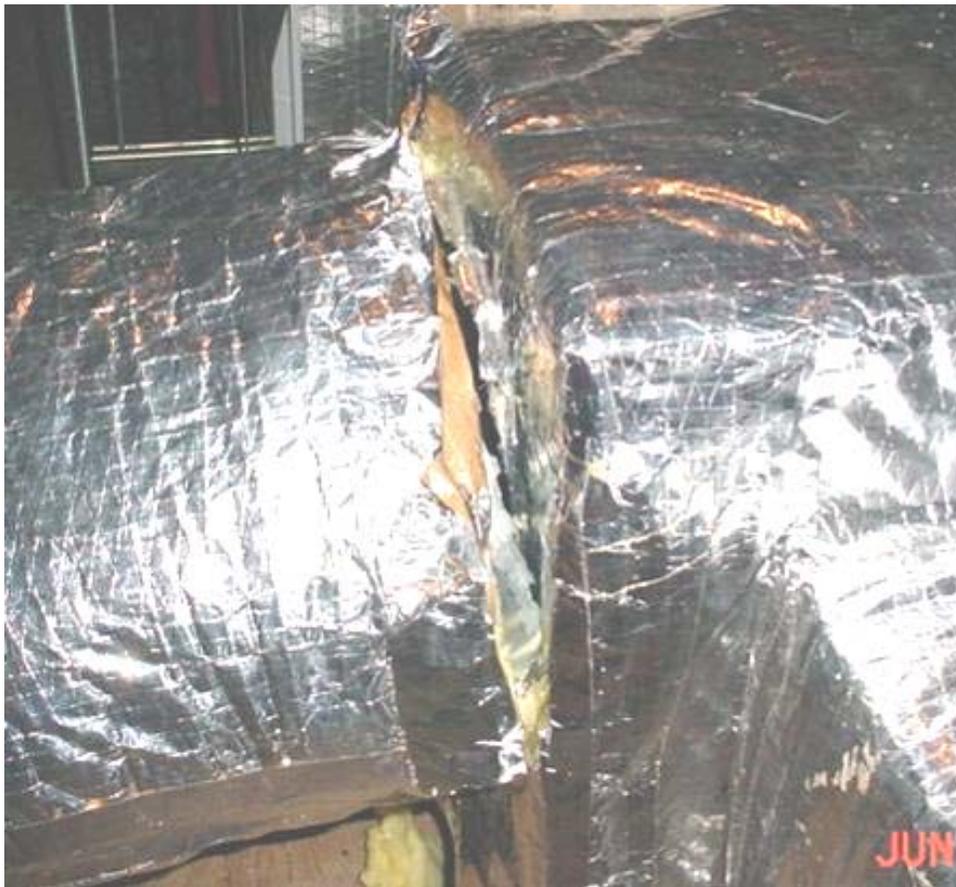
Picture 6

Temperature readings ranged from 68° F to 74° F, which were within or close to the lower end of the MDPH recommended comfort guidelines at the time of the assessment. The MDPH recommends that indoor air temperatures be maintained in a range of 70° F to 78° F in order to provide for the comfort of building occupants. In many cases concerning indoor air quality, fluctuations of temperature in occupied spaces are typically experienced, even in a building with an adequate fresh air supply. BEH staff visited the attic to examine the AHU with Mr. Medeiros and found that the main duct had become detached from the AHU (Pictures 6 and 7), making it difficult at best to control temperature. Pressurization of the attic can also force dirt, dust and other airborne particulates such as fiberglass (from insulation) into occupied areas, which can provide a source of skin and/or respiratory irritation. During the assessment the duct was temporarily reattached by Mr. Medeiros (Picture 8).

Section of Ductwork Detached from AHU

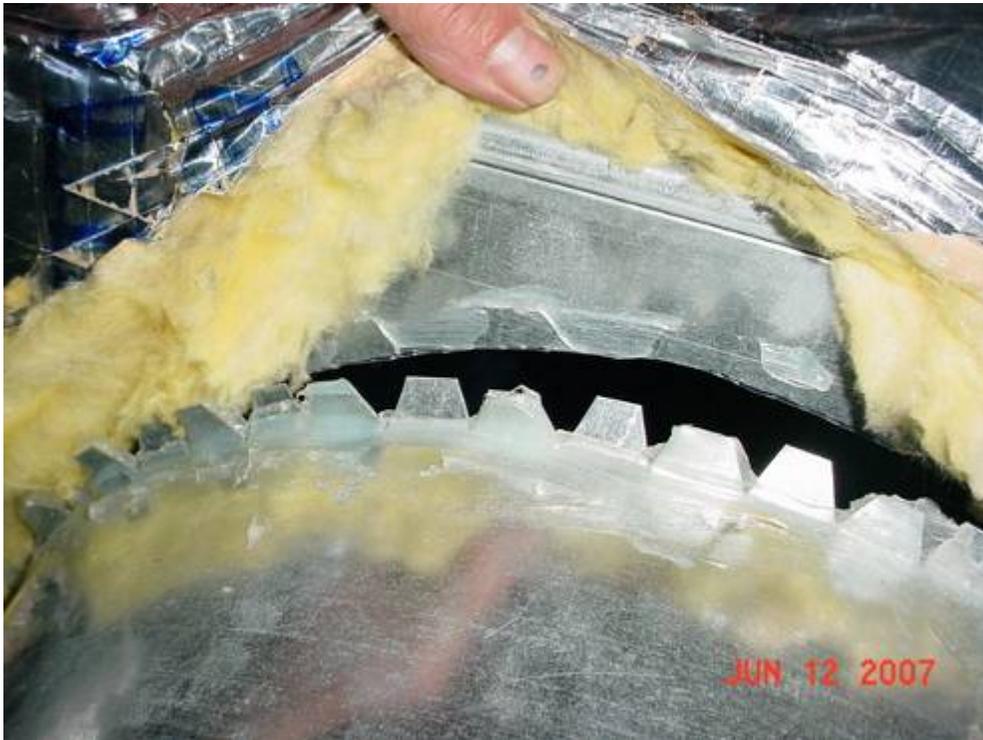
Picture 7

Close-Up of Ductwork Detached from AHU

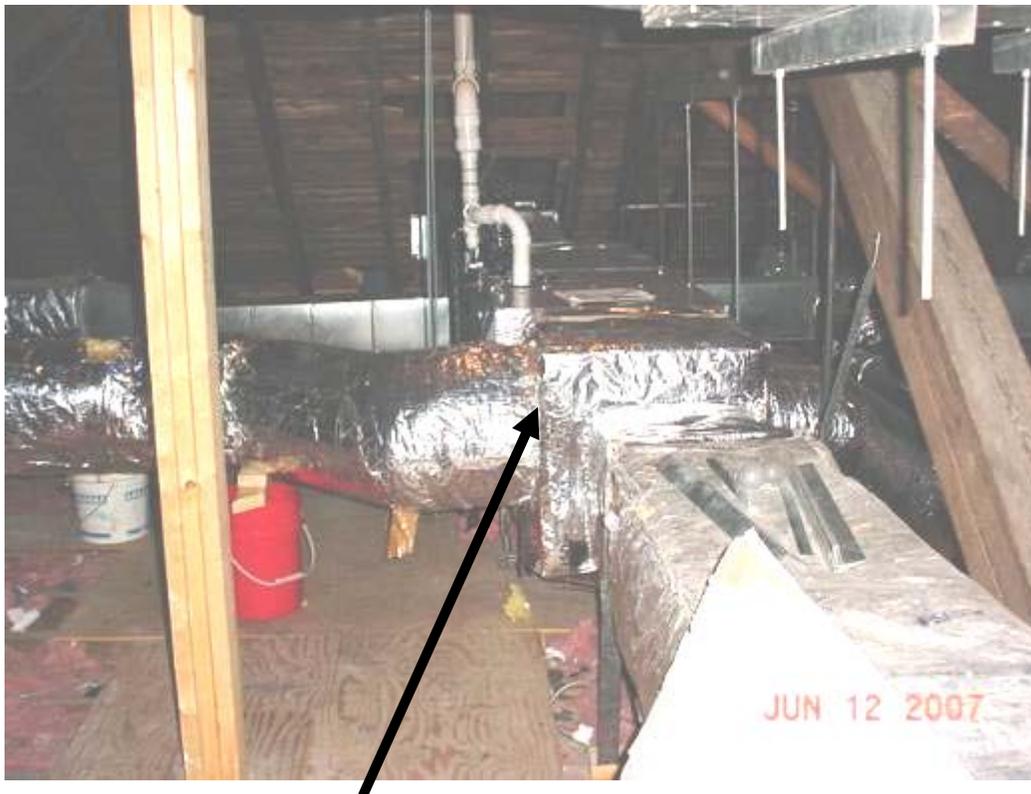
Picture 8

Section of Ductwork (Arrow) Temporarily Re-attached to AHU

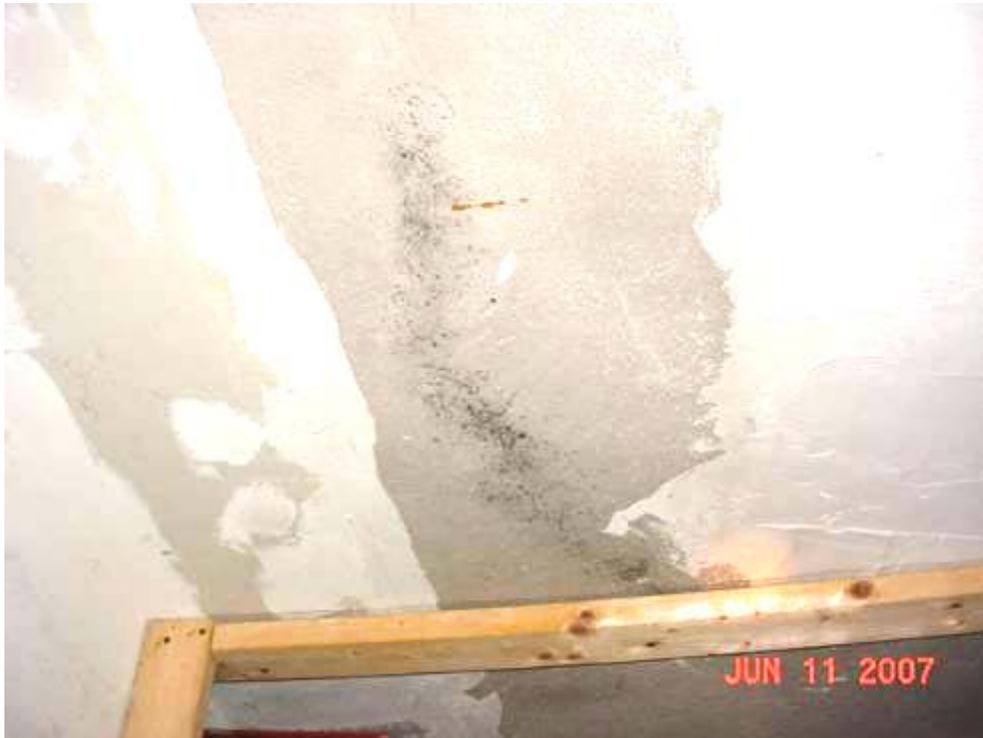
Picture 9

Dark staining, (possibly mold growth), was observed on the surface of the plaster ceiling and on stone walls in the corner of the maintenance storage room (Pictures 9 and 10). Although plaster and stone are not good media for mold growth, mold can grow on the surface of these materials if they are dusty in concert with moisture.

Dark Staining (Center) on Surface of Plaster Ceiling in Maintenance Storeroom

5. Clean dark surfaces of ceiling plaster and stone walls in maintenance storeroom suspected of being mold growth with an appropriate antimicrobial followed by soap and water. Ensure surfaces are dried (e.g., with fans) properly to prevent further mold growth.

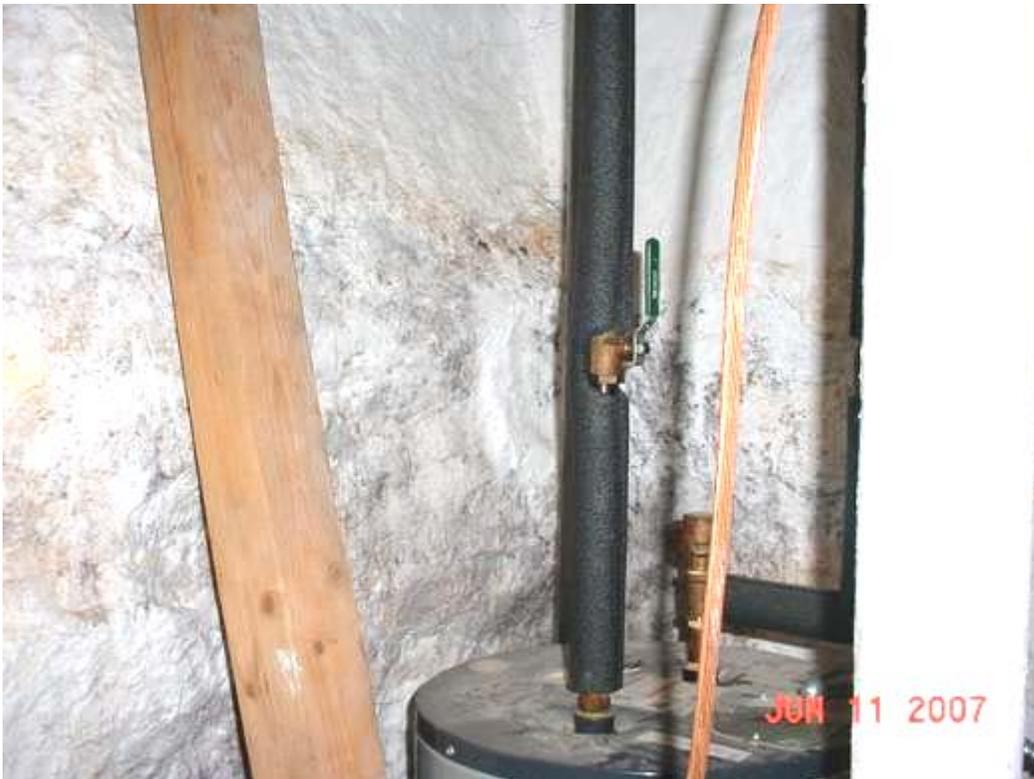
Picture 10

Dark Staining on Stone Foundation in Corner of Maintenance Storeroom

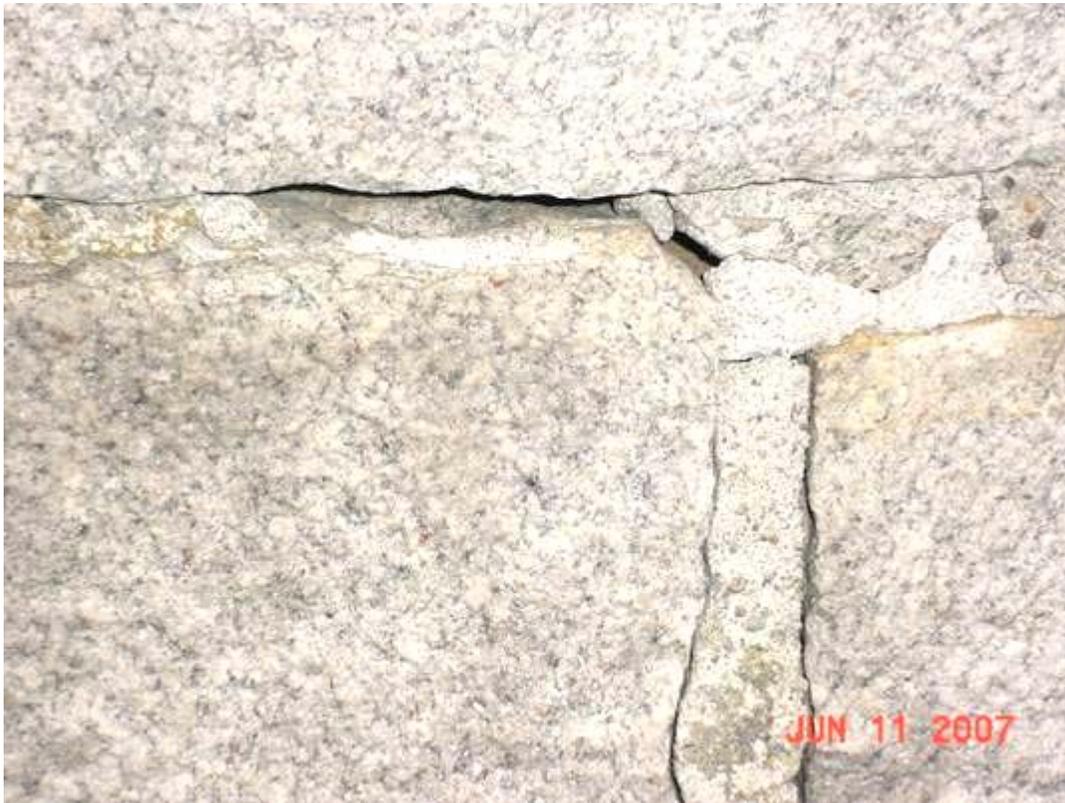
Picture 11

BEH staff examined conditions on the exterior of the building and observed missing/damaged mortar in several areas around the foundation that could be potential sources of water infiltration (Pictures 11 to 12). The US Environmental Protection Agency (US EPA) and the American Conference of Governmental Industrial Hygienists (ACGIH) recommends that porous materials be dried with fans and heating within 24 to 48 hours of becoming wet (ACGIH, 1989; US EPA, 2001). If porous materials are not dried within this time frame, mold growth may occur.

Missing/Damaged Mortar around Foundation Blocks

8. Repoint damaged areas of foundation to prevent water infiltration and further damage.
9. Ensure plants have drip pans. Examine drip pans periodically for mold growth and disinfect with an appropriate antimicrobial where necessary. Keep plants away from the air stream of univents.

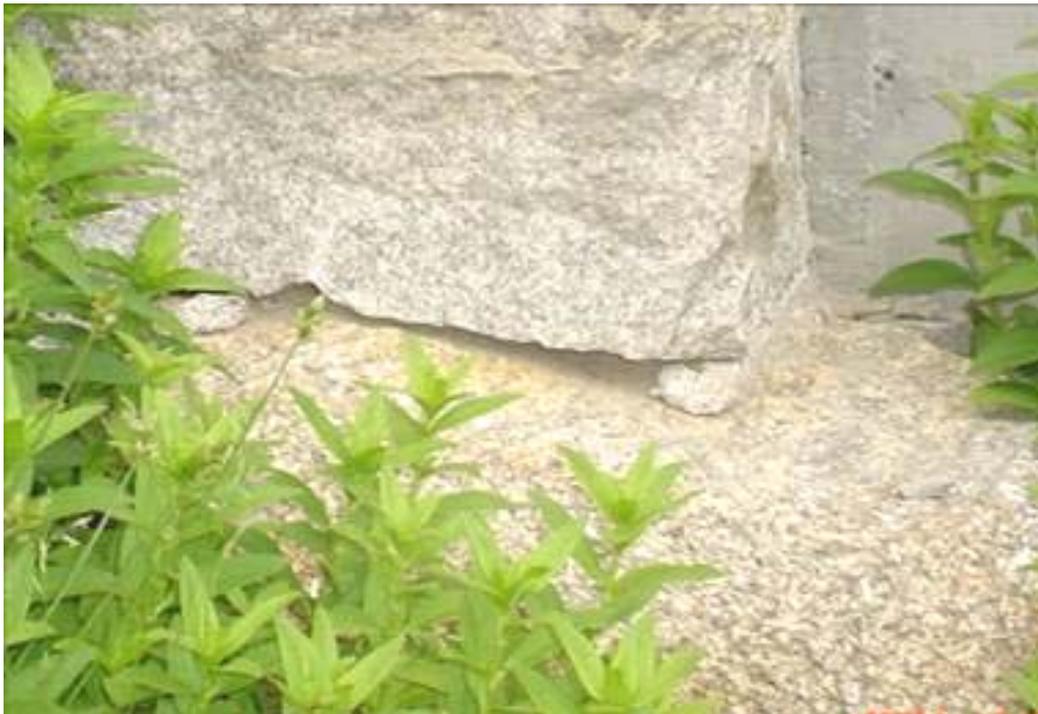
Picture 12

Missing/Damaged Mortar around Foundation Blocks

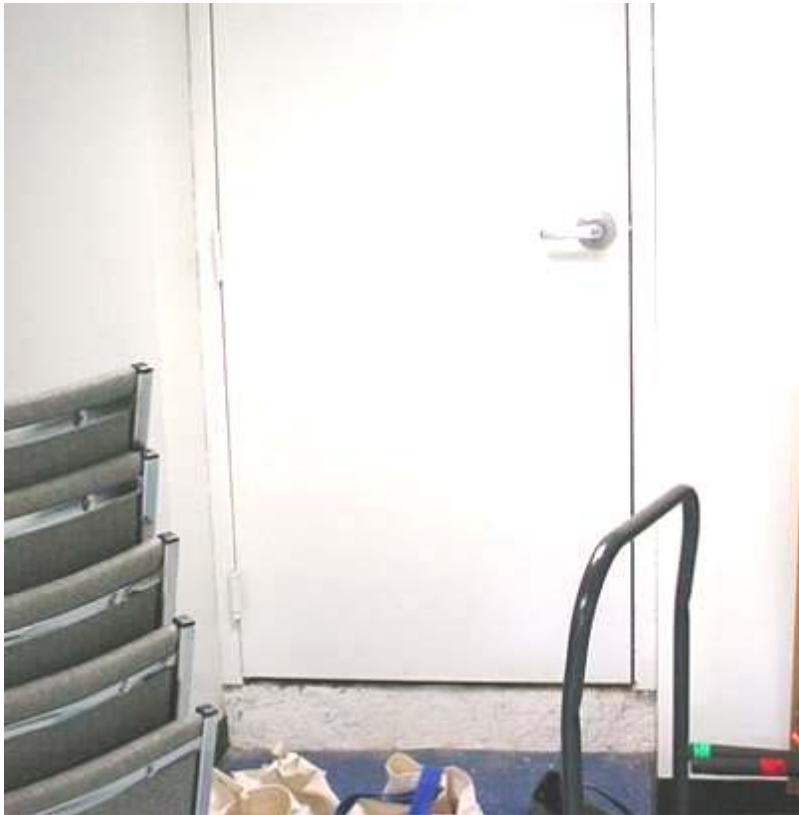
Picture 13

Musty odors were detected in the exercise room. The most likely source of odors was spaces around the door that opens into the unfinished dirt crawlspace (Picture 13). Open utility holes were also observed in ceilings and walls of the maintenance storeroom (Pictures 14 and 15), which can provide a means of odors and particulates into occupied areas.

Spaces around Crawlspace Door in Exercise Room

6. Install weather-stripping around crawlspace door and seal all open utility holes in walls/ceilings to prevent odors/moisture from penetrating into occupied areas.

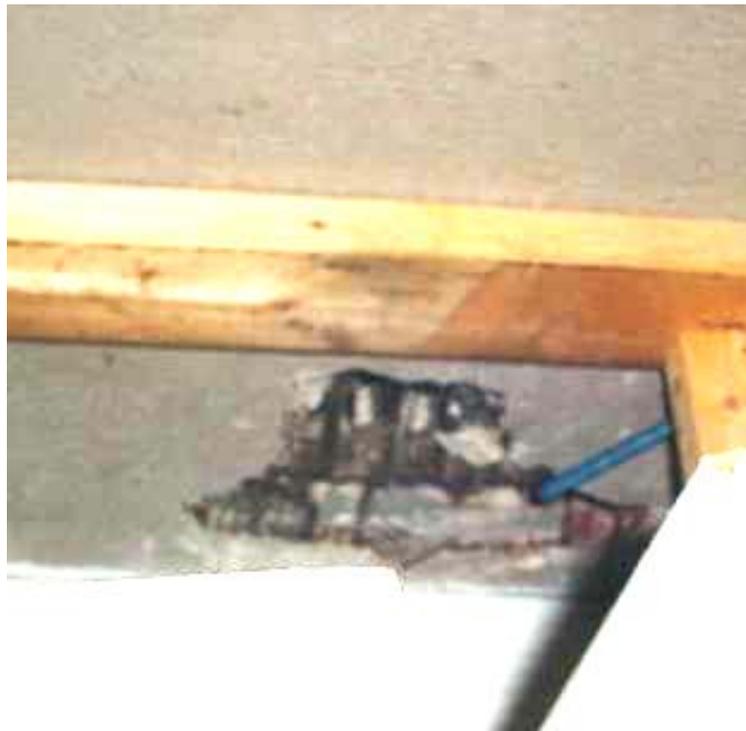
Picture 14

Open Utility Hole in Wall Plaster in Maintenance Storeroom

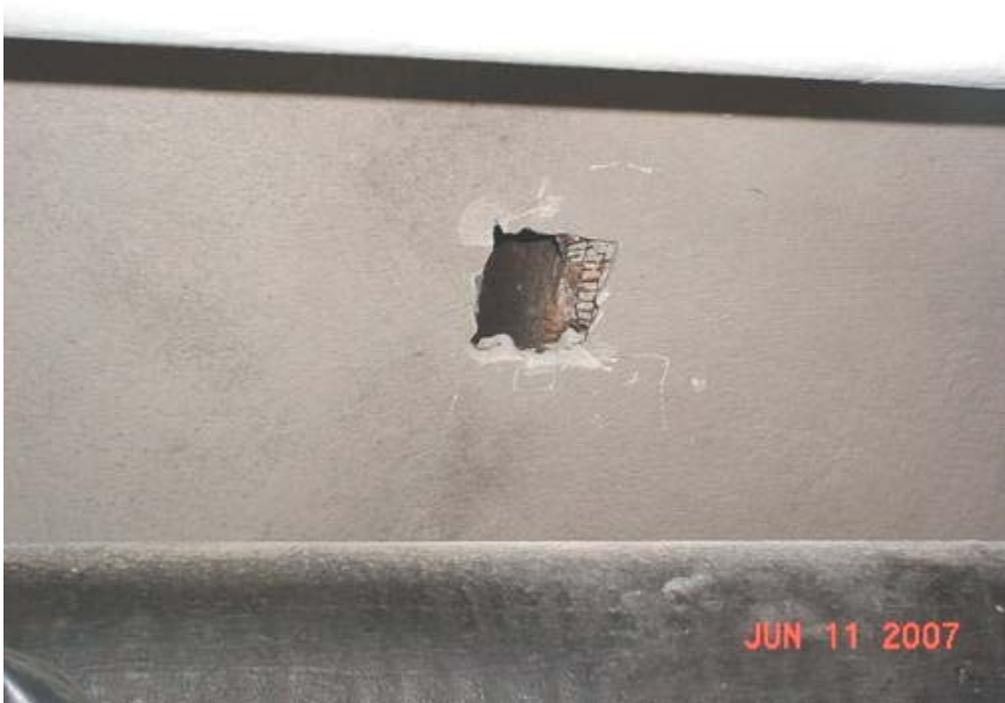
Picture 15

Open Utility Hole in Ceiling Plaster in Maintenance Storeroom

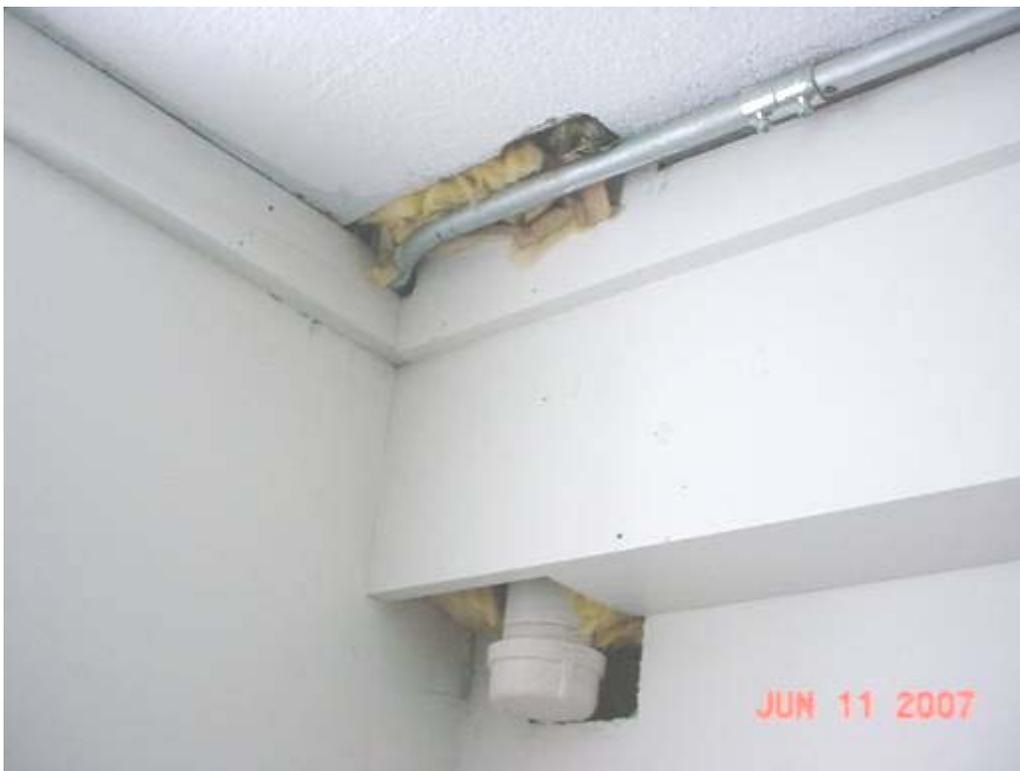
Picture 16

Several other conditions that can potentially affect indoor air quality were identified. Open utility holes in the basement office were observed with exposed fiberglass insulation. Exposed fiberglass insulation was also observed around the kitchen water heater (Pictures 16 and 17). Fiberglass insulation can serve as a skin, eye and respiratory irritant.

Open Utility Holes and Exposed Fiberglass Insulation in Basement Office

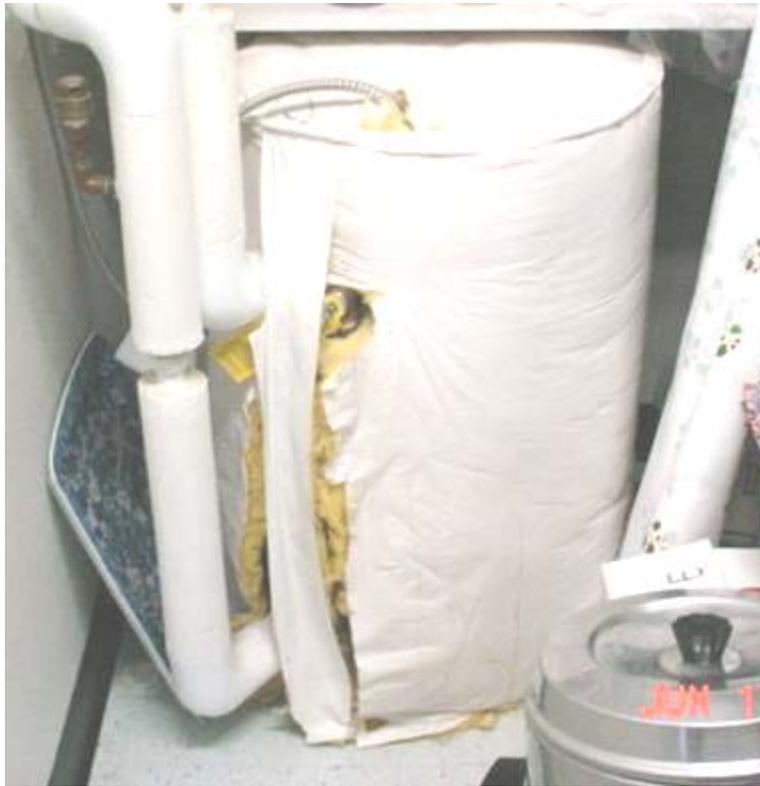
Picture 17

Exposed Fiberglass Insulation around Kitchen Water Heater

10. Re-wrap insulation around kitchen water heater to prevent exposure to fiberglass insulation.
11. Remove bees/wasps nests in a manner as to not introduce insects and/or pesticides into the building.

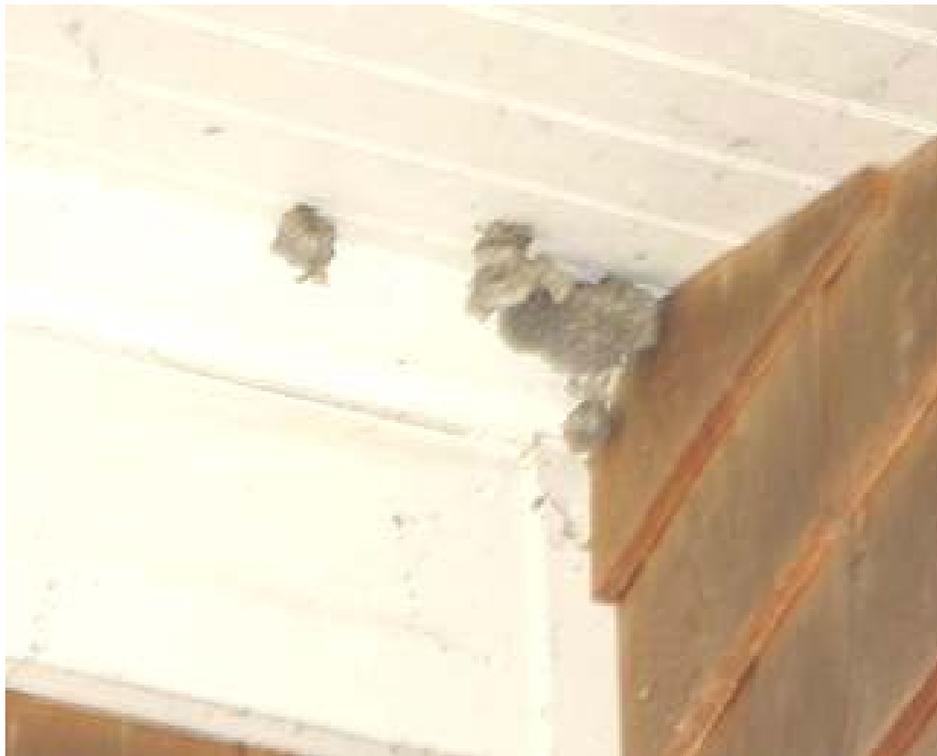
Picture 18

Finally, several bees/wasps nests were observed on the outside of the building (Picture 18). These nests should be removed in a manner as to not introduce insects and/or pesticides into the building.

Bees/Wasps Nests around Perimeter of Building
