INDOOR AIR QUALITY ASSESSMENT

**Amherst Regional Middle School
170 Chestnut Street
Amherst, Massachusetts**

Prepared by:
Massachusetts Department of Public Health
Bureau of Environmental Health
Indoor Air Quality Program
April 2008

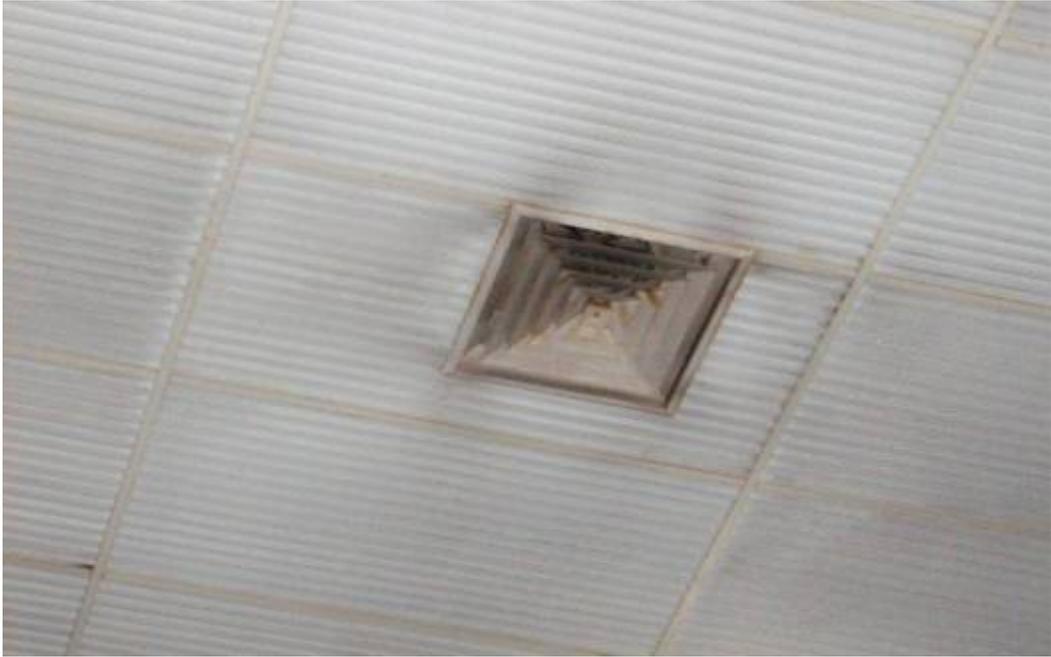
Picture 1

Air Supply Diffuser Located In Ceiling Tile above Pool

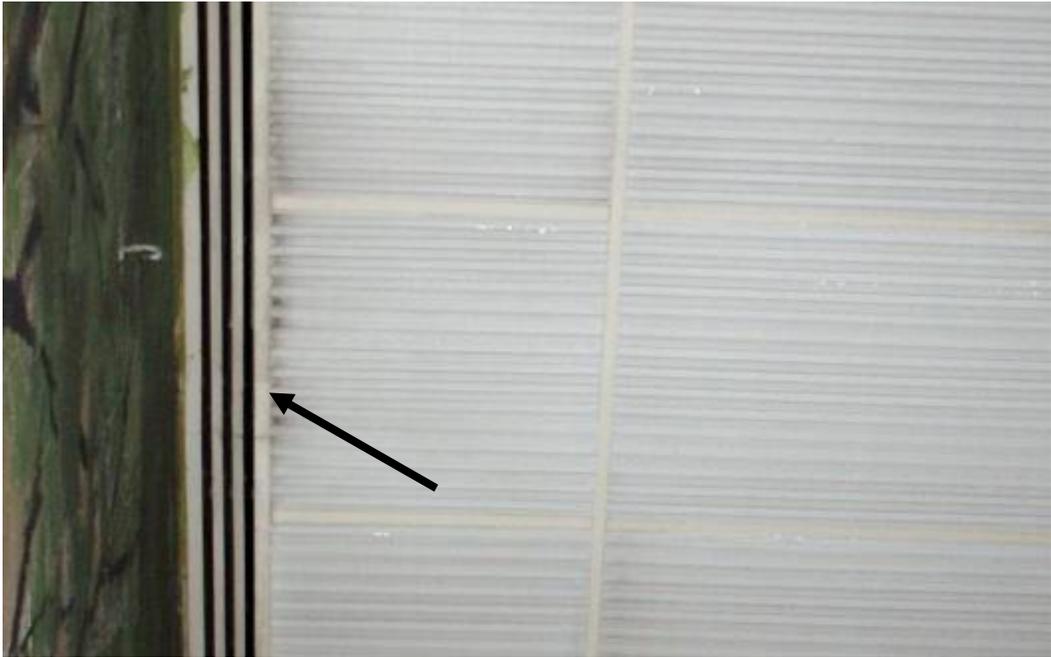
Picture 2

Air Supply Diffuser Located At Ceiling/Wall Juncture Above Pool Deck

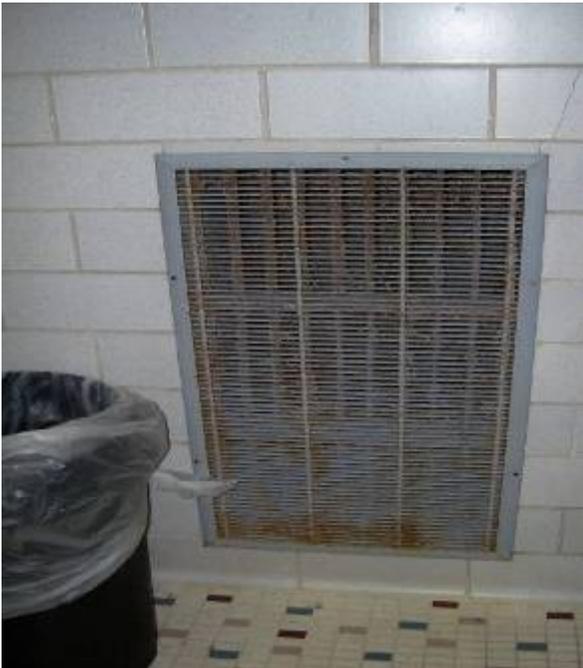
Picture 3

Exhaust Vent in Pool Area

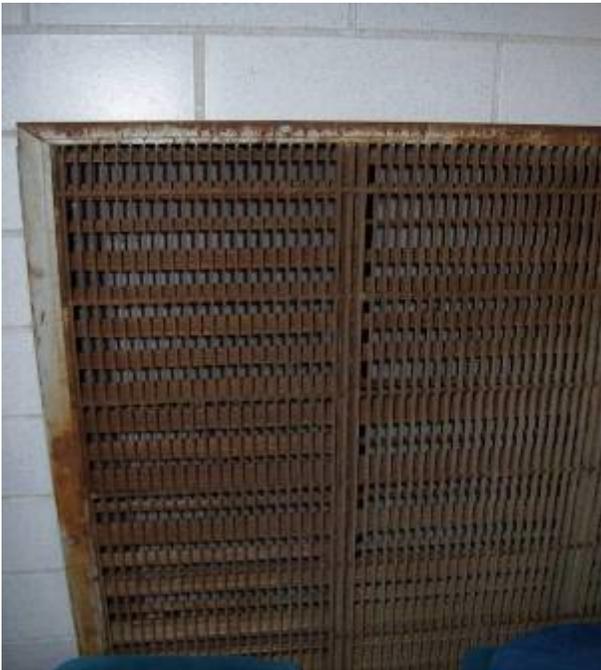
Picture 4

would not be at its optimum. The oxidation observed on the louvers may also prevent the louvers from being adjusted in order to balance the system. In that event, the louvers would be required to be repaired or replaced in order to properly balance the system.

Exhaust Vent in Pool – Note Heavy Oxidation

1. Consider consulting an HVAC engineer to examine and balance the ventilation system in the pool area. Balancing should occur every five years. Consideration could also be given to the cleaning of heating coils on AHUs.

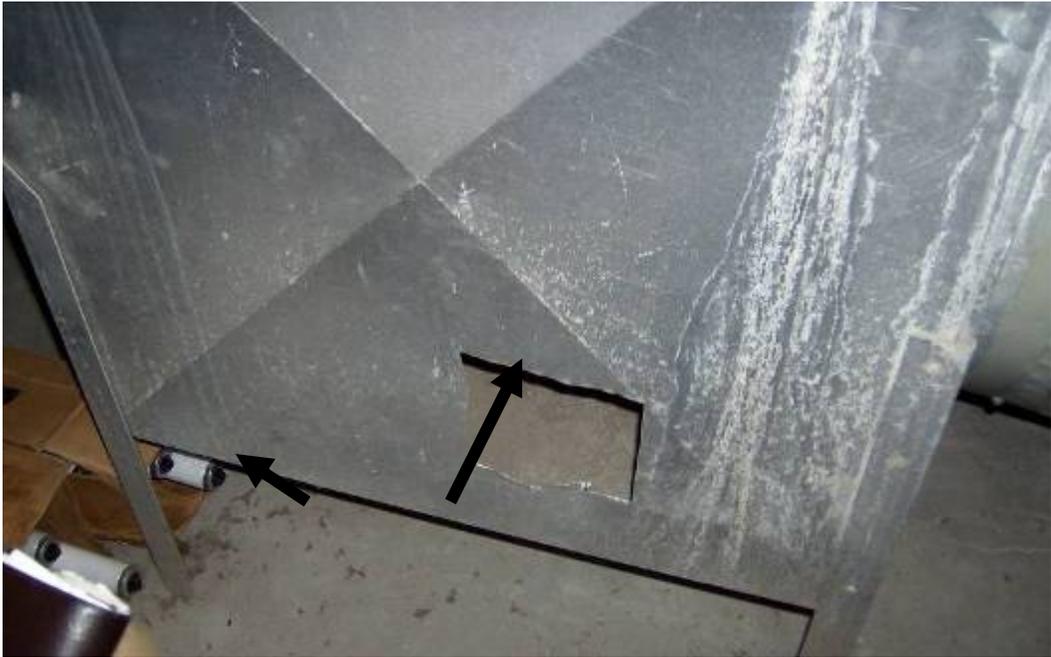
Picture 5

The air-handling units (AHUs) are located in a mechanical room adjacent to the pool. One AHU had a hole cut into the sheet metal (Picture 5). The opening should be properly sealed. In the same photo, boxes of fluorescent light bulbs are shown being stored on the floor adjacent to and below a portion of one of the AHUs. Breakage of these glass bulbs can cause injuries and, if broken, may release mercury and/or other hazardous compounds. Therefore, the bulbs must be stored, transported and disposed of in a manner which will not cause a hazard. Additionally, insulation on a portion of the AHU was not in good repair (Picture 6).

**Whole Cut Into AHU
Also Note Boxes of Fluorescent Bulbs Stored On Floor**

2. Consider storing fluorescent bulbs away from the AHU in a secure area where the bulbs would not be subject to accidental breakage. Additionally, spent bulbs should be stored in a secure area, until such time that the bulbs can be properly disposed of to minimize the potential for the release of mercury into the environment. Refer to EPA's Mercury Storage and Transportation Guidance for such procedures ([Appendix B](#)). If a fluorescent bulb does break despite these efforts, utilize Massachusetts Department of Environmental Protection's cleanup guidelines for mercury bulbs ([Appendix C](#)). Additional guidance concerning mercury spill clean up is provided by BEH's IAQ Program ([Appendix D](#)).

3. Remove water damaged ceiling tiles in hallway outside of pool area to investigate and remedy water damage. Replace with new ceiling tiles.
4. Seal hole in the AHU.

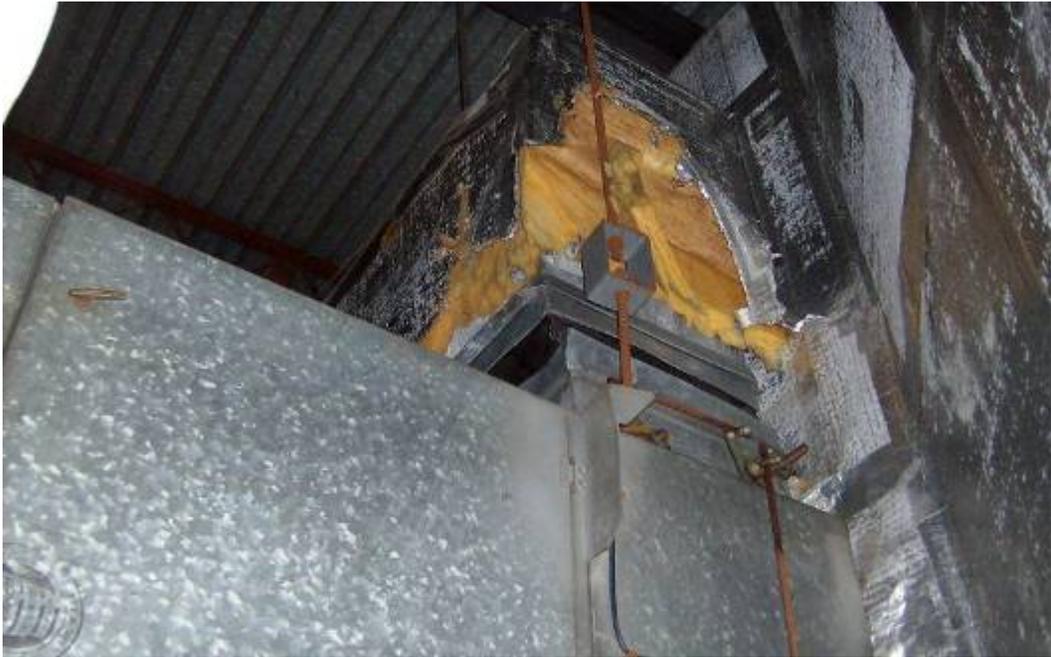
Picture 6

Insulation Is In Disrepair

5. Consider replacing/repairing insulation on AHU.
6. Consider adopting scrupulous cleaning practices. For buildings in New England, periods of low relative humidity during the winter are often unavoidable. Therefore, scrupulous cleaning practices should be adopted to minimize common indoor air contaminants whose irritant effects can be enhanced when the relative humidity is low. To control for dusts, a HEPA filter equipped vacuum cleaner in conjunction with wet wiping of all surfaces is recommended. Drinking water during the day can help ease some symptoms associated with a dry environment (throat and sinus irritations).

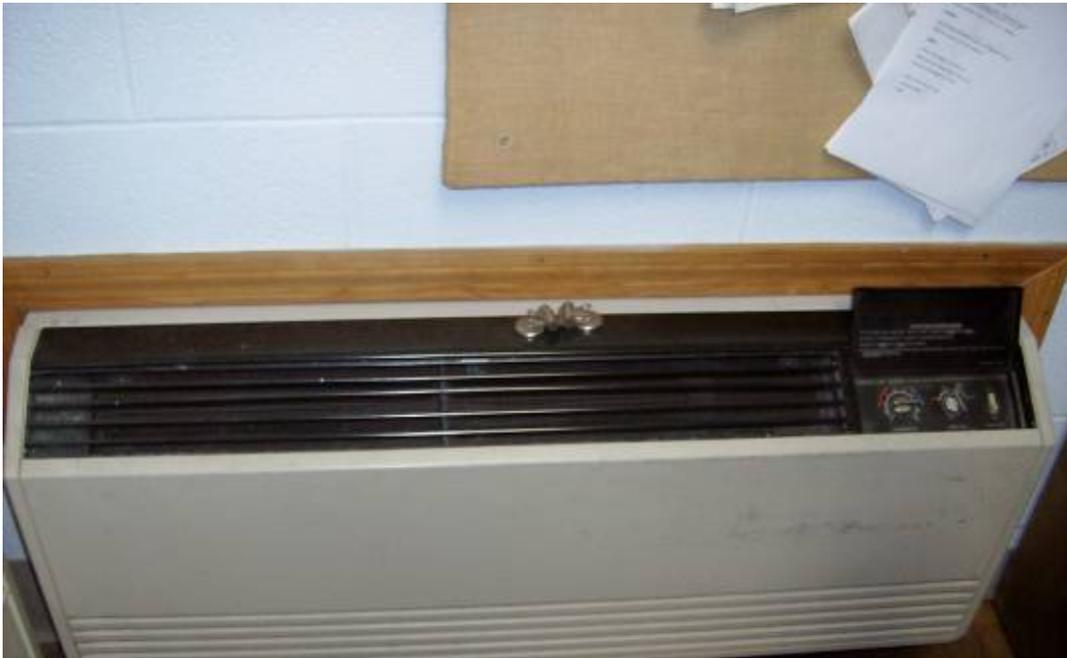
Picture 7

Univent in Facilities Transportation Office

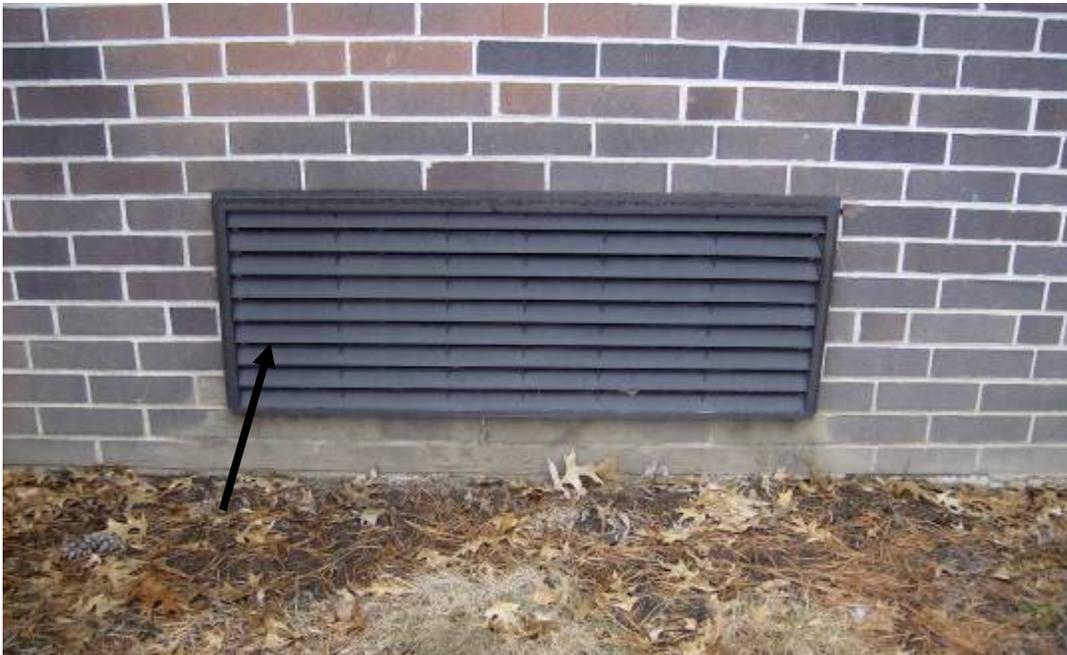
Picture 8

The Facilities Transportation Offices utilize univents for air supply (Picture 7). From the exterior of the building, the particulate matter being drawn into the system is easily visible on the brick wall below the air intake (Picture 8). With the air intakes so close to the ground, the filters must be changed on a regular basis due to excessive exposure to debris and moisture. It was reported that filters are changed twice a year, June/July and February. Filter changes done twice a year are usually sufficient under most circumstances. All belts are serviced during the summer. The Facilities and Transportation Department has the ability to monitor and adjust AHUs and univents in all areas of every school in the Amherst-Pelham Regional School District through a computerized monitoring system. The temperature of every classroom in any building can be monitored and adjusted utilizing this system. Functioning fresh air supply and exhaust ventilation is necessary to provide for the comfort of the occupants in this building.

**Univent Fresh Air Intake (UFAI),
Note Particulate/Debris Being Pulled Into System**

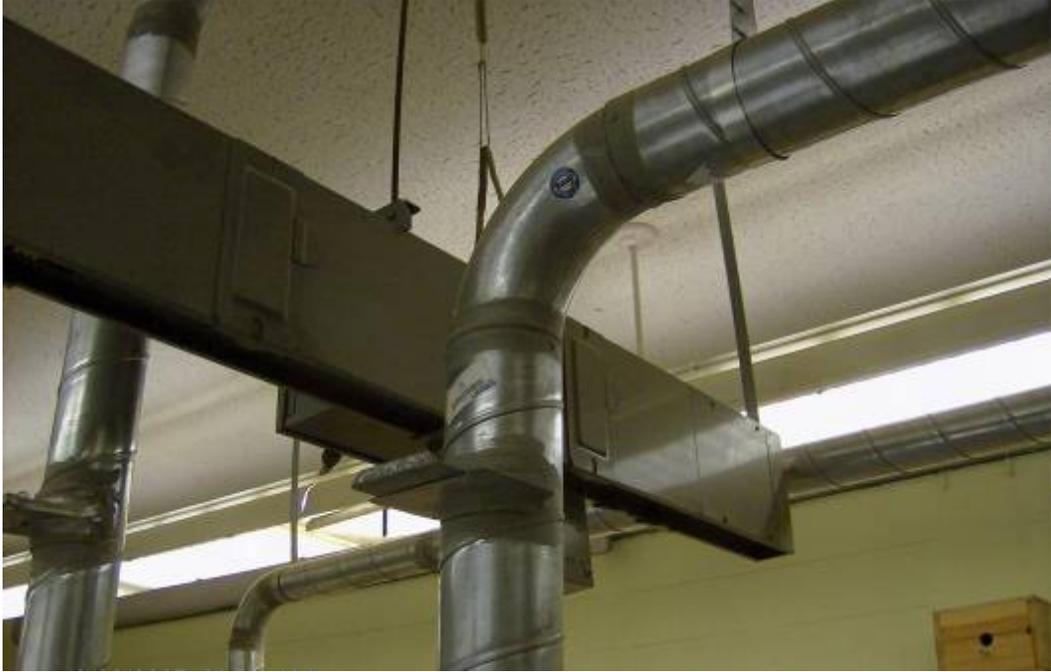
Picture 9

classes. It was noted that the odor of the wood shop was noticeable outside of the shop. The interior of the wood shop was clean and dust-free. The sawdust collection system appeared to be in very good condition (Picture 9). The ventilation system was operational at the time of the BEH/IAQ visit. The noticeable wood odor in the hall was more than likely due to the fact that the door to the shop was open at the time of the visit.

Wood Shop Dust Collection System
