INDOOR AIR QUALITY ASSESSMENT

**City Hall Annex
77 Park Street
Attleboro, Massachusetts 02703**

Prepared by:
Massachusetts Department of Public Health
Bureau of Environmental Health
Indoor Air Quality Program
October 2008

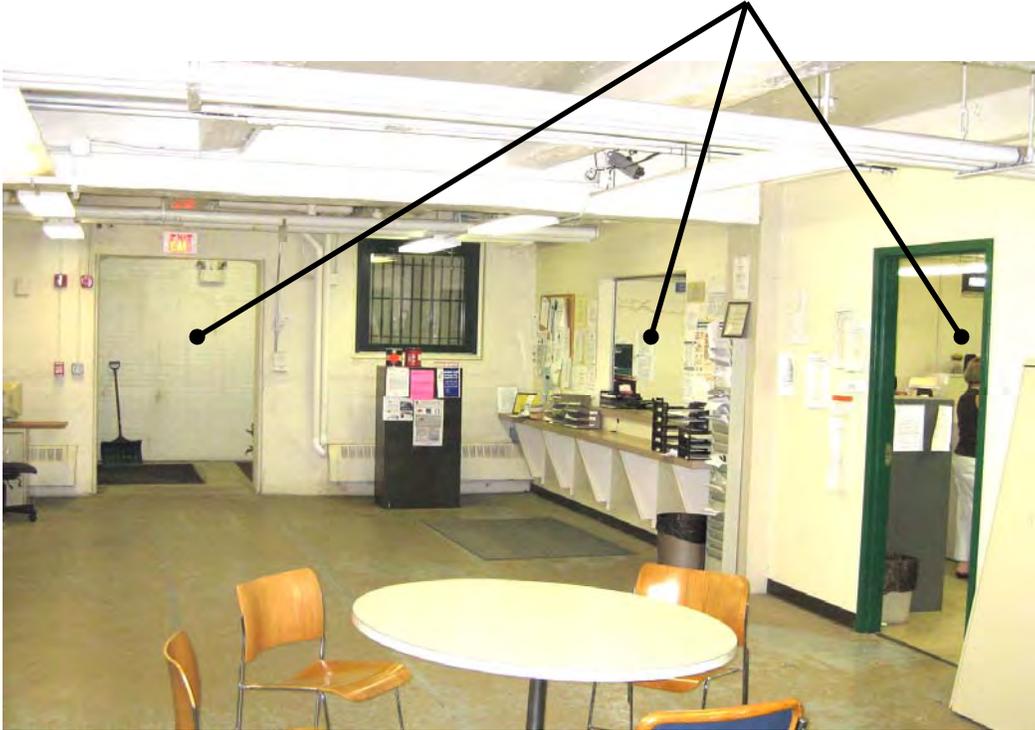
Picture 1

surrounding space. The building department has a roll-up business window and an interior door that opens into the unconditioned meeting room, and reportedly remains open over the course of the business day (Picture 1). In addition, the main entrance/foyer has no interior door, which allows for the introduction of unconditioned, outside air into the space every time the exterior door is opened (Pictures 1 and 2). Normally, entrance ways/foyers/exits have a set of interior doors that create a barrier between unconditioned transient areas and conditioned occupied areas.

**Open Business Window and Interior Door to Building Department,
Also Note Open Doorway to Main Entrance (Left)**

13. Keep door to building department closed.
14. Install weather-stripping on bottom of exterior door.
15. Consider installing interior doors at the main entrance to create a barrier between conditioned and unconditioned areas.

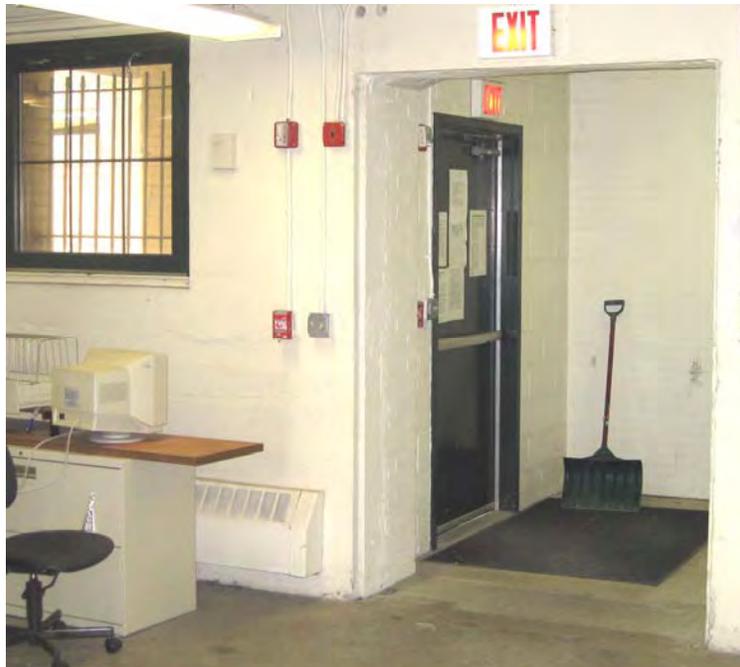
Picture 2

Exterior Door to Main Entrance CHA, Note no Door/Barrier between Entrance and Interior

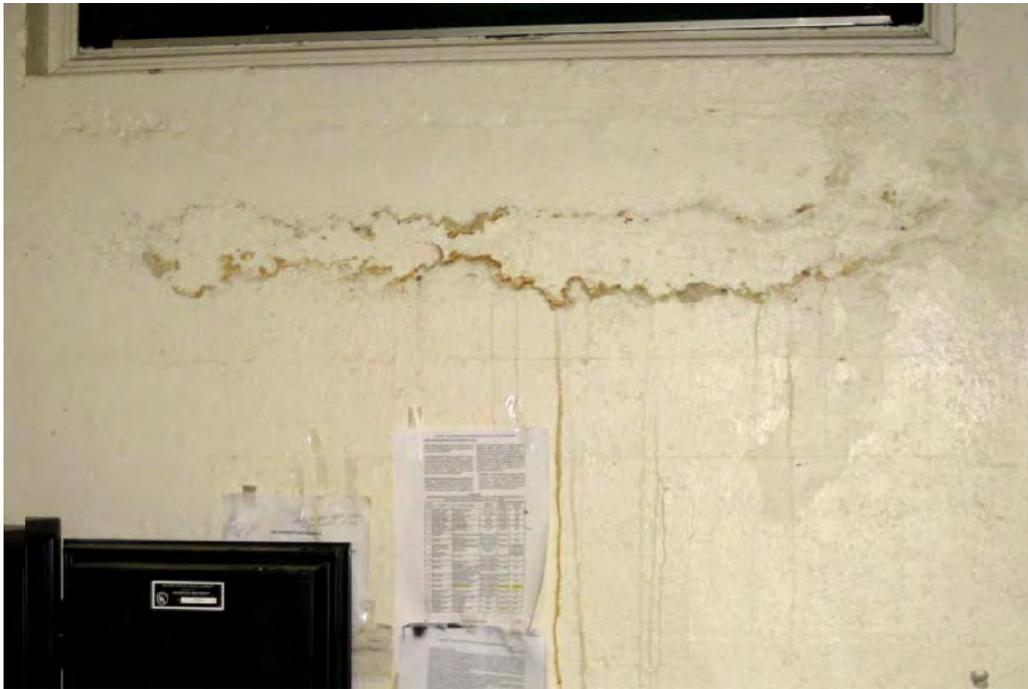
Picture 3

Water damaged masonry walls, peeling paint and efflorescence were observed in the building department, plans examiner's office and storeroom (Pictures 3 through 5). Efflorescence is a characteristic sign of water damage to masonry (e.g., brick, concrete) and mortar, but it is not mold growth. As moisture penetrates and works its way through mortar and masonry, water-soluble compounds in mortar and masonry dissolve, creating a solution. As the solution moves to the surface of the mortar or masonry, the water evaporates, leaving behind

white, powdery mineral deposits. Water damage is most likely the result of water penetration through the building envelope. The damage in the building department roughly corresponds to the level of an exterior drain at the bottom of a concrete-lined window well (Pictures 6 and 7). The drain appeared to be clogged with debris at the time of the assessment (Picture 7).

**Evidence of Water Penetration through Exterior Foundation Wall in Building Department:
Water Damaged Masonry, Efflorescence and Stained Paint: Note Area of Water Damage Roughly
Corresponds with the Level of an Exterior Drain Directly outside of Window**

2. Discard water damaged/mold colonized porous items (e.g., pictures, cardboard boxes, books/papers).
3. Clean, disinfect and repair/seal water damaged masonry walls.

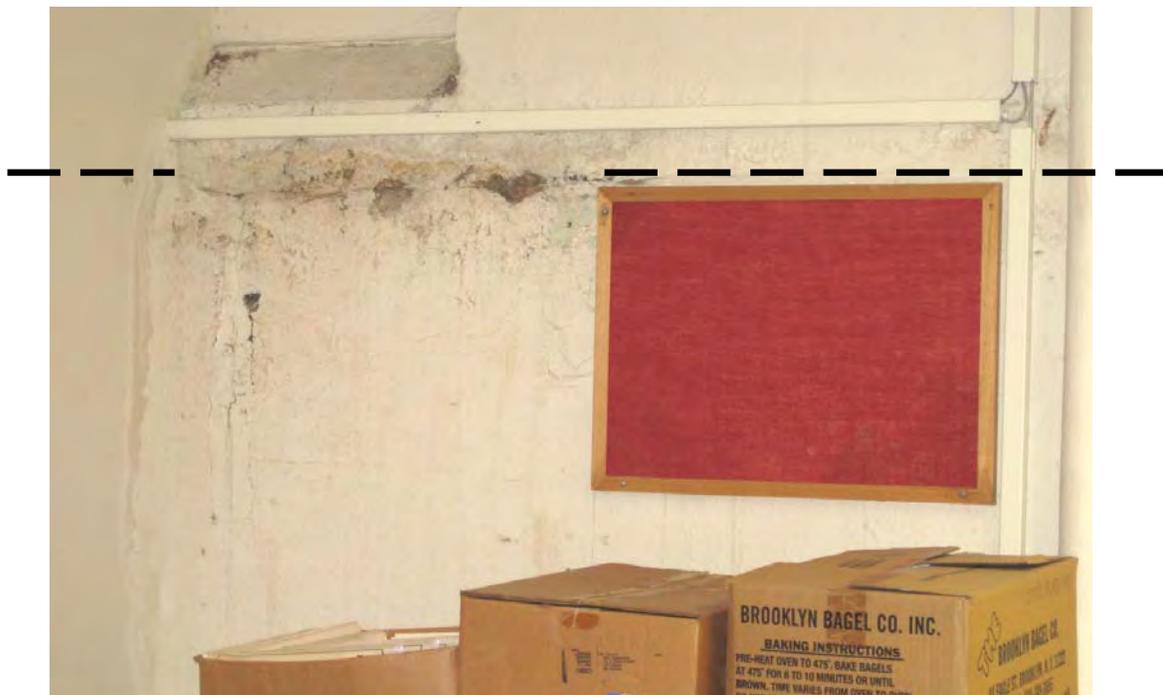
Picture 4

The damage in the plans examiner's office and storeroom corresponds to the level of the parking lot as evidenced by the horizontal plane of water damage (Pictures 4 and 5). As previously mentioned, several months prior to the assessment the asphalt surrounding the building was reportedly removed, re-paved and re-graded to improve drainage away from the building (Pictures 8 and 9). No further water penetration issues were voiced at the time of the assessment.

**Evidence of Water Penetration through Exterior Foundation Wall in Plans Examiner's Office:
Water Damaged Masonry, Efflorescence and Stained Paint: Note Horizontal Line, Which Roughly
Corresponds with the Level of the Tarmac Outside**

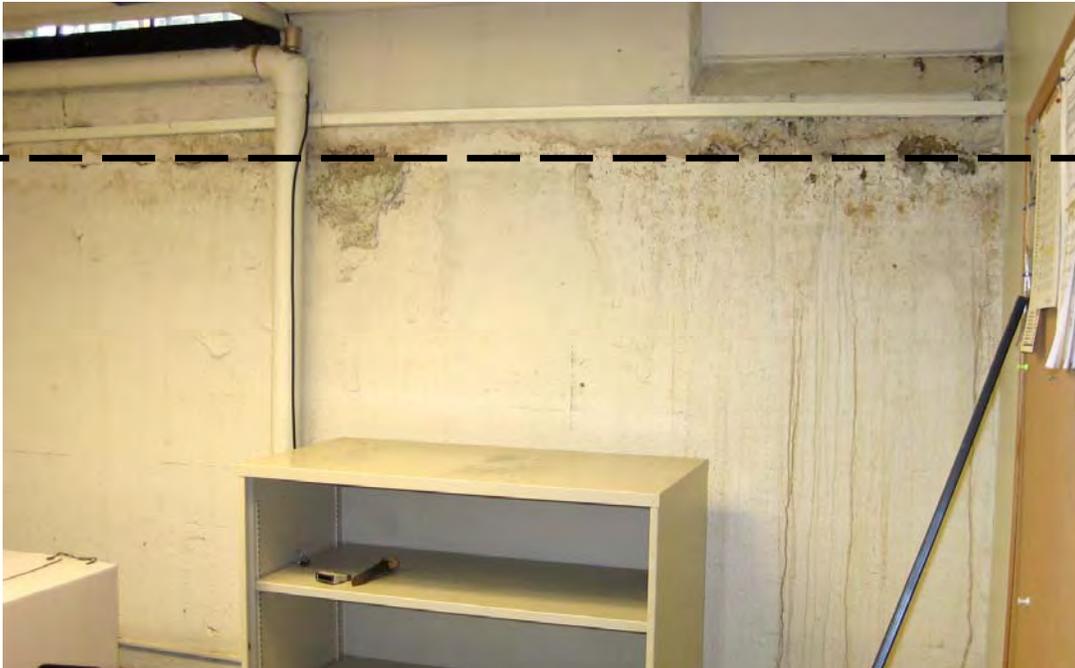
Picture 5

Evidence of Water Penetration through Exterior Foundation Wall in Storage Room (Plans Examiner's Office): Water Damaged Masonry, Efflorescence and Stained Paint: Note Horizontal Line, Which Roughly Corresponds with the Level of the Tarmac Outside

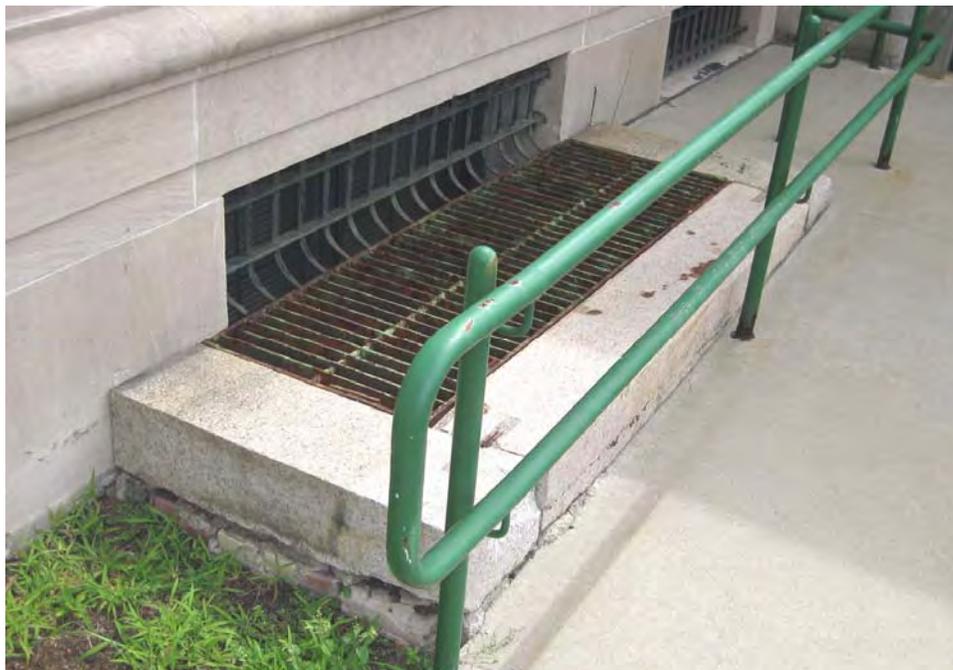
Picture 6

Window Well outside of Building Department

11. Unclog drain at bottom of window well outside of building department. Inspect periodically for proper drainage, make repairs as needed.
12. Consider installing a sliding glass or other security window to maintain comfort in the building department.

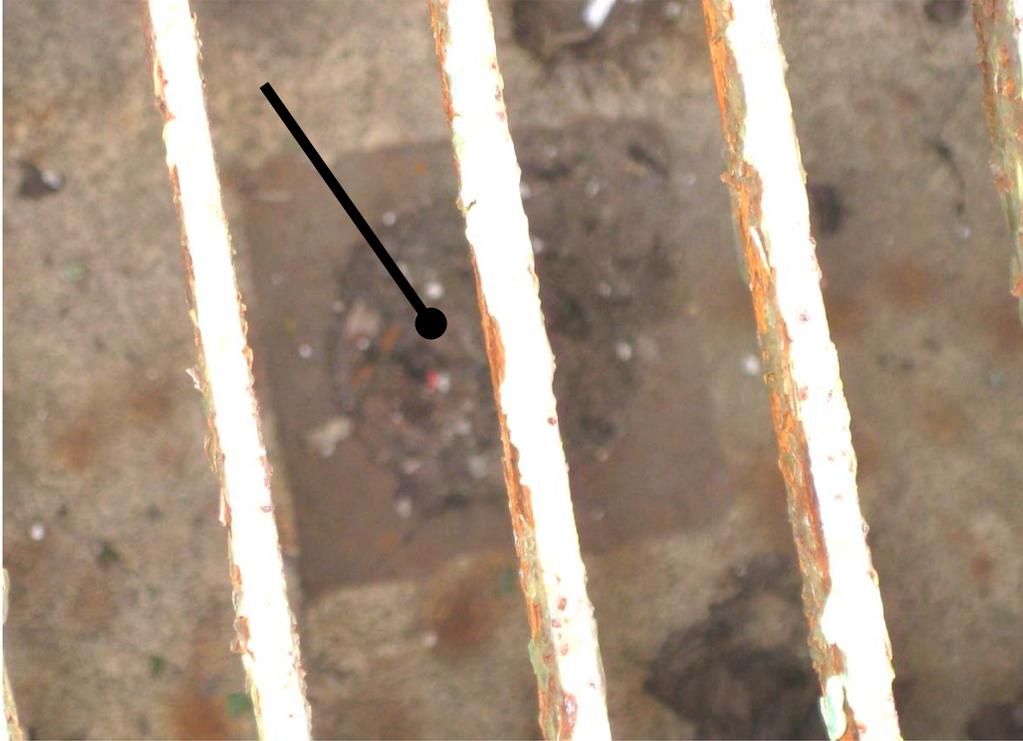
Picture 7

Clogged Drain at bottom of Window Well of outside Building Department (Shown in Previous Picture)

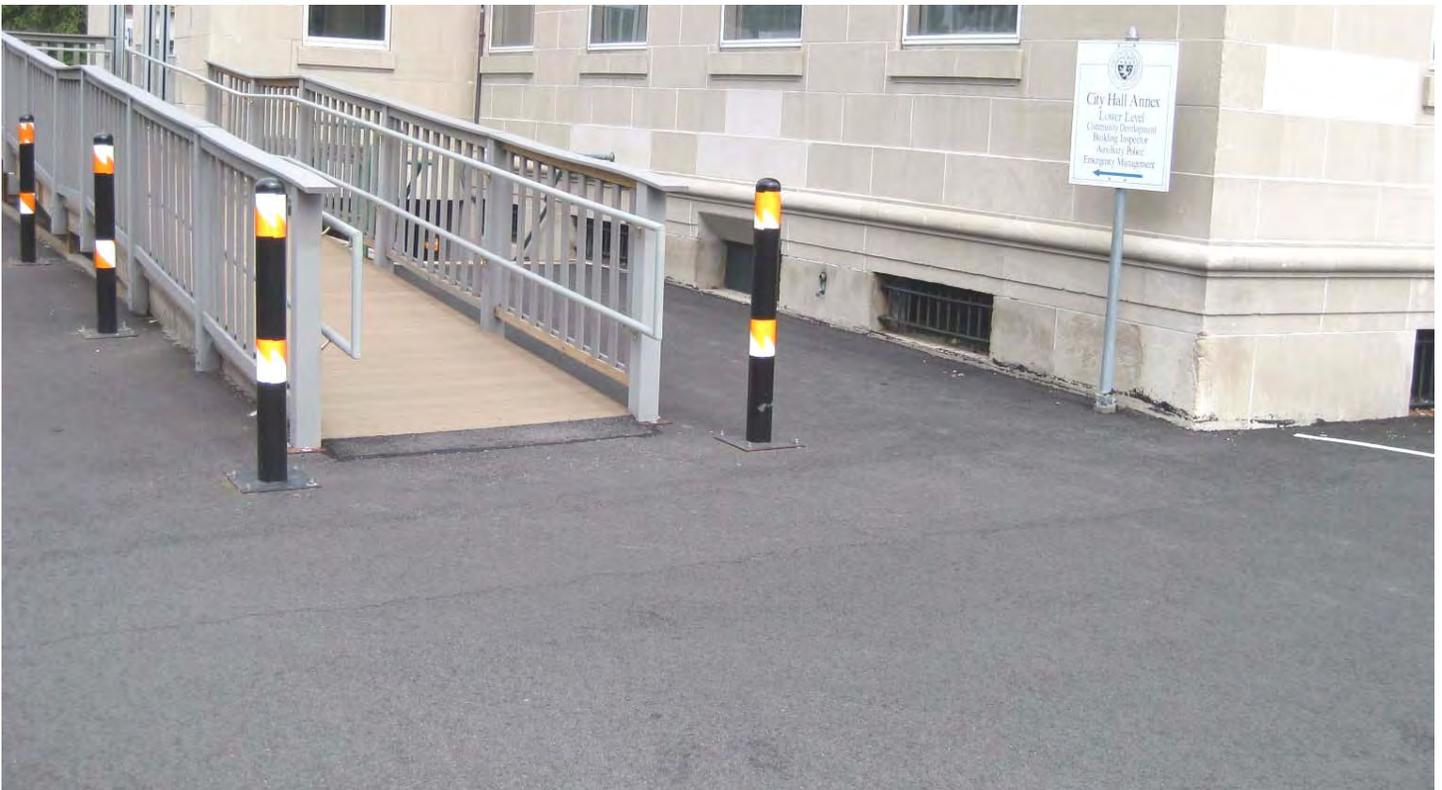
Picture 8

Tarmac Re-graded to Drain Away from Building

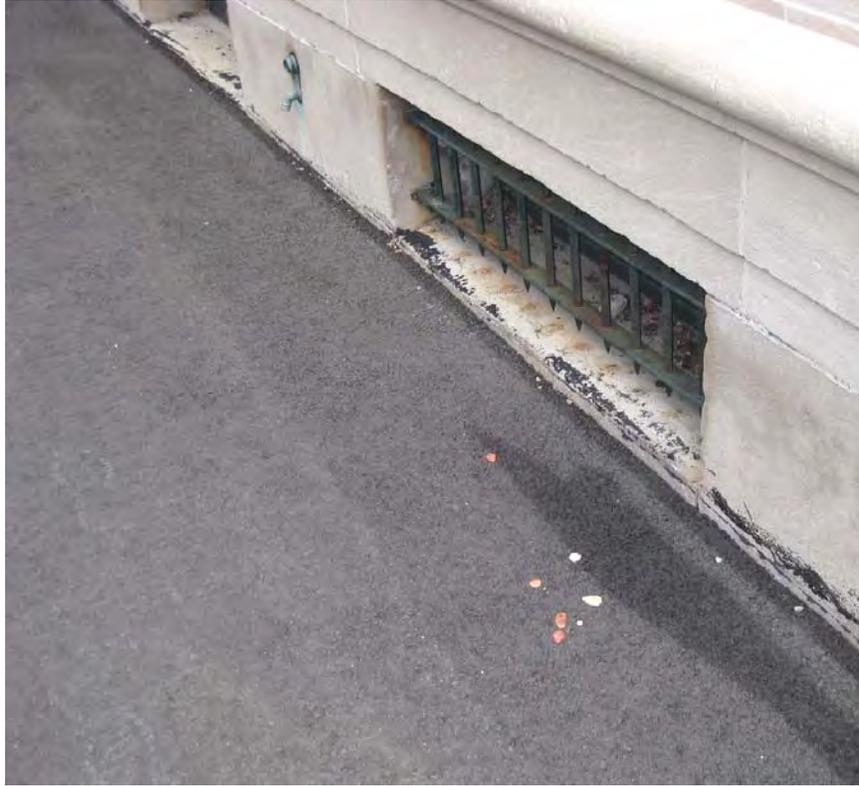
Picture 9

Tarmac Re-graded to Drain Away from Building

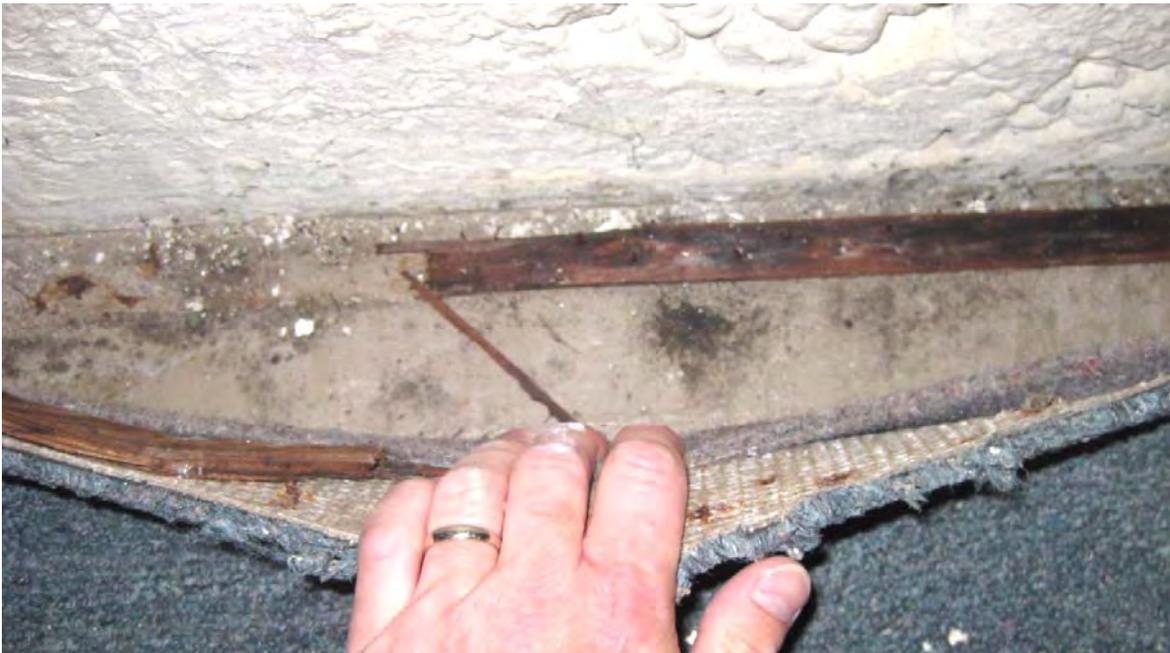
Picture 10

In order for building materials to support mold growth, a source of water exposure is necessary. Identification and elimination of water moistening building materials is necessary to control mold growth. Materials with increased moisture content over normal concentrations may indicate the possible presence of mold growth. Elevated moisture readings were measured and visible water damage and/or mold growth was detected/observed beneath carpeting and wooden tack strips along exterior walls of the plans examiner's office and storeroom (Picture 10).

Water Damaged/Mold Colonized Wooden Tack Board, Carpeting and Backing in Plans Examiner's Storeroom

1. Consider full removal and replacement of carpeting; carpeting is generally not recommended in below grade areas. If not feasible, remove carpeting approximately 2 to 3 feet from exterior walls. Remove and discard water damaged/mold colonized wooden tack strips. Disinfect floor beneath carpet with an appropriate antimicrobial agent, clean and dry. Consider replacing carpet with tile or other non-porous floor material.

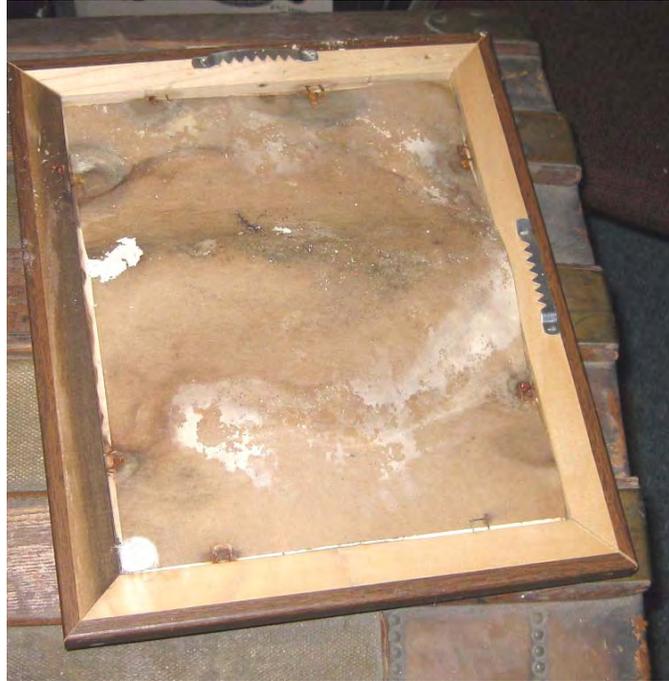
Picture 11

Other water damaged porous items were also observed colonized with mold including framed pictures and cardboard boxes (Pictures 11 and 12). Many of which are stored in the boiler room directly on the concrete floor, which is an unconditioned area that is prone to elevated humidity and condensation.

Water Damaged/Mold-Colonized Picture in Plans Examiner's Storeroom

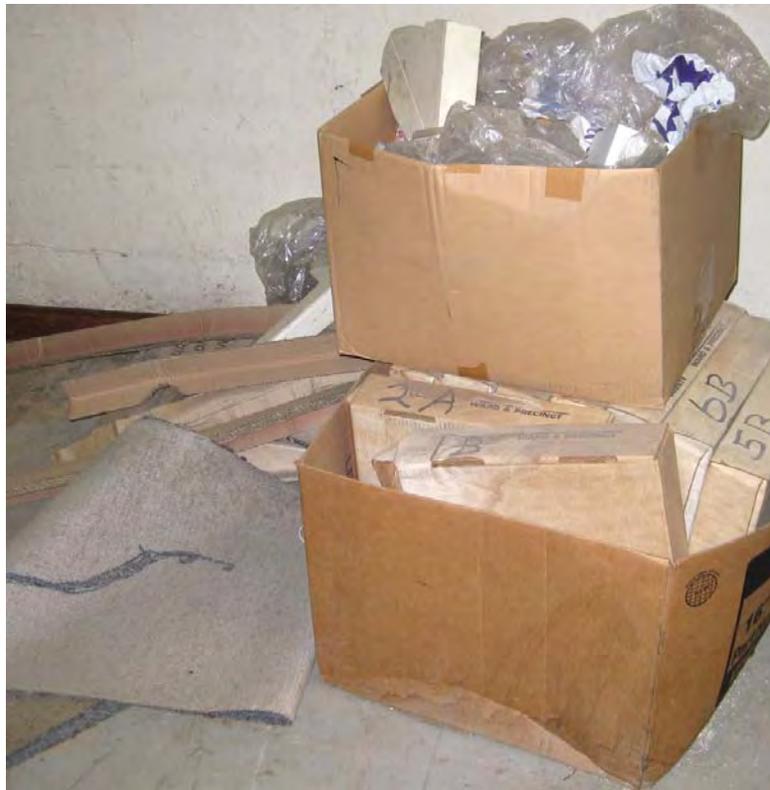
Picture 12

Water Damaged/Mold-Colonized Porous Items on Floor of the Boiler Room

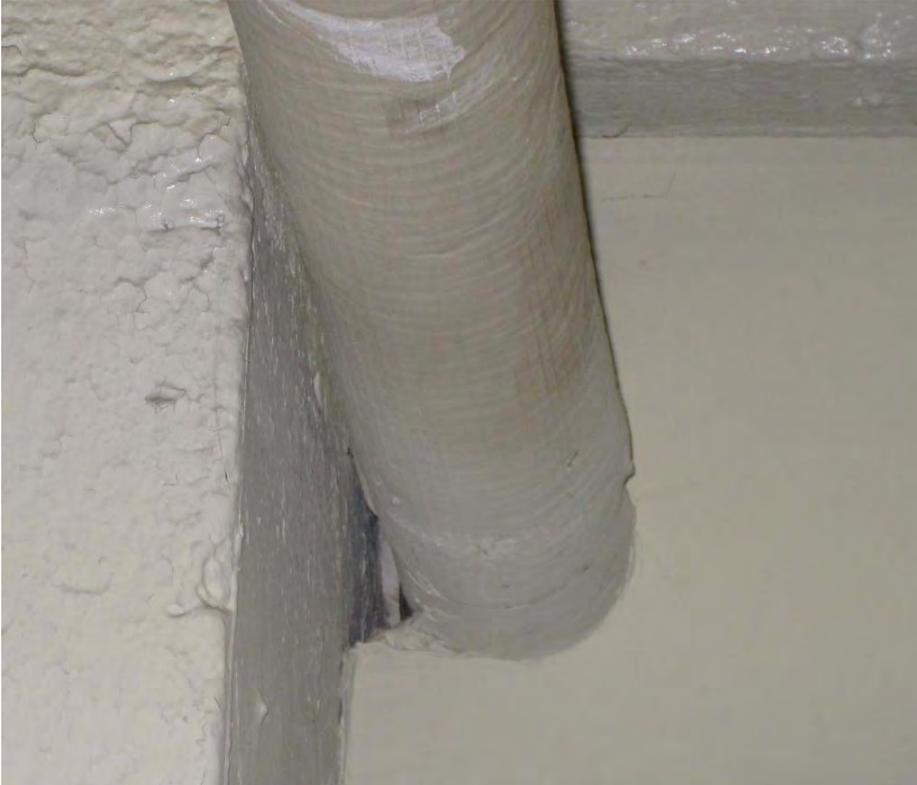
Picture 13

build up. In addition, these materials can accumulate on flat surfaces (e.g., desktops, windowsills and carpets) in occupied areas and subsequently be re-aerosolized causing further irritation. Finally, open utility holes were observed in the boiler room wall, which can serve as pathways for drafts, dust and debris into adjacent occupied areas (Pictures 13 and 14).

Space around Utility Pipe in Boiler Room Wall

19. Clean/change filters for the air handler and ACs as per the manufactures instructions or more frequently if needed.
20. Seal open utility holes in boiler room walls to prevent migration of drafts, odors and particulates into adjacent areas.

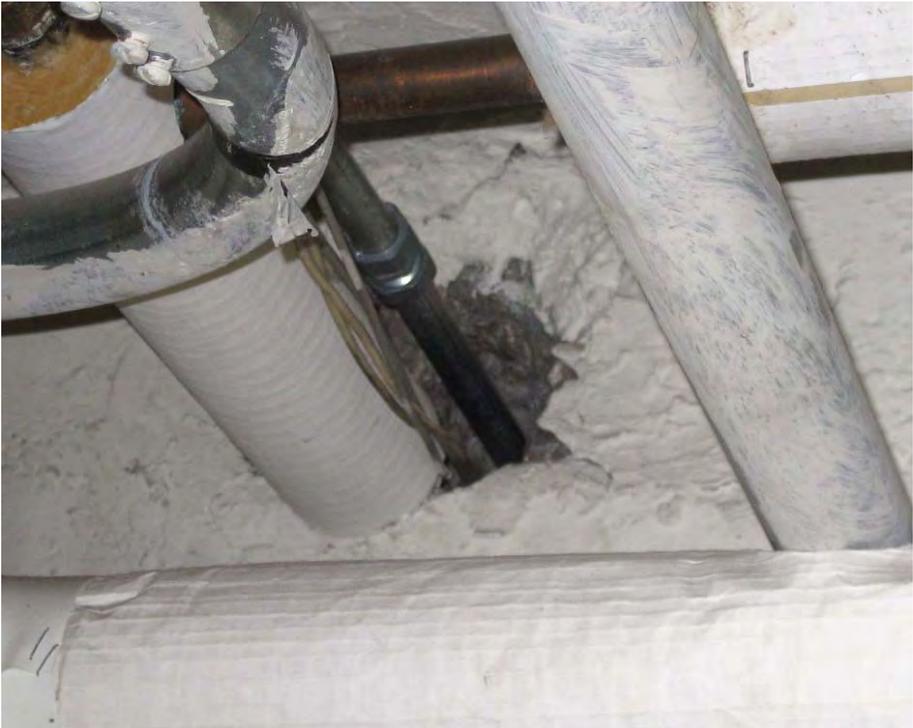
Picture 14

Space around Utility Pipe in Boiler Room Wall
