# **INDOOR AIR QUALITY ASSESSMENT**

**Massachusetts Department of Social Services  
67 Mechanic Street  
Attleboro, Massachusetts 02703**

Prepared by:  
Massachusetts Department of Public Health  
Bureau of Environmental Health  
Indoor Air Quality Program  
June 2008

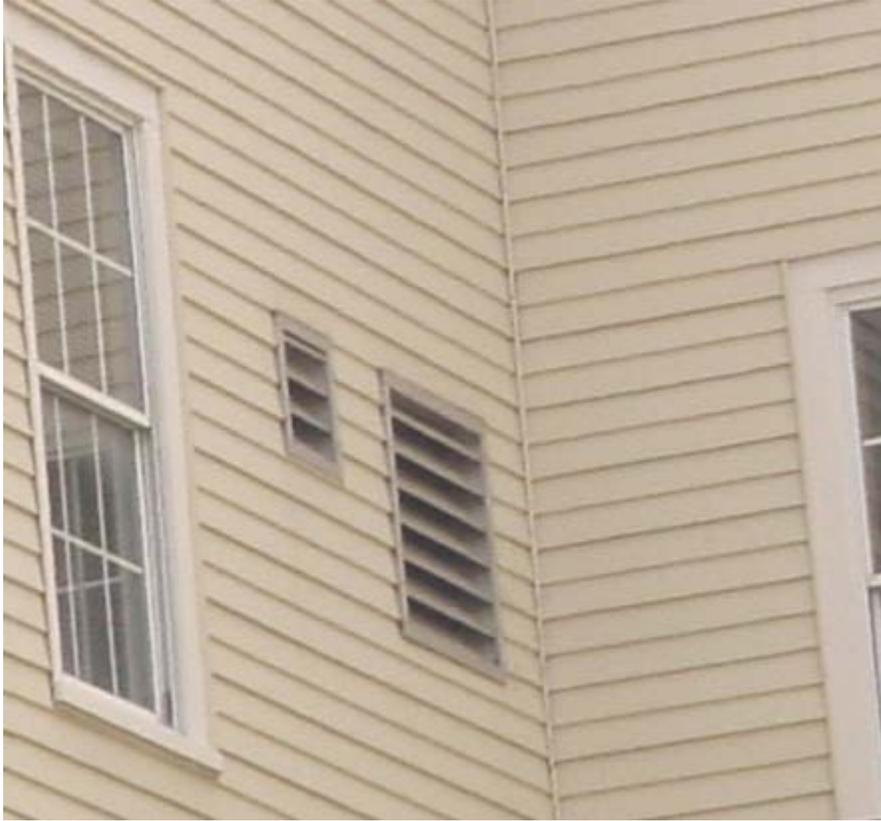
**Picture 1**

**Fresh Air Intake for 2<sup>nd</sup> Floor AHU**

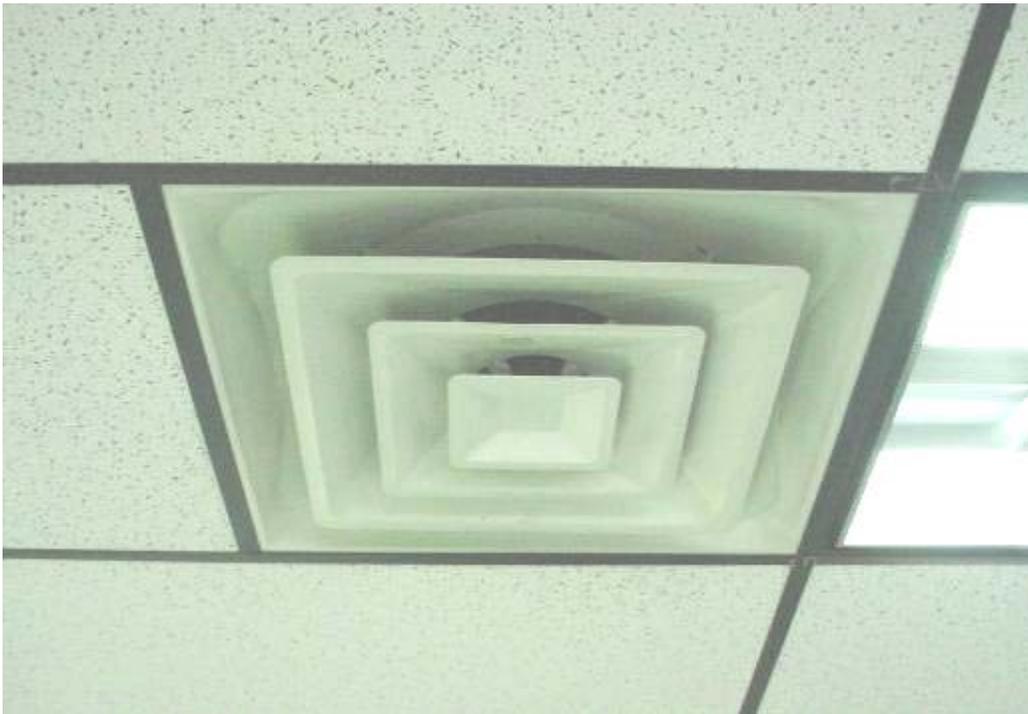
**Picture 2**

**Ceiling-Mounted Supply Diffuser**

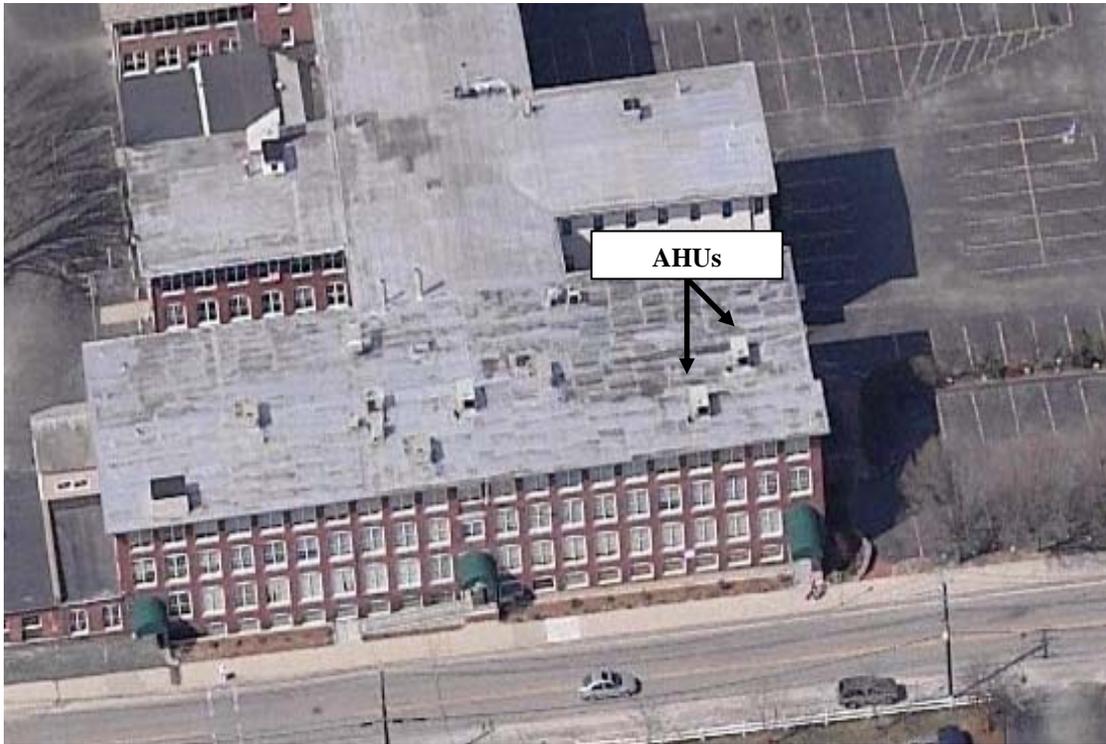
**Picture 3**

**Aerial View of 67 Mechanic Street, Arrows Indicate Location of Air Handling Units/Intakes for DSS 3<sup>rd</sup> Floor**

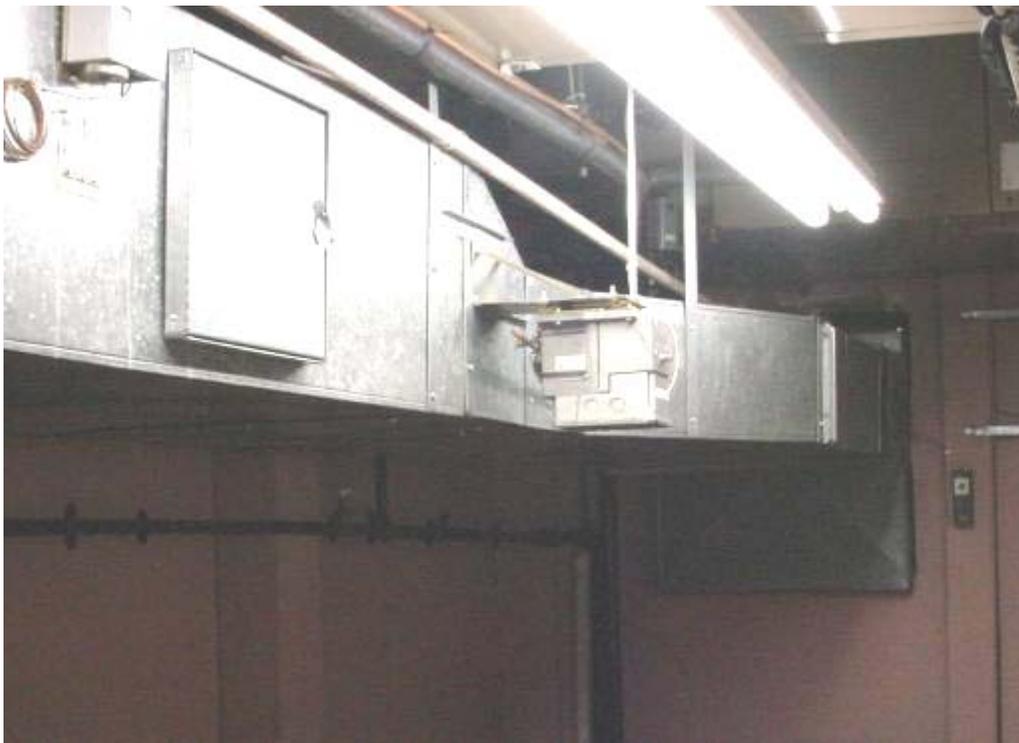
**Picture 4**

**AHU in 2<sup>nd</sup> Floor Mechanical Room**

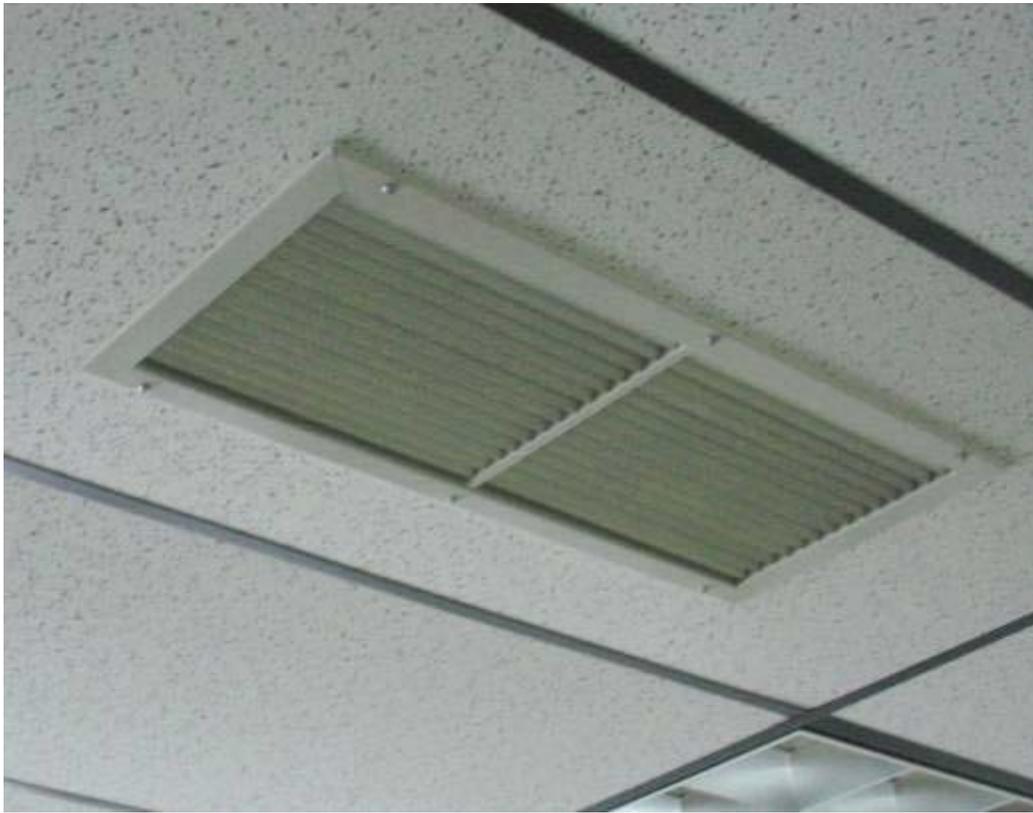
**Picture 5**

**Ceiling-Mounted Return Vent**

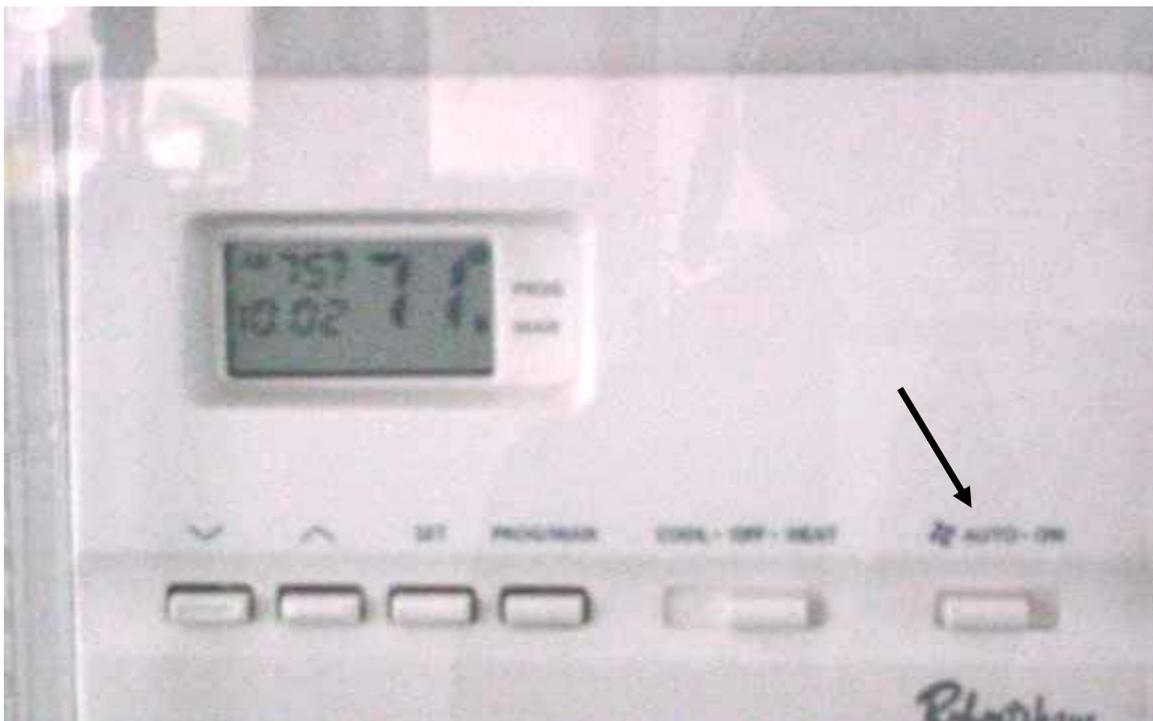
**Picture 6**

Thermostats that control the HVAC system have fan settings of “on” and “automatic”. The “automatic” setting on the thermostat activates the HVAC system at a preset temperature. Once the preset temperature is reached, the HVAC system is deactivated. At the time of the assessment all thermostats in the DSS space were operating in the fan “auto” mode (Picture 6).

**Digital Thermostat, Note Fan in "Auto" Setting**

MDPH recommends that thermostats be set in the fan “on” mode during occupied periods to provide continuous airflow.

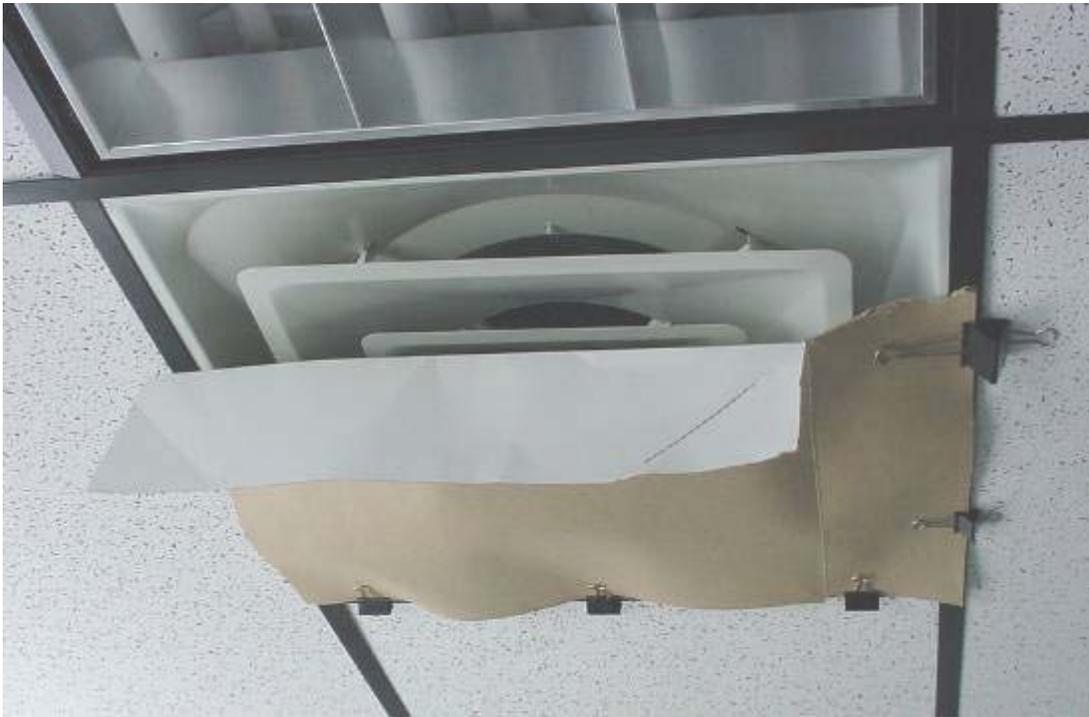
**Picture 7**

Although measurements were within MDPH parameters during the assessment, temperature control complaints were expressed by occupants in several areas. In one area the air diffuser was obstructed limiting airflow (Picture 7). Blocking supply diffusers limits the ability of the HVAC system to deliver air and causes air to back up in the duct, forcing more air out of other diffusers without such obstructions. As a result, increased airflow can cause more temperature/comfort complaints as well as an increase in noise produced by the velocity of air forced through the diffusers.

**Air Diffuser Partially Obstructed by Cardboard**

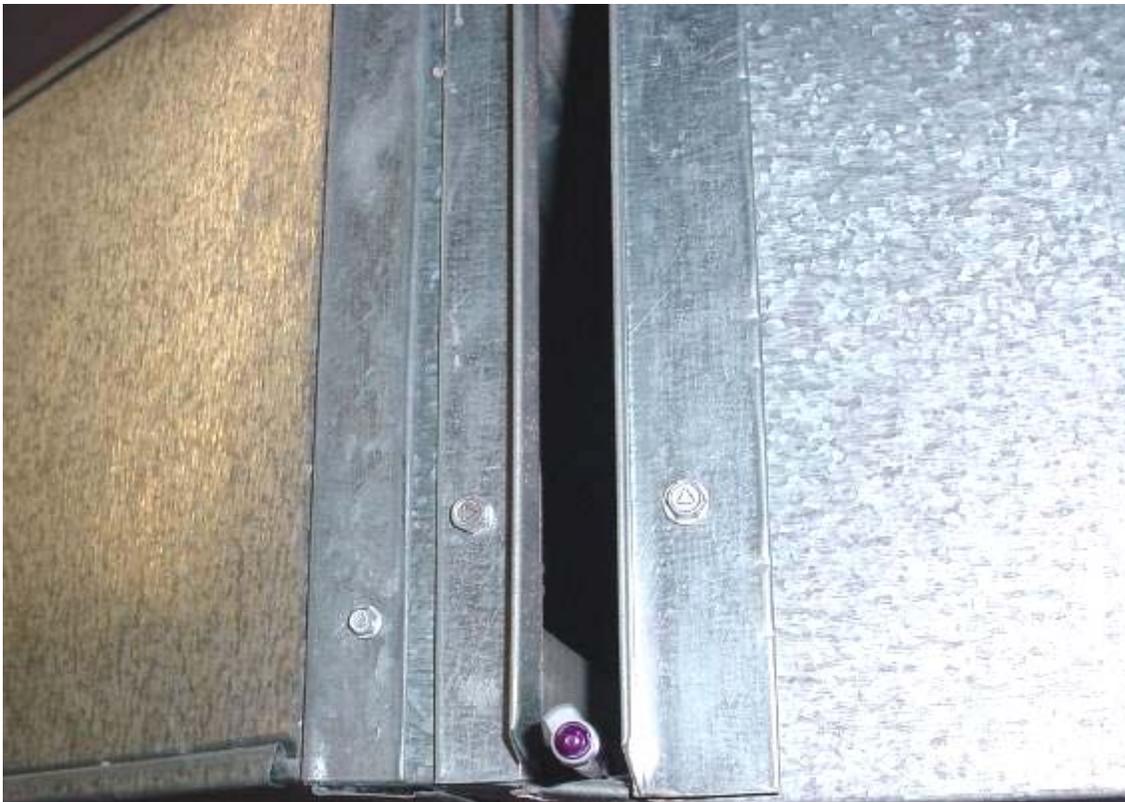
**Picture 8**

BEH also observed breaches in supply ductwork and a hole in the floor of the 2<sup>nd</sup> floor mechanical room (Pictures 8 and 9). Compromised integrity of ductwork may reduce the efficiency of the system to heat/cool and distribute air and draw in airborne particulates that can bypass filters. The hole in the floor can serve as a pathway for odors from the floor below to migrate into the mechanical room where they can be entrained into the system via breaches in the ductwork and be distributed to occupied areas.

**Breach in Ductwork in 2<sup>nd</sup> Floor Mechanical Room, Pen Inserted by BEH Staff**

6. Clean air diffusers, exhaust, return vents and adjacent ceiling tiles periodically of accumulated dust.
7. Seal breach in ductwork in 2<sup>nd</sup> floor mechanical room.

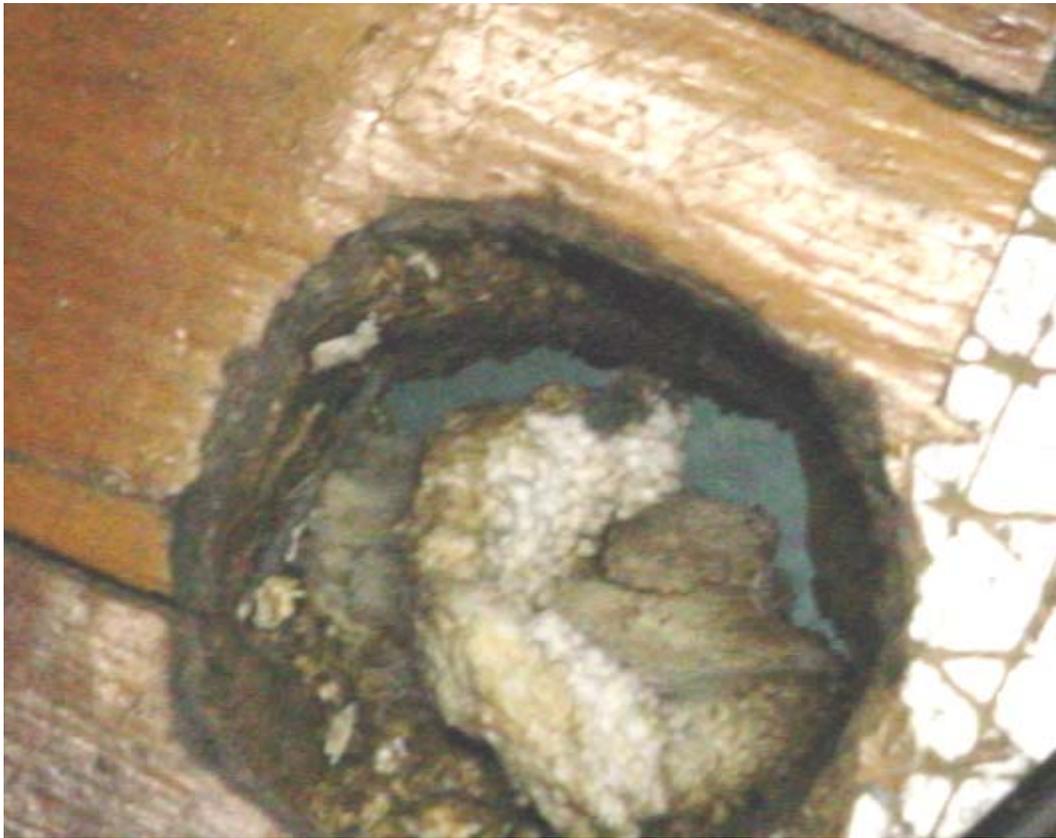
**Picture 9**

**Hole in Floor of 2<sup>nd</sup> Floor Mechanical**

8. Seal hole in floor of 2<sup>nd</sup> floor mechanical room.
9. Refer to resource manuals and other related indoor air quality documents located on the MDPH's website for further building-wide evaluations and advice on maintaining public buildings. These documents are available at:  
<http://www.state.ma.us/dph/MDPH/iaq/iaqhome.htm>.

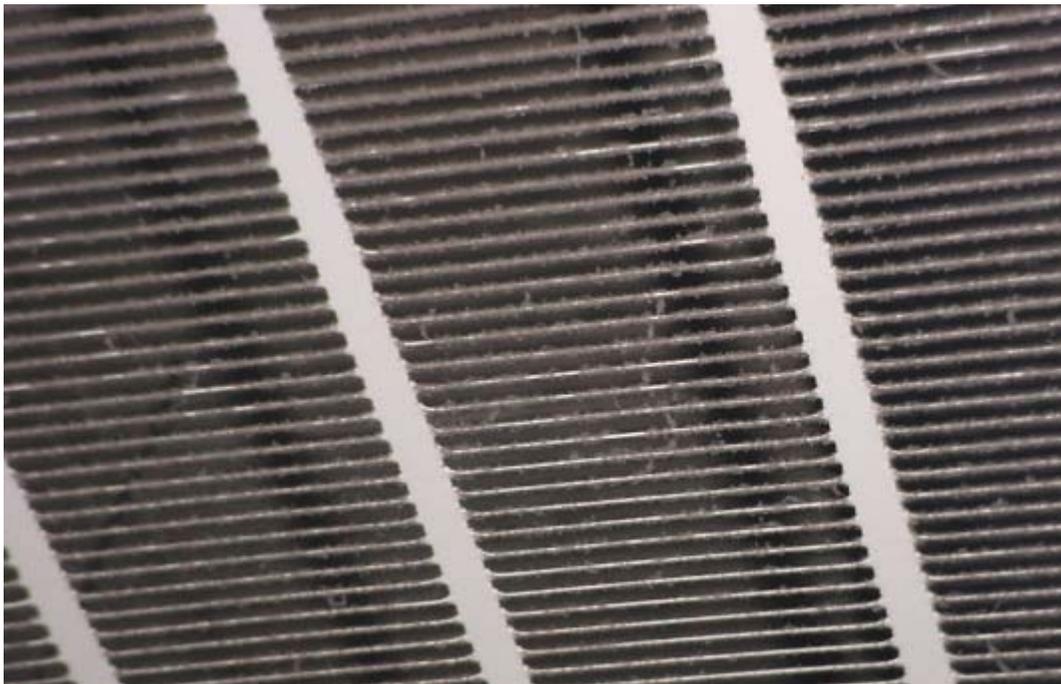
**Picture 10**

Finally, a number of supply diffusers and return vents were observed to have accumulated dust/debris (Picture 9). Dust can be irritating to eyes, nose and respiratory tract.

**Dust/Debris Accumulated on Return Grate**

10. Clean air diffusers, exhaust, return vents and adjacent ceiling tiles periodically of accumulated dust. If soiled ceiling tiles cannot be cleaned, replace.
