INDOOR AIR QUALITY ASSESSMENT

**Division of Capital Asset Management
One Ashburton Place
Boston, Massachusetts 02108**

Prepared by:
Massachusetts Department of Public Health
Bureau of Environmental Health
Indoor Air Quality Program
May 2008

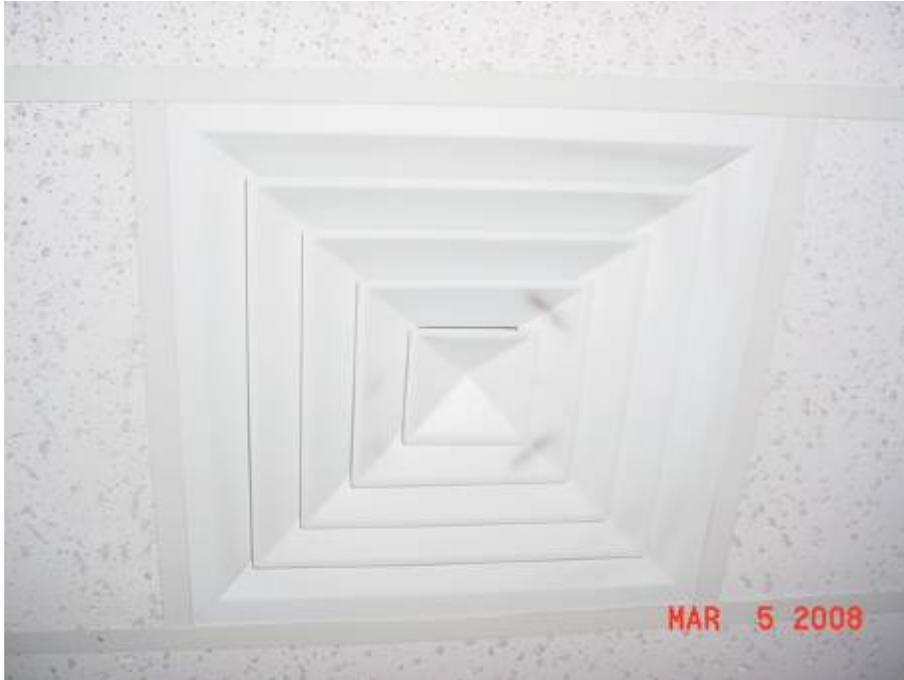
Picture 1

It can be seen from Tables 1 and 2 that carbon dioxide levels were below 800 parts per million (ppm) in all areas surveyed, indicating adequate air exchange in occupied spaces. On the DCAM floors, ventilation is provided by heating, ventilation and air-conditioning (HVAC) units. Fresh air is supplied to each floor by a combination of air diffusers located on the light fixtures in the suspended ceiling and induction units located at the base of the windows. On the 10th, 14th and 16th floors, exhaust ventilation is provided by ducted return air vents located on the light fixtures in the suspended ceiling. However, on the 15th floor, it appears that the HVAC system configuration has been substantially altered. Fresh air is supplied by ceiling mounted diffusers with exhaust ventilation provided by plastic grilles in the suspended ceiling, converting the HVAC system into a ceiling plenum return system.

Ceiling Mounted Air Diffusers

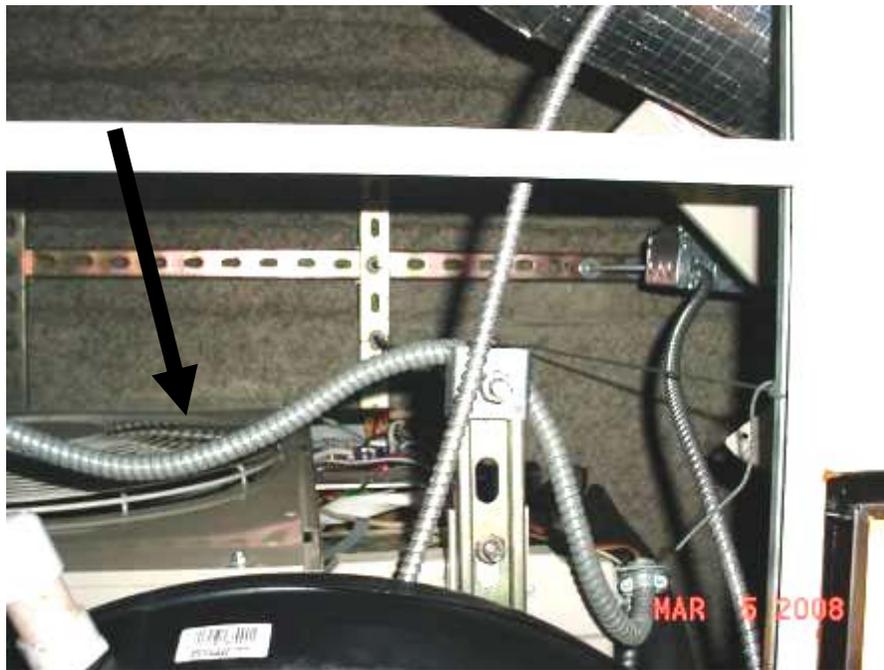
Picture 2

- The kitchen area does not have an exhaust vent that is separate from the general HVAC system. In this condition, waste heat from cooking and other kitchen appliances is allowed to enter the ceiling plenum.
- On the south side of the 15th floor, the center aisle of this cubicle area does not have evenly spaced fresh air diffusers. The lack of fresh air diffusers can allow for heated air from computer equipment and the 15th floor kitchen to remain and accumulate in this area.
- The computer mainframe room has a chiller system retrofitted into the suspended ceiling (Picture 2). The purpose of a chiller is to provide chilled coolant for wall-mounted air-conditioning units in the mainframe room. In order to chill the coolant, a chiller has a large fan to draw air over the coils to remove heat. The heated air from this chiller is

then *ejected into the 15th floor ceiling plenum*. The operation of this equipment would create a zone of heated air around the fan and disturb dust and other debris in the ceiling.

**Chiller Located In the Ceiling Plenum above the Computer Mainframe Room
Note Fan**

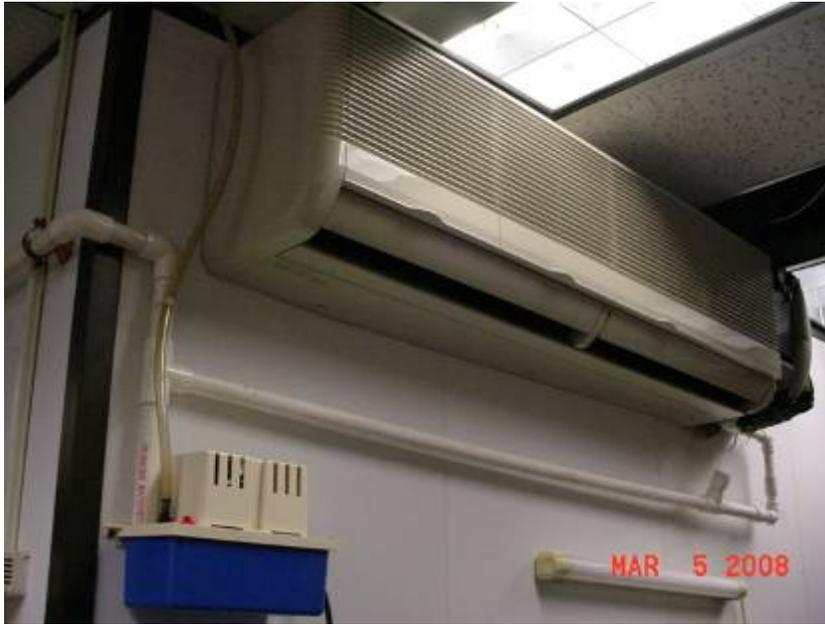
Picture 3

Of note is the computer mainframe room on the 15th floor. No fresh air supply or exhaust system was identified in this area; however, the space is used as a permanent office space. Mainframe rooms are usually configured to regulate the temperature of the computer equipment. If this area is to be used for office space, fresh air supply and exhaust ventilation should be provided.

Several potential sources of water damage and mold growth were observed. Of note is the air-conditioning equipment in the computer mainframe room (Picture 3). Each of these units generates condensation during operation, which must be appropriately drained. BEH staff checked the slope of the drain pipe and found it to be sloped away from the condensation pumps (Picture 4). In this condition, water will accumulate within this pipe. Standing water can be a mold growth medium.

Wall-Mounted Air Conditioner in Mainframe Room

1. Provide a fresh air supply and exhaust system for the computer mainframe room if used as office space. If not feasible, do not use this location as office space.
2. Examine the various methods that can be used to direct the heated airflow produced by the operation of the chiller fan above the computer mainframe room to the return vent for the main building's HVAC system.
3. Examine the feasibility of providing exhaust ventilation for the 15th floor kitchen.
4. Examine the feasibility of reconfiguring offices to remove desk chairs from close proximity to induction units.

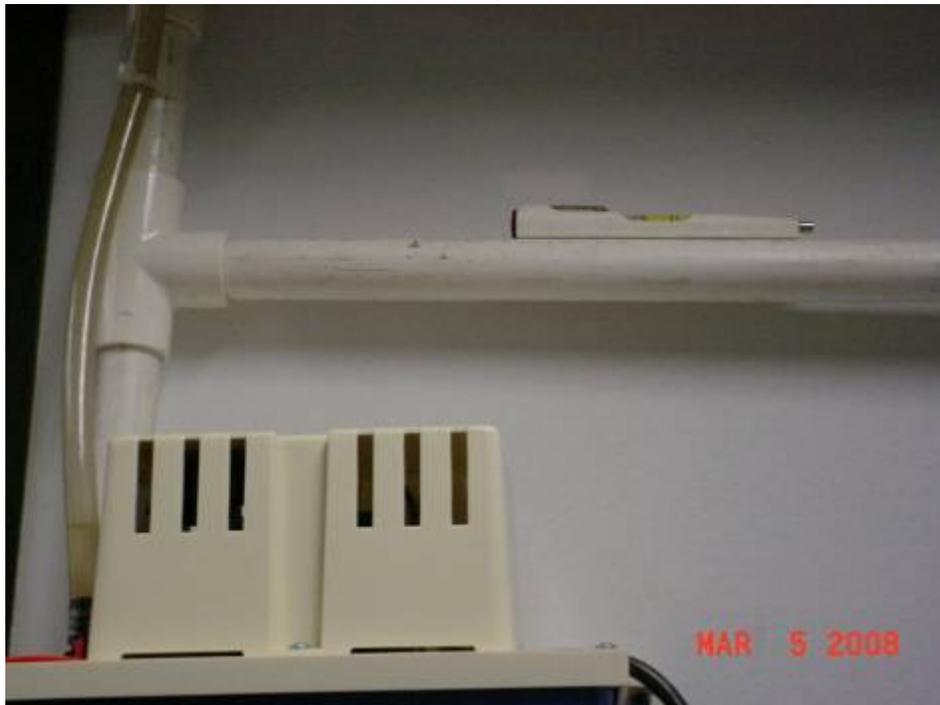
Picture 4

**Drain Pipe for Wall Mounted Air Condition
Note the Pipe Is Sloped Away From the Condensation Pump**

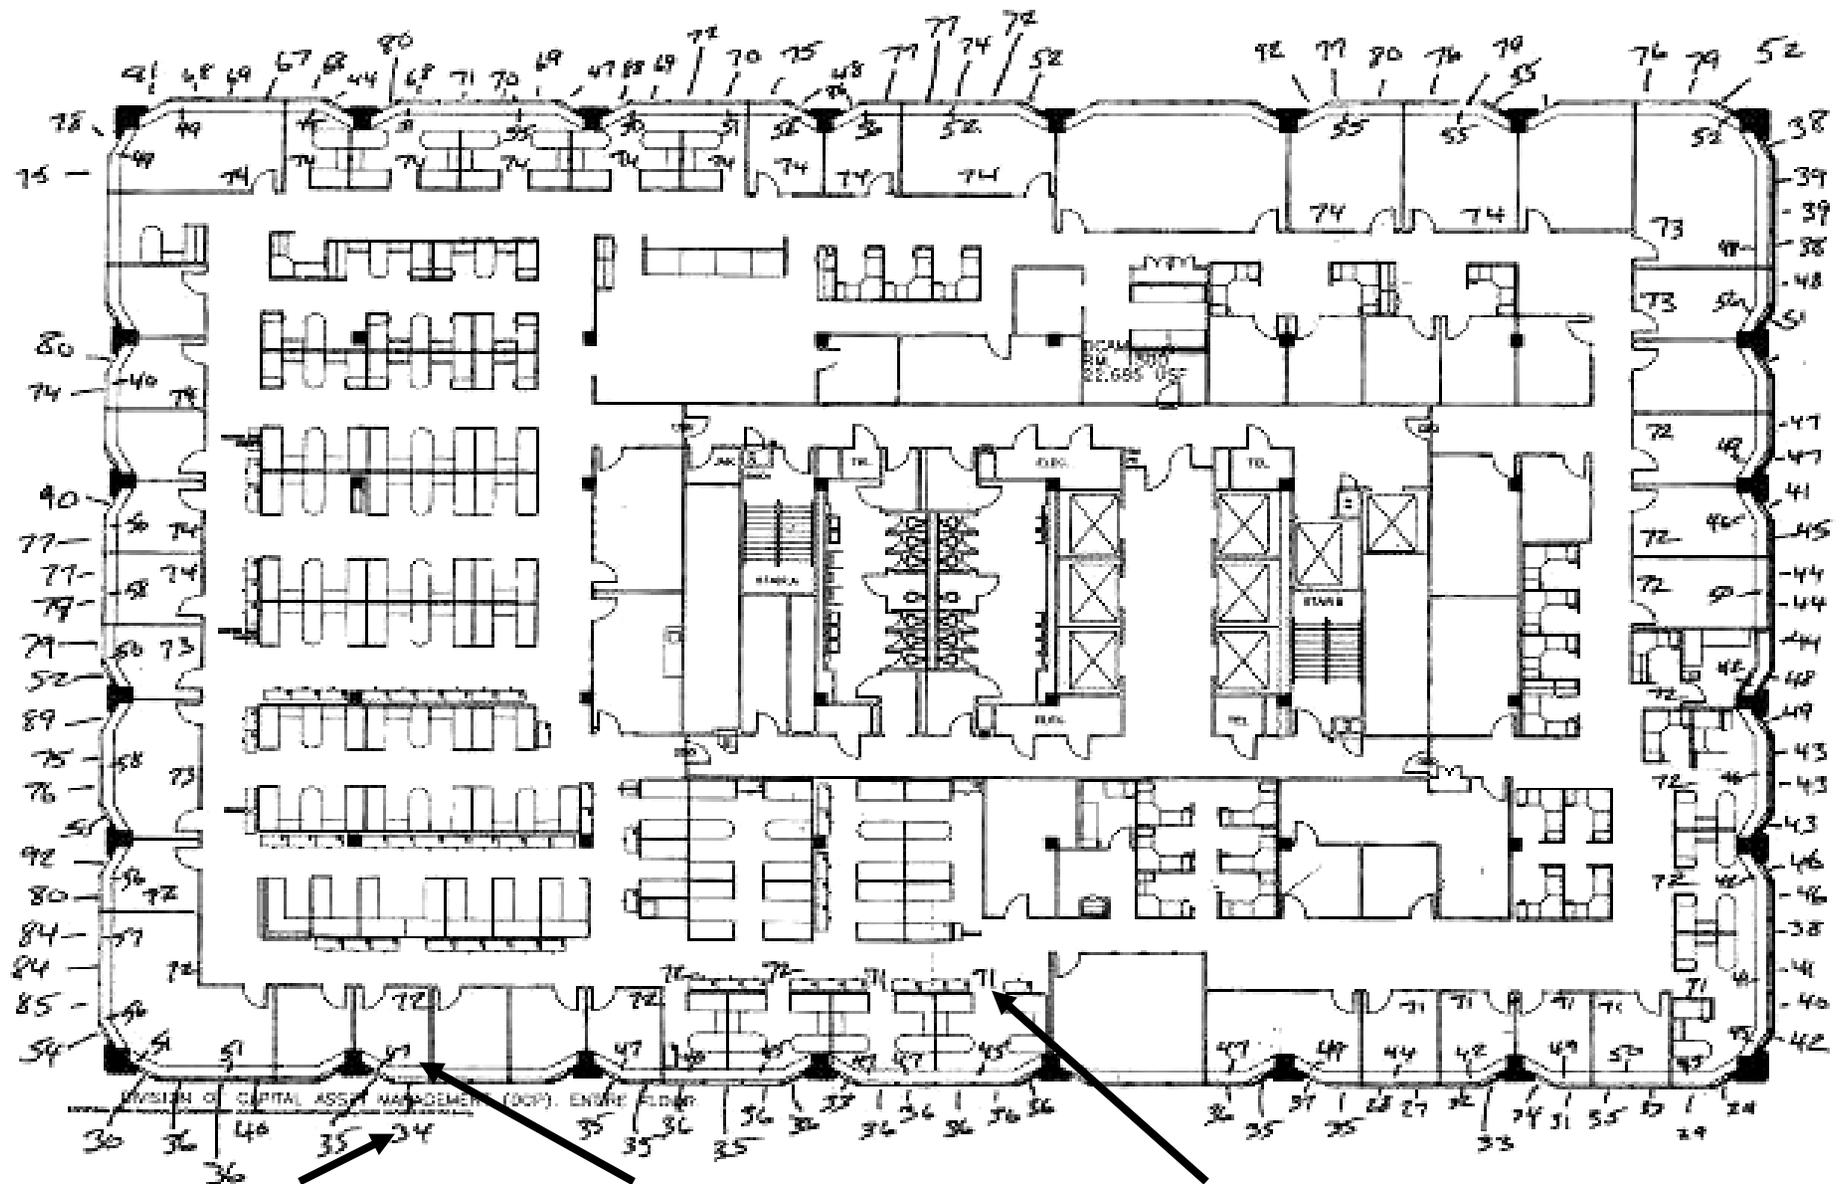
Figure 1

- The configuration of the window system makes the building highly susceptible to uneven heating due to solar gain. The window system of the building consists of a single pane of glass installed inside a metal frame. When exposed to direct sunlight, the glass and metal of the windows become a significant heat source. BEH staff measured the temperature of the window glass around the most of the 15th floor (Figure 1) (outdoor temperature of 42°F at ground level/Table 2). Window glass on the 15th floor was in direct sunlight, partial sunlight or in shade. Windows on the south and west walls were in direct sunlight and temperature measurements ranged from 75°F to 92°F (Figure 1). Windows on parts of the west wall were in partial sunlight and temperature measurements ranged from 67°F to 80°F (Figure 1). . Windows on the north and east wall were in shade and temperature measurements ranged from 27°F to 47°F (Figure 1). Some offices had an extreme temperature range (over 40°F) between individual windowpanes in the same room. As an example, the commissioner's office located on the northeast corner of the 15th floor, had window pane temperatures that ranged from 38°F to 79°F (Figure 1).

- Temperatures of induction unit fresh air supply grilles were also measured. The surface temperature was measured in a range from 41°F to 58°F (Figure 1). The window systems in areas along the shaded side of the building (north and east walls) are *actually heated* by the induction units [window pane temperature ranges from 27°F to 47°F (Figure 1)]. This range in temperature may indicate that the induction unit boxes are also influenced by solar gain, as is the window system. If desks are located within the

Figure of Surface Temperatures of Window Panes and Induction Units; and Room Temperatures of Various Locations on the outer wall of the 15th floor One Ashburton Place, Boston, MA

- a. Examine the feasibility of whether induction unit air temperature can be increased in areas that are prone to having cold window panes in the heating season.

- b. Examine the feasibility of whether induction unit air temperature can be decreased in areas that are prone to having warm window panes in the heating season.

- c. Examine induction units to determine whether the inclusion of insulation can provide better temperature control.
7. Consider balancing mechanical ventilation systems every 5 years, as recommended by ventilation industrial standards (SMACNA, 1994).
