**INDOOR AIR QUALITY ASSESSMENT
FOLLOW-UP
MOLD INVESTIGATION**

**Henry Lord Middle School
151 Amity Street
Fall River, MA 02721**

Prepared by:
Massachusetts Department of Public Health
Bureau of Environmental Health
Indoor Air Quality Program
October 2008

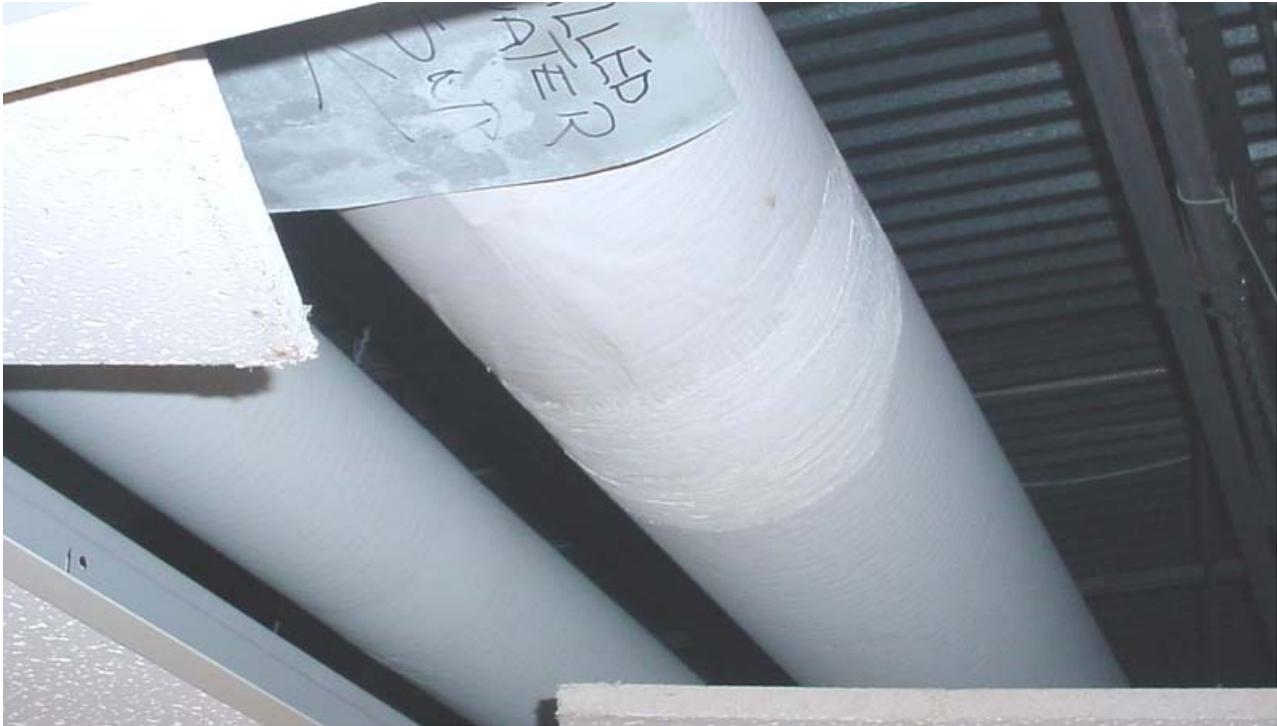
Picture 1

At the time of the BEH follow-up assessment all mold-colonized chilled water pipe insulation had been removed and replaced by a professional insulation firm (Pictures 1 and 2). In addition, other water damaged porous building materials (e.g., ceiling tiles and gypsum wallboard) had been replaced (Pictures 3 and 4). Although the majority of mold-colonized cork boards and stored materials had been removed, several other items (e.g., exercise mats, bulletin boards and paper items) were recommended for removal (Picture 5).

Replaced Chilled Water Pipe Insulation in Classroom

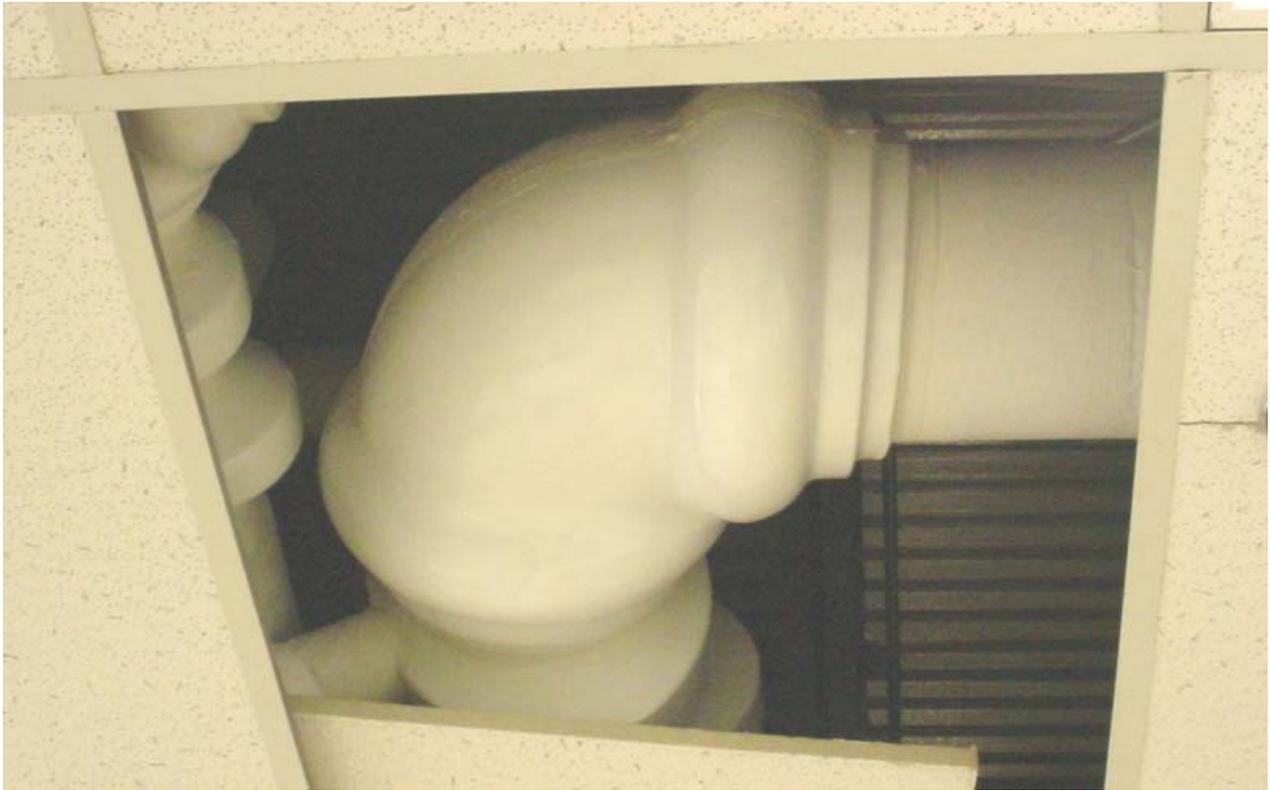
Picture 2

Replaced Chilled Water Pipe Insulation in Classroom

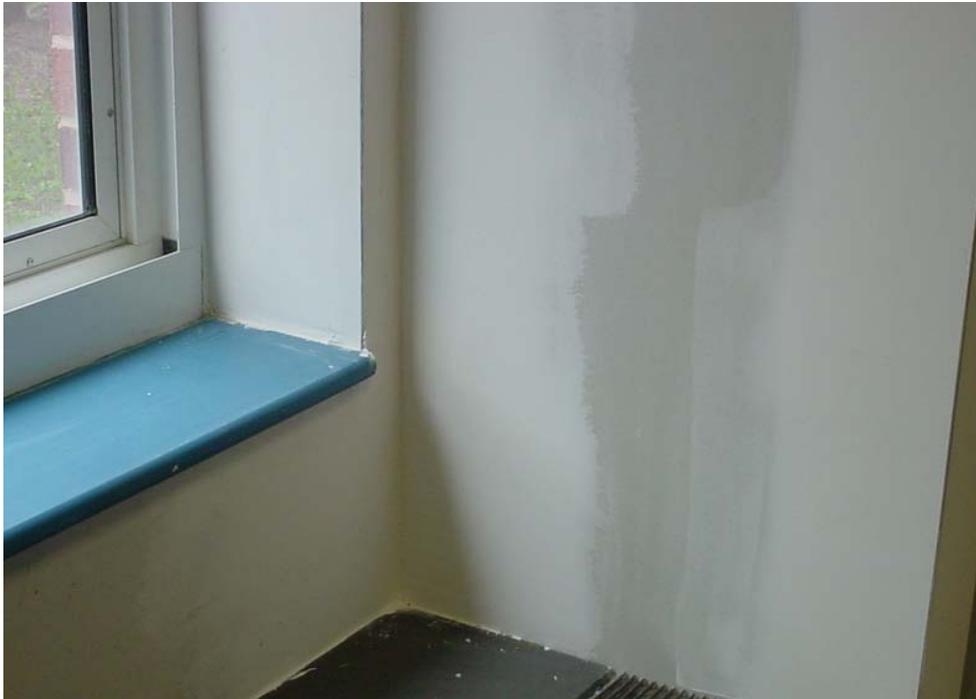
Picture 3

Replaced Gypsum Wallboard in Classroom

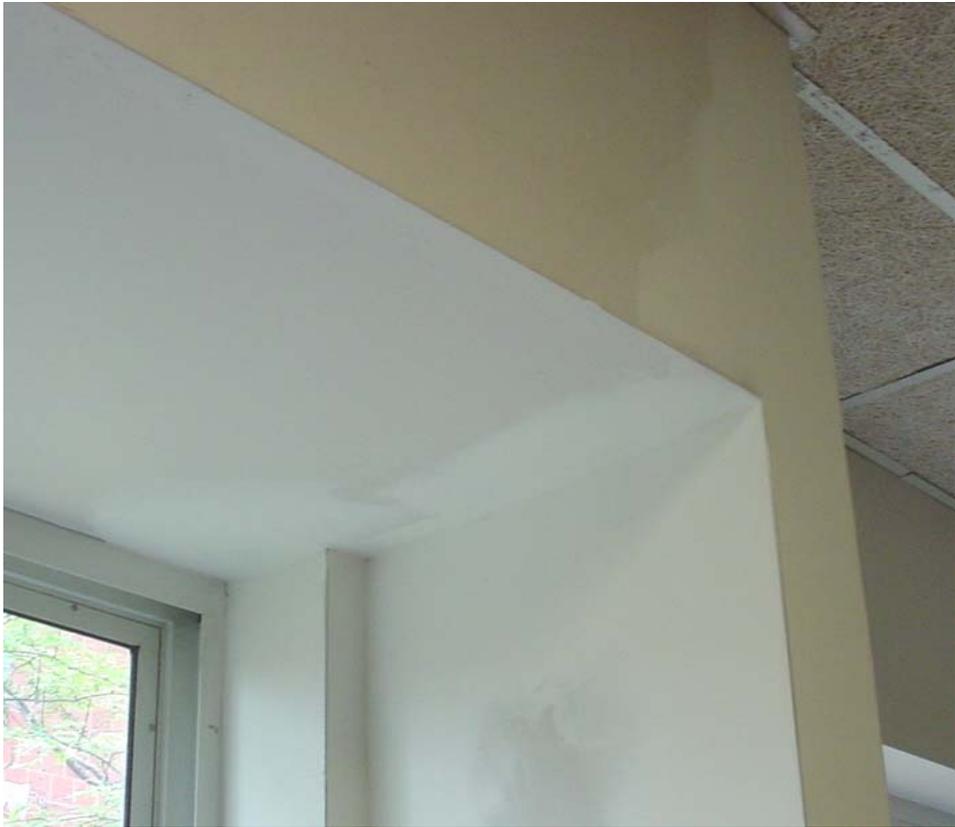
Picture 4

Replaced Gypsum Wallboard in Classroom

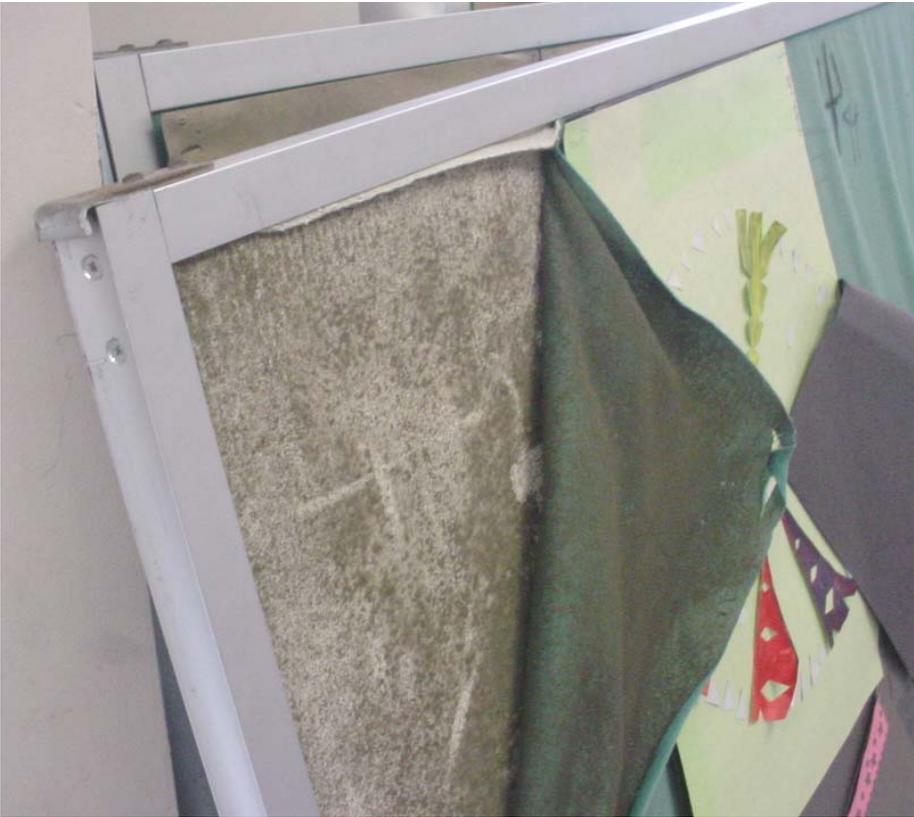
Picture 5

Mold Growth beneath Fabric on Bulletin Boards

1. Discard any remaining mold-colonized materials (e.g., bulletin boards, gym mats, books).
2. Continue with plans to consult with a building engineer to evaluate the building and its HVAC system to address chronic moisture issues.
3. Develop an Operation and Maintenance (O & M) Plan to monitor for water-damaged building materials and, in particular, pipe insulation in areas of chronic moisture issues.
4. Building occupants should notify the maintenance department if mold/moisture issues occur so that prompt action may be taken.
5. Scrape and prime rusted metal ceiling tracks and univent cabinets. Contact the univent manufacture to determine the proper products/options for repainting.

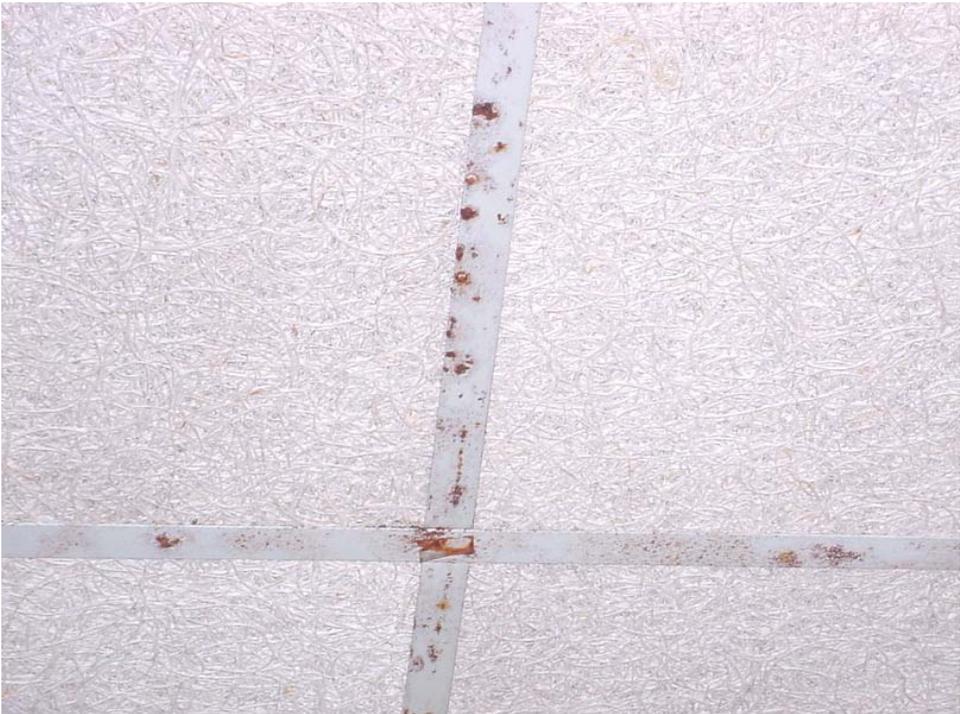
Picture 6

Finally, although non-porous metal surfaces of dropped ceiling tracks and univent cabinets had been cleaned, they showed dark, unsightly, oxidation stains from chronic moisture exposure (Pictures 6 through 9).

Oxidation (Rust Stains) from Chronic Moisture on Metal Ceiling Tracks

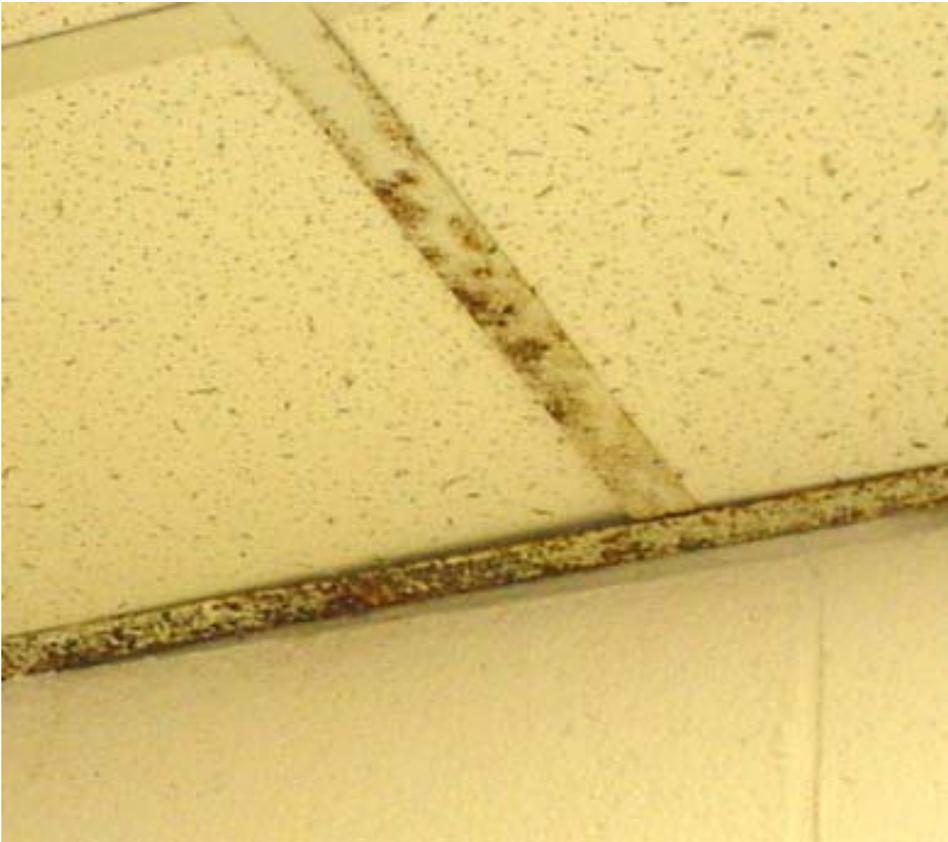
Picture 7

Oxidation (Rust Stains) from Chronic Moisture on Metal Ceiling Tracks

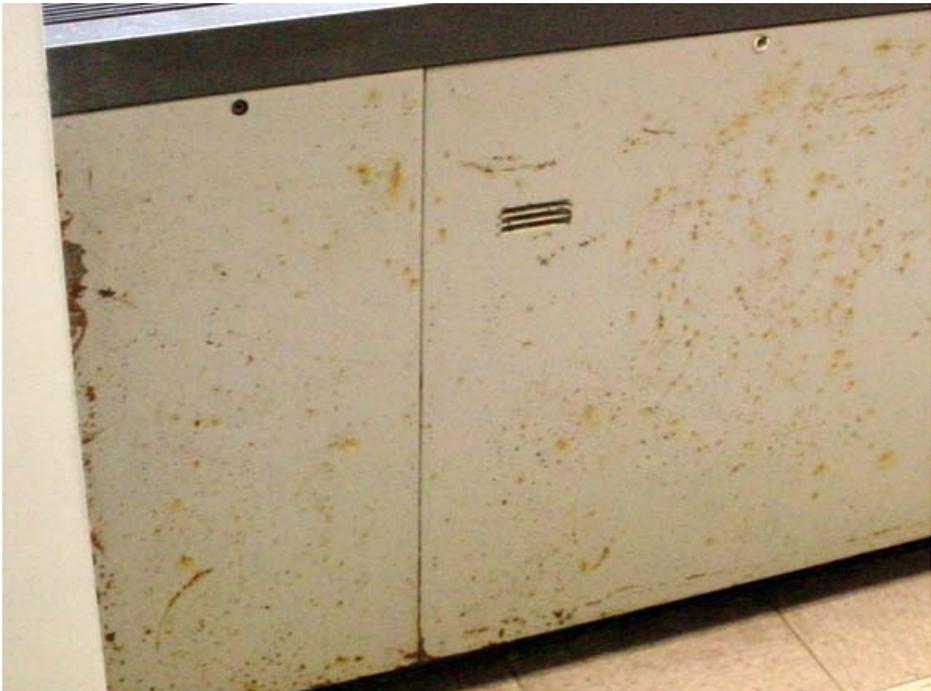
Picture 8

Oxidation (Rust Stains) from Chronic Moisture on Surface of Metal Univent Cabinet

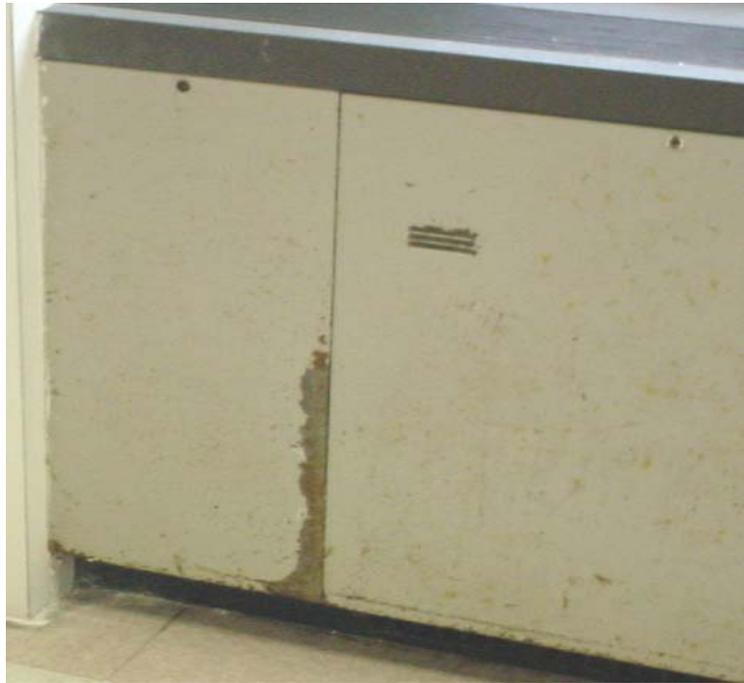
Picture 9

Oxidation (Rust Stains) from Chronic Moisture on Surface of Metal Univent Cabinet
