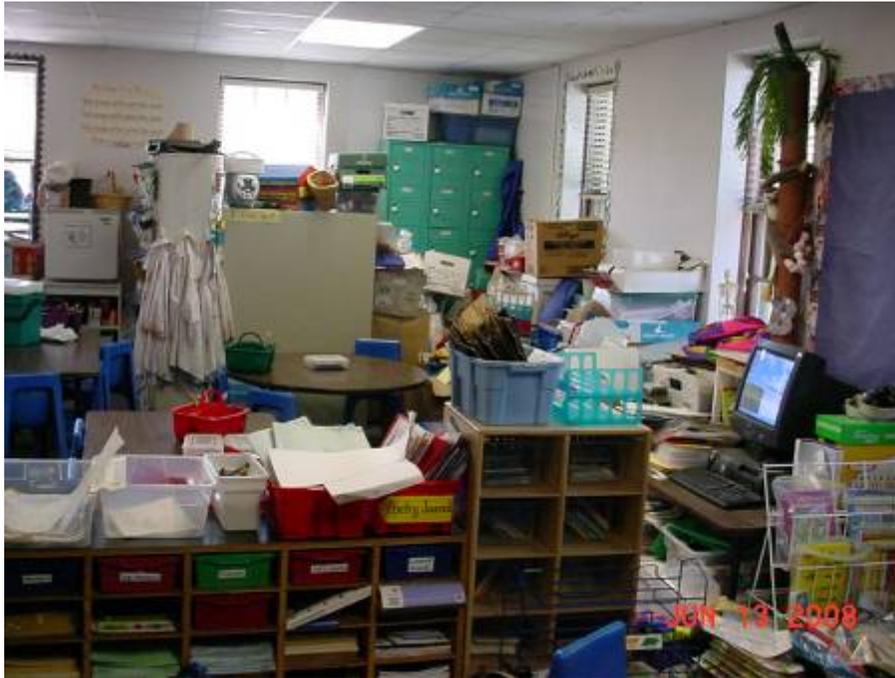
**Picture 1**

**Stored Materials Blocking a Unit Ventilator**

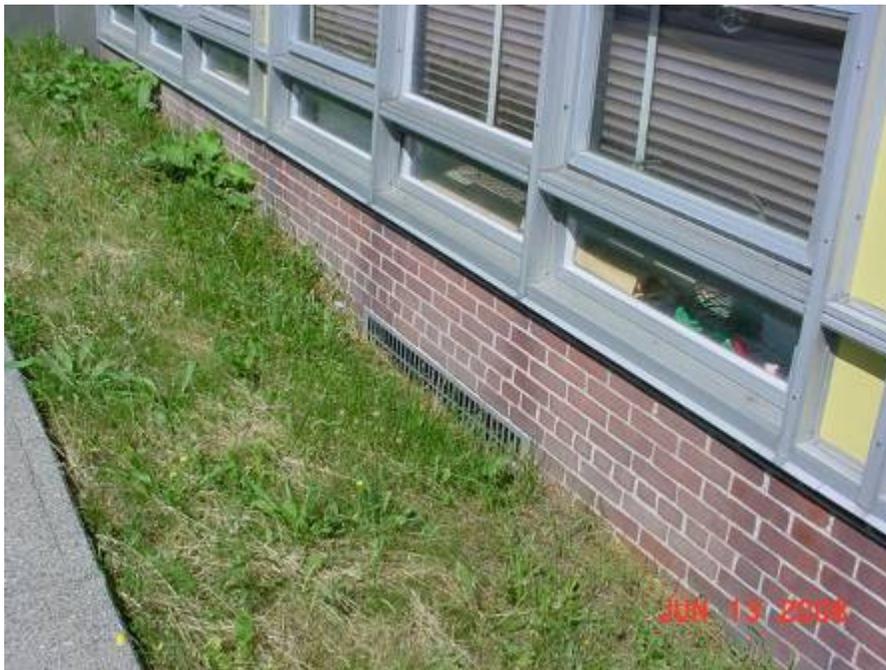
**Pitcher 2**

**Fresh Air Intakes Located Below Grade**

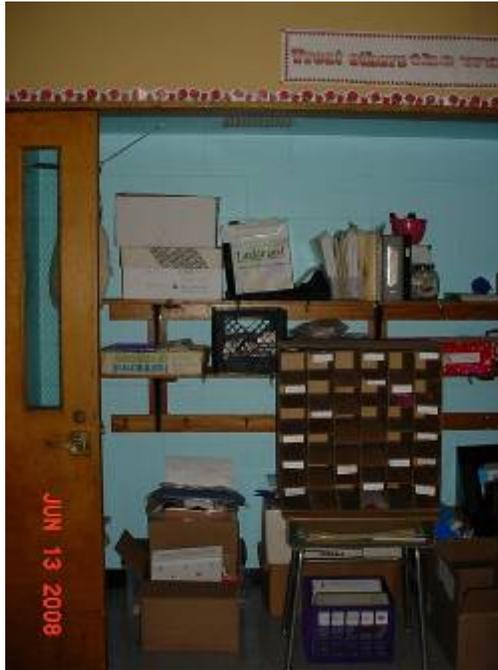
**Picture 3**

**Exhaust Vents Located In Closet Ceiling**

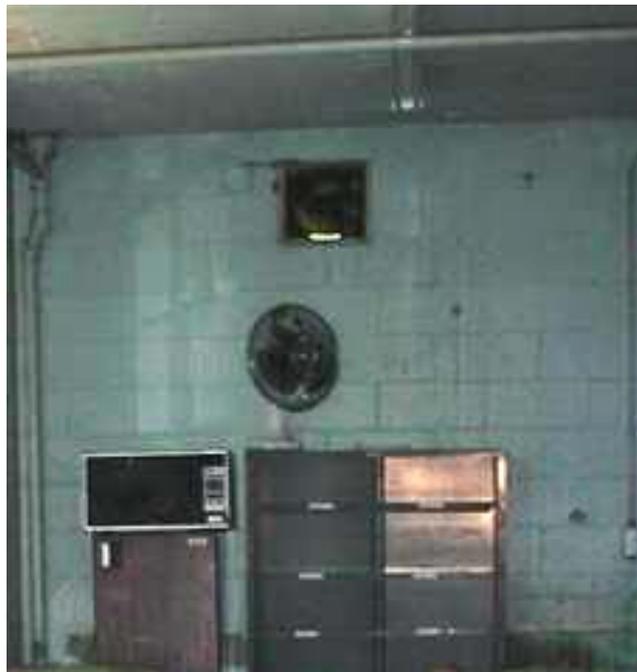
**Picture 4**

**Exhaust Fan in Copy Room**

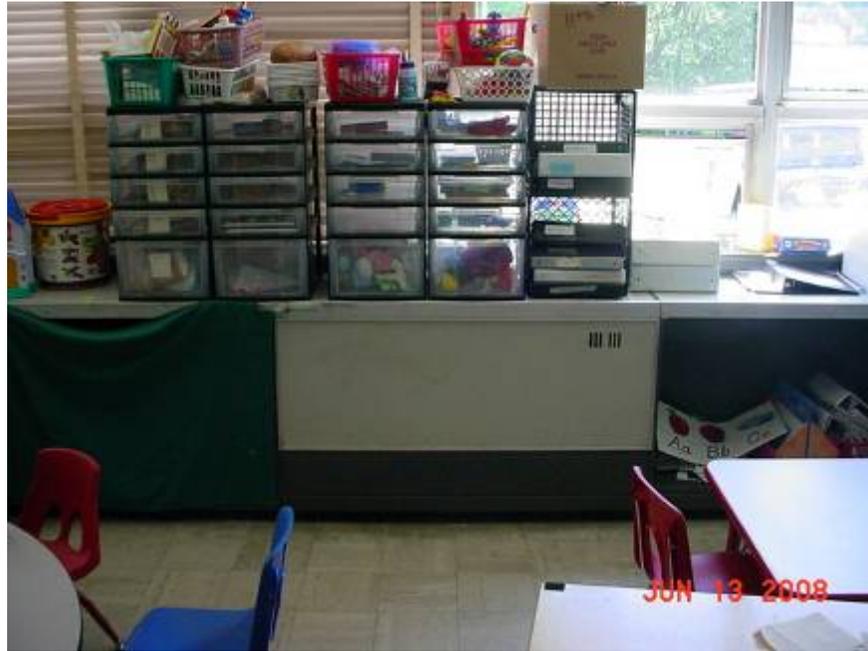
**Picture 5**

**Unit Exhaust Ventilator**

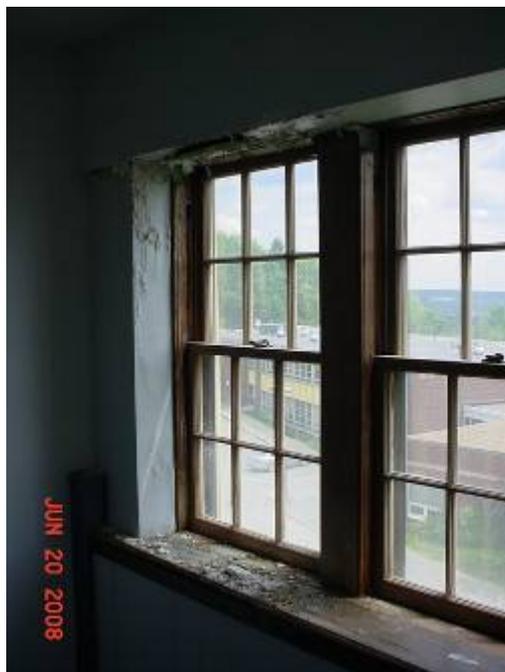
**Picture 6**

**Water Damage Due To Window Leaks**

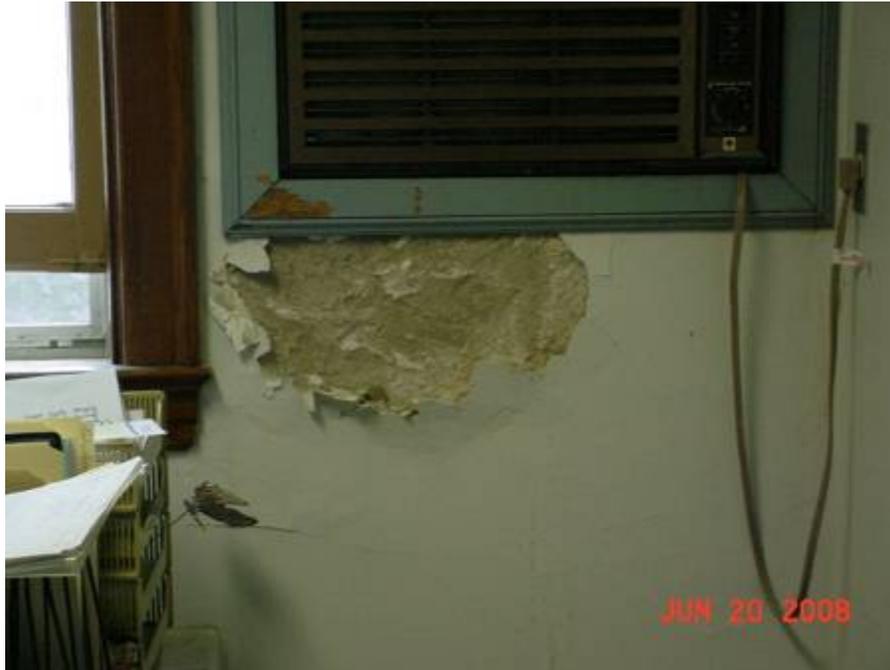
**Picture 7**

**Water Damage Plaster through Air Conditioning Installation**

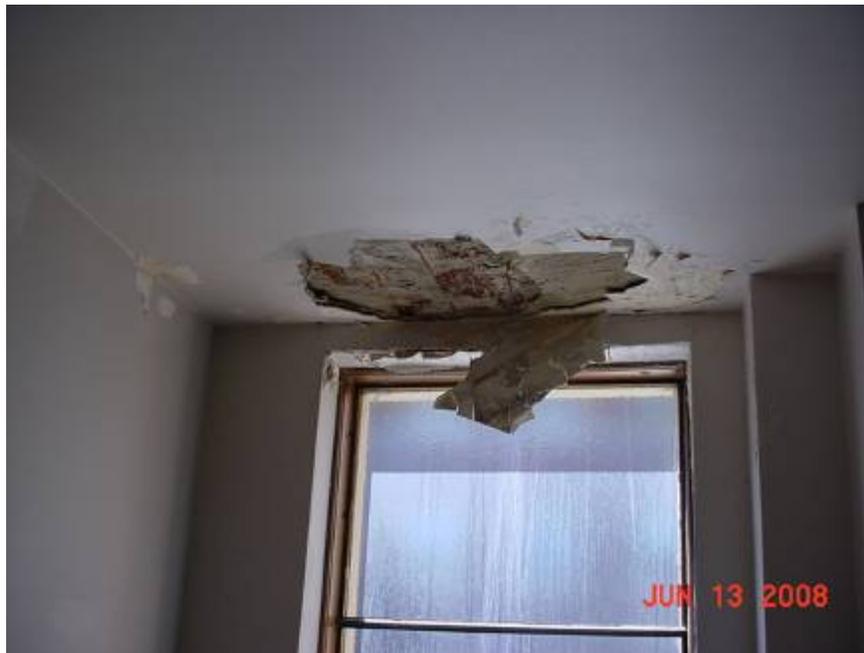
**Picture 8**

**Example of Damaged Plaster in Rear Area of Former Altar**

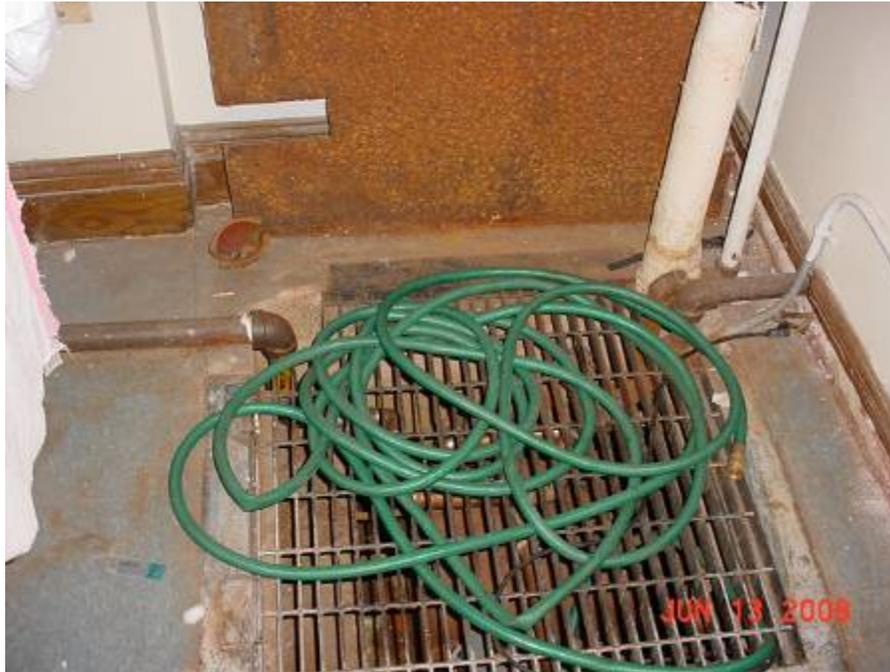
**Picture 9**

**Sump Pump in Nurse's Office Closet**

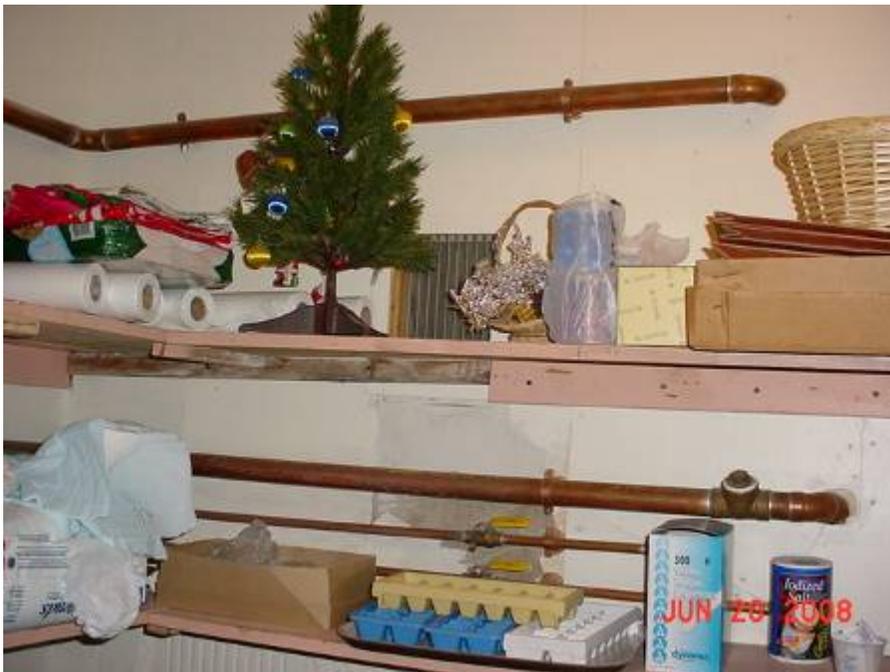
**Picture 10**

**Vent in Closet in Nurse's Office**

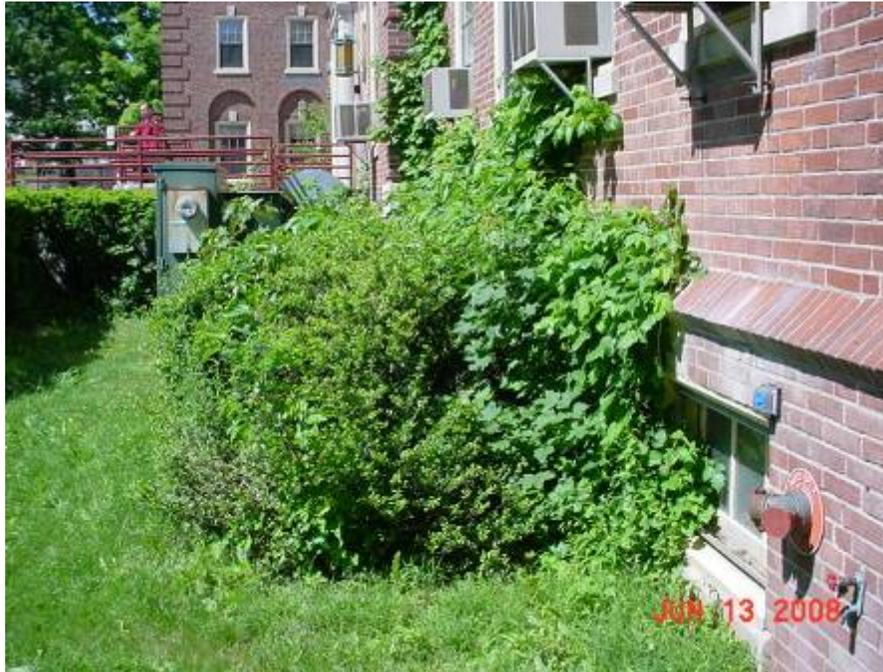
**Picture 11**

**Plants against Exterior Wall, West Building**

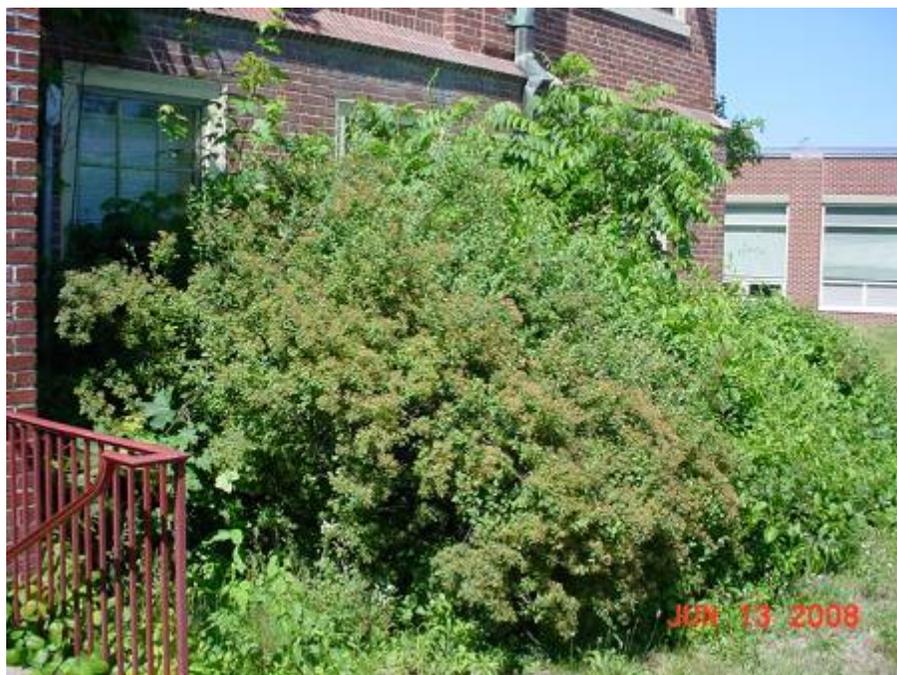
**Picture 12**

**Plants against Exterior Wall and Windows Systems, West Building**

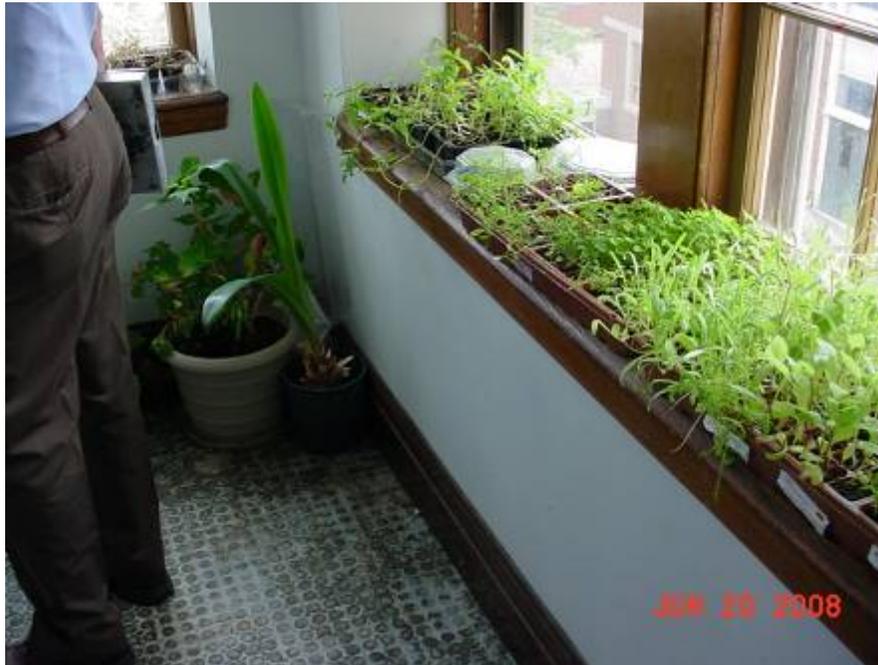
**Picture 13**

**Plants Located At the Top of a Stairwell in the West Building**

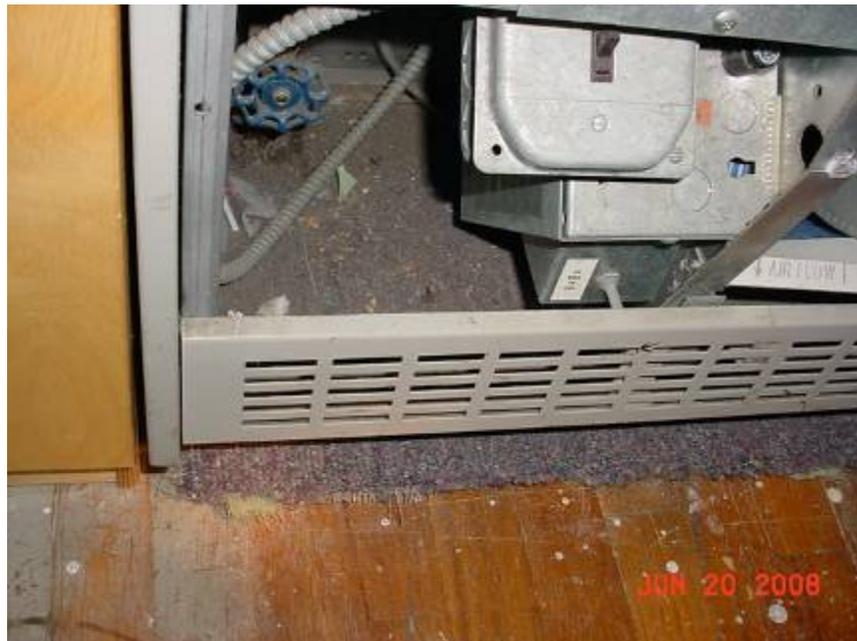
**Picture 14**

**Unit Ventilator Installed Over Wall To Wall Carpeting**

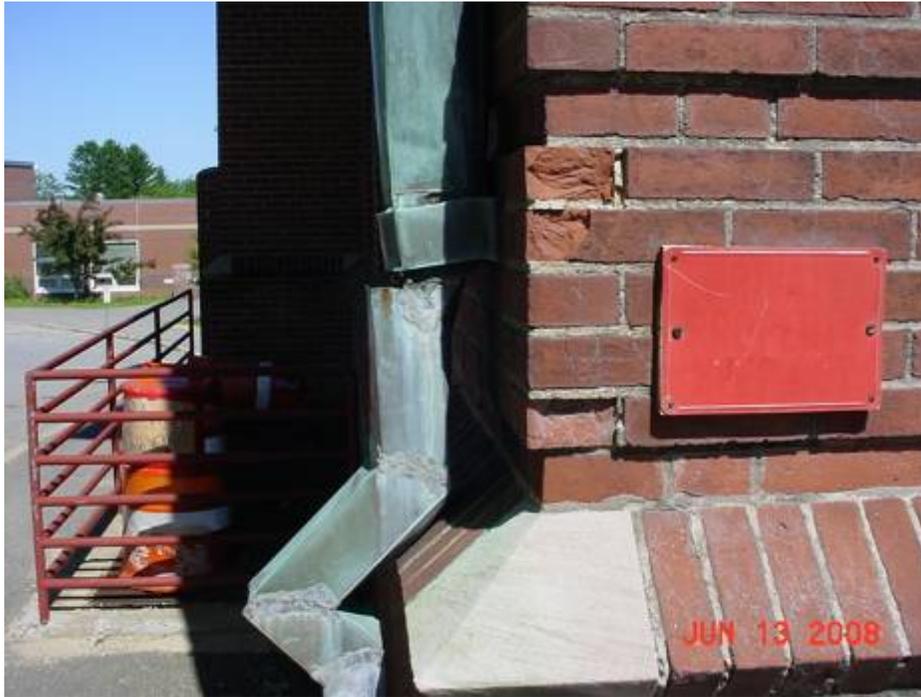
**Picture 15**

**Hole in Downspout**

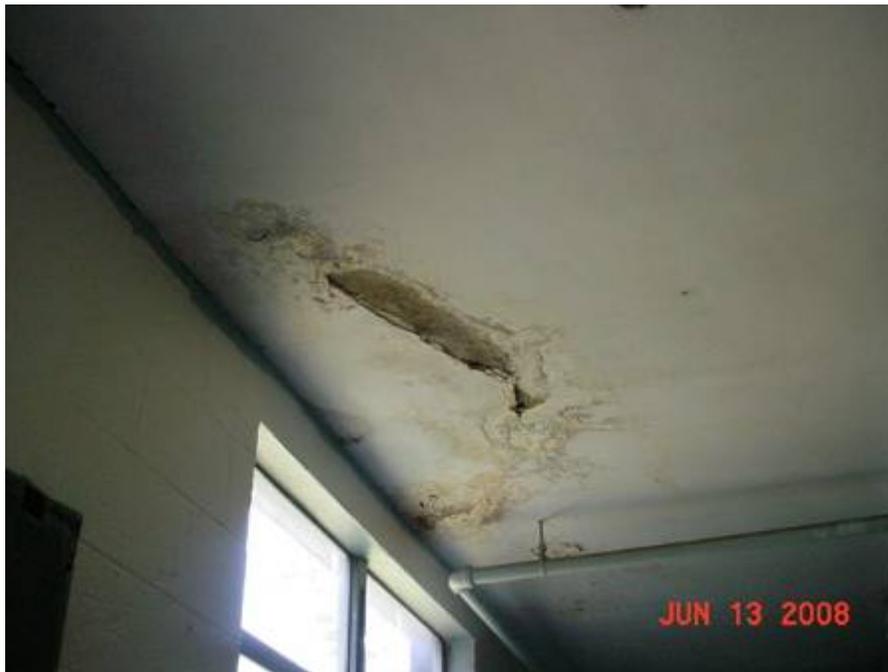
**Picture 16**

**Example of Water-Damage on Ceiling of the Copier Room**

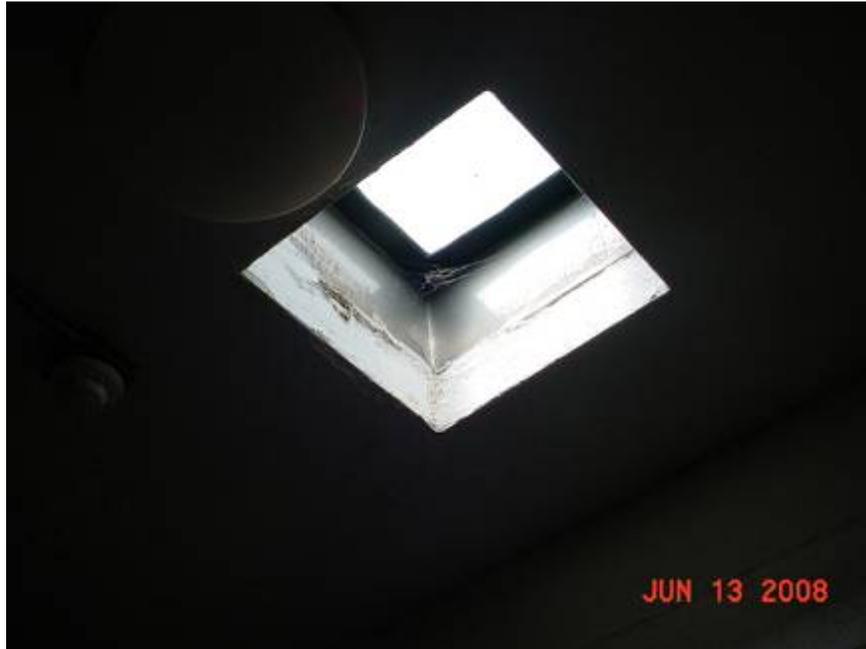
**Picture 17**

**Water-Damage Around Skylight Outside Of Copier Room**

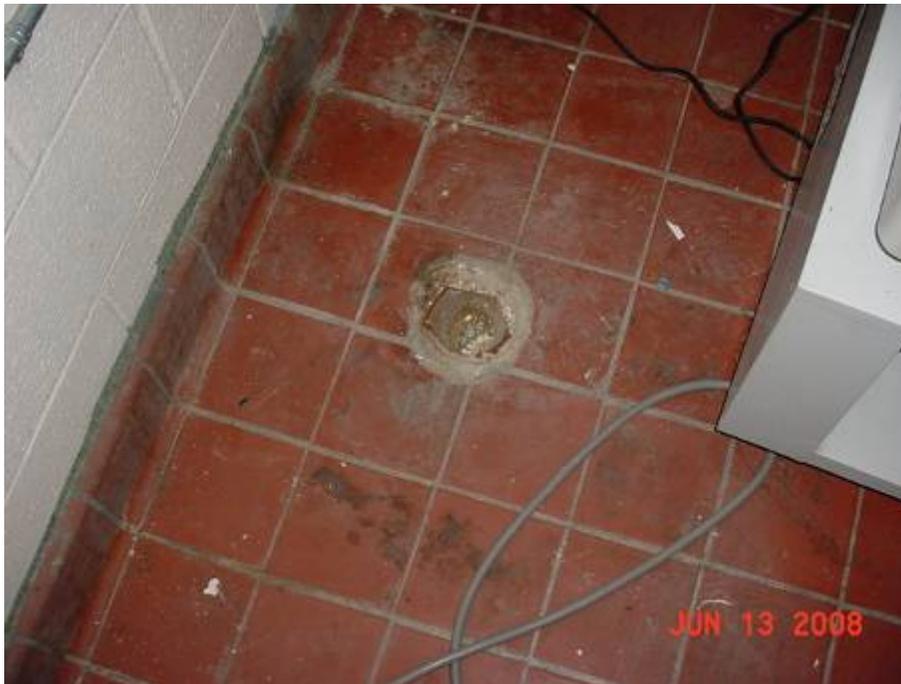
**Picture 18**

**Capped Drain in Copier Room**

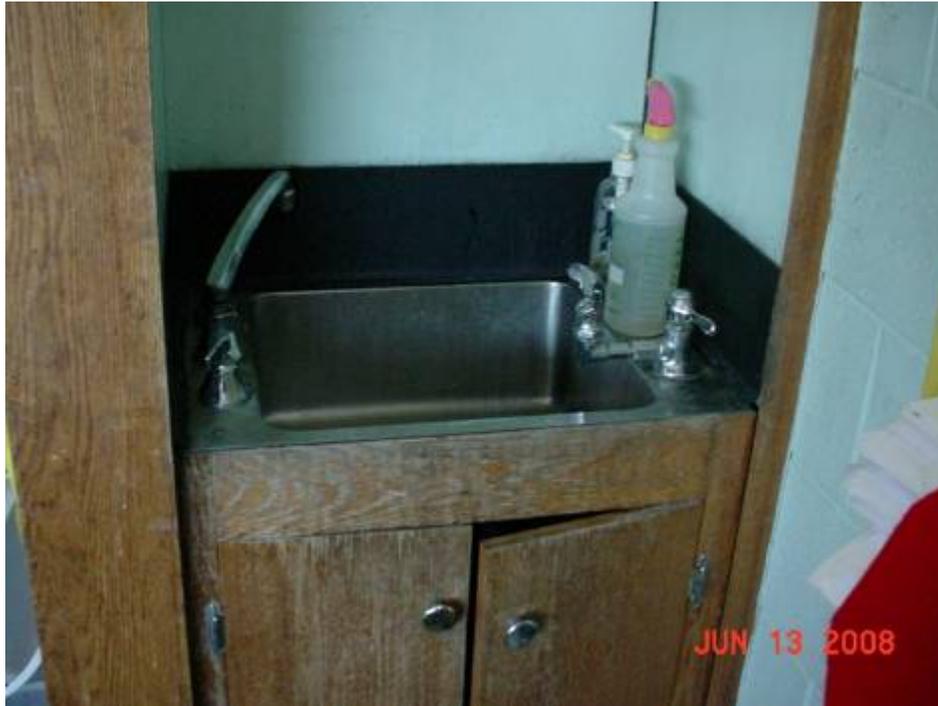
**Picture 19**

**Example of Water-Damaged Sink Cabinet**

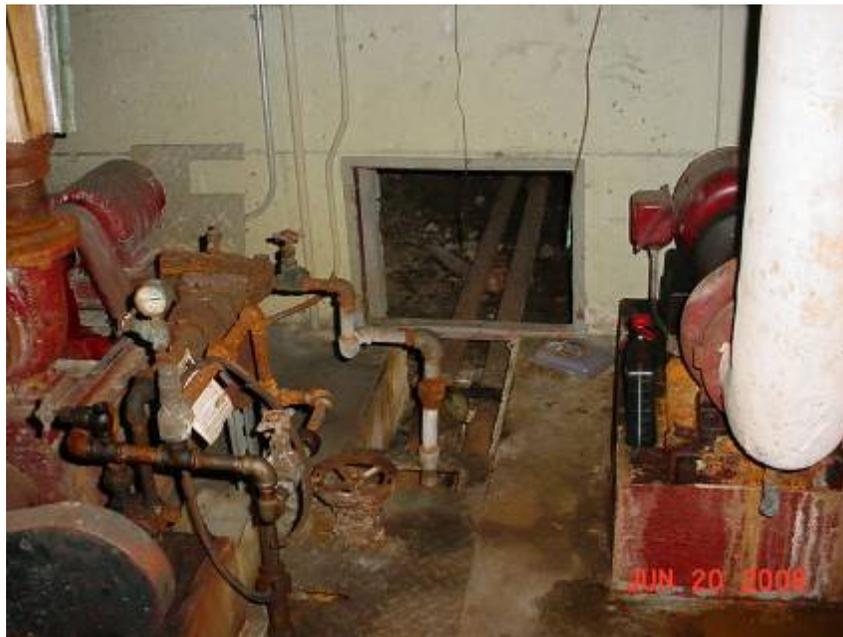
**Picture 20**

**Entrance to Crawlspace beneath the North Building in the Boiler Room**

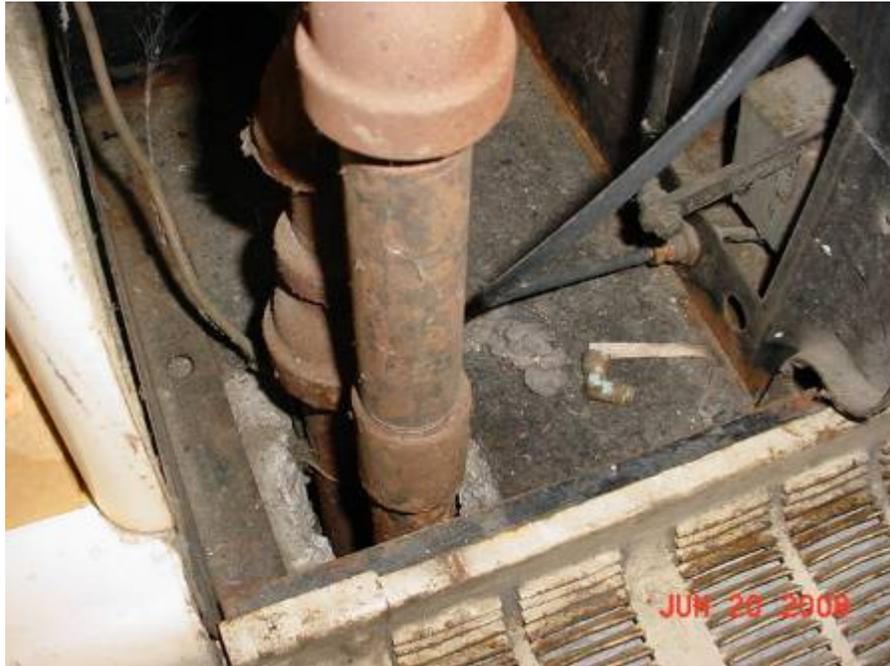
**Picture 21**

**Hole in the Floor Around Heating Pipe Inside Of Unit Ventilator**

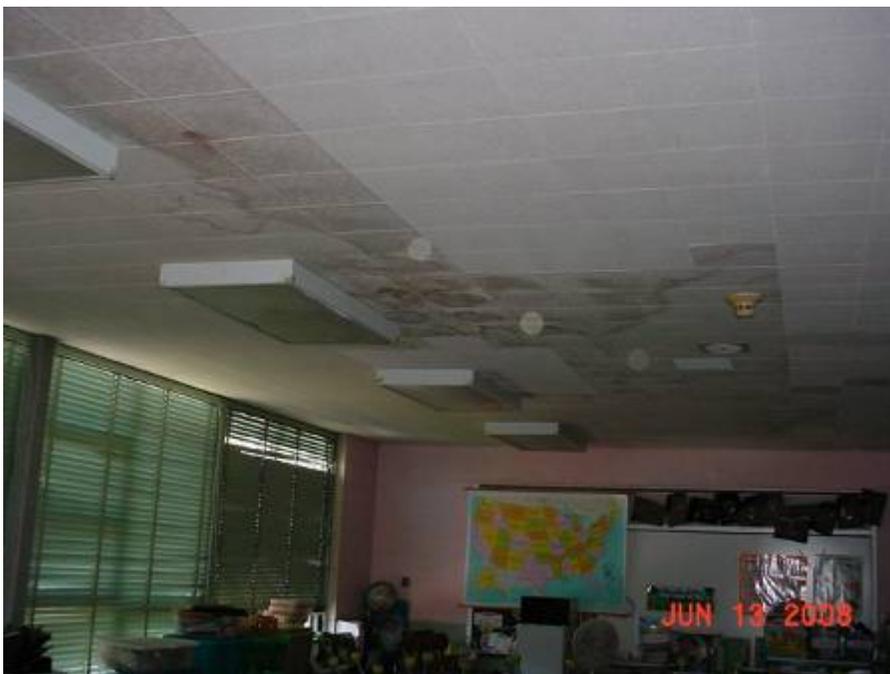
**Picture 22**

**Water Damaged Ceilings in the Top Floor of the South Building**

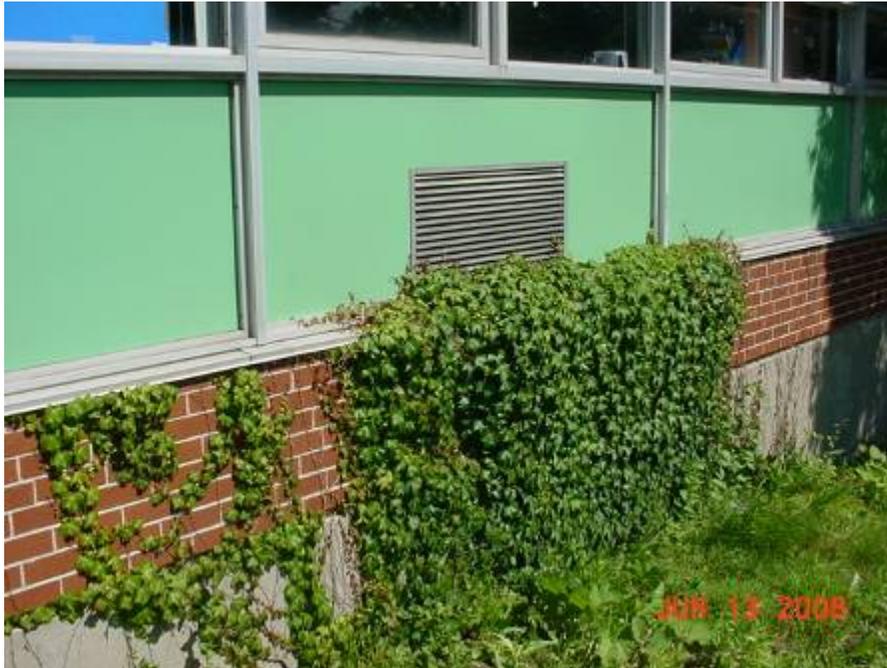
**Picture 23A**

**Plants Obstructing Unit Ventilator Fresh Air Intake**

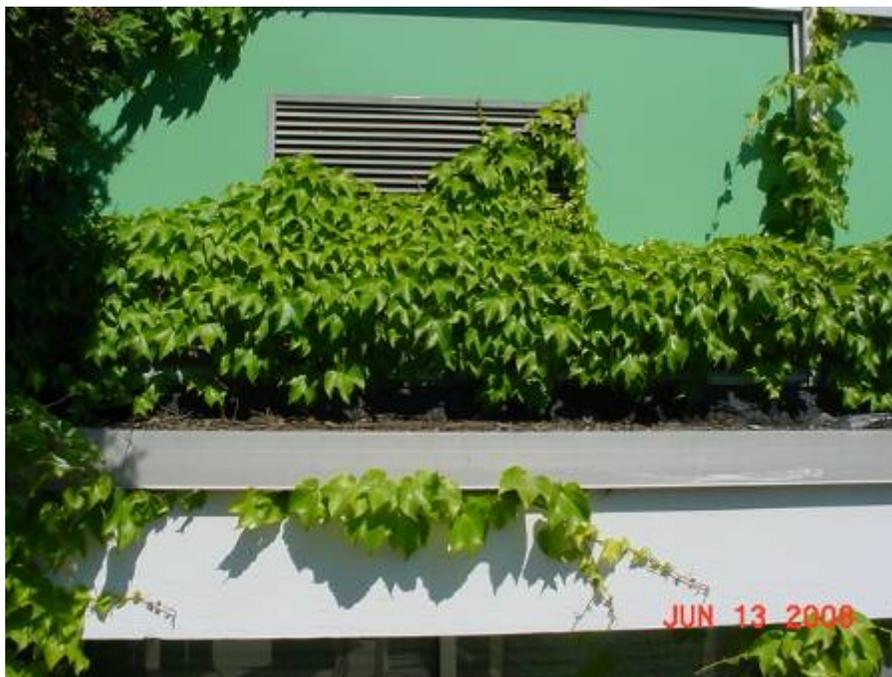
**Picture 23B**

**Plants Obstructing Unit Ventilator Fresh Air Intake**

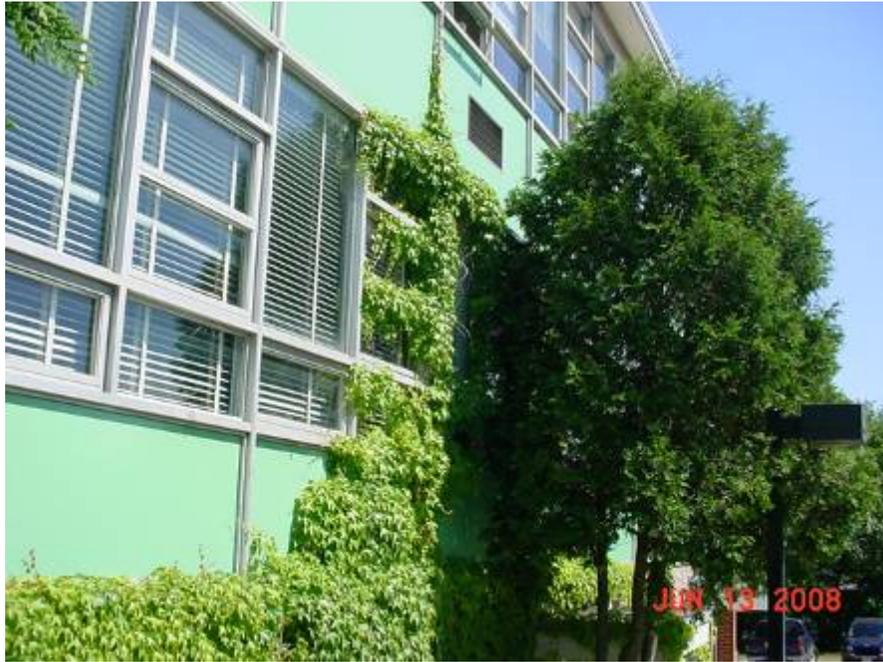
**Picture 24**

**Ivy Growth of the Exterior Wall of the South Building**

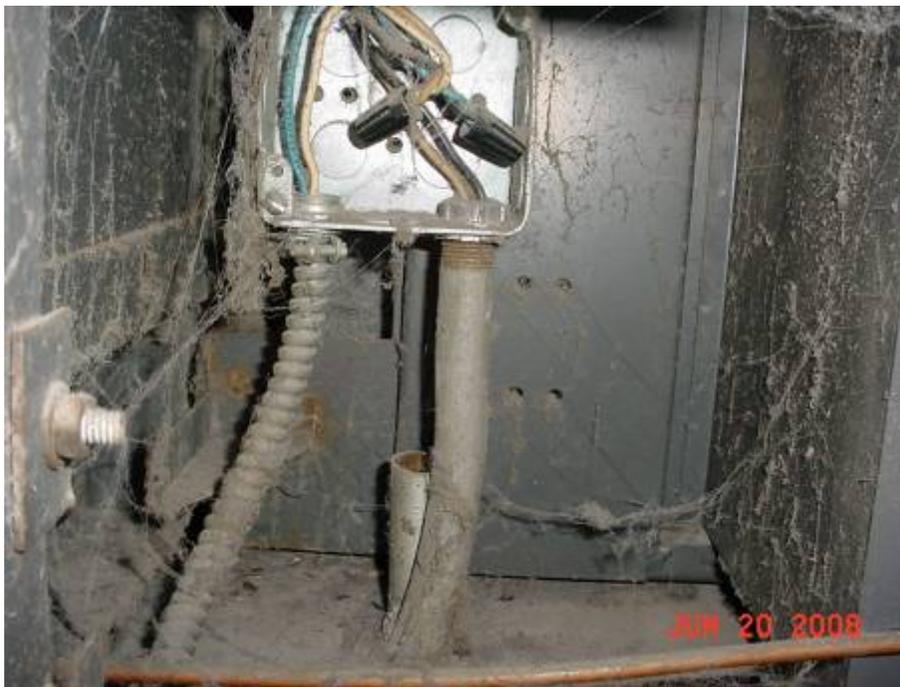
**Picture 25**

**Open Electrical Conduit in Unit Ventilator**

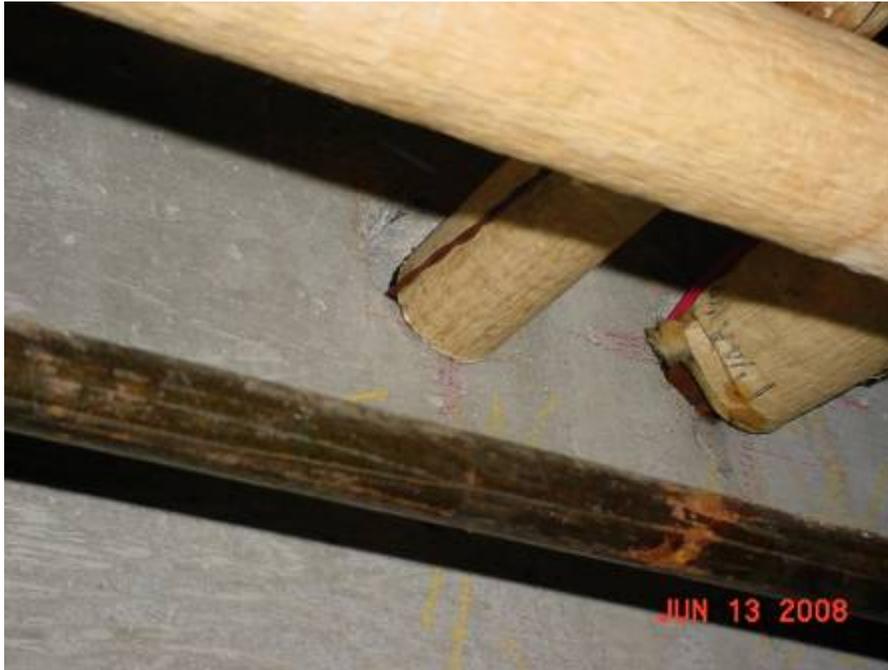
**Picture 26**

**Space in Wall of Room 25 and Crawlspace**

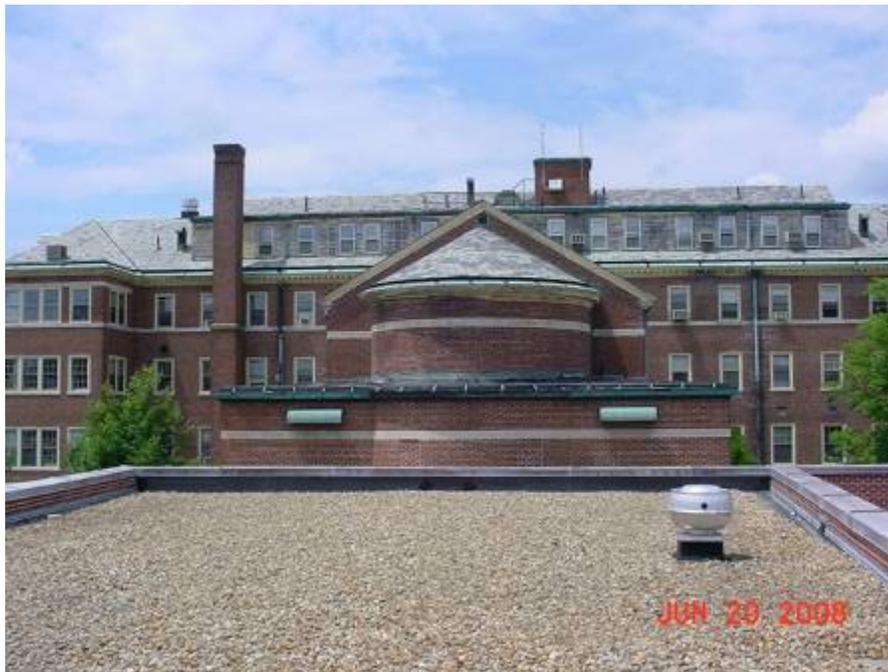
**Picture 27**

**Parapet That Forms the Library Roof**

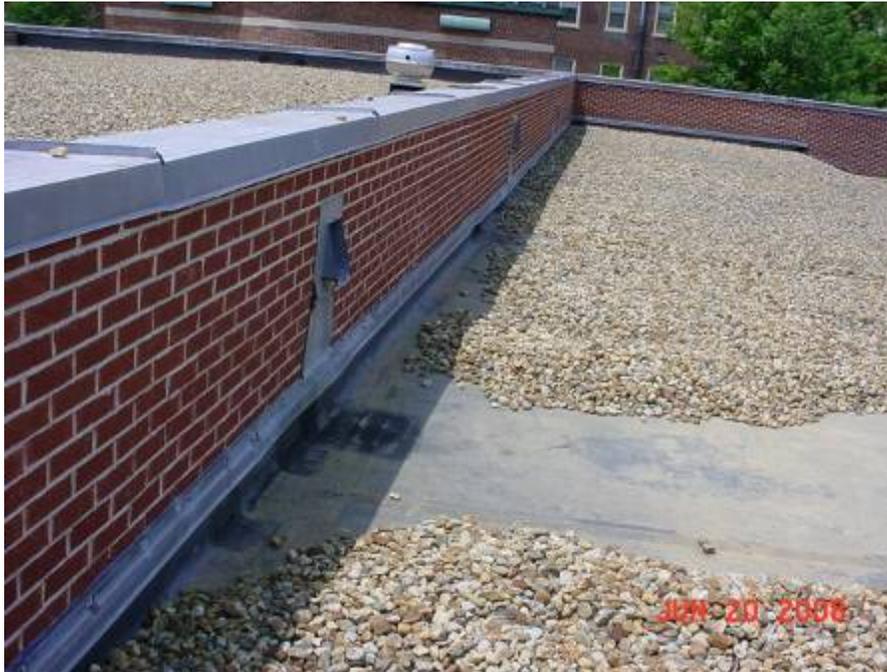
**Picture 28**

**North Parapet Wall That Forms the Library Roof with Three Scuppers**

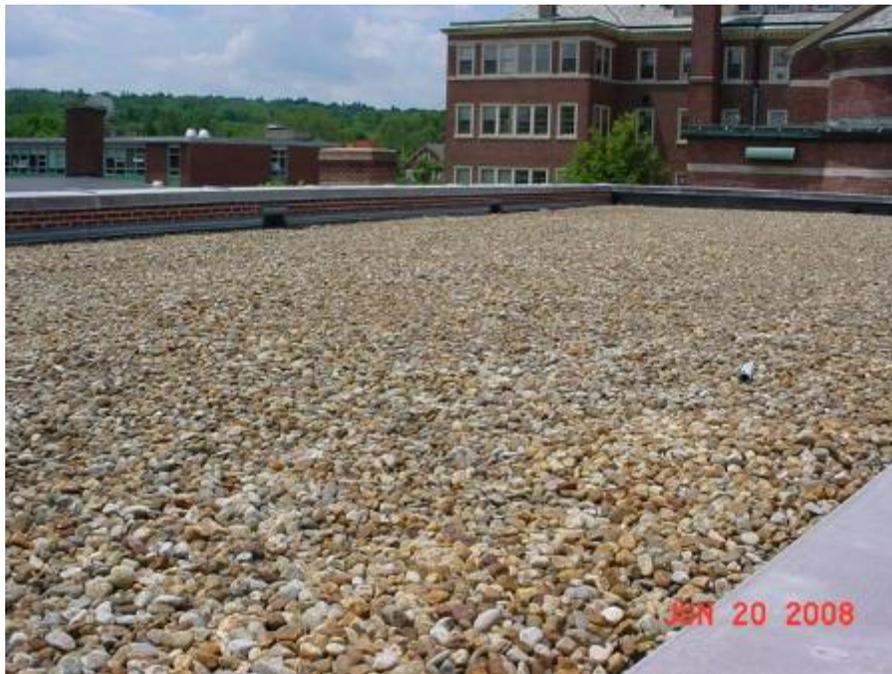
**Picture 29**

**South Parapet Wall That Forms the Library Roof with Two Scuppers**

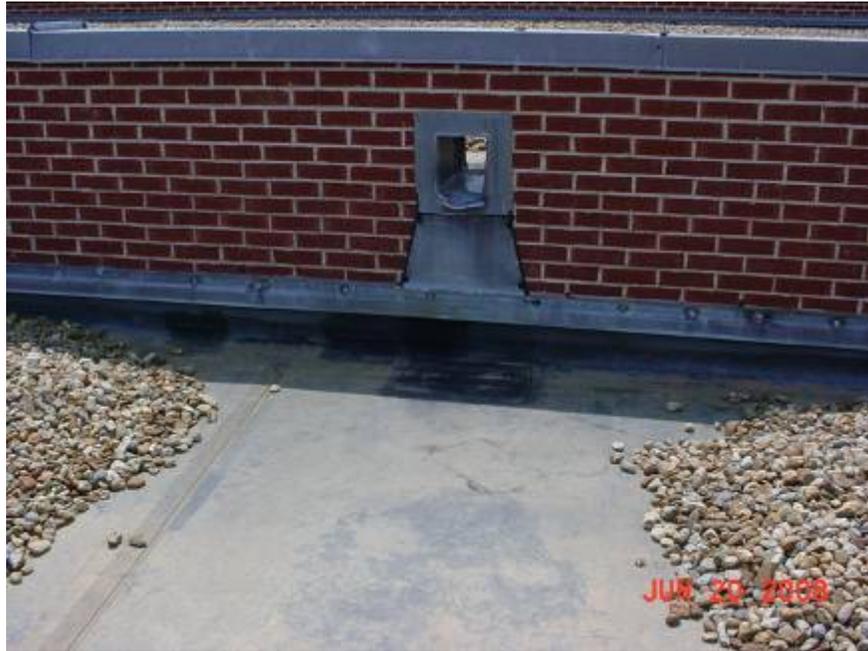
**Picture 30**

**The Parapet Scupper That Empties Water onto the Lower Roof above Room 115, Note Patching In Roof Membrane**

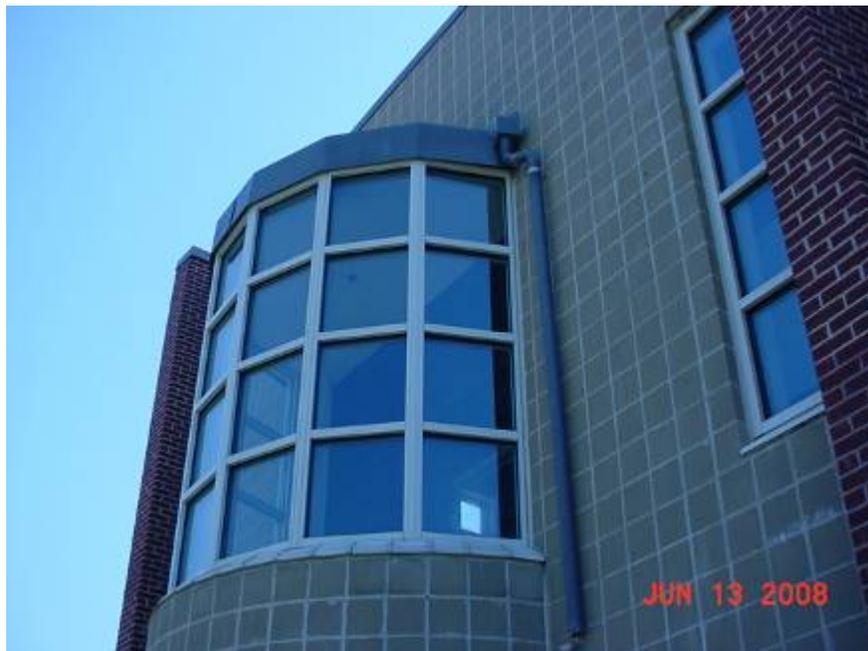
**Picture 31**

**Library Balcony, View from Ground Level**

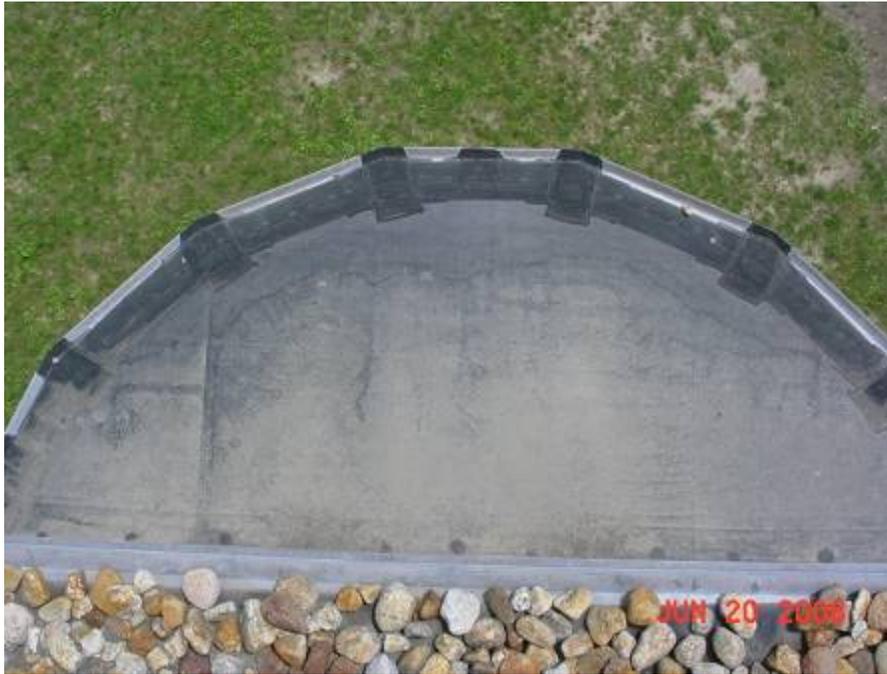
**Picture 32**

**Roof Of The Library Balcony, Note Staining Pattern On The Roof Membrane Indicating The Water Is Being Directed Toward The Building Exterior Wall**

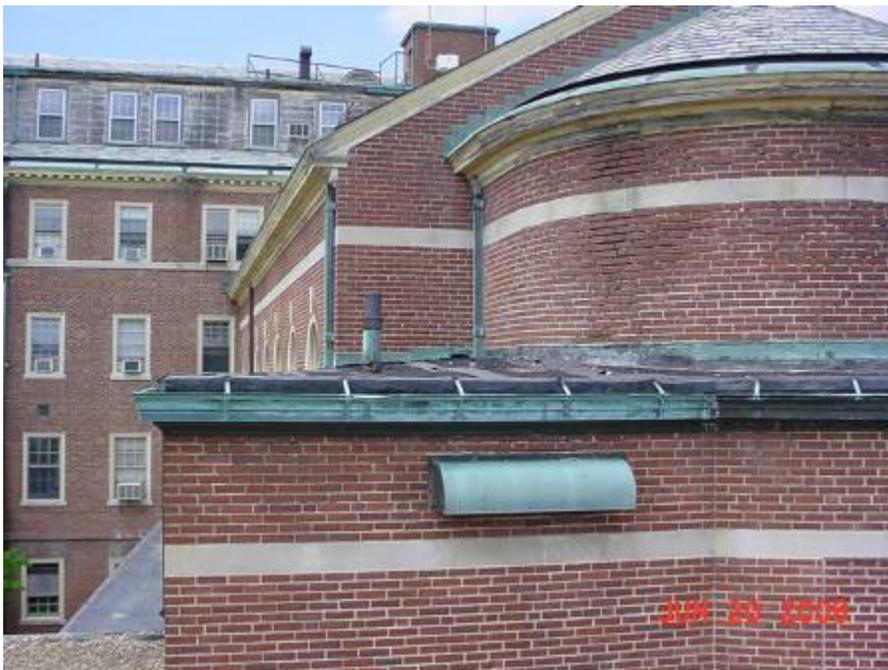
**Pictures 33**

**Example of Copper Flashing On the West Building Roof**

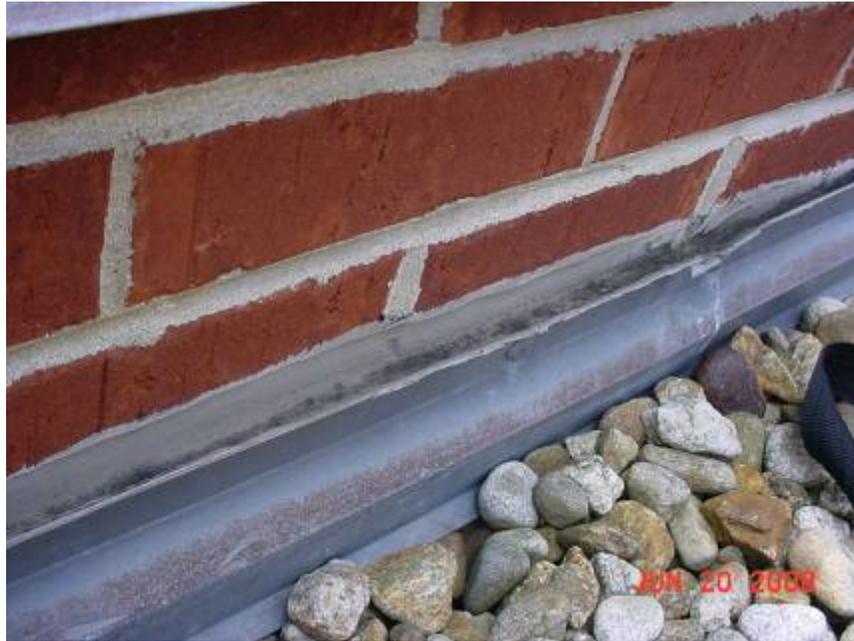
**Picture 34**

**Roof Membrane On The East Building Attached To The Next Year Wall Of The North Building By Mechanical Fasteners, Note The Sealant Compound Installed Between The Seem Of The Metal Fasteners And Exterior Brick Wall**

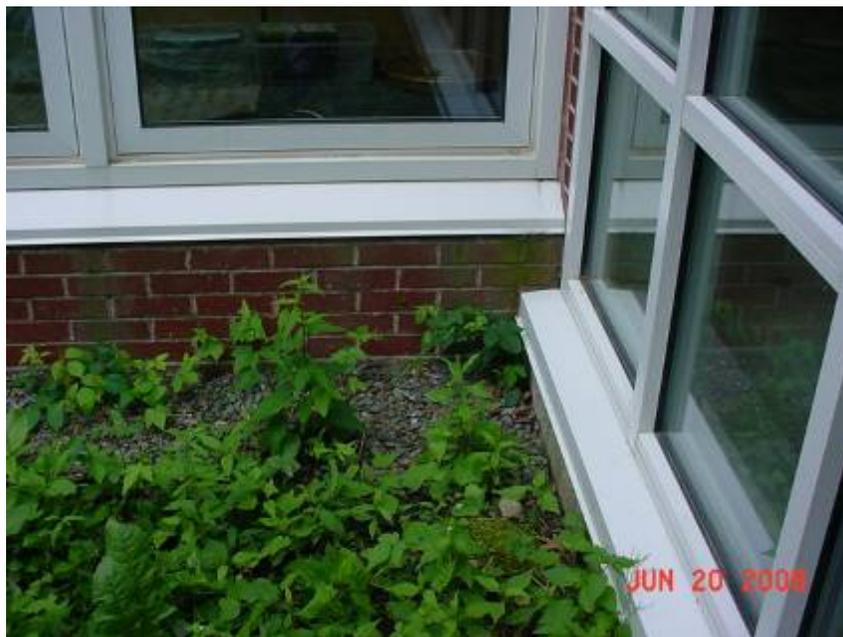
**Picture 35**

**Exterior Brick Wall of the East Building, West Facing Exterior Wall**

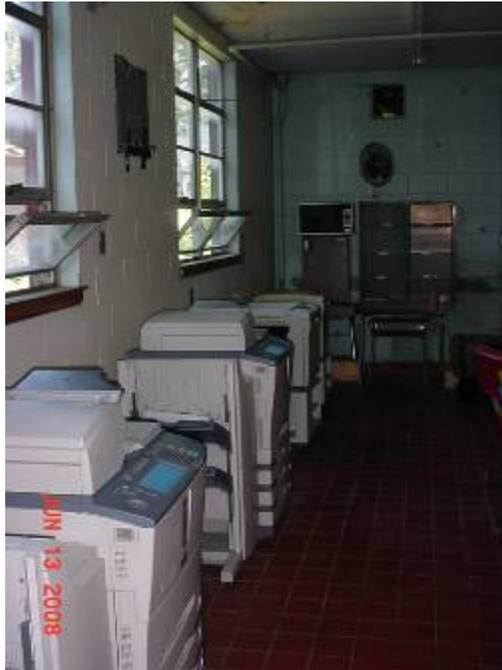
**Picture 36**

**Photocopiers in the Copier Room**

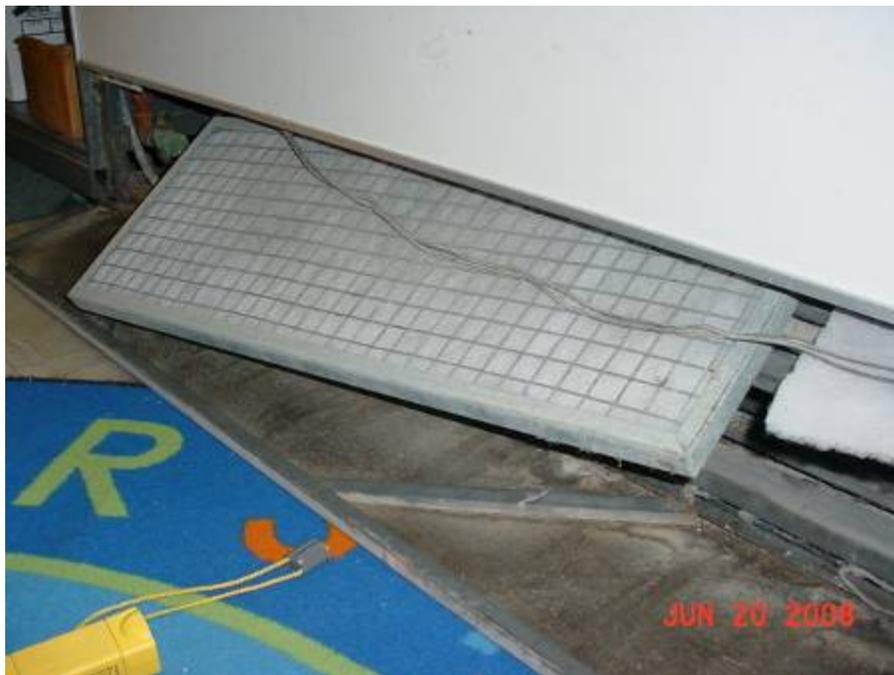
**Picture 37**

**Filter Media in Metal Frame Installed Inside Unit Ventilators**

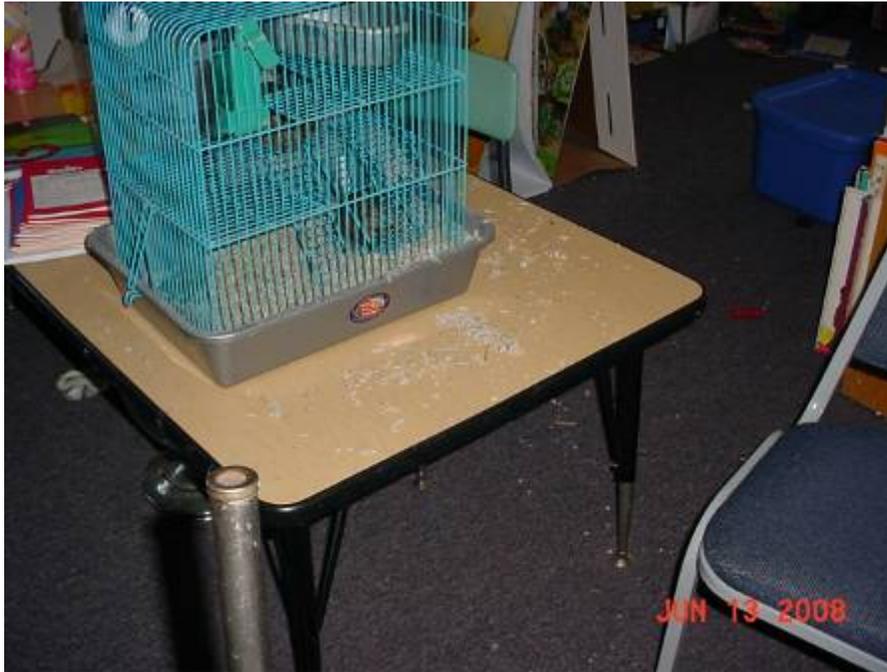
**Picture 38**

**Pet Bedding on Table and Wall To Wall Carpeting**
