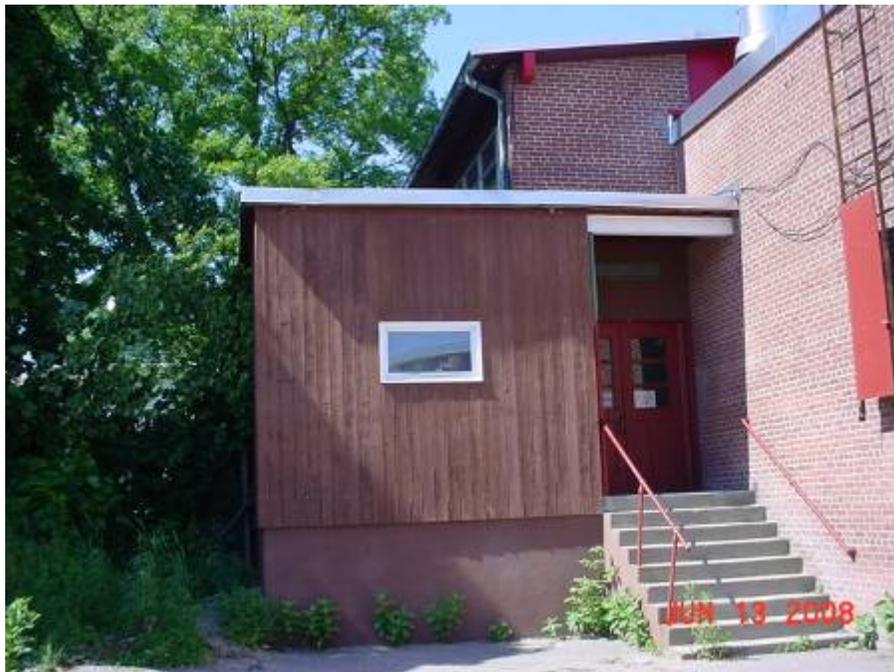
**Picture 39**

**Structure That Forms the Copier Room/Gymnasium Equipment Storage Room**

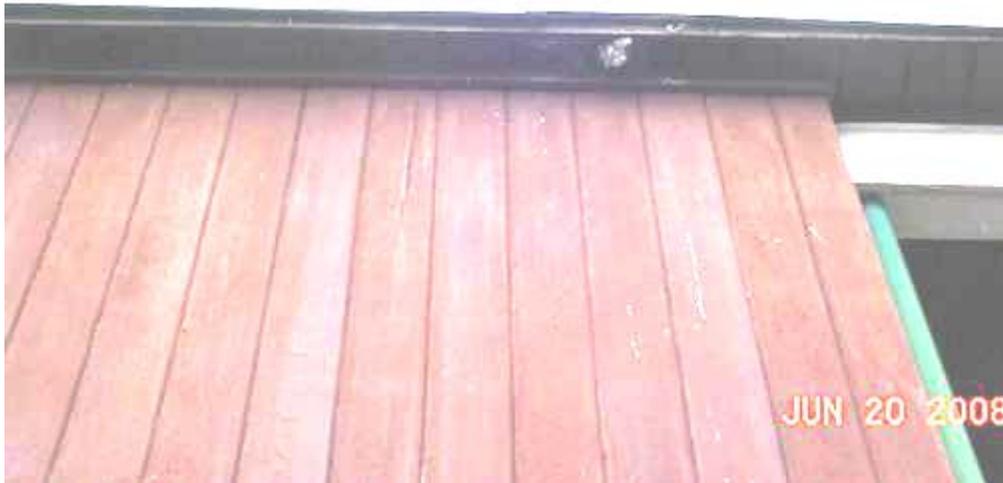
**Picture 40**

**Damaged Soffit of Copier Room/Gymnasium Equipment Storage Room where Birds were Observed Roosting**
