**INDOOR AIR QUALITY ASSESSMENT
MOLD INVESTIGATION**

**Betsey B. Winslow Elementary School
561 Allen Street
New Bedford, MA 02740**

Prepared by:
Massachusetts Department of Public Health
Bureau of Environmental Health
Indoor Air Quality Program
October 2008

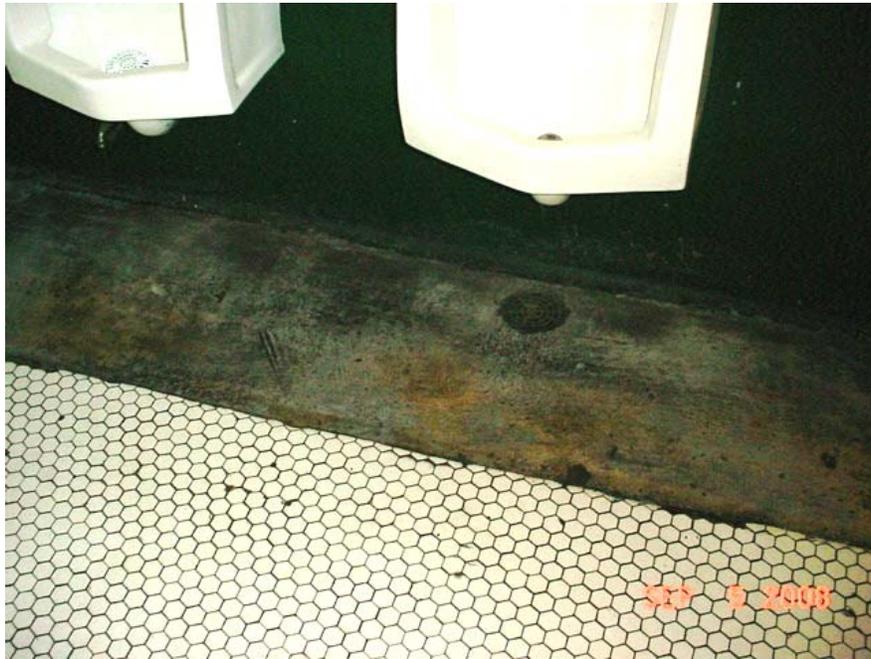
Picture 1

As discussed previously, a rain event caused toilet backflow in the basement level restrooms. The floor of the restroom consists of ceramic tile and cement (Pictures 1 and 2), which can be readily cleaned and disinfected. No porous materials (i.e. carpeting, gypsum wallboard) or other school materials (i.e. books) were moistened as a result of this event.

Floor and Wall of Basement Restroom

1. In order to prevent future sewage back-up in the basement restrooms, consideration should be given to installing a backflow preventer on the school sewage line.
2. Consult “Mold Remediation in Schools and Commercial Buildings” published by the US Environmental Protection Agency (US EPA, 2001) for more information on mold. This document can be downloaded from the US EPA website at:

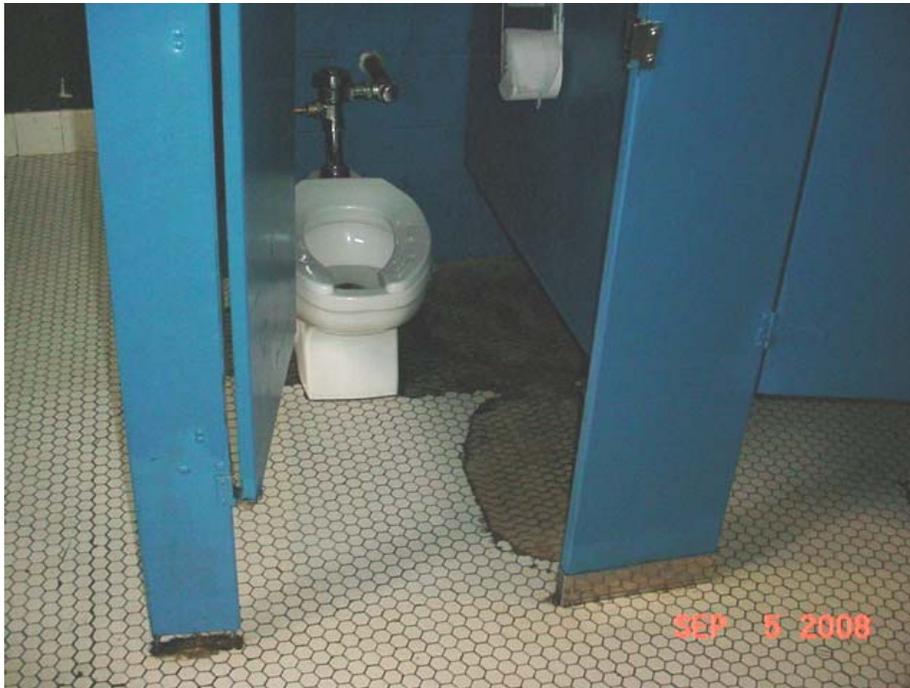
Picture 2

Floor and Wall of Basement Restroom
