# **INDOOR AIR QUALITY ASSESSMENT**

**Massachusetts Rehabilitation Commission  
40 Industrial Park Road  
Plymouth, Massachusetts**

Prepared by:  
Massachusetts Department of Public Health  
Bureau of Environmental Health  
Indoor Air Quality Program  
May 2008

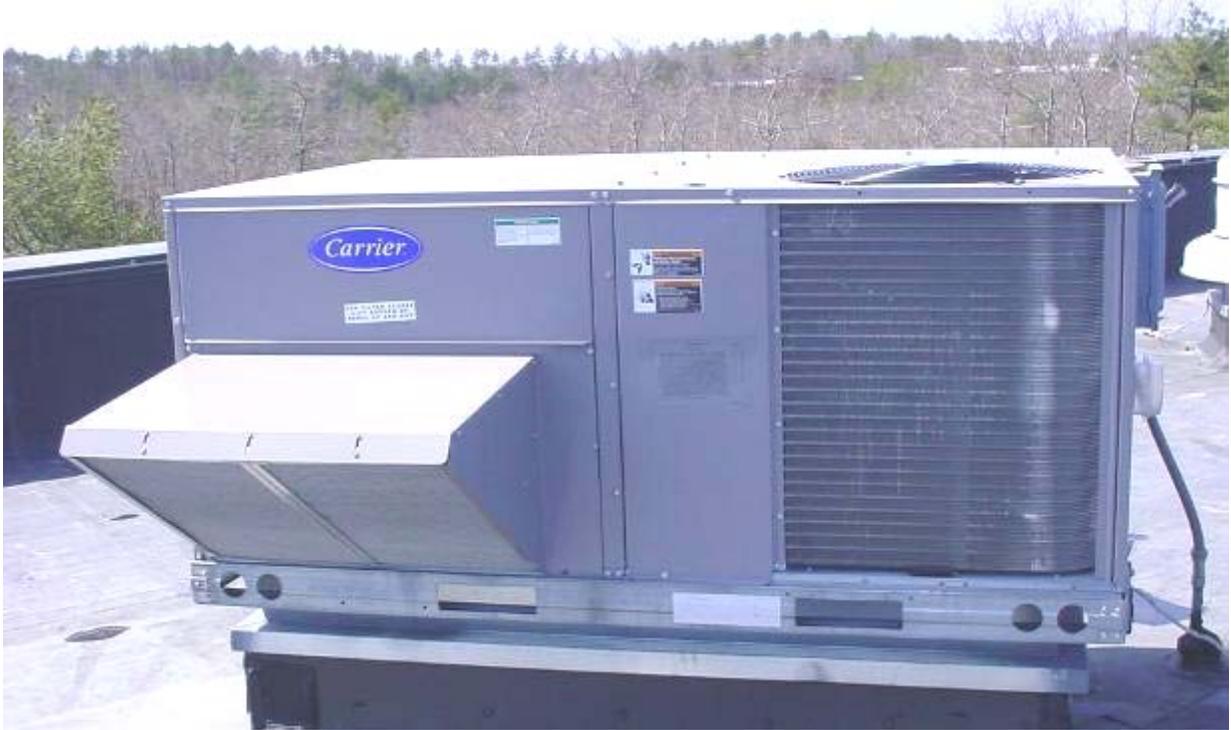
**Picture 1**

It can be seen from Table 1 that carbon dioxide levels were below 800 ppm (parts per million) in all areas surveyed, indicating adequate air exchange at the time of the assessment. The HVAC system consists of a rooftop air handling unit (AHU) (Picture 1), which draws in outside air through an air intake and distributes it to occupied areas via ceiling-mounted air diffusers (Pictures 2 through 4). Return air is ducted back to rooftop AHUs by ceiling-mounted grills (Picture 2). The HVAC system is maintained by a private HVAC engineering firm, who were on site the day of the assessment changing filters and performing preventative maintenance.

**Rooftop Air Handling Unit**

4. Operate the HVAC system continuously in the fan "on" mode during periods of occupancy to maximize air exchange.

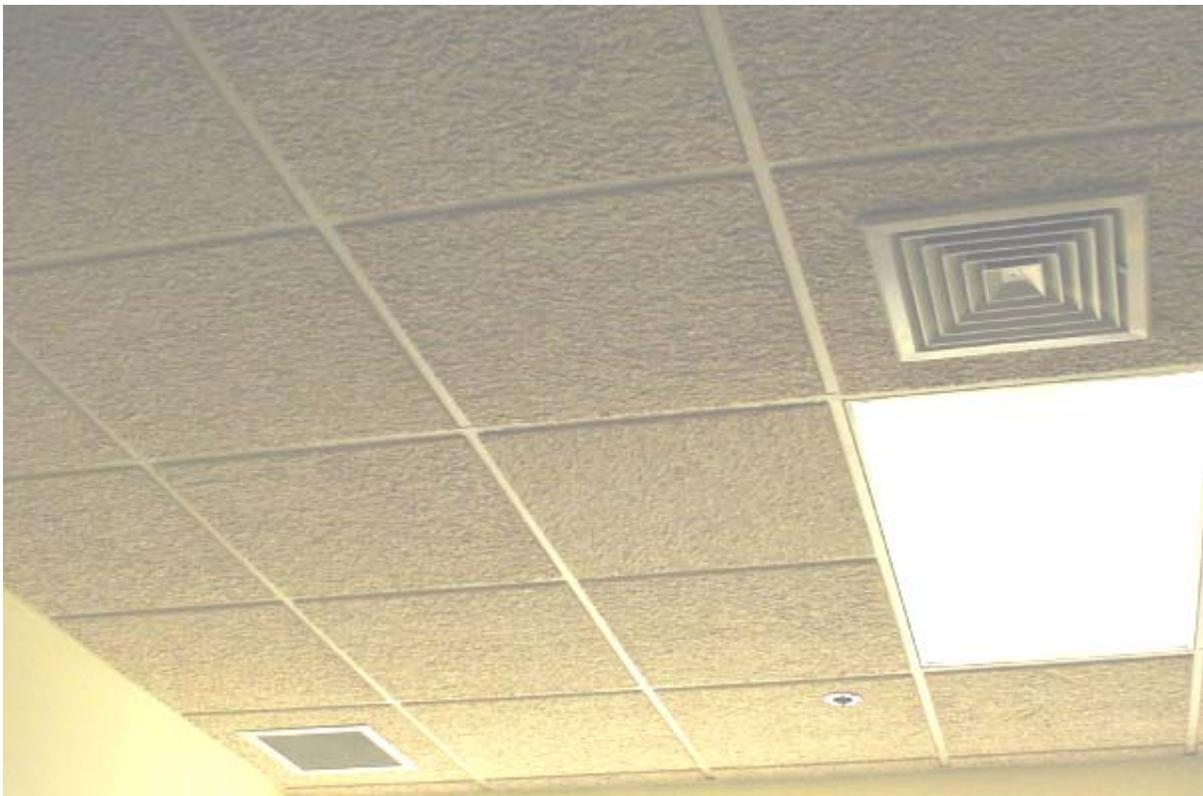
**Picture 2**

A number of supply diffusers, return vents and adjacent ceiling tiles were observed to have accumulated dust/debris (Pictures 2 through 4). Finally, missing/dislodged ceiling tiles were noted in the fax room and in the Bookkeeper's office, which can provide a pathway for accumulated dusts/debris to migrate into occupied areas. Dust can be irritating to eyes, nose and respiratory tract.

**Supply Diffuser (Top Right) and Return Vent (Bottom Left)**

11. Clean air diffusers, exhaust, return vents and adjacent ceiling tiles periodically of accumulated dust. If soiled ceiling tiles cannot be cleaned, replace.

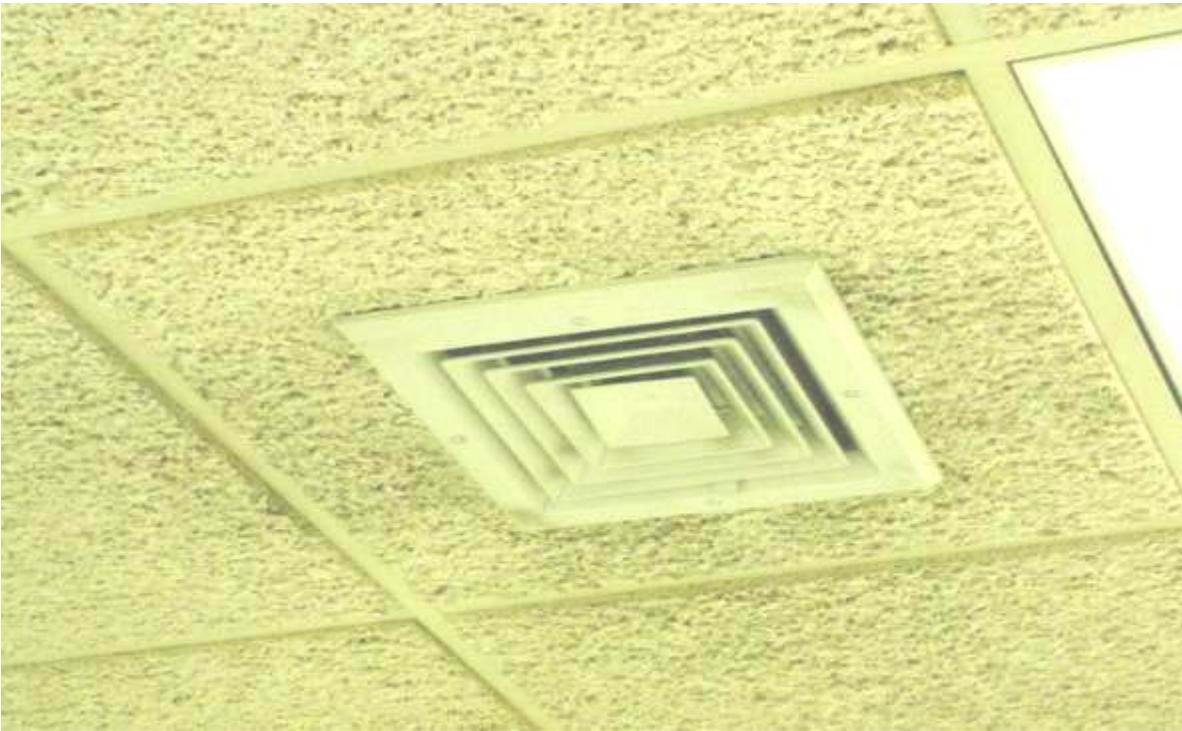
**Picture 3**

**Ceiling-Mounted Supply Diffuser, Note Dust/Debris Accumulation on Louvers and Adjacent Ceiling Tiles**

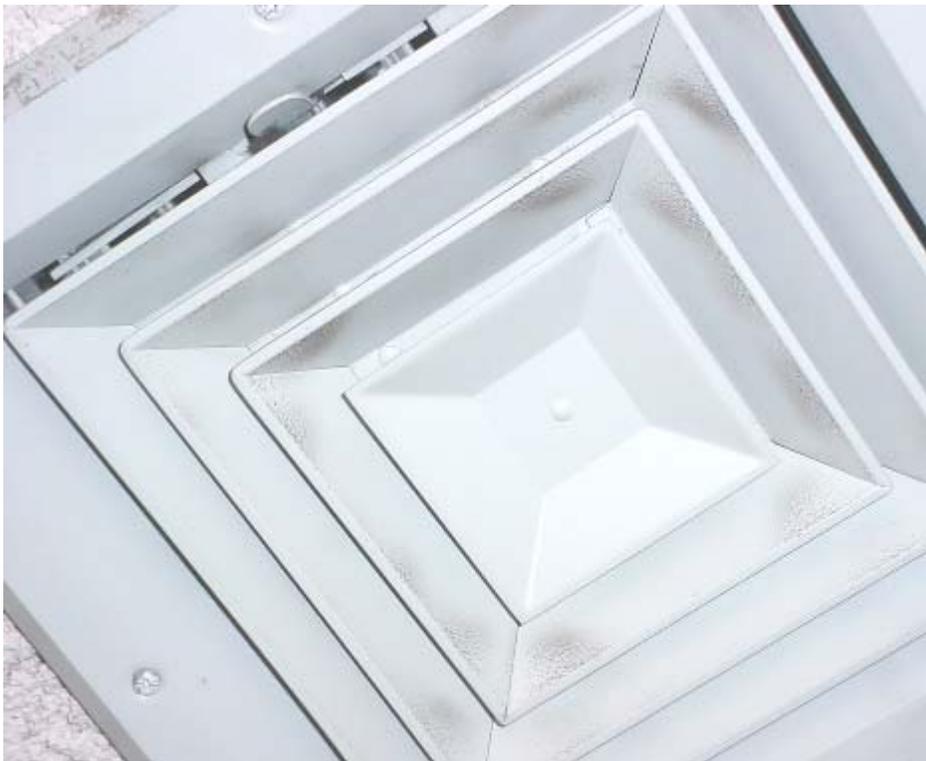
**Picture 4**

**Ceiling-Mounted Supply Diffuser, Note Dust/Debris Accumulation on Louvers**

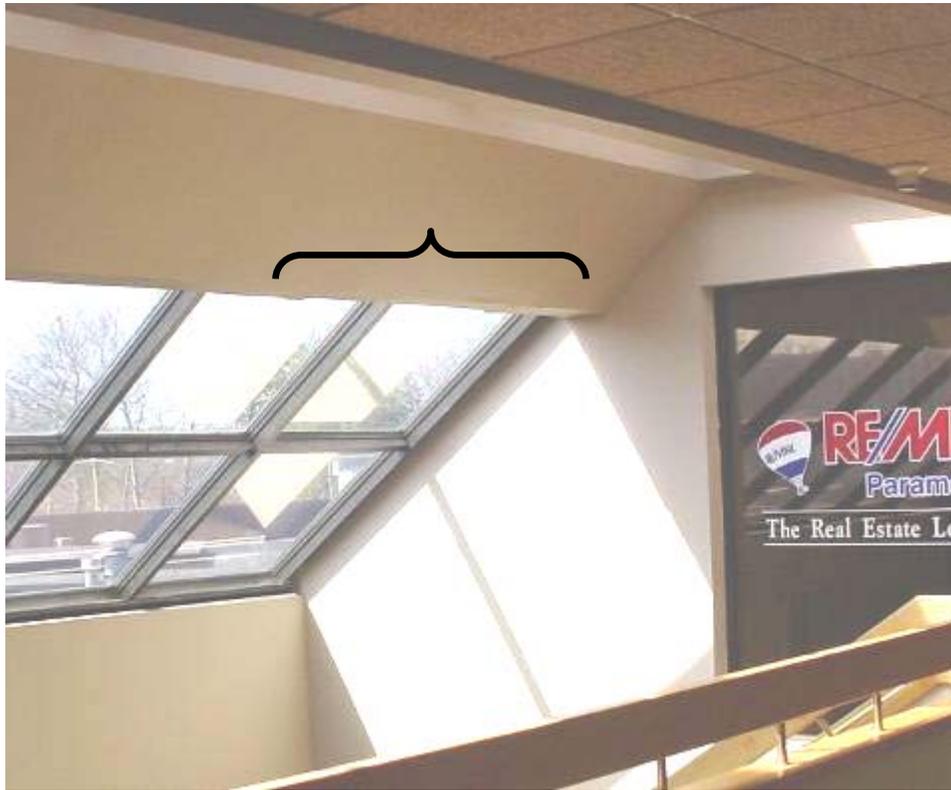
**Picture 5**

Several areas had evidence of water penetration in the form of water-damaged ceiling plaster below the skylight in the mezzanine (Pictures 5) and stained windows, walls and carpeting in the Area Director's and in the Head Clerk's office (Pictures 6 through 8). Occupants reported leakage in these areas during heavy, wind-driven rain. According to Jim Schulze, Facilities Manager, water penetration was reportedly occurring due to masonry water penetration (Pictures 9 through 11) and that plans were in the process to have exterior walls sealed to prevent further water penetration.

**Water Damaged Ceiling around Skylight**

2. Continue with plans to waterproof exterior brickwork. Examine all roof and window flashing for proper installation/integrity, make repairs as needed.

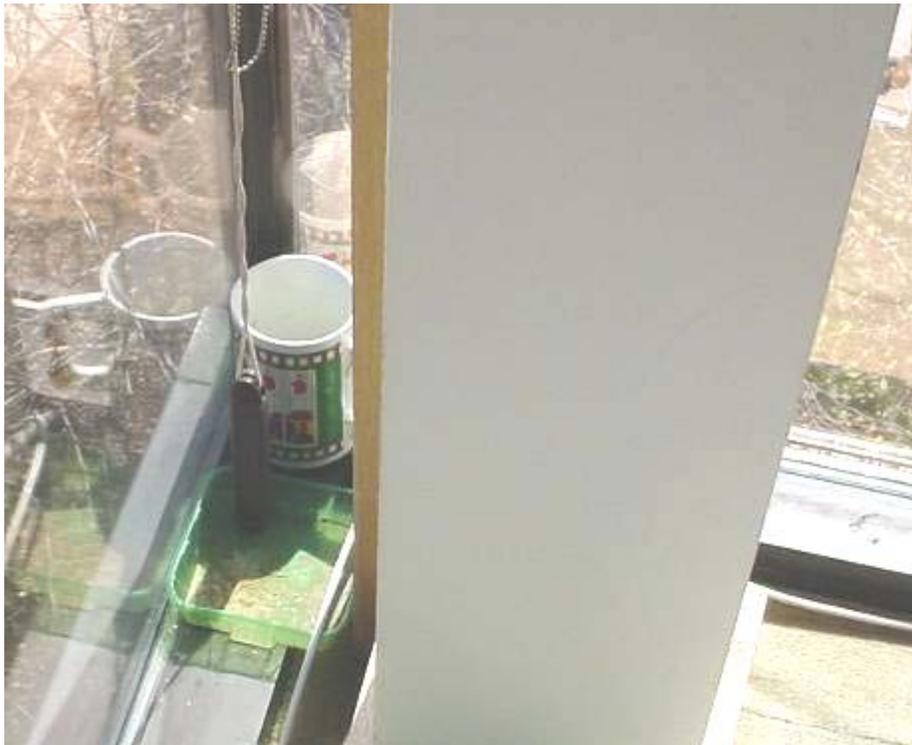
**Picture 6**

**Containers Stationed on Floor behind Column (Left) to Catch Leaks in Area Director's Office**

3. Until exterior measures are taken to prevent further water penetration, consider removing carpeting from the edge of exterior walls prone to leakage (~1-foot).

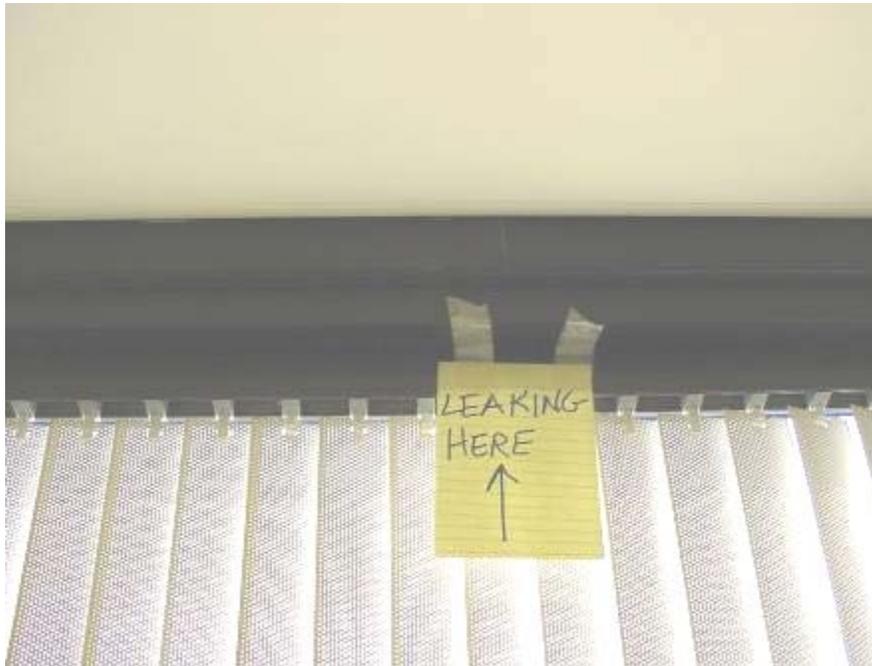
**Picture 7**

**Area of Reported Leaks along Window Frame/Ceiling in Head Clerk's Office,  
Sign Courtesy of Occupant**

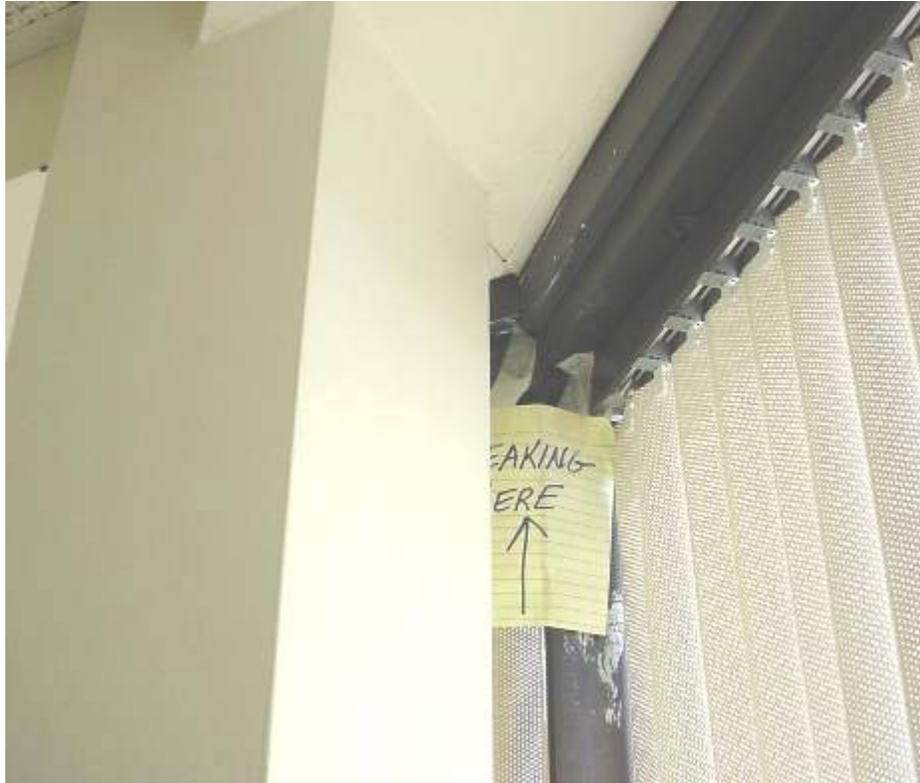
**Picture 8**

**Area of Reported Leaks along Window Frame/Ceiling in Head Clerk's Office,  
Sign Courtesy of Occupant**

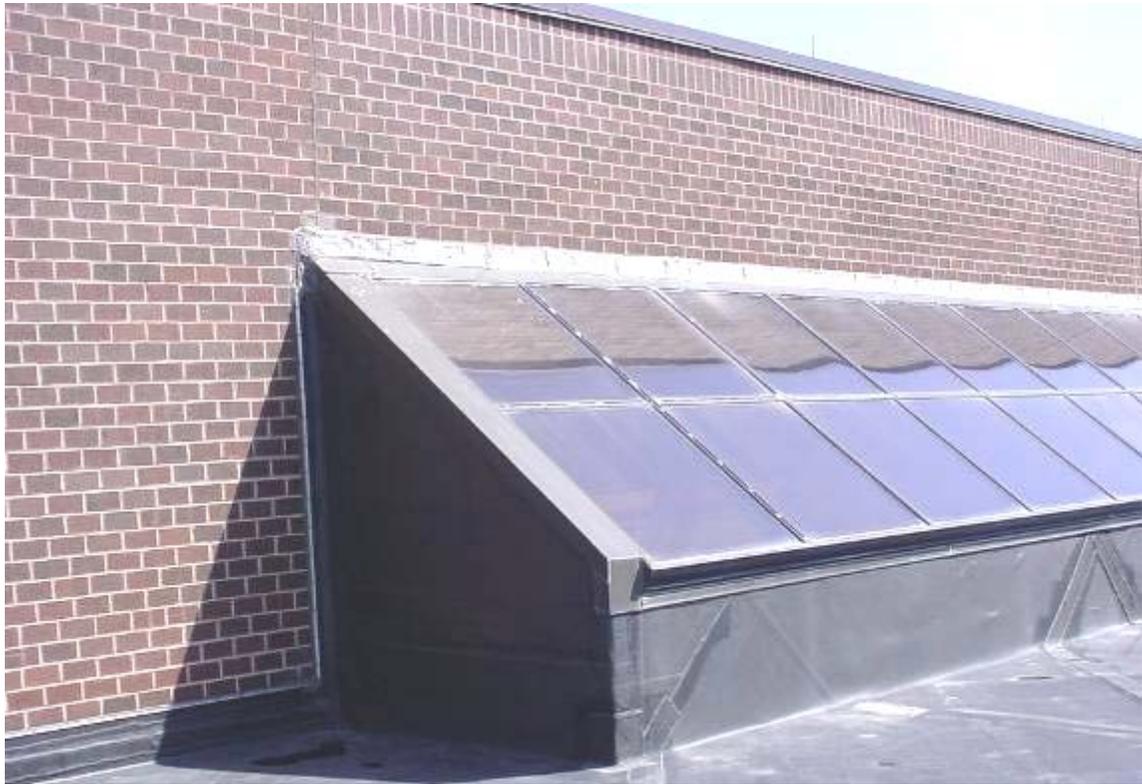
**Picture 9**

**Masonry Wall and Skylight above Mezzanine Leak**

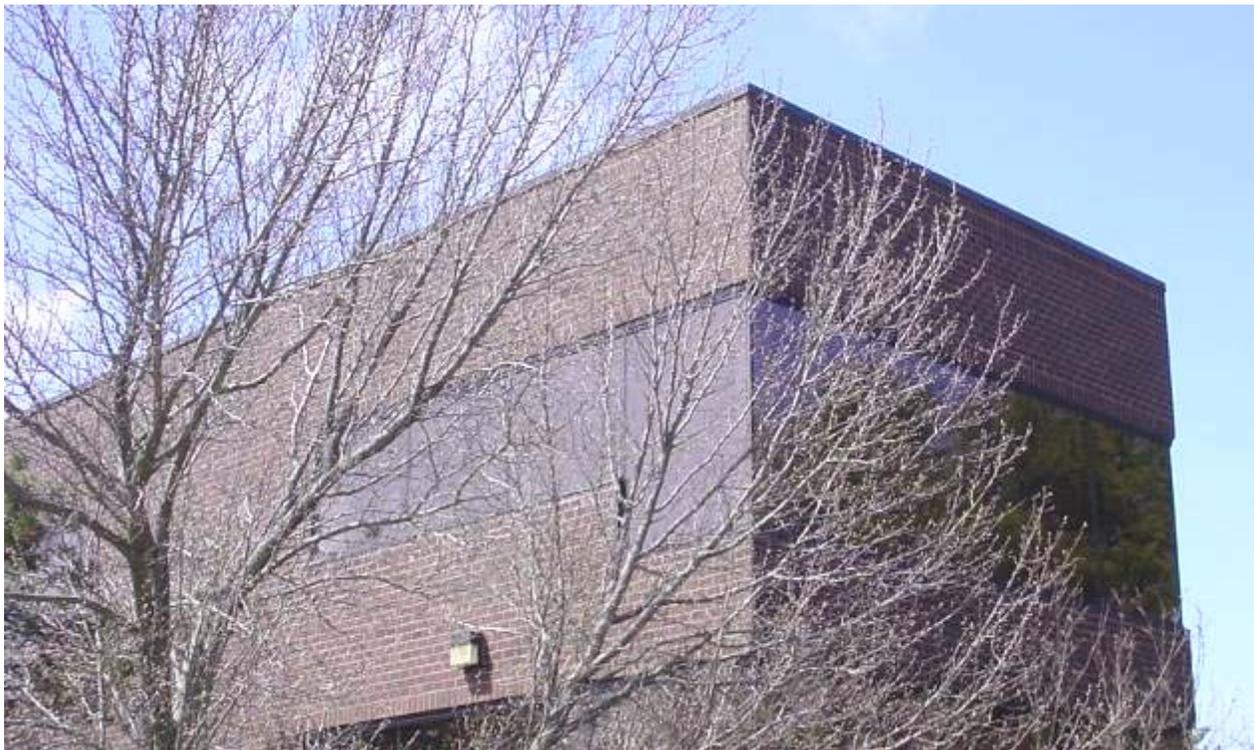
**Picture 10**

**Northwest Corner of Leakage/Area Director's Office**

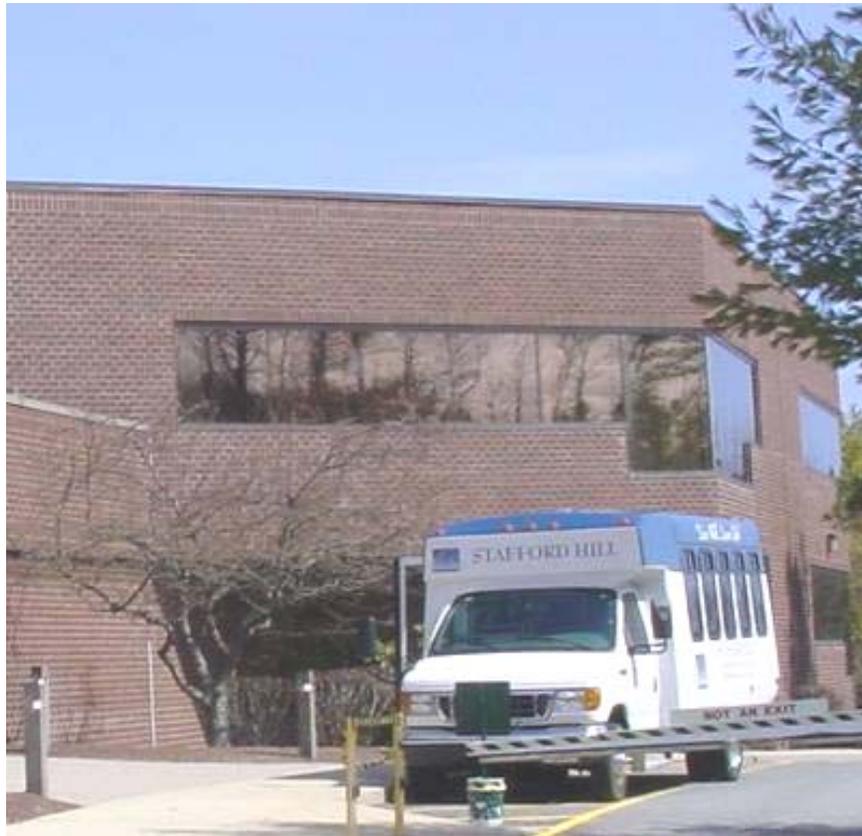
**Picture 11**

**Northern Exterior Wall Area of Leakage, Approximate Area of Head Clerk's Office**

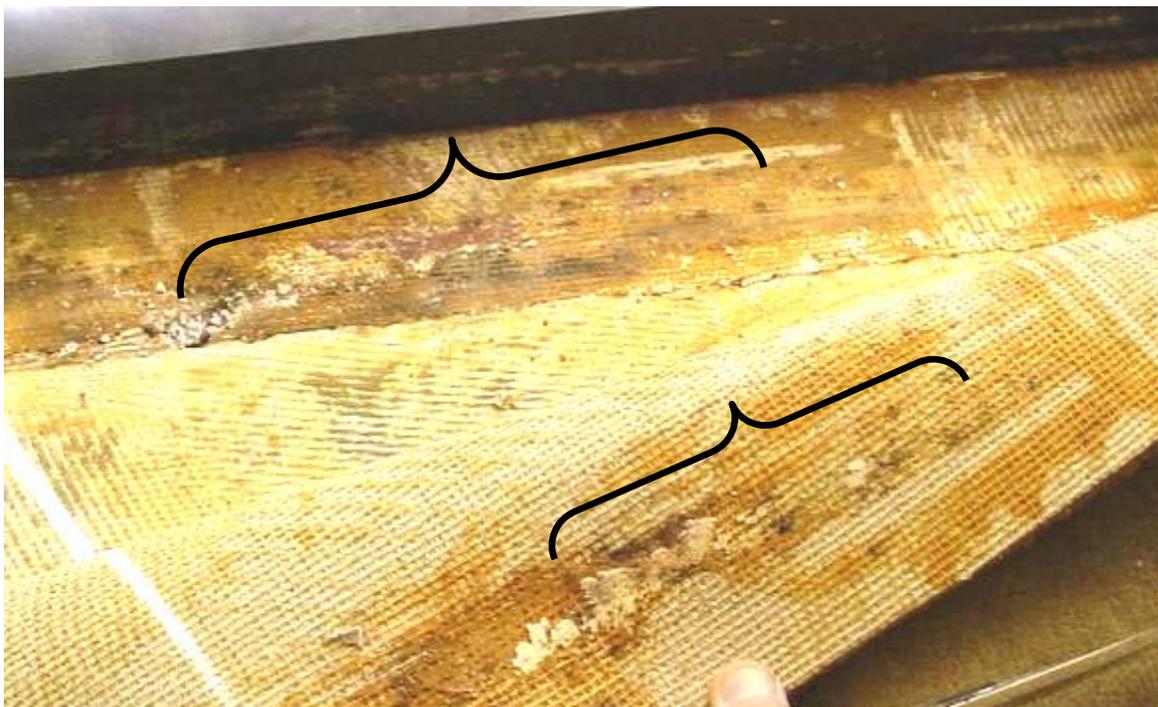
**Picture 12**

BEH staff removed ceiling tiles/carpeting in a number of areas impacted by water penetration for examination. All areas appeared dry at the time of the assessment and no visible mold growth and/or associated odors were observed/detected, with one exception. An area of dark staining that may have been mold was observed on a small section of carpeting in the Head

**Dark Staining beneath Carpet in Head Clerk's Office**

Clerk's office directly under the area of leakage (Picture 12). With the assistance of Mr. Mello, Mr. Holmes removed the stained section of carpet and recommended that the floor surface be cleaned and disinfected (Picture 13).

1. Ensure that area where carpet was removed (Pictures 12 and 13) and mold growth around kitchen sink (Picture 14) is cleaned/disinfected. This measure will remove actively growing mold colonies that may be present. For more information on mold consult with "Mold Remediation in Schools and Commercial Buildings" published by the US Environmental Protection Agency (US EPA, 2001). Copies of this document can be downloaded from the US EPA website at:  
[http://www.epa.gov/iaq/molds/mold\\_remediation.html](http://www.epa.gov/iaq/molds/mold_remediation.html).

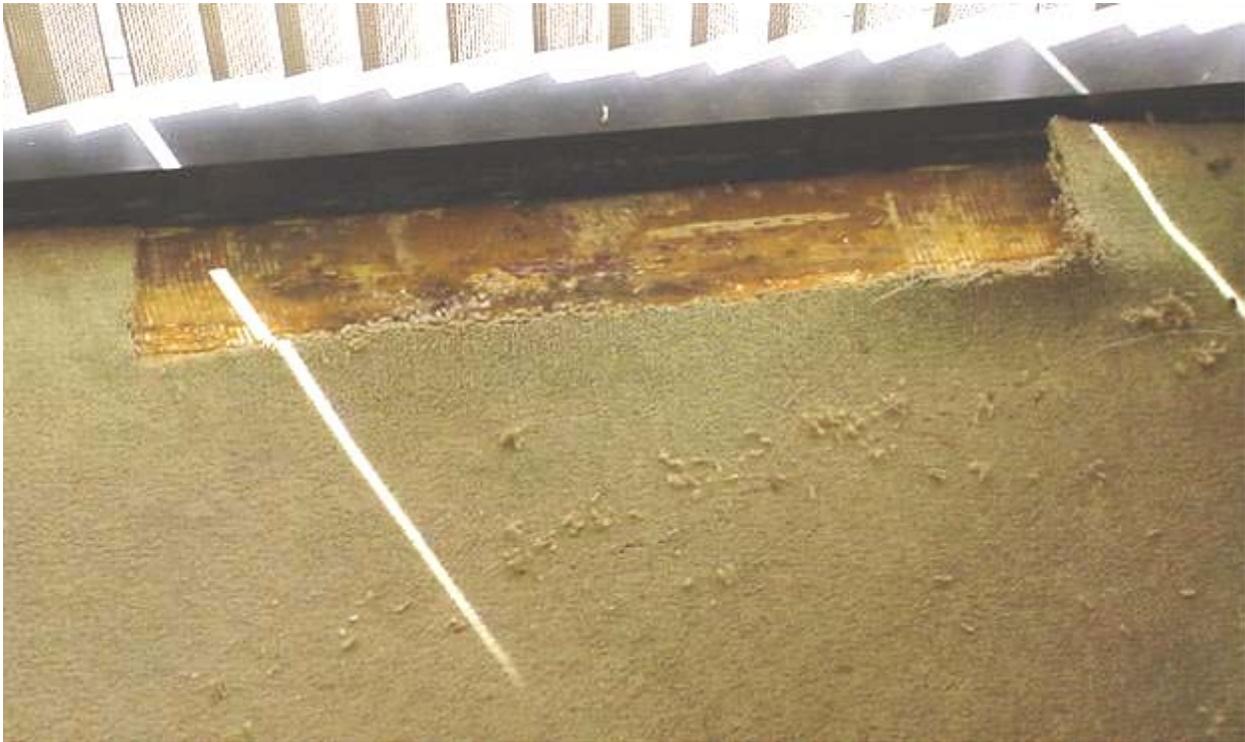
**Picture 13**

**Section of Carpeting Removed (Shown in Preceding Picture)**

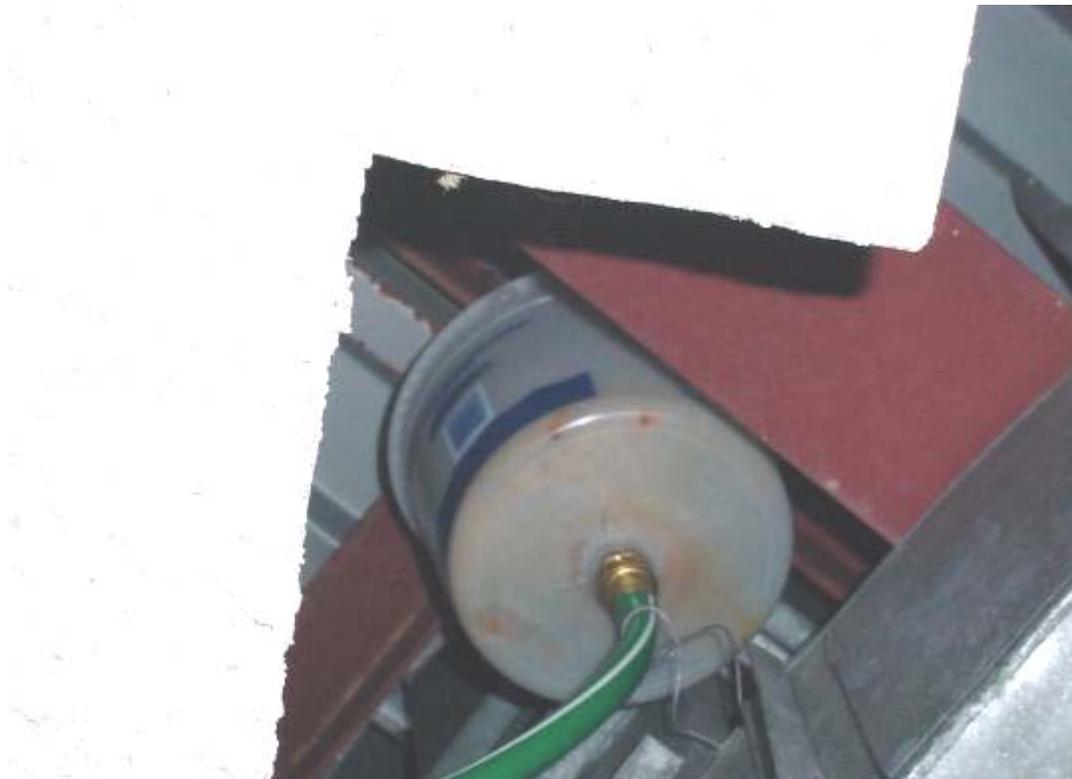
**Picture 14**

Mr. Mello reported that previous leaks were observed in the waiting room. Mr. Holmes removed tiles to examine conditions in the ceiling plenum and found a bucket stationed to catch water with a hose attached draining into an adjacent custodial closet (Pictures 14 and 15). At the time of the assessment it was not clear if the leak in this area had been repaired.

**Bucket with Hose Attached above Ceiling in Waiting Room**

7. Ensure leak is repaired above ceiling system in waiting room. If repaired, remove drainage system installed in ceiling plenum (Pictures 14 and 15). Continue to work with building management to identify and repair any water leaks as they may occur.

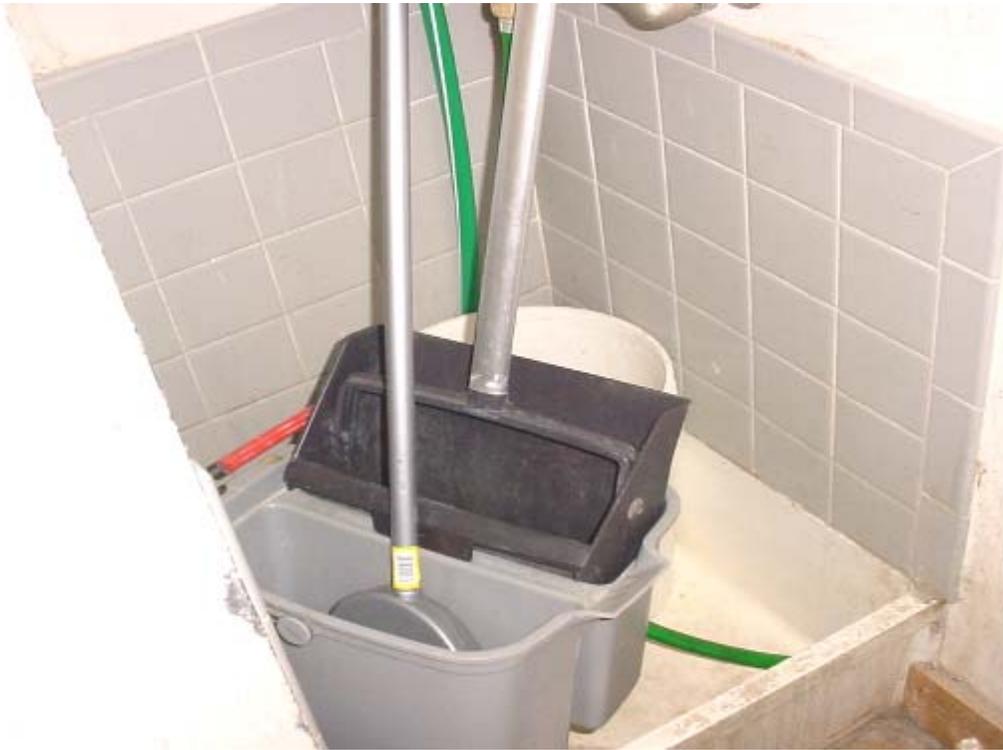
**Picture 15**

**Terminus of Drainage Hose (Shown in Preceding Picture)**

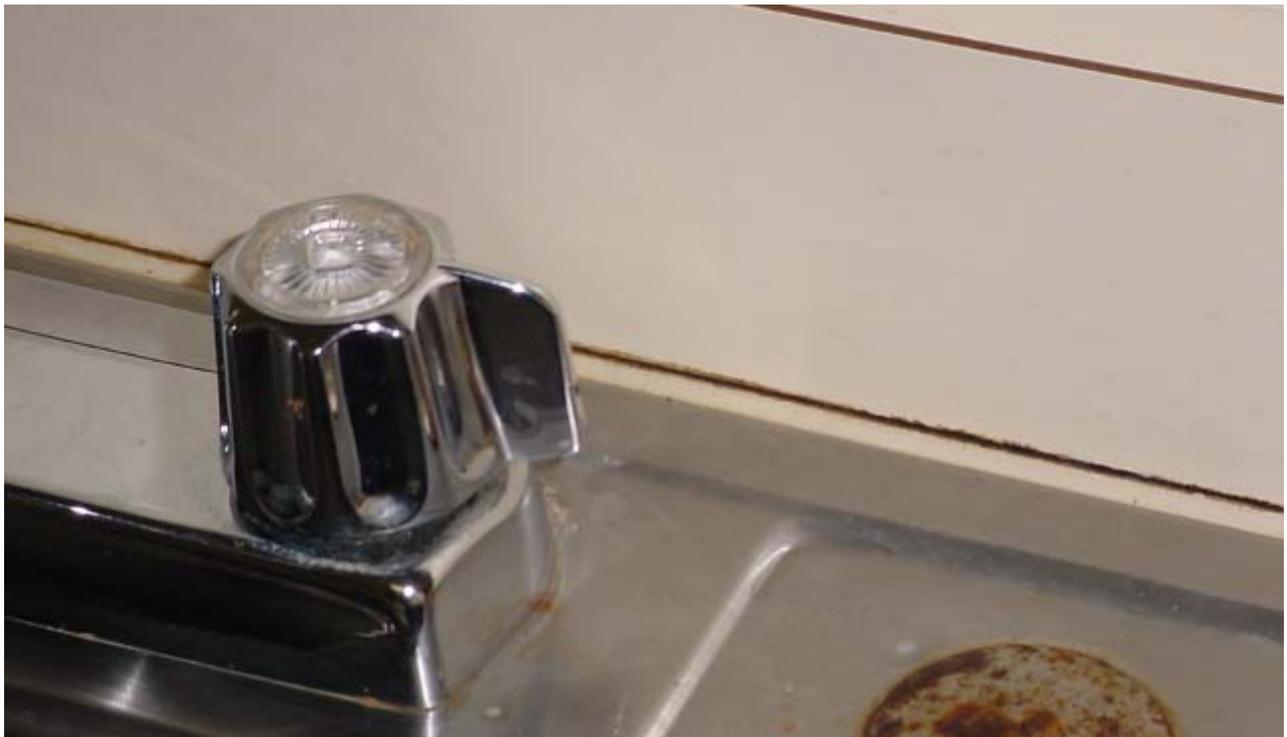
**Picture 16**

**Mold Growth (Dark Staining) between Sink Countertop and Backsplash**

Visible mold growth was observed in an area unrelated to leaks in the building envelope. A dark staining was observed along the sink countertop/backsplash in the kitchen (Picture 16). This area should be cleaned and disinfected with a mild detergent or antimicrobial agent.
