# **INDOOR AIR QUALITY ASSESSMENT**

**Cape Cod Community College  
Wilkens Library  
2240 Iyannough Road  
West Barnstable, Massachusetts 02668**

Prepared by:  
Massachusetts Department of Public Health  
Bureau of Environmental Health  
Indoor Air Quality Program  
September 2008

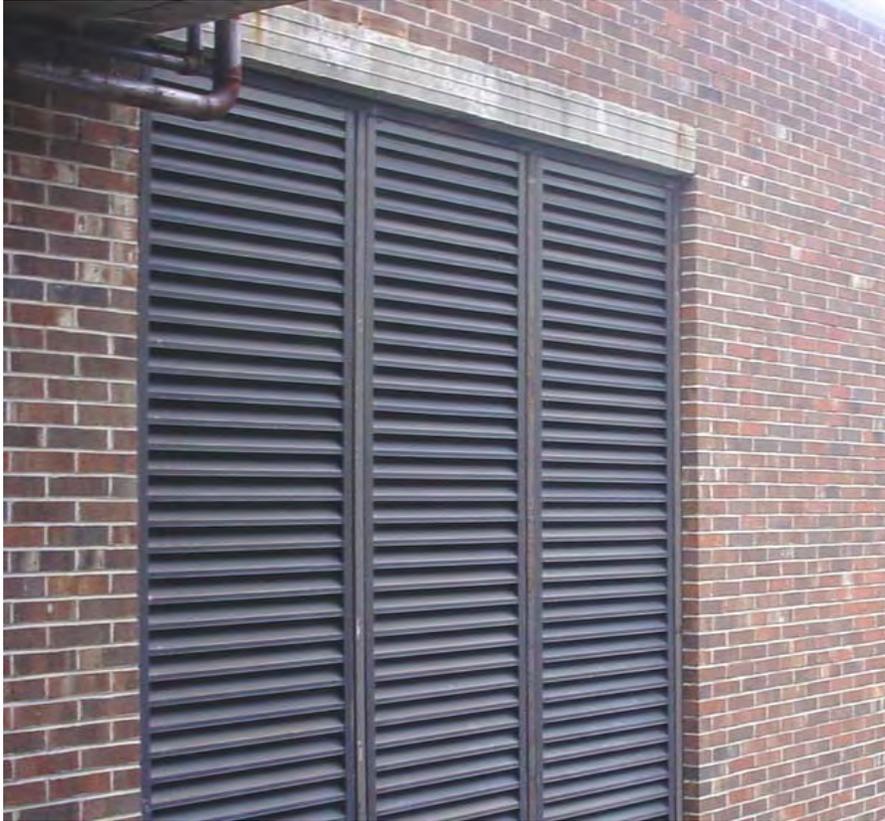
**Picture 1**

**Fresh Air Intake for Library HVAC System**

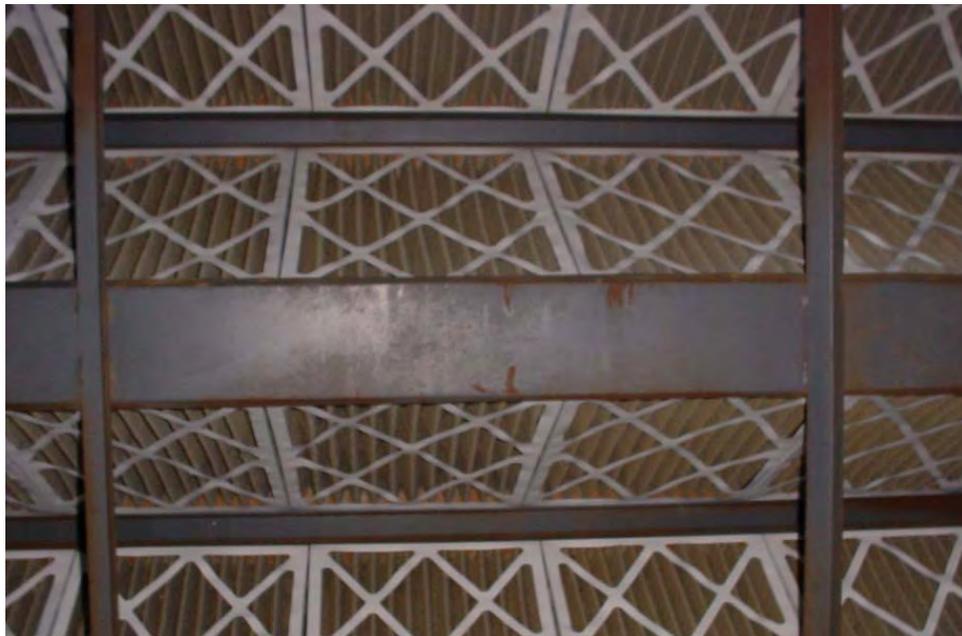
**Picture 2**

**Pleated Filter Bank for Library HVAC System**

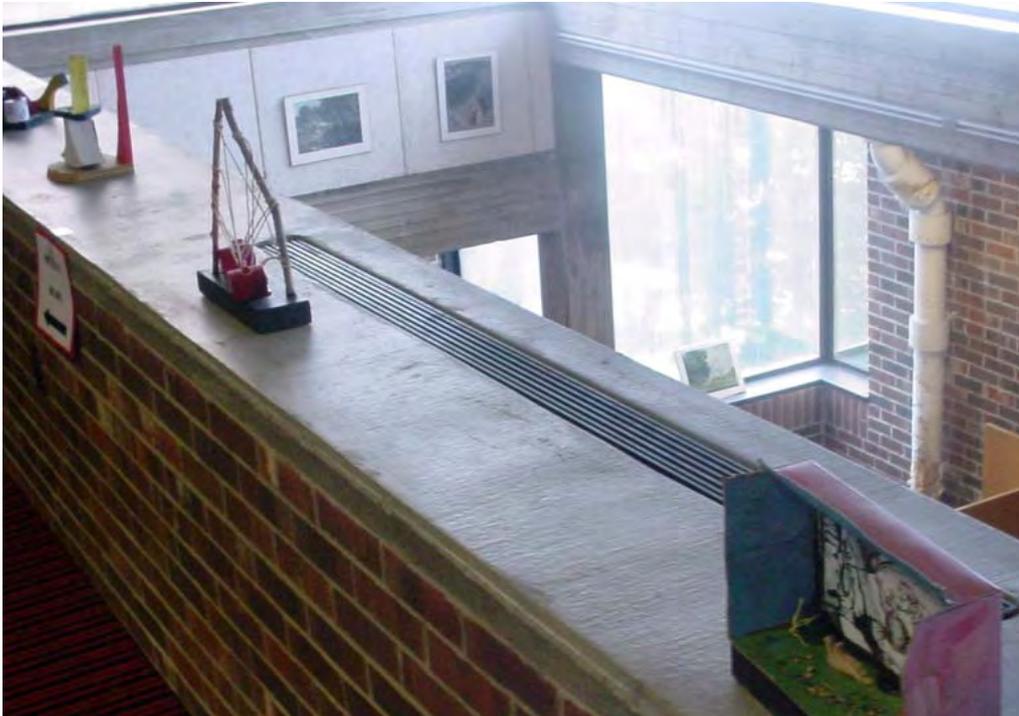
**Picture 3**

**Wall-Mounted Supply Vent**

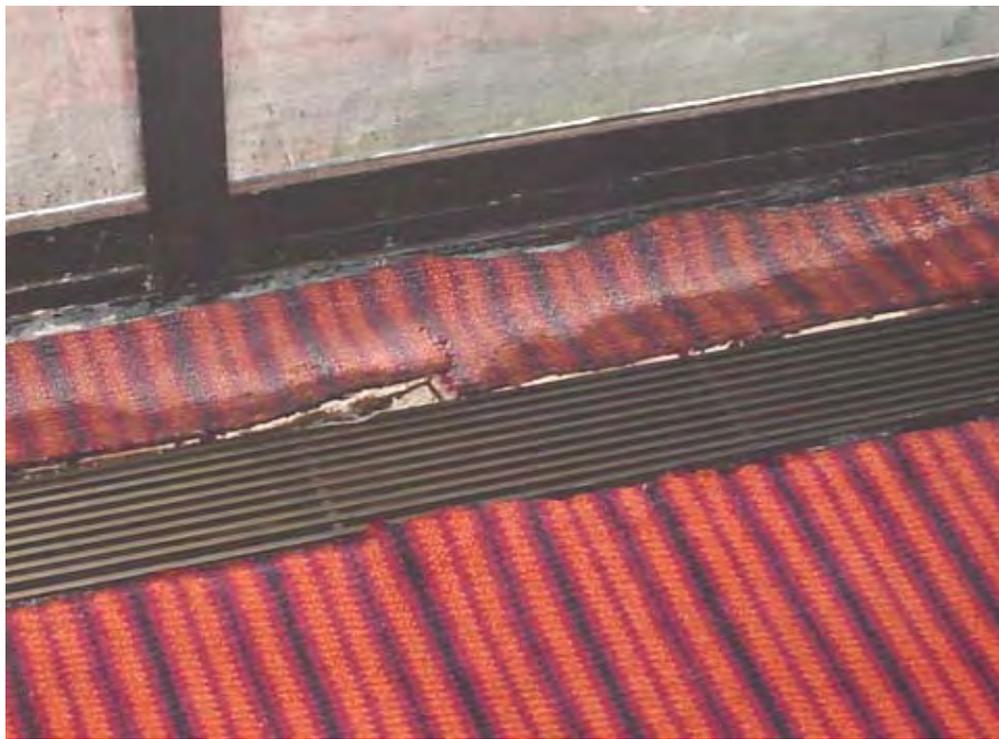
**Picture 4**

Delmhorst probe is equipped with three lights that are visual aids indicating moisture level. Readings that activate the green light indicate a sufficiently dry level, those that activate the yellow light indicate borderline conditions and those that activate the red light indicate elevated moisture content. The probe is inserted into the surface of porous materials for measurement. Elevated moisture readings were measured and visible water damage and/or mold growth was detected/observed beneath carpeting along exterior walls on the 1<sup>st</sup> and 2<sup>nd</sup> floors (Table 1/Pictures 4, 14-16) and on fiberglass insulation around roof drains (Table 1/Pictures 17 and 18).

**Floor-Mounted Supply Vent, Note Water Damaged/Loosened Carpeting (Top)**

1. Remove carpeting approximately 2 to 3 feet from exterior walls. Disinfect floor beneath carpet with an appropriate antimicrobial agent, clean and dry. Consider replacing carpet with tile or other non-porous floor material.

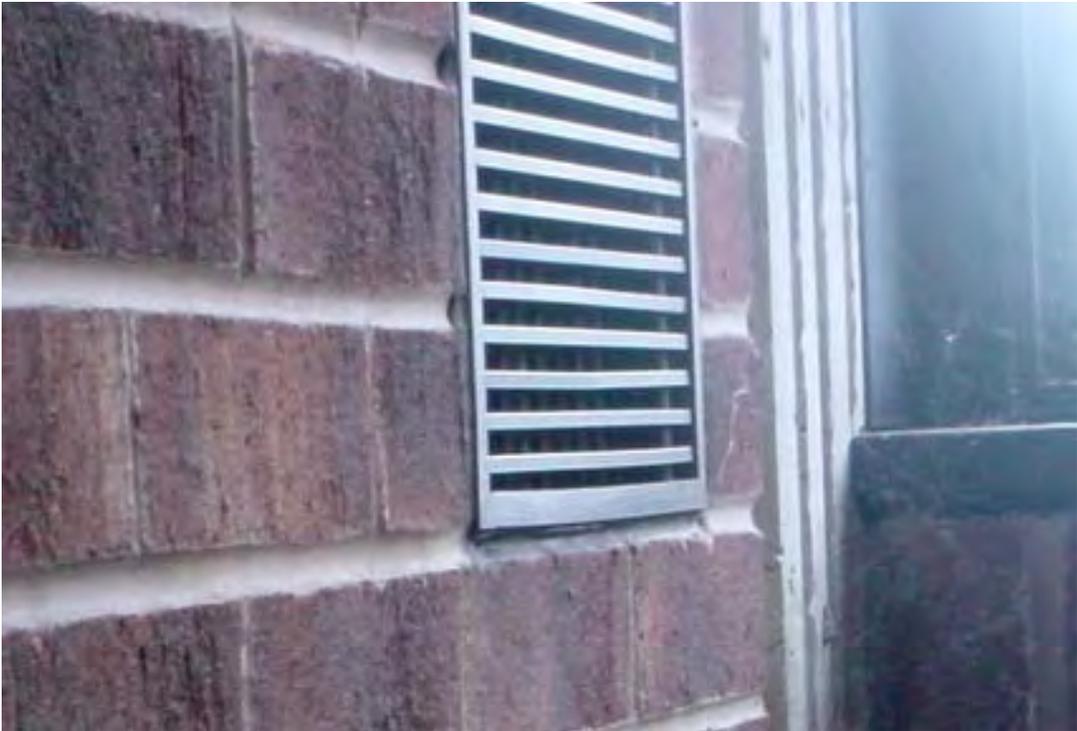
**Picture 5**

**Wall-Mounted Return Vent**

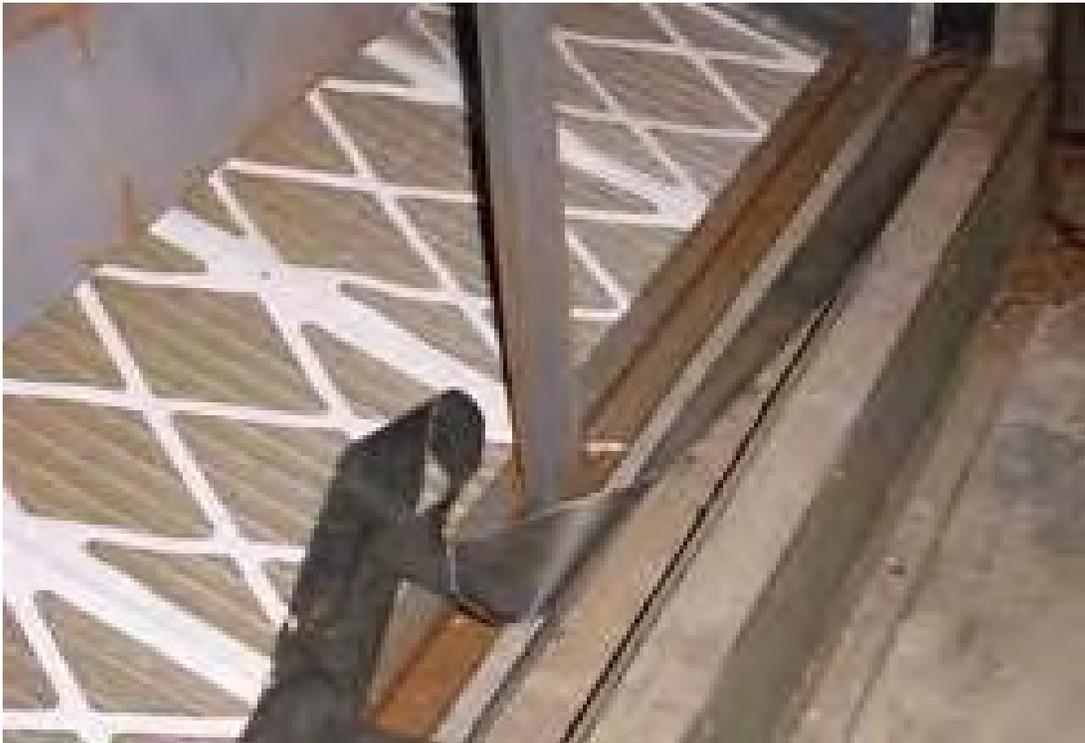
**Picture 6**

The AHU in the ground floor mechanical room had a large gasket connecting the air mixing room to the filter bank. BEH staff found this gasket badly damaged at the time of the assessment (Pictures 6 through 8). Without the gasket intact, the AHU draws in unfiltered air/odors/pollutants from the mechanical room; this can also make temperature/comfort control difficult. It is also important to note that the HVAC components are original equipment, dating 30 to 40 years old. Efficient function of such aged equipment is difficult to maintain, since compatible replacement parts are often unavailable.

**Missing/Damaged Rubber Gasket (Foreground)**

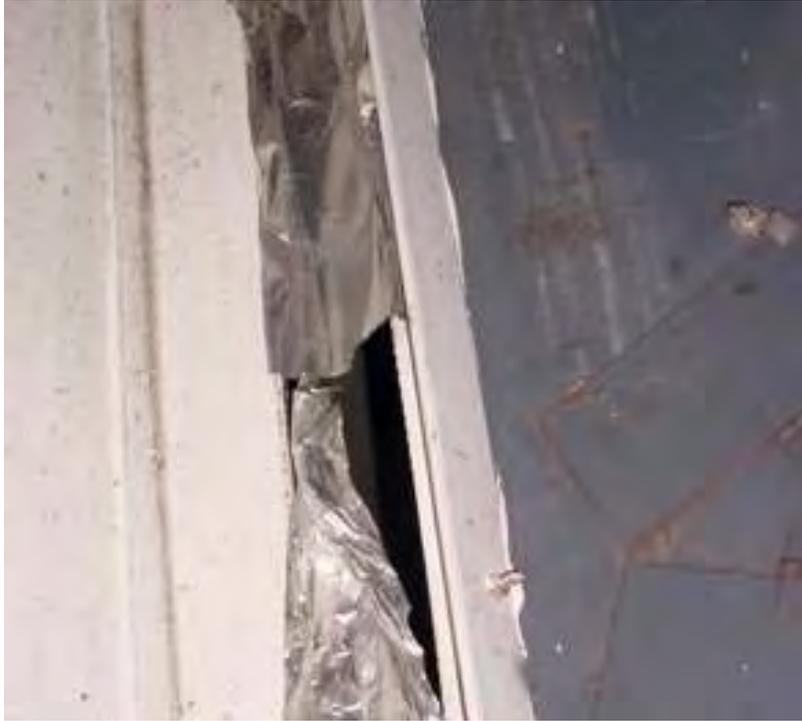
**Picture 7**

**Missing/Damaged Sealant (Foil) along Side of AHU (Vertical)**

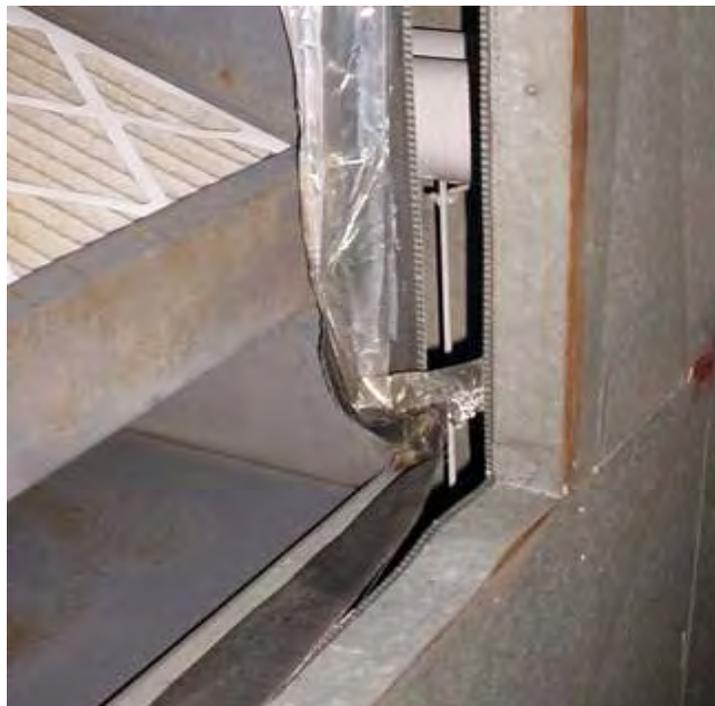
**Picture 8**

**Missing/Damaged Rubber Gasket (Foreground)/Foil Tape (Vertical) Note Open Space between Duct and Mixing Room Allowing for Uncontrolled Air to Enter System**

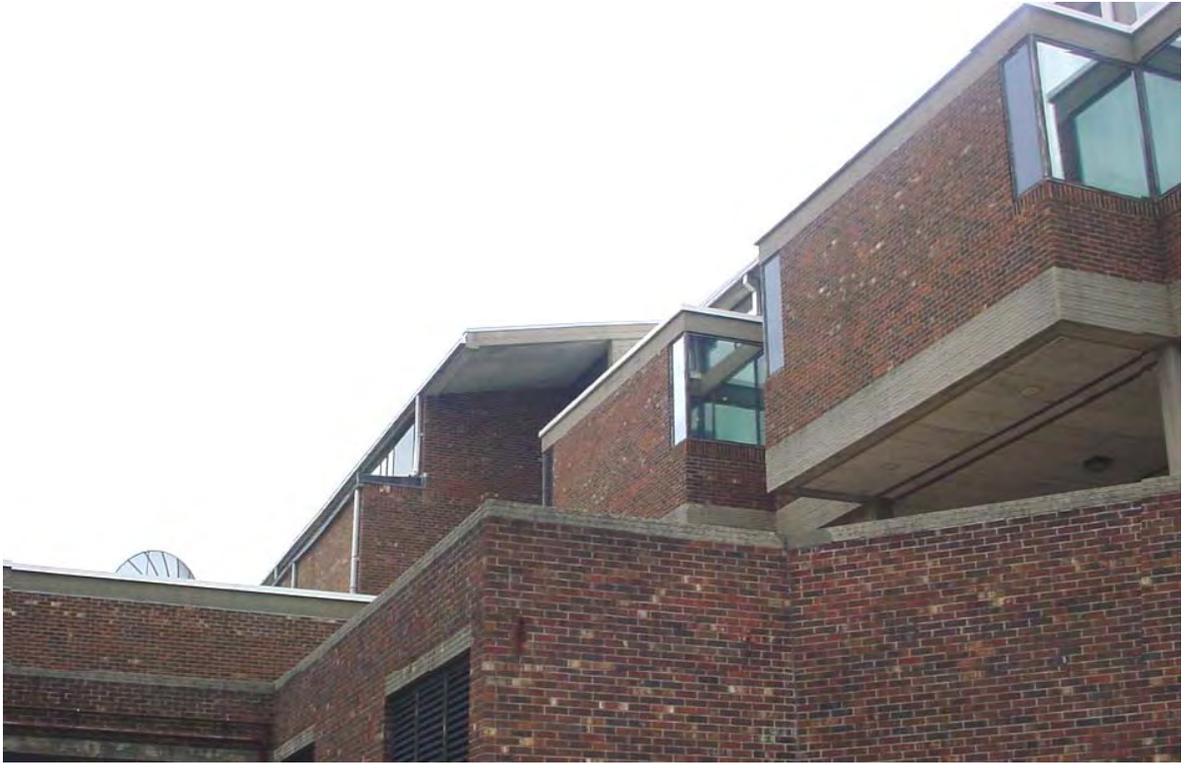
**Picture 9**

As previously mentioned, the construction design of the WL involves many exterior roofs, walls and surfaces that are adjacent to each other. These surfaces/building materials require specific drainage and water tight specifications (e.g., flashing, gutters/roof drains, weep holes, roofing materials). The amount of different surfaces built into the design of the WL make it an extremely difficult building to maintain watertight integrity (Pictures 9 through 11). Efflorescence on interior brick (Pictures 12 and 13) and other water damaged materials in the building illustrate the water penetration throughout the building. Efflorescence is a characteristic sign of water penetration through building materials, but it is not mold growth. As moisture penetrates and works its way through mortar/exterior brick, water-soluble compounds dissolve, creating a solution. As this solution moves to the surface of the brick, the water evaporates, leaving behind white, powdery mineral deposits. This condition indicates that moisture is migrating through exterior brick walls.

**Multiple Wall and Roof Surfaces at the CCCC Library Building**

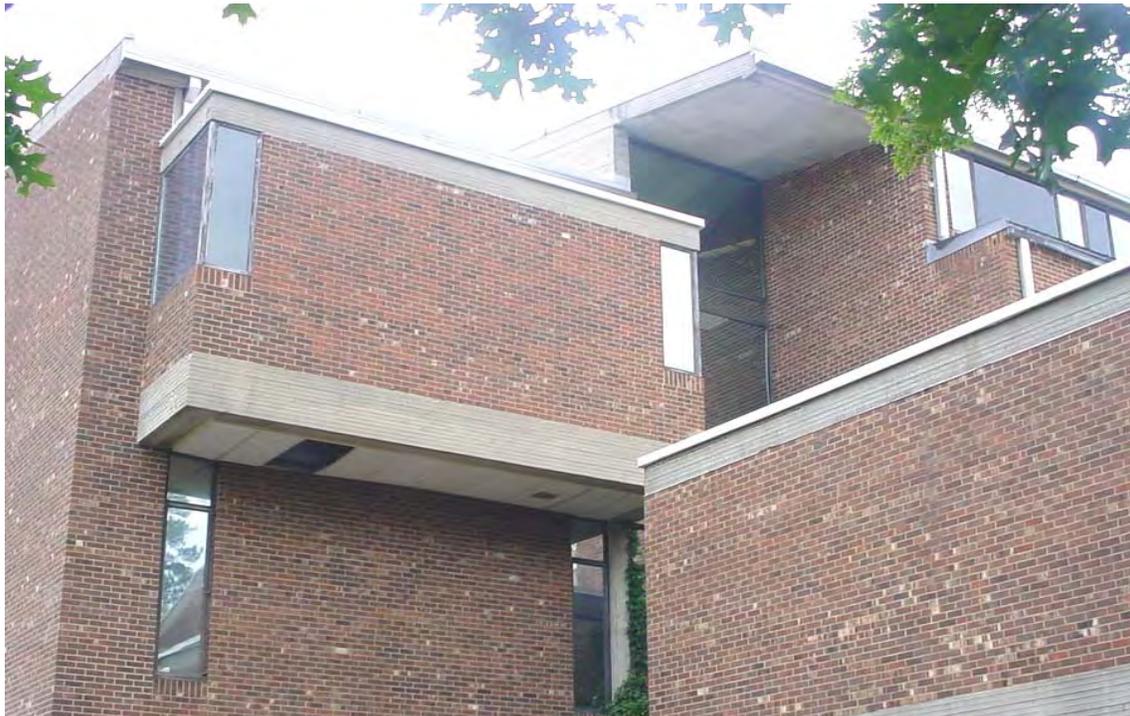
**Picture 10**

**Multiple Wall and Roof Surfaces at the CCCC Library Building**

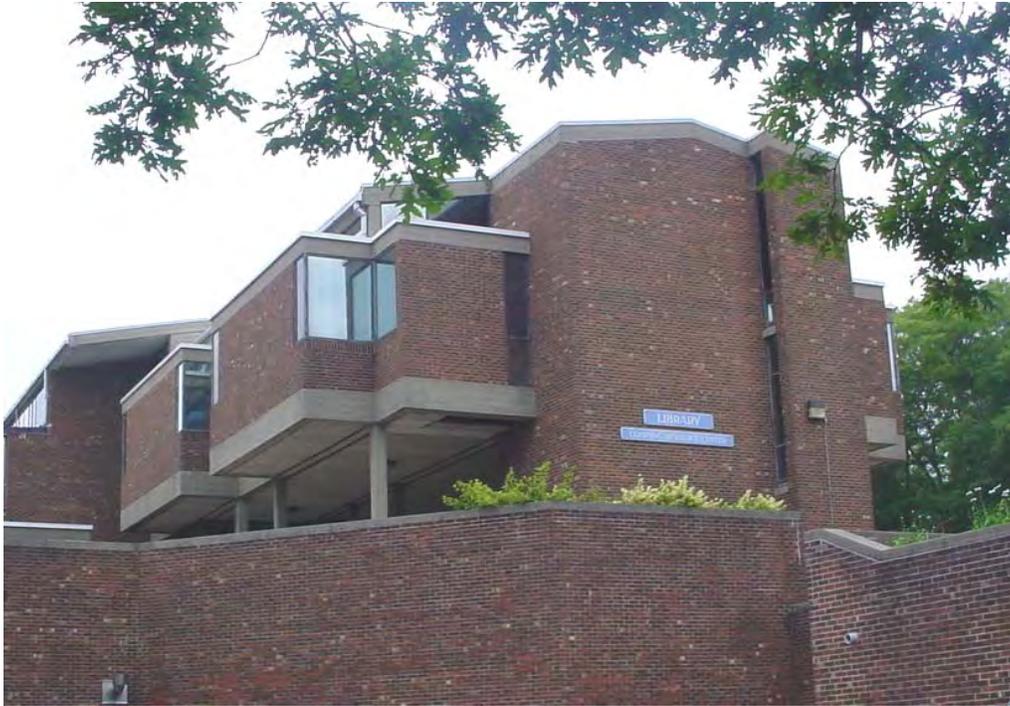
**Picture 11**

**Multiple Wall and Roof Surfaces at the CCCC Library Building**

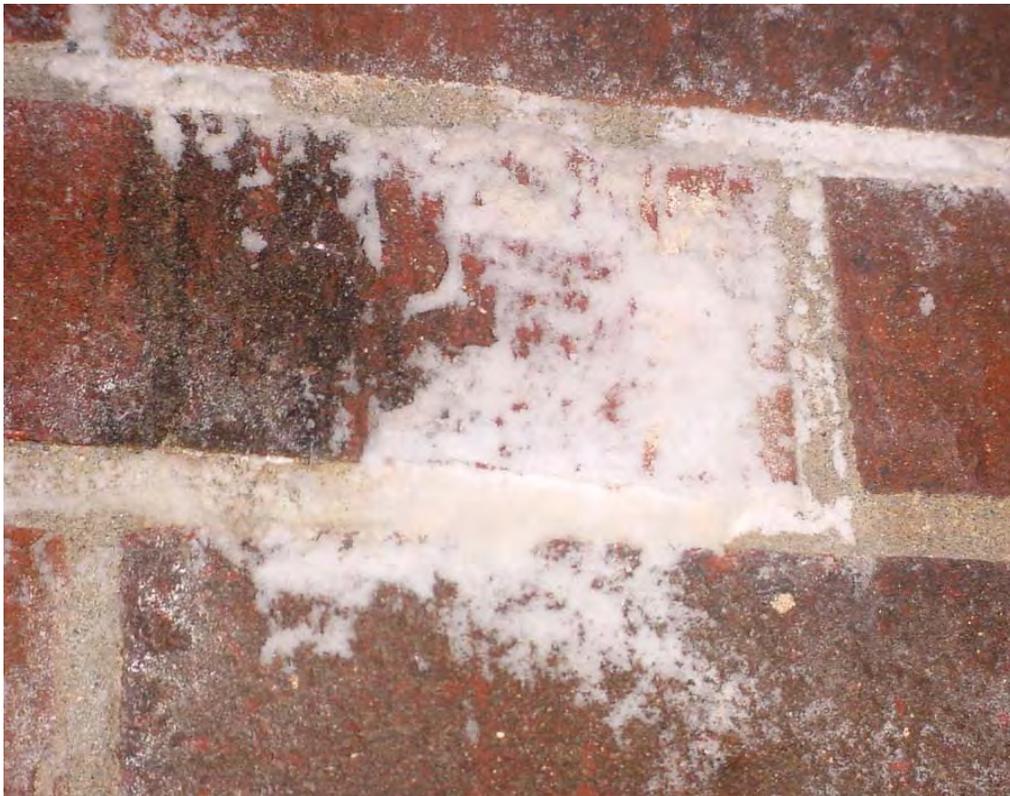
**Picture 12**

**Efflorescence (i.e., Mineral Deposits) on Interior Brick**

10. Clean efflorescence from the surface of interior walls using a HEPA filtered vacuum cleaner. Note, until exterior brick in these areas is re-pointed or sealed, efflorescence may reoccur.

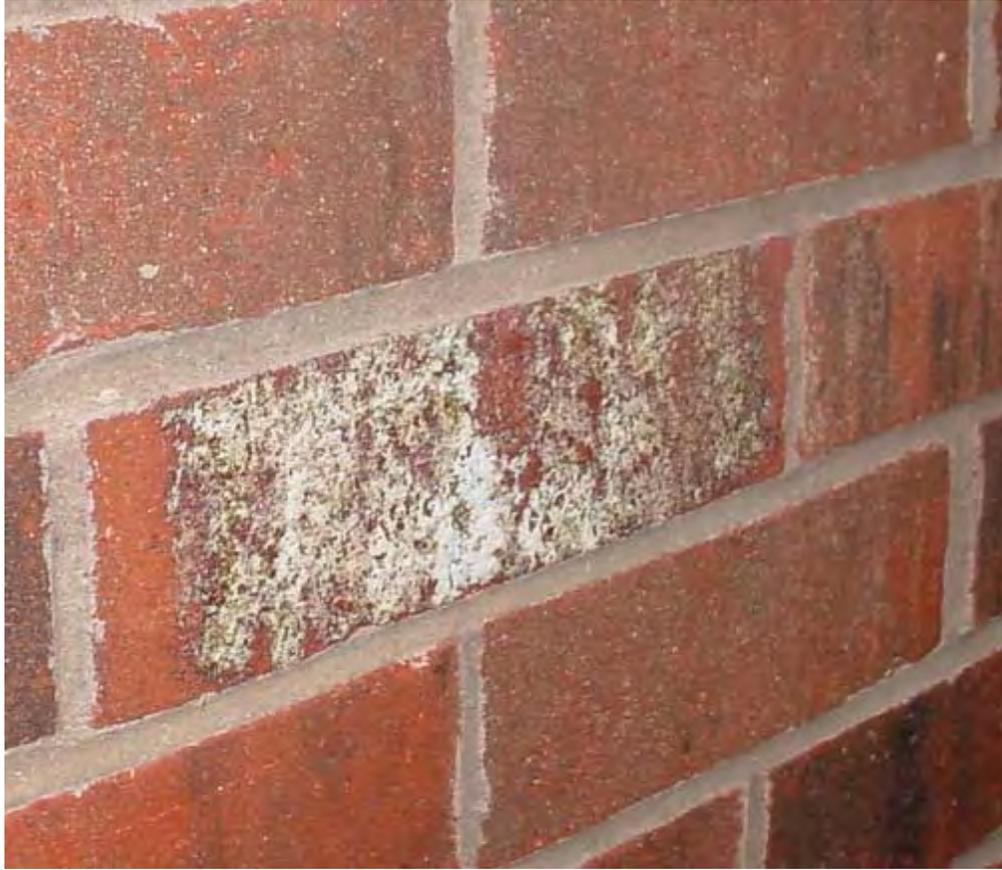
**Picture 13**

**Efflorescence (i.e., Mineral Deposits) on Interior Brick**

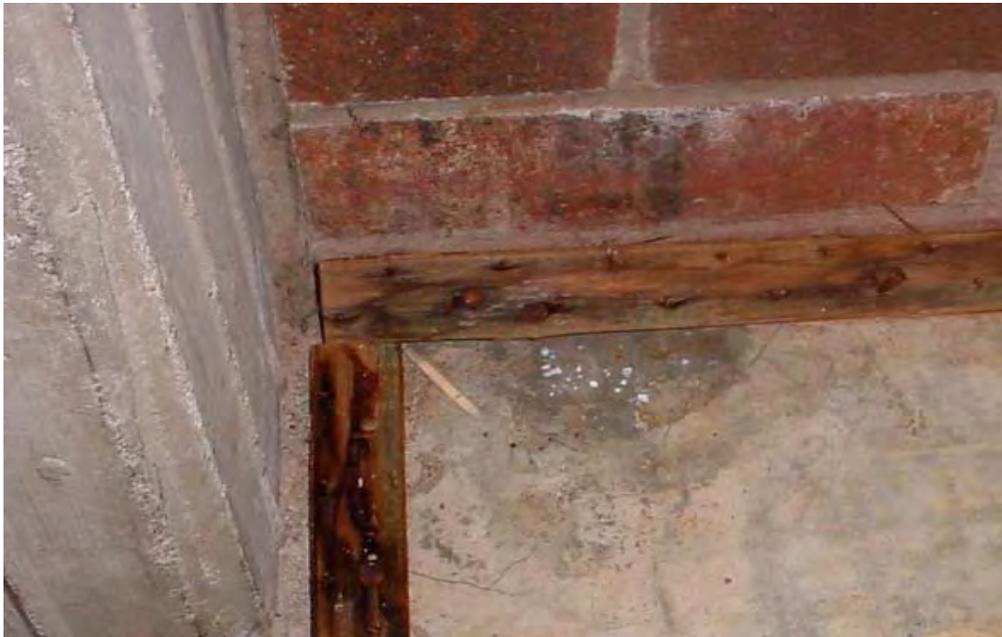
**Picture 14**

**Water Damaged/Mold Colonized Wooden Tack Strips beneath Carpeting along Exterior Walls 2<sup>nd</sup> Floor**

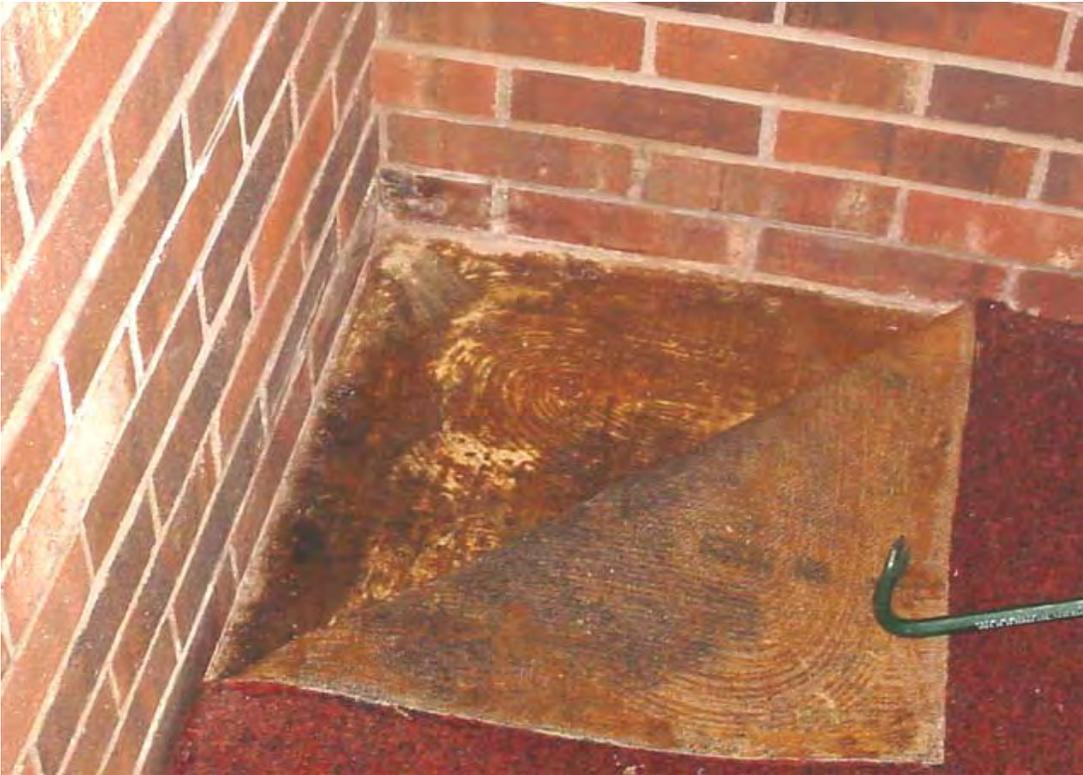
**Picture 15**

**Water Damaged/Mold Colonized Carpeting along Exterior Walls 2<sup>nd</sup> Floor**

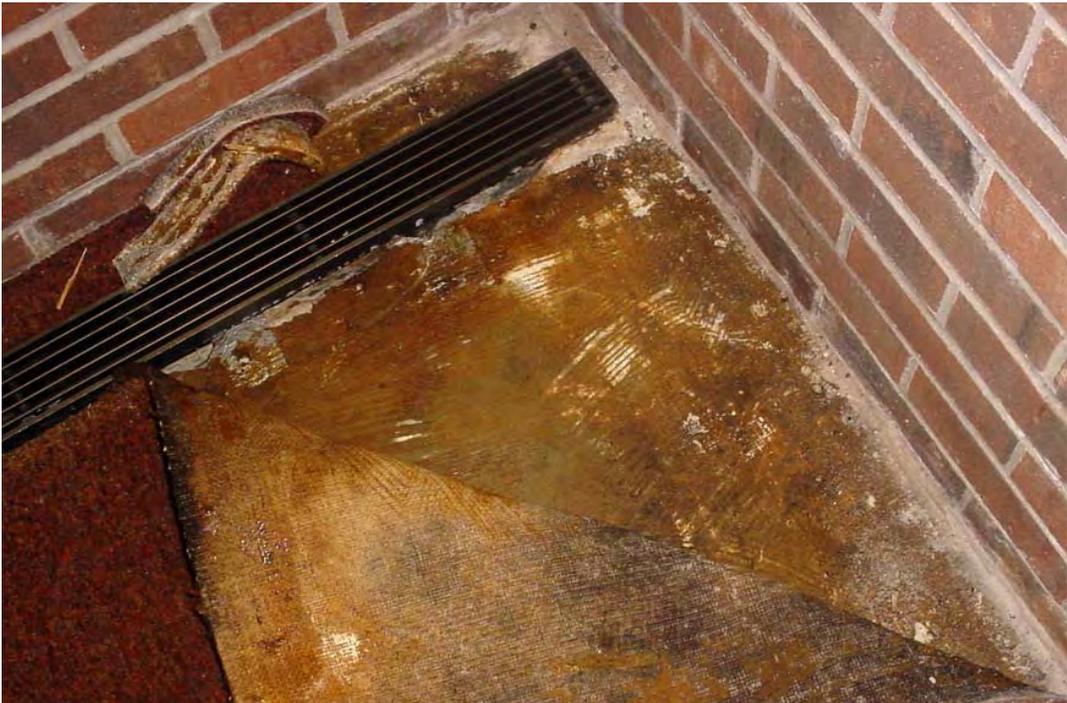
**Picture 16**

**Water Damaged/Mold Colonized Carpeting along Exterior Walls**

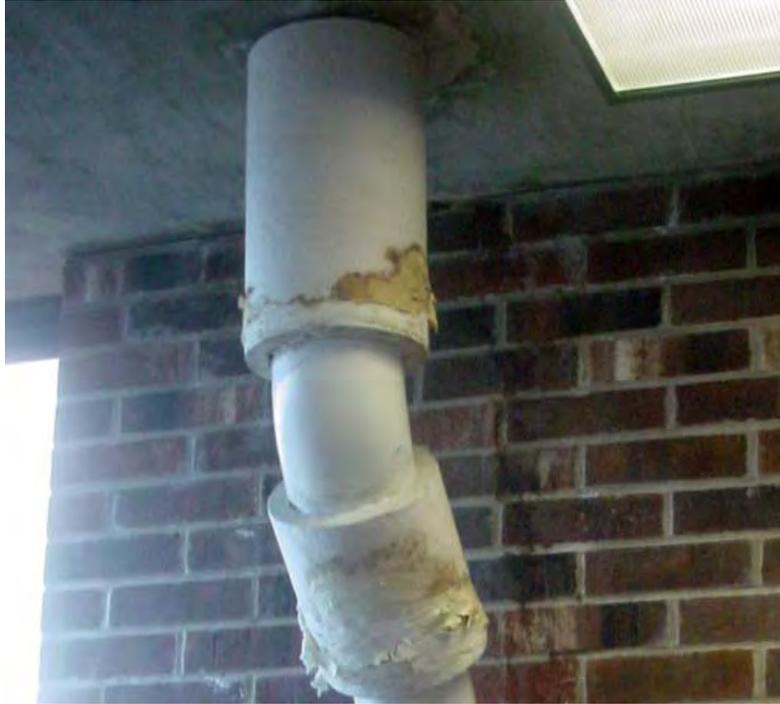
**Picture 17**

**Water Damaged/Mold Colonized Insulation around Roof Drains**

2. Remove/replace water damaged/mold colonized roof drain insulation.
3. Inspect roof drains for leaks/proper drainage and make repairs if needed.
4. Contact an HVAC engineer to evaluate the ventilation control system particularly the modulation of fresh air intake louvers. Consider having fresh air control dampers calibrated to limit outside air intake on hot, humid days during air-conditioning season.

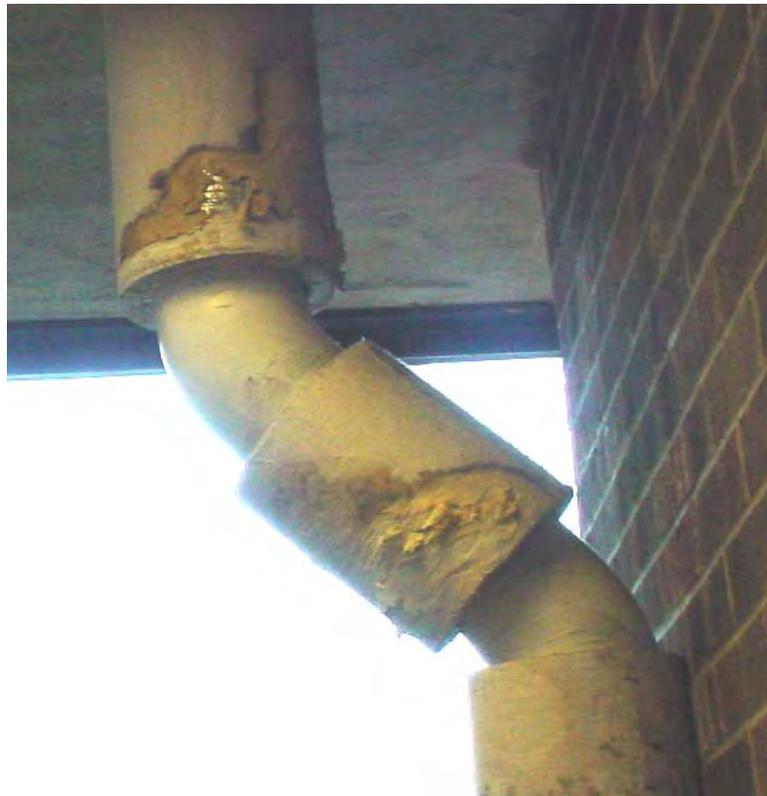
**Picture 18**

**Water Damaged/Mold Colonized Insulation around Roof Drains**

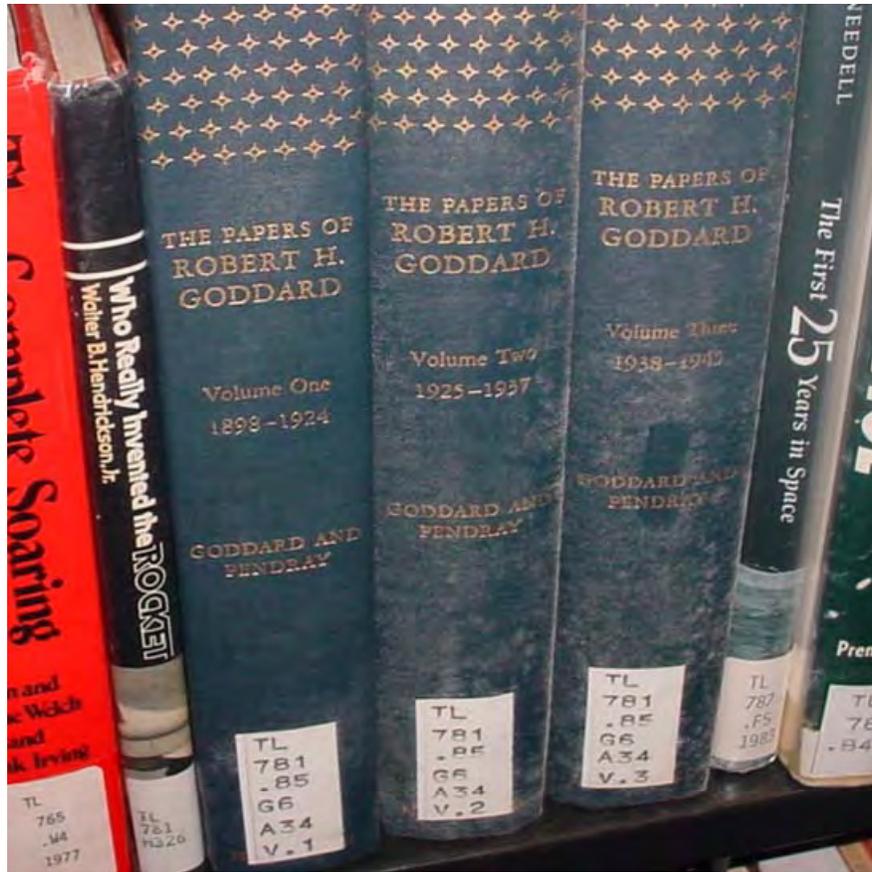
Picture 19

Mold Colonized Spines of Textile-Covered Books

8. Clean surface mold from spines of books *in place* with a vacuum cleaner equipped with a high efficiency particle arrestance (HEPA) filter. As an additional measure, vacuum books that do not have visible mold colonies, but are located in areas impacted by mold.

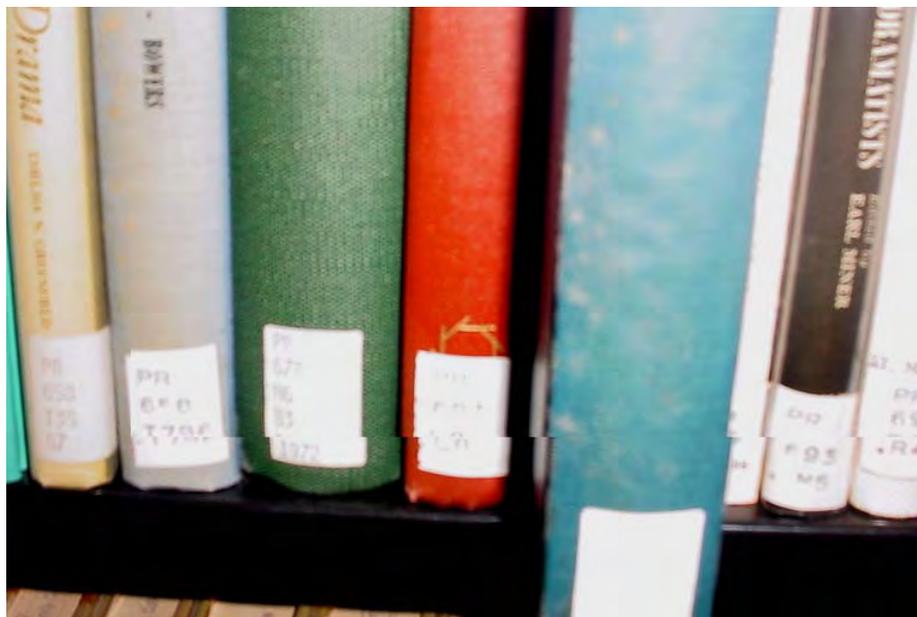
Picture 20

Mold Colonized Spines of Textile-Covered Books
