INDOOR AIR QUALITY ASSESSMENT EMERGENCY RESPONSE

**Massachusetts Department of Revenue
40 Southbridge Street
Worcester, Massachusetts 01608**

Prepared by:
Massachusetts Department of Public Health
Bureau of Environmental Health
Indoor Air Quality Program
July 2008

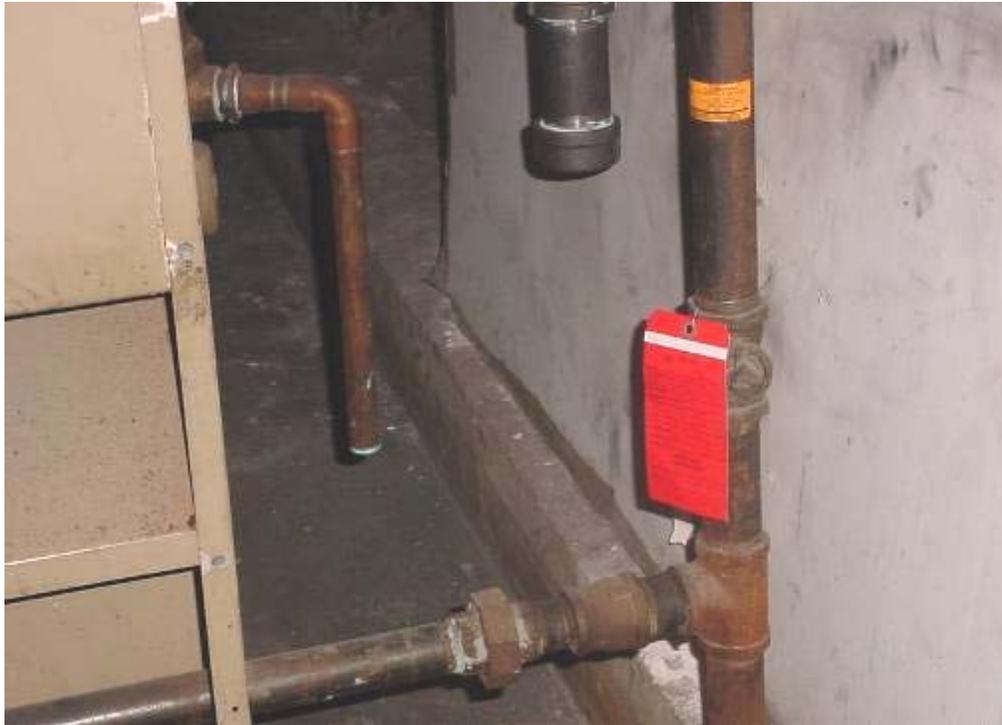
Picture 1

Red Tag on Faulty Furnace

1. The furnace should remain deactivated until repairs are made and confirmed by city officials.
2. Seal all potential pathways of migration for combustion pollutants in the boiler room to upper floors (e.g., conduits, utility holes, flues).
3. Ensure that appropriate means to vent furnace pollutants exist.
4. Seal all holes in floors, wall and ceiling of HVAC system air mixing rooms.
5. Consider installing carbon monoxide detectors in occupied areas.

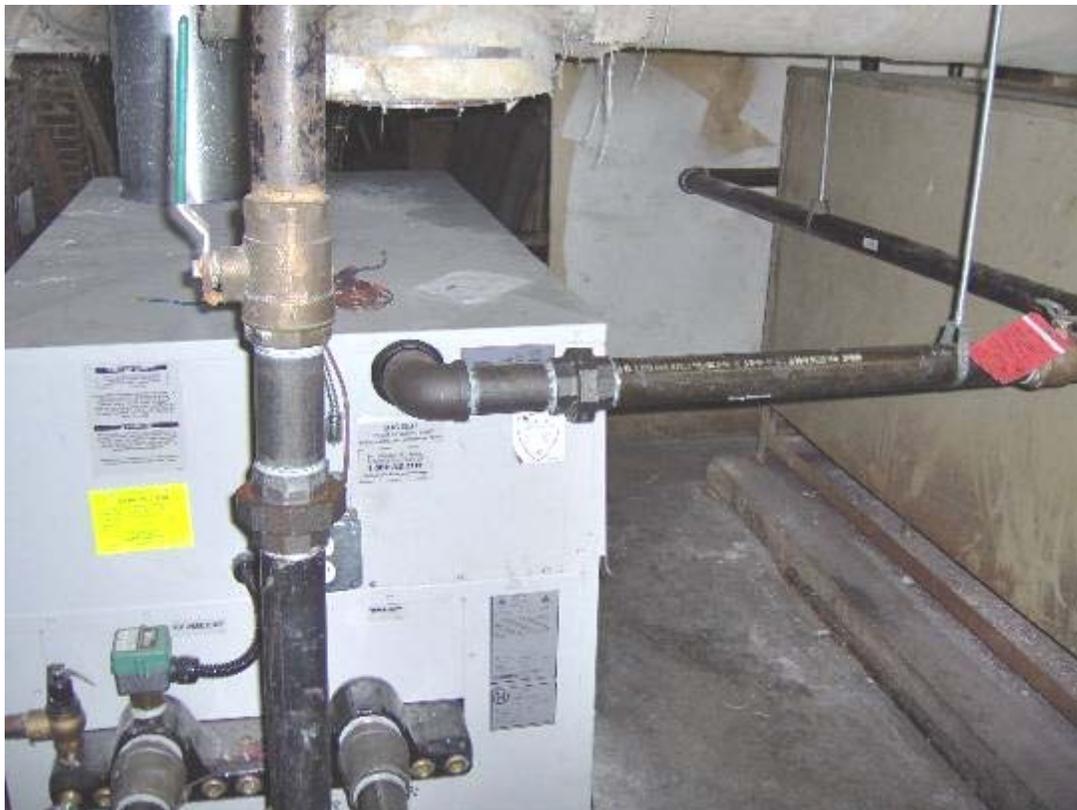
Picture 2

Second Tagged-Out Furnace in the Basement

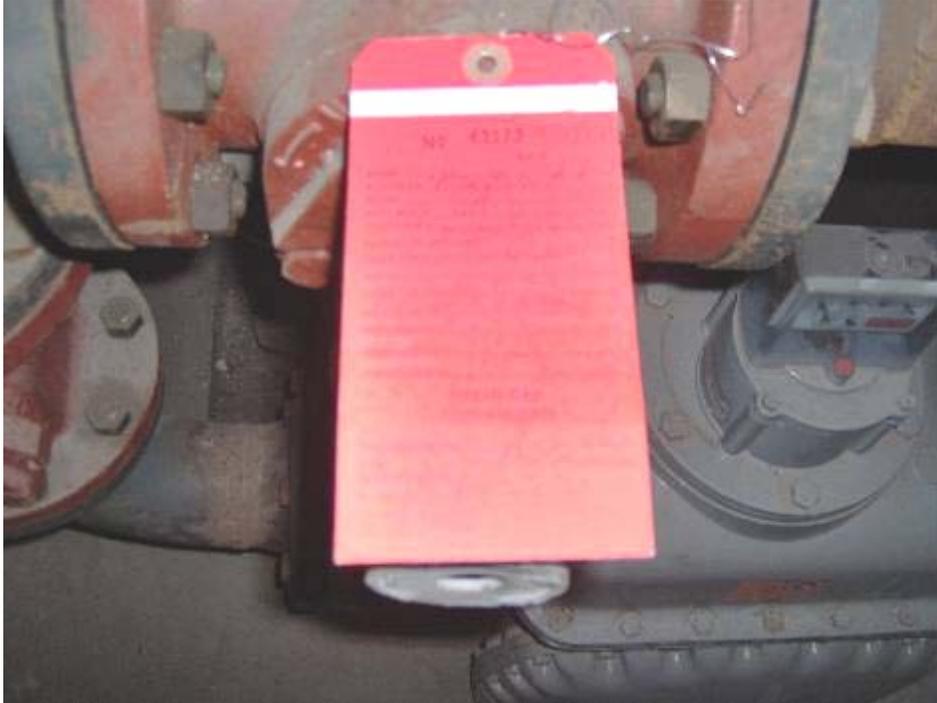
Picture 3

Tagged Gas Supply

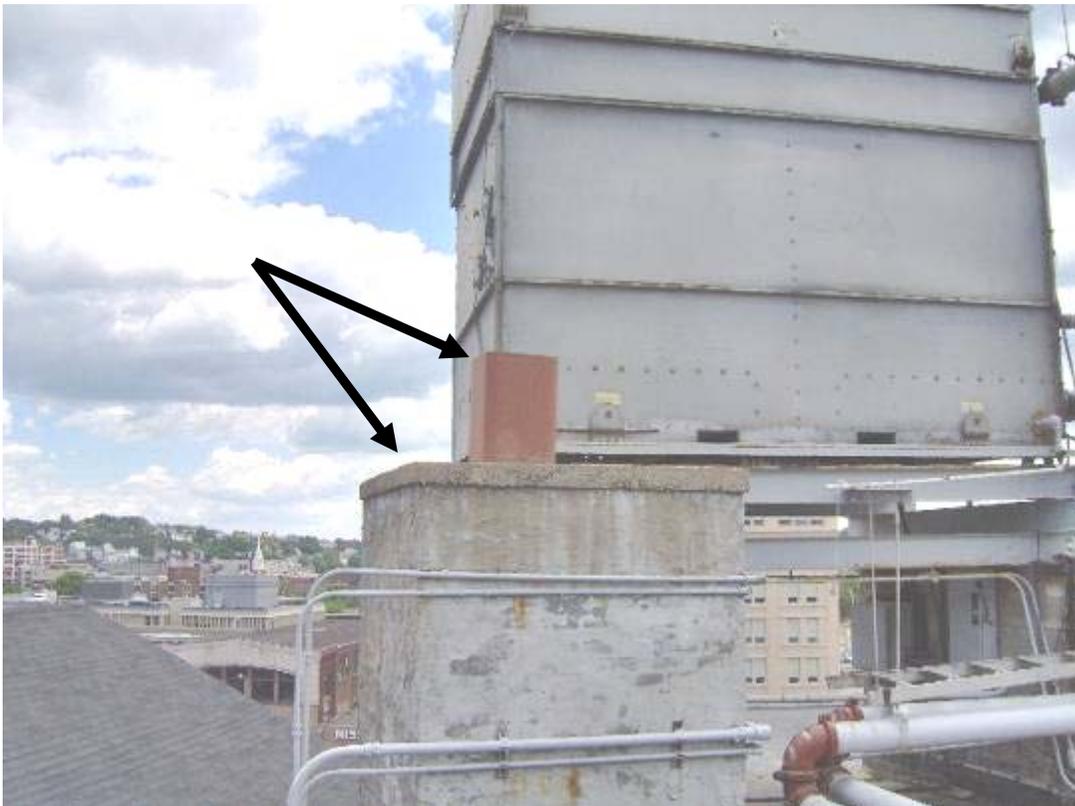
Picture 4

The source of the carbon monoxide was identified by the WFD as the furnaces located in the basement. Carbon monoxide produced by the furnaces was entrained by the mechanical ventilation system where it was distributed throughout the building, and in particular, on the fourth floor. According to the WFD, the highest concentration of carbon monoxide (800 ppm) was measured within ventilation shafts (Appendix A). The furnaces and gas supply were deactivated and tagged by the Worcester Division of Code Enforcement (WDCE) to prevent reactivation until repairs are conducted (Pictures 1 through 3). An evaluation by the WDCE building inspector found that the boilers were tied to a “restricted chimney where someone had installed a 12” rectangular clay liner on the top. This would have caused a back pressure to occur in the chimney system” (Picture 4) (Appendix B). Therefore, no means existed for combustion products to exhaust via the chimney. As a result, combustion products released by the furnace would accumulate in the basement.

Chimney/Clay Liner on Roof (Note Size of Clay Pipe Compared to the Size of the Original Chimney Opening)

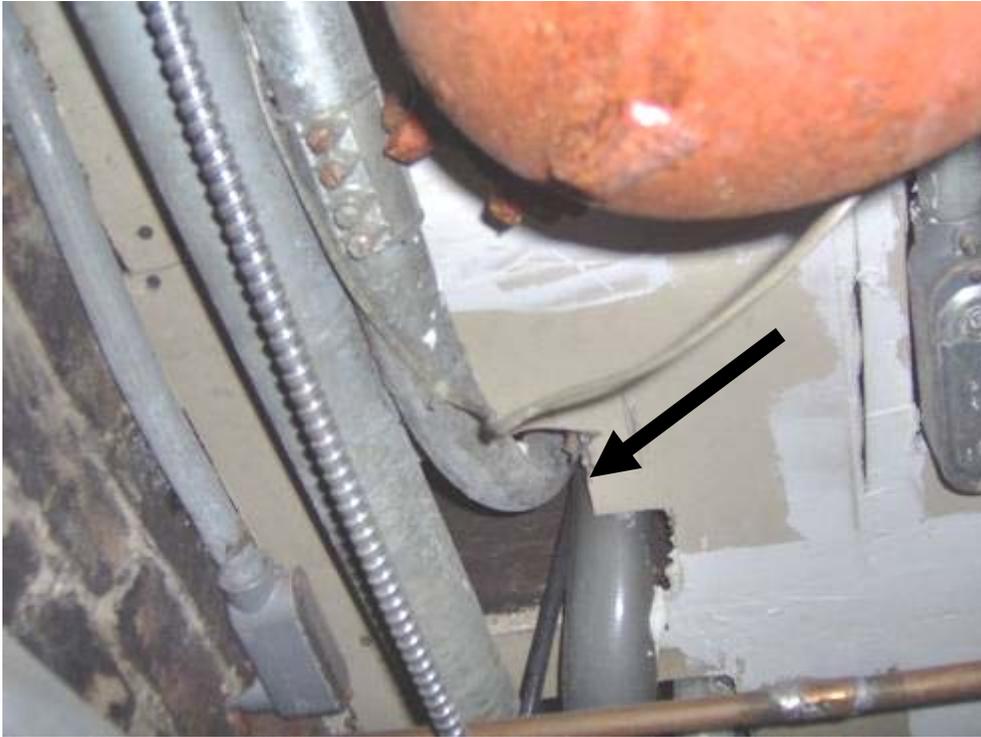
Picture 5

In this instance, interior wall cavities above the furnace were the likely pathway for combustion air to rise through the building. BEH staff identified large holes around an electrical conduit in the ceiling above the furnaces (Picture 5). Under the conditions noted, such holes would provide a means for pollutants to enter and rise through the wall spaces above the basement.

Hole for Electrical Conduit in Ceiling above the Furnaces in the Basement

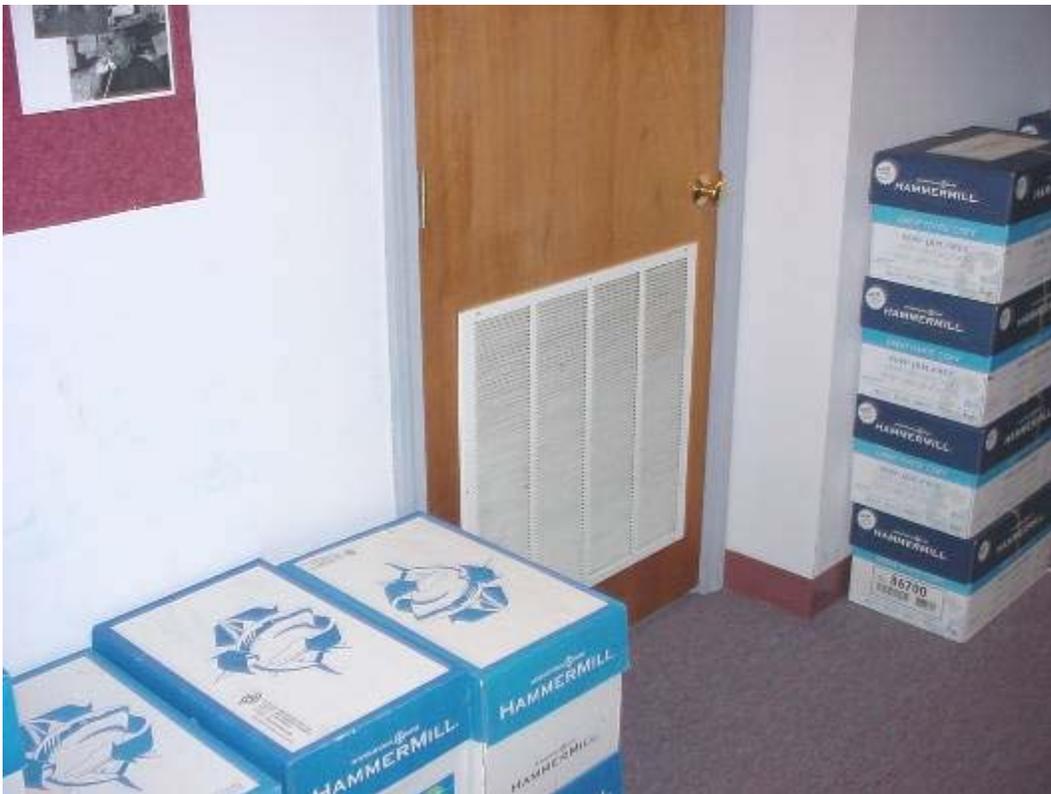
Picture 6

The AHU servicing the reception and north section of the fourth floor enhances the upward air movement. The return air vent is not connected to any ductwork; rather, it draws air into a filter located on the side of the AHU. Air is drawn from the occupied spaces through a fixed louver in the door of the AHU room (Picture 6). In this configuration, the AHU draws air from the occupied areas by the hallways, or in other words, the hallways are the return air duct system for this AHU. The operation of the AHU would result in a depressurization of the air within the closet. If any holes exist in the AHU closet floor, walls or ceiling, the AHU would draw air (and pollutants) from the wall cavity and distribute that air to occupied areas serviced by that AHU. It is likely that this AHU drew air and carbon monoxide from the wall cavity through a large hole in its wall (Picture 7). Once inside the AHU closet, carbon monoxide was then distributed to areas that were serviced by that AHU (e.g., the reception area and the north section of the fourth floor).

Passive Door Vent for Air Mixing Room near Fourth Floor Reception

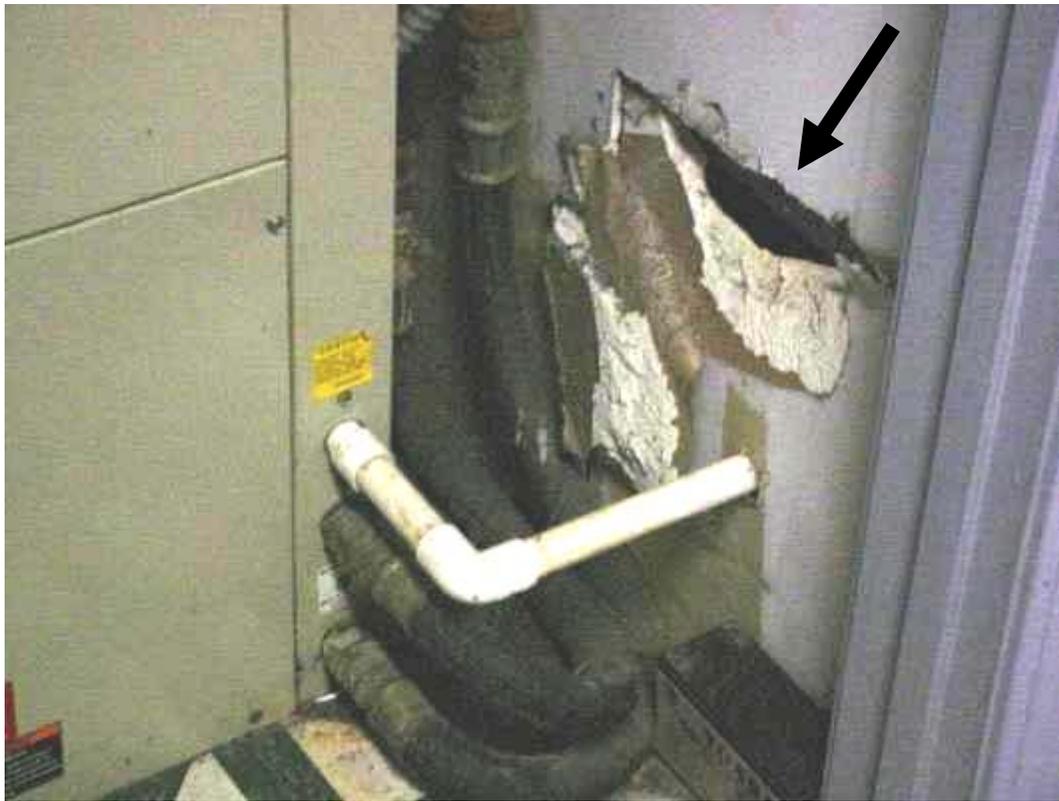
Picture 7

Other means for products of combustion to migrate from the basement into the occupied space include: the elevator shaft, the stairwell and abandoned chimneys that pass through the DOR space. While these are possible migration routes for carbon monoxide, BEH staff believe the most likely area where products of combustion related to the furnace appears to be the interior wall space where carbon monoxide was captured and distributed into the fourth floor.

Hole in Wall of Air Mixing Room near Fourth Floor Reception That Allows for Air to be Drawn from The Wall Cavity above the Furnace Room
