INDOOR AIR QUALITY ASSESSMENT

**Agassiz Elementary School
20 Child Street
Jamaica Plain, MA**

Prepared by:
Massachusetts Department of Public Health
Bureau of Environmental Health
Indoor Air Quality Program
September 2009

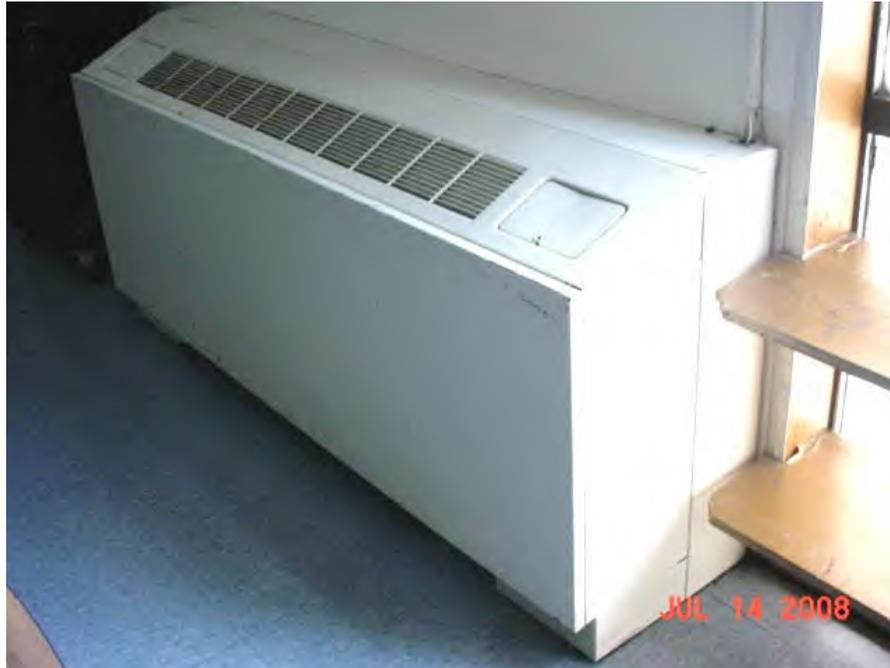
Picture 5

Fan coil units (FCU) in each classroom facilitate airflow and provide temperature control (Picture 5). FCUs do not provide fresh air to rooms; rather, they re-circulate air and provide auxiliary heating and cooling as needed. A FCU draws air from the room through an intake located at the base of the unit. Air is filtered and conditioned by a coil, then distributed back to the room through an air diffuser atop the unit (Figure 1). Each FCU is controlled by a switch with settings for “low”, “medium”, “high”, and “off” (Picture 6). Filters for a number of FCUs were occluded with dust (Picture 7); many filters were also falling out from the bottom of FCUs due to missing/damaged brackets (Picture 8). Filters that cannot be placed into brackets cannot provide adequate filtration. In a number of areas, FCUs were found deactivated and/or obstructed by furniture, books and other stored materials (Picture 9). In order for FCUs to facilitate airflow as designed, air diffusers and return vents must remain free of obstructions. Importantly, these units must remain “on” and be allowed to operate while rooms are occupied.

Classroom FCU

6. Operate FCUs during periods of school occupancy to facilitate airflow in classrooms.
7. Close classroom doors to maximize air exchange.
8. Consider adopting a balancing schedule of every 5 years for all mechanical ventilation systems, as recommended by ventilation industrial standards (SMACNA, 1994).

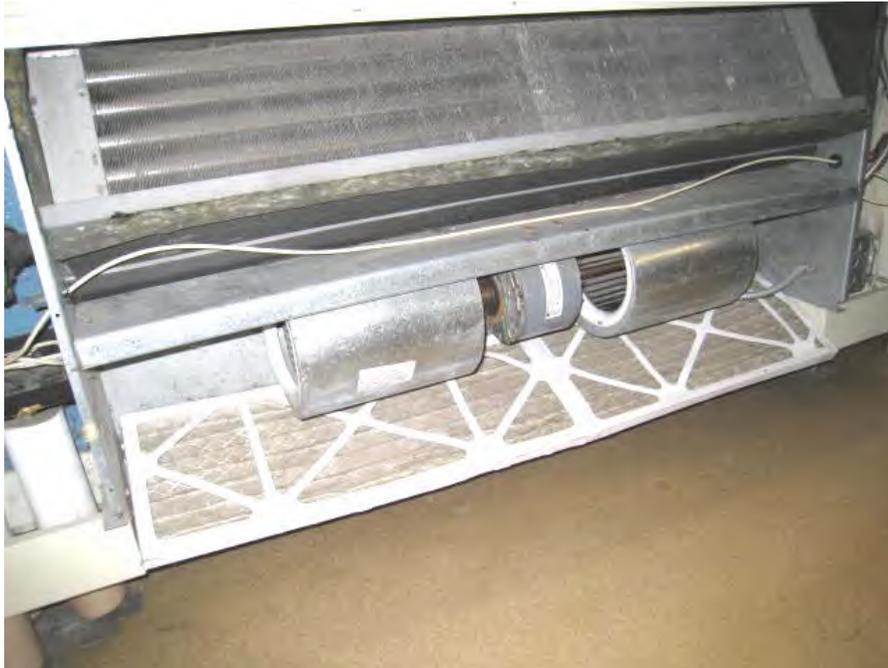
Picture 7

Occluded filter, note that filter is sitting in FCU and off floor

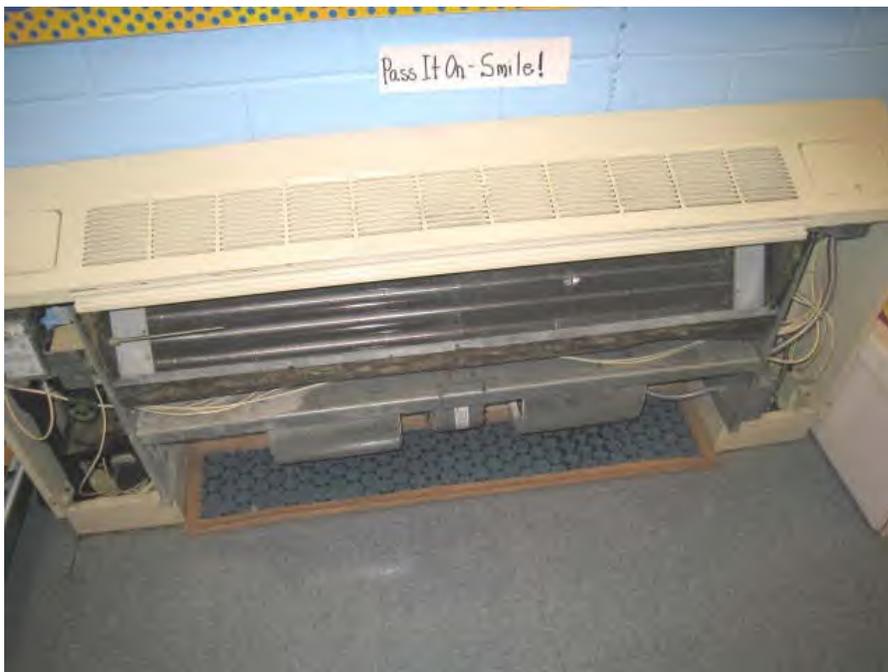
Picture 8

Filter sitting on floor due to missing brackets

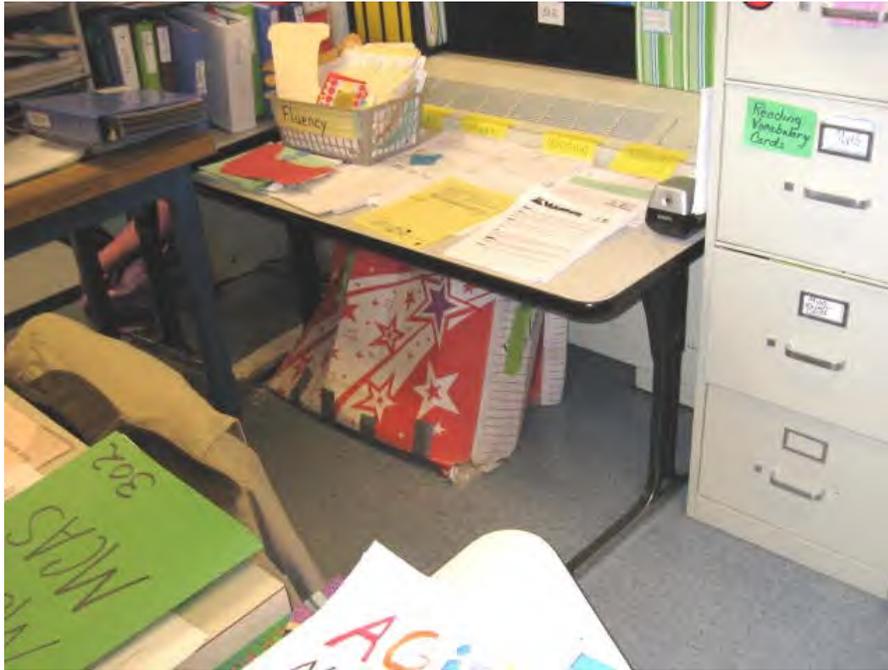
Picture 9

Items placed in front of FCU

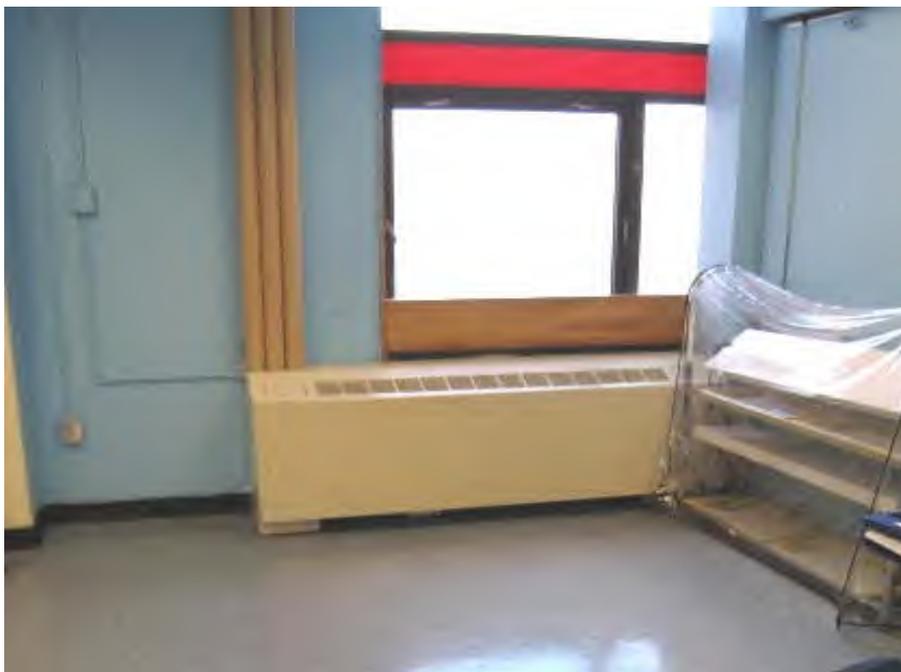
Picture 10

Supply and return heating system pipes connected from FCU to ceiling instead of along walls

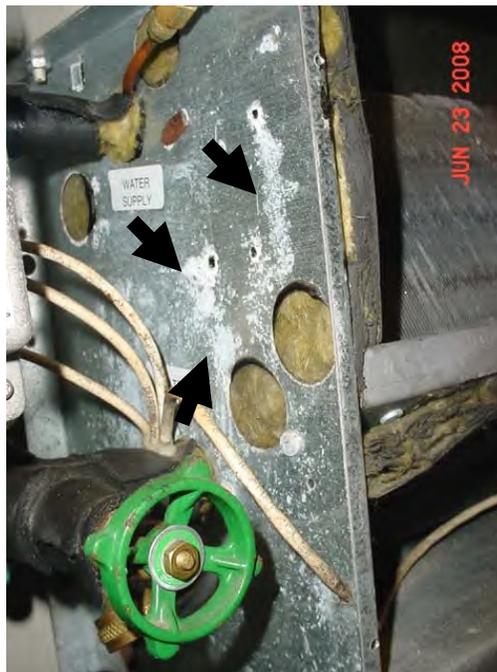
Picture 12

FCU insulation losing adherence to surfaces, resulting in condensation

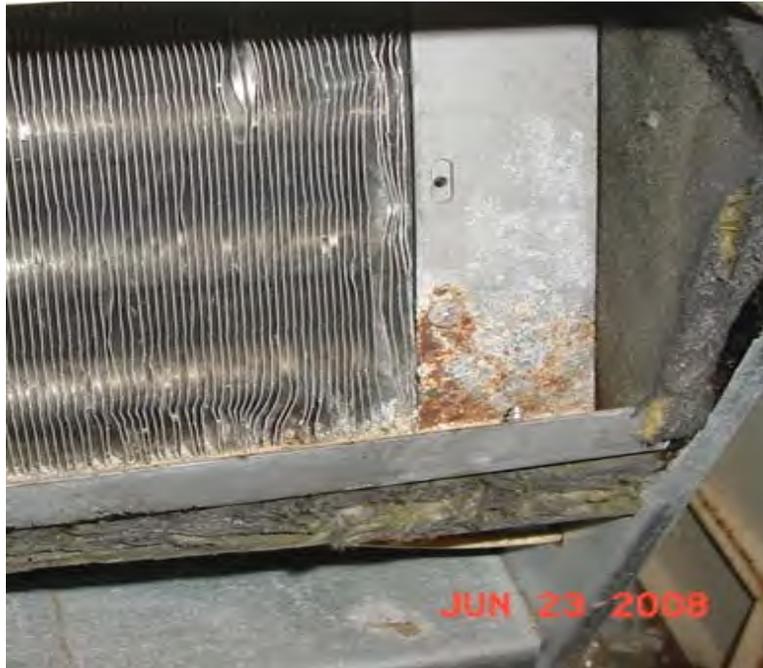
Picture 13

Damaged FCU insulation

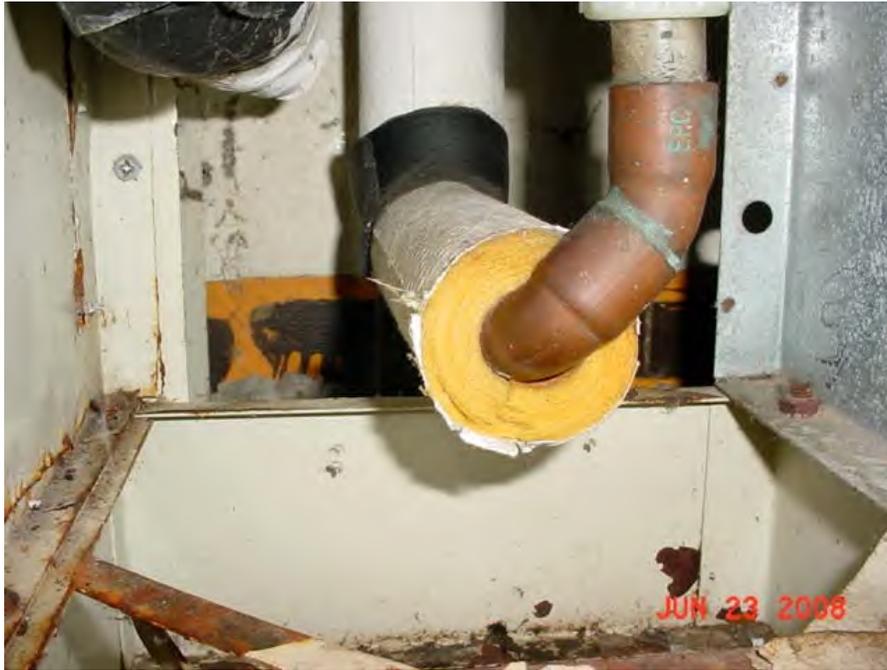
Picture 15

FCU cabinets appeared to be rusting and degrading (Picture 15), indicating frequent exposure to moisture. During the July 14, 2008 assessment, BEH staff observed condensation collected on the surfaces of a number of FCUs in classrooms (Picture 16), which can damage the exterior of the cabinet. Condensation generated on the surface can indicate that the FCU is operating at a temperature below the dew point. Raising the FCU temperature would reduce condensation generated on the FCU surface.

Rusting below insulated pipes

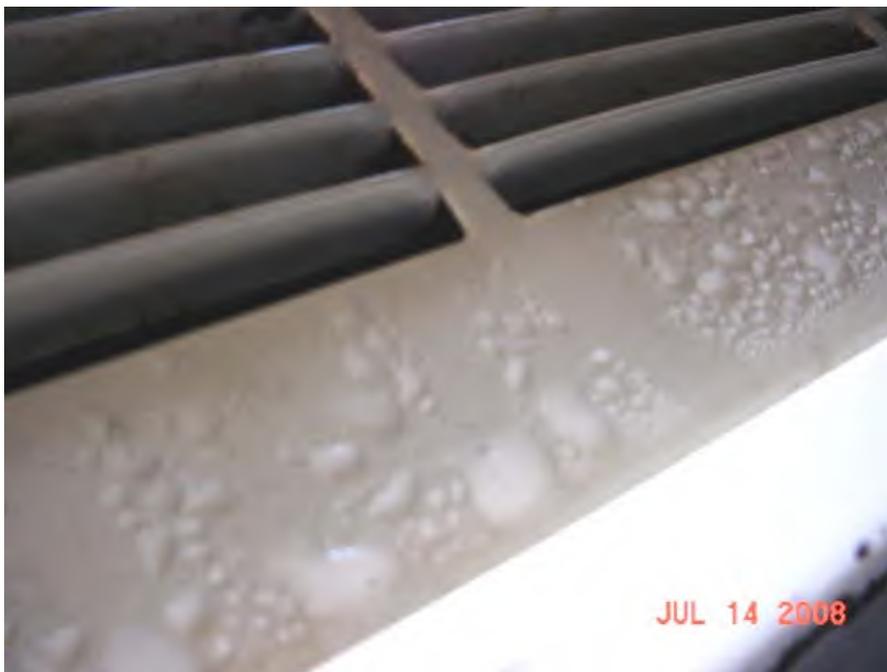
Picture 16

Condensation on surface of FCU

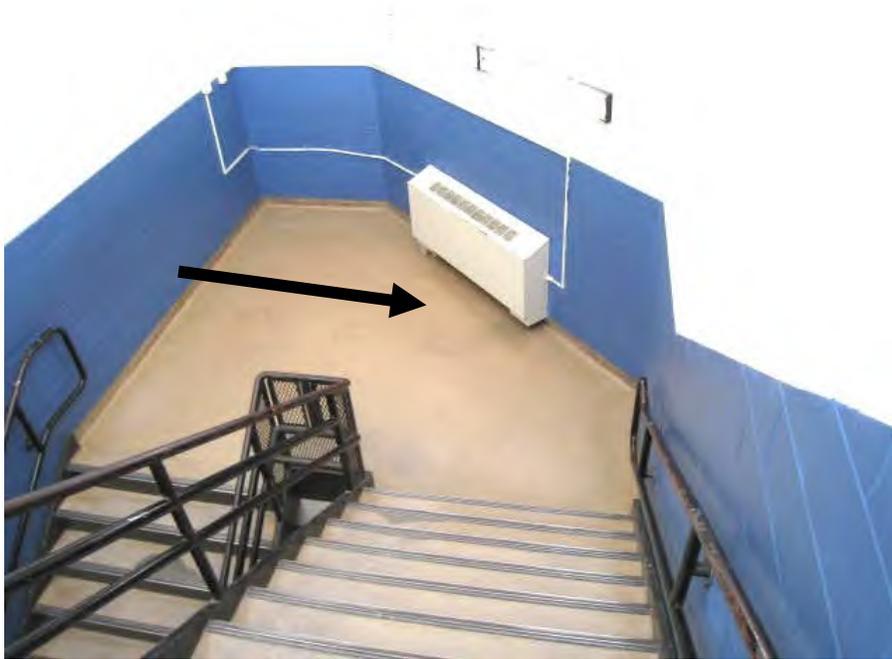
Picture 17

The floor below FCUs located in the stairwells appeared to have water staining, indicating that water had pooled on the floor as a result of condensation generated during hot, humid weather (Picture 17). As previously discussed, insulation within the FCUs was observed to be damaged and deteriorated, which can result in the formation of condensation within the units. This can result in damage to the interior of the FCU cabinet.

FCU in stairwell with floor stained from water leaking

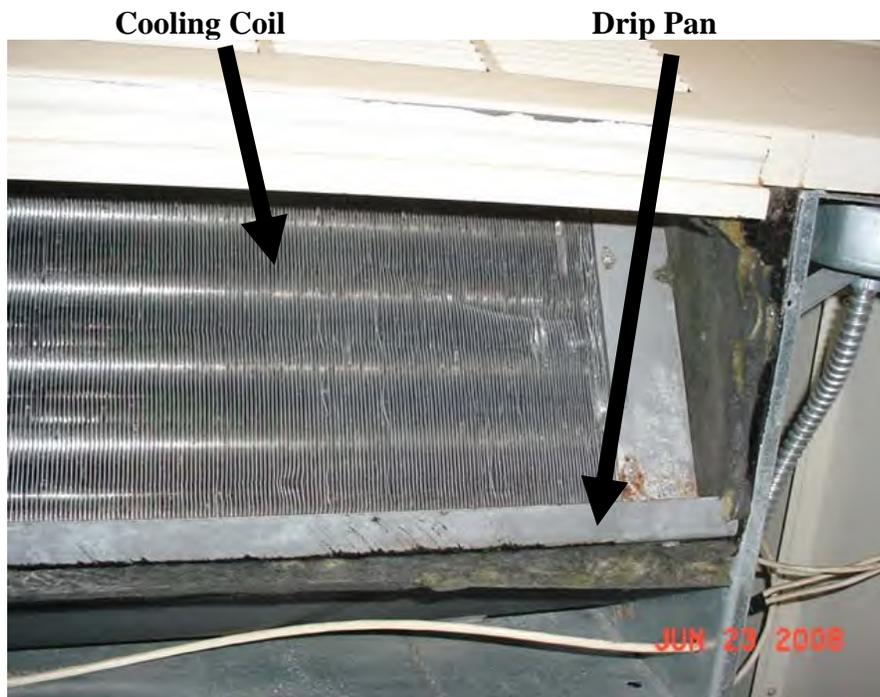
Picture 18

Several AES employees reported to BEH staff that musty odors emanated from the FCUs when the units were activated. BEH staff found accumulated debris in drip pans, which serves as a source of microbial growth and suggests that the units are not routinely cleaned (Pictures 18 and 19). When a FCU operates in the cooling mode, drip pans collect and drain the condensation that accumulates on the coils. A drip pan below the coils directs water through a drain pipe to an auxiliary drain pan (Picture 19). Over time, drip pans can collect debris. Lack of/or damaged insulation in turn, causes condensation, which has resulted in moistening and rusting of the cabinet interior. Drip pans should be cleaned regularly to prevent accumulation of debris and ensure proper drainage; they should also be properly insulated. This type of on-going maintenance serves to prevent deterioration and ensure integrity of the drainage system.

FCU cooling coil and debris in drip pan

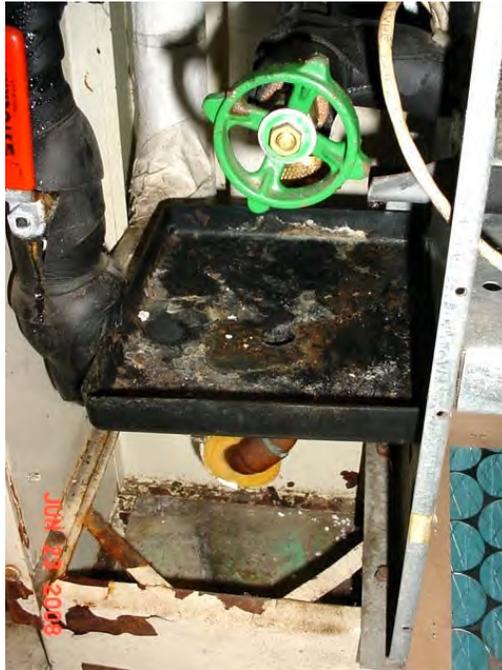
Picture 19

Auxiliary drain pan, note debris in pan, lack of insulation on copper drain pipe elbow, rust on cabinet components and water staining on floor of cabinet

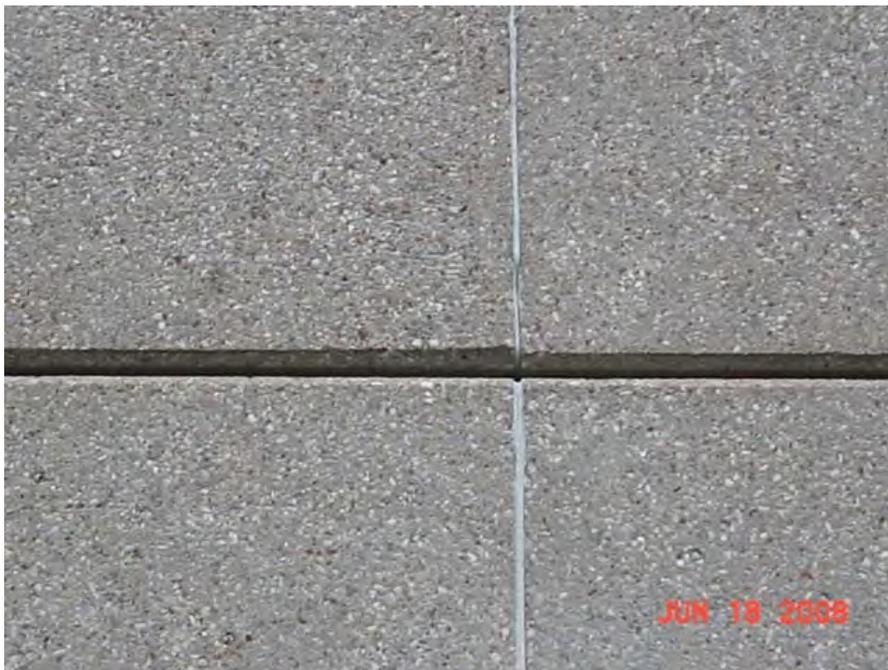
Picture 20

The building's exterior wall consists of metal window frames with stone panels secured to a steel frame. A space was observed between the window frames and panel joints where water can collect (Picture 20). Over time, water pooling in these joints have corroded the window frames, evident by water staining below the windows (Pictures 21 and 22). In some areas, the window frame exterior appeared damaged, allowing moisture-laden air to move into the building and further contributing to water penetration (Picture 23). Water intrusion through the building exterior coupled with the aforementioned condensation produced as a result of the window configuration (i.e., single-pane glass framed in metal) has resulted in the deterioration of the

Spaces between stone panels

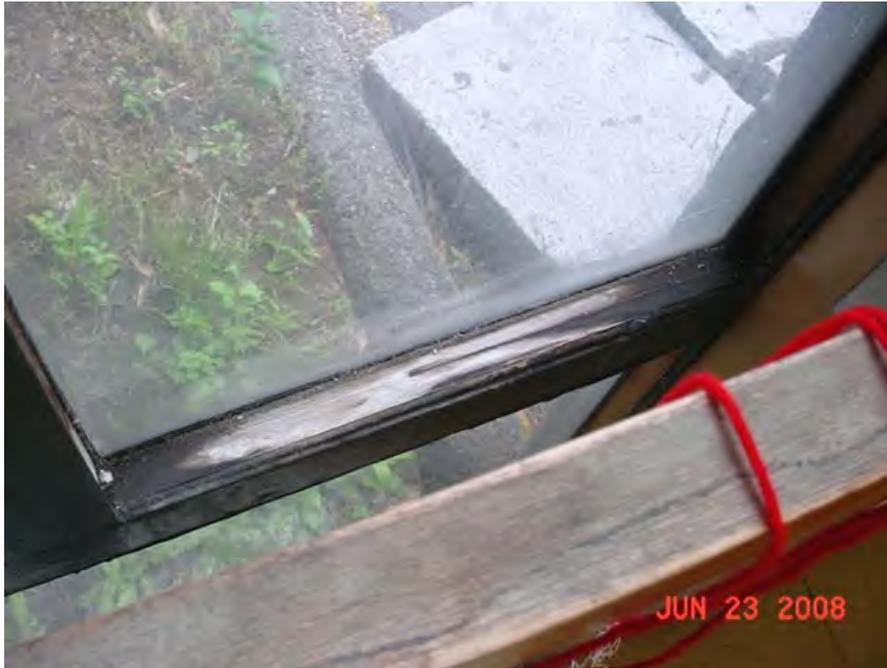
Picture 21

Water damaged stained window frame wood

1. Remove/replace original, water-damaged wood sills from the base of all windows if wood is water stained or materially degrading.
2. Operate both supply and exhaust ventilation continuously during periods of school occupancy to maximize air exchange.

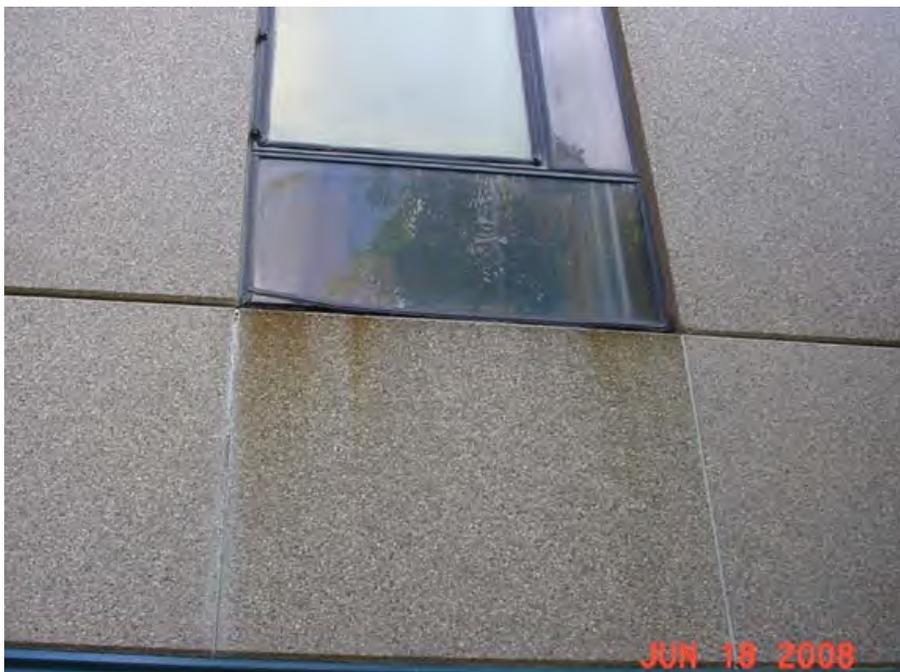
Picture 22

Staining from rainwater, note damaged window frames

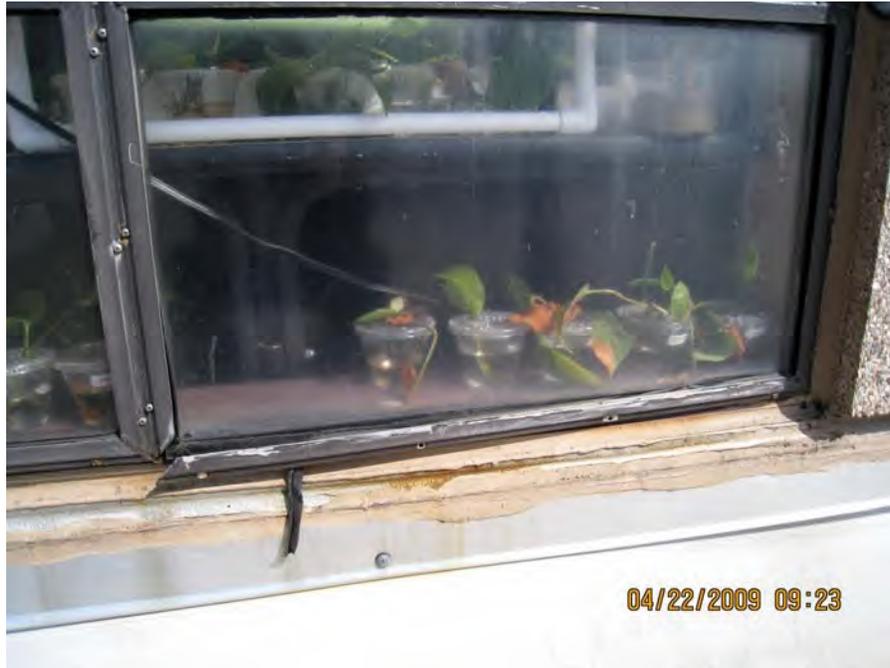
Picture 23

Damaged window frame

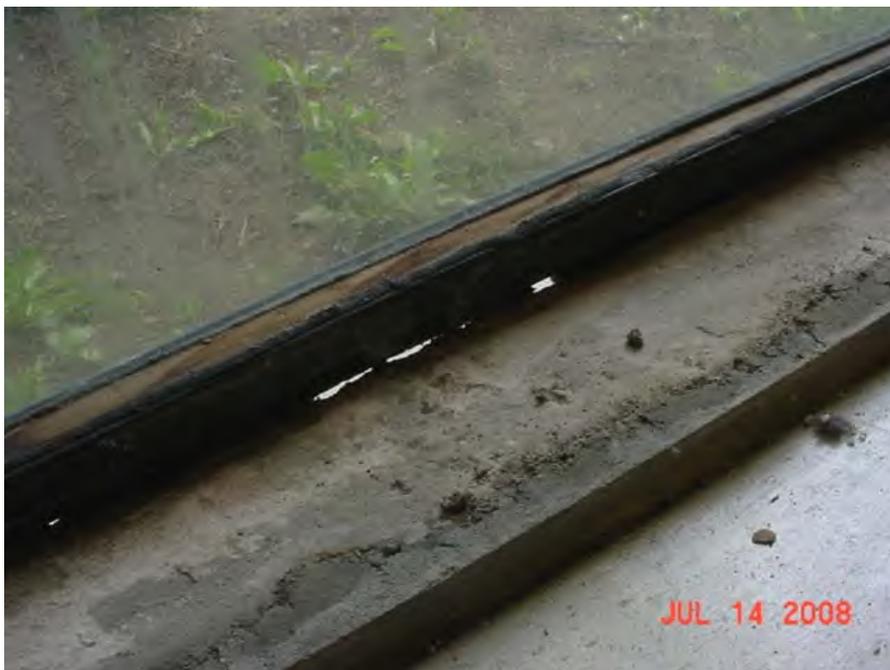
Picture 24

window system. As discussed previously, wooden window sills showed signs of rot due to chronic exposure to moisture. Where wooden window sills have been removed, spaces could be observed in the window's metal frame, window glass was cracked/broken, and caulking was missing/damaged (Pictures 24 and 25); these conditions can be attributed to water penetration to the building as well as creating another pathway for water to enter the building. During the December 11, 2008 assessment, precipitation was observed to be penetrating into the building through window frames.

Breach in window frame where wooden sill was removed

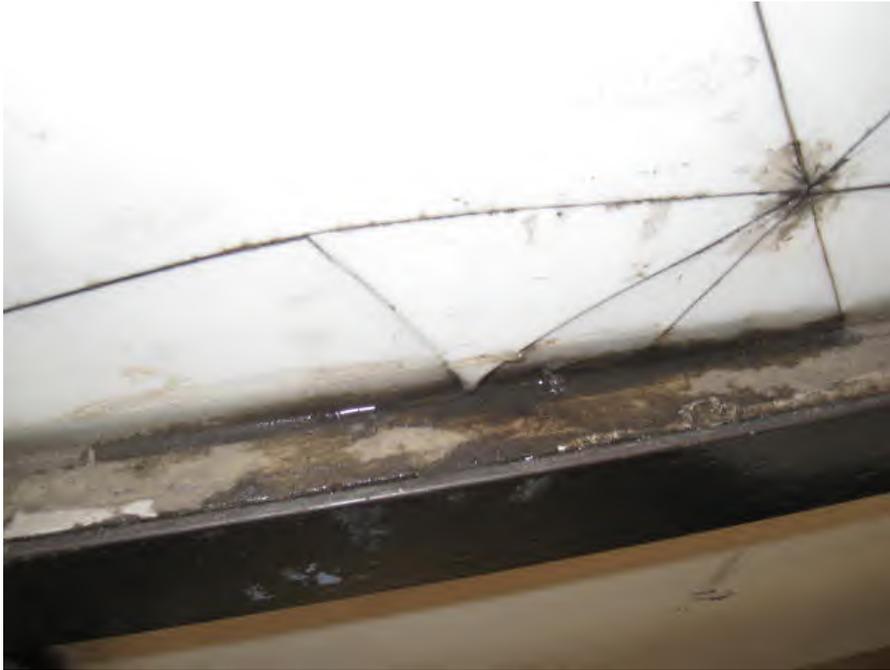
Picture 25

Hole in window frame, broken glass, water penetration

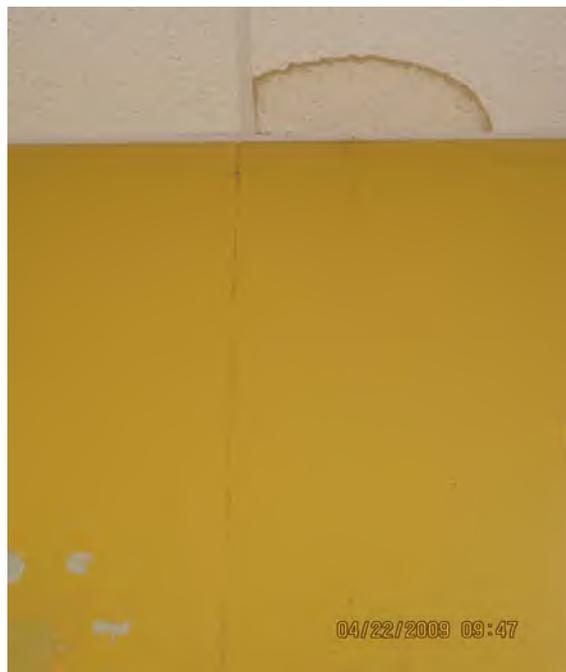
Picture 26

Furthermore, under certain weather conditions (i.e., wind-driven rain), water can penetrate through the panel joints into the building. Ceiling tiles along the exterior wall were water damaged (Picture 26), and walls along the exterior exhibited water staining and efflorescence (Pictures 26 to 28). Efflorescence is a characteristic sign of water damage to brick and mortar, but it is not mold growth. As moisture penetrates and works its way through mortar, brick or plaster, water-soluble compounds dissolve, creating a solution. As the solution moves to the surface of the material, the water evaporates, leaving behind white, powdery mineral deposits. Such water related damage was observed primarily in west-facing classrooms (i.e., kindergarten areas).

Water damaged ceiling tile and water staining of wall

13. Ensure leaks are repaired. Remove/replace water damaged ceiling tiles. Examine the areas above and around for mold growth. Disinfect areas of water leaks with an appropriate antimicrobial.

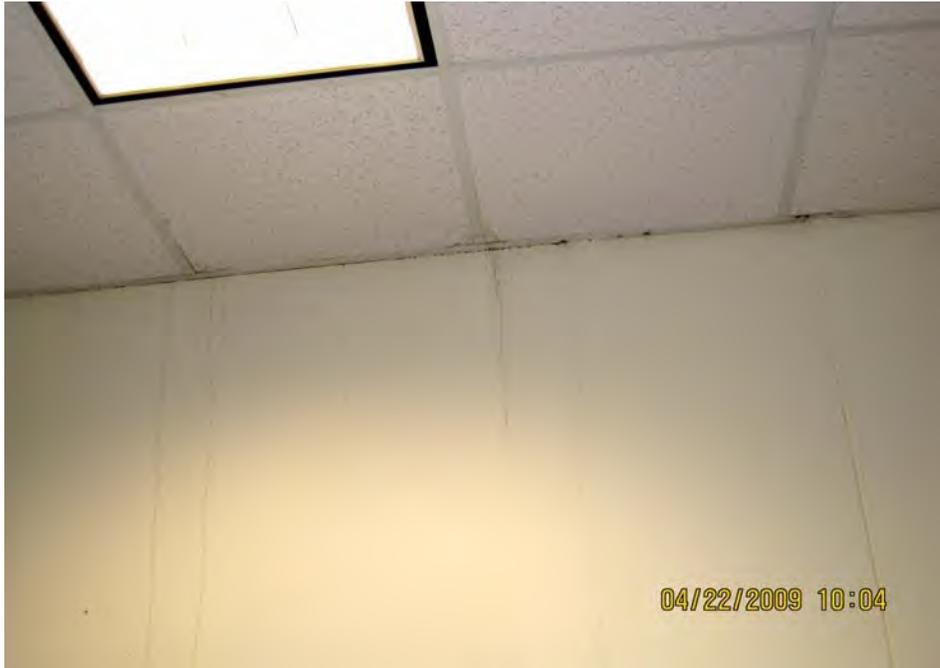
Picture 27

Water drip stains down wall

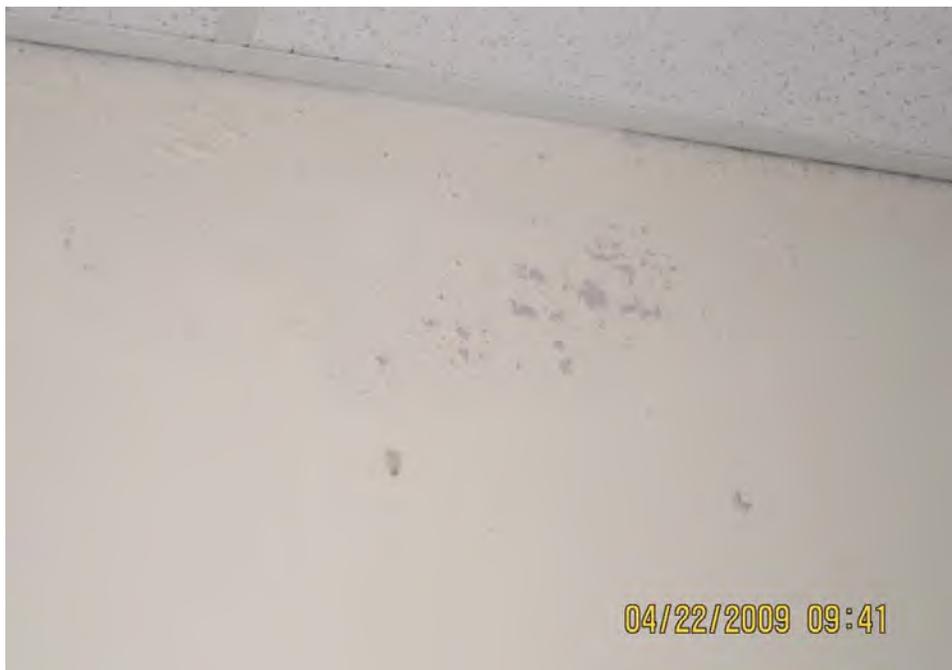
Picture 28

Efflorescence and peeling paint

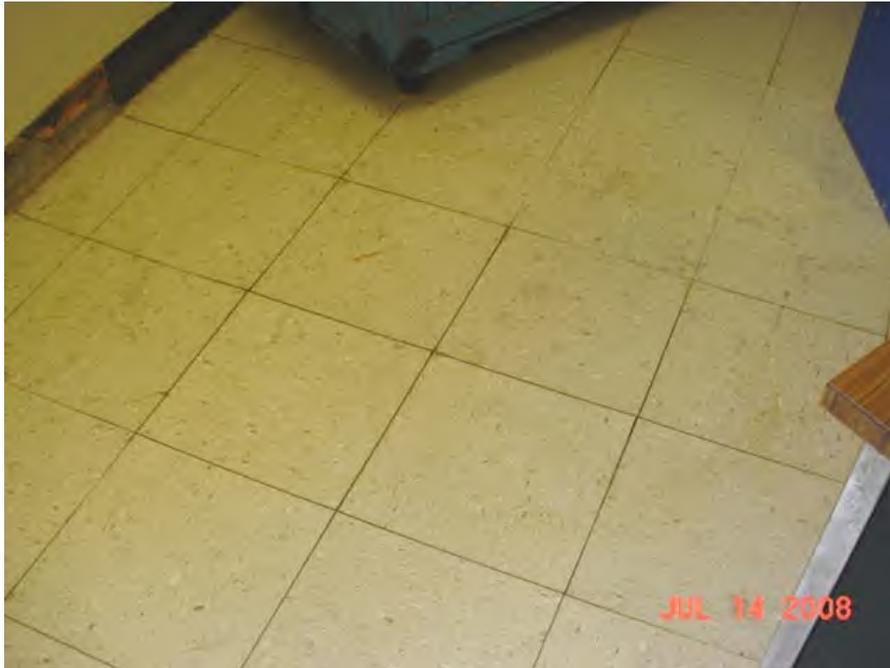
Picture 29

During the July 14, 2008 assessment, BEH staff observed a number of water stained and displaced floor tiles in first floor kindergarten classrooms (Pictures 29), located at the western side of the building. Standing water was observed in one classroom (Picture 30). Water is often reported to appear around floor plugs in this area (Picture 31), suggesting that this area may have a high water table. Along the exterior, water staining around the building apron indicates that water may be pooling against this side of the building (Picture 32). Since this portion of the

Stained/lifting floor tiles

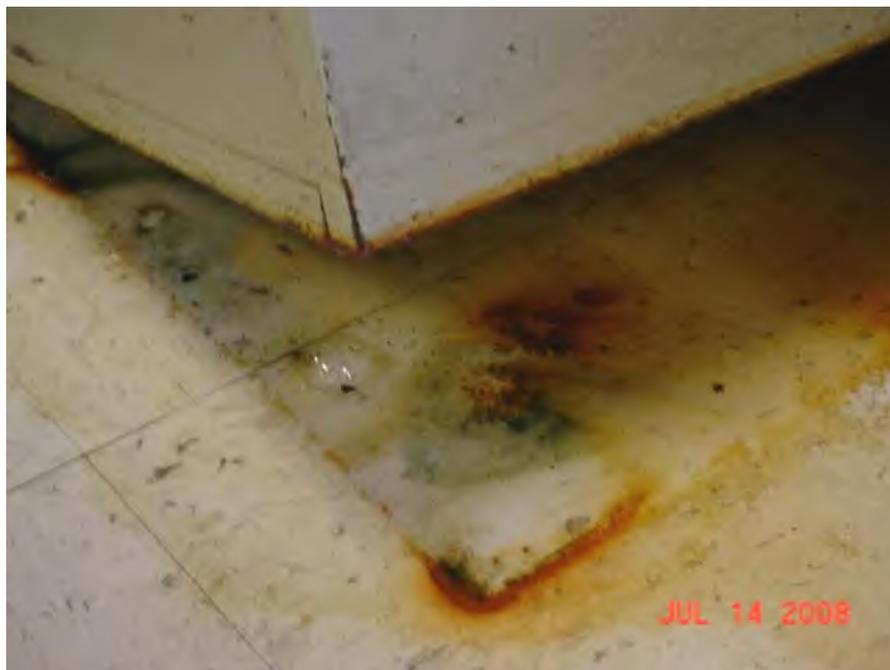
Picture 30

Standing water on floor beneath filing cabinet

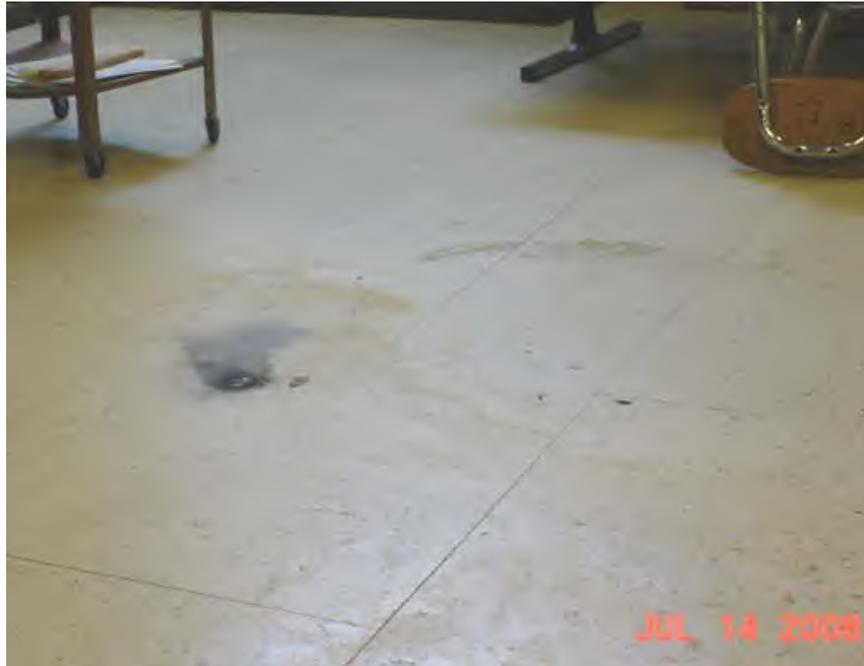
Picture 31

Plug in floor, note staining indicating water leakage

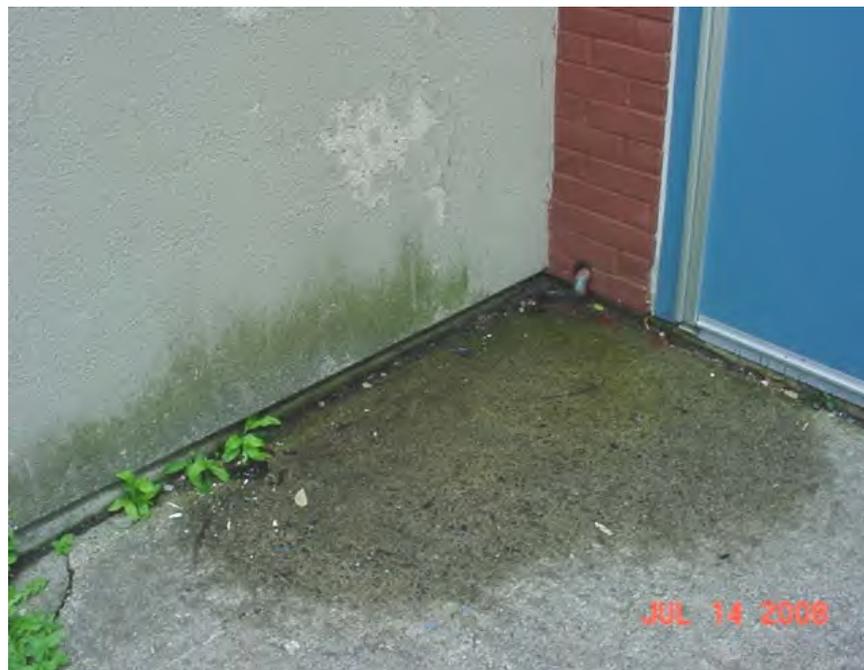
Picture 32

building resides on a cement slab foundation, it is likely that water pooling against the building filtrates through the slab and ultimately enters the classrooms.

Signs of water pooling against the building

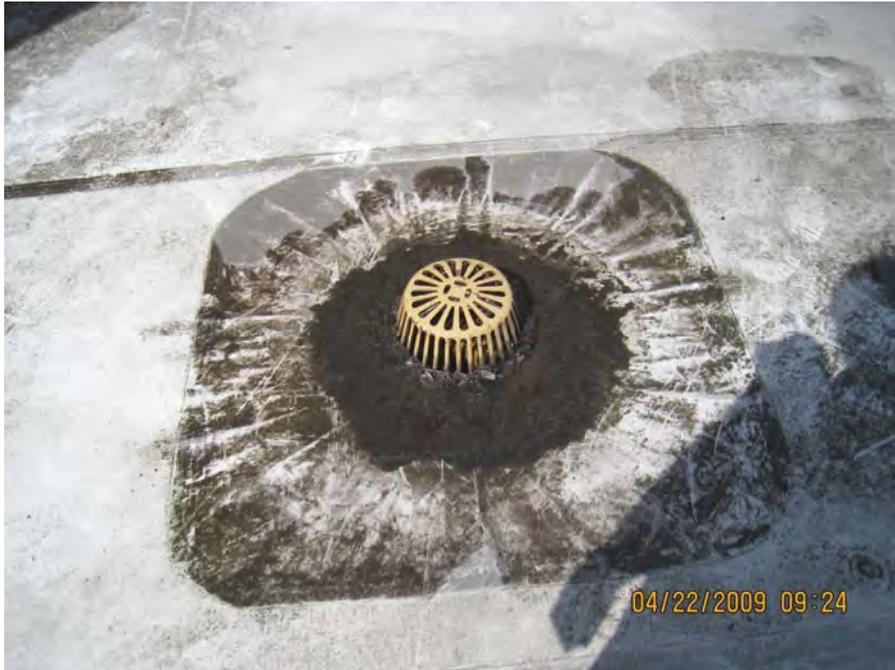
Picture 33

An examination of the roof conducted on April 22, 2009 revealed pooling water in a number of areas, including areas around clogged roof drains (Picture 33) and areas lacking drainage, especially near the sloped roofs of stairwells (Picture 34). Where water was pooling at the base of the sloped stairwell roofs, BEH staff observed peeling paint, efflorescence, and cracks to ceiling and wall plaster in stairwells within the building (Picture 35). Accumulated dirt/debris on the roof (Picture 36) has also resulted in plant growth. It appears that attempts have been made to reseal/tape holes/tears to the roof; however, some roof patches did not appear to be adhering (Picture 37). Freezing and thawing of pooling water during winter months can further damage the roof, causing leaks and subsequent water penetration to the interior of the building. Pooling water can also become stagnant, which can lead to mold and bacterial growth or serve as a breeding ground for mosquitoes.

Clogged roof drain

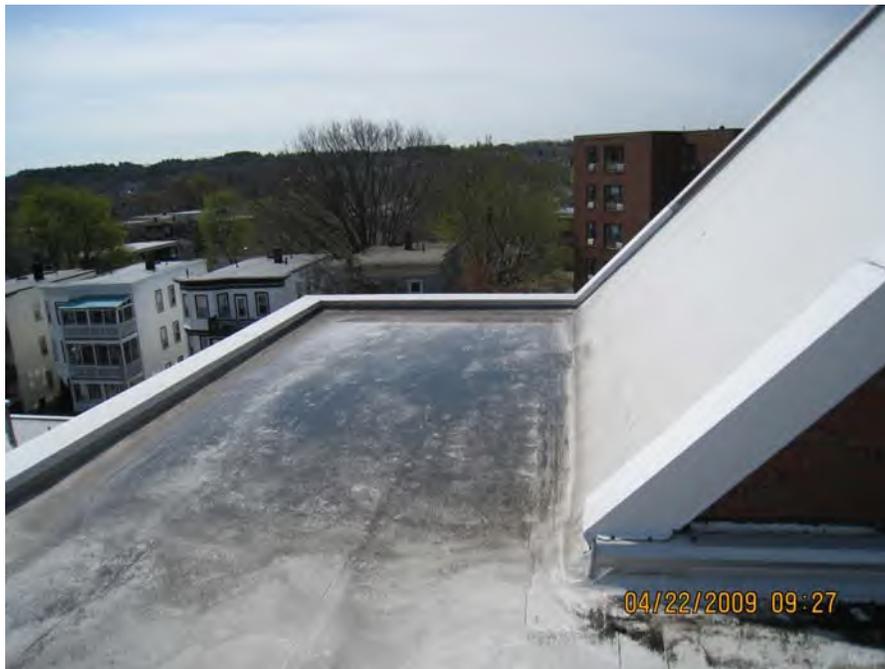
Picture 34

Accumulated water on roof below slope

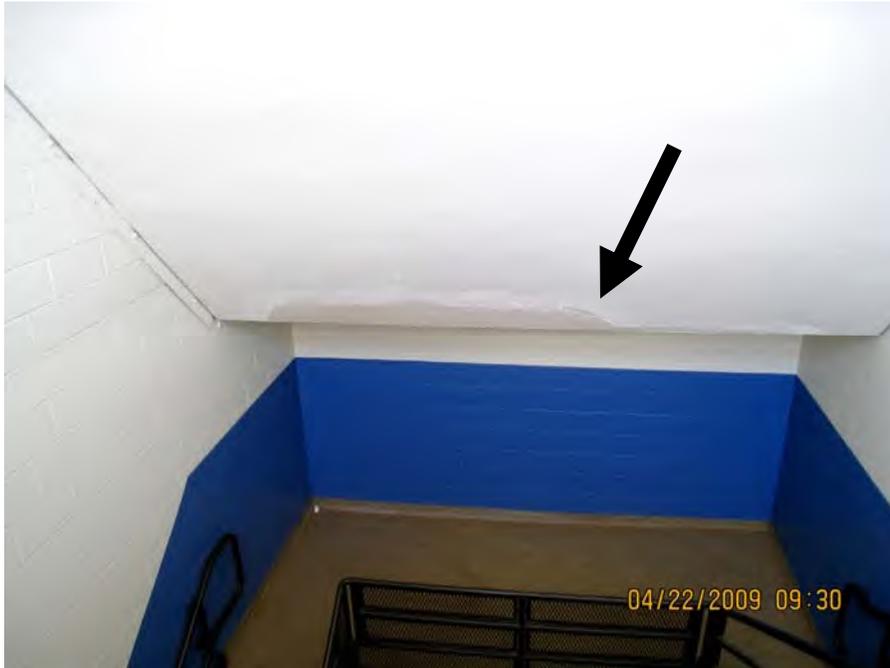
Picture 35

Efflorescence around Plaster Patch, corresponds to pooling water noted in Picture 34

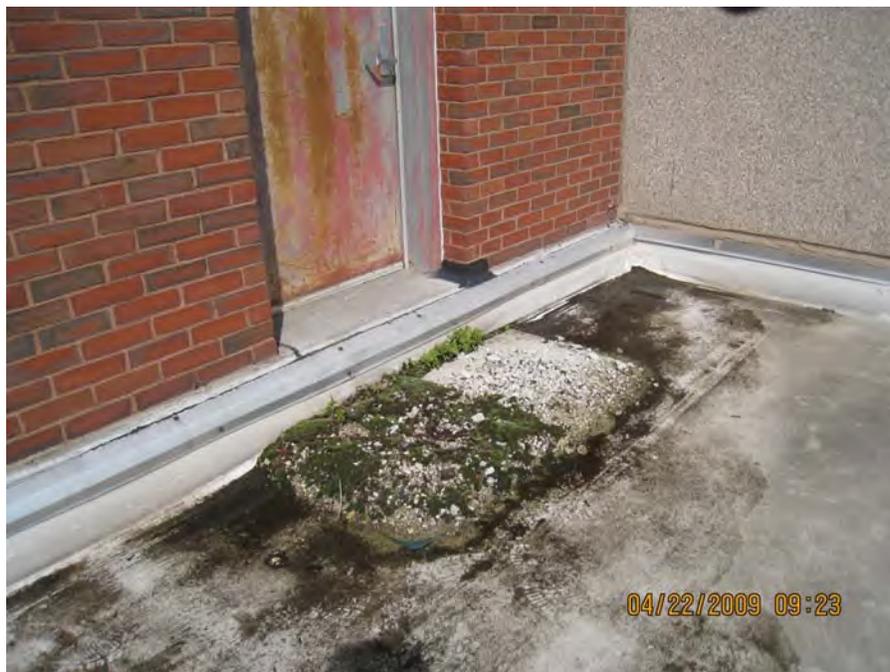
Picture 36

Accumulated materials on roof, note plant growth

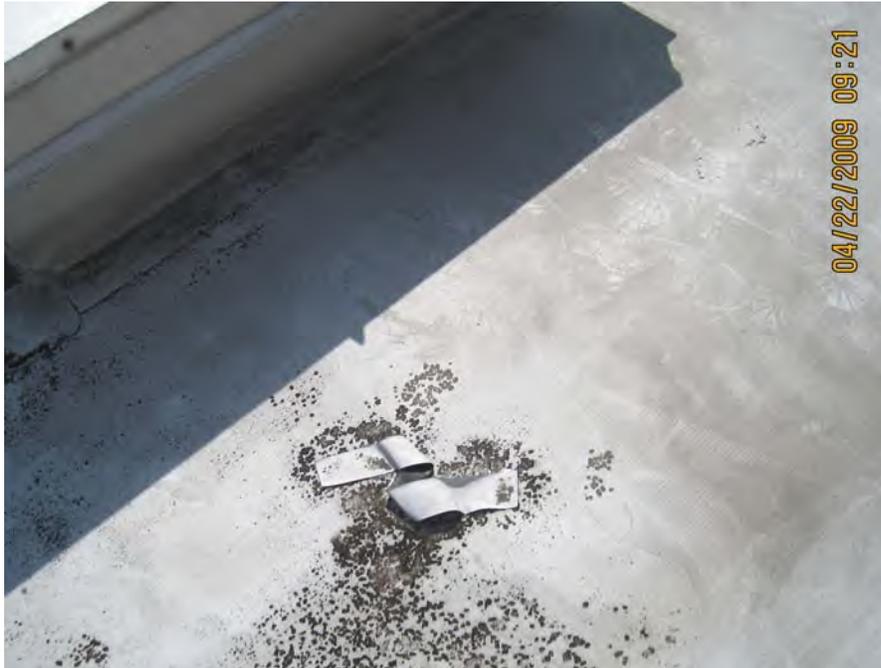
Picture 37

Lifted repair sections on roof

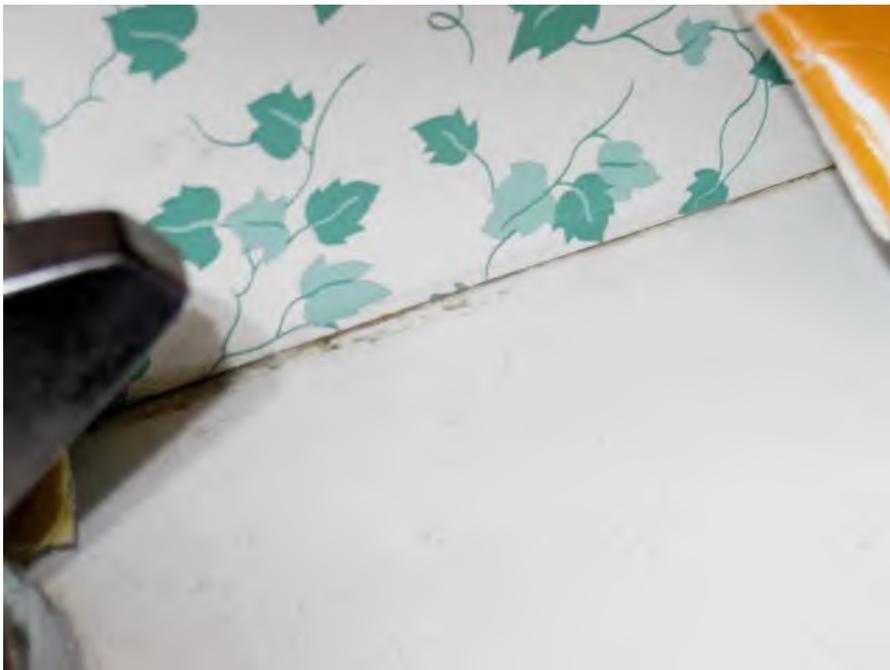
Picture 38

Open seams between sink countertops and walls were observed in several rooms (Picture 38). If not watertight, water can penetrate through the seam, causing water damage. Improper drainage or sink overflow can lead to water penetration into the countertop, cabinet interior and areas behind cabinets. Water penetration and chronic exposure of porous and wood-based

materials can cause these materials to swell and show signs of water damage. Repeated moistening of porous materials can result in mold growth.

Example of open seam between sink countertops and walls

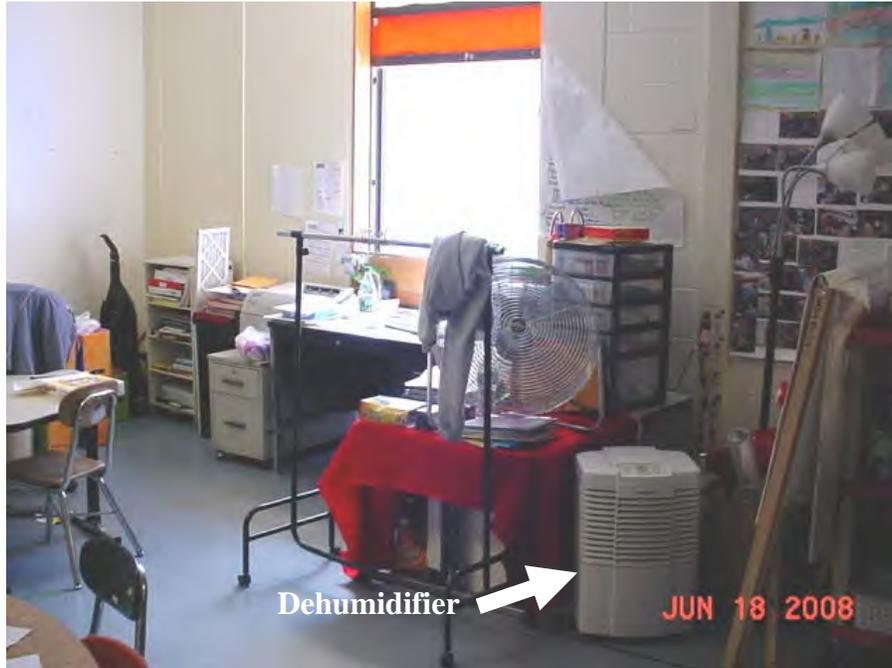
Picture 39

A dehumidifier was observed in classroom 101 (Picture 39). The occupant and/or maintenance staff should periodically examine, clean, and disinfect the unit as per the manufacturer's instructions to prevent mold/bacterial growth and associated odors, especially in the dehumidifier's condensation collection bucket. This dehumidifier was found operating with the classroom window *open*. Dehumidifiers should not be operating with the windows open since the moisture would be drawn *into* the classroom from the outdoors. Having windows open defeats the purpose of removing moisture from the room.

Dehumidifier operating with the window open

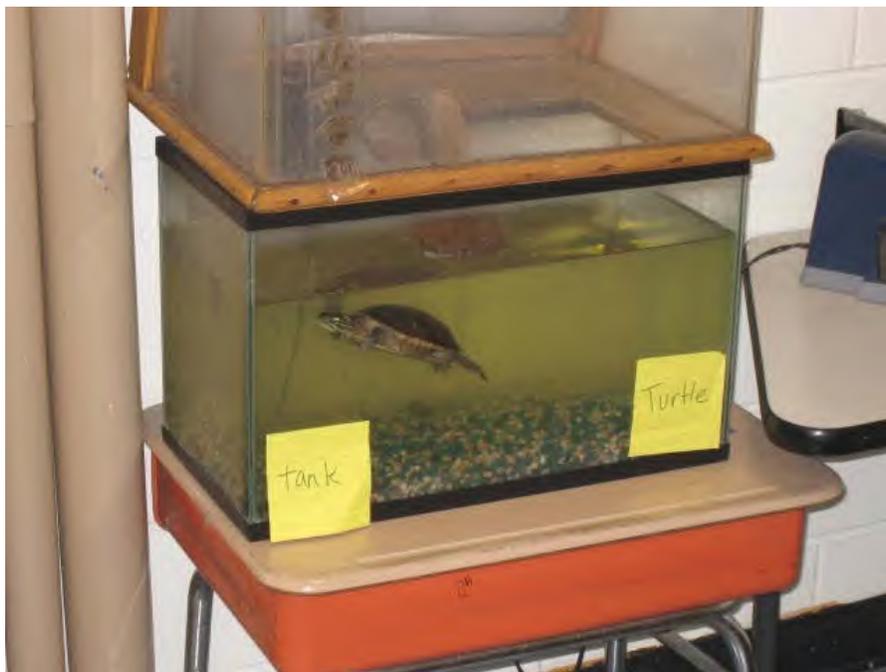
Picture 40

Aquarium appearing green with growth

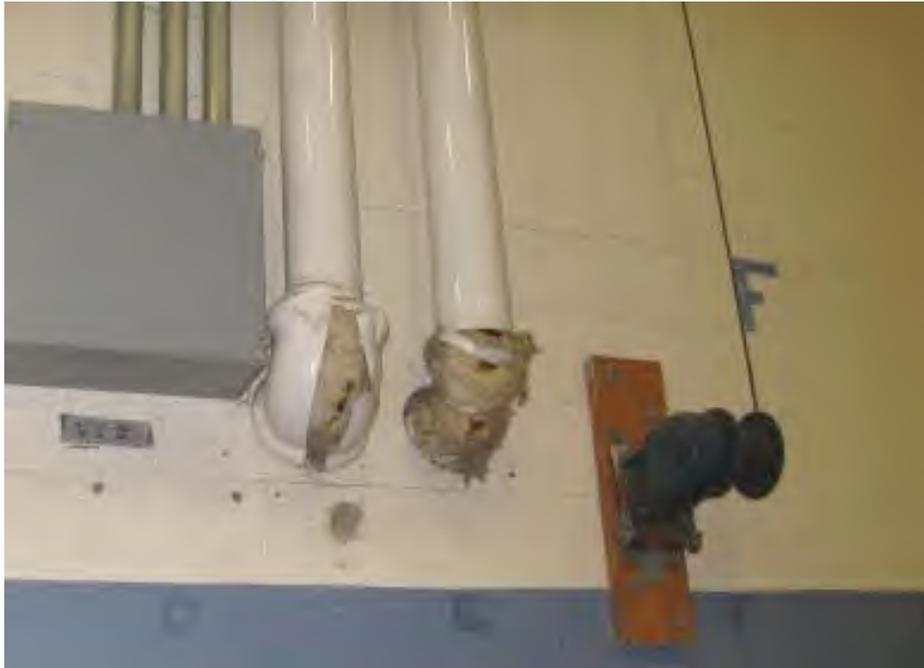
Picture 43

Exposed and/or damaged fiberglass insulation was observed around pipes in the gym (Picture 43), as well as around duct work in the AHU room and the aforementioned FCUs. Exposed fiberglass insulation can provide a source of eye, skin and respiratory irritation. Damaged insulation should be repaired to prevent aerosolization.

Exposed fiberglass insulation
