INDOOR AIR QUALITY ASSESSMENT

**Agassiz Elementary School
20 Child Street
Jamaica Plain, MA**

Prepared by:
Massachusetts Department of Public Health
Bureau of Environmental Health
Indoor Air Quality Program
September 2009

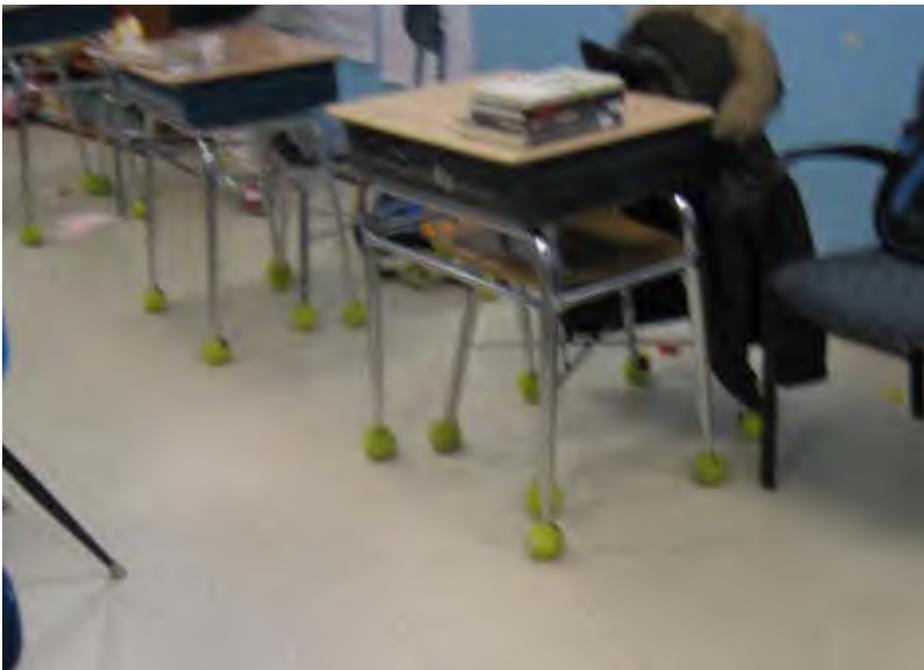
Picture 44

source of respiratory irritants. Constant wearing of tennis balls can produce fibers and off gas VOCs. Tennis balls are made with a natural rubber latex bladder, which becomes abraded when used as a chair leg pad. Use of tennis balls in this manner may introduce latex dust into the school environment. Some individuals are highly allergic to latex (e.g. spina bifida patients) (SBAA, 2001). It is recommended that the use of materials containing latex be limited in buildings to reduce the likelihood of symptoms in sensitive individuals (NIOSH, 1997). A question and answer sheet concerning latex allergy is attached as Appendix D (NIOSH, 1998).

Tennis Balls on Chair Legs

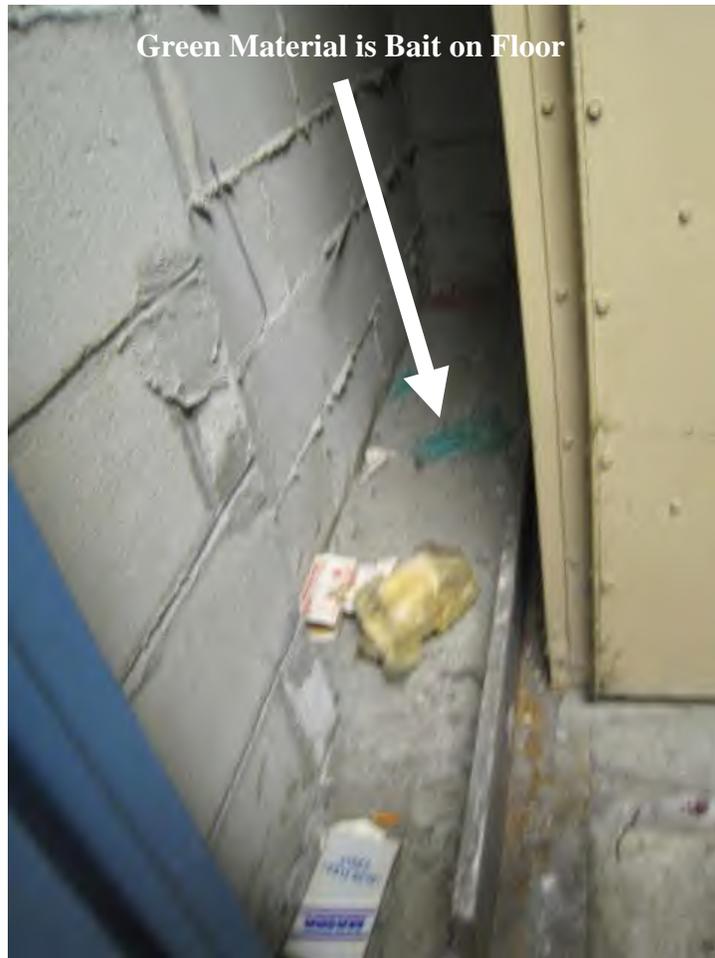
Picture 45

Bait traps in AHU room
