INDOOR AIR QUALITY ASSESSMENT

**Duxbury Middle School
71 Alden Street
Duxbury, Massachusetts 02332**

Prepared by:
Massachusetts Department of Public Health
Bureau of Environmental Health
Indoor Air Quality Program
December 2009

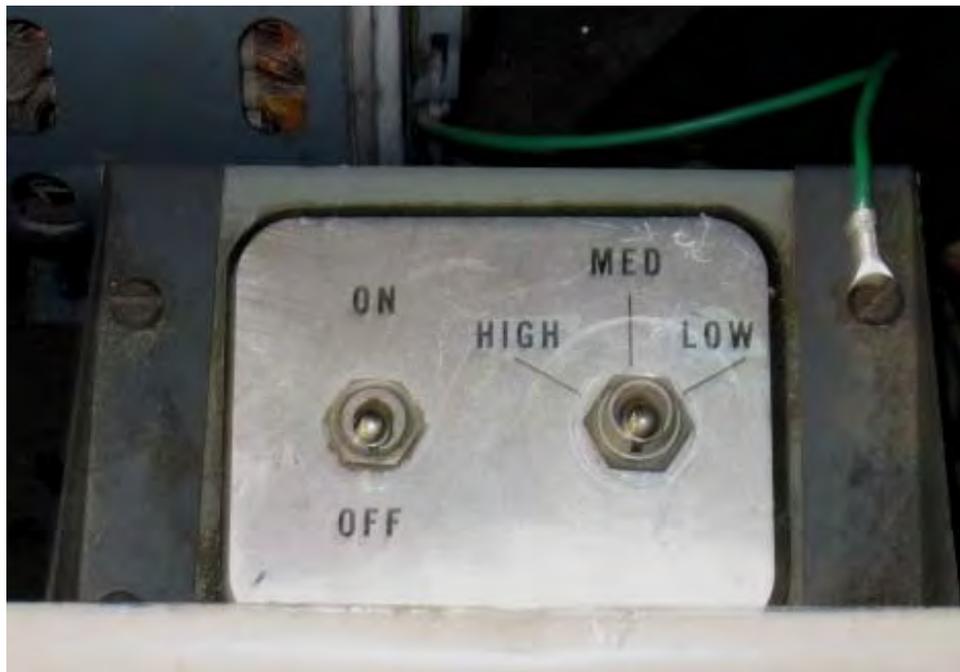
Picture 6

Univents have control settings of 'on or off' and 'low, medium or high' ([Picture 6](#)). Univents were found 'off' in many areas ([Table 1/Picture 6](#)); therefore, there was no means to provide mechanical ventilation to these classrooms at the time of the assessment. In several cases, univent fresh air intakes were sealed on the exterior of the building with plywood or cardboard and duct tape ([Pictures 7 and 8](#)). In order for univents to provide fresh air as designed, intakes/returns must remain free of obstructions. Importantly, these units must remain 'on' and be allowed to operate while rooms are occupied.

Univent Control Switches, Note Unit Switched to the “Off” Position

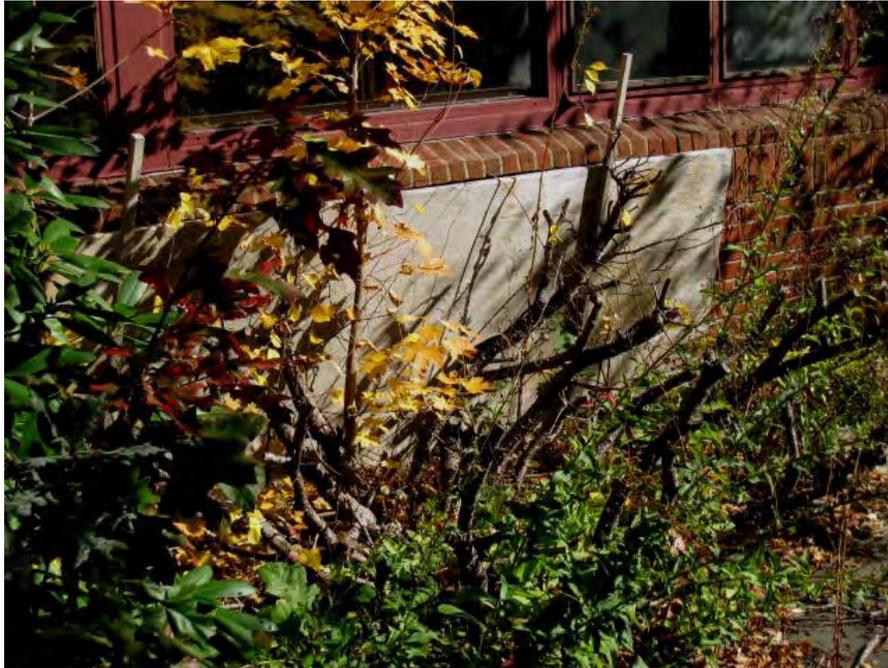
Picture 7

Univent Fresh Air Intake (in courtyard) Sealed With Plywood

3. Inspect exhaust motors and belts for proper function. Repair and replace as necessary.
4. Remove all blockages from univents and exhaust vents to ensure adequate airflow.

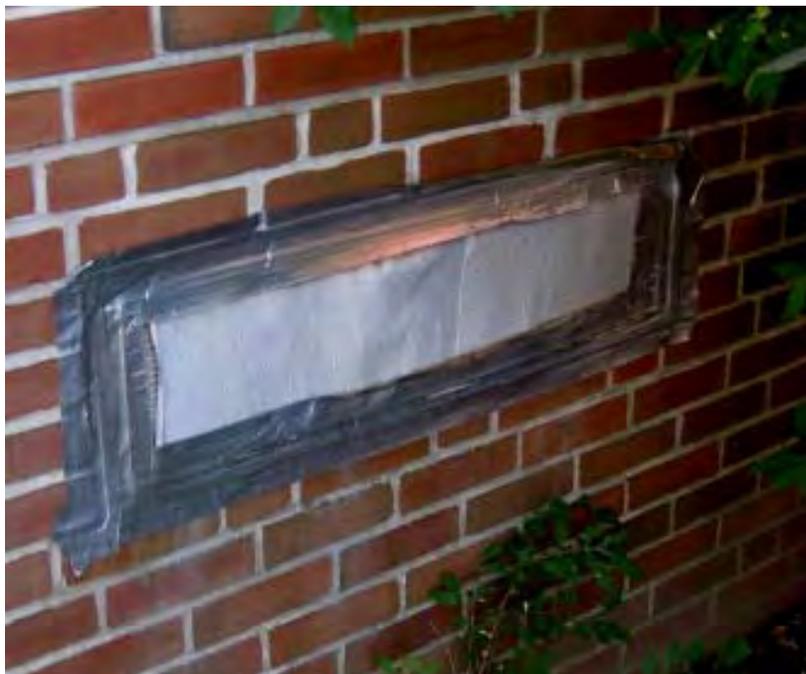
Picture 8

Univent Fresh Air Intake (along front of building) Sealed With Cardboard and Duct Tape

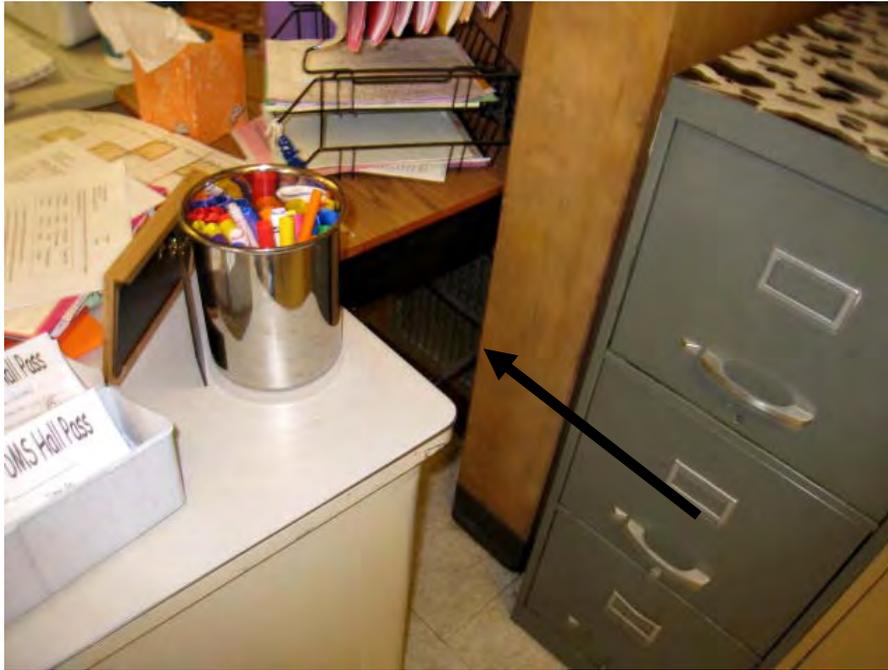
Picture 11

Exhaust Vent Obstructed by Classroom Furniture

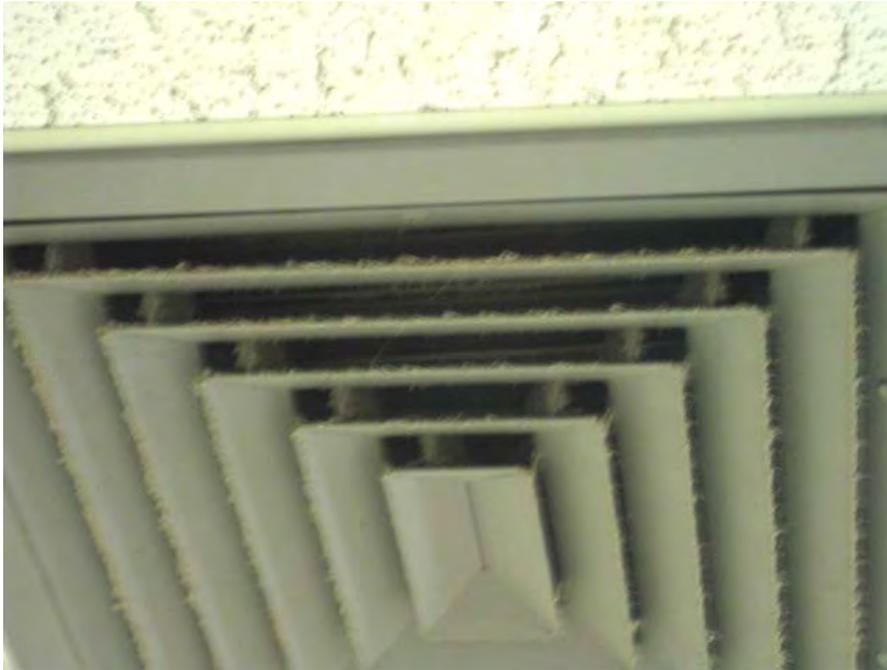
Picture 14

A number of air diffusers, exhaust/return vents and personal fans (Picture 14 through 16 and 42) were observed to have accumulated dust. If exhaust vents are not functioning, backdrafting can occur, which can re-aerosolize accumulated dust particles. Re-activated univents and fans can also aerosolize dust accumulated on vents/fan blades.

Ceiling-Mounted Supply Diffuser, Note Accumulated Dust/Debris

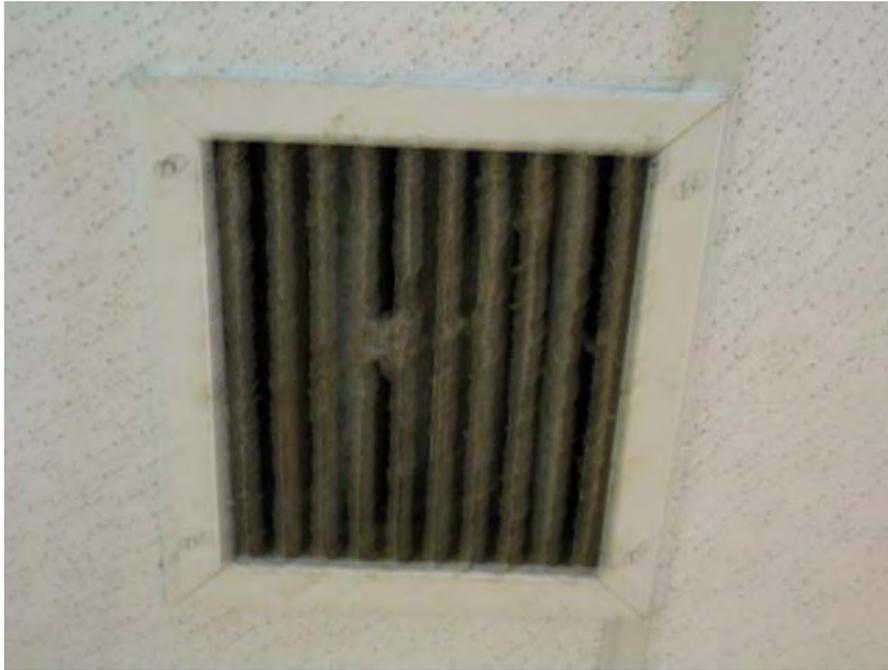
Picture 15

Ceiling-Mounted Return Vent, Note Accumulated Dust/Debris

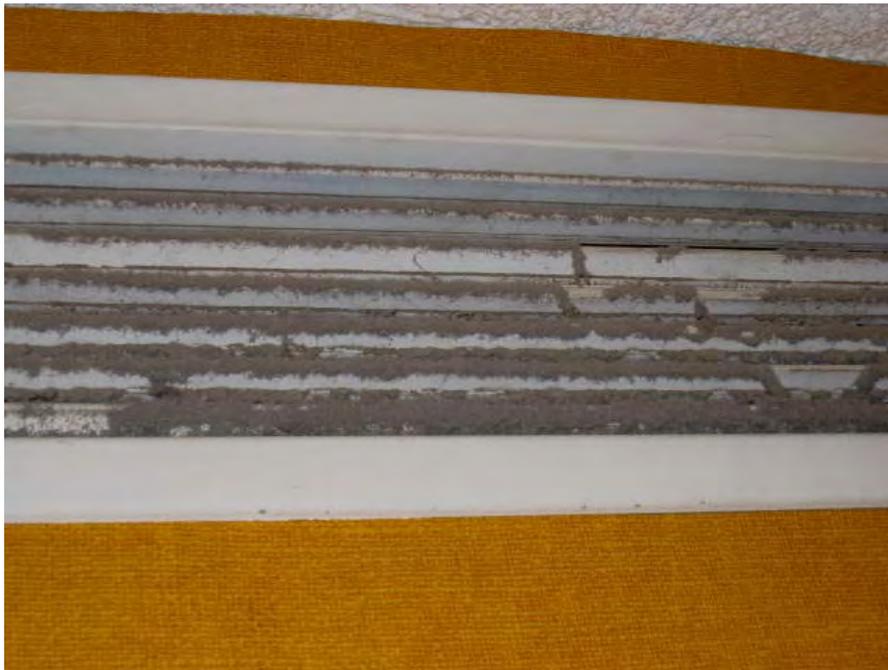
Picture 16

Wall-Mounted Return Vent, Note Accumulated Dust/Debris

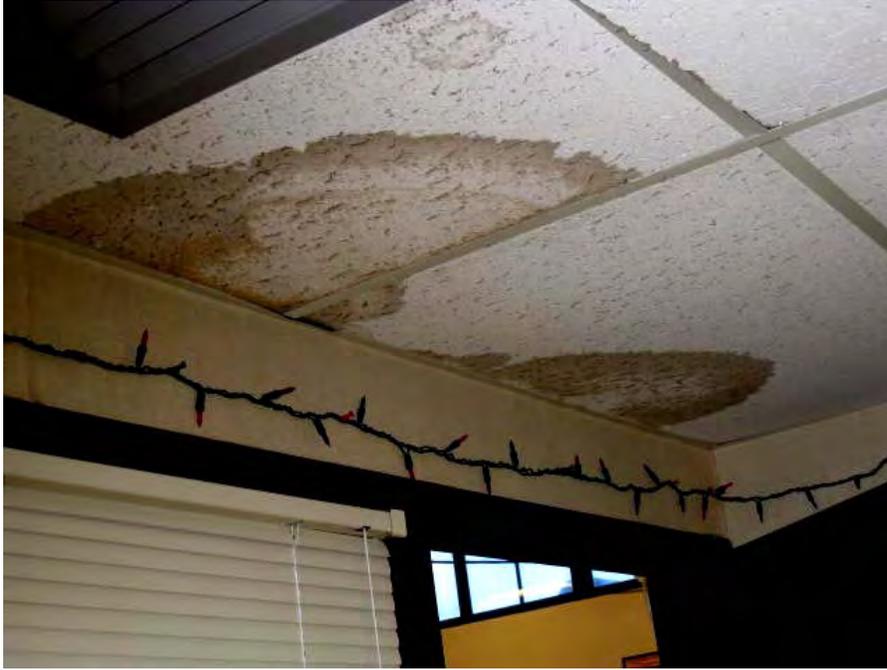
Picture 17

Water Damaged Ceiling Tiles in Classroom

10. Ensure roof/window/plumbing leaks are repaired and remove/replace any remaining water-stained ceiling tiles.
11. Move plants along the exterior of univent air intakes approximately 5-feet to prevent entrainment of pollen, moisture or mold.

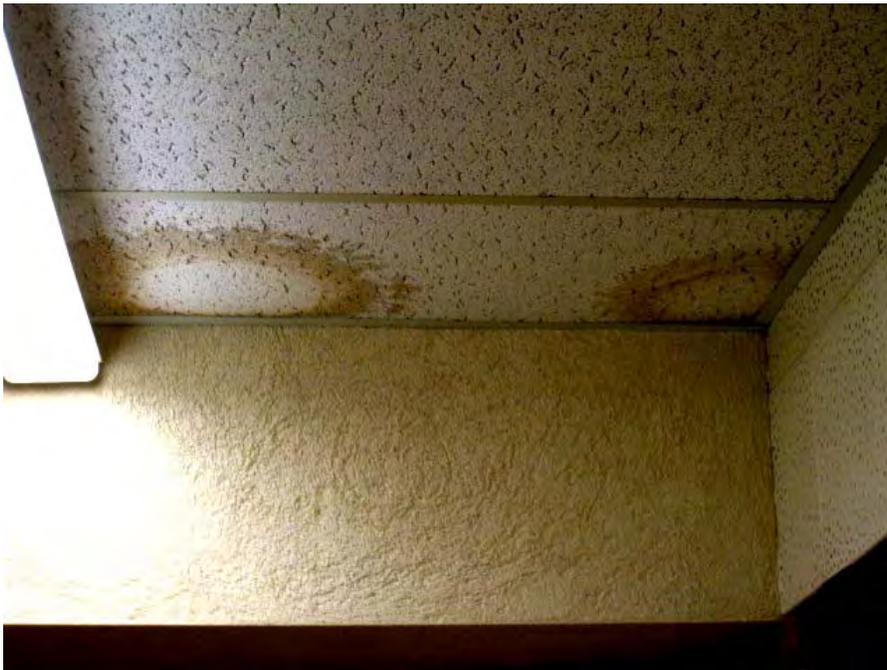
Picture 18

Water Damaged Ceiling Tiles

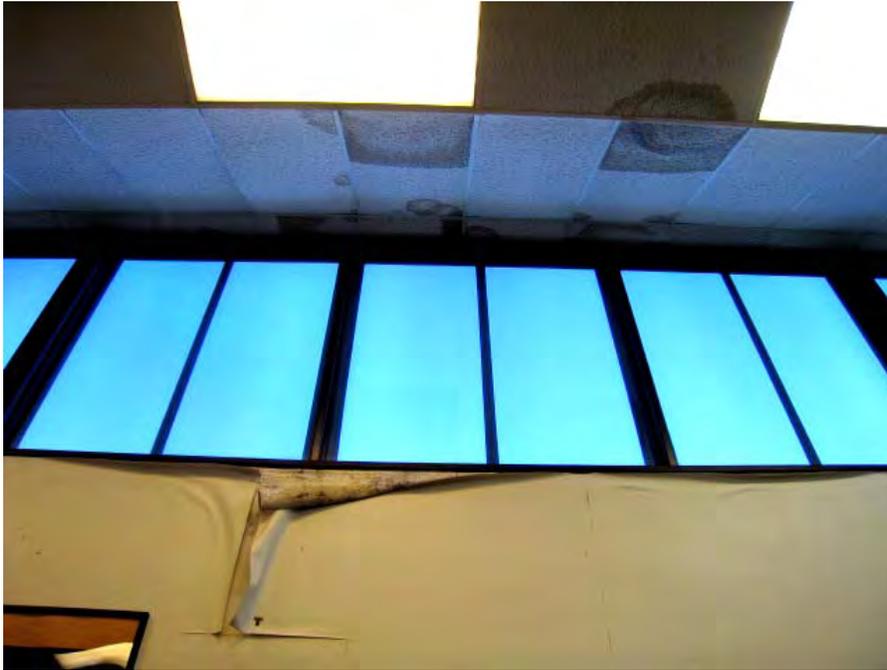
Picture 19

BEH staff also conducted moisture testing of water-damaged wallboard in the upper library, which was found to have elevated moisture content. Mr. Burgess reported that the library roof had been repaired over the summer of 2009. Chronic leakage was observed in the form of water damaged ceiling tiles and peeling vinyl wallpaper ([Pictures 19](#) through [21](#)). Although the leak has been repaired, the vinyl wall paper acts as a vapor barrier, trapping moisture behind it, causing it to peel, damaging wallboard beneath it and promoting mold growth. At the time of the assessment, BEH staff recommended that the damaged wallpaper and

Water Damaged Ceiling Tiles, Wallboard and Peeling Vinyl Wall Paper in the Upper Library

moistened wallboard be removed using the US Environmental Protection Agency (US EPA) guidance “Mold Remediation in Schools and Commercial Buildings”. In subsequent correspondence with Mr. Burgess, he reported that removal/replacement of the water damaged wallboard in the library was scheduled for the Veterans Day 2009 break.

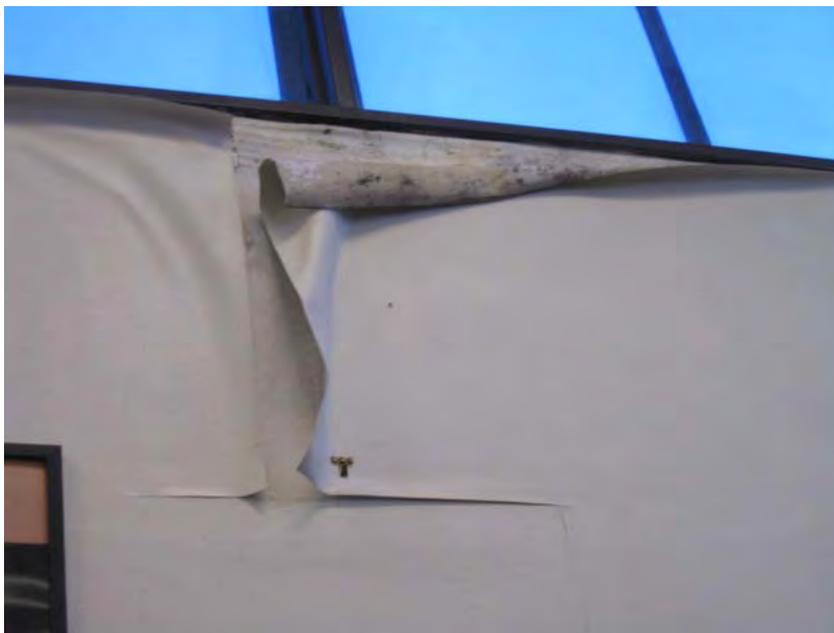
Picture 20

Water Damaged Wallboard and Peeling Vinyl Wall Paper in the Upper Library

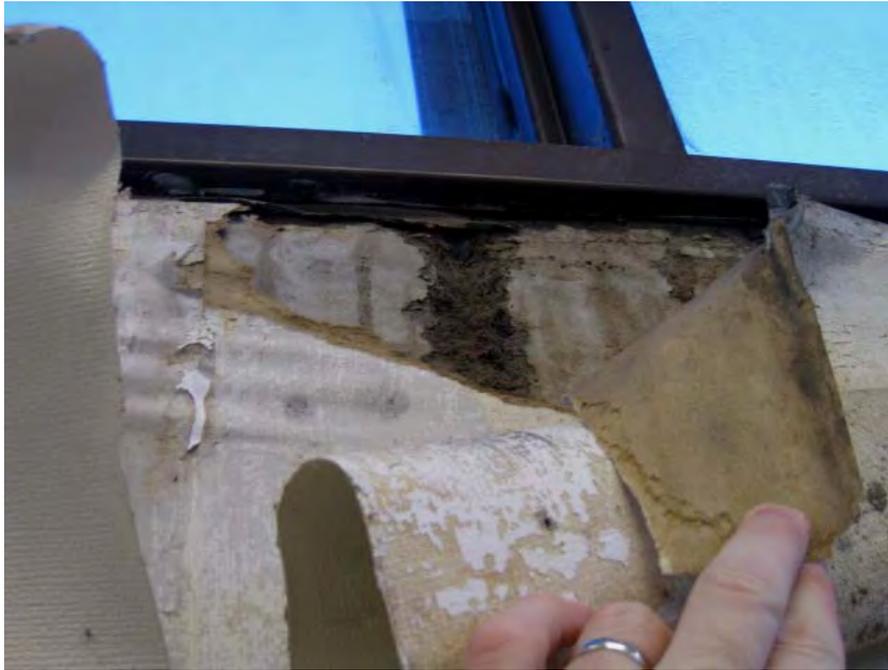
Picture 21

Close-Up of Water Damaged Wallboard in Upper Library

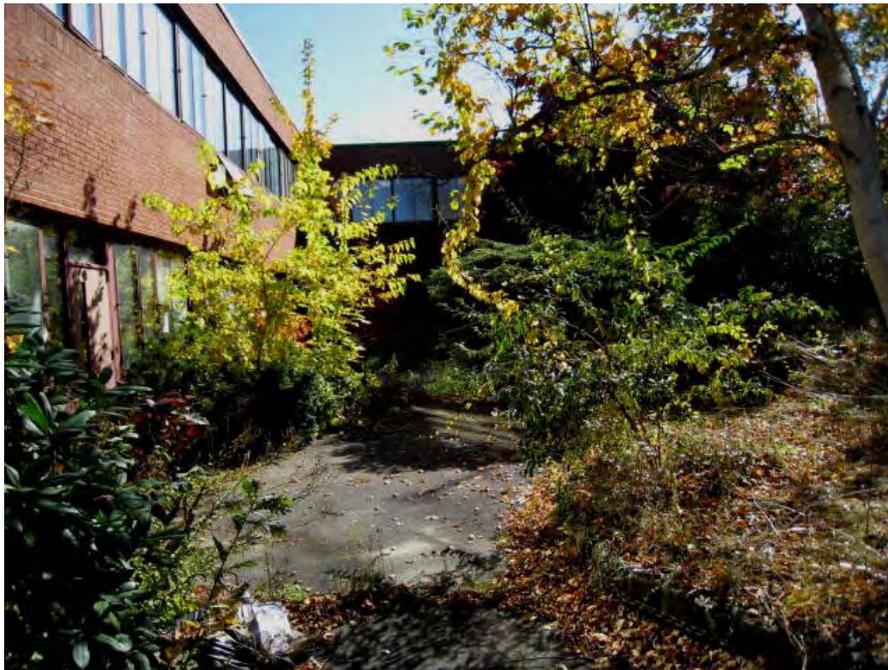
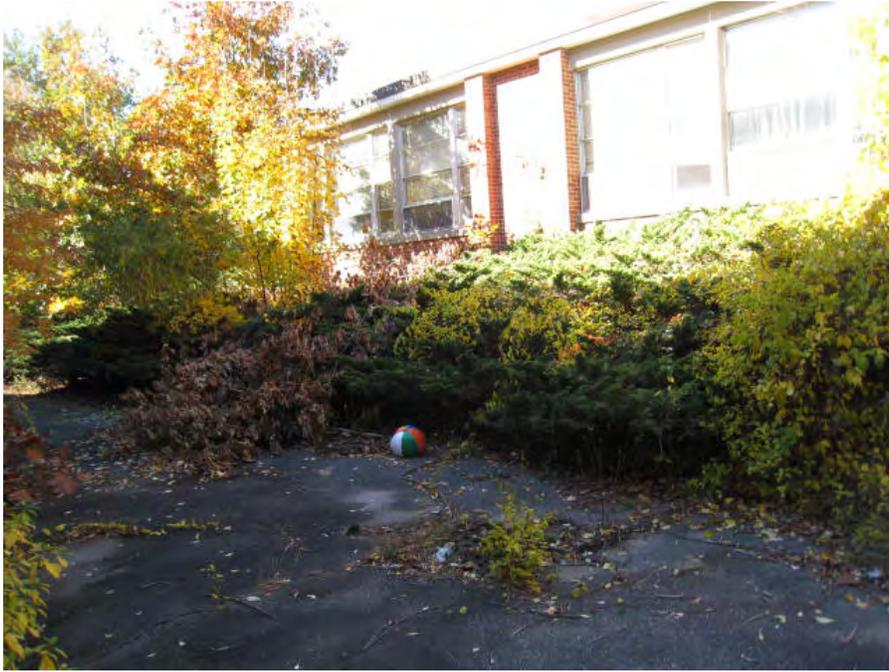
- Overgrown plants/trees/bushes against the building throughout the courtyard and around the perimeter of the building ([Pictures 24](#) through [27](#))
- Plants growing in close proximity to fresh air intakes ([Picture 27](#))
- Missing/damaged sealant between expansion joints and masonry ([Picture 28](#));

Overgrown Plants/Shrubs/Trees against Exterior Walls in Courtyard

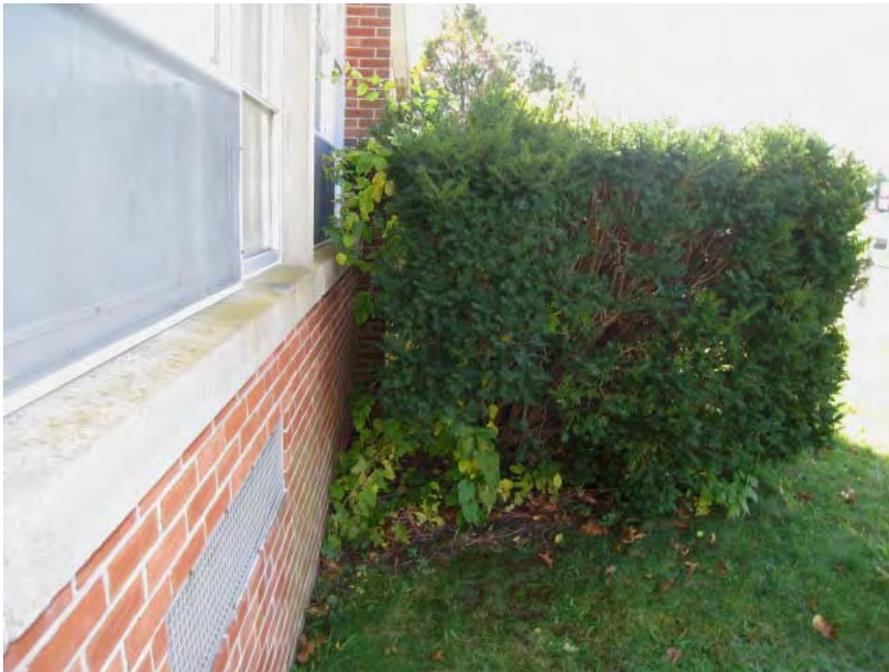
Picture 26

Over Grown Shrubs/Plants against Exterior Wall

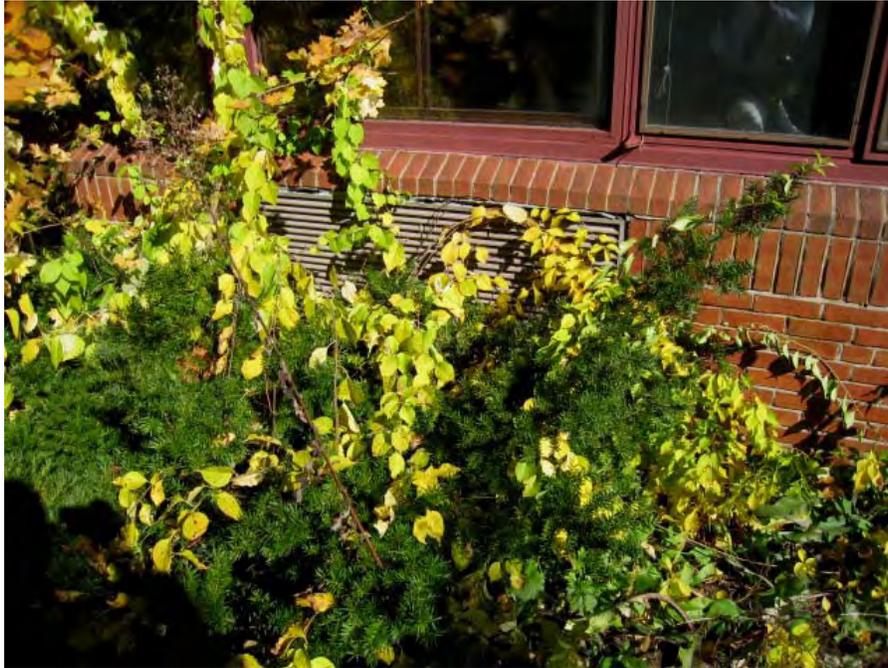
Picture 27

Overgrown Shrubs against Exterior Wall in Courtyard, Note Fresh Air Intake for Univent

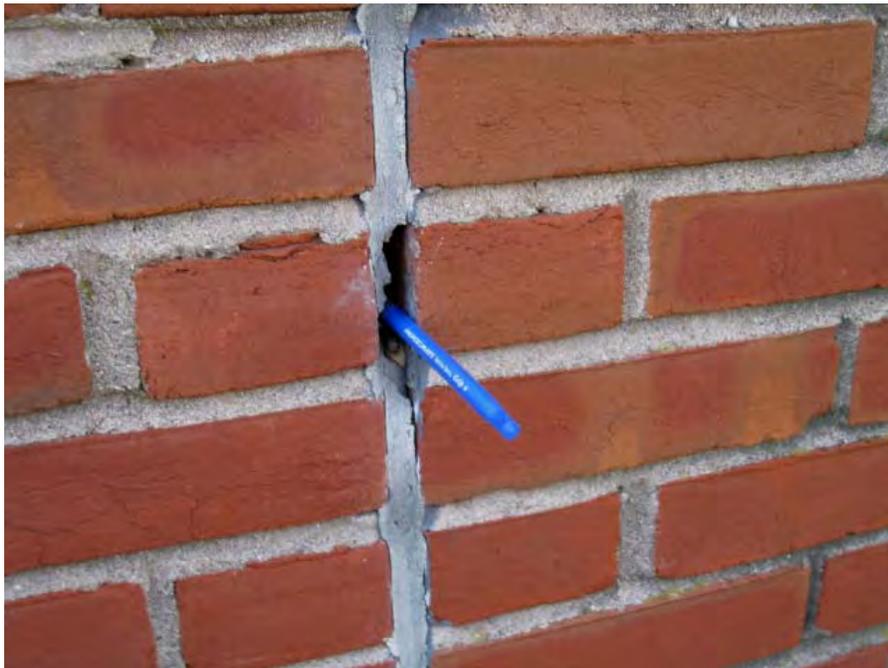
Picture 28

Missing Damaged Sealant in Expansion Joint, Pen Inserted by BEH to Show Depth

15. Seal spaces in masonry/joints and univent fresh air intakes.
16. Contact a masonry firm or general contractor to repair holes/breaches in exterior walls to prevent water penetration, drafts and pest entry.

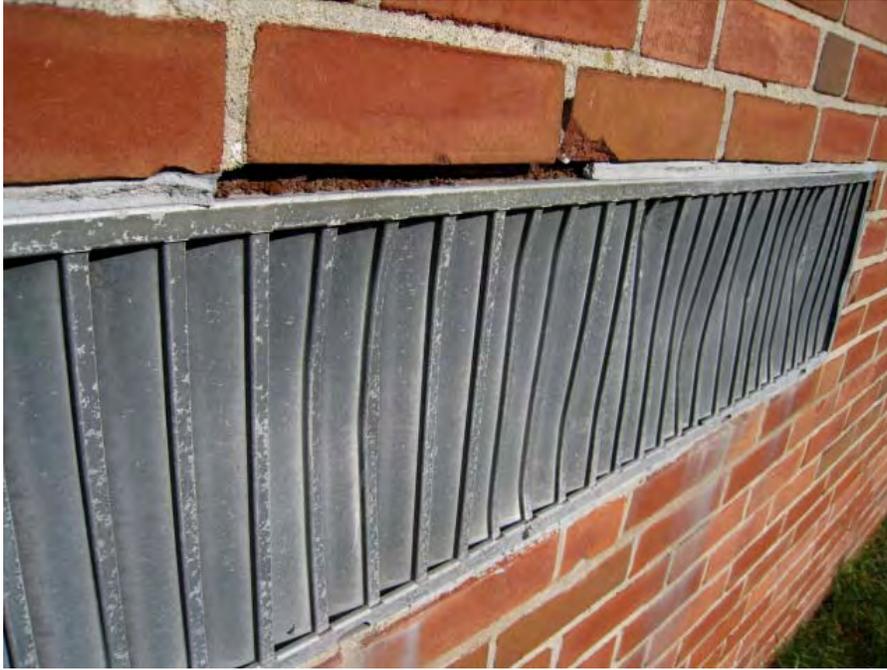
Picture 29

- Missing/damaged sealant around univent air intakes ([Picture 29](#));
- Damaged/corroded exterior metal doors ([Pictures 30](#) and 31);
- Clinging plants on exterior brick ([Picture 32](#)); and,
- Severely damaged/missing exterior caulking around windows, which in some cases has resulted in moss growth both outside and *inside* window panes ([Pictures 33](#) through 38).

Missing Damaged Sealant around Univent Air Intake

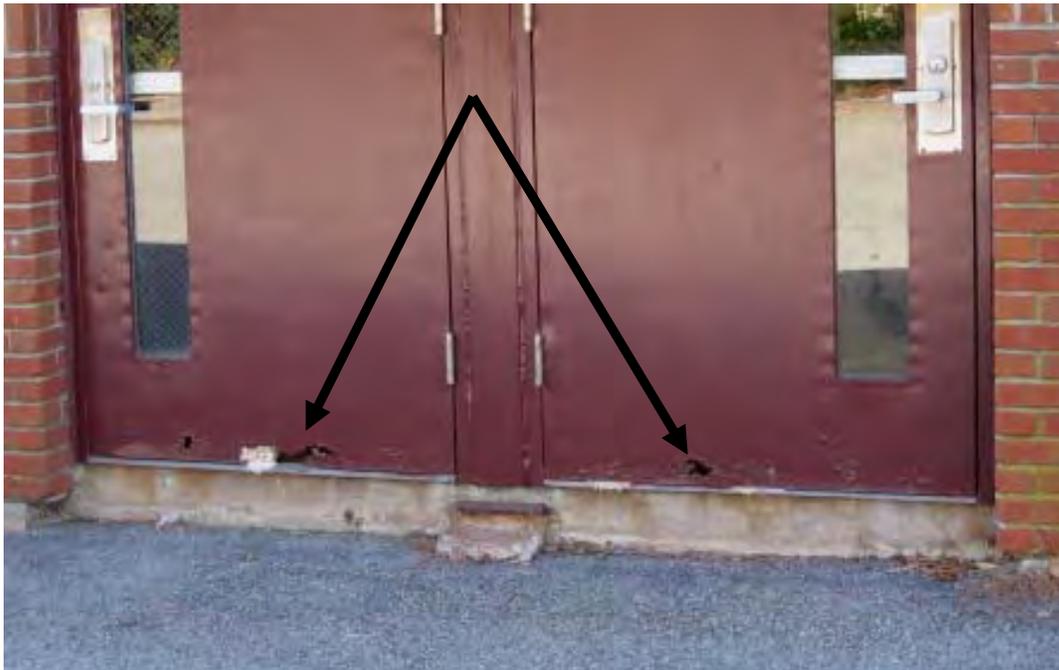
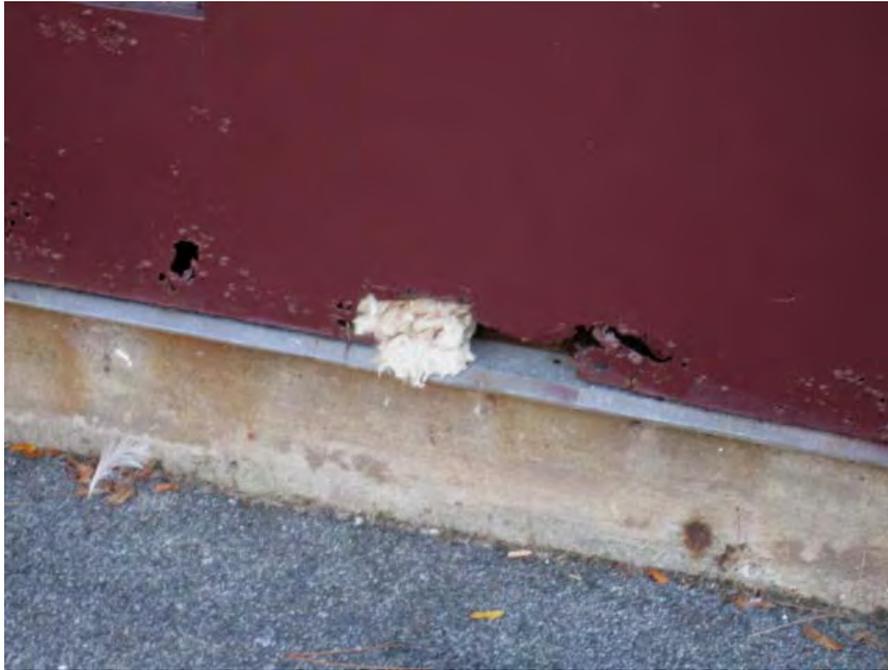
Damaged/Corroded Metal Exterior Doors

Close-Up of Damaged/Corroded Metal Exterior Doors

17. Make repairs to exterior doors to seal holes.
18. Relocate or consider reducing the amount of materials stored in classrooms to allow for more thorough cleaning of classrooms. Clean items regularly with a wet cloth or sponge to prevent excessive dust build-up.

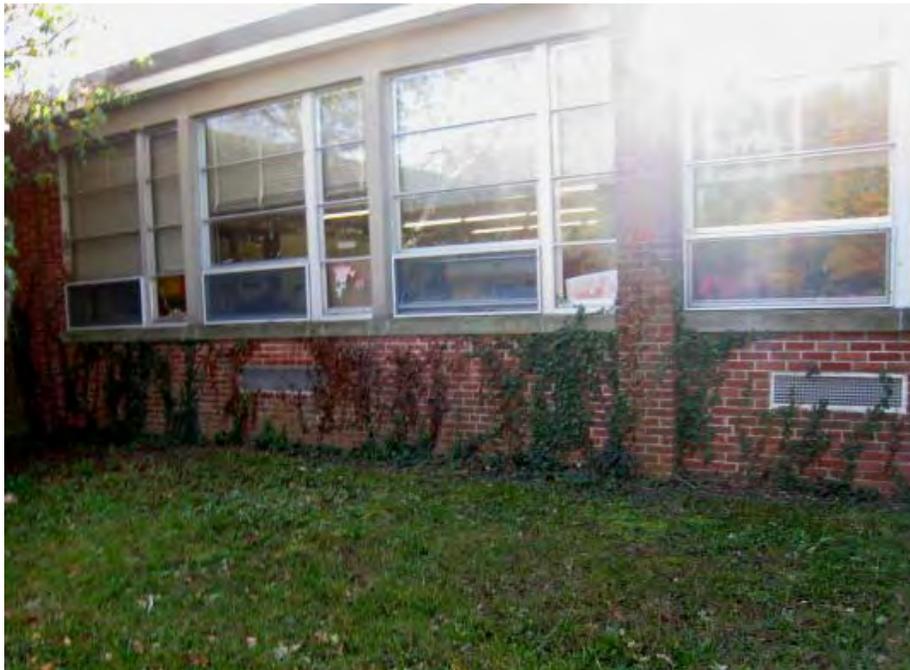
Picture 32

Clinging Plants on Exterior Brick

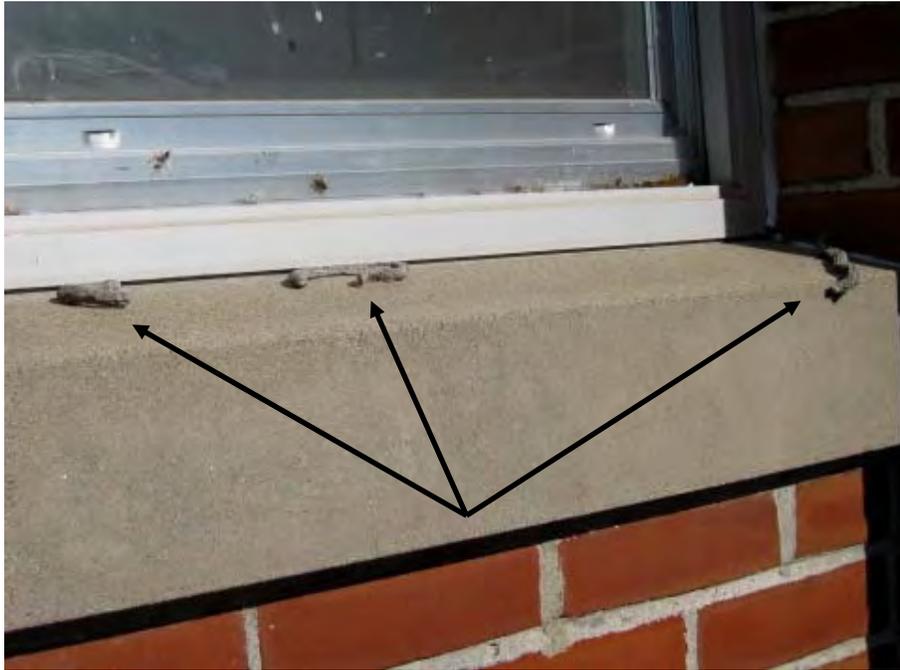
Picture 33

Loose Caulking on Exterior Window Sill

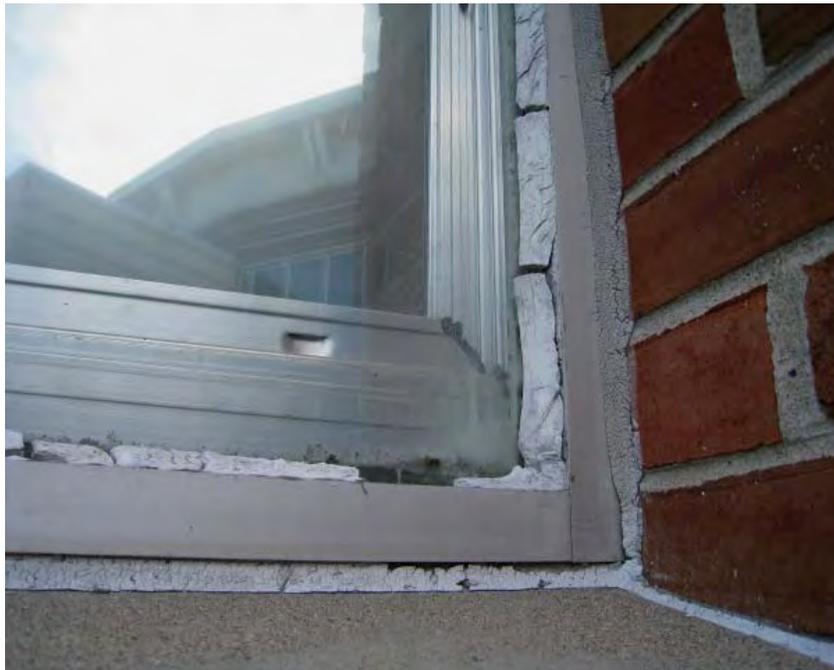
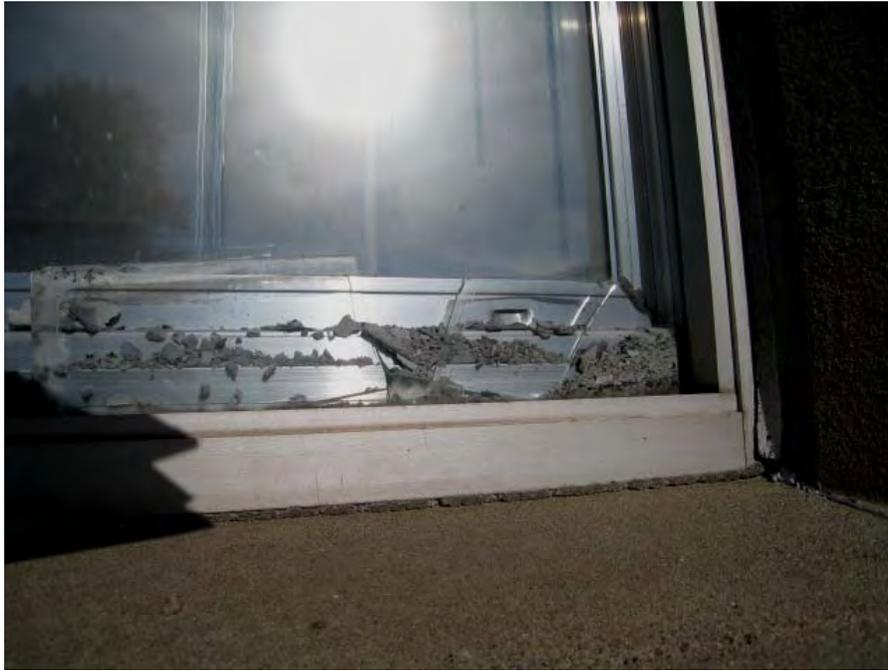
Severely Damaged/Missing Caulking around Exterior Windows

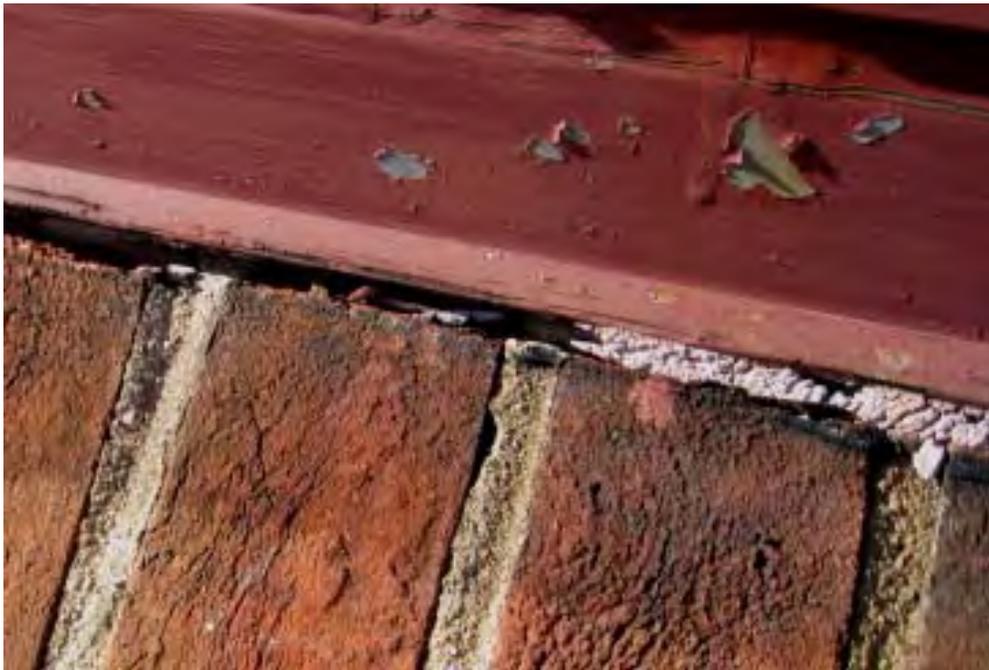
Picture 36

Severely Damaged/Missing Caulking around Exterior Window Frame

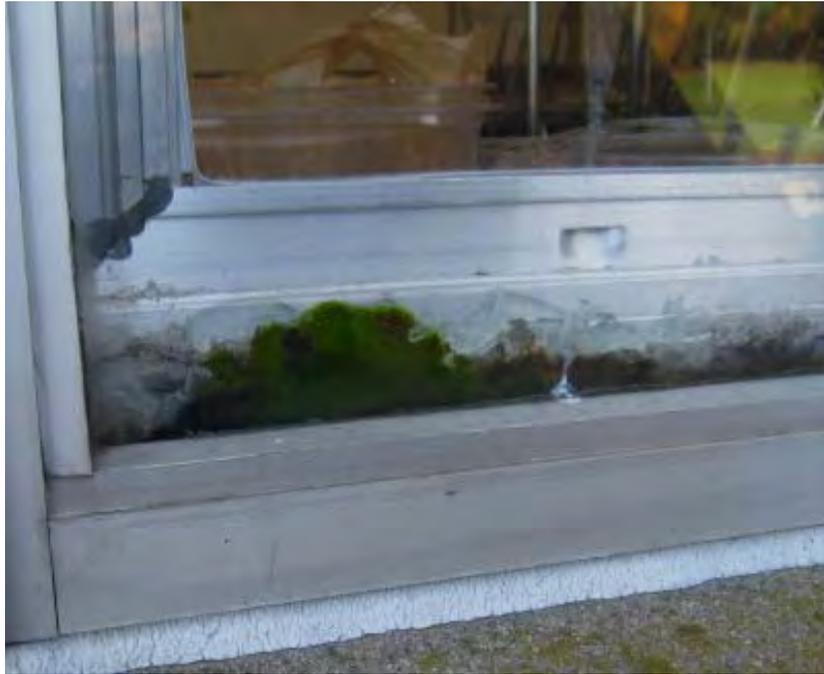
Picture 37

Moss Growth Inside Window Pane

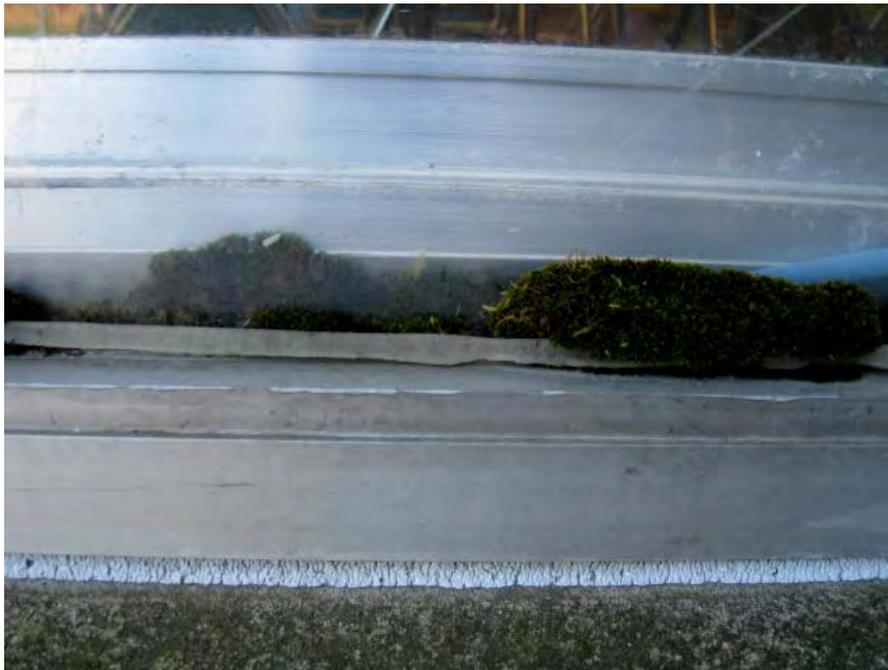
Picture 38

Moss Growth Inside and Outside of Window Pane

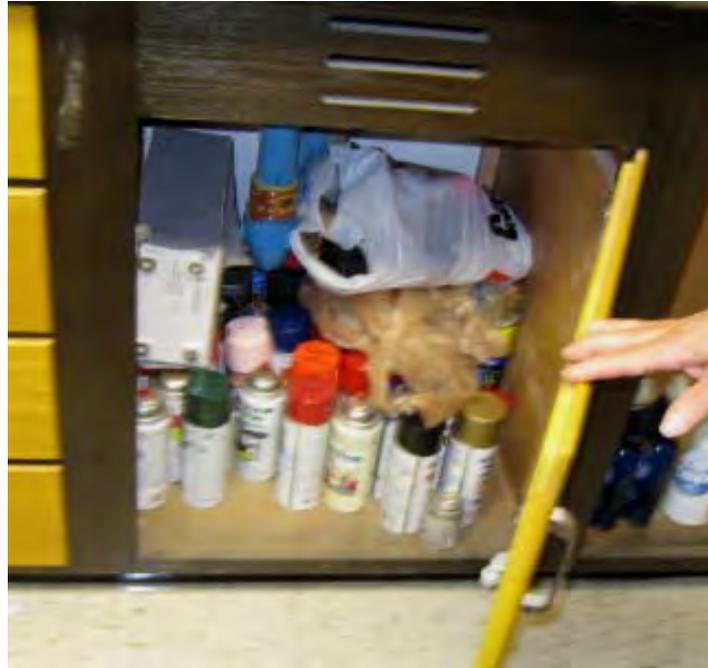
Picture 39

Multiple Cans of Spray Paint in Classroom Cabinet under Sink

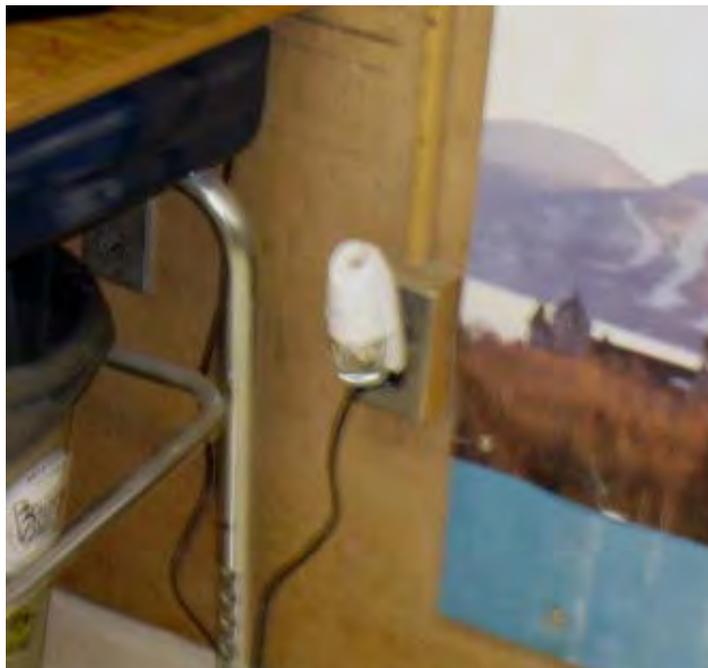
Picture 40

Plug in air deodorizers and other scented materials (i.e., reed/oil diffusers) were observed in some areas ([Table 1/Pictures 40](#) and 41). Air deodorizers can contain chemicals that can be irritating to the eyes, nose and throat of sensitive individuals. Furthermore, deodorizing agents do not remove materials causing odors, but rather mask odors that may be present in the area.

Plug-in Air Deodorizer

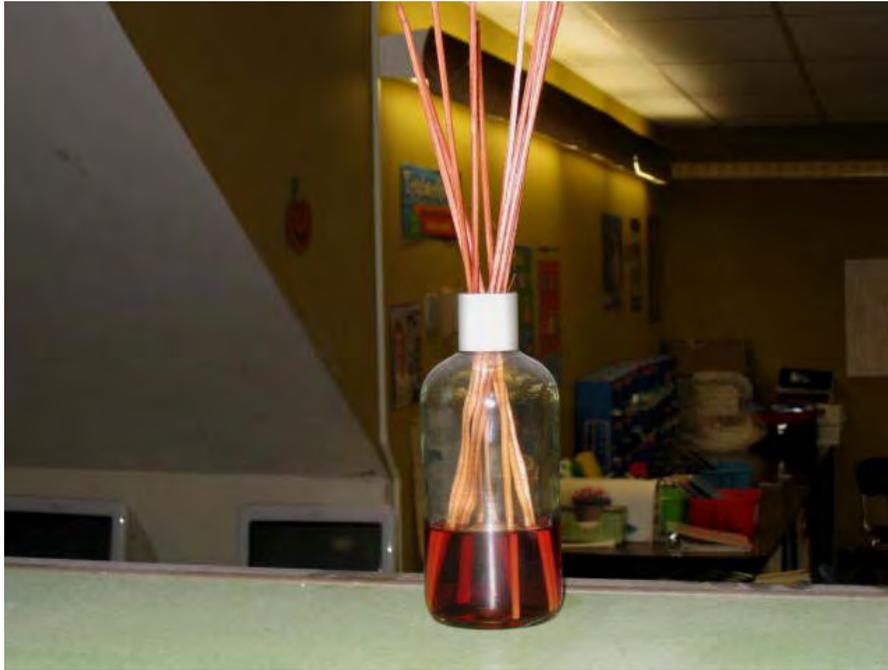
Picture 41

Reed/Oil Deodorizer

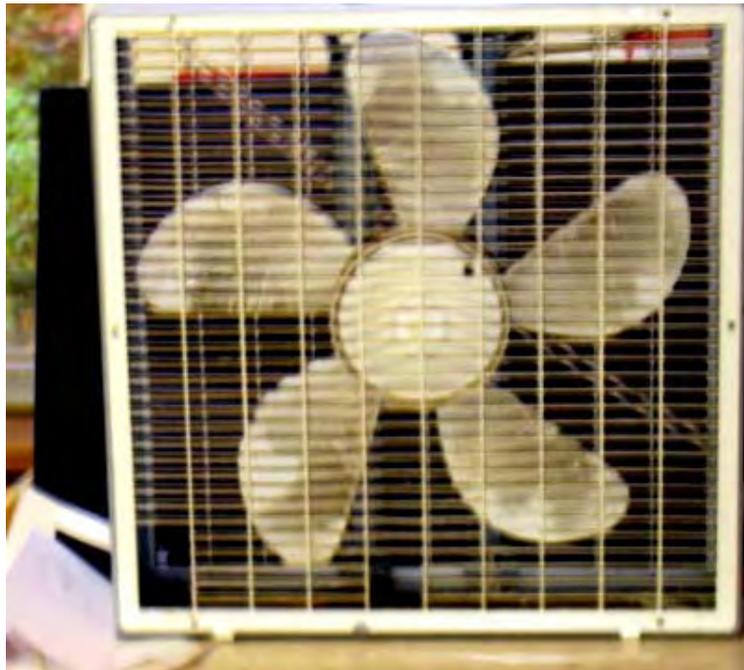
Picture 42

Personal Fan in Classroom with Accumulated Dust/Debris on Fan Blades

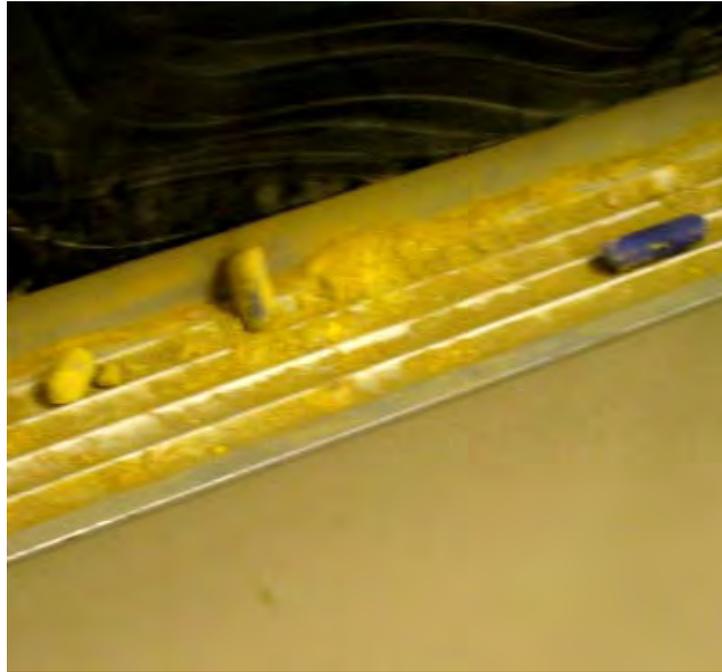
Picture 43

An accumulation of chalk dust and dry erase particulate was observed in some classrooms ([Picture 43](#)). When windows are opened or univents are operating, these materials can become airborne. Once aerosolized, they can act as irritants to eyes and the respiratory system.

Accumulated Chalk Dust

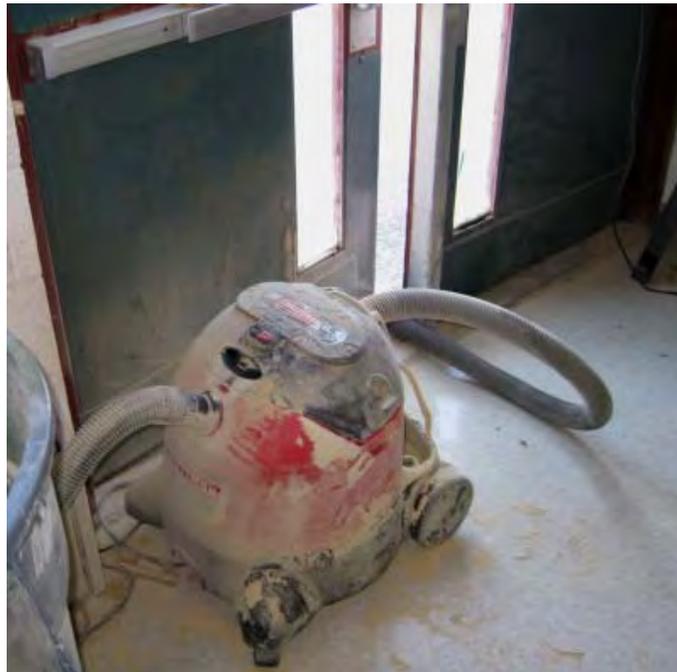
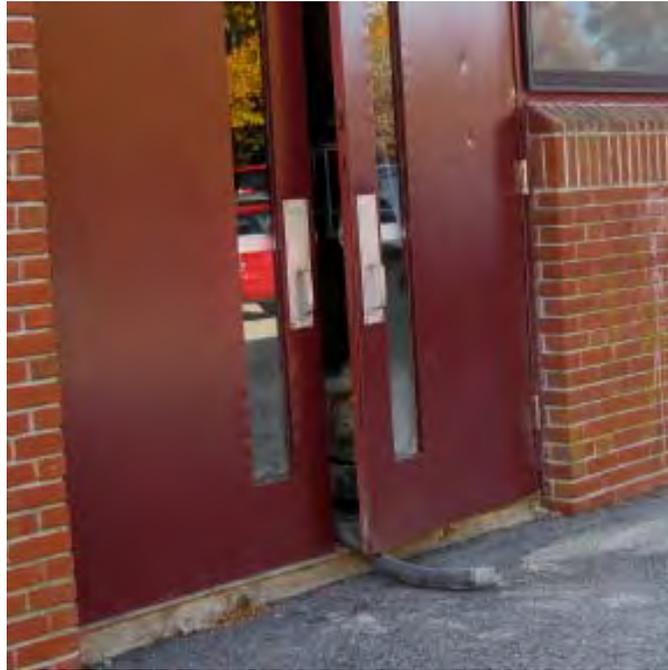
Finally, piles of wood dust and debris were observed on wood cutting machines and flat surfaces in the wood shop. It appeared that the room contains a local exhaust system dedicated to collecting dust from equipment, however, at the time of the assessment a shop-vac was set up to draw wood dust to exhaust out of an exterior door ([Pictures 44](#) and 45), which can lead to security issues.

Shop-Vac in Wood Shop with Exhaust Hose in Open Exterior Door

Exhaust Hose from Shop-Vac (in Wood Shop) in Open Exterior Door

22. Restore operation of the local wood dust collection system in the wood shop, make repairs as needed. Ensure that excess wood dust is cleaned after completion of projects.

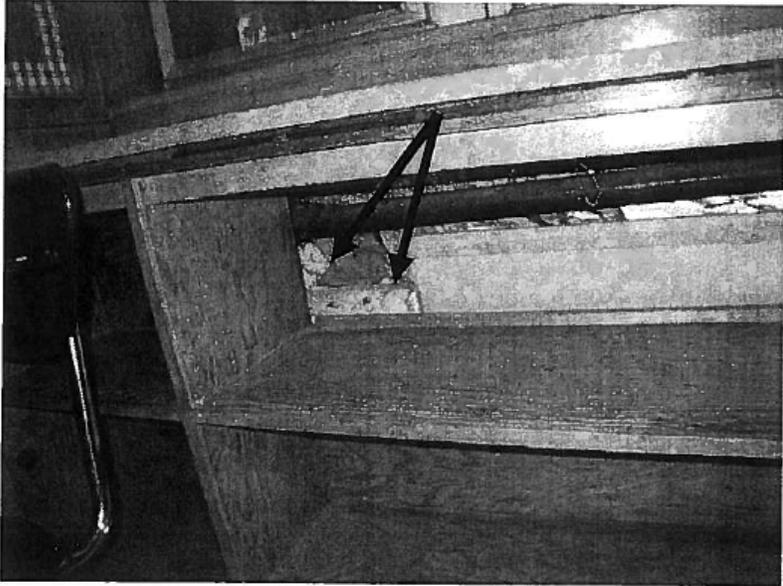
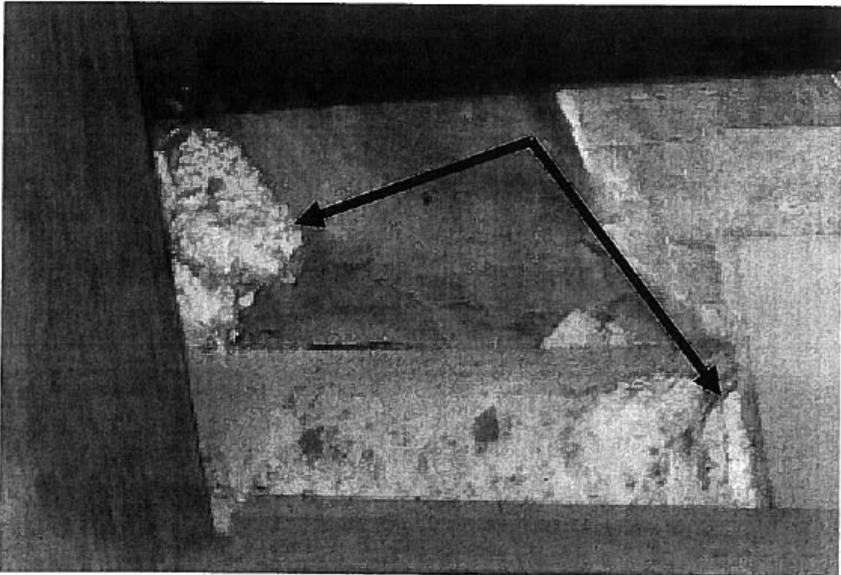
At the rear of classroom 109, BEH staff observed damaged/exposed insulation that may contain asbestos around hot water pipes that feed the unit ventilator (univent; Pictures 1 and 2). It appears that the original univent in room 109 (Picture 3) was replaced with a more modern unit (Picture 4). Installation of this new univent required the destruction of the adjacent cabinet for access to hot water pipes feeding the univent. It was unknown at the time of the assessment when this work had occurred. In subsequent conversation with Mr. Burgess, it was reported that this work was conducted approximately 6 years ago as a result of a frozen pipe.

Exposed Pipe Insulation Left Corner of Shelf, Note Back Panel of Cabinet has Been Removed to Access Pipes

Close-Up of Exposed Pipe Insulation Left Corner of Shelf

During the assessment, BEH staff found damaged insulation material that likely contained asbestos. The presence of this material and the recommendation to encapsulate it by a licensed asbestos remediation firm was documented in a letter released subsequent to the MDPH inspection ([Appendix B](#)).
