INDOOR AIR QUALITY ASSESSMENT

**Massachusetts Department of Mental Health
North County Services Site
515 Main Street
Fitchburg, Massachusetts 01420**

Prepared by:
Massachusetts Department of Public Health
Bureau of Environmental Health
Indoor Air Quality Program
June 2009

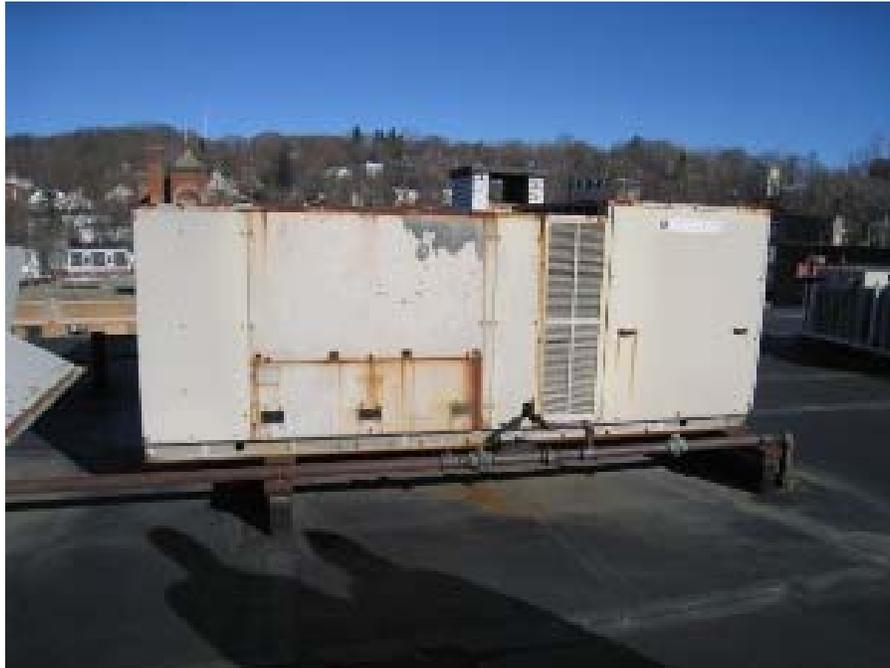
Picture 1

Ventilation was provided by a large rooftop AHU (Picture 1). In summer 2008, the AHU reportedly failed to operate and could not be repaired. Rather than replacing the faulty unit, the building owner chose to connect an AHU that serviced the vacant third floor suite to the DMH/NCSS ductwork (Picture 2). Fresh air is supplied to the DMH/NCSS through ducted air diffusers, and stale air and contaminants are removed by a plenum exhaust system (Pictures 3, 4). A plenum is the open space above the suspended ceiling through which return air travels back to the AHU. The majority of the offices utilize undercut doors to exhaust air through numerous ceiling mounted exhaust grates located in the hallway. A large number of ceiling tiles were observed to be cracked, broken or ill-fitting, which will reduce the efficiency of the exhaust

Original Air Handling Unit (AHU) for DMH

1. Consider installation of new air handling unit for DMH/NCSS.
2. Consider removal of utility sink from hallway.

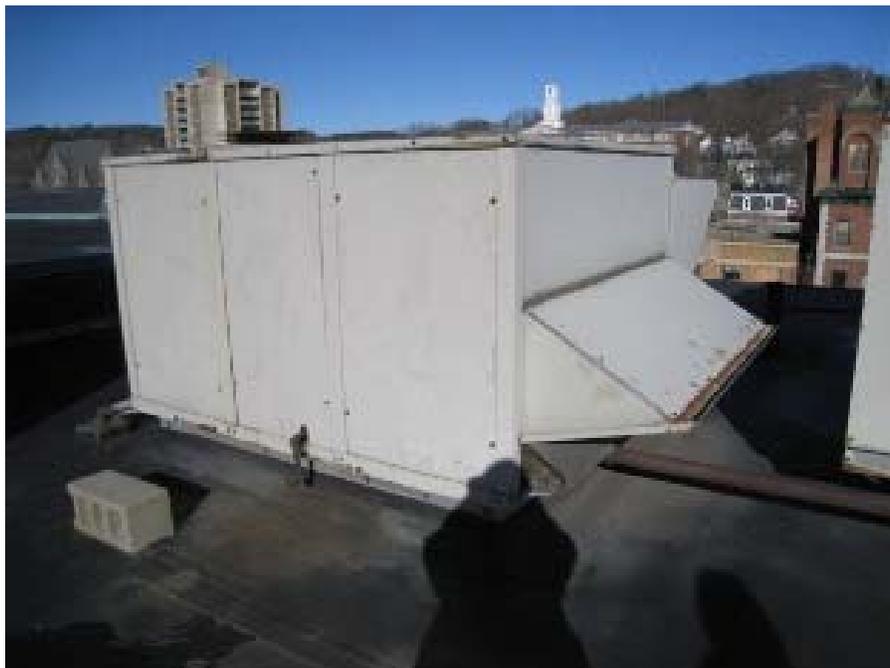
Picture 2

Third Floor AHU, Now Servicing DMH (Second Floor)

1. Contact an HVAC engineering firm to assess whether the current AHU configuration is providing air distribution in an adequate manner. Ensure that any existing duct openings or connections that could draw air from the vacant third floor unit are sealed.
2. Eliminate standing water from roof.
3. Ensure roof drains are routinely inspected and maintained.
4. Ensure leaks are repaired and replace water damaged ceiling tiles. Examine the area above and around these areas for mold growth. Disinfect areas of water leaks with an appropriate antimicrobial.
5. Ensure that all cracked and broken ceiling tiles are replaced and that they fit snugly within their frames.
6. Consider providing plants with drip pans and avoid over-watering. Examine drip pans periodically for mold growth. Disinfect with an appropriate antimicrobial where necessary.

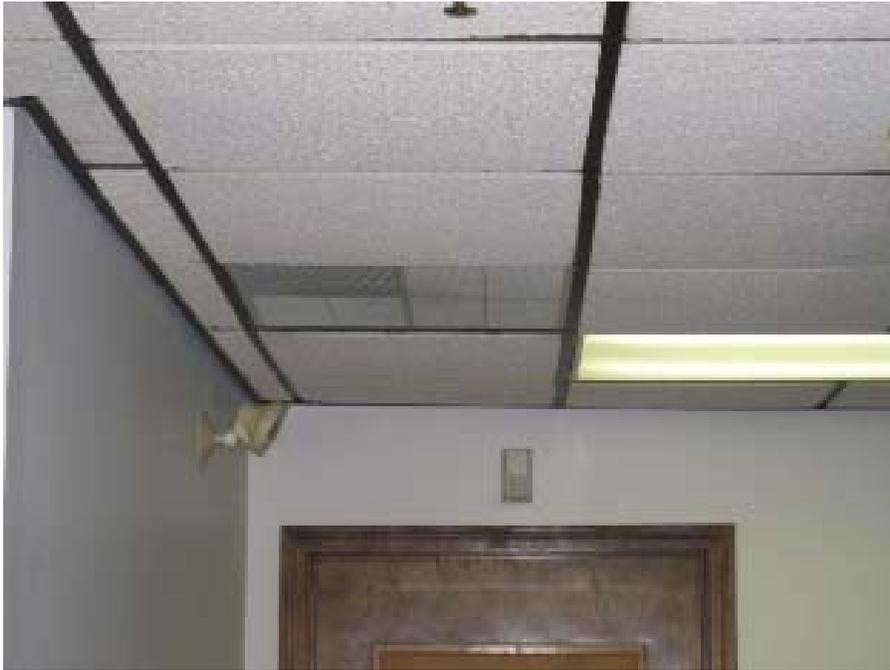
Picture 3

Fresh Air is Supplied Through Ducted Air Diffusers

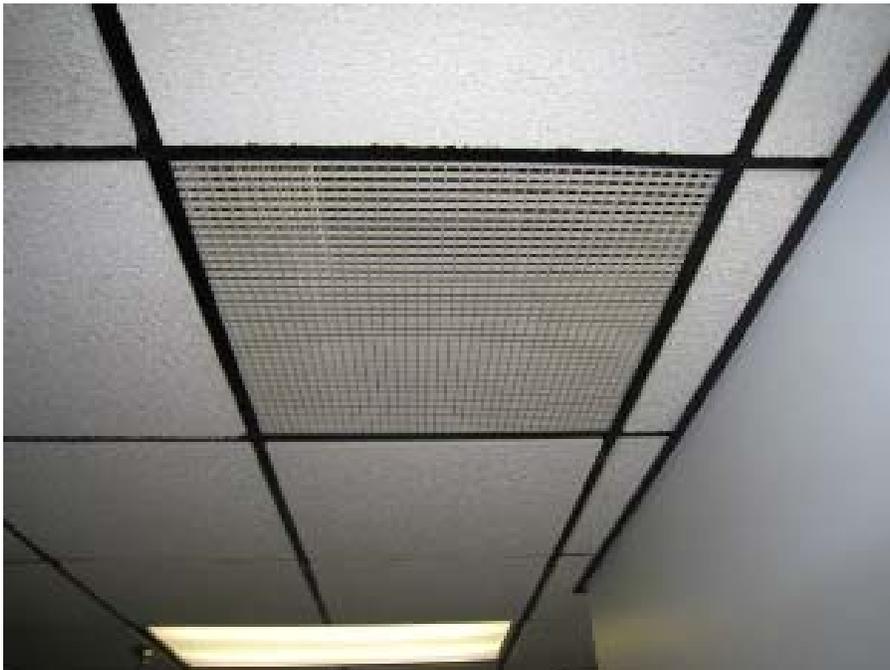
Picture 4

Plenum Exhaust System

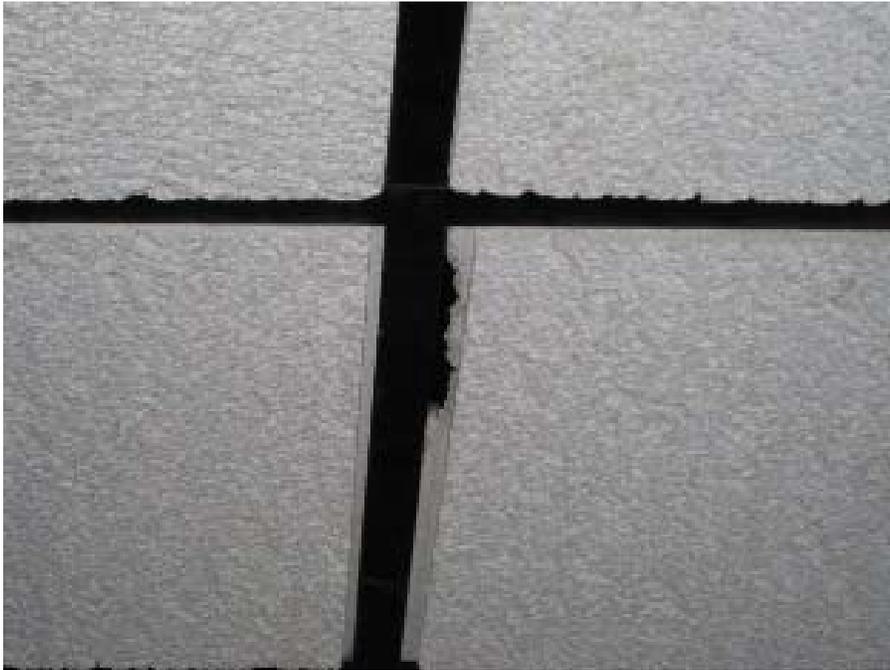
Picture 5

system (Picture 5). Additionally, these spaces can allow dust and other contaminants to enter the DMH/NCSS.

Ceiling Tile in Disrepair

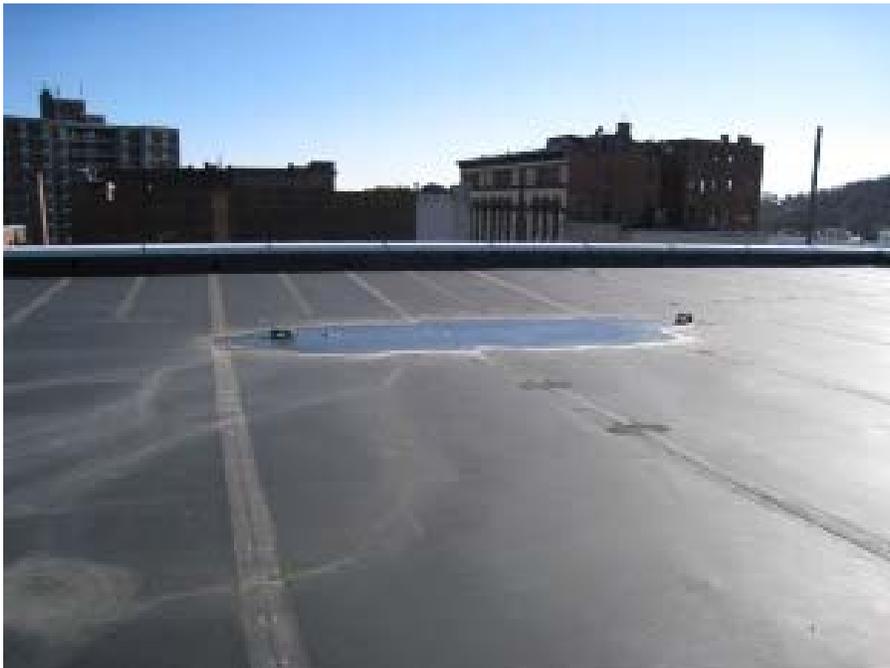
Picture 6

Several potential sources of water damage and/or mold growth were observed. Standing water was evident on the rubber membrane roof (Picture 6). Standing water allows more contact time of the rain water with the seams on the roof, which can lead to water penetration through the membrane of the roof to the interior of the building.

Standing Water on Roof

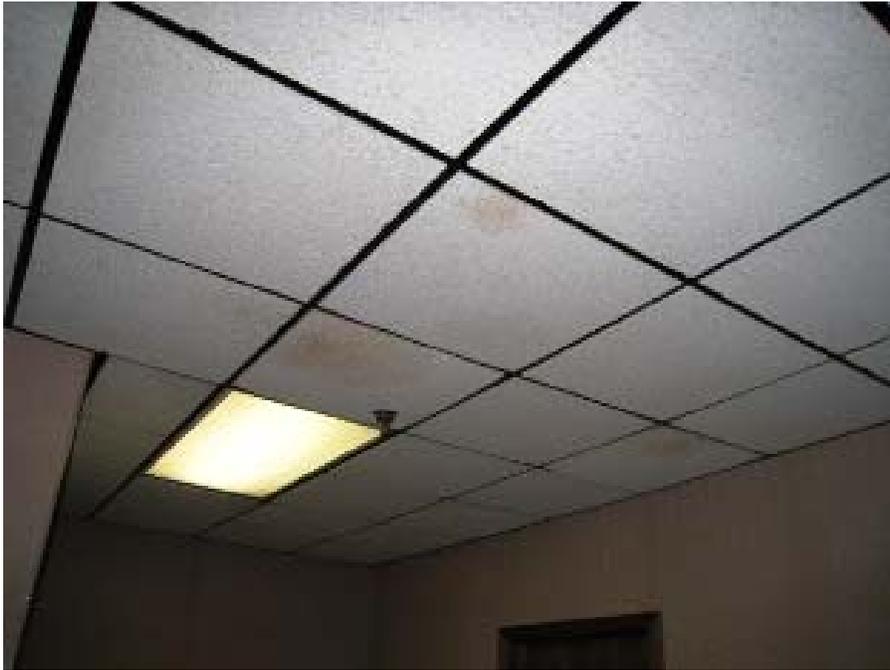
Picture 7

Upon entering the building, a strong musty odor was observed. Numerous ceiling tiles in the hallway exhibited buckled and water damaged areas (Picture 7). The source of the water damage in the hallway must be identified and remedied prior to the replacement of the tiles.

Numerous Buckled and Water Damaged Ceiling Tiles in Exterior Hallway

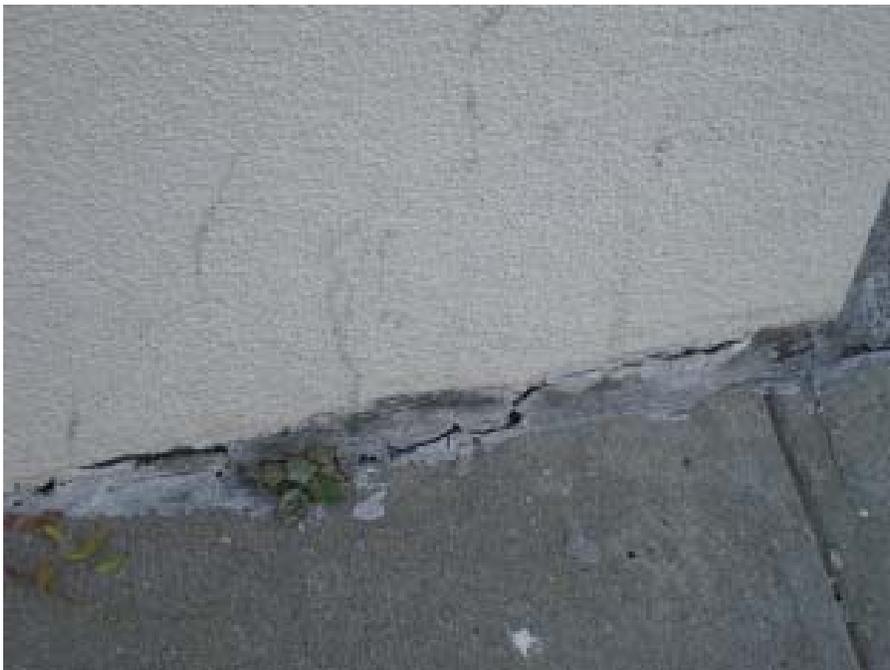
Picture 8

Some conditions noted on the exterior of the building could also contribute to musty odors within the DMH/NCSS. The sealant along the exterior base of the building appears to be damaged (Picture 8). In this condition, water, unconditioned air and pests/insects may enter the building's envelope. As water penetrates the interior brick surfaces and is exposed to the elements, particularly the conditions of freezing and thawing, the building's components can further deteriorate. Some plant growth was observed in these areas as well. The growth of roots against exterior walls can bring moisture in contact with the foundation. Plant roots can eventually penetrate, leading to cracks and/or fissures in the sublevel foundation. Over time, this

process can undermine the integrity of the building envelope, providing a means of water entry into the building via capillary action through foundation concrete and masonry (Lstiburek & Brennan, 2001).

**Deteriorated Sealant on Exterior of DMH
Note Plant Growth**

22. Repair sealant on exterior of building and remove plant growth at the base of the building.
23. Operate ventilation system continuously during periods of occupancy to maximize air exchange.

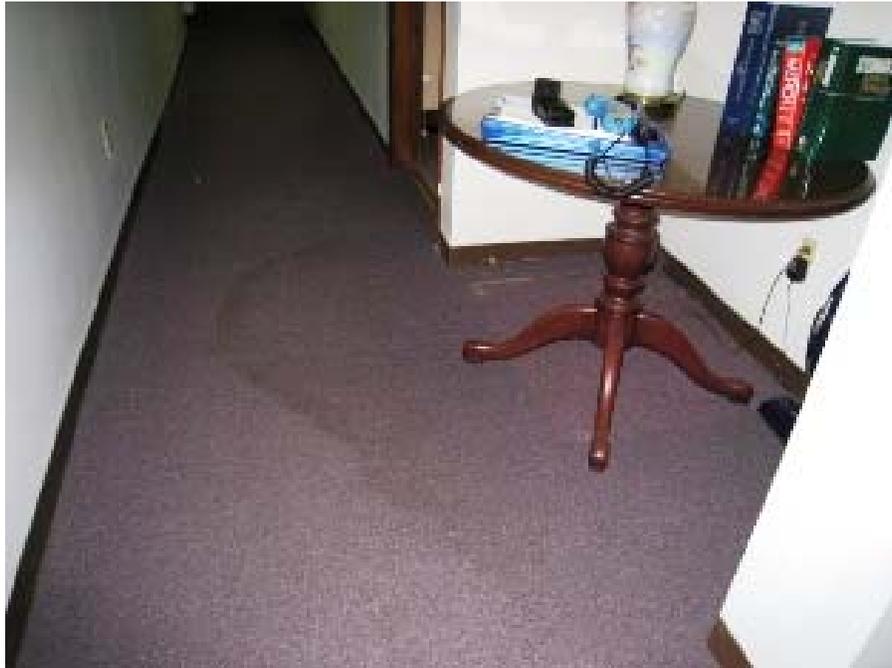
Picture 9

The interior hallway had stained carpet from a chronic leak that was reportedly repaired approximately six months prior to this visit. Additionally, a utility sink is located in the hallway over a carpeted area (Pictures 9, 10). As can be seen from the picture, the utility sink is located in a small alcove, with drywall in close proximity to the sink on three sides. Spills around the sink can moisten drywall and carpeting, which if not dried, can lead to mold colonization.

Stained Carpet Due to Chronic Leak

9. Discontinue the use of air deodorizers as well as reed diffusers.
10. Consider carpet removal in areas of previous leaks.
11. Clean personal fans, air diffusers, exhaust and return vents periodically of accumulated dust.

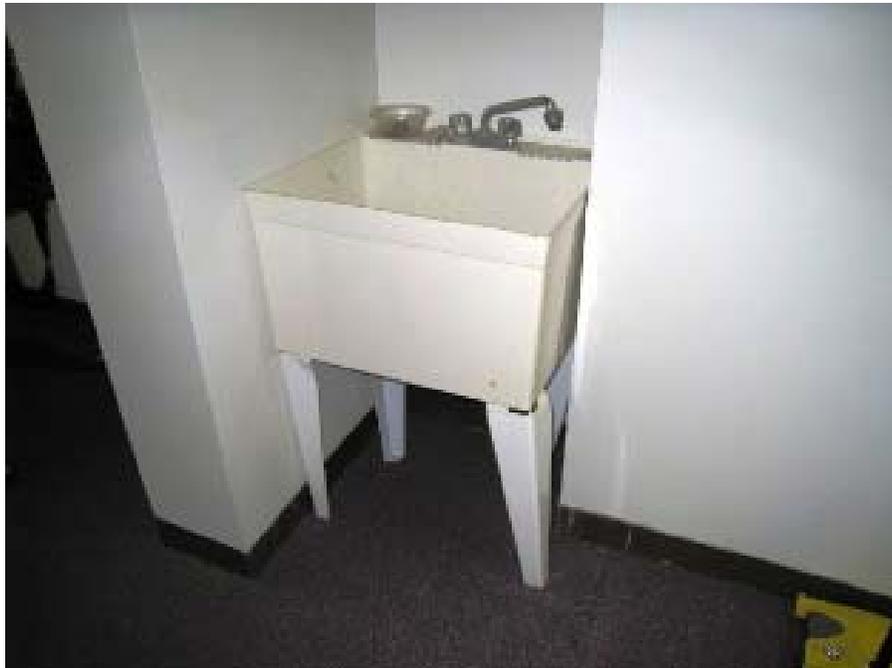
Picture 10

Utility Sink Located Over Carpet

7. Consider elimination of dry erase materials. If that is not feasible, consider utilizing products that emit fewer VOCs.
8. Provide a non-porous mat beneath utility sink on carpeted floor. Consider providing non-porous splash guards against drywall above rim of utility sink to prevent damage to adjacent drywall.

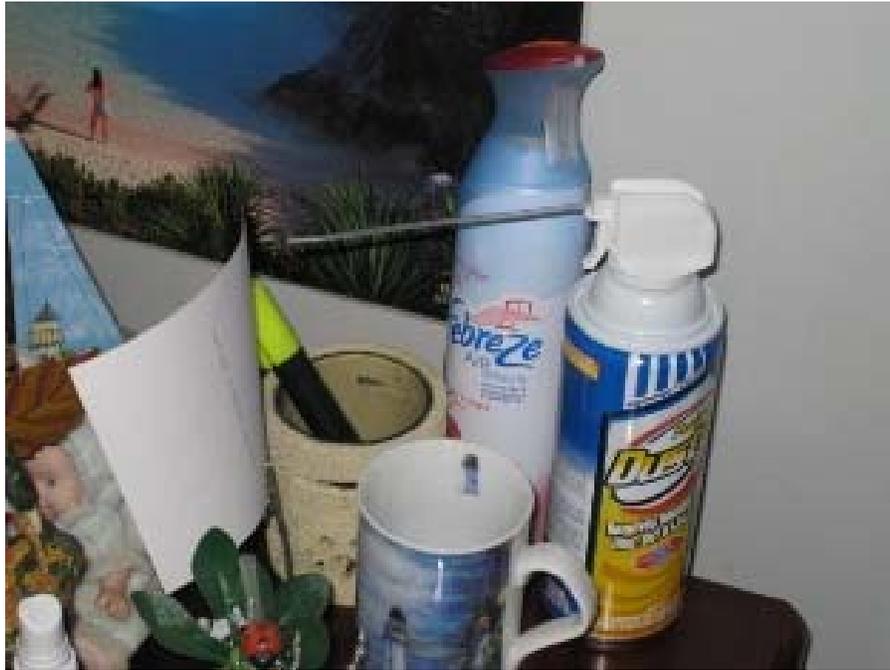
Picture 11

Air fresheners and deodorizing materials were observed in several areas (Pictures 11, 12). Air deodorizers contain chemicals that can be irritating to the eyes, nose and throat of sensitive individuals. Many air fresheners contain 1,4-dichlorobenzene, a VOC which may cause reductions in lung function (NIH, 2006). Furthermore, deodorizing agents do not remove materials causing odors, but rather mask odors that may be present in the area.

Air Freshener

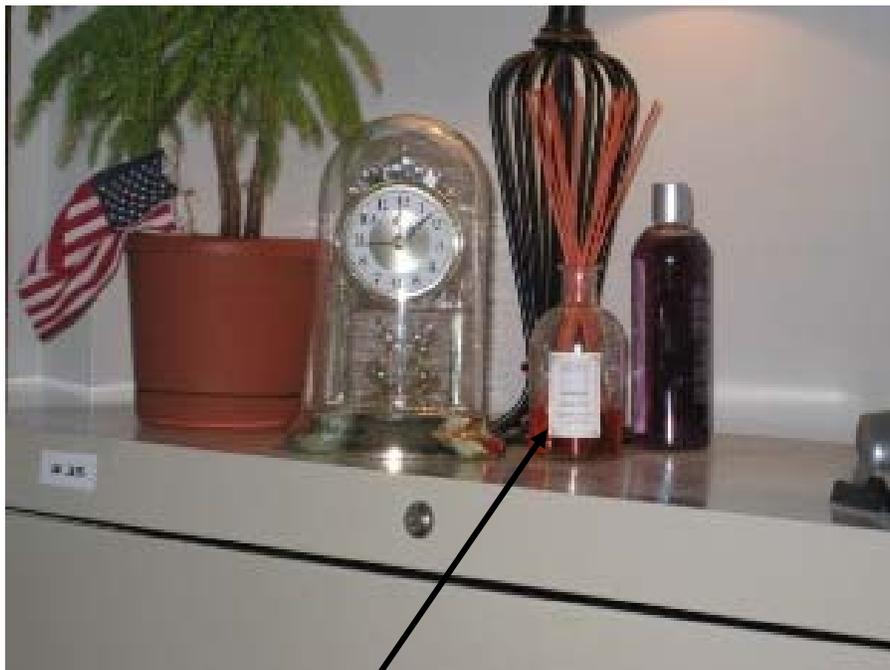
Picture 12

Reed Diffuser

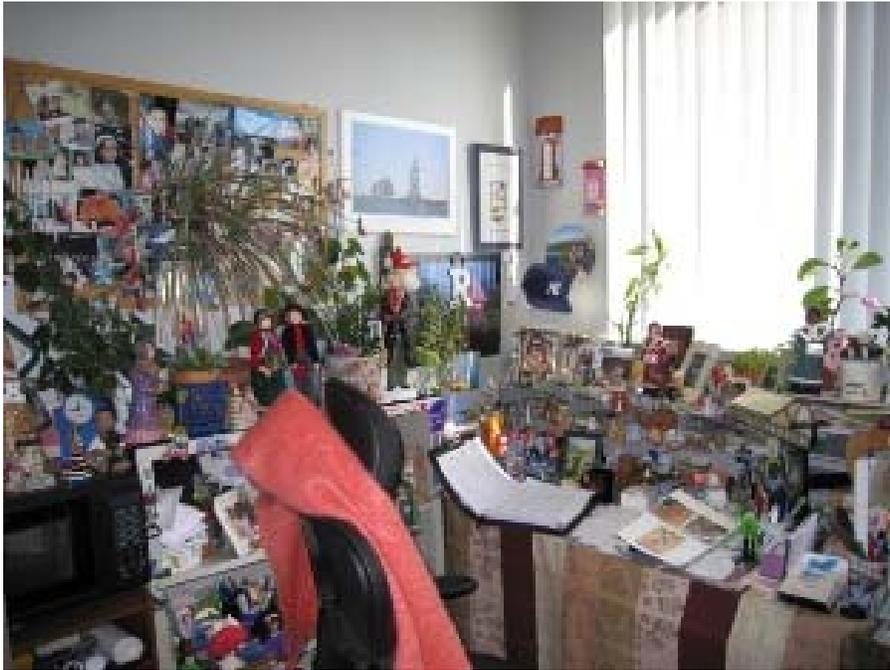
Picture 13

Other conditions that can affect indoor air quality were observed during the assessment. In several areas, items were observed on the floor, windowsills, tabletops, counters, bookcases and desks (Picture 13). The large number of items on flat surfaces provides a source for dusts to accumulate and makes it difficult for custodial staff to clean. Items should be relocated and/or be cleaned periodically to avoid excessive dust build up. Accumulation of these dusts can be re-aerosolized causing further irritation.

Numerous Items Stored on Flat Surfaces

12. Remove loose paint chips from exhaust grate.
13. Relocate or consider reducing the amount of materials stored on flat surfaces to allow for more thorough cleaning. Clean items regularly with a wet cloth or sponge to prevent excessive dust build-up.

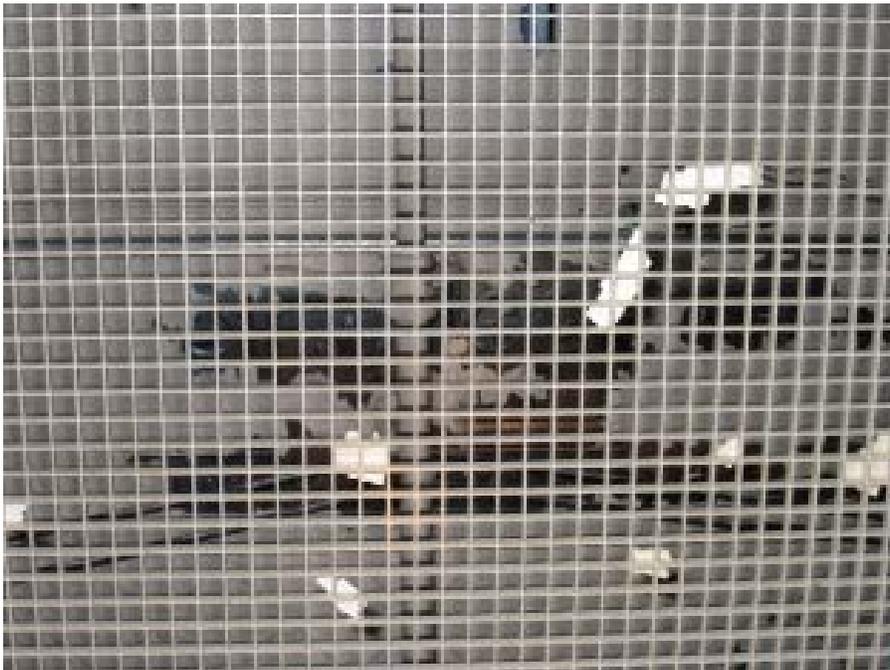
Picture 14

Several personal fans and return/exhaust vents had accumulated dust and debris. In the large conference room, the exhaust grate had an accumulation of what appeared to be paint chips from the ceiling above resting upon it (Picture 14). This debris can provide a surface on which

dusts can accumulate. Dust can be a source for eye and respiratory irritation. Exhaust vents appeared to be nonfunctioning at the time of the survey. If exhaust vents are not functioning, back-drafting can occur and can re-aerosolize dust particles. Personal fans with dust can serve to distribute particles once activated.

Fallen Debris From Ceiling Above Exhaust Grate

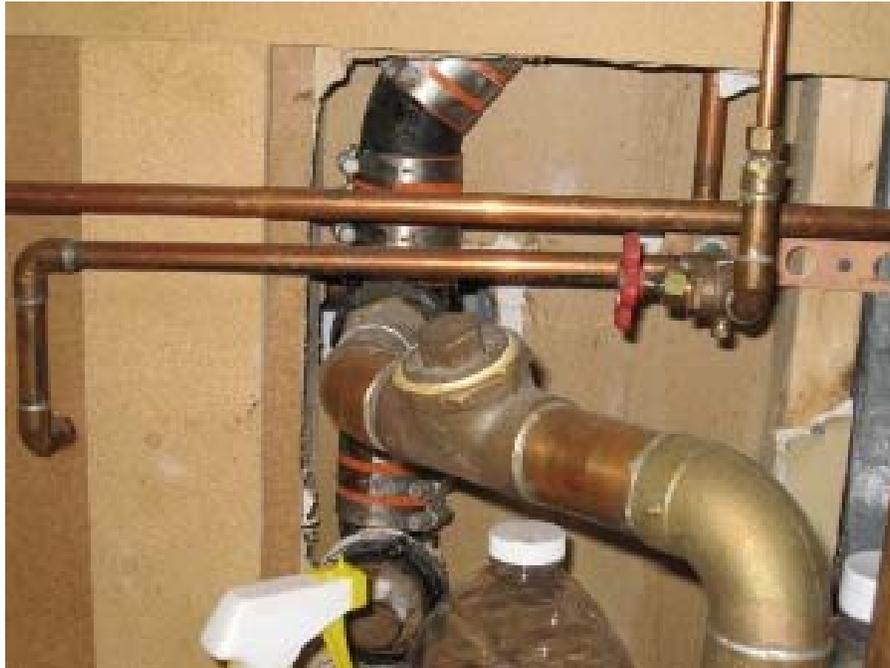
Picture 15

A large open section of the wall beneath the kitchen sink was observed (Picture 15). Interior framing was clearly visible. Additionally, numerous open penetrations and utility holes were observed at the DMH/NCSS, particularly in the back hallway (Picture 16). Open utility holes can provide a means of egress for odors, fumes, dusts and vapors between rooms and floors. In addition, these materials can migrate into the air handling equipment and be distributed to occupied areas.

Large Penetration Into the Framing of the Building

14. Replace drywall in kitchen below the sink. Seal spaces around utility holes and breaches in walls/floors with an appropriate fire-rated sealant.
15. Survey basement for moisture infiltration. If located, remove any porous, water damaged materials in accordance with EPA Guidelines for Mold Remediation in Schools and Commercial Buildings.

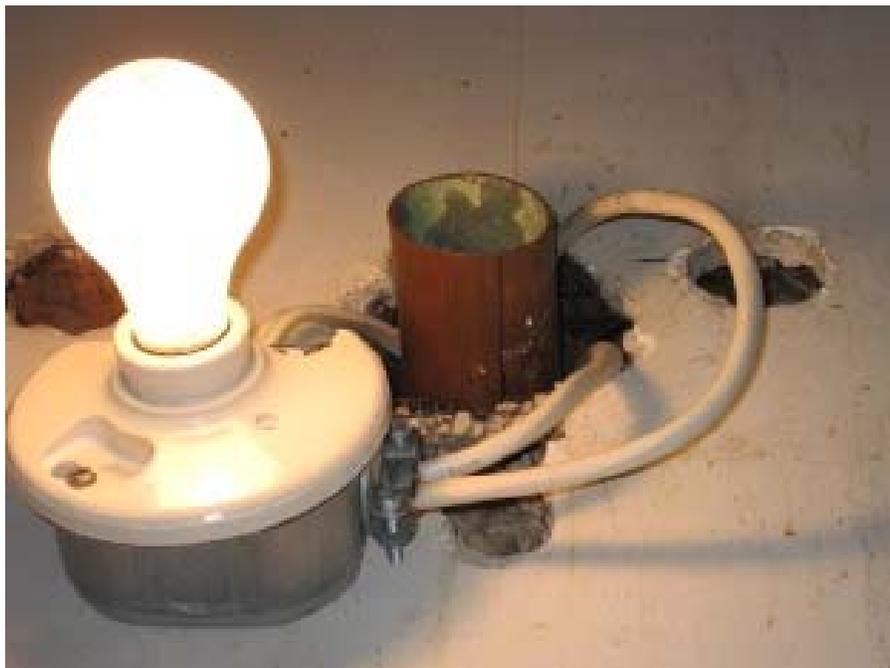
Picture 16

Open Utility Holes

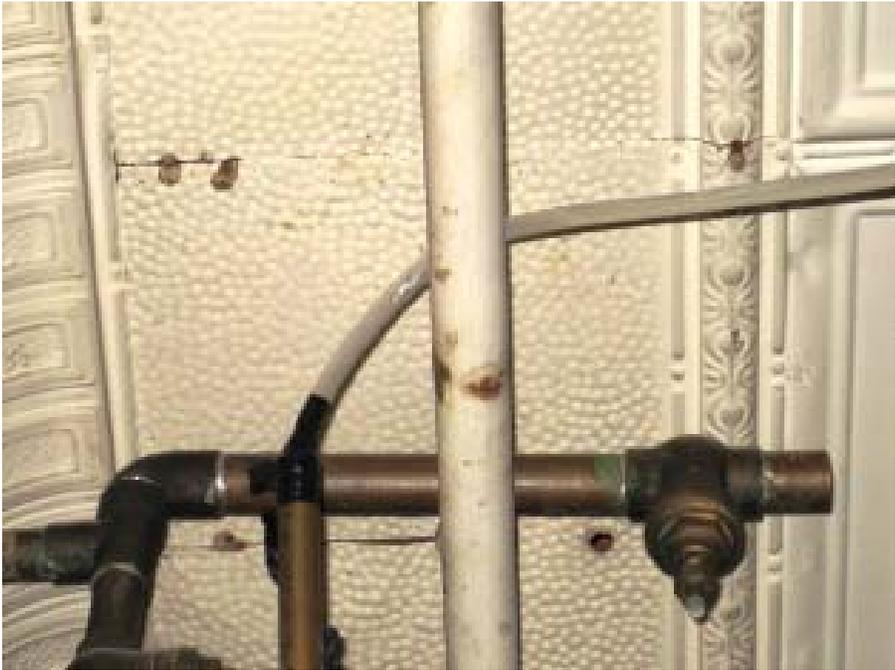
Picture 17

The condensation line for the air conditioner in the server room appears to be connected directly to the sewer line (Picture 17). This condition may allow sewer gases to enter the building. It may be prudent to contact a plumber to ensure the connection is in compliance with the plumbing code and will not allow migration of sewer gases and odors into the interior of the building.

Connection of Condensation Line to Sewer Line

18. Ensure any penetrations through common wall with adjacent property are sealed with an appropriately fire-rated sealant.
19. Contact a licensed plumber to examine the connection from the air conditioning unit in the server room to the soil pipe to ensure it is a proper connection and to ensure sewer gas cannot migrate back into the building from the connection.
