INDOOR AIR QUALITY ASSESSMENT

**Hanson Town Hall
542 Liberty Street
Hanson, Massachusetts 02341**

Prepared by:
Massachusetts Department of Public Health
Bureau of Environmental Health
Indoor Air Quality Program
October 2009

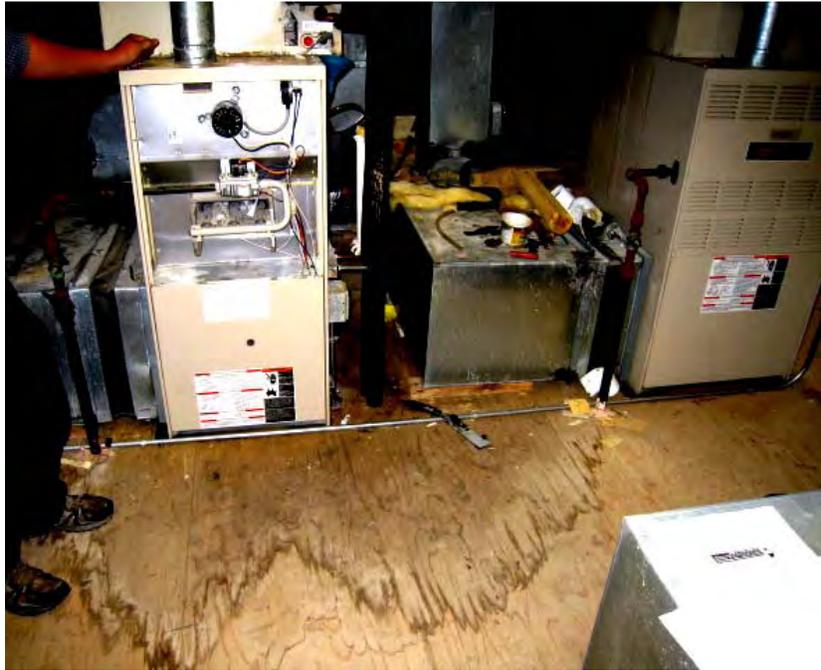
Picture 1

In order for building materials to support mold growth, a source of water exposure is necessary. As previously indicated, the assessment was prompted by mold concerns among PCD employees who are housed on the top floor directly below the attic AHU that had chronic leaks. Following the most recent leak; the AHU was disconnected, areas of leaks were dried out and damaged portions of the carpet had been removed. No current water damage, visible mold growth or associated odors were observed/detected in the PCD at the time of the MDPH/BEH assessment.

BEH staff examined conditions in the attic above the PCD in an effort to identify any water damaged building materials or mold growth. Evidence of water damage in the form of stained plywood around the AHUs was observed; however, no visible mold growth or associated

odors were observed/detected. Mr. Clemens noted that no drip pans were installed beneath the attic AHUs (Picture 1), and that he would suggest installation of drip pans for the incoming unit and possible retrofit for existing units.

Attic AHUs, Note Water Damaged Plywood from Chronic Leakage and Lack of Drip Pans Installed beneath AHUs

1. Continue with plans to replace faulty AHU in attic.
2. Operate the HVAC system continuously in the fan “on” mode during periods of occupancy to maximize air circulation and filtration.

5. Install drip pans beneath attic AHUs to prevent water penetration into occupied areas.
6. Consider installing additional supply vents in meeting room A, or installing an additional wall-mounted AC unit for use during maximum occupancy.

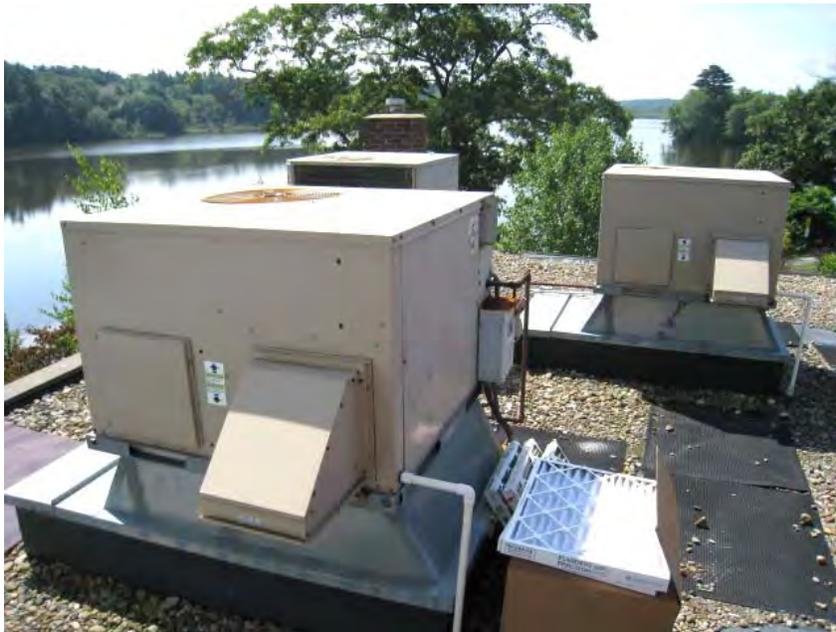
Picture 2

Rooftop AHUs

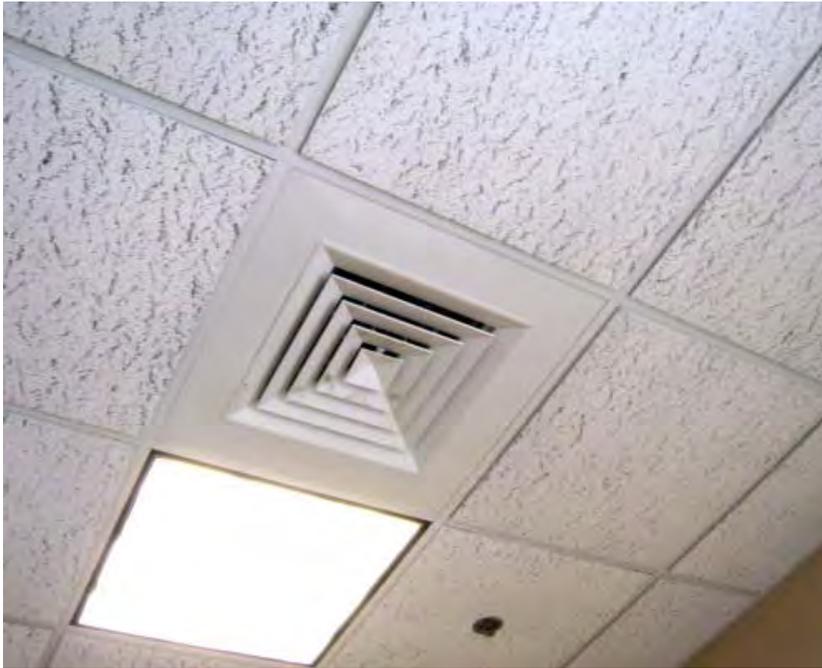
Picture 3

Several supply, exhaust and return vents were observed to have accumulated dust/debris (Pictures 3 and 4). If exhaust vents are not functioning, backdrafting can occur, which can re-aerosolize accumulated dust particles. Supply vents can aerosolize accumulated dust once activated.

Ceiling-Mounted Air Diffuser

18. Clean supply, exhaust and return vents periodically of accumulated dust.
19. Clean carpeting annually or semi-annually in soiled high traffic areas as per the recommendations of the Institute of Inspection, Cleaning and Restoration Certification (IICRC). Copies of the IICRC fact sheet can be downloaded at:
http://www.cleancareseminars.com/carpet_cleaning_faq4.htm (IICRC, 2005)

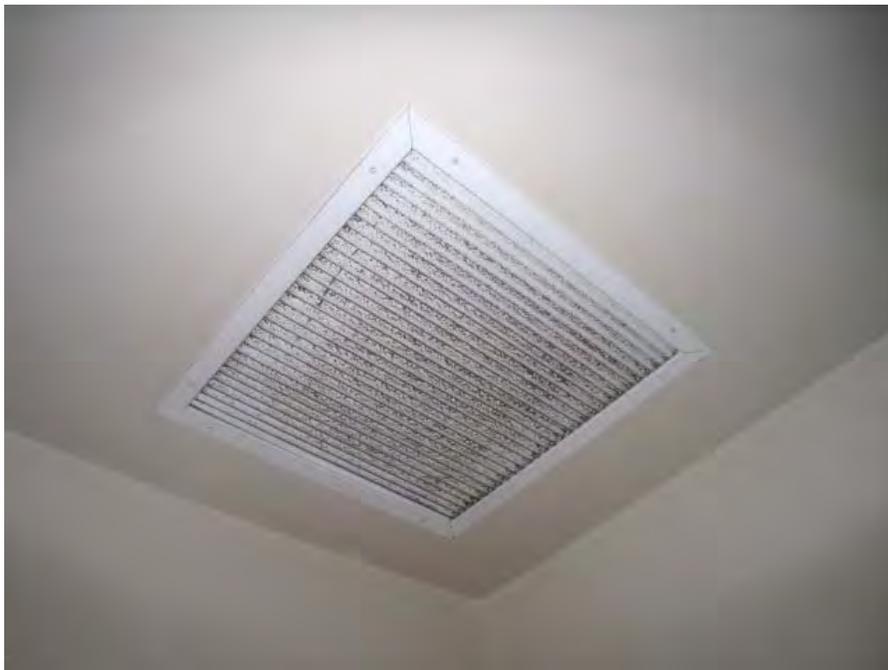
Picture 4

Ceiling-Mounted Return Vents, Note Dust/Debris Accumulation

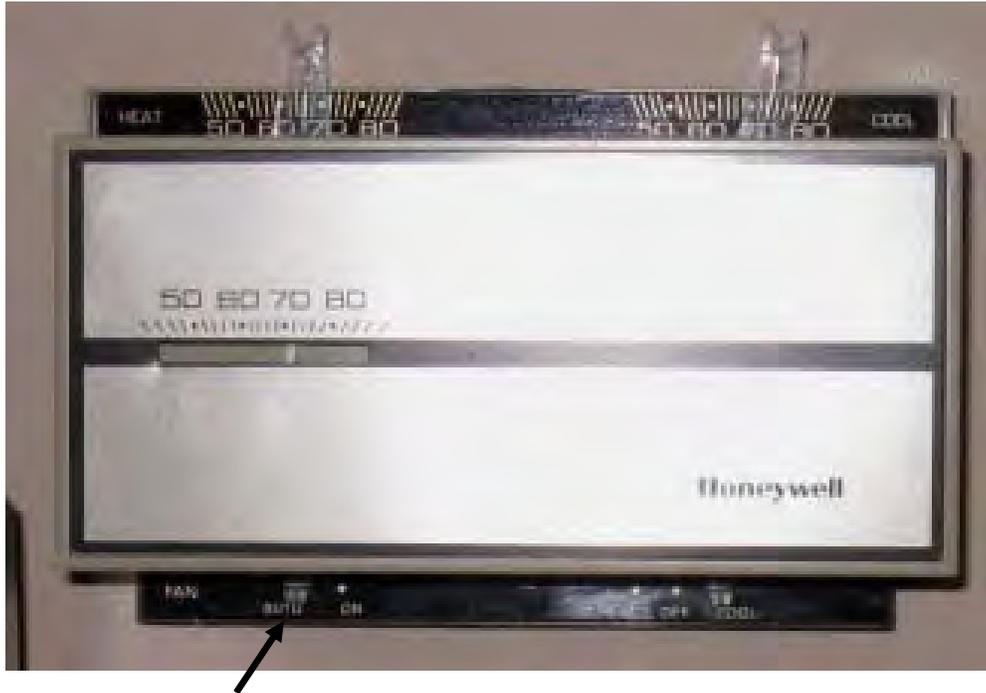
Picture 5

The HVAC system is controlled by digital thermostats (Picture 5). Airflow is controlled using a fan switch that has two settings, *on* and *auto*. When the fan is set to *on*, the system provides a continuous source of air circulation and filtration. The *automatic* setting on the thermostat activates the HVAC system at a preset temperature. Once the preset temperature is reached, the HVAC system is deactivated. Therefore, no mechanical ventilation is provided until

Digital Thermostat, Note Fan Switch to Auto (Bottom Left)

the thermostat re-activates the system. The MDPH recommends that digital thermostats be set to the fan “on” setting to provide continuous air circulation.

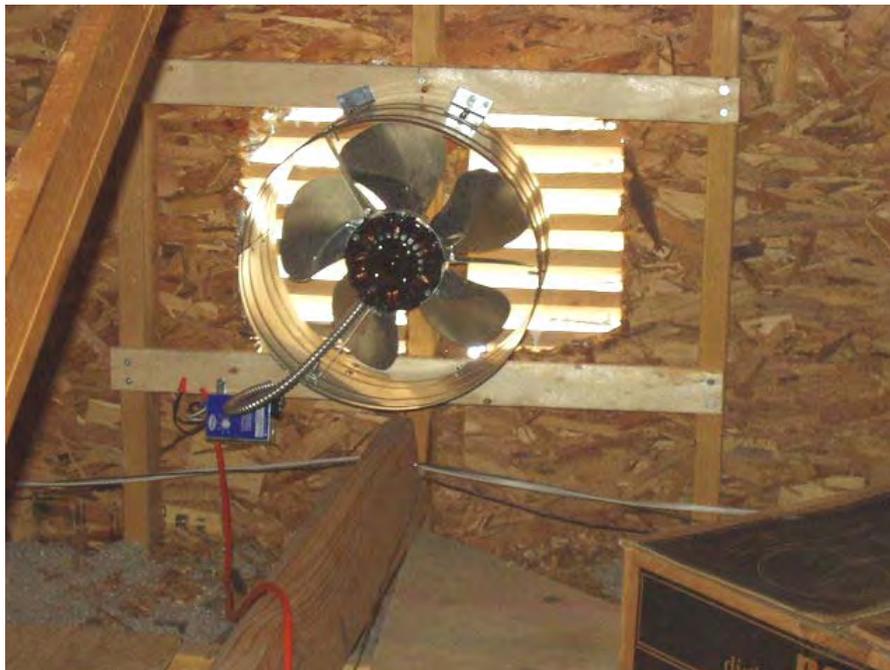
Picture 6

Example of Attic Fan (in Home), Triggered by Excessive Heat

3. Work with town officials to develop a preventive maintenance program for all HVAC equipment.
4. Consult with HVAC engineering firm for advice on proper attic ventilation and/or the insulation of attic ductwork to improve cooling/comfort. Determine whether the installation of an attic fan would be beneficial to reduce heat and excess humidity in the attic during summer months.

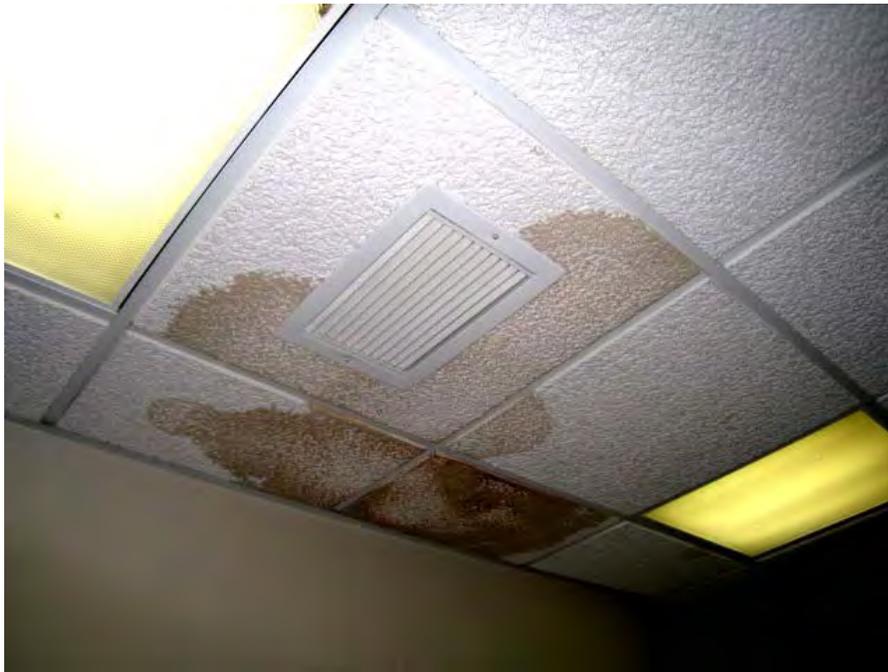
Picture 8

Water damaged ceiling tiles were seen in a number of areas, particularly beneath the flat roof of the 1946 addition (Pictures 8 through 10). Water-damaged ceiling tiles indicate leaks from either the roof or plumbing system and can provide a source for mold growth. These tiles should be replaced after a water leak is discovered and repaired.

Water Damaged Ceiling Tiles

15. Remove/replace water damaged ceiling tiles. Examine the area above and around these areas for mold growth. Disinfect areas of water leaks with an appropriate antimicrobial.

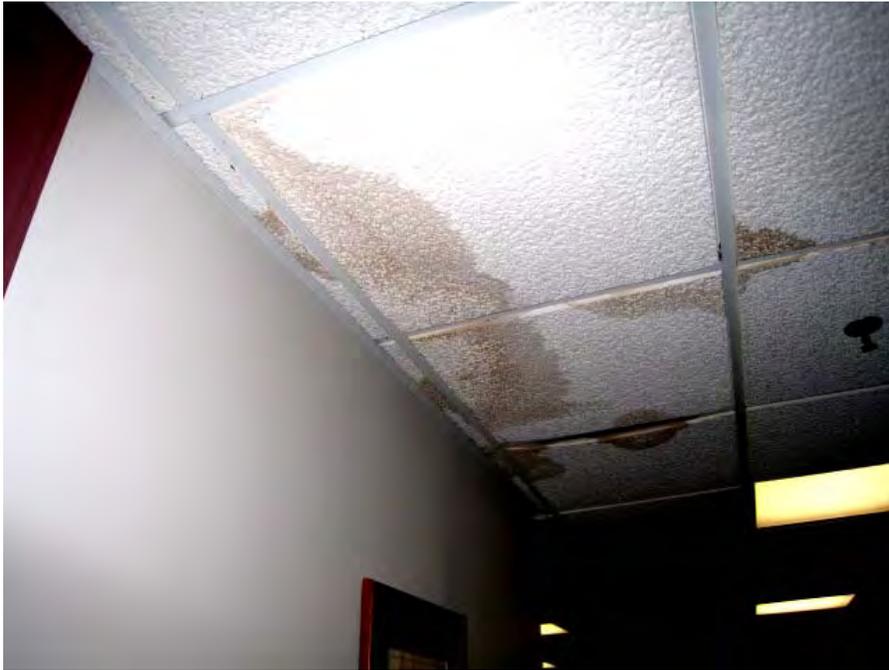
Picture 9

Water Damaged Ceiling Tiles

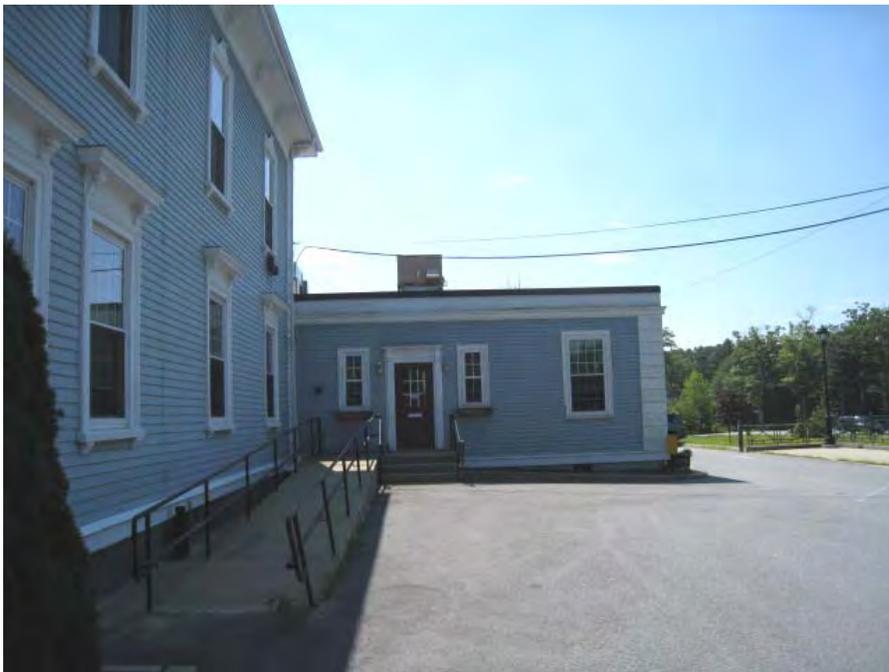
Picture 10

Flat Roof of 1946 Addition

14. Continue to make repairs of roof leaks on the flat roof over the 1946 portion of the building. Consideration should be made to replace the roof to prevent chronic roof leaks.

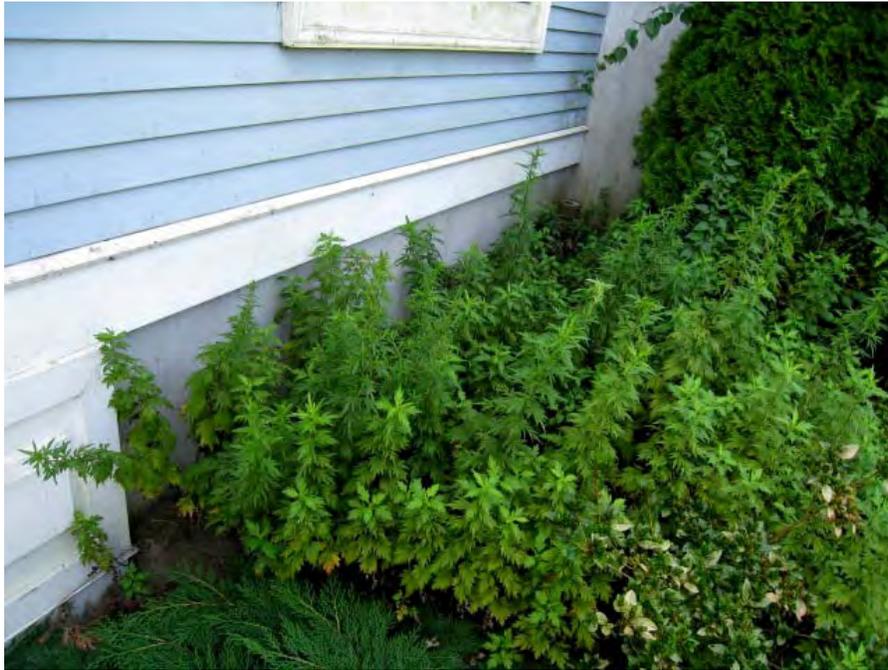
Picture 11

- Plants and trees were observed growing in close proximity to the foundation and building exterior (Pictures 11 and 12). Plants in close proximity to the building envelope can cause water damage to brickwork and mortar. Water can eventually penetrate the brick subsequently freezing and thawing during the winter. This freezing/thawing action can weaken bricks and mortar, resulting in damage.

Plant Growth against the Building

12. Trim plant growth 3 to 5-feet away from exterior of building and HVAC equipment.
13. Ensure dehumidifiers are cleaned and maintained as per the manufacturer's instruction to prevent microbial growth.

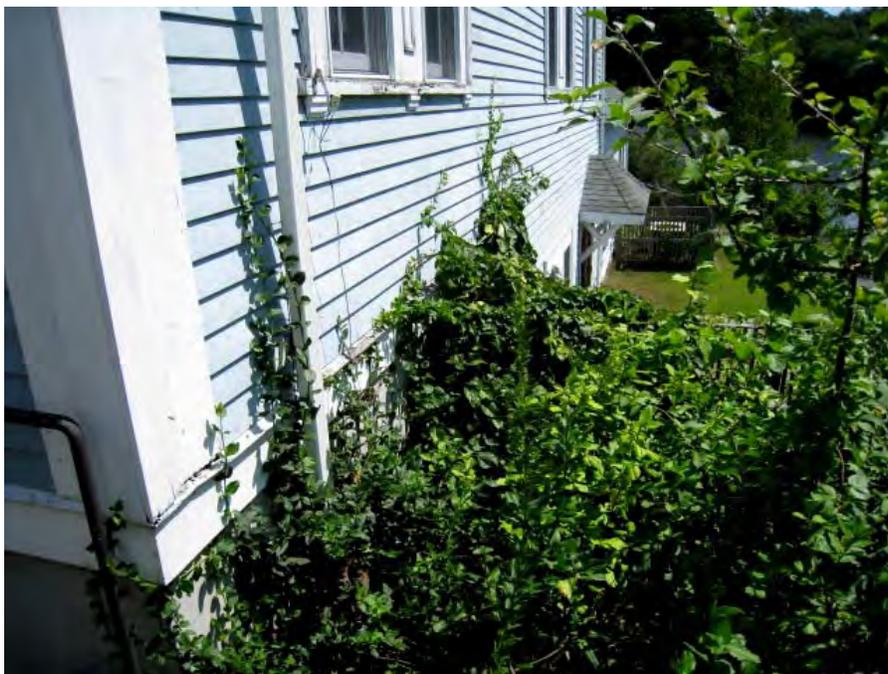
Picture 12

Plant Growth against the Building

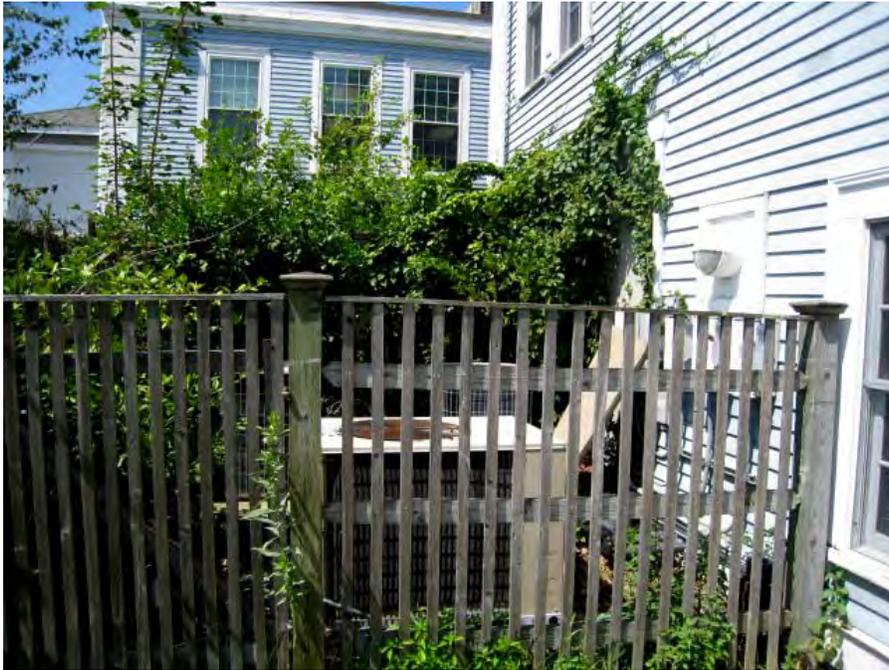
Picture 13

- Plants and trees were observed growing in close proximity to HVAC equipment, which can hold moisture against metal surfaces accelerating deterioration (Picture 13).
- Damaged/rotted wooden windowsills were observed (Pictures 14 and 15).
- Damaged/rotted wood and open seams in exterior walls were observed (Pictures 16).
- Poor drainage/overflow from a stairwell drain and rotted wooden door at the rear of the building was also observed (Pictures 17 through 19). It is also important to note that there is no lip to the doorframe to prevent water penetration; directly inside the door is wall to wall carpeting that reportedly gets wet during heavy rain.

Plant Growth in Close Proximity to HVAC Equipment

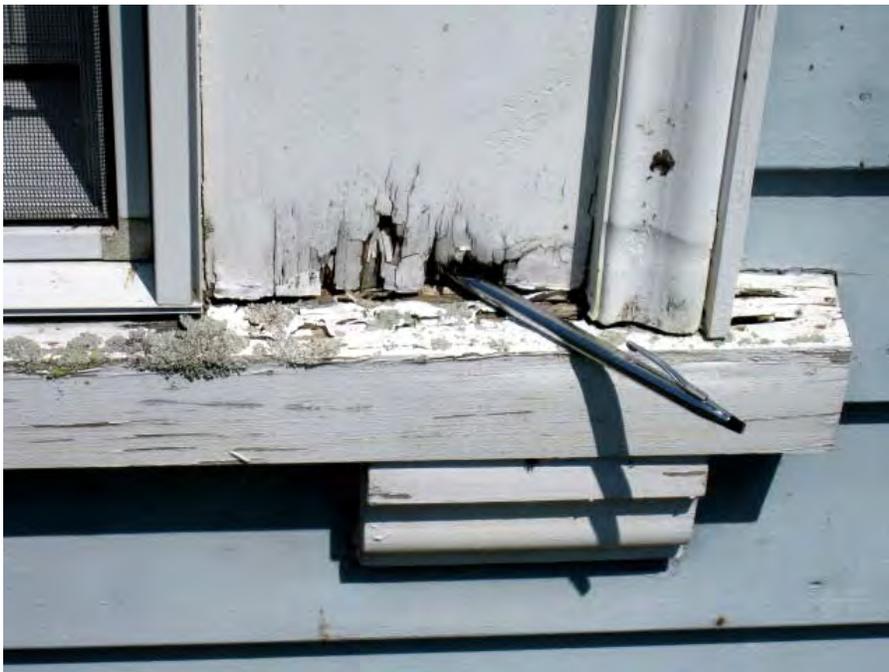
Picture 14

Damaged/Rotted Wooden Window Frame

8. Replace water damaged/rotted wooden window frames/sills.
9. Seal seams and replace water damaged/rotted wood on exterior walls.
10. Take measures to prevent water penetration through the exterior door at the base of rear stairwell, this may include several steps, which may include:

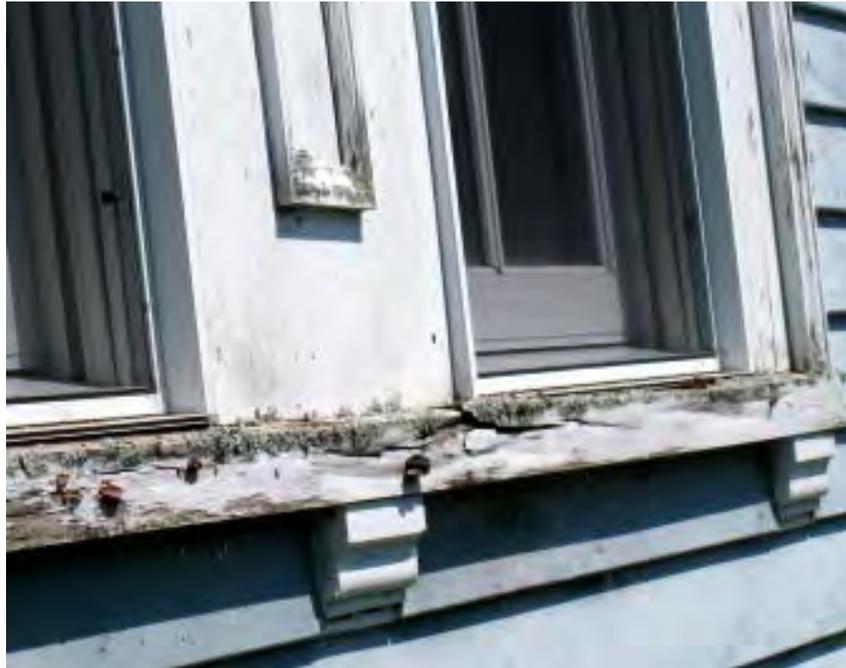
Picture 15

Damaged/Rotted Wooden Windowsill

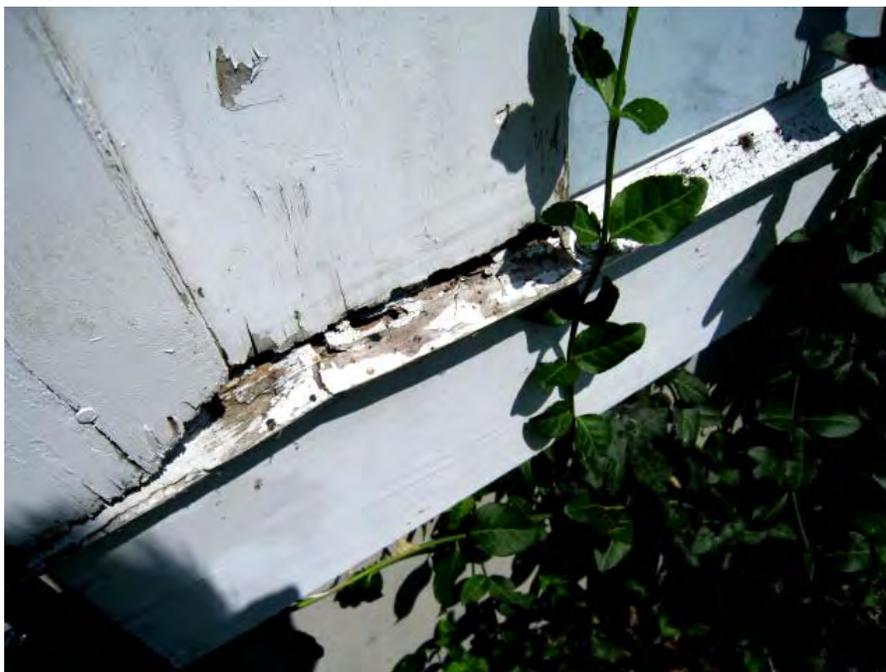
Picture 16

Wood Rot between Seams

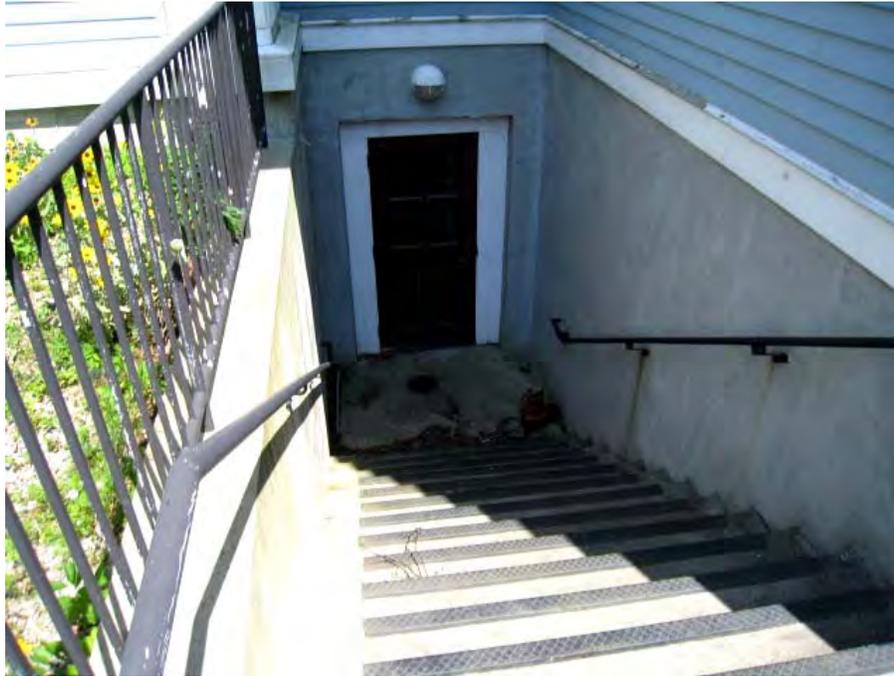
Picture 17

Rear Stairwell Note Drain and Wooden Door at Bottom

- Re-grading the surface around rear stairwell drain to improve drainage;
 - Replacement of the wooden door with a steel-framed door with lip to prevent water penetration; and/or

- Permanent removal of the door, if not an essential means of egress (in accordance with local fire codes).
11. Remove carpeting from interior of rear stairwell and replace with a non-porous flooring material.

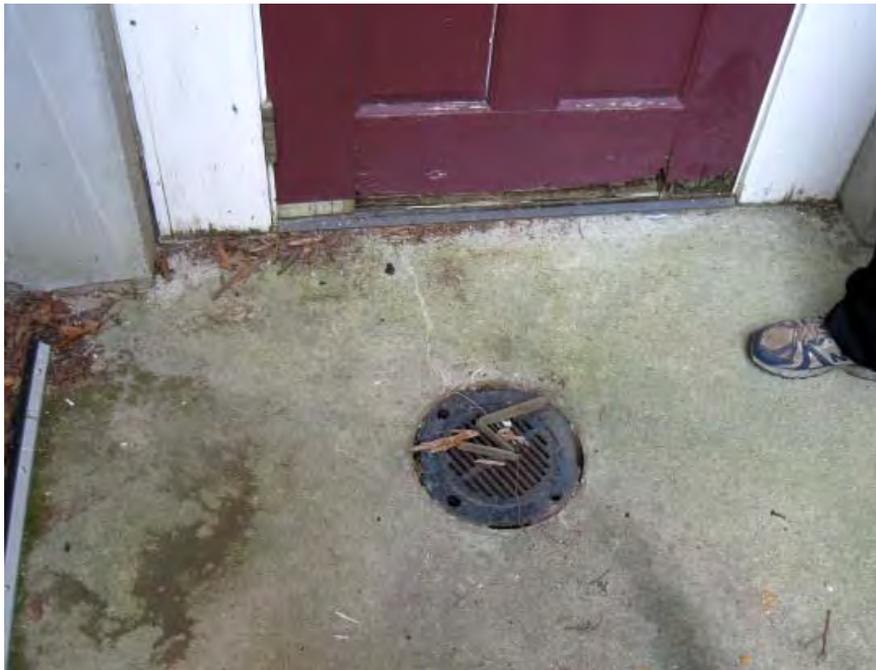
Picture 18

Close-Up of Drain at Base of Stairwell, Note Rot/Damage to Bottom of Wooden Door

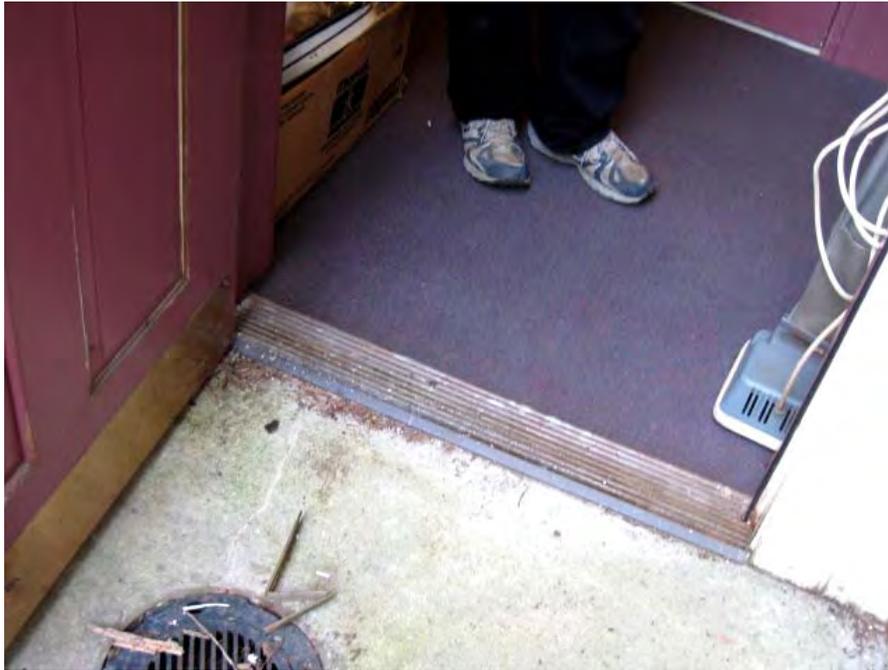
Picture 19

Note no Lip to Prevent Water Penetration and Carpet Directly inside Door

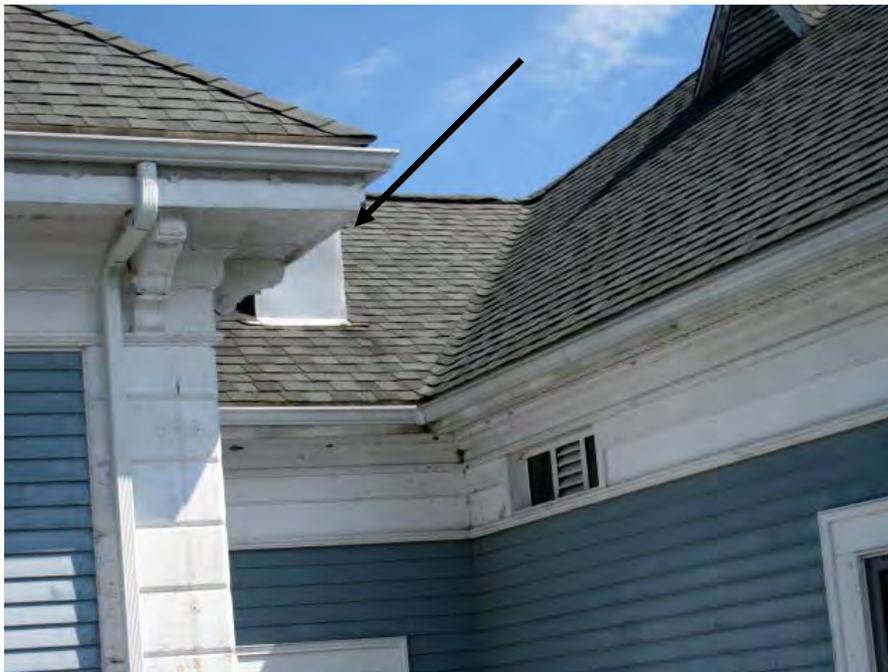
Picture 20

Finally, restrooms are equipped with exhaust vents that operate via a rooftop motor (Picture 20). The vents were not drawing air at the time of the assessment. Exhaust ventilation

is necessary in restrooms to remove excess moisture and to prevent odors from penetrating into adjacent areas.

Rooftop Exhaust Vent/Motor for Restrooms

16. Restore exhaust ventilation in restrooms to remove odors and moisture, make repairs as necessary.
