# **INDOOR AIR QUALITY ASSESSMENT**

**Ipswich Middle/High School  
130 – 134 High Street  
Ipswich, Massachusetts 01938**

Prepared by:  
Massachusetts Department of Public Health  
Bureau of Environmental Health  
Indoor Air Quality Program  
April 2009

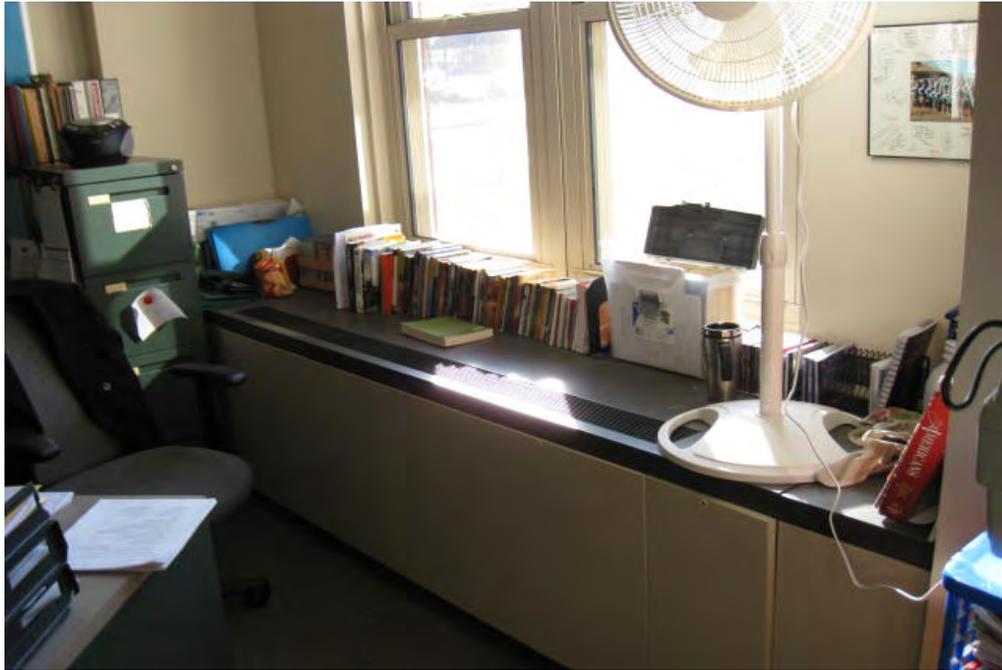
**Picture 1**

Fresh air is supplied to classrooms by unit ventilator (univent) systems (Picture 1). A univent draws air from the outdoors through a fresh air intake located on the exterior wall of the building and returns air through an air intake located at the base of the unit ([Figure 1](#)). Fresh and return air are mixed, filtered, heated and provided to classrooms through an air diffuser located in the top of the unit.

**Univent**

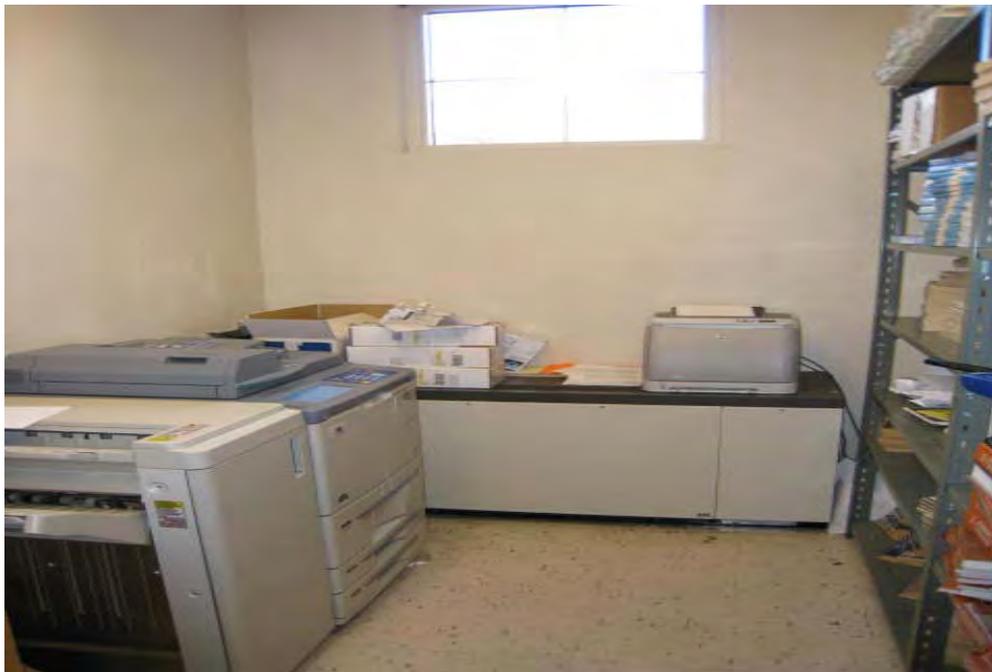
**Picture 2**

BEH staff found univents switched 'off' in a number of areas, preventing adequate ventilation of these rooms (Table 1). In addition, books, furniture and other stored items were blocking the top and front of univent air diffusers and returns, thereby limiting airflow in these rooms (Pictures 2 to 4). Further, an accumulation of debris and dust was observed in the air diffusers of several univents (Picture 5). In order for univents to provide fresh air as designed,

**Office Equipment and Documents on Univent**

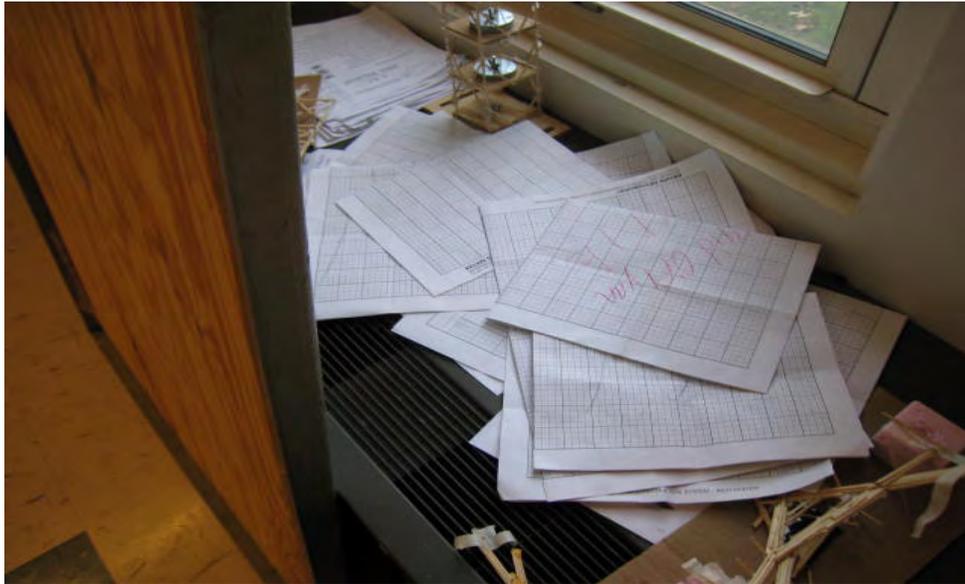
**Picture 3**

**Clutter on Univent**

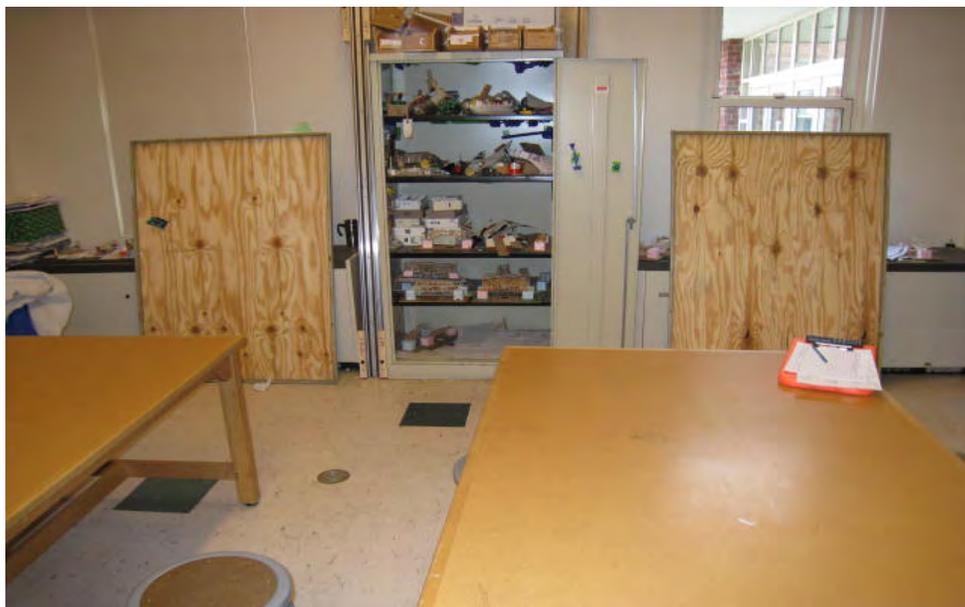
**Picture 4**

**Two Large Wood Panels Blocking Univents**

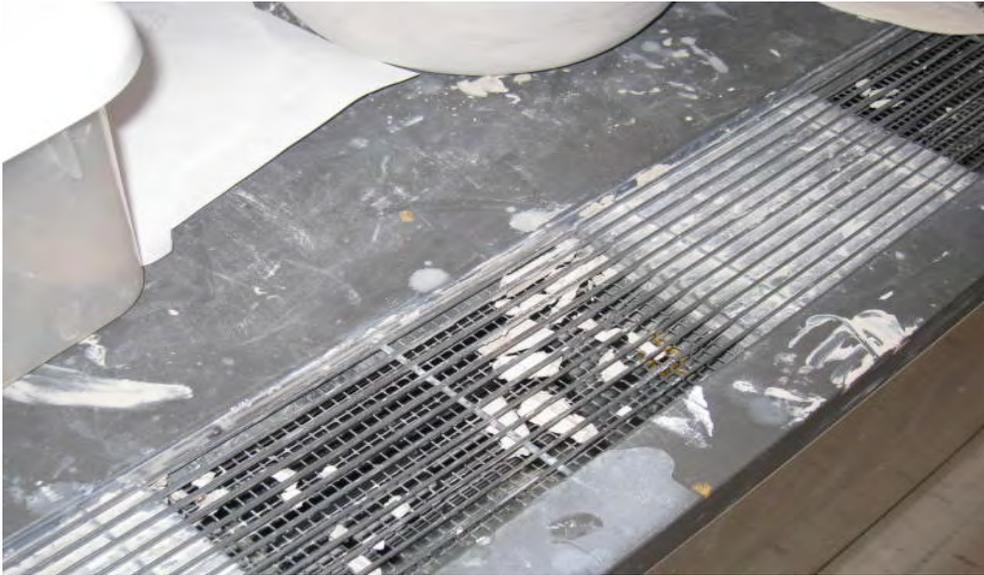
**Picture 5**

**Debris in Univent**

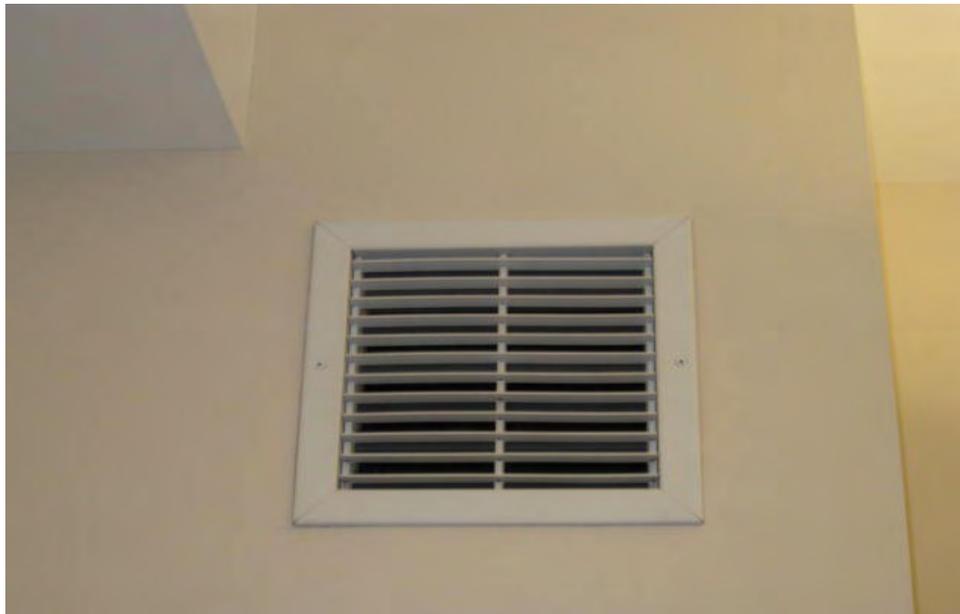
**Picture 6**

**Wall Mounted Exhaust**

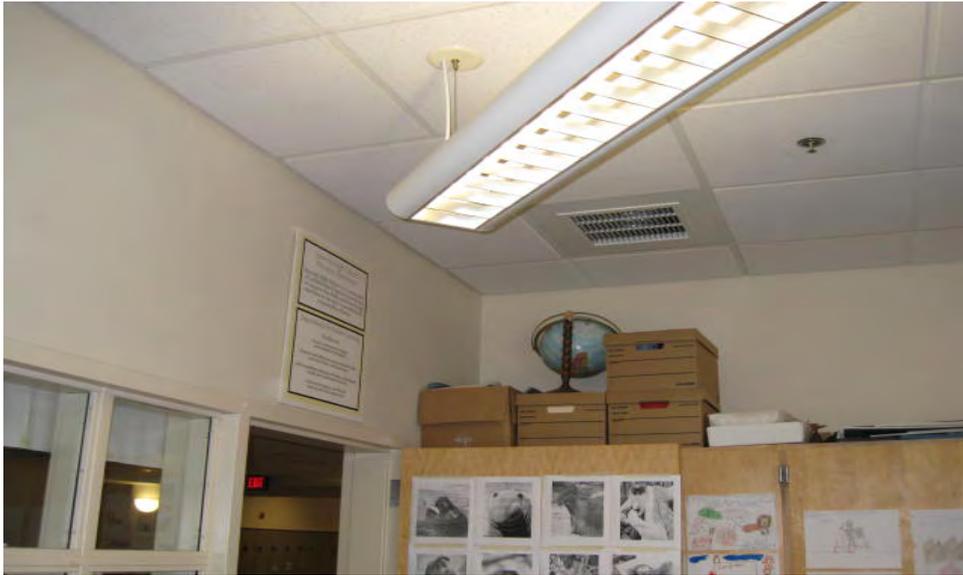
**Picture 7**

**Ceiling Mounted Exhaust (note open door)**

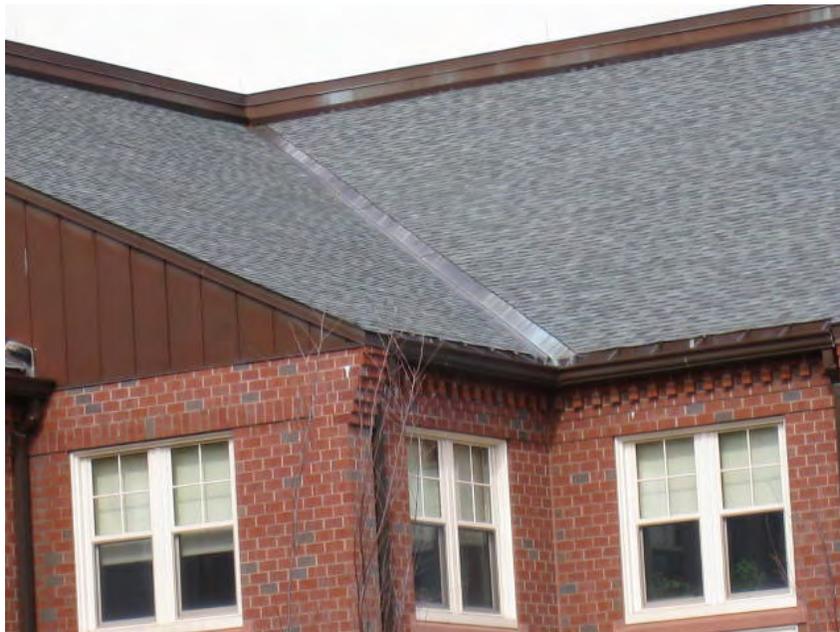
**Picture 8**

**Roof Valley**

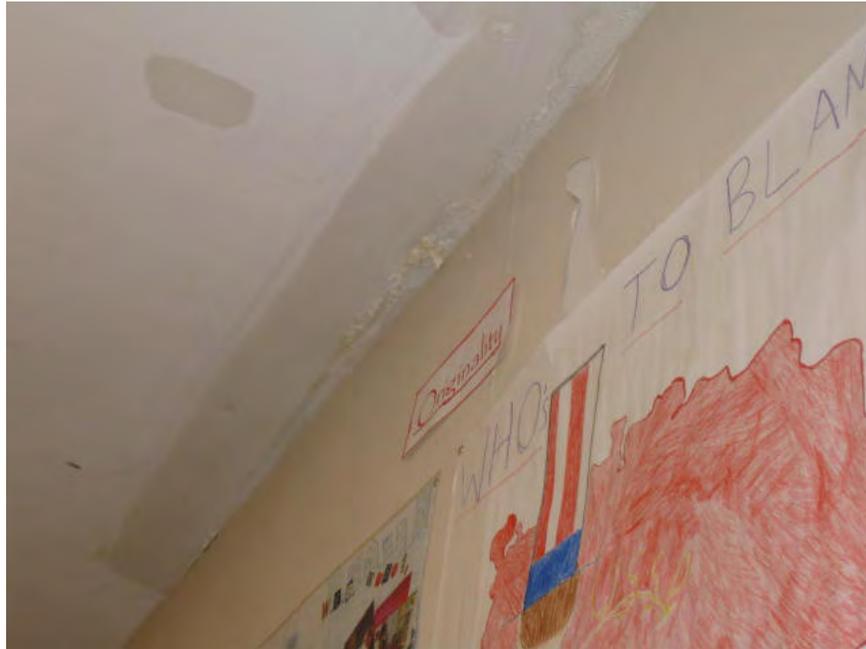
**Picture 9**

**Repaired Ceiling GW in classroom below roof valley**

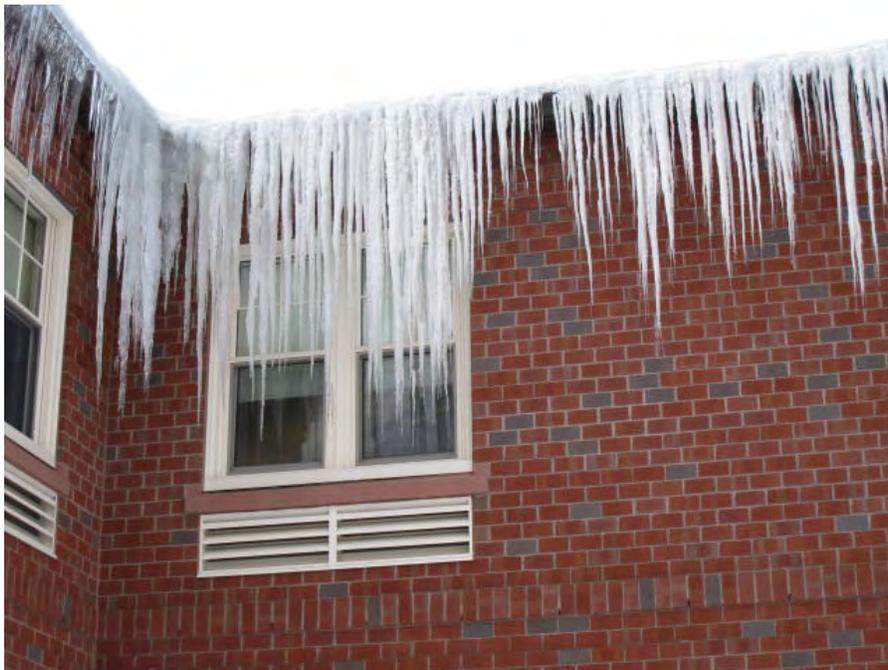
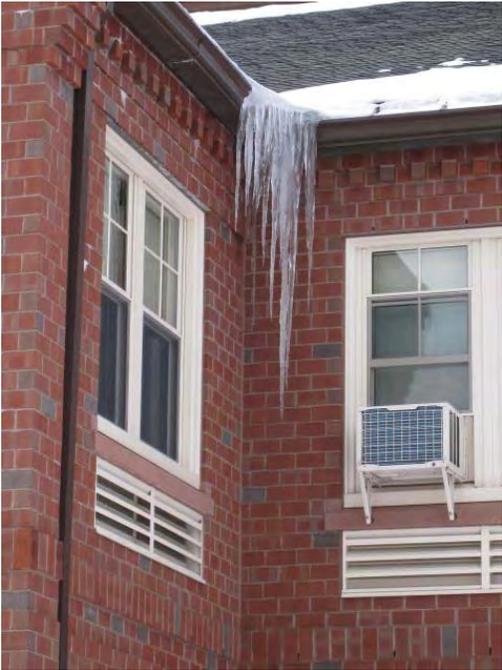
The IMHS east wing has a history of water leaks through its roof. IMHS staff reported that in the winter of 2006, ice dams caused roof leaks resulting in damage to ceiling gypsum wallboard and insulation in the attic. The roof and damaged insulation was reportedly repaired/replaced (Pictures 8 and 9). At the time of the January 2009, the roof of the east wing was found to have large ice dams, particularly on side of the building facing north (Picture 10 and 11).

**Ice Dam of Roof Edge**

**Ice Dam on Roof Edge**

1. Consult with a building engineer concerning the best methods to retrofit the roof to prevent ice dams. Methods may include the installation of soffit and ridge vents in the existing roof.
2. Make efforts to have the non-cement sections of the attic space complete covered with insulation to reduce heat loss into the attic space. Penetrations for ductwork through the attic floor should be sealed. Consideration should be given to covering the insulation and floor joist with flooring to prevent heat loss and provide r means of access for maintenance staff to inspect and conduct repairs to the roof as needed.
3. Consider providing exhaust ventilation for rooms B224 and B226.

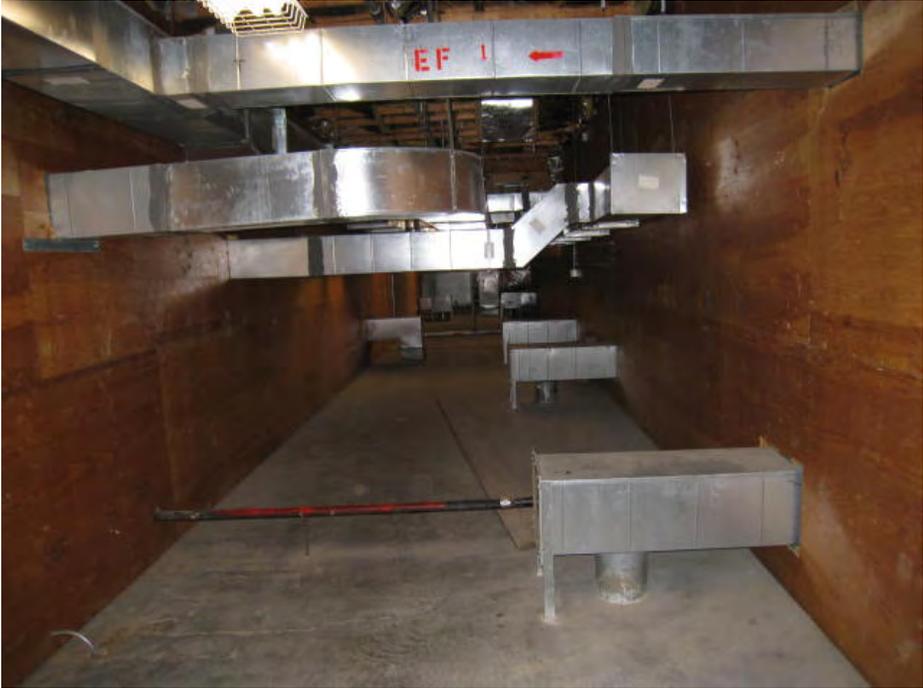
**Picture 12**

**Cement attic floor section**

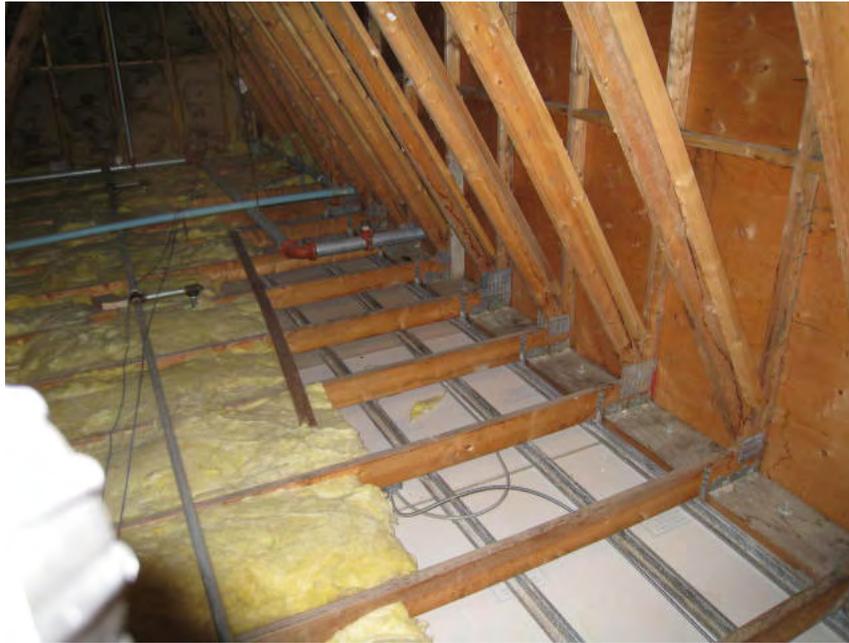
**Picture 13**

Neither ridge vents nor soffit vents were visible on the east wing roof. The insulation around the GW/joists in the attic floor was either missing (Picture 13) or had significant spaces that would readily allow heated air to move from occupied areas into the attic space. This lack of insulation allows heat to gather in the attic roof peak, subsequently melting snow on the roof to form ice dams. The draw of air from occupied areas through cracks and crevices in ceilings and walls can be increased, resulting in more heated air penetrating into the attic space. Another confounding problem is moistening of insulation resulting from these ice dams. The ability of insulation to prevent temperature transfer is decreased if the material becomes moistened. The loss of temperature control can result in more heat transfer into the attic space, creating larger ice dams and more water penetration. The conditions contributing to the creation of the ice dams should be corrected to prevent moisture problems.

**Attic with wood joists and fiberglass insulation bales  
Note Missing Insulation from surface of GW**

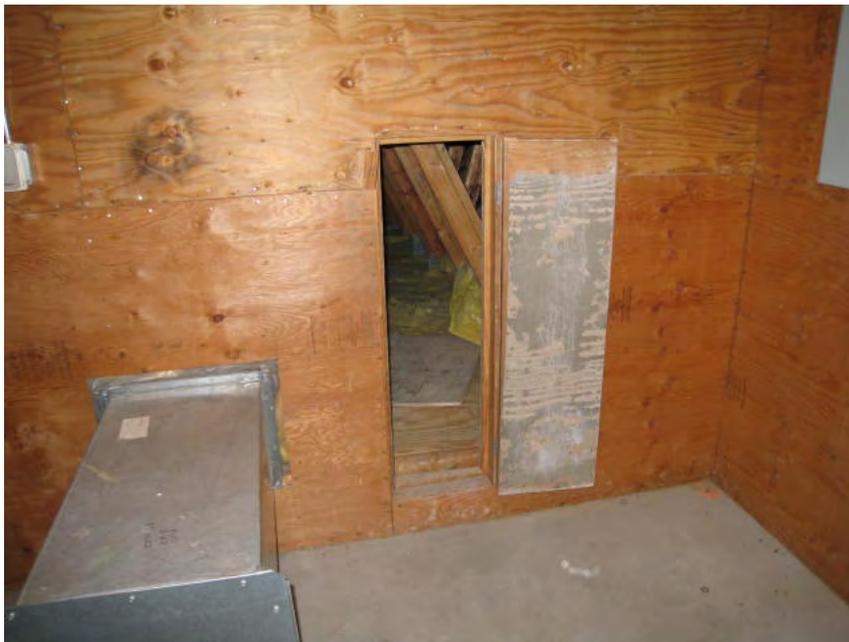
**Picture 14**

**Plywood wall with entrance into wood/GW section.  
Note cement floor in foreground**

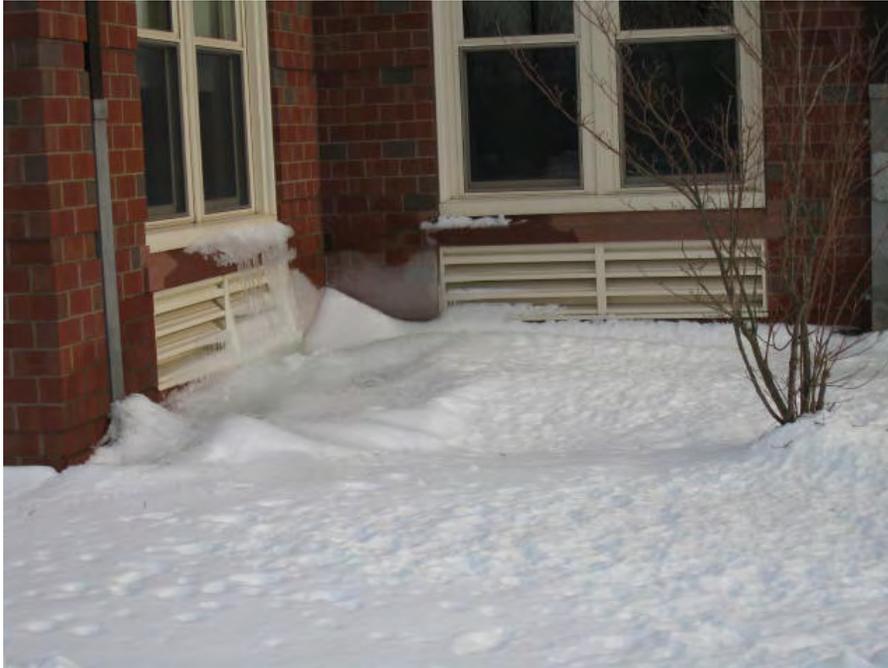
**Picture 15**

**Univent Fresh Air Intake Partially Blocked by Ice**

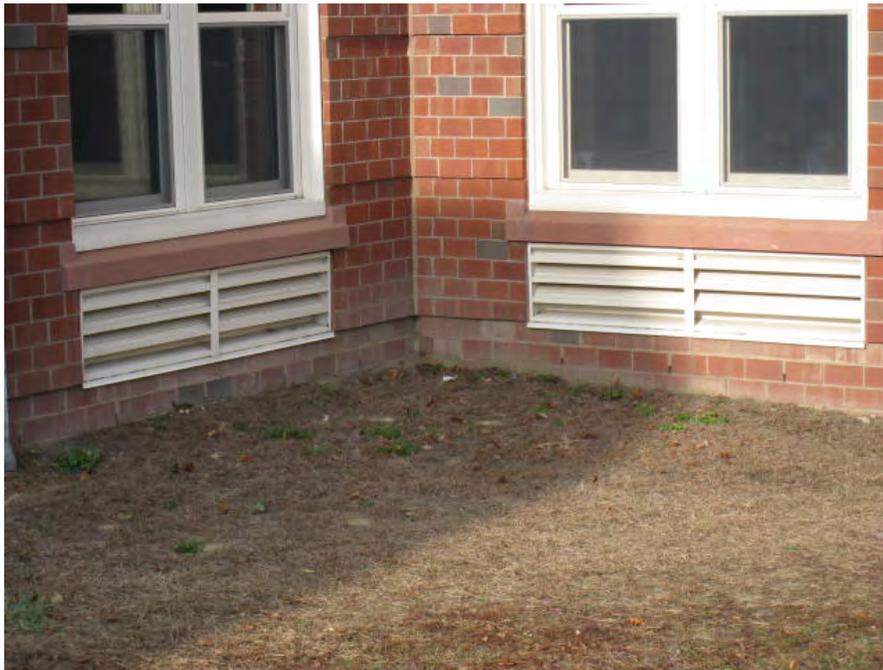
**Picture 16**

**Univent Fresh Air Intake Less than one foot above ground level**

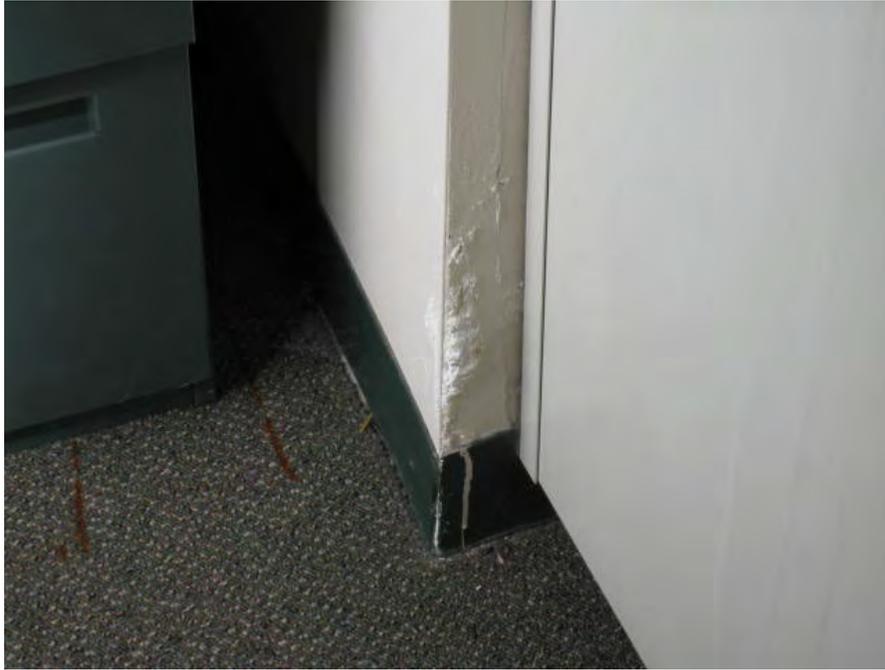
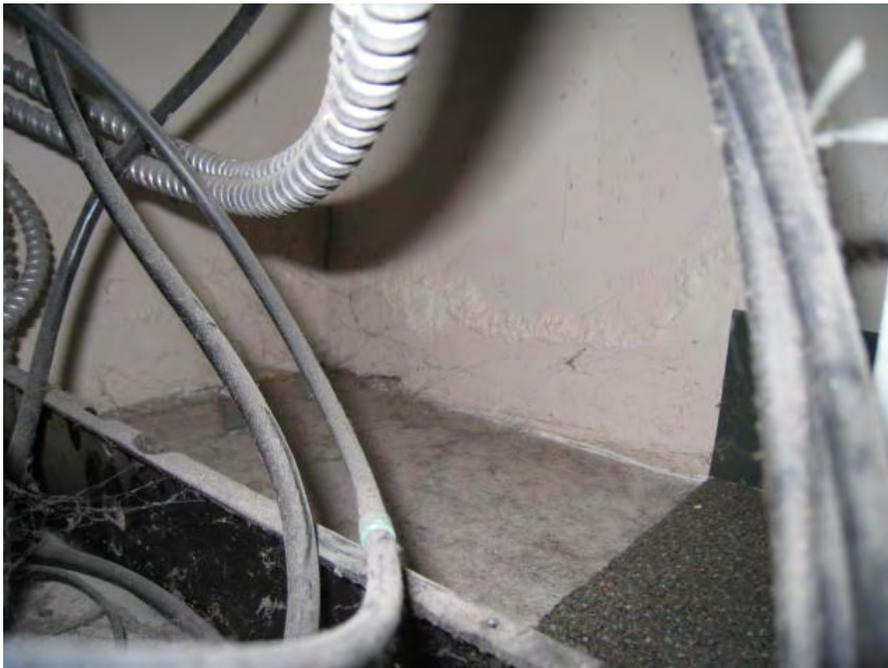
In the east wing, BEH staff identified rooms with water-damaged GW around the univents (Pictures 17 and 18; Table 3). Damaged GW around univents was endemic of east- and south-facing classrooms of the east wing. The source of this water damage is likely driving rain from an easterly direction.

**Example of Water Damaged GW around Univent**

**Example of Water damaged GW in univent cabinet,  
Note no discoloration, indicating no mold growth**

1. Remove water-damaged GW around univents.
2. Remove cement from the drip edge of window sills.
3. Examine the installation of univent fresh air intake vents for possible leaks, particularly for univents on the east and south exterior walls of the east wing.
4. Ice and snow blocking univent fresh air intakes should be routinely removed after snow storms.
5. Use openable windows in conjunction with mechanical ventilation to facilitate air exchange. Care should be taken to ensure windows are properly closed at night and weekends to avoid the freezing of pipes and potential flooding.
6. Consider adopting a balancing schedule of every 5 years for all mechanical ventilation systems, as recommended by ventilation industrial standards (SMACNA, 1994).
7. Examine attic exhaust motors for proper function. Repair/replace belts and parts as necessary.

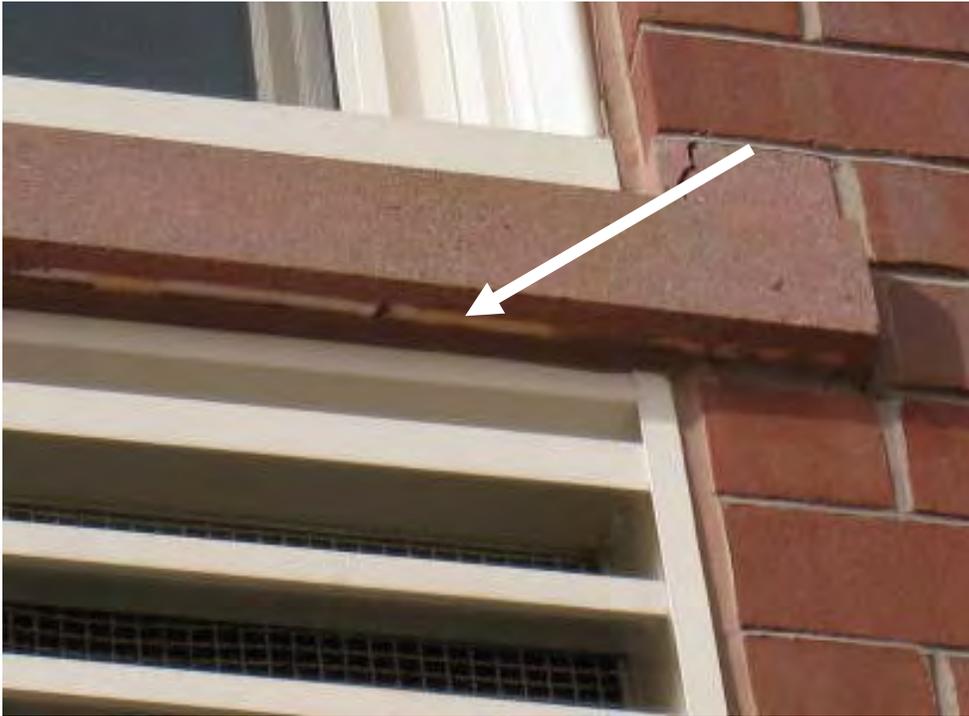
**Picture 19**

**Window Sill Drip edge filled with cement**

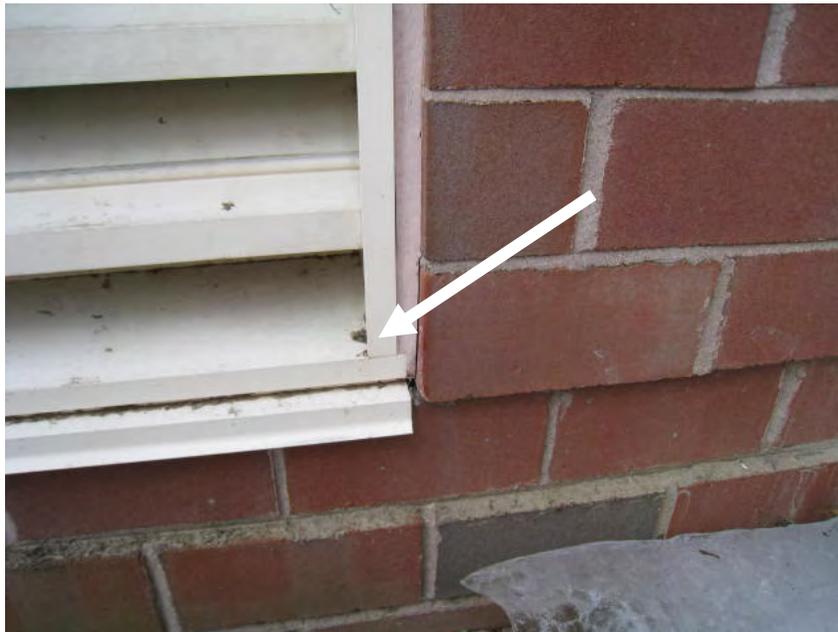
**Picture 20**

**Crack in Fresh Air Intake Vent Sealant**

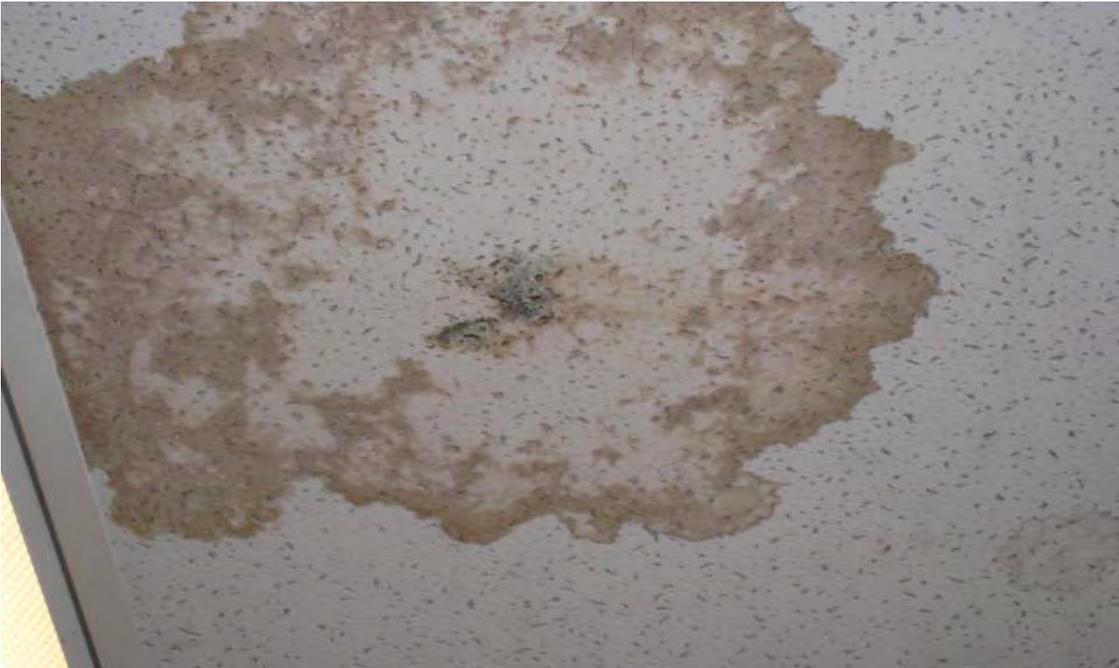
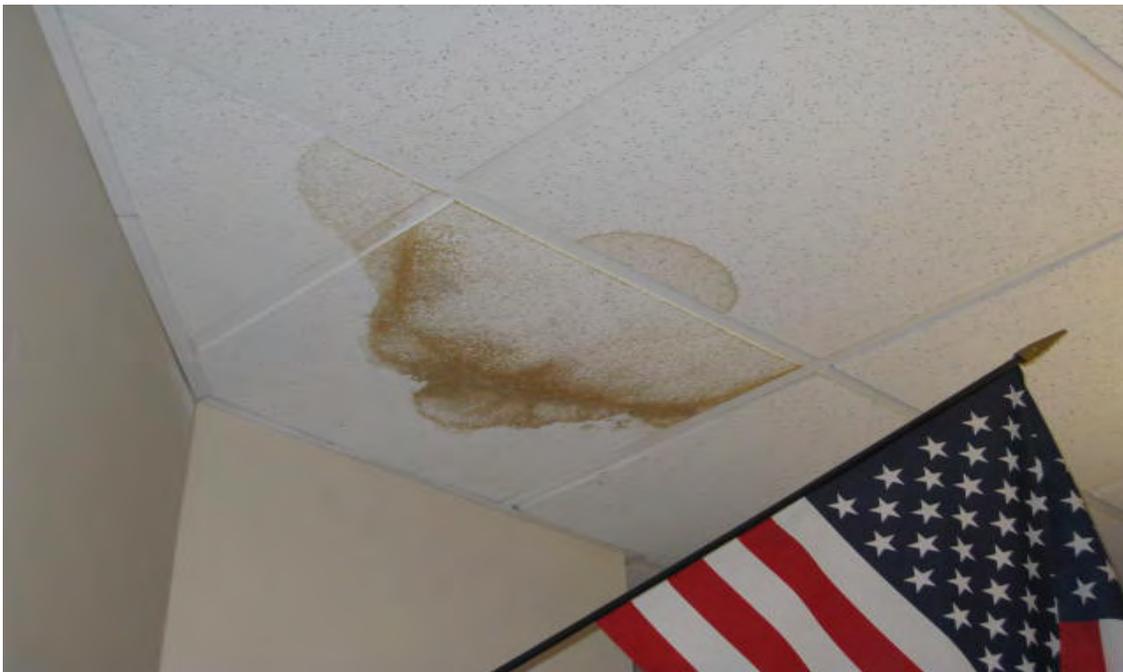
Several rooms had water-damaged ceiling tiles which can indicate leaks from either the roof and/or plumbing system (Pictures 21 and 22). Water-damaged ceiling tiles can provide a source for mold growth and should be replaced after a water leak is discovered and repaired.

**Water Damaged Ceiling Tile**

**Water Damaged Ceiling Tiles**

9. Repair any existing water leaks and replace any remaining water-damaged ceiling tiles. Examine the area above these tiles for mold growth. Disinfect areas of water leaks with an appropriate antimicrobial, as needed.

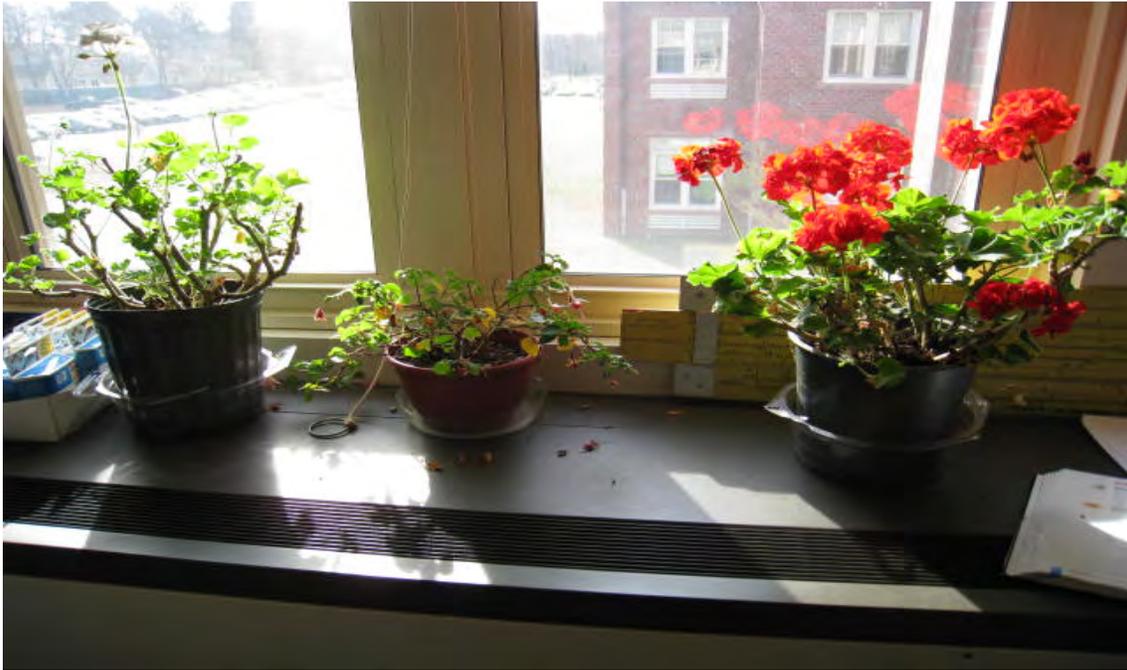
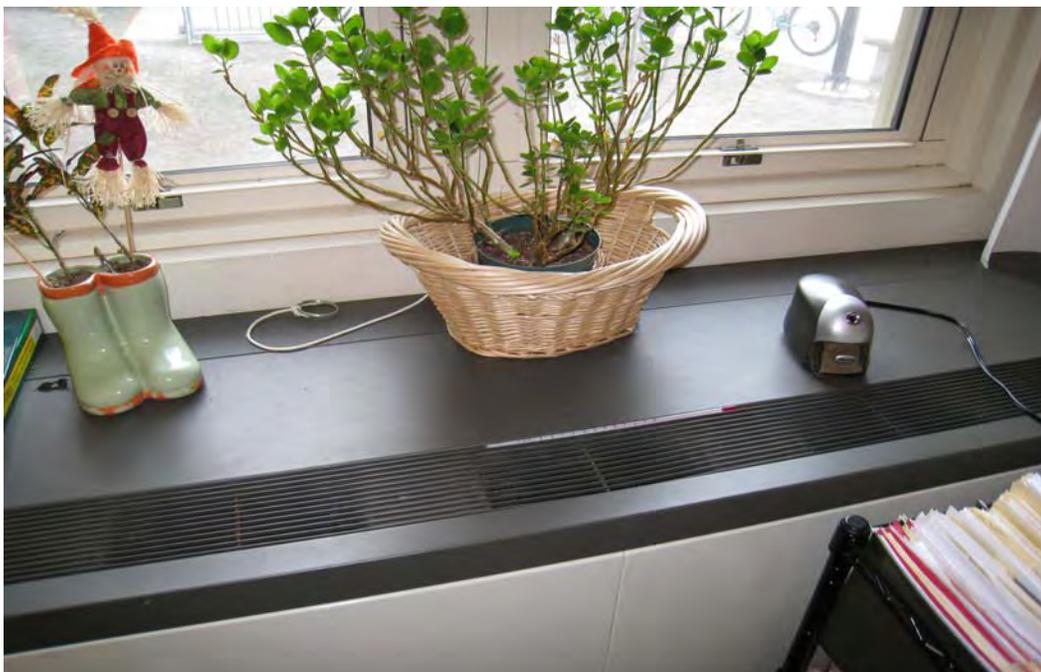
Plants were noted in several classrooms (Pictures 23 and 24). Plants can be a source of pollen and mold which can be respiratory irritants to some individuals. Plants should be properly maintained and equipped with drip pans and should be located away from univents to prevent the aerosolization of dirt, pollen and mold.

**Plants near Univent**

**Plants, Straw Items, and Pencil Sharpener near Univent**

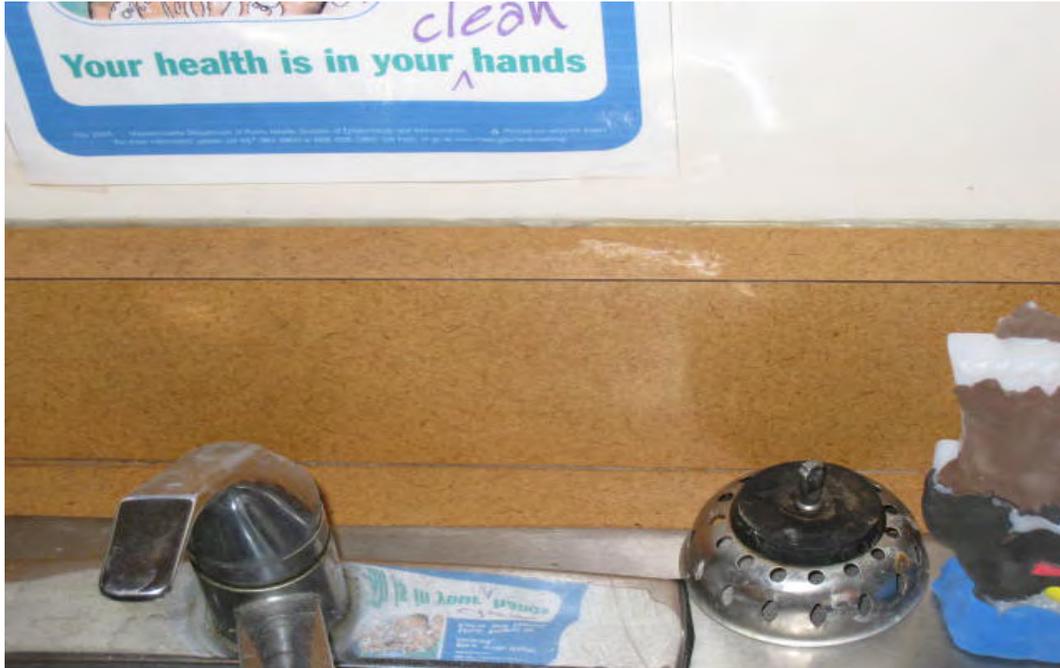
**Picture 25**

Open seams between sink countertops and walls were observed in some rooms (Picture 25). If not watertight, water can penetrate through the seam, causing damage. Improper drainage or sink overflow can lead to water penetration into the countertop, cabinet interiors and areas behind cabinets. Water penetration and chronic exposure of porous and wood-based materials can cause these materials to swell and show signs of water damage. Repeated moistening of porous materials can result in mold growth.

**Open Seam between Sink Countertop and Wall**

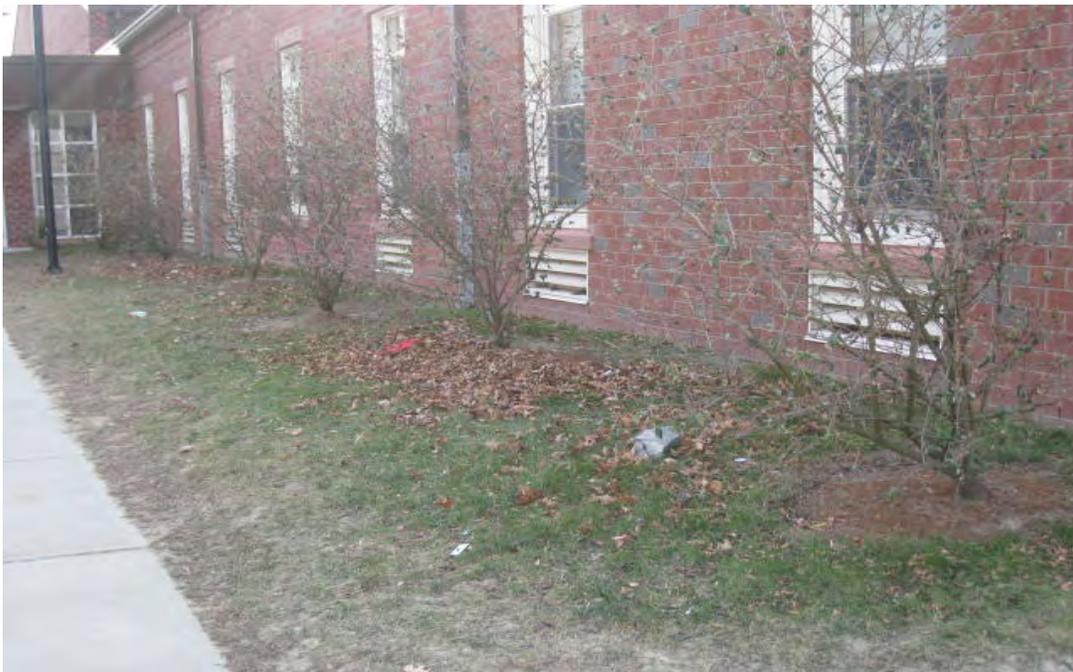
**Picture 26**

Around the exterior of the IMHS, trees were observed growing in close proximity to the building and univent fresh air intakes (Picture 26). Trees, shrubs, and plants can hold moisture against exterior brick and prevent drying. Additionally, vegetation growing on or near the fresh air intakes can provide a source for pollen and odors to be entrained into the building by the air handling equipment. The aforementioned condition represents a potential moisture penetration source. Over time, this condition can undermine the integrity of the building envelope and provide a means of water entry into the building via capillary action through foundation concrete and masonry (Lstiburek & Brennan, 2001).

**Trees and Leaf Debris in Close Proximity to Univent Intakes and Building**

16. Trim trees along exterior walls back approximately 5 feet to prevent moisture impingement; and clear any leaf and organic debris from the areas near univent intakes.
17. Consider adopting the US EPA (2000) document, “Tools for Schools”, as an instrument for maintaining a good indoor air quality environment in the building. This document is available at: <http://www.epa.gov/iaq/schools/index.html>.
18. Refer to resource manual and other related indoor air quality documents located on the MDPH’s website for further building-wide evaluations and advice on maintaining public buildings. These documents are available at: [http://mass.gov/dph/indoor air](http://mass.gov/dph/indoor_air).

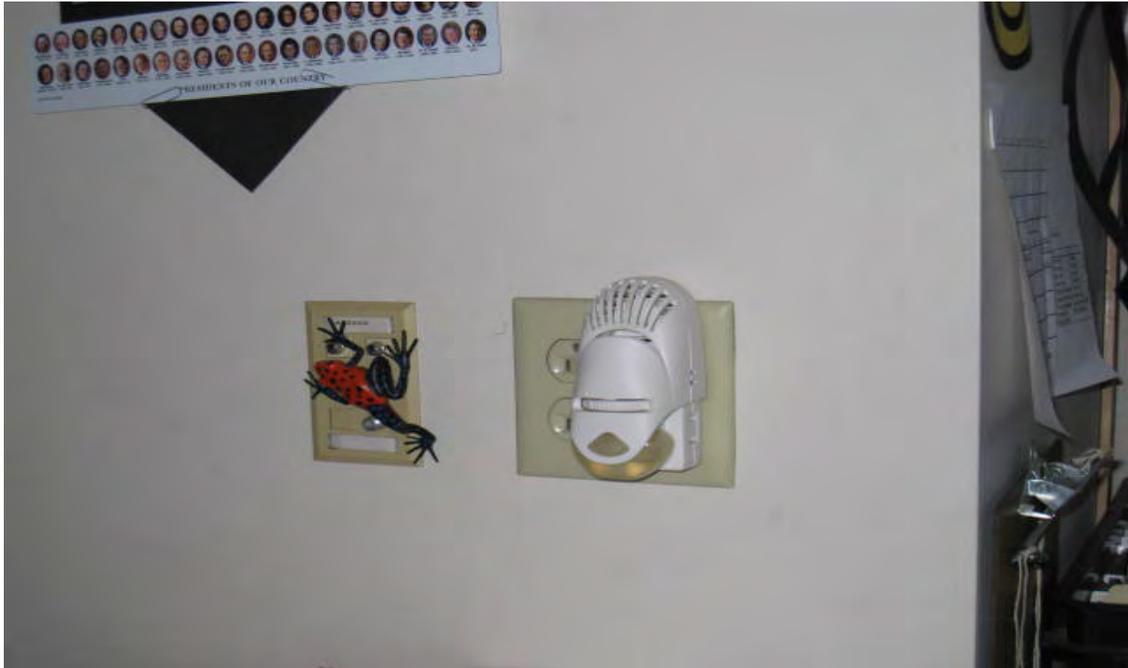
**Picture 27**

Air fresheners and deodorizing materials were observed in a number of areas (Picture 27). Air deodorizers contain chemicals that can be irritating to the eyes, nose and throat of sensitive individuals. Many air fresheners contain 1,4-dichlorobenzene, a VOC which may cause reductions in lung function (NIH, 2006). Furthermore, deodorizing agents do not remove materials causing odors, but rather mask odors that may be present in the area.

**Plug-In Air Freshener**

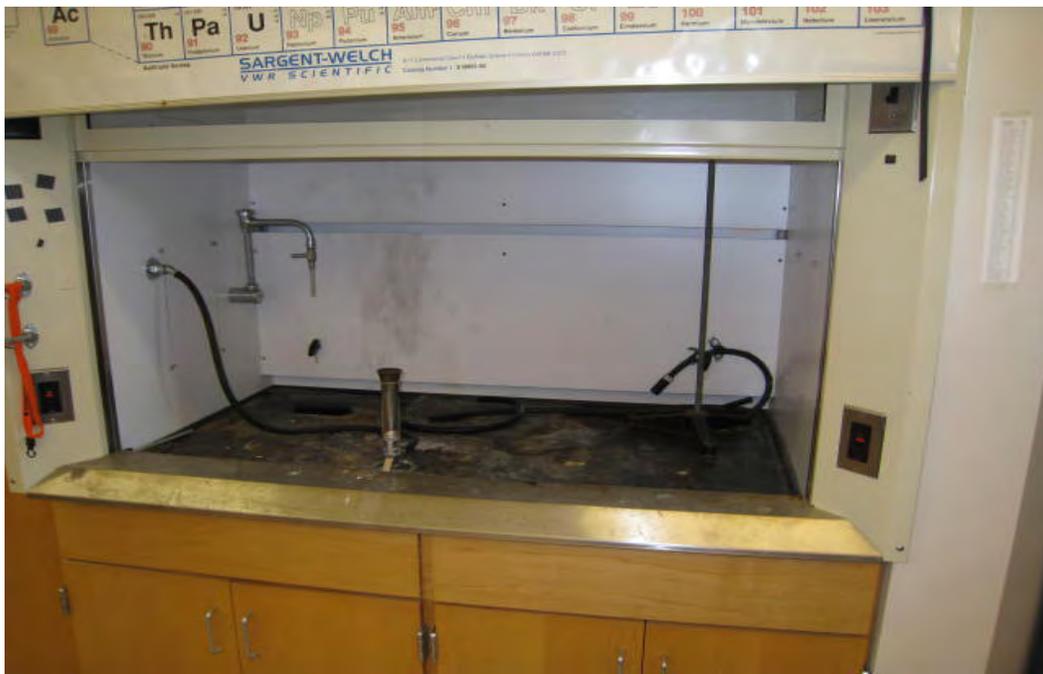
**Picture 28**

Other conditions that can affect indoor air quality were observed during the assessment. The chemistry classrooms contain chemical fume hoods (Picture 28), which capture and exhaust contaminants at the source. At the time of the MDPH assessment, the efficacy of the draw of air through this equipment could not be determined. Chemical hoods should be calibrated on an annual basis as recommended by the manufacturer to ensure proper function.

**Fume Hood in Science Lab**

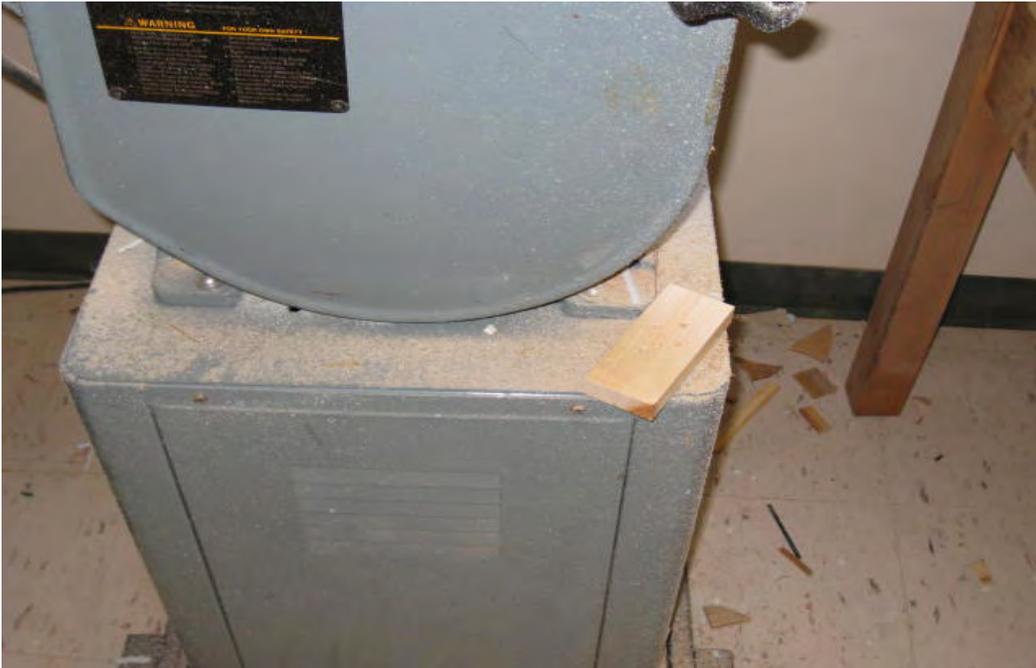
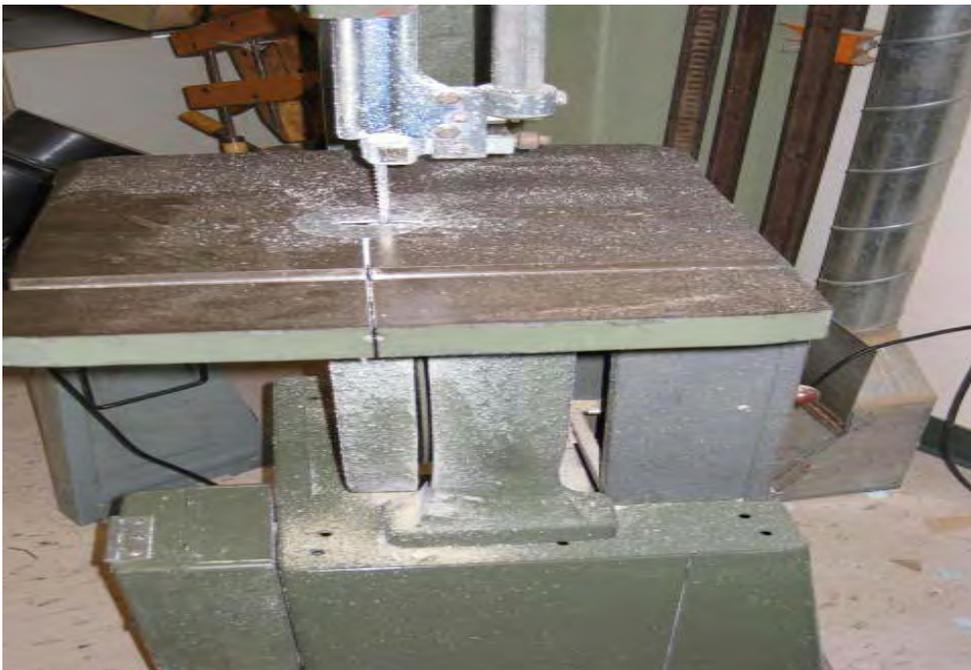
The woodshop machine room contains various wood cutting equipment that lacks dedicated local exhaust to collect saw dust and debris. As a result, saw dust and debris was accumulated on the machines, floor and flat surfaces (Pictures 29 and 30). Although this classroom had general exhaust ventilation, a local dedicated exhaust ventilation system should be used for woodworking operations. Wood dust is a fine particulate, which can be easily aerosolized and become irritating to the eyes, nose, throat and respiratory system. In addition, under certain conditions, wood dust is a fire hazard.

**Sawdust and Wood Debris in Machine Room**

**Sawdust in Machine Room**
