INDOOR AIR QUALITY ASSESSMENT

**Eames Way Elementary School
164 Eames Way
Marshfield, Massachusetts 02050**

Prepared by:
Massachusetts Department of Public Health
Bureau of Environmental Health
Indoor Air Quality Program
March 2009

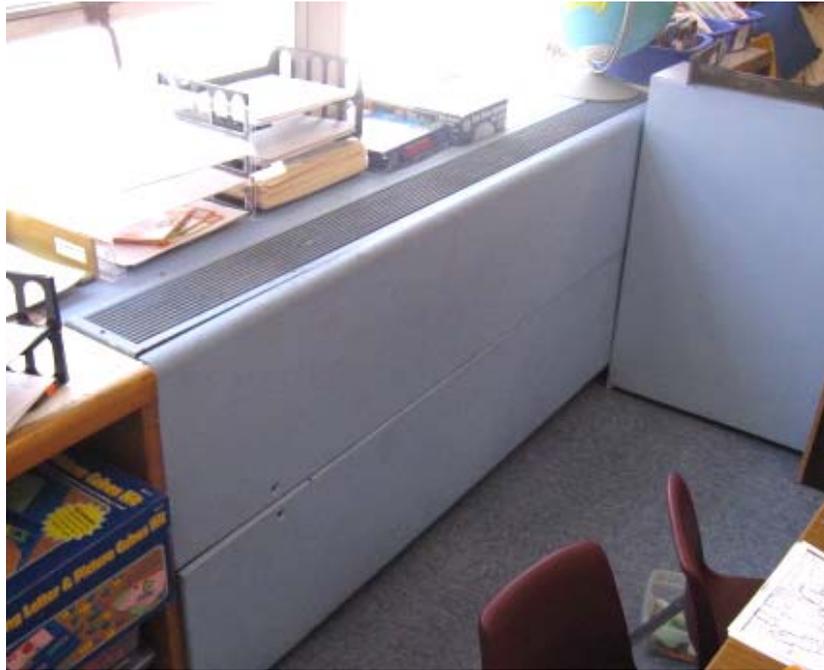
Picture 1

Fresh air in classrooms is supplied by unit ventilator (univent) systems (Picture 1). A univent draws air from outdoors through a fresh air intake located on the exterior wall of the building (Picture 2) and returns air through an air intake located at the base of the unit ([Figure 1](#)). Fresh and return air are mixed, filtered (Picture 3), heated and provided to classrooms through an air diffuser located in the top of the unit. Univents are reportedly original equipment from the 1960's. Univents of this age can be difficult to maintain because replacement parts are often

Vintage Univent Circa 1960's

1. Contact an HVAC engineering firm for an assessment of the ventilation system's control system (e.g., controls, air intake louvers, thermostats). Based on the age and availability of parts for ventilation components, such an evaluation is necessary to determine the operability and feasibility of repairing/replacing the equipment.
2. Consider replacing interlocking ceiling tiles with drop ceiling tile system.

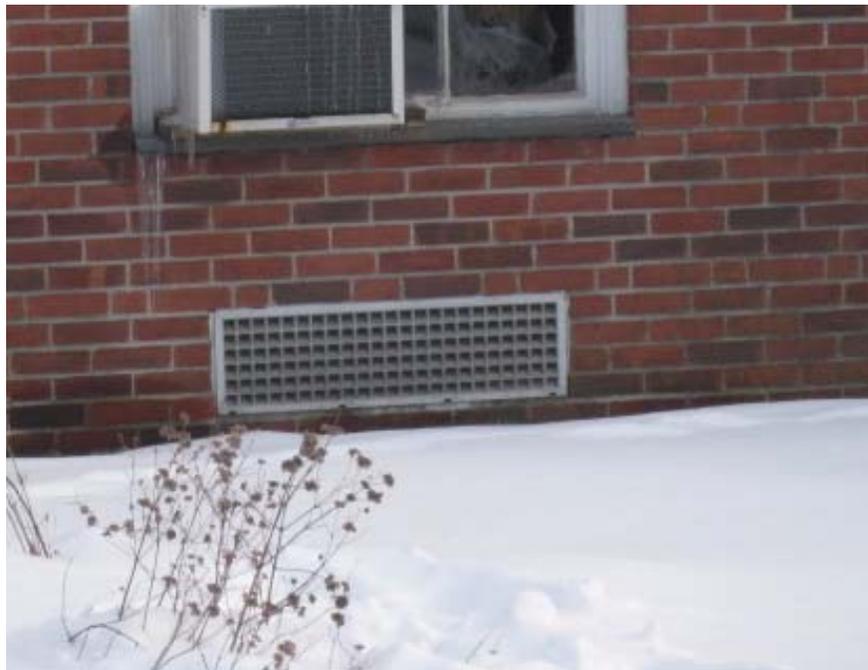
Picture 2

Univent Fresh Air Intake

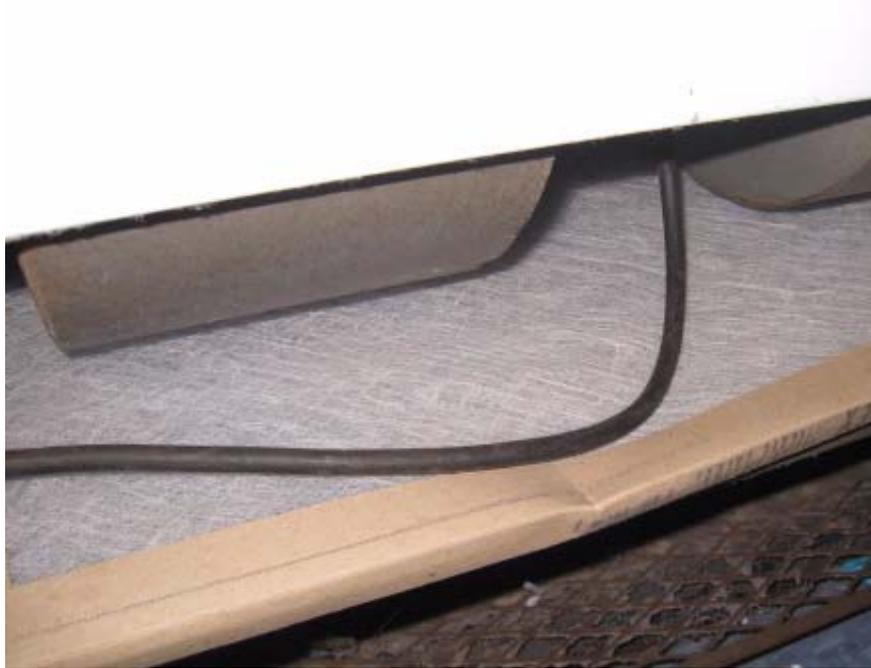
Picture 3

It was also reported that univent filters are changed once per year. In most cases filters are typically changed two to four times a year. Univents were equipped with fibrous mesh filters that provide minimal filtration of respirable particulates (Picture 3). Univents should be equipped with filters that strain particulates from airflow. In order to decrease aerosolized particulates, disposable filters with an increased dust spot efficiency can be installed in univents. The dust spot efficiency is the ability of a filter to remove particulates of a certain diameter from

Fibrous Mesh Filter in Classroom Univent

20. Increase univent/HVAC filter changes from two to four times a year.
21. Consider increasing the dust-spot efficiency of HVAC filters. Prior to any increase of filtration, each piece of air handling equipment should be evaluated by a ventilation engineer as to whether it can maintain function with more efficient filters.

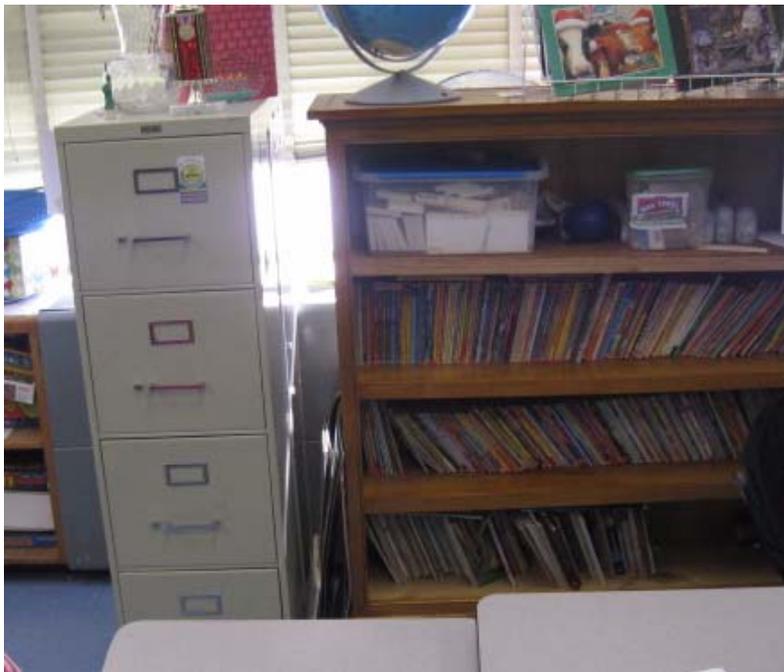
Picture 4

unavailable. In several classrooms, items were seen on and/or in front of univents obstructing airflow (Picture 4). Univents in classrooms 3 and 15 were reportedly deactivated by occupants, due to excessive heat. In order for univents to provide fresh air as designed, air diffusers, intakes and return vents must remain free of obstructions. Importantly, these units must remain “on” and be allowed to operate while rooms are occupied.

Classroom Univent, Note Return Vent (Front Bottom) Obstructed by Furniture/Items

2. Restore exhaust ventilation in upper wing, make repairs as necessary.
3. Remove all blockages from univents and exhaust vents to ensure adequate airflow.

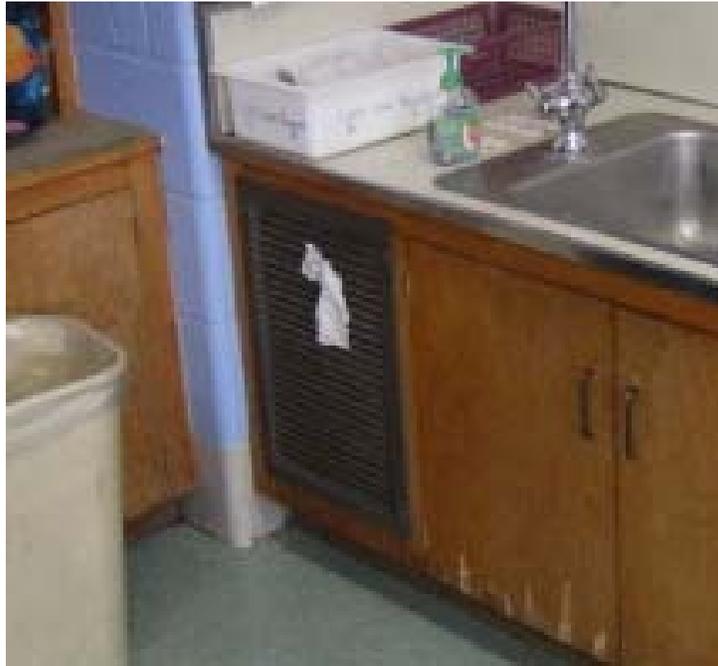
Picture 5

The main exhaust vent in classrooms is located on the front face of sink cabinets (Picture 5). Supplementary exhaust vents are located in coat closets (Picture 6). As previously mentioned, exhaust vents were not drawing air in the upper wing classrooms during the assessment, which can indicate that motors were deactivated or inoperable. Similarly exhaust vents in the gym were not drawing air. Exhaust vents in the main office and several other areas are located in the ceiling (Picture 7). The exhaust vent in the main office is activated by a wall switch (Picture 8) and was also found deactivated at the time of the assessment. Without adequate supply and exhaust ventilation, excess heat and environmental pollutants can build up and lead to indoor air/comfort complaints.

Classroom Exhaust Vent in Sink Cabinet, Note Tissue Indicating Draw of Air

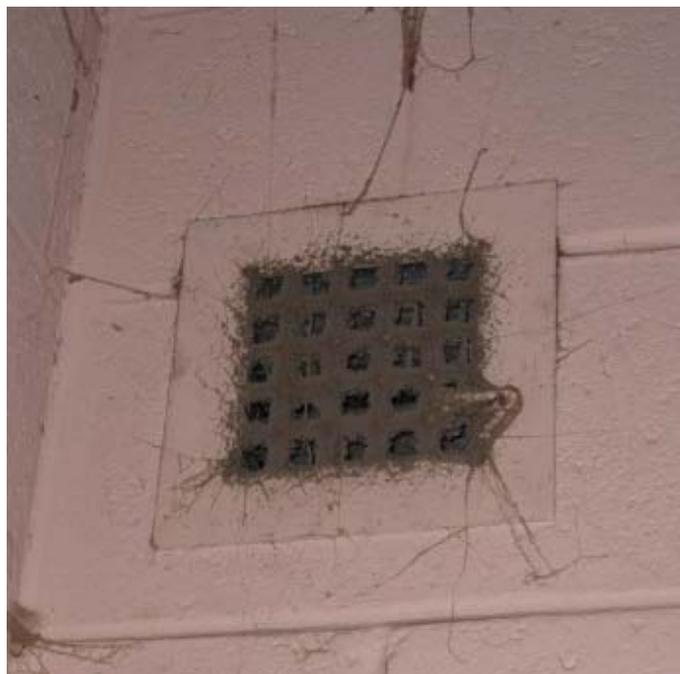
Picture 6

A number of personal fans, exhaust/return vent and air conditioners/filters were observed to have accumulated dust, particularly the vents in coat closets (Pictures 23 through 24). If exhaust vents are not functioning, backdrafting can occur, which can re-aerosolize accumulated dust particles. Re-activated fans can also aerosolize dust accumulated on vents/fan blades. Accumulated dust and debris was also observed in and around the wall-mounted radiator in the music office (Picture 25).

Classroom Closet Exhaust Vent, Note Accumulated Dust/Debris

19. Clean personal fans, univent air diffusers and exhaust vents periodically of accumulated dust. Particular attention should be paid to closet exhaust vents and exterior wall (near AC/radiator) in main office.

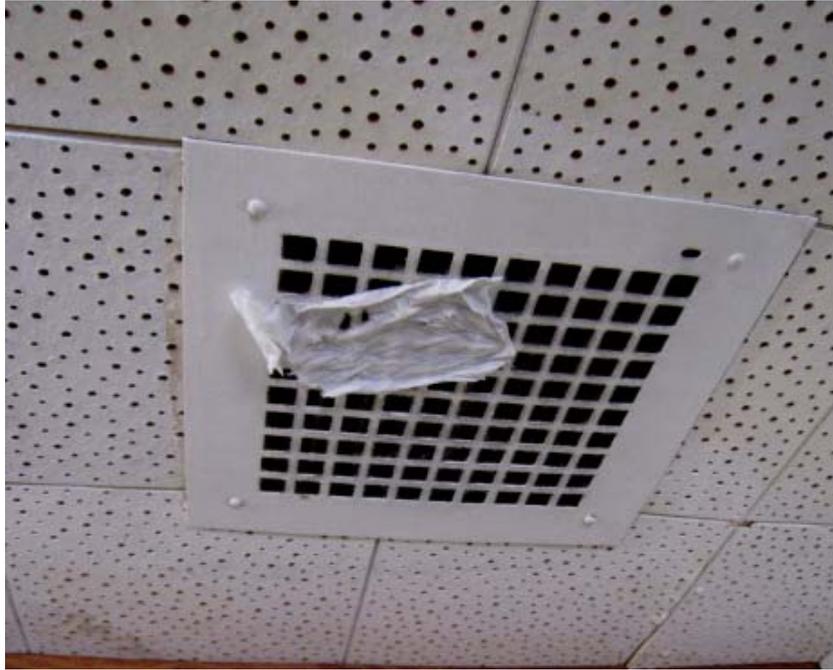
Picture 7

Ceiling Exhaust Vent in Main Office, Note Tissue Indicating Draw of Air

1. Operate both supply and exhaust ventilation *continuously* during periods of school occupancy. Consider contacting an electrician to install automatic timer for exhaust ventilation in main office to operate during work hours.

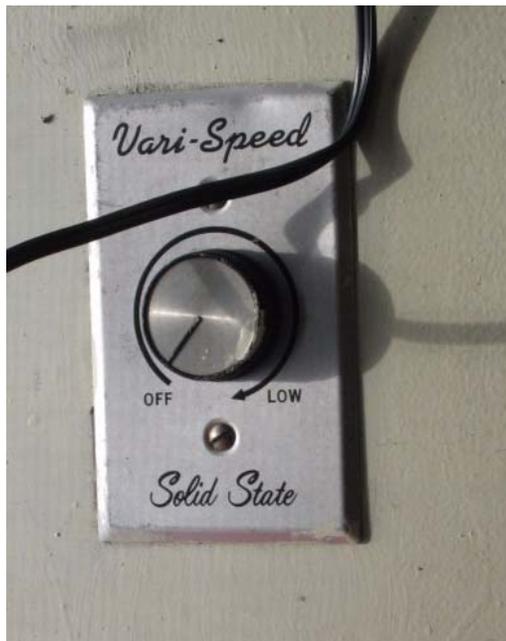
Picture 8

Wall Switch Used to Activate Exhaust Vent in Main Office

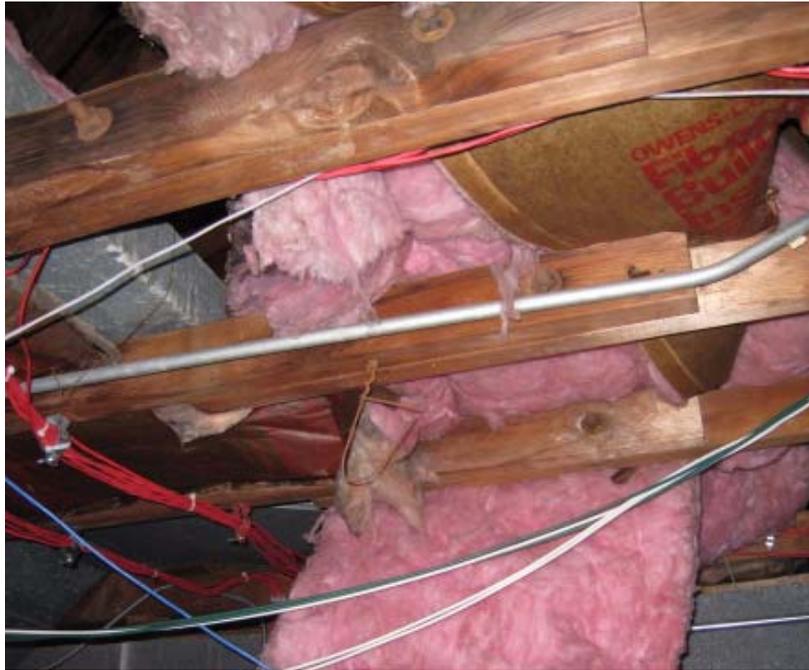
Picture 9

temperature and maintain comfort with equipment of this vintage (> 40 years old). BEH staff observed conditions above ceiling tiles in the main hallway (near the front entrance) and noted bats of insulation that were dislodged, damaged or hanging (Picture 9). This area is near a centrally located cupola (Picture 10). Cold drafts were detected upon removal of ceiling tiles, which indicates a source of unimpeded airflow from the cupola into the building. The building also has original single-paned windows, which are loose and drafty in many areas. These breaches can lead to heat/energy loss and make temperature control difficult.

Dislodged/Damaged/Hanging Fiberglass Insulation above Ceiling in Main Hallway

8. Fix leaks in cupola. Remove/replace water damaged drop ceiling tiles and insulation in main hallway.
9. Clean white material in ceilings of coat closets using a HEPA filtered equipped vacuum cleaner in conjunction with light sanding (if needed).

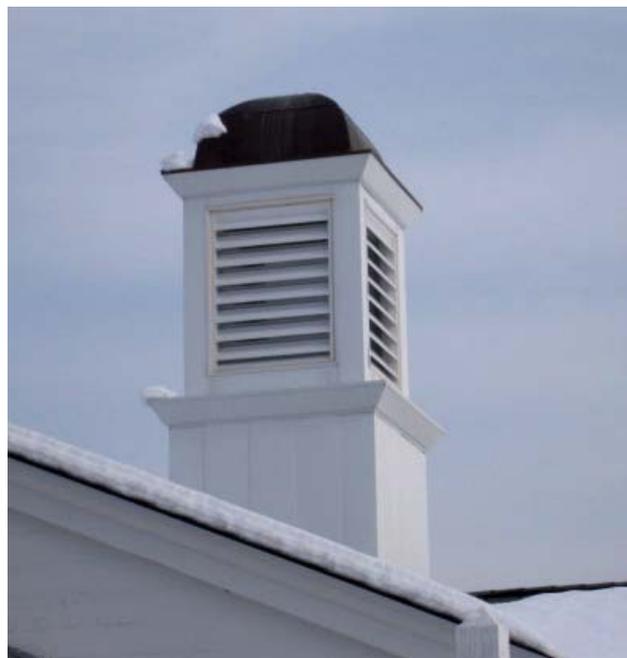
Picture 10

In order for building materials to support mold growth, a source of water exposure is necessary. Identification and elimination of the source of water moistening building materials is necessary to control mold growth. In this case, the main source of water penetration over the years has been the roof, which, as stated previously, was replaced in 2007. Although the roof has been replaced, residual water damage in the form of damaged ceiling tiles and staining on wooden beams/ceilings was seen throughout the building.

Centrally Located Cupola

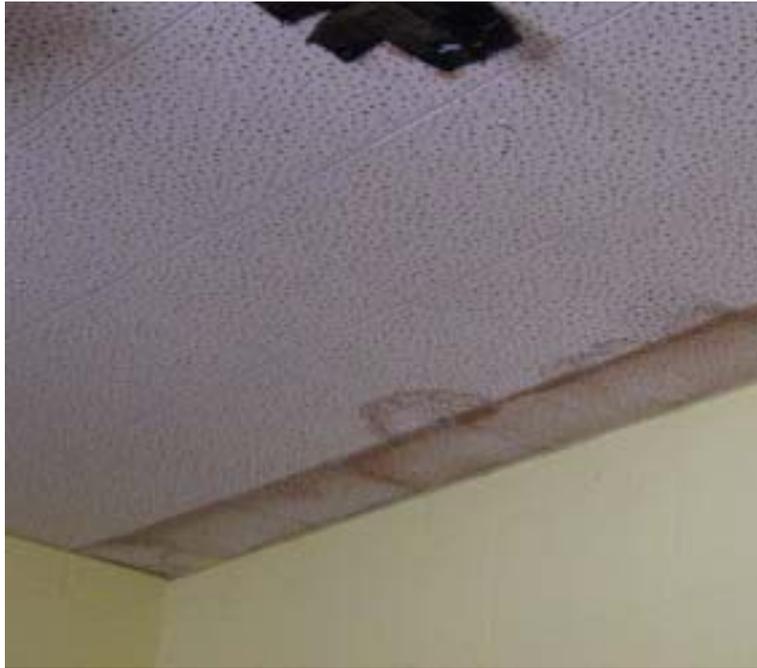
Picture 11

In most areas ceiling tiles are of an inter-locking type (as opposed to drop ceiling tiles), which makes removal/replacement difficult (Pictures 11 and 12). Water-damaged ceiling tiles can provide a source of mold growth and should be replaced after a water leak is discovered and repaired. Active leaks were reported in the main hallway. Occupants believed the leaks were most likely the result of water penetration through the cupola (Picture 10). BEH staff removed drop ceiling tiles in this area and observed dark staining on the surface of paper backed insulation, which may indicate mold growth (Pictures 13 and 14). White staining on the wooden ceilings of coat closets was also observed, which may indicate either mold growth or efflorescence (Picture 15). Efflorescence is a characteristic sign of water damage but it is not mold growth. As moisture penetrates and works its way through building materials, water-soluble compounds dissolve, creating a solution. As the solution moves to the surface the water evaporates, leaving behind white, powdery mineral deposits.

Water Damaged “Interlocking” Ceiling Tiles in PT/OT Room

10. For removal/replacement of interlocking ceiling tiles, such removal would be considered a renovation activity that can release debris/particulates. In order to minimize occupant exposure, repairs should be done while the area is unoccupied.

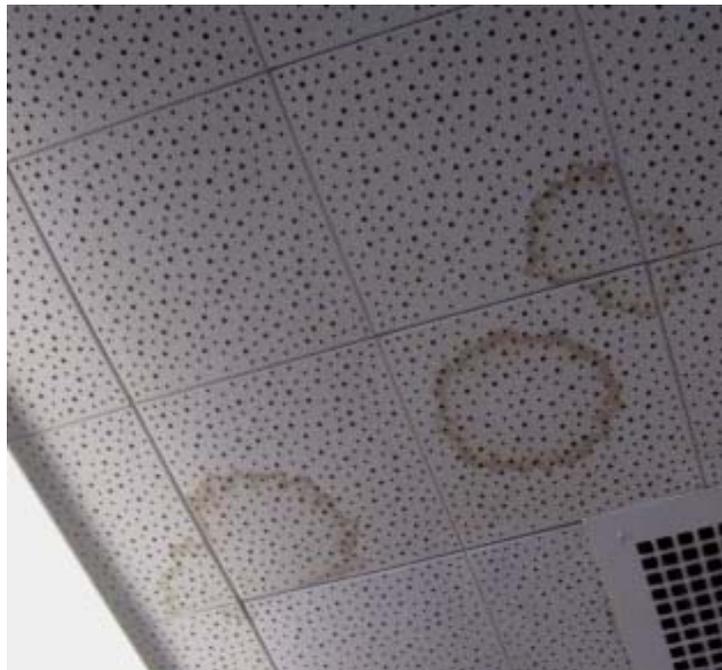
Picture 12

Water Damaged “Interlocking” Ceiling Tiles in Main Office

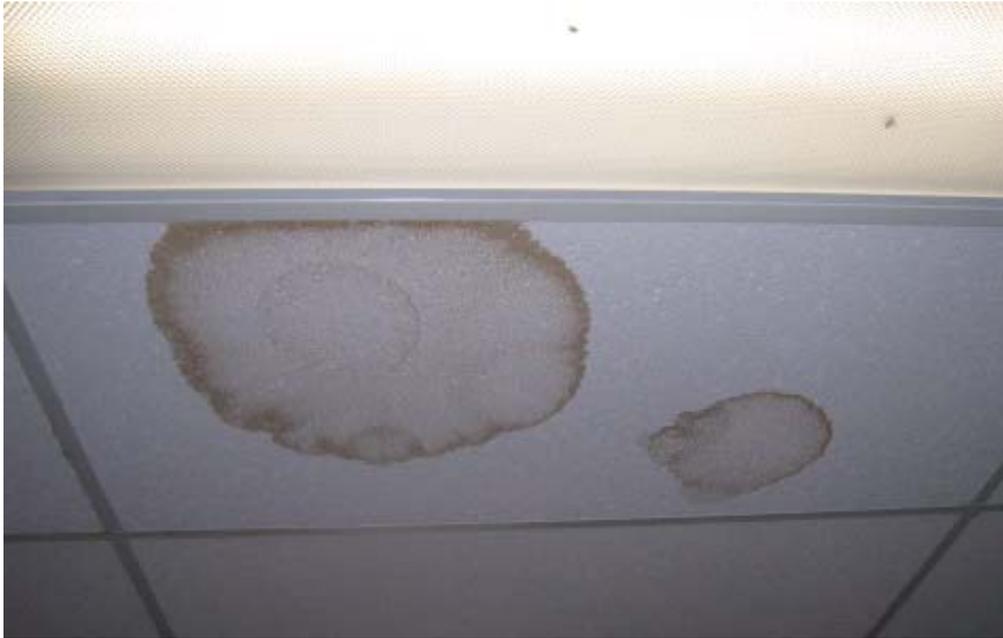
Picture 13

Water Damaged "Drop" Ceiling Tiles in Main Hallway

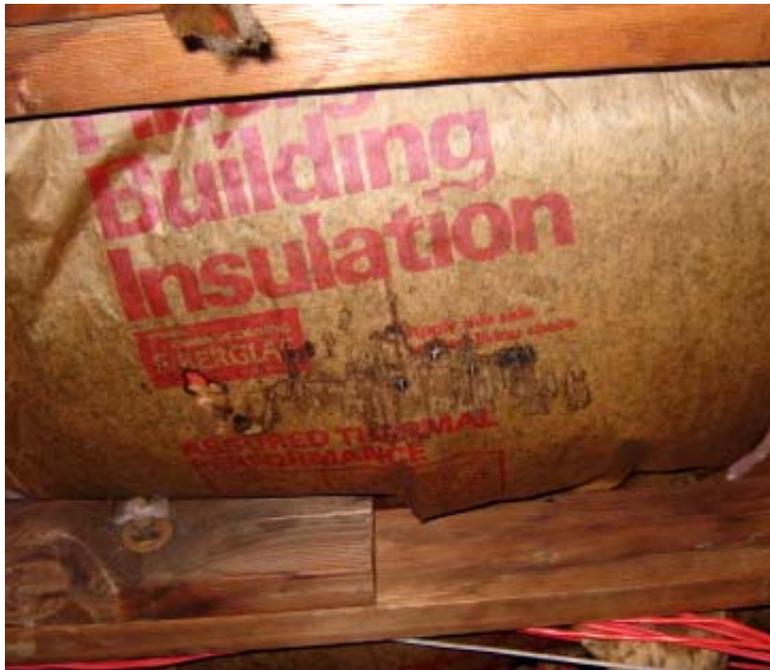
Picture 14

Dark Staining Indicating Possible Mold Growth on Insulation Paper Backing in Main Hallway near Entrance

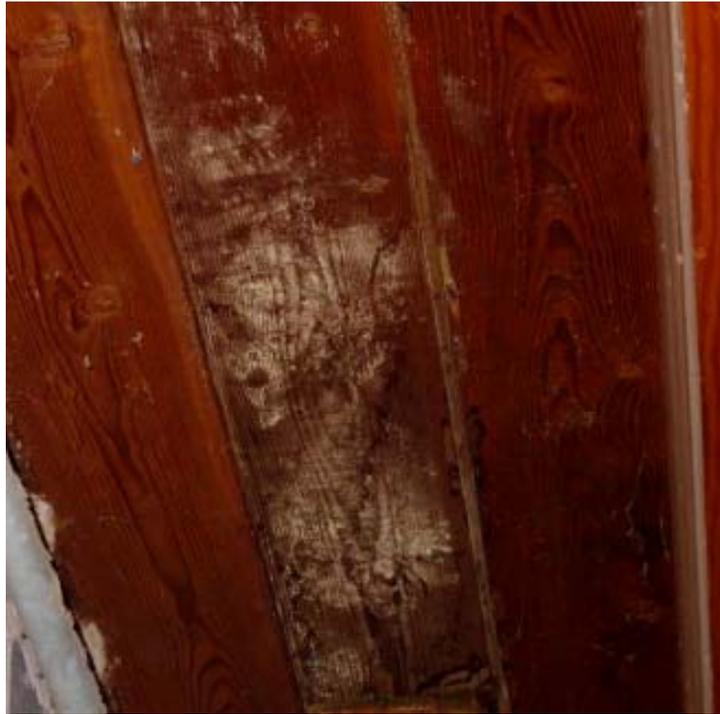
Picture 15

White Material (Possible Mold Growth) on Ceiling of Coat Closet

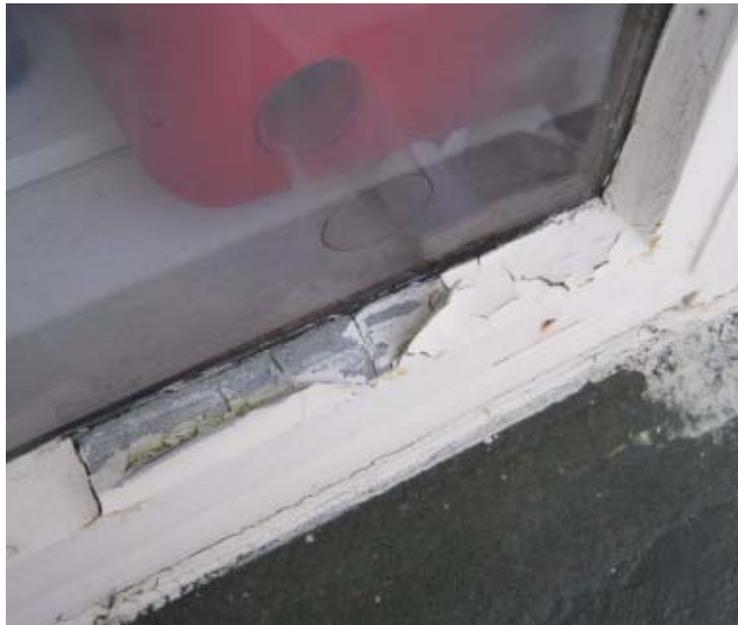
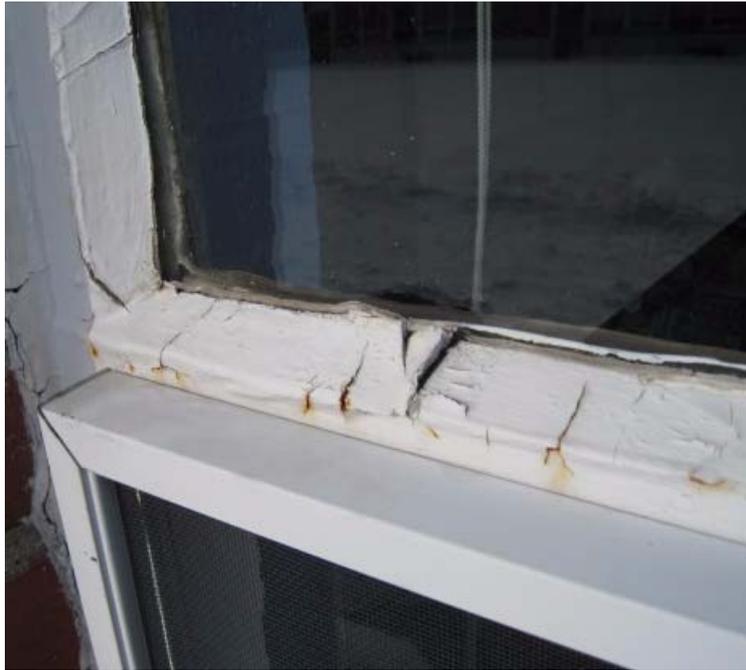
Several other areas of the building showed evidence of historical water damage and or had potential sources of moisture, which could lead to mold growth. Throughout the school, caulking around interior and exterior windowpanes was crumbling, missing or damaged (Pictures 16 and 17). Water penetration through window frames can lead to mold growth under certain conditions. Repairs of window leaks are necessary to prevent further water penetration. A broken window in the music office has resulted in chronic water penetration illustrated by severe water damage and mold growth to the wooden windowsill (Picture 18). Water staining and peeling paint was observed beneath a skylight in the main hallway (Picture 19), which appears to be historic damage.

Missing/Damaged Exterior Window Caulking around Original Single-Paned Windows

11. Contact a masonry firm or general contractor to repair holes/breaches in exterior walls to prevent water penetration, drafts and pest entry.
12. Seal around windows/frames to prevent drafts and water penetration.

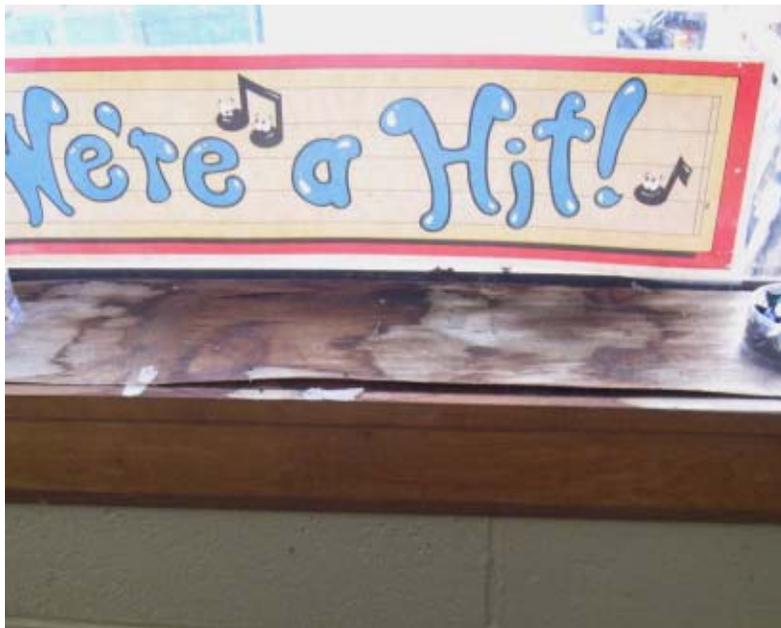
Picture 18

**Severely Water Damaged/Mold Colonized Wooden Windowsill
and Broken Window in Music Office**

13. Repair broken window in music office and remove/replace water damaged/mold colonized wooden windowsill.
14. Scrape loose paint from skylight, seal and repaint.

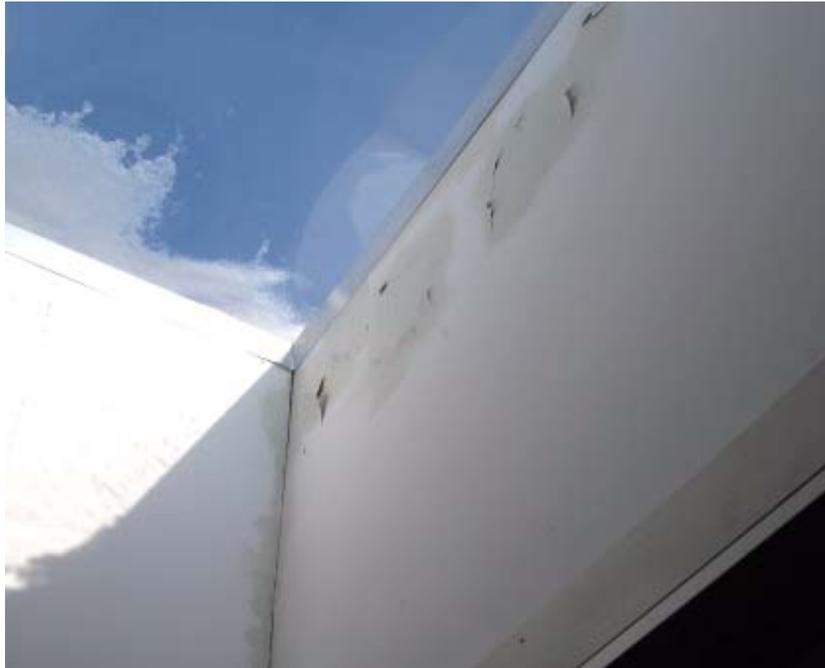
Picture 19

Peeling Paint Staining below Skylight in Main Hallway

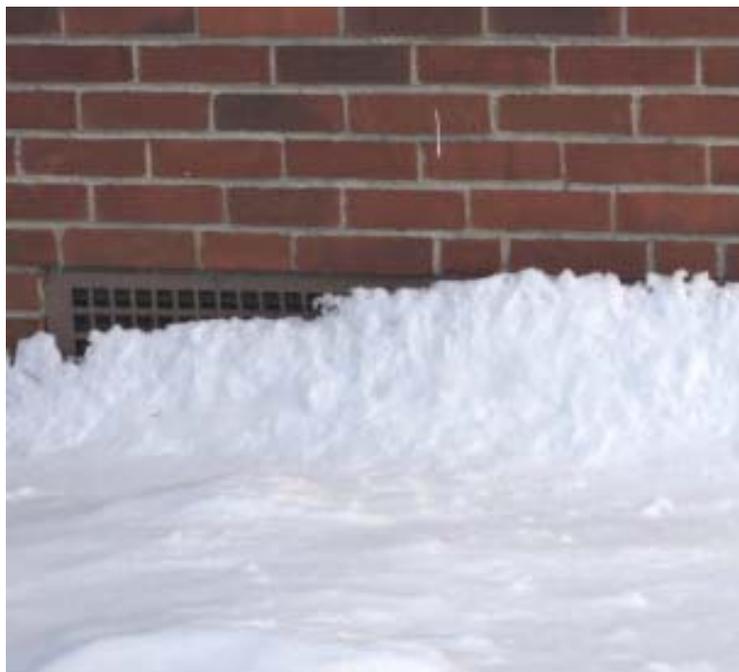
Picture 20

The assessment occurred shortly after a heavy snowstorm. As a result, several fresh air intakes near the gym were blocked by snowdrifts (Picture 20), which both limits the draw of fresh air into the room and likely results in increased moisture inside each univent

Snow Drifts Partially Covering Fresh Air Intake

15. Avoid over-watering plants and examine drip pans periodically for mold growth. Disinfect with an appropriate antimicrobial where necessary.
16. Ensure univent air intakes along exterior of the building are cleared of snow drifts.

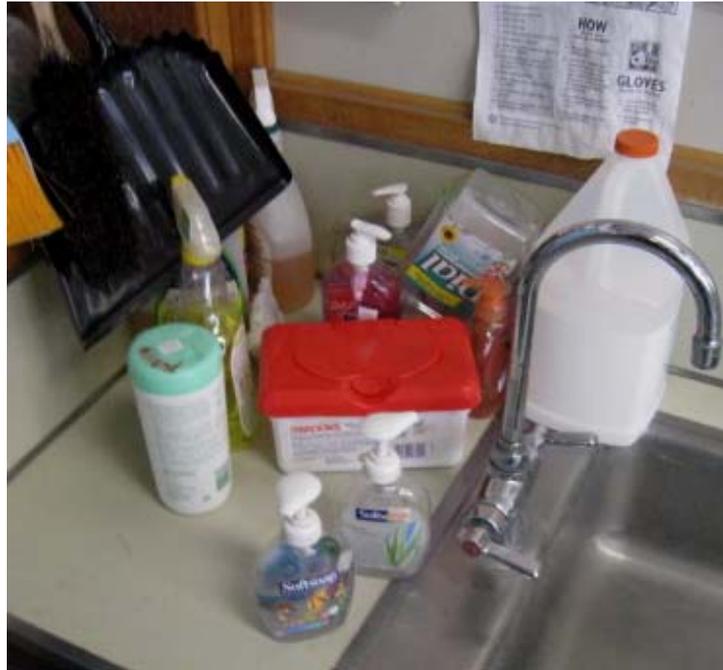
Picture 21

The majority of classrooms contained dry erase boards and related materials. Materials such as dry erase markers and dry erase board cleaners may contain VOCs, such as methyl isobutyl ketone, n-butyl acetate and butyl-cellusolve (Sanford, 1999), which can be irritating to the eyes, nose and throat. Cleaning products were also observed on countertops or below sinks in a number of classrooms (Picture 21). Like dry erase materials, cleaning products contain VOCs and other chemicals. These chemicals can be irritating to the eyes, nose and throat and should be kept out of reach of students.

Spray Cleaning Products on Sink Countertop in Classroom

24. Store cleaning products properly and out of reach of students.
25. Replace latex-based tennis balls with latex-free tennis balls or glides.
26. For more advice on mold please consult the document "Mold Remediation in Schools and Commercial Buildings" published by the US Environmental Protection Agency (US EPA, 2001). Copies of this document can be downloaded from the US EPA website at: http://www.epa.gov/iaq/molds/mold_remediation.html.

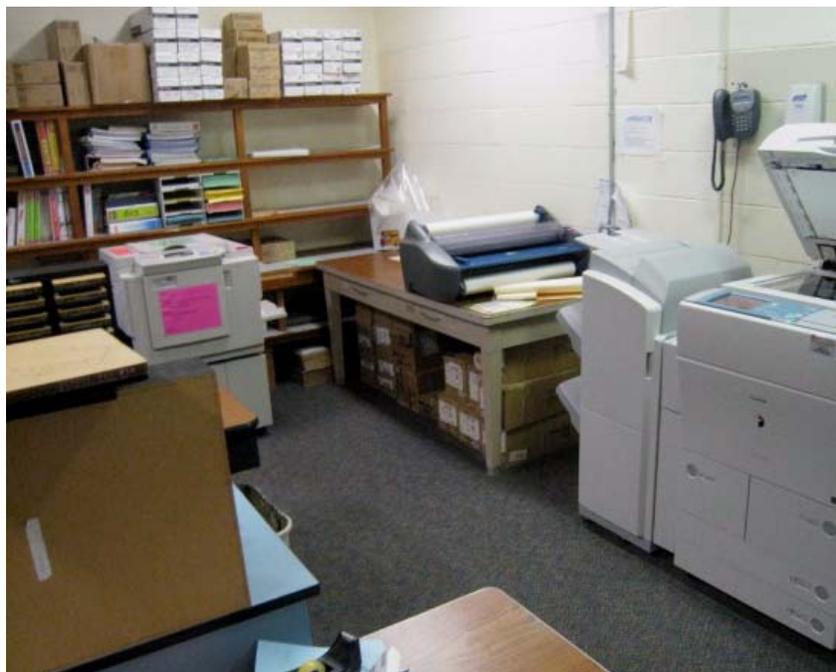
Picture 22

In the teacher's workroom, photocopiers and a laminator were noted (Picture 22). VOCs and ozone can be produced by photocopiers, particularly if the equipment is older and in frequent

use. Ozone is a respiratory irritant (Schmidt Etkin, 1992). Excess heat, VOCs and odors can be produced by lamination machines. This area is not equipped with windows to introduce fresh/outside air or local exhaust ventilation to help remove/reduce excess heat and odors.

Photo Copiers and Lamination Machine in Unvented Teacher's Workroom

3. Consider replacing window systems to prevent air infiltration and water penetration.
4. Install local exhaust ventilation in teacher's workroom.

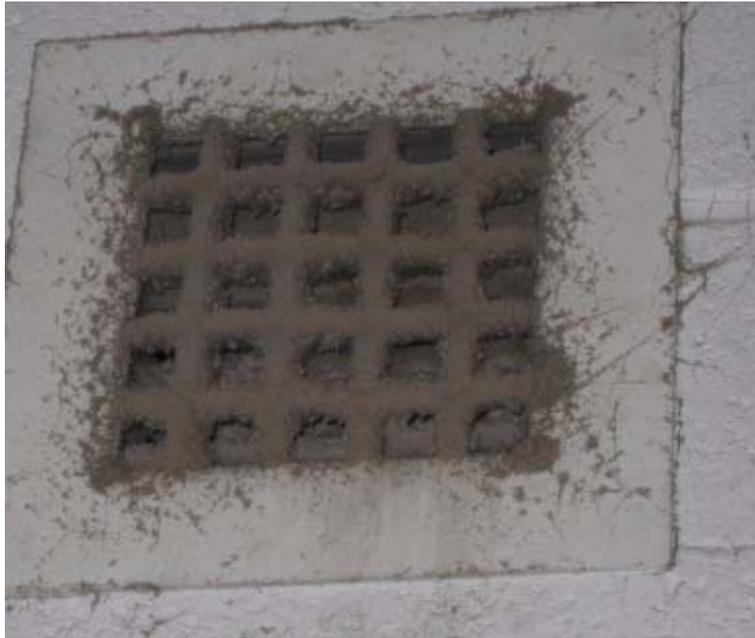
Picture 23

Classroom Closet Exhaust Vent, Note Accumulated Dust/Debris

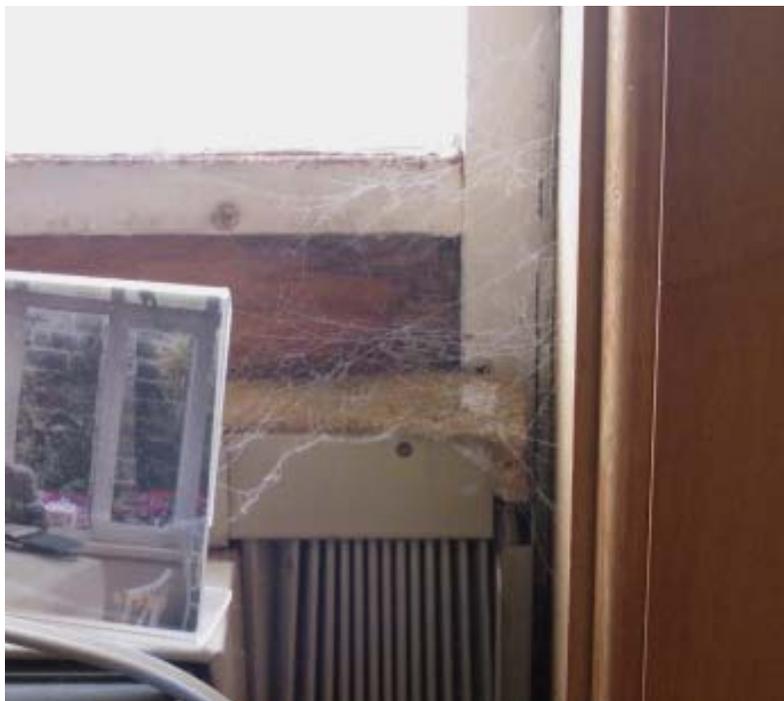
Picture 24

Cobwebs near AC in Main Office

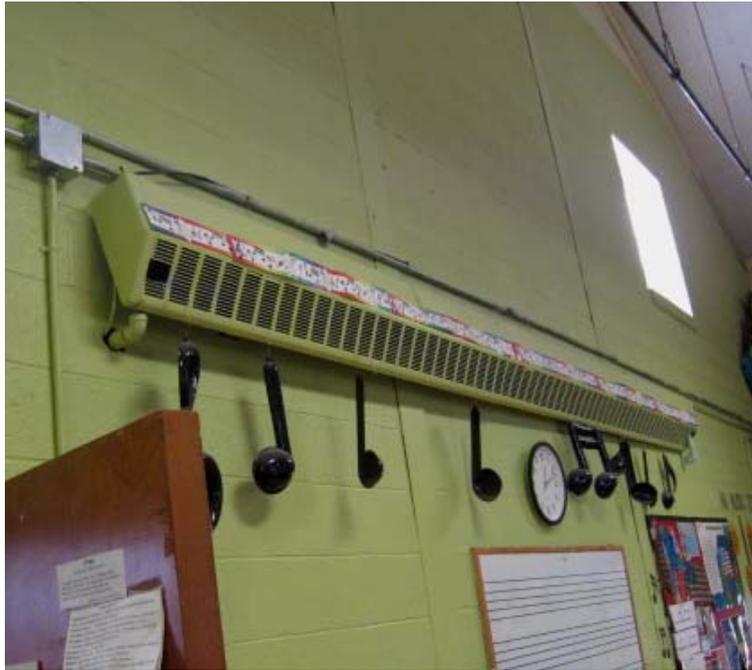
Picture 25

Accumulated Dirt, Dust/Debris in/around Wall-Mounted Radiator in Music Office

22. Clean AC filters as per the manufacture's instructions or more frequently if needed.
23. Inspect wall-mounted radiator/housing in music offices periodically, clean as needed.
Consider "blowing out" unit with pressurized air for thorough cleaning/removal of accumulated dust/debris.

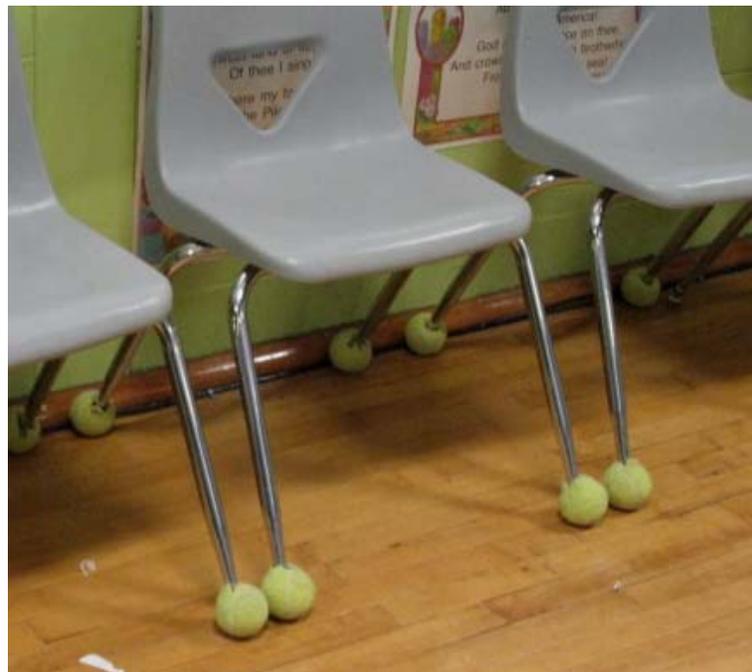
Picture 26

Finally, in an effort to reduce noise from sliding chairs, tennis balls had been sliced open and placed on chair legs (Picture 26). Tennis balls are made of a number of materials that are a source of respiratory irritants. Constant wearing of tennis balls can produce fibers and off-gas VOCs. Tennis balls are made with a natural rubber latex bladder, which becomes abraded when used as a chair leg pad. Use of tennis balls in this manner may introduce latex dust into the school environment. Some individuals are highly allergic to latex (e.g., spina bifida patients) (SBAA, 2001). It is recommended that the use of materials containing latex be limited in buildings to reduce the likelihood of symptoms in sensitive individuals (NIOSH, 1997). A question and answer sheet concerning latex allergy is attached as [Appendix B](#) (NIOSH, 1998).

Tennis Balls on Chair Legs
