# INDOOR AIR QUALITY ASSESSMENT

**Winthrop Elementary School  
162 First Street  
Melrose, Massachusetts 02176**

Prepared by:  
Massachusetts Department of Public Health  
Bureau of Environmental Health  
Indoor Air Quality Program  
June 2009

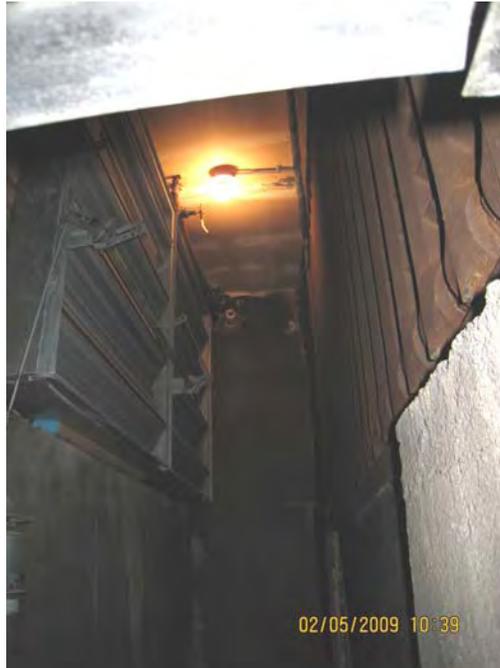
**Picture 1**

Fresh air to classrooms in the 1926 building is provided by an AHU located in a large air mixing room on the ground floor of the building. Fresh air is passively provided to the air mixing room (Picture 1). Air is drawn through heating elements and into a fan unit (Picture 2), where it is filtered (Picture 3). Heated air is distributed to classrooms via ductwork located in a crawlspace beneath the 1926 building that connects the AHU to classroom air diffusers. Exhaust ventilation is provided by rooftop fans connected to wall vents. Obstructions to exhaust vents were observed during the assessments (Tables 1 and 2; Pictures 4 and 5). During the May 2009 assessment, BEH staff observed a folder taped across the bottom portion of a supply vent

**Make up fresh air and heating elements in the air mixing room**

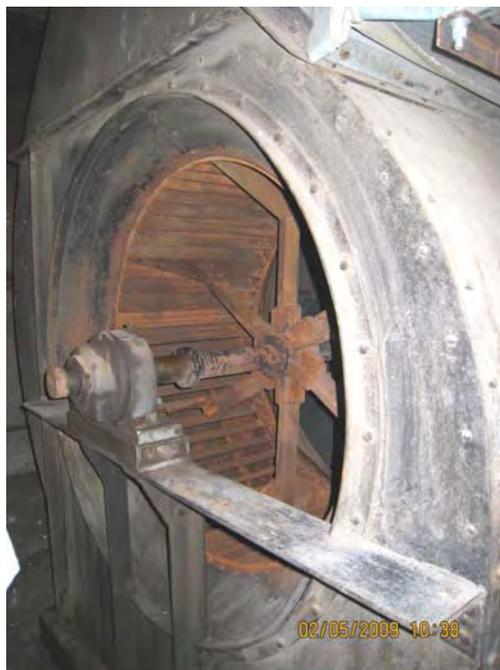
**Picture 2**

**Fan unit in air mixing room**

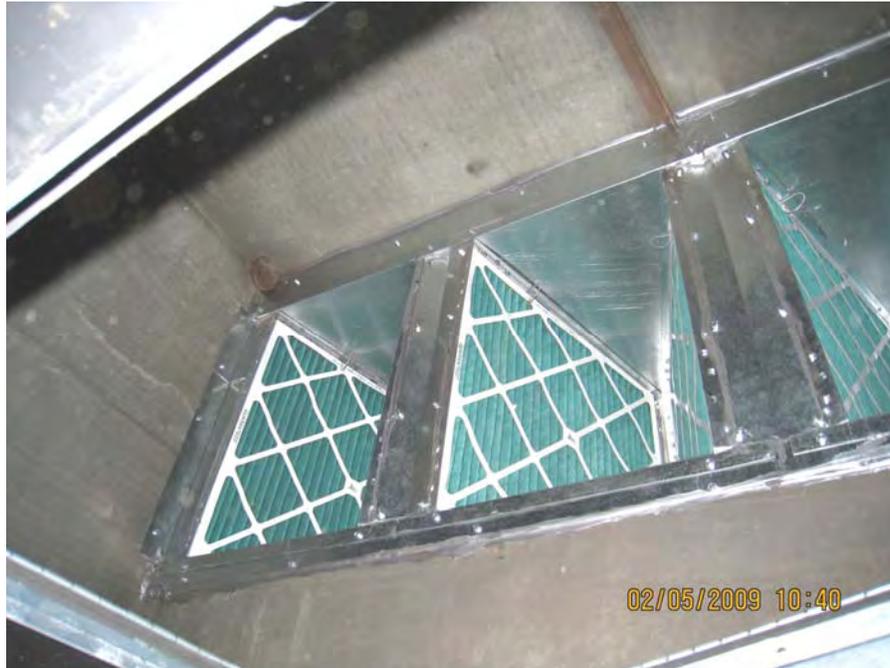
**Picture 3**

As described in previous reports, the WES AHU was not originally designed to have a filtration system. As a result of the new filter system, the ability of the AHU to supply air to classrooms was likely reduced because of the pressure drop. To best address this, BEH staff recommended balancing and adjusting the system to improve air exchange with the AHU operating with pleated filters.

**Pleated filters in the AHU**

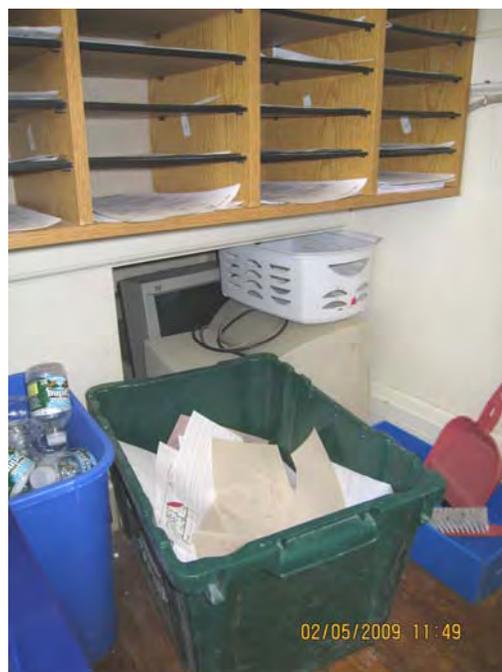
**Picture 4**

**Items stored in exhaust 'cubby' hole**

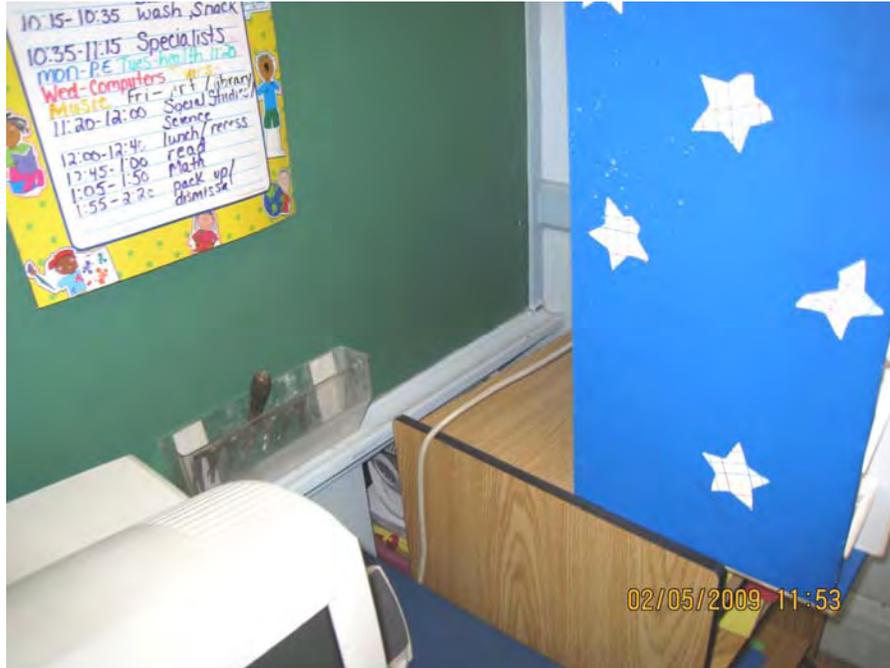
**Picture 5**

**Exhaust 'cubby' blocked**

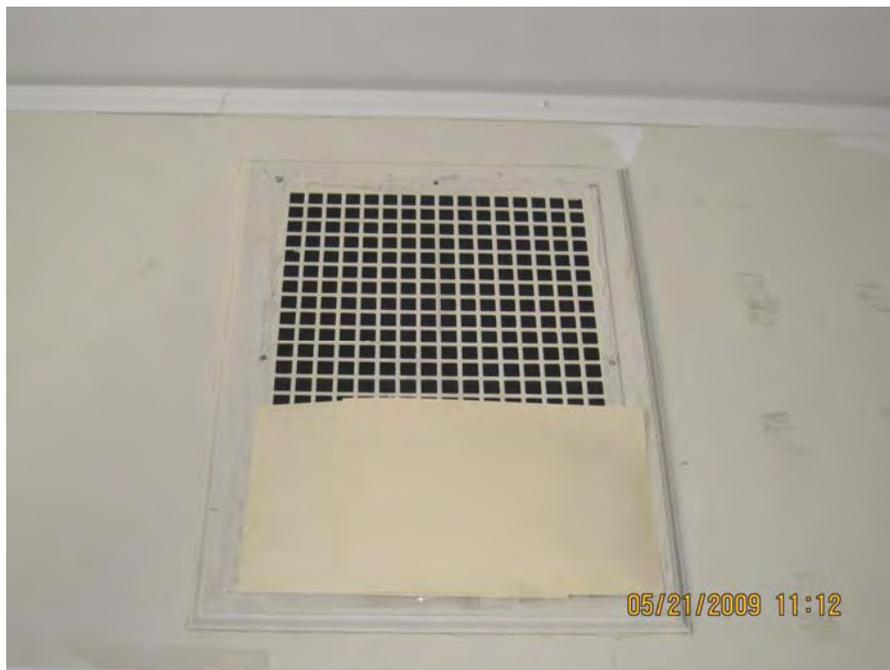
**Picture 6**

**Folder partially blocking supply vent**

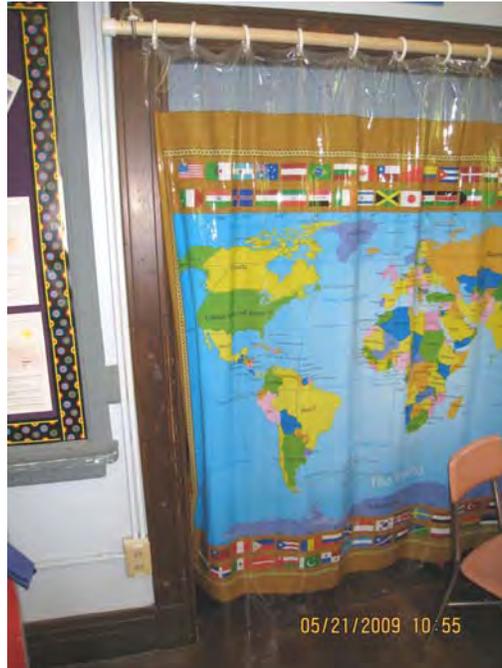
**Picture 7**

(Picture 6) and a vinyl curtain drawn over a closet area where an exhaust vent is located, preventing adequate movement of air from the classroom to the closet exhaust (Picture 7).

**Vinyl curtain in front of closet preventing exhaust**

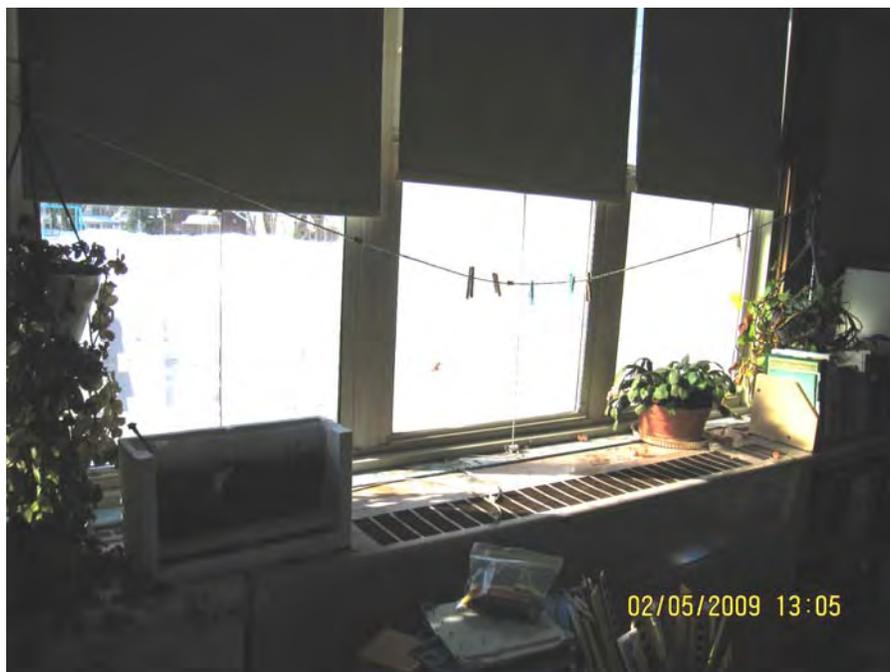
**Picture 8**

**Items stored in front of univent**

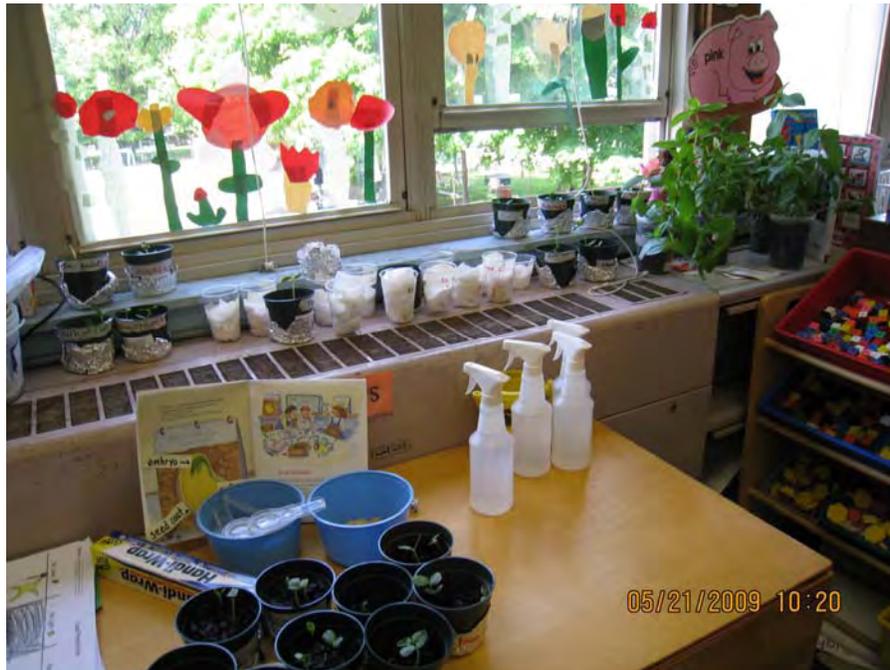
**Picture 9**

Several classrooms had a number of plants, some of which were located on univents (Picture 9). Moistened plant soil and drip pans can be a source of mold growth. Plants should be equipped with drip pans; the lack of drip pans can lead to water pooling and mold growth. Plants are also a source of pollen. Plants should be located away from the air stream of ventilation sources to prevent the aerosolization of mold, pollen or particulate matter throughout the classroom.

**Plants and other items/furniture stored on top/in front of univent**

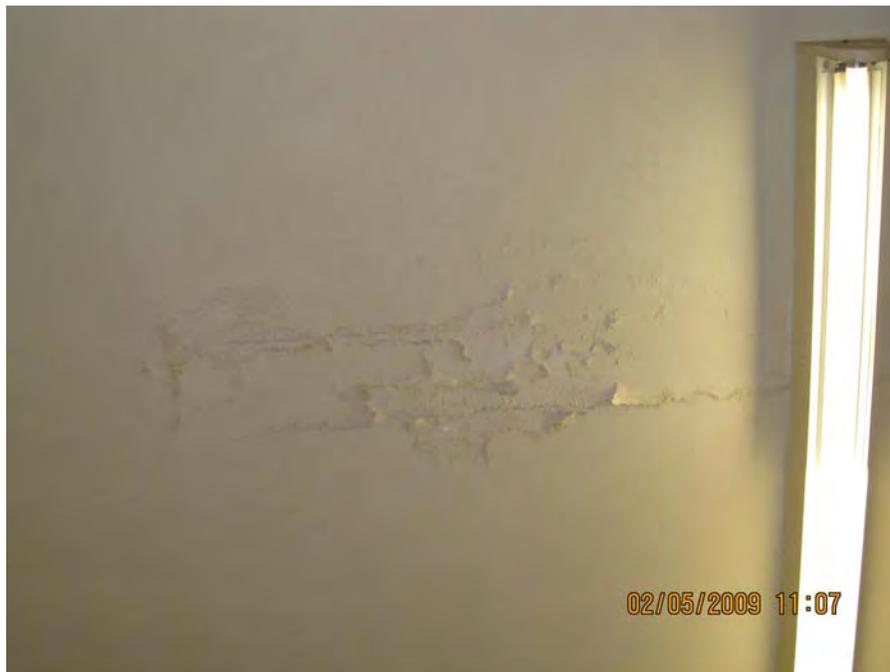
**Picture 10**

Several potential sources of water damage and/or mold growth were observed during the assessment. Evidence of water penetration, including peeling paint and water stains to ceiling plaster and ceiling tiles were observed at the WES (Pictures 10 and 11). The source causing such damage is either water leaks from pipes, the roof or moisture penetration through the building’s

envelope. Moisture accumulation below the surface of the paint is the most likely cause of peeling paint; however, the materials to which the paint is applied are not likely to support mold growth. Water-damaged ceiling tiles can provide a source for mold growth and should be replaced after a water leak is discovered and repaired. Tiles at the WES were glued directly to the ceiling. This type of ceiling tile is difficult to remove; appropriate precautions should be taken when removing and replacing these tiles.

**Peeling ceiling paint**

8. Ensure leaks are repaired as they are discovered. Repoint/repair exterior walls/foundation to prevent water penetration and pest entry.
9. Replace water damaged, missing and ill-fitting ceiling tiles. Examine the area above and around these areas for mold growth. Disinfect areas of water leaks with an appropriate antimicrobial.

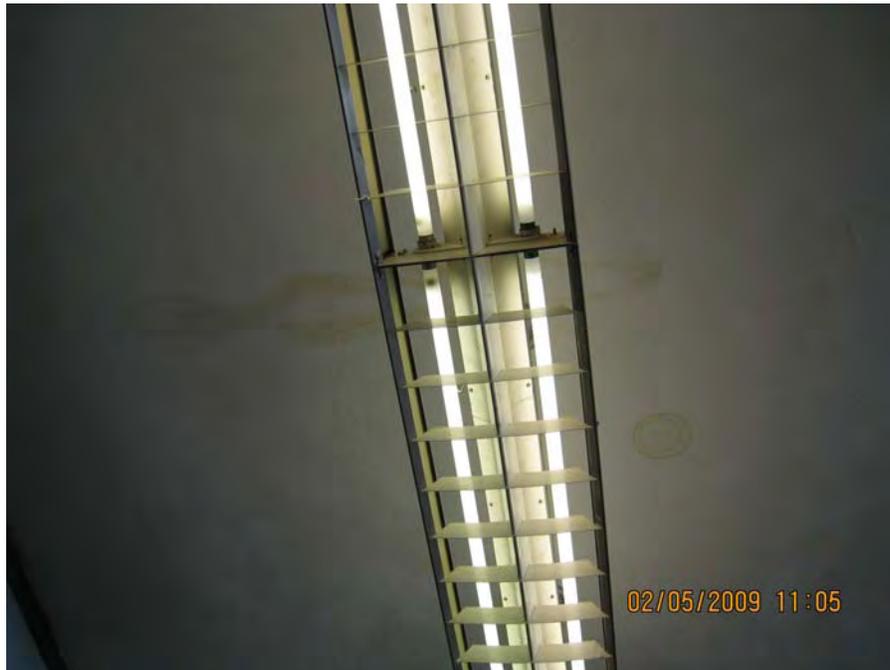
**Picture 11**

**Water stained ceiling plaster**

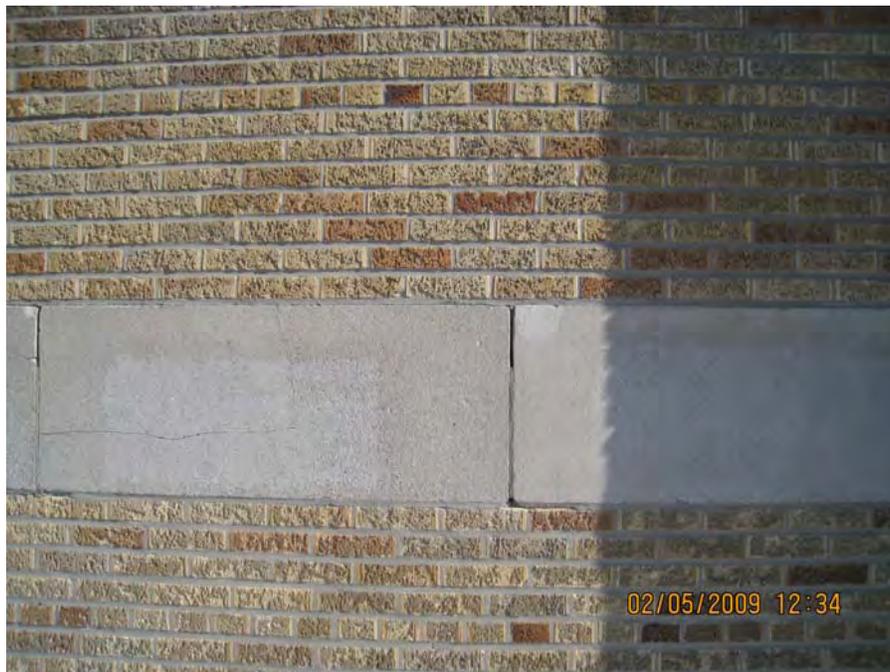
**Picture 12**

BEH staff examined the exterior of the building to identify breaches in the building envelope that could provide a source of water penetration. Several potential sources were identified such as damaged brickwork and missing/damaged mortar around masonry (Pictures 12 to 14). These conditions can undermine the integrity of the building envelope and provide a means of water entry by capillary action into the building through exterior walls, foundation concrete and masonry (Lstiburek & Brennan, 2001). In addition, they can serve as pathways for insects, rodents and other pests into the building.

**Breaches in foundation wall**

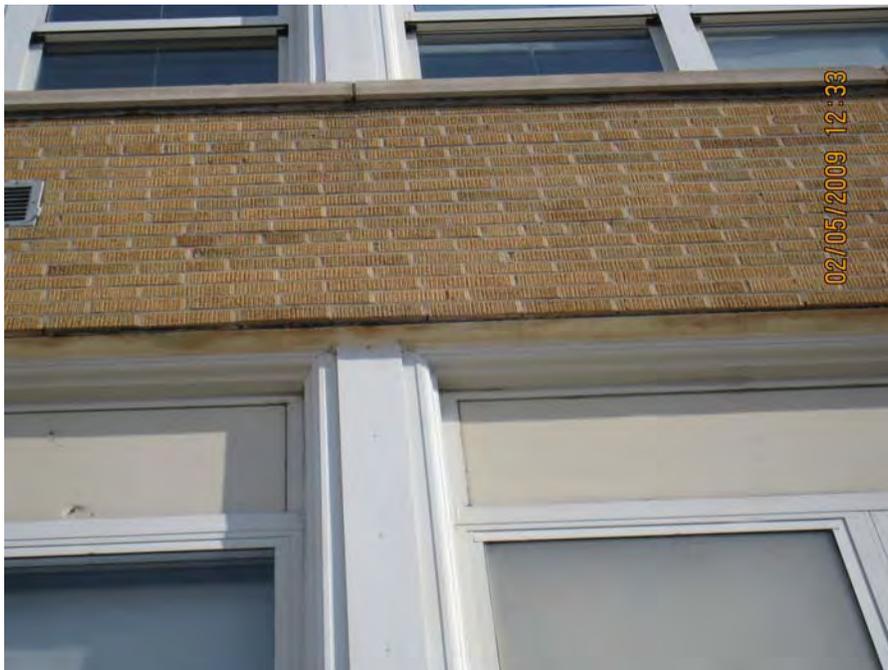
**Picture 14**

**Degraded sealant above window**

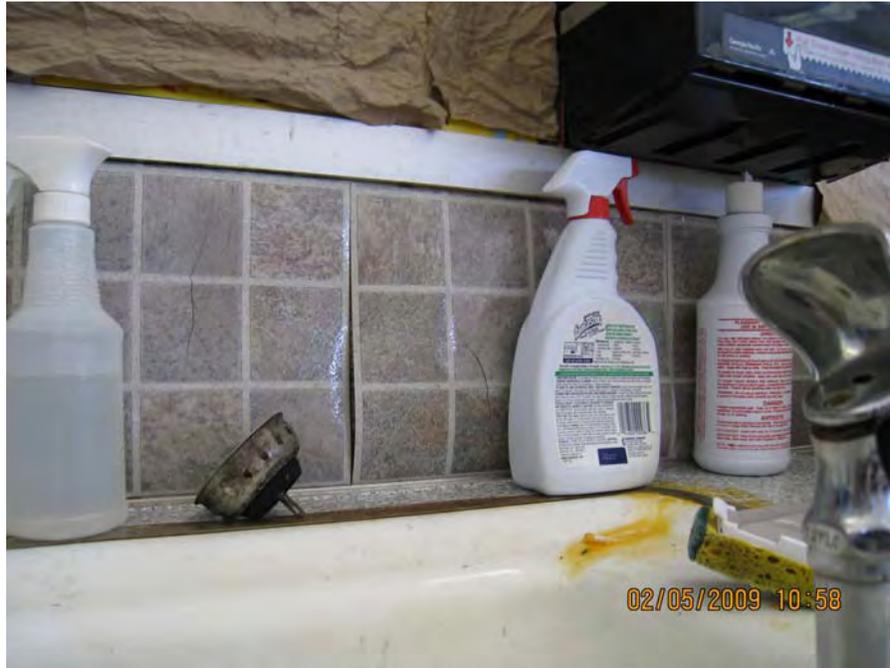
**Picture 15**

Open seams between sink countertops and walls were observed in several rooms. In many rooms, the vinyl covering for the sink countertop and backsplash were peeling or not laying flat, exposing the wood boards (Picture 15 to 17). If not watertight, water can penetrate through seams and other openings, causing water damage. Improper drainage or sink overflow can lead

to water penetration into the countertop, cabinet interior and areas behind cabinets. Water penetration and chronic exposure of porous and wood-based materials can cause these materials to swell and show signs of water damage.

**Vinyl backsplash no longer flush with wall**

11. Seal areas around sinks to prevent water damage to the interior of cabinets and adjacent wallboard. Repair/replace vinyl covering to prevent damage to countertop and backsplash. If necessary, replace damaged wood countertops.

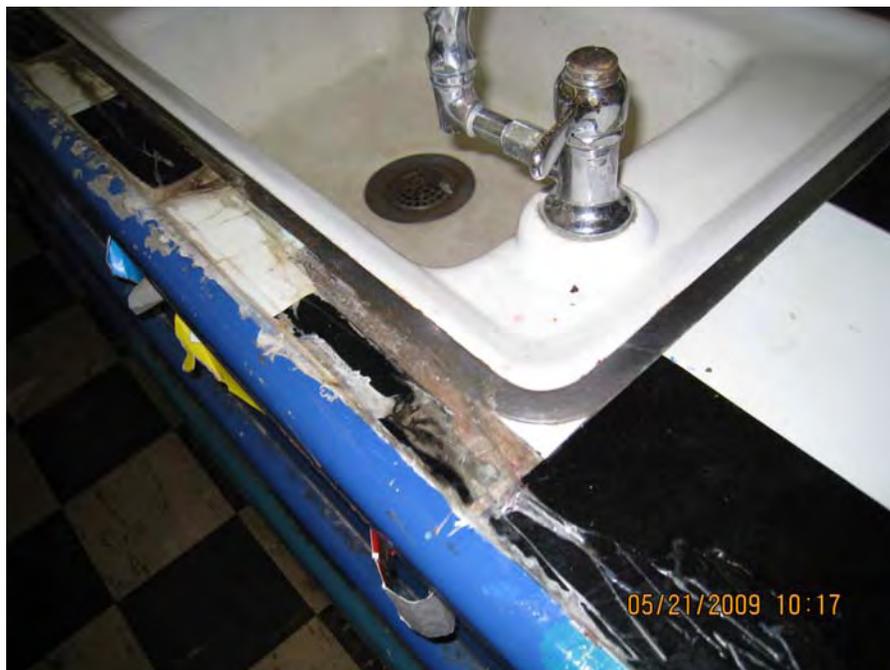
**Picture 16**

**Damaged vinyl countertop covering**

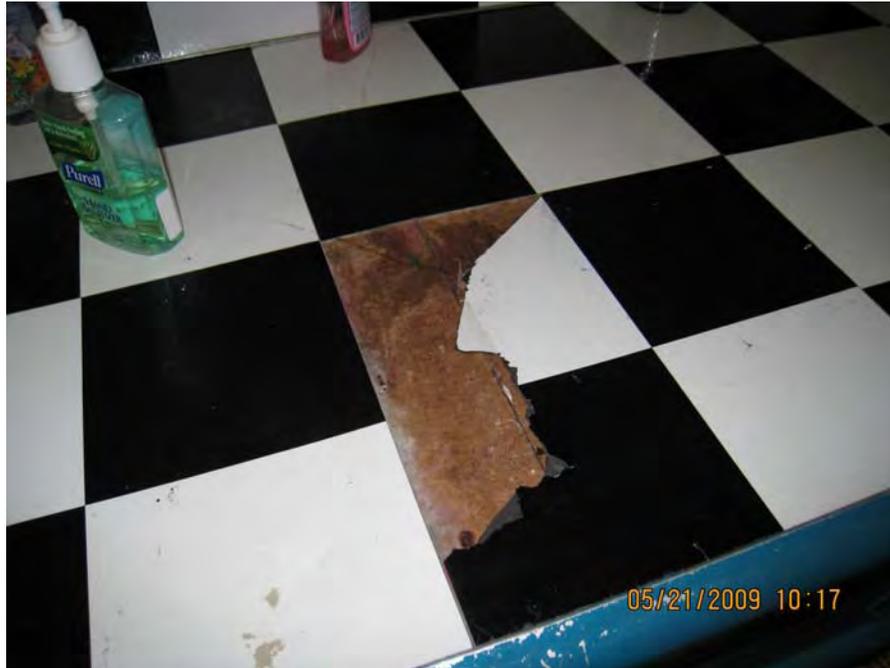
**Picture 17**

**Damaged vinyl countertop covering**

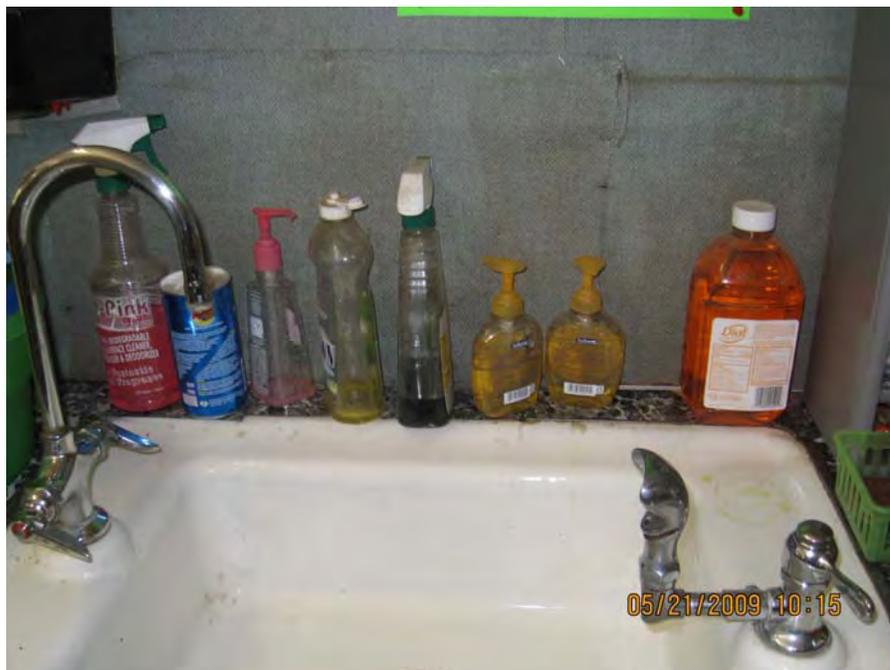
**Picture 18**

Cleaning products were found on countertops and in unlocked cabinets beneath sinks in some classrooms (Picture 18). Like dry erase materials, cleaning products contain chemicals that can be irritating to the eyes, nose and throat of sensitive individuals. These products should be properly labeled and stored in an area inaccessible to children. Additionally, Material Safety Data Sheets (MSDS') should be available at a central location for these products in the event of an emergency. Consideration should be given to providing teaching staff with school issued cleaning supplies to prevent any potential for adverse chemical interactions between residues left from cleaners used by the schools facilities staff and those left by cleaners brought in by others.

**Assortment of cleaners**

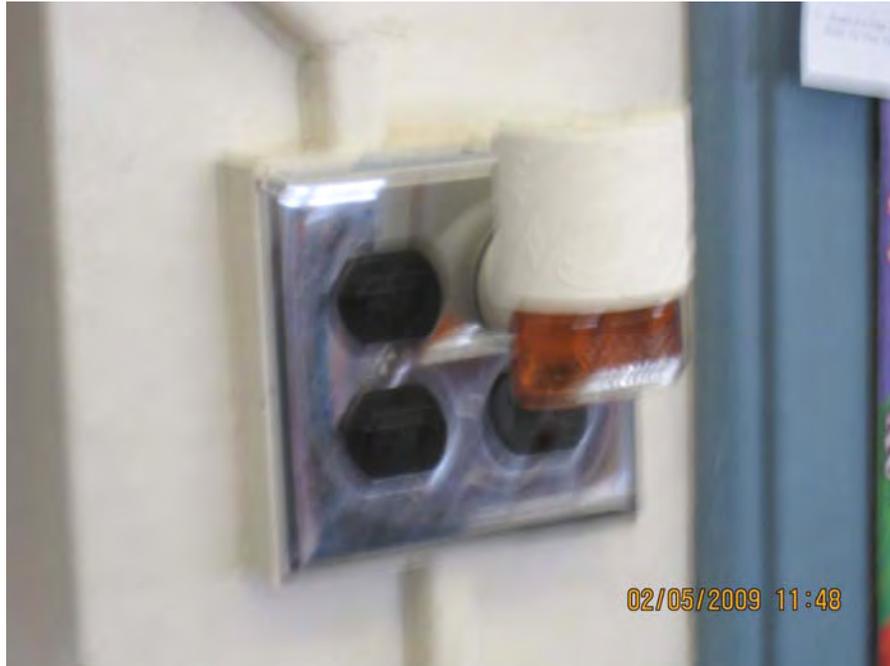
**Picture 19**

Both spray and plug-in air deodorizers (Picture 19) were observed in a number of rooms throughout the school. Air deodorizers contain chemicals that can be irritating to the eyes, nose

and throat of sensitive individuals. Many air fresheners contain 1,4-dichlorobenzene, a VOC which may cause reductions in lung function (NIH, 2006). Furthermore, deodorizing agents do not remove materials causing odors, but rather mask odors that may be present in the area.

**Plug-in air deodorizer**

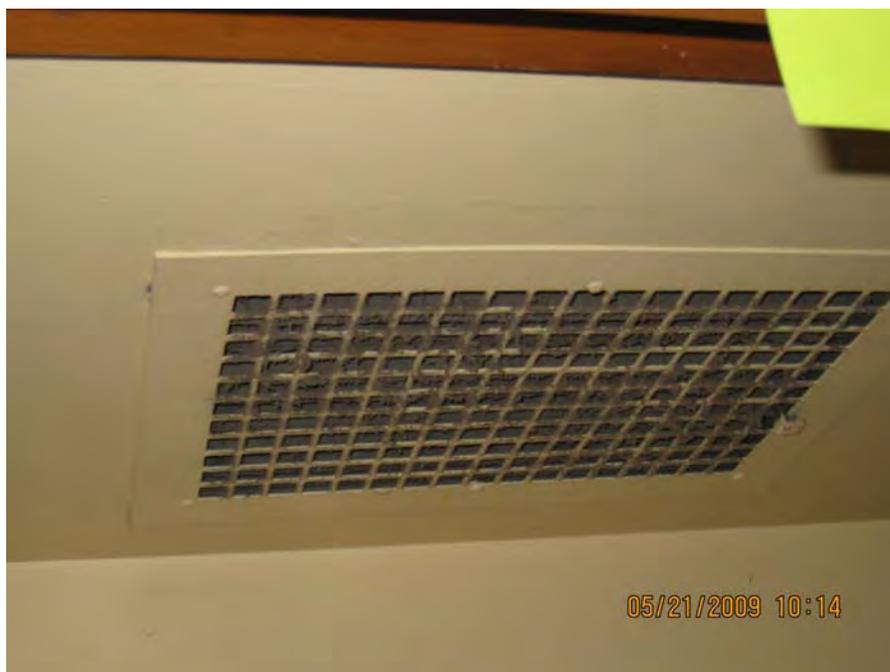
**Picture 20**

A number of exhaust/return vents as well as the interior of univents and personal fans were observed to have accumulated dust/debris (Pictures 20 to 22). If exhaust vents are not functioning, backdrafting can occur, which can re-aerosolize accumulated dust particles. Re-activated supply vents and fans can also aerosolize dust accumulated on vents/fan blades.

**Exhaust vent occluded with dust**

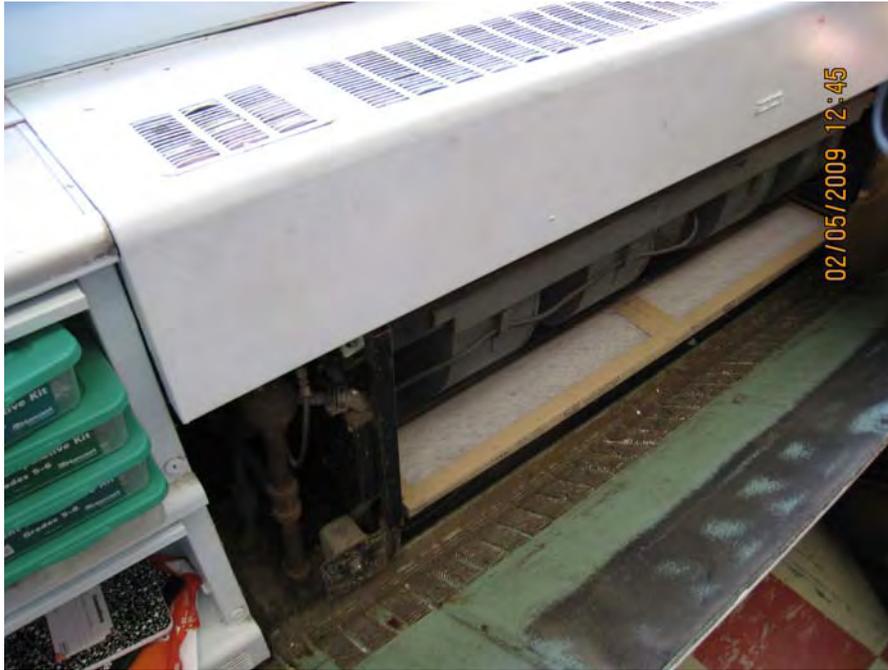
**Picture 21**

**Dust in univent cabinet**

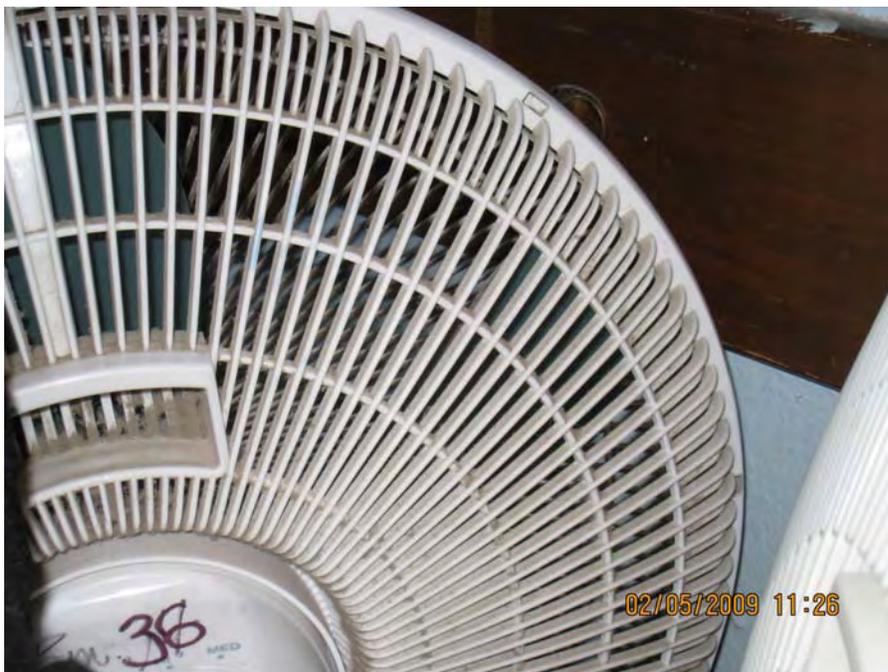
**Picture 22**

**Personal fan occluded with dust**

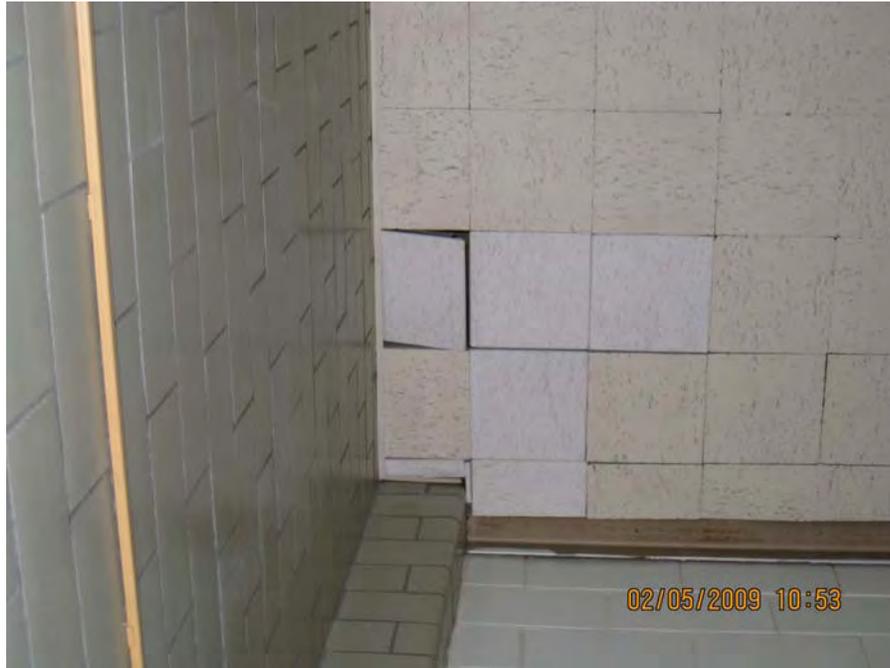
**Picture 23**

Missing and ajar ceiling tiles were observed in some areas of the MES (Picture 23). Missing ceiling tiles can provide a means of egress for odors, fumes, dusts and vapors between rooms and floors. The movement of ceiling tiles can introduce dirt, dust and particulate matter into occupied areas. These materials can be irritating to certain individuals.

**Ajar ceiling tile**

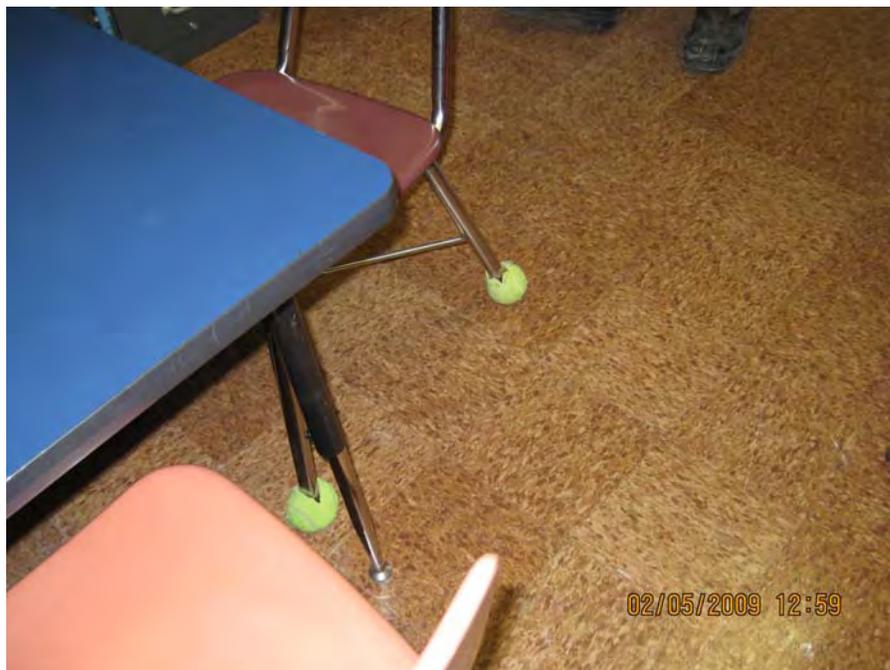
**Picture 24**

Lastly, tennis balls were observed on chair legs during the February 5, 2009 assessment. These tennis balls were likely installed as an effort to reduce noise from sliding chairs (Picture 24). Tennis balls are made of a number of materials that are a source of respiratory irritants. Constant wearing of tennis balls can produce fibers and off gas VOCs. Tennis balls are made with a natural rubber latex bladder, which becomes abraded when used as a chair leg pad. Use of tennis balls in this manner may introduce latex dust into the school environment. Some individuals are highly allergic to latex (e.g., spina bifida patients) (SBAA, 2001). It is recommended that the use of materials containing latex be limited in buildings to reduce the likelihood of symptoms in sensitive individuals (NIOSH, 1997). A question and answer sheet concerning latex allergy is attached as [Appendix B](#) (NIOSH, 1998). It is important to note that tennis balls were not observed on chair legs during the May 21, 2009 assessment.

**Tennis balls on chair legs**
