INDOOR AIR QUALITY ASSESSMENT

**John A. Parker Elementary School
705 County Street
New Bedford, Massachusetts 02740**

Prepared by:
Massachusetts Department of Public Health
Bureau of Environmental Health
Indoor Air Quality Program
March 2009

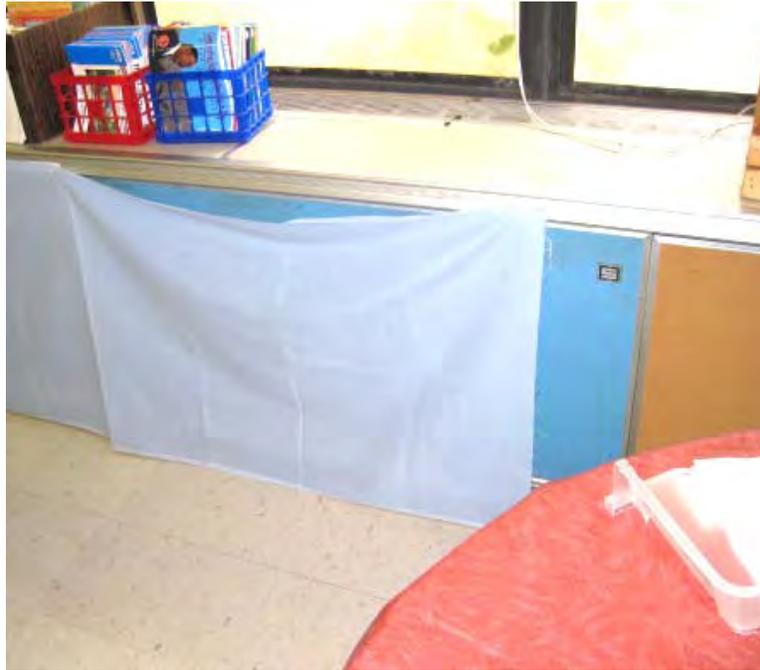
Picture 1

Fresh air is supplied to classrooms by unit ventilator (univent) systems (Pictures 1 through 3). A univent draws air from the outdoors through a fresh air intake located on the exterior wall of the building (Picture 4) and returns air through an air intake located at the base of the unit ([Figure 1](#)). Fresh and return air are mixed, filtered, heated and provided to classrooms through an air diffuser located in the top of the unit. Univents have control settings of off, low, med or high (Picture 5). Univents were found deactivated in a number of areas and/or obstructed by furniture, books and other materials (Pictures 1 and 2). In order for univents to provide fresh air as designed, air diffusers, intakes and return vents must remain free of obstructions. Importantly, these units must remain “on” and be allowed to operate while rooms are occupied.

Classroom Univent, Note Return Vent (Along Bottom/Front) is Obstructed by Sheet

3. Remove all blockages from univents and exhaust vents to ensure adequate airflow.
4. Close classroom doors are closed to maximize air exchange.
5. Replacing missing univent cabinet panels.

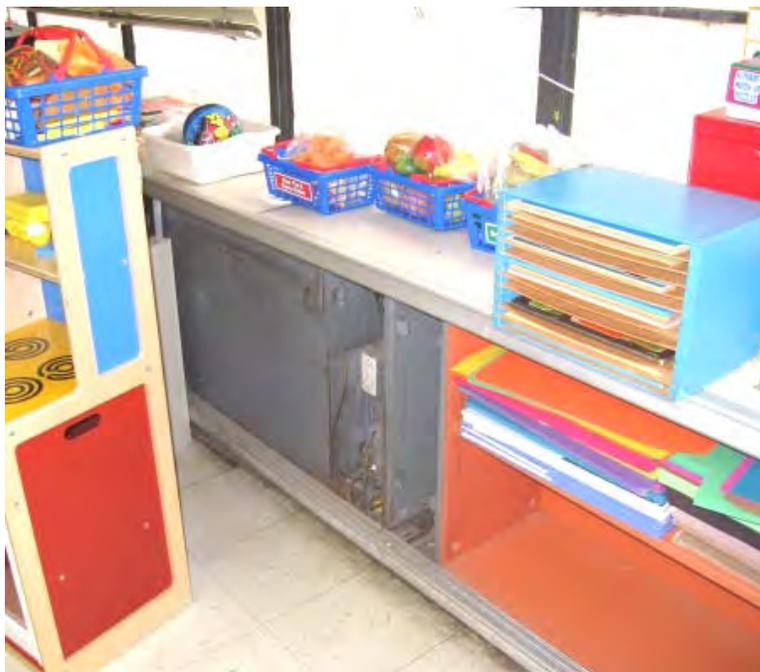
Picture 2

Univents are original 1960s equipment, nearly 50 years old. Efficient function of such equipment can be difficult to maintain since compatible replacement parts are often unavailable. In a few cases (e.g., classroom 3), univents were missing panels, exposing the interior of the units, which could be a safety issue and/or lead to damage of interior components (Pictures 2 and 3).

Classroom Univent Missing Front Panel, Also Note Items on/around Univent Obstructing Airflow

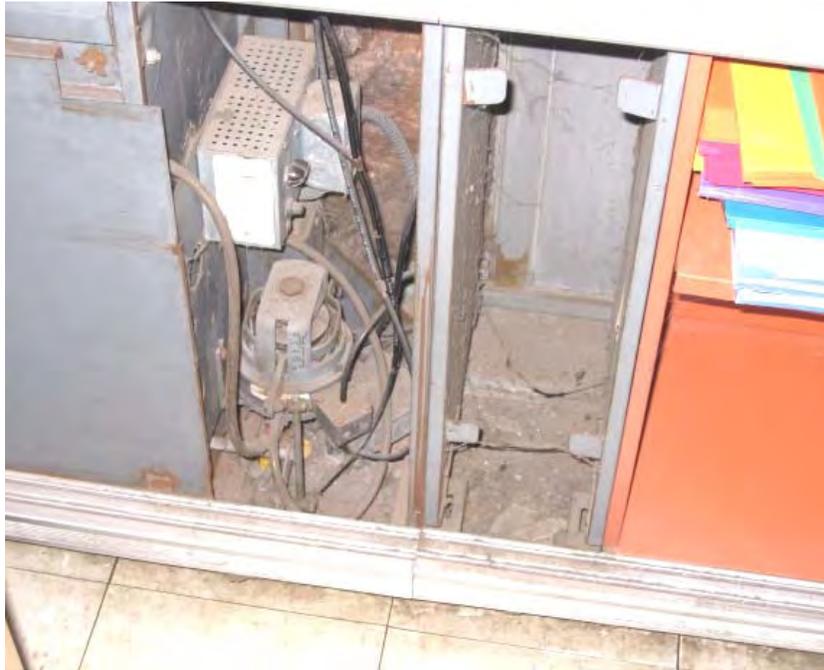
Picture 3

Classroom Univent Missing Front Panel Exposing Mechanical Components

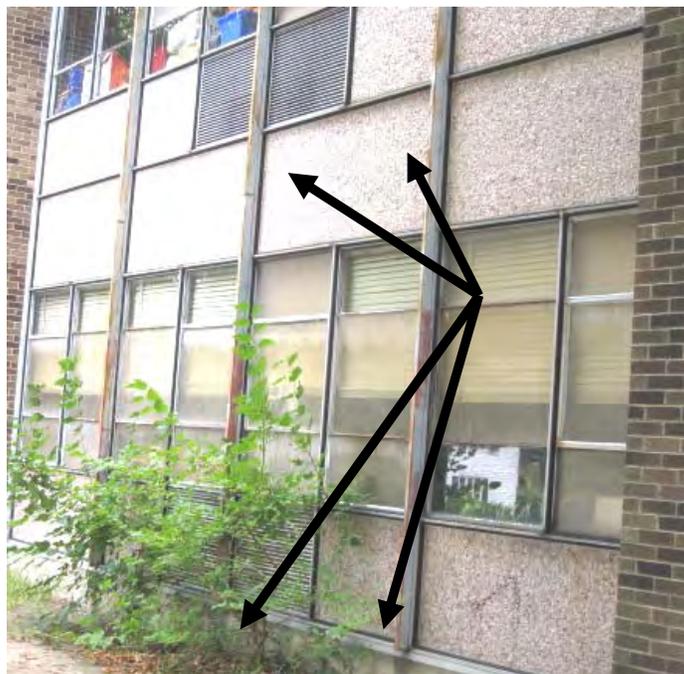
Picture 4

Trees/plants were observed growing in close proximity to exterior walls and in front of univent fresh air intakes (Pictures 4, 17 and 18). Trees, shrubbery and flowering plants hold moisture against exterior brick and prevent drying, which can lead to damage to building components and possible water infiltration and mold growth. Plant growth can also be a source of mold and pollen, and should be located away from fresh air intakes to prevent the aerosolization of mold, pollen or particulate matter throughout the building.

Univent Fresh Air Intakes, Note Trees in Close Proximity to Vents at Ground Level

13. Seal joints/wall junctions with an appropriate sealing compound.
14. Remove plants/small trees growing at base of exterior walls and/or in front of univent air intakes. Trim tree branches (of fully grown trees) away from above roof and exterior walls.

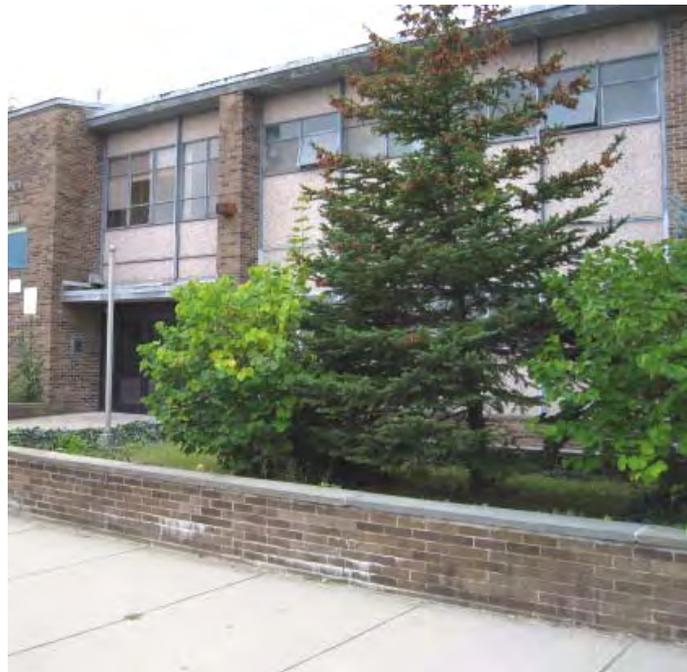
Picture 8

As discussed previously, a severe rain event resulted in water infiltration to the interior of the building. School maintenance staff reported that water penetration occurs primarily along the northeast (front façade) of the building (Picture 8), and that the main source of entry was through univent fresh air intakes. At the time of the assessment, building materials were dry and no mold growth was observed.

Northeast Front Façade of Building, Where Water Penetration Reportedly Occurs

10. Consider installing rain shields over univent air intakes along the northeast/front of the building to prevent water infiltration (see Pictures 28 and 29 for an example).

2. Take measures to prevent water accumulation/infiltration along front northeast side of building; this may entail installing a french drain, gutters/downspouts or other means of directing water away from building.
3. Contact an HVAC engineering firm for an assessment of the ventilation system's control system (e.g., controls, air intake louvers, thermostats). Based on the age, physical deterioration and availability of parts for ventilation components, such an evaluation is necessary to determine the operability and feasibility of repairing/replacing the equipment.

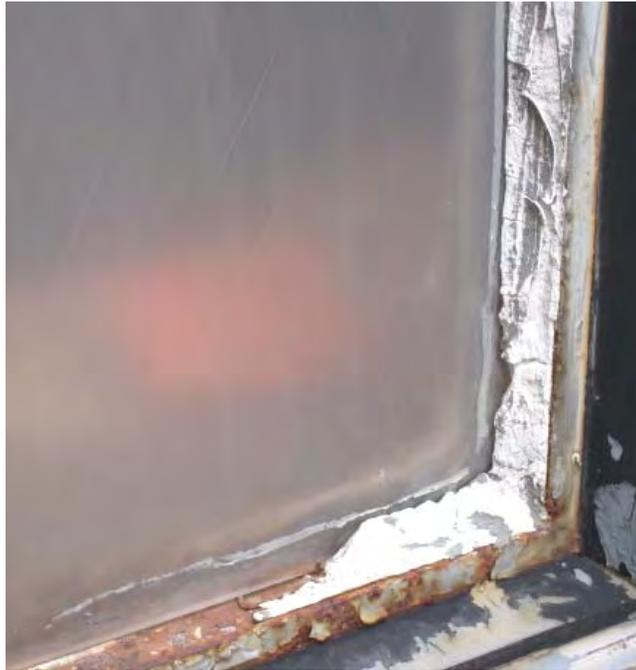
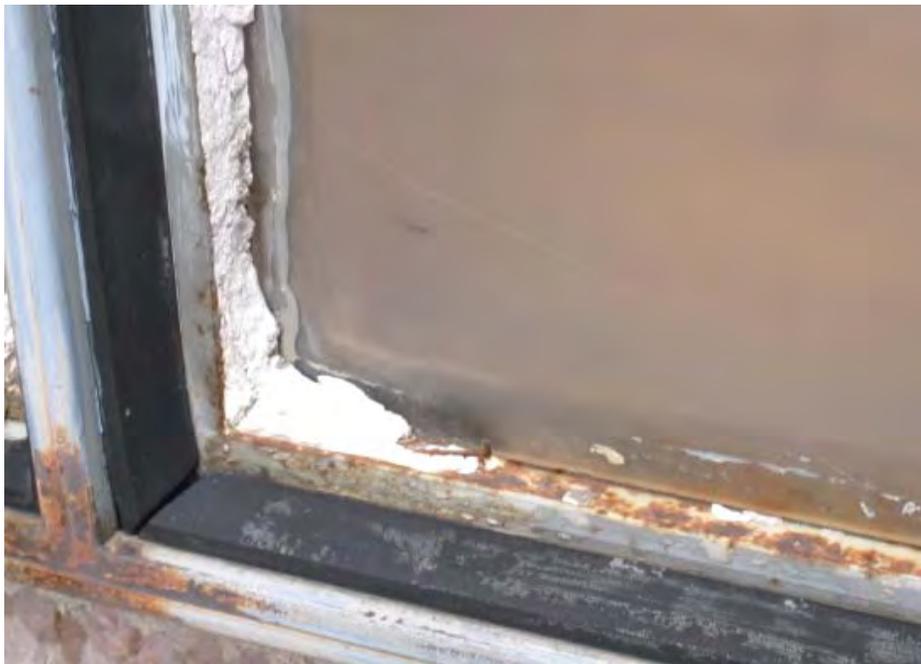
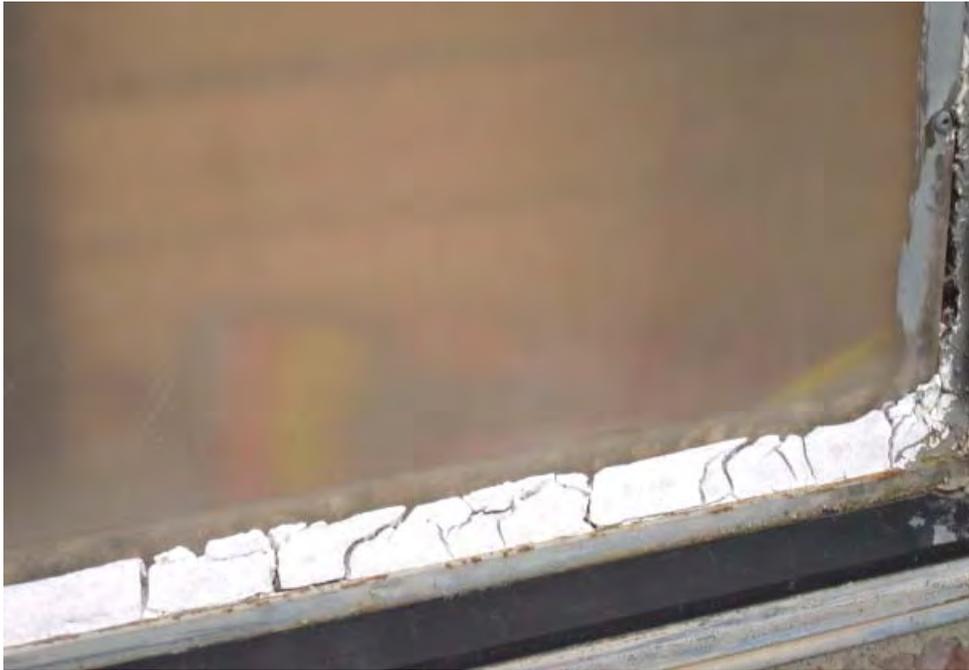
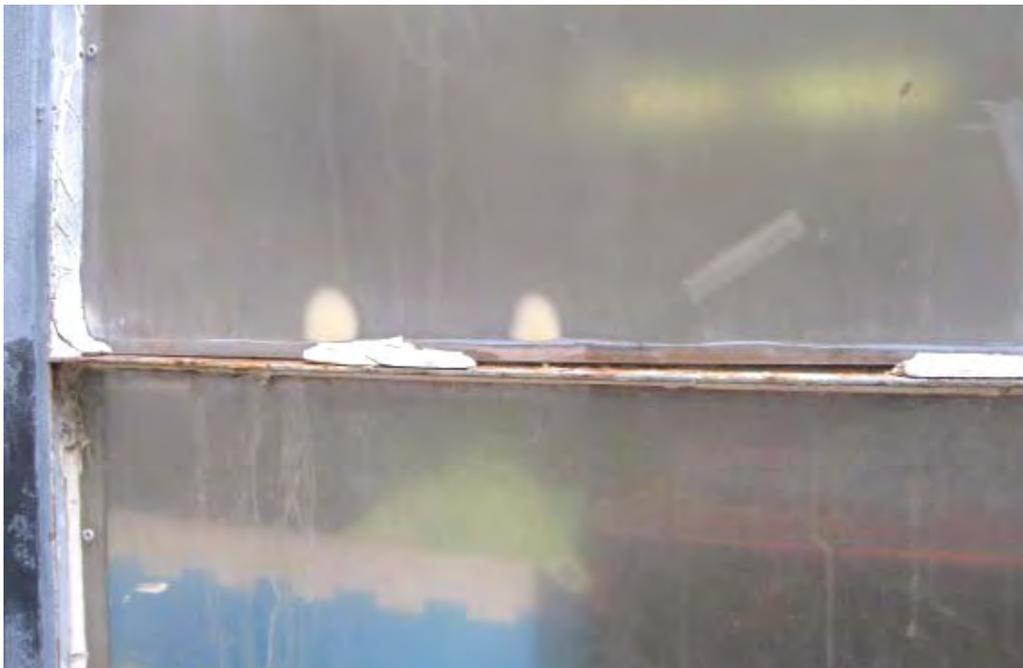
Several other potential sources of water damage/water infiltration were observed in the building. Throughout the school, caulking around interior and exterior windowpanes was crumbling, missing or damaged (Pictures 9 through 12). As previously mentioned, air infiltration was noted around windows, which has resulted in chronic water penetration illustrated by water damaged ceiling tiles and wood along window frames throughout the building (Pictures 13 and 14). Water penetration through window frames can lead to mold growth under certain conditions. Repairs of window leaks are necessary to prevent further water penetration. Missing/damaged joint/expansion compound was also observed along exterior walls, which can provide a source of water penetration (Picture 15).

Plexiglass/Lexan Windows and Missing/Damaged Exterior Window Caulking

11. Seal windows to prevent drafts, pest entry and water penetration.
12. Until building envelope repairs can be made, refrain from storing porous materials (e.g., books, papers, boxes) in areas that are prone to water infiltration.

1. Consider replacing window systems to prevent air infiltration and water penetration.

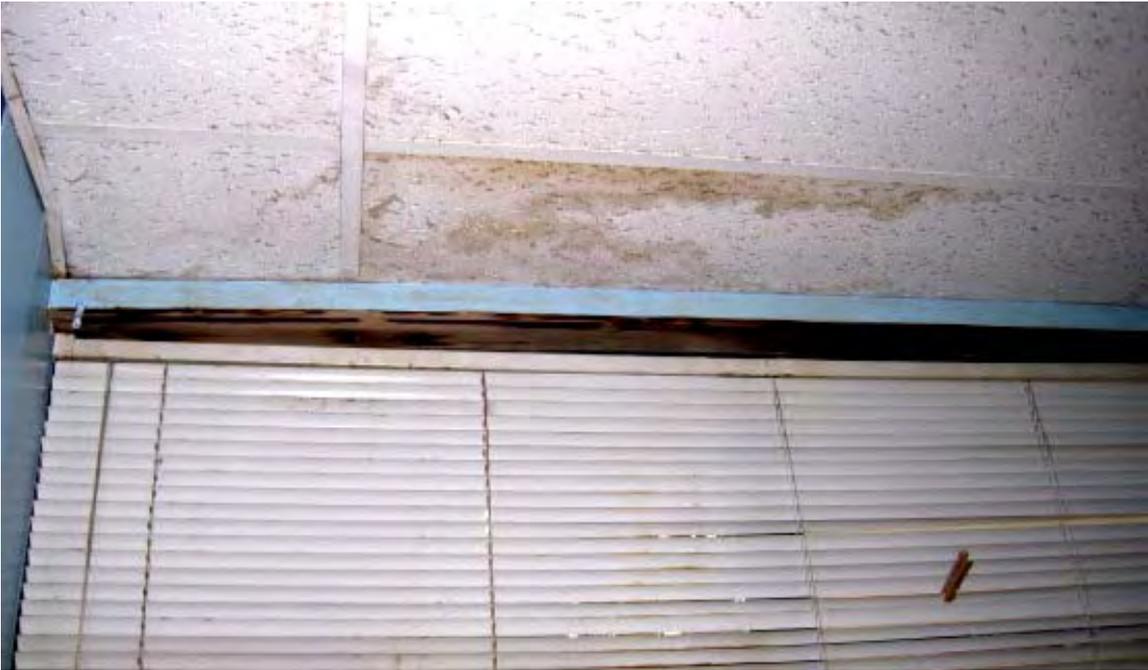
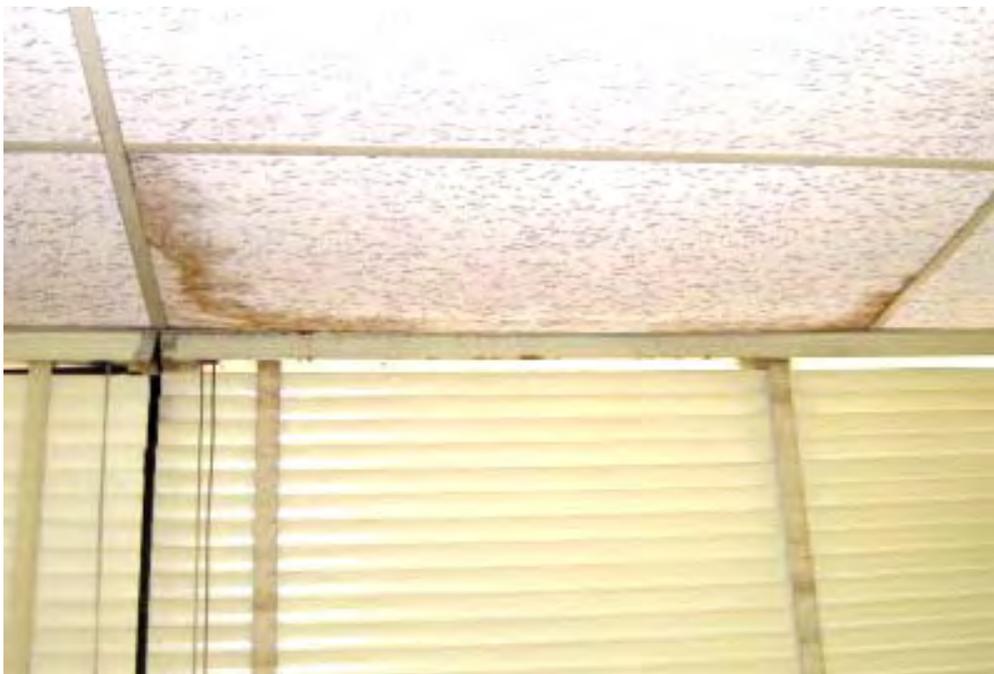
Water Damaged Ceiling Tiles and Wood Adjacent to Window Frames

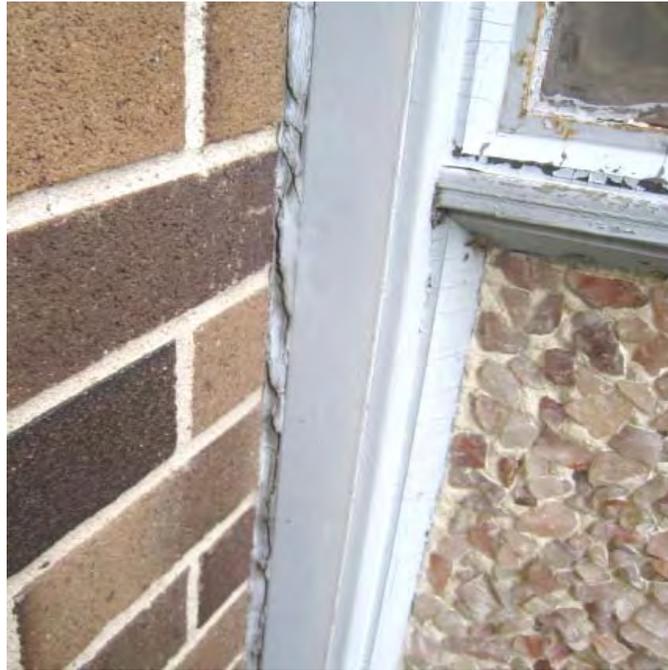
Picture 15

Missing/Damaged Joint Compound along Exterior Walls

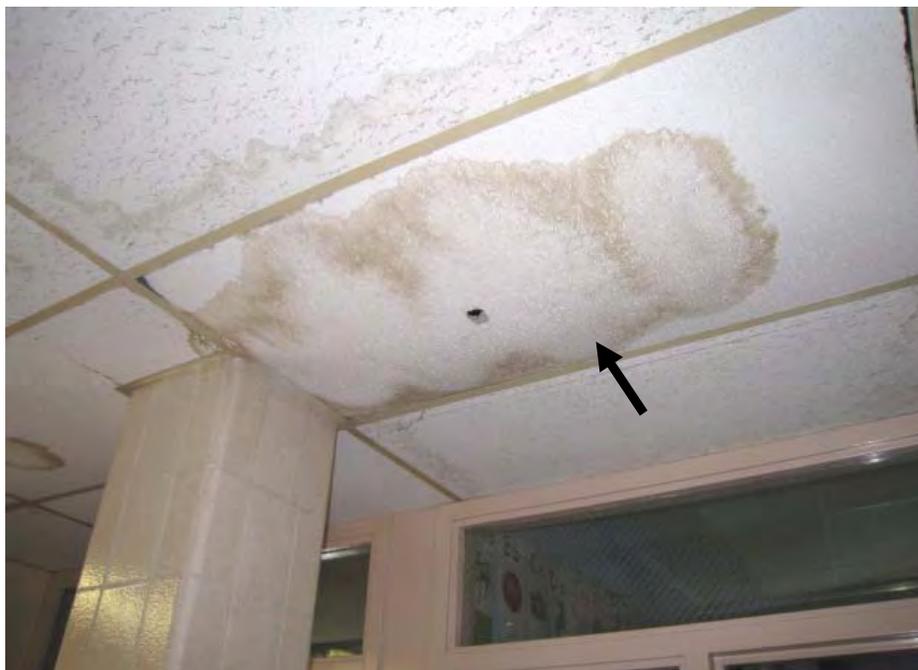
Picture 16

Water-damaged ceiling tiles were observed in hallways and other interior areas (not along exterior walls) which may indicate current or historic roof/plumbing leaks (Picture 16). Water-damaged ceiling tiles can provide a source of mold and should be replaced after a water leak is discovered and repaired.

Water Damaged Ceiling Tiles in 2nd Floor Hallway, Note Hole in Center of Tile for Drainage

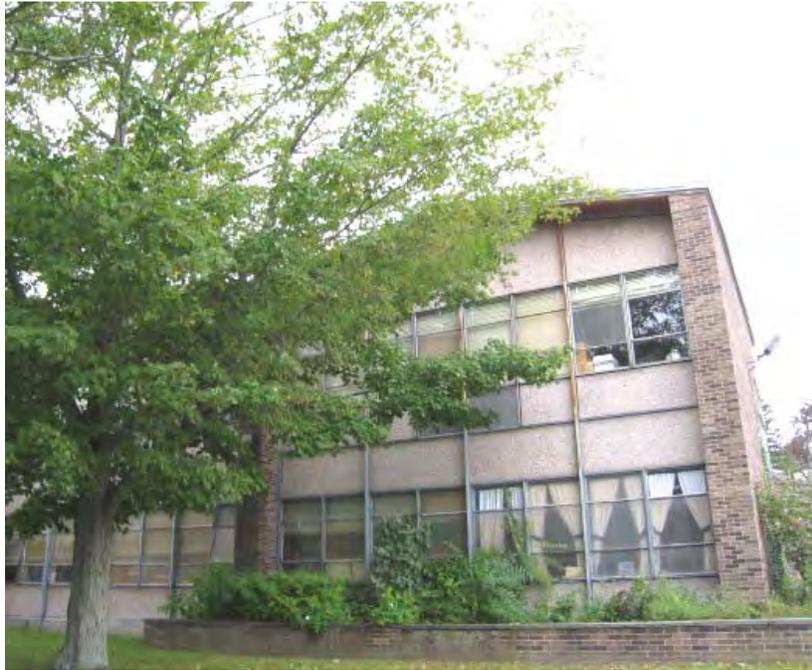
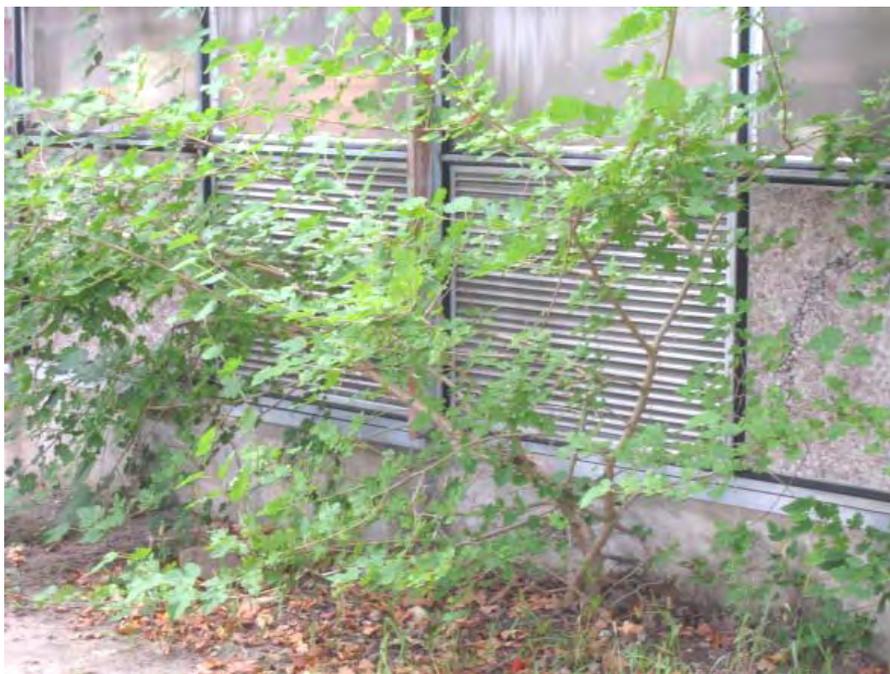
Trees/Plants in Close Proximity to Exterior Walls

Trees/Plants in Close Proximity to Exterior Walls/Univent Fresh Air Intakes

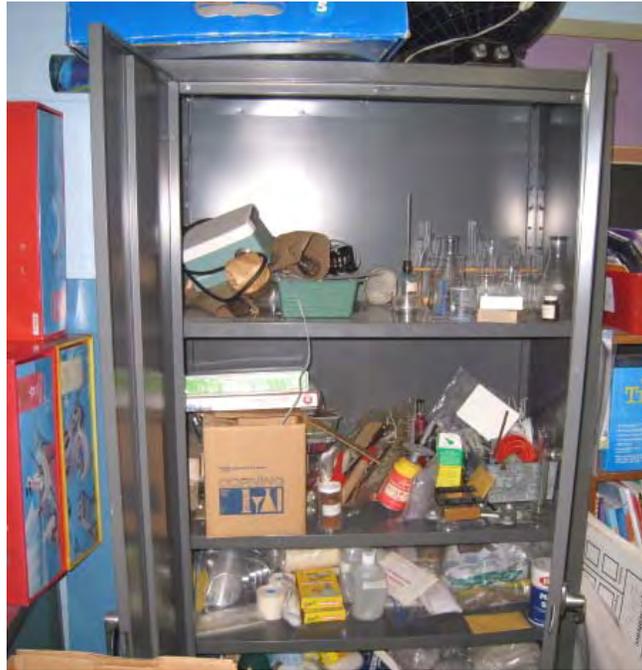
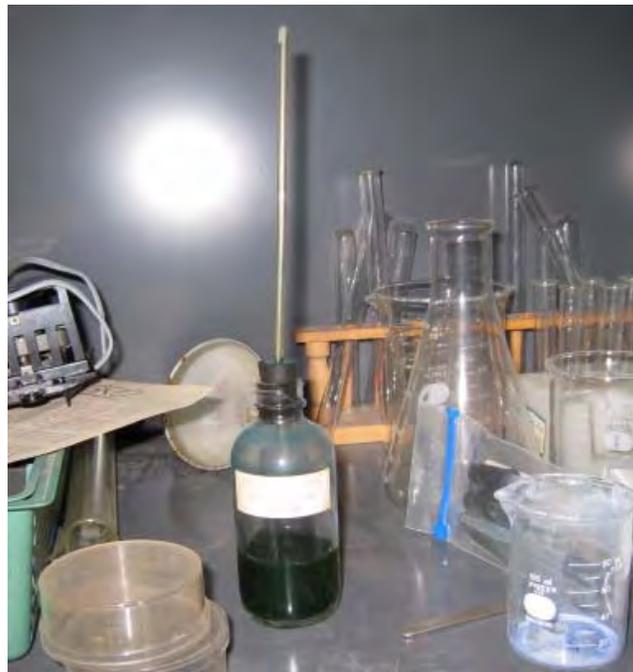
A glass container labeled HCl (hydrochloric acid) was found in an unlocked storage locker in Resource Room 20 (Pictures 19 and 20). The container had a rubber stopper that had a hollow glass tube through it, which would allow the acid to vent into the cabinet and into the room providing a source of eye, skin and respiratory irritation. Acids should be kept in an appropriate secure acid storage cabinet. Also noted was a lawnmower stored inside the cafeteria/gym. Odors and off-gassing of VOCs from gasoline can have an adverse effect on indoor air quality. In addition, storing gas-powered equipment in occupied areas may be a fire hazard.

Unlocked Storage Cabinet in Resource Room 20

Glass Container Labeled HCl (Hydrochloric Acid) in Storage Locker in Resource Room 20, Note Rubber Stopper and Hollow Glass Tube

15. Consider installing local exhaust ventilation for photocopiers and laminator in main office.
16. Remove container of HCl in storage locker in Resource Room 20. Have a complete inventory done in all storage areas and classrooms. Discard hazardous materials or empty containers of hazardous materials in a manner consistent with environmental statutes and regulations. Follow proper procedures for storing and securing hazardous

materials. Obtain Material Safety Data Sheets (MSDS') for chemicals from manufacturers or suppliers. Be sure all materials are labeled clearly.

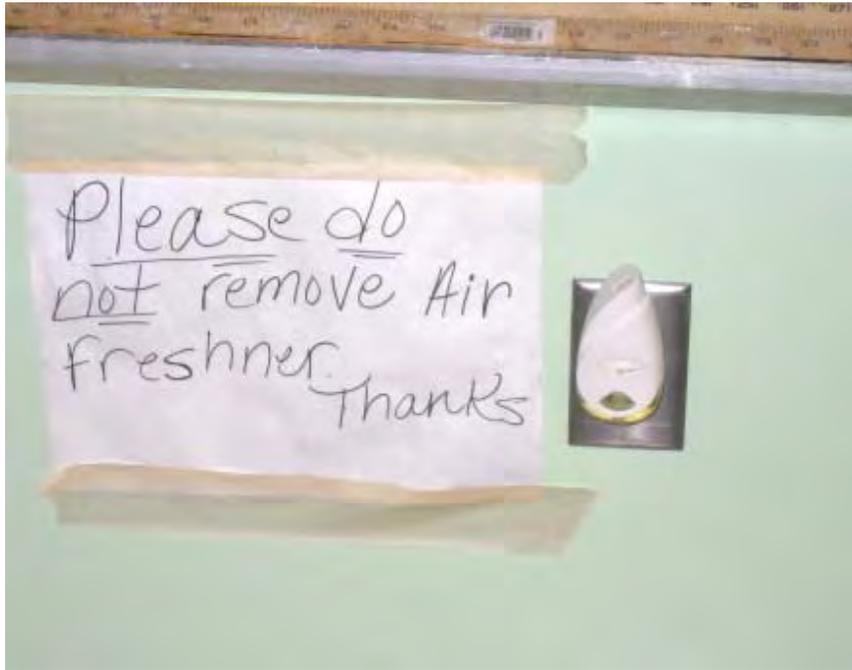
Picture 21

A strong scent of deodorizer was detected upon entry into classrooms 7 and 22. The source of the odors was identified as plug-in air fresheners (Picture 21). Air fresheners contain chemicals that can be irritating to the eyes, nose and throat of sensitive individuals. Further, air fresheners do not remove materials causing odors, but rather mask odors which may be present in the area.

Plug-In Air Freshener in Classroom

22. Refrain from using strongly scented materials (e.g., plug-in air fresheners).
23. Consider adopting the US EPA document, "Tools for Schools" to maintain a good indoor air quality environment on the building (US EPA, 2000). This document can be downloaded from the Internet at: <http://www.epa.gov/iaq/schools/index.html>.

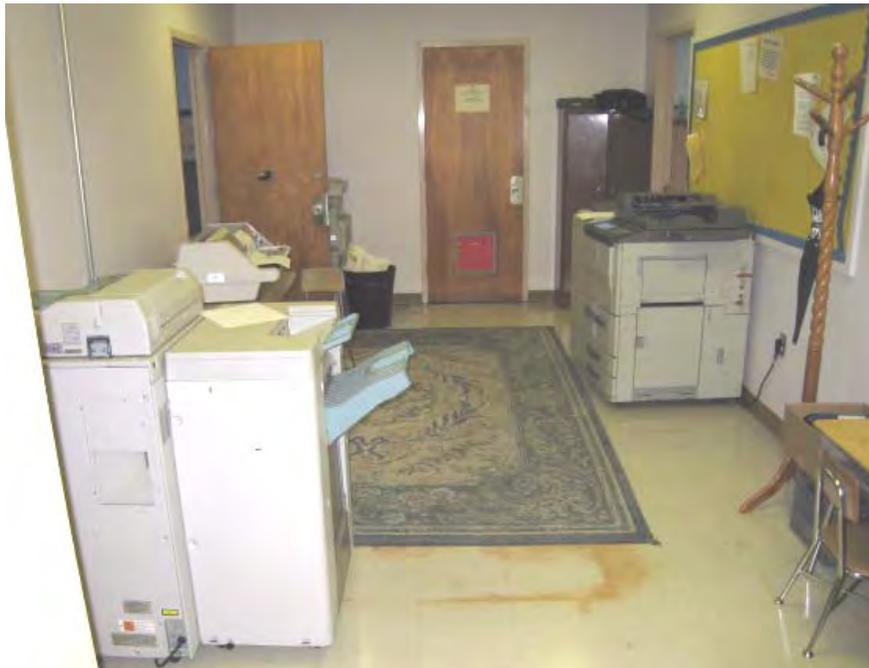
Picture 22

The main office contains photocopiers and lamination machines (Picture 22). This area is not equipped with local exhaust ventilation to help reduce excess heat and odors. Lamination machines can produce excess heat and irritating odors during use. VOCs and ozone can be produced by photocopiers, particularly if the equipment is older and in frequent use. Ozone is a respiratory irritant (Schmidt Etkin, 1992).

Photocopiers and Lamination Machines in Main Office

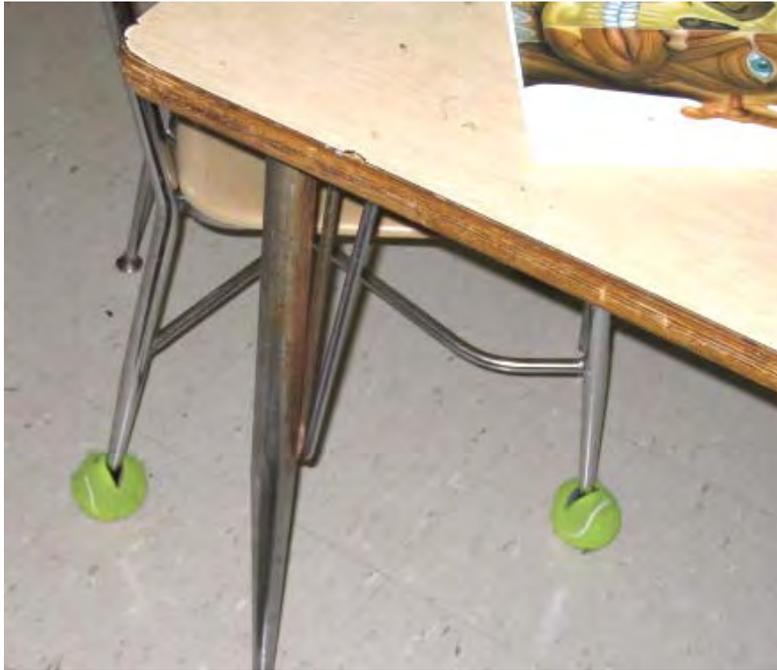
Picture 23

In an effort to reduce noise from sliding chairs, tennis balls had been sliced open and placed on chair legs (Picture 23). Tennis balls are made of a number of materials that are a source of respiratory irritants. Constant wearing of tennis balls can produce fibers and cause TVOCs to off-gas. Tennis balls are made with a natural rubber latex bladder, which becomes abraded when used as a chair leg pad. Use of tennis balls in this manner may introduce latex dust into the school environment. Some individuals are highly allergic to latex (e.g., spina bifida patients) (SBAA, 2001). It is recommended that the use of materials containing latex be limited in buildings to reduce the likelihood of symptoms in sensitive individuals (NIOSH, 1997). A question and answer sheet concerning latex allergy is attached as Appendix B (NIOSH, 1998).

Tennis Balls on Chair Legs

20. Store gas-powered equipment outside the building in accordance with local fire codes.
21. Replace latex-based tennis balls with latex-free tennis balls or glides.

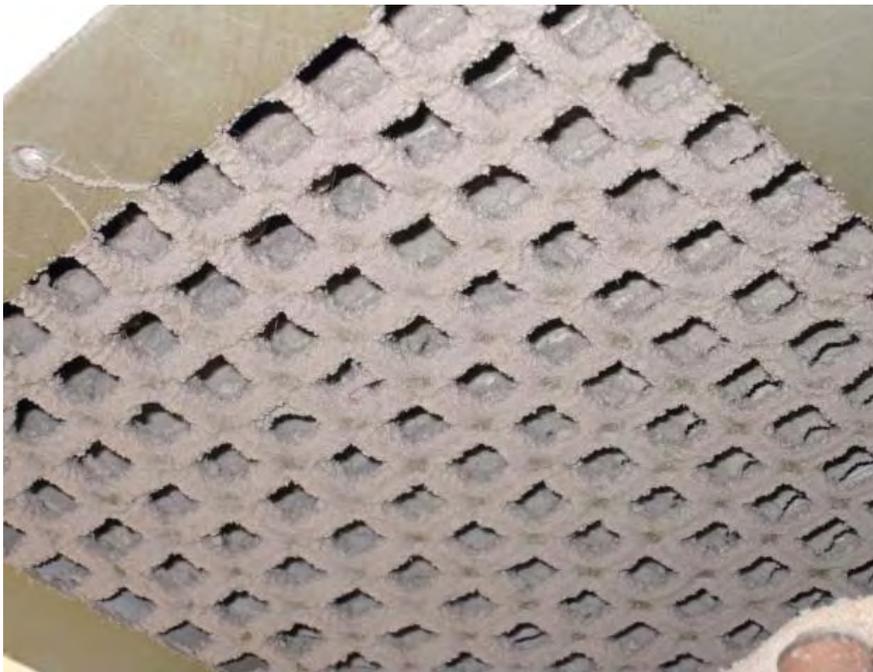
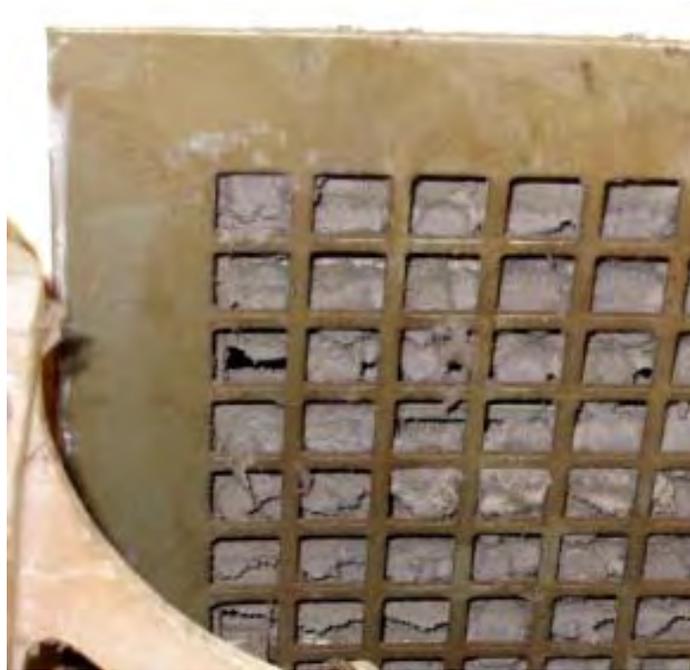
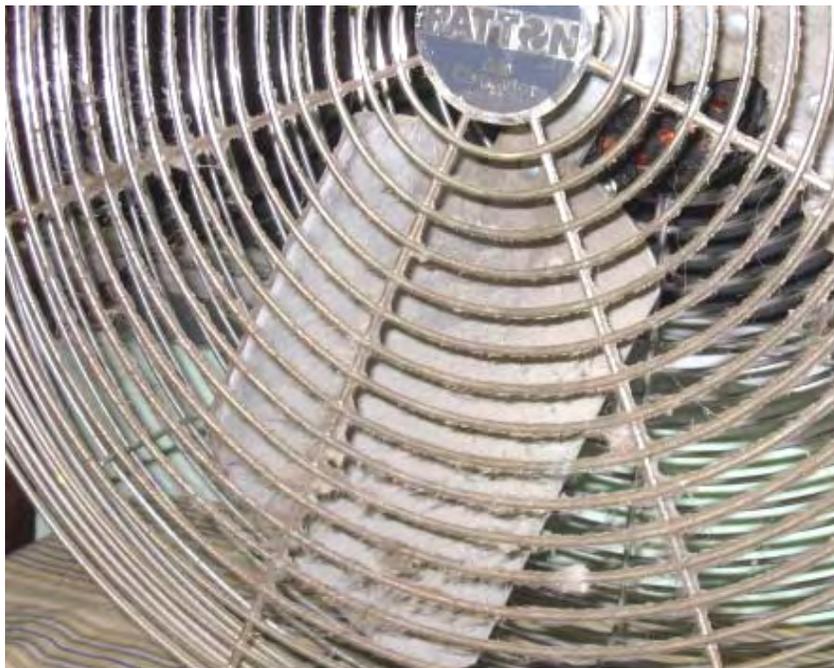
A number of exhaust/return vents, univent air diffusers, personal fans were observed to have accumulated dust (Pictures 24 through 26). If exhaust vents are not functioning, backdrafting can occur, which can re-aerosolize accumulated dust particles. Re-activated univents and fans can also aerosolize dust accumulated on vents/fan blades.

Accumulated Dust/Debris on Surface of Exhaust Vent

Accumulated Dust/Debris on Surface of Exhaust Vent, Note Vent almost Completely Obstructed Preventing Airflow

Accumulated Dust/Debris on Fan Blades/Cage

18. Clean personal fans, univent air diffusers, return vents and exhaust vents periodically of accumulated dust.
19. Consider replacing window blinds or cleaning them on a regular schedule to prevent dust accumulation.

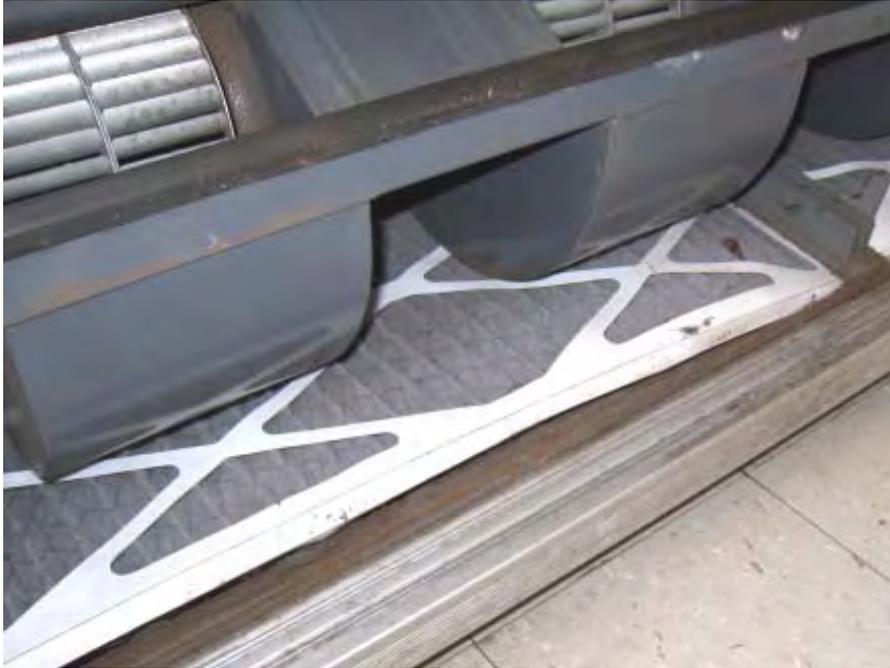
Picture 27

Finally, BEH staff inspected filters for classroom univents and found the filters coated with dirt/dust and accumulated material (Picture 27). A debris-saturated filter can obstruct airflow and may serve as a reservoir of particulates that can be re-aerosolized and distributed to occupied areas via the ventilation system.

Classroom Univent Filters

6. Change filters for air-handling equipment (e.g., univents and AHUs) as per the manufacturer’s instructions or more frequently if needed. Vacuum interior of units prior to activation to prevent the aerosolization of dirt, dust and particulates. Ensure filters fit flush in their racks with no spaces in between allowing bypass of unfiltered air into the unit.
