INDOOR AIR QUALITY ASSESSMENT

**Registry of Motor Vehicles
278 Union Street
New Bedford, Massachusetts 02740**

Prepared by:
Massachusetts Department of Public Health
Bureau of Environmental Health
Indoor Air Quality Program
May 2009

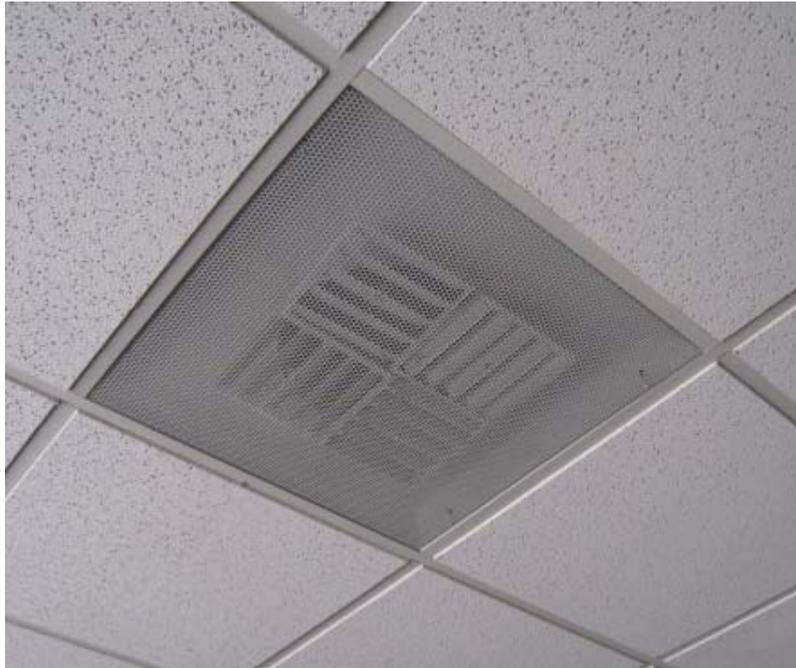
Picture 1

The heating, ventilating and air-conditioning (HVAC) system consists of four air-handling units (AHUs) or heat pumps, located in the basement. Fresh air is drawn into the AHUs through air intakes on the exterior wall and delivered to occupied areas via ceiling-mounted air diffusers (Picture 1). Return air is drawn into ceiling-mounted vents and ducted back to the AHUs (Picture 2). A digital wall-mounted thermostat controls the HVAC system and has fan settings of “on” and “automatic”.

Ceiling-Mounted Supply Diffuser

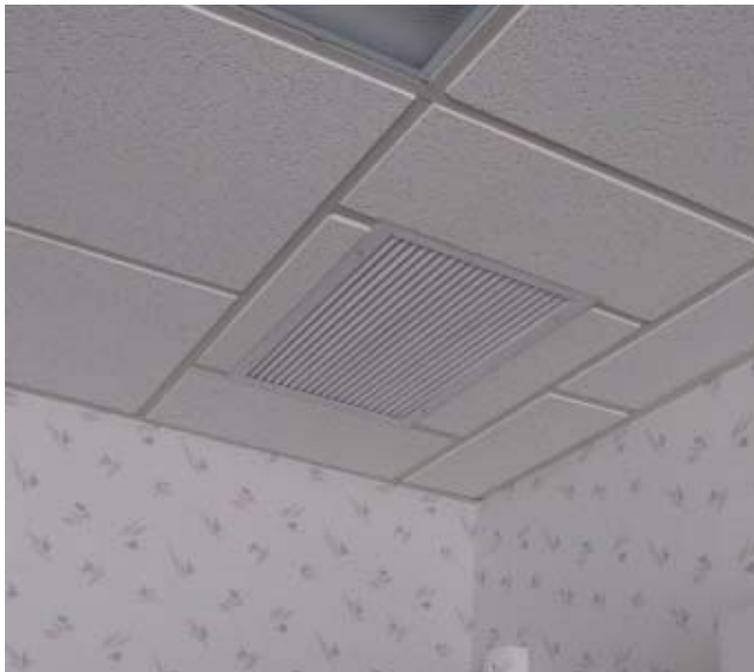
Picture 2

Ceiling-Mounted Return Vent

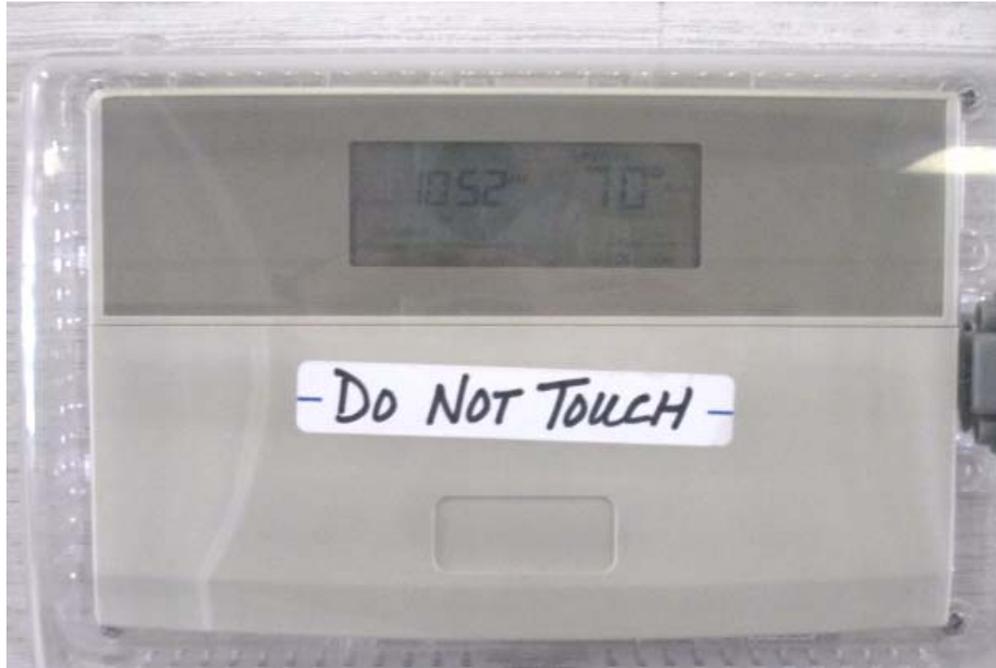
Picture 3

Mr. Warren reported that previous to the BEH assessment occupants complained of a lack of airflow/discomfort and that the fan setting was typically set to the “auto” setting. The automatic setting on the thermostat activates the HVAC system at a preset temperature. Once the preset temperature is reached, the HVAC system is deactivated. Therefore, no mechanical ventilation is provided until the thermostat re-activates the system. Without a continuous source of fresh outside air and removal via the exhaust/return system, indoor environmental pollutants can build-up and lead to indoor air quality/comfort complaints. At Mr. Warren’s direction, the thermostat was set to the fan” on” setting at the time of the assessment (Picture 3). BEH staff also recommended that the RMV work with their building’s HVAC vendor to increase outside air intake.

Digital Thermostat for HVAC System

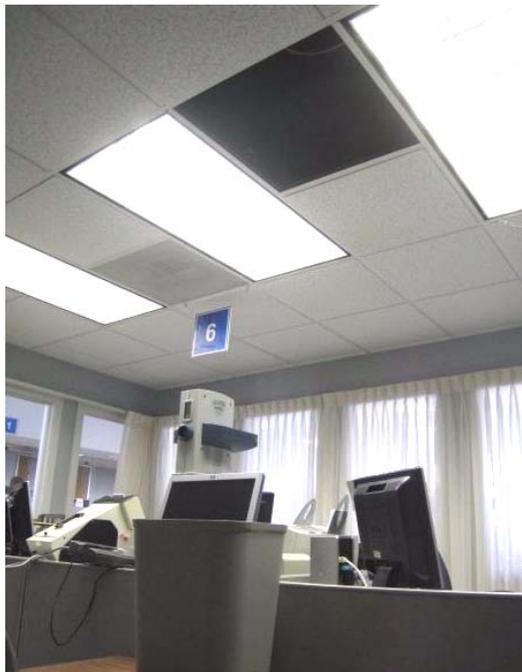
Picture 4

Mr. Warren reported that the building has had chronic roof leaks and prior to the RMV occupancy, the roof was reportedly repaired. In addition a contract with a flooding restoration firm, ServiceMaster, was secured to conduct remediation and removal of water damaged materials. At the time of the assessment, a roof leak had occurred in rooms 6 & 7, in a centrally located area. Prompt investigation and repair of the leak was hampered due to heavy snow and ice on the roof. To mitigate these effects, water damaged-ceiling tiles were removed, and a bucket was placed in the area to collect water (Picture 4). No obvious mold growth was noted as a result of the current leak; however, white staining on wooden beams in the ceiling plenum was observed, which may indicate either historic mold growth or efflorescence due to water penetration through the building envelope (Picture 5).

Roof Leak in Rooms 6 & 7, Note Tile Removed to Catch Water in Bucket (below)

1. If not completed, continue with plans to make roof repairs. Monitor rooms 6 & 7 for further leaks. Report to building management for prompt action.

2. Replace any remaining water-stained ceiling tiles.
3. Periodically inspect basement sump pump and floor drain for proper function, particularly after heavy rains. Make repairs as needed.

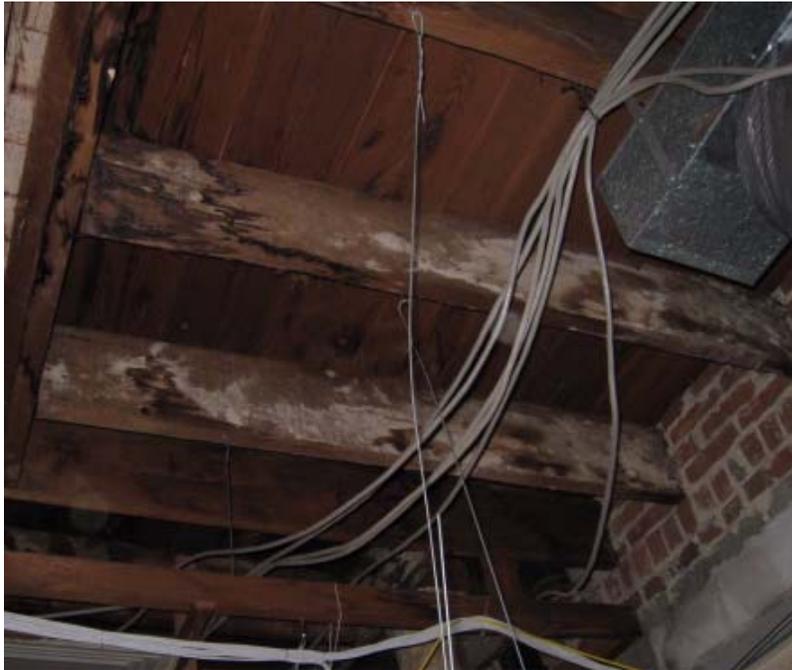
Picture 5

Efflorescence is a characteristic sign of water damage but it is not mold growth. As moisture penetrates and works its way through building materials, water-soluble compounds

White Staining on Wooden Beams above Rooms 6 & 7

dissolve, creating a solution. As the solution moves to the surface the water evaporates, leaving behind white, powdery mineral deposits. At the time of the assessment, BEH staff recommended that the material be cleaned. In subsequent correspondence with Mr. Warren, he reported that the beams had been cleaned by ServiceMaster.

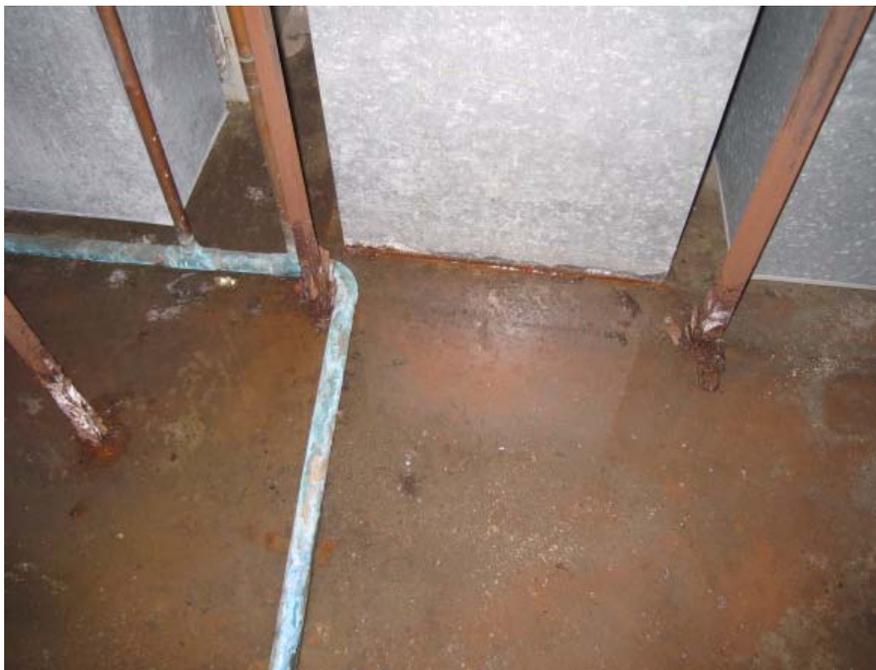
Picture 6

Standing water was observed in the basement in close proximity to the AHUs for the HVAC system (Picture 6). Although the area was equipped with a sump pump and floor drain, it filled with water and appeared to have not worked for some time (Pictures 7 and 8). Standing water can become stagnant and be a source for mold, bacteria and associated odors, which can be entrained into the ventilation system. In addition, exposure of metal components of the AHUs to water can compromise the integrity of the units (Picture 6). At the time of the assessment, BEH staff strongly recommended to Mr. Warren that the sump pump be repaired/replaced and that the drain be unclogged. In subsequent correspondence with Mr. Warren, he reported that both issues were corrected.

Standing Water near Air Handling Units in Basement, Note Base of Units Starting to Rust

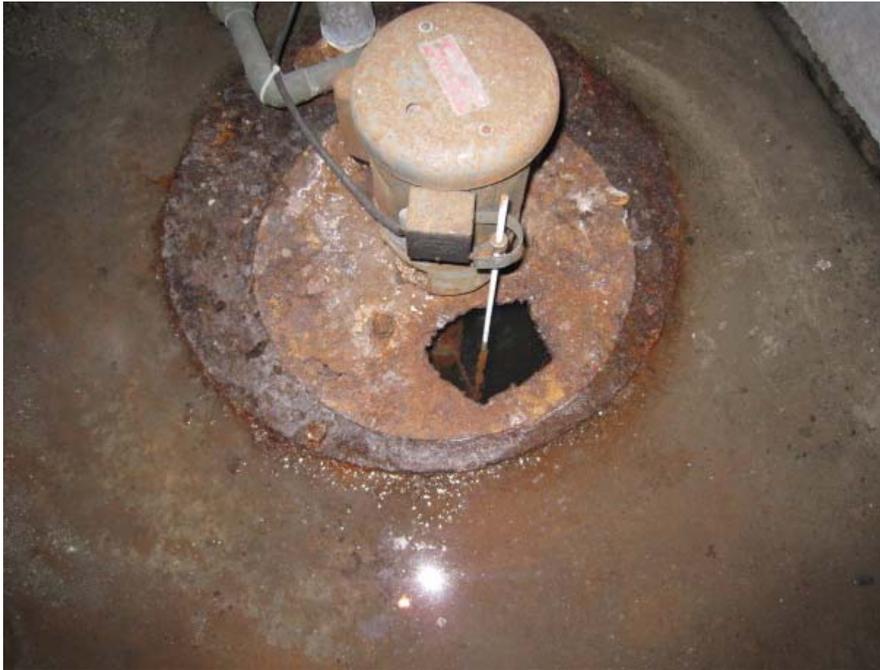
Picture 7

Inoperable Sump Pump Filled with Standing Water

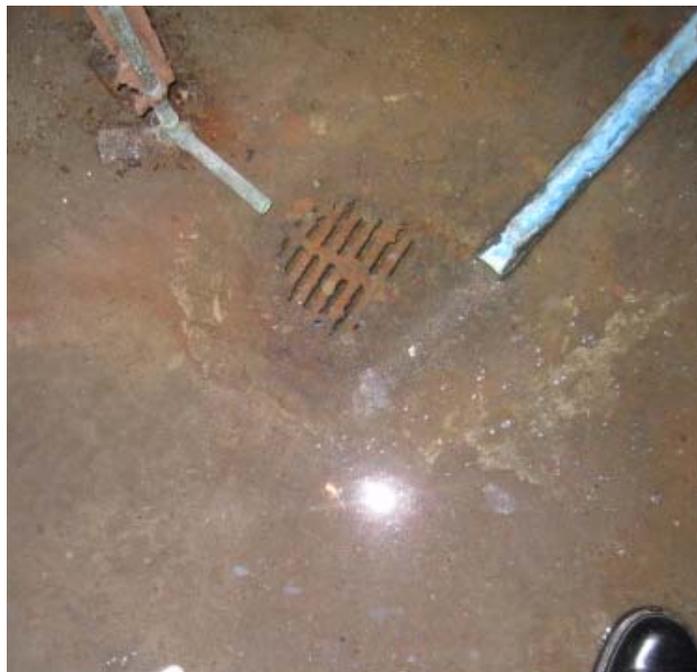
Picture 8

Inoperable Floor Drain Filled with Standing Water

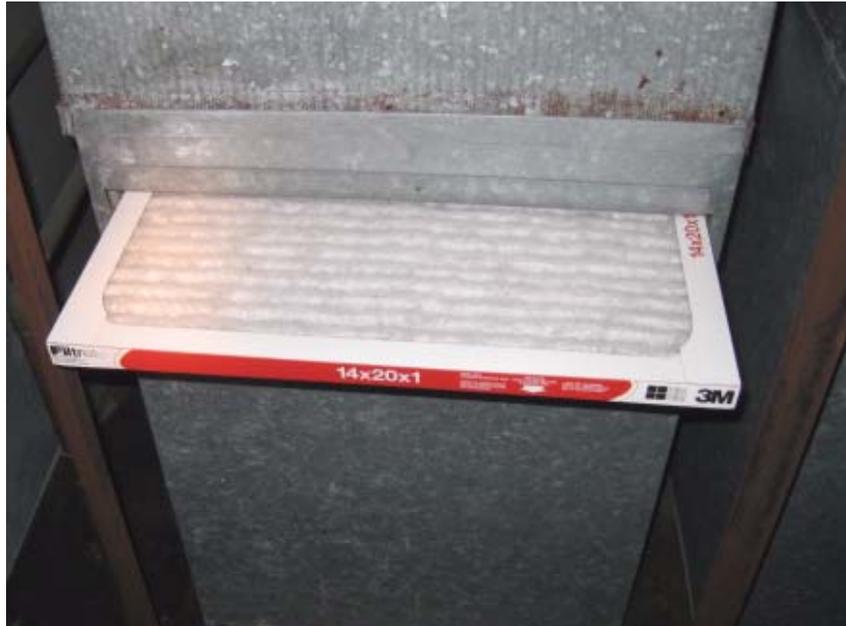
Picture 9

Other conditions that can affect indoor air quality were observed during the assessment. The HVAC filters installed at the RMV are high efficiency-pleated filters (Picture 9) that are changed six times a year under a preventative maintenance plan by a private HVAC engineering firm. Although filters were clean and appeared to have been recently changed, the filters did not fit properly. Filters were observed extending out of their filter slots and had spaces on either side (Pictures 10 and 11). In addition, the units did not have filter access panels installed. The lack of access panels will render the AHU casing non-airtight and draw air from the basement space into the unit. As air bypasses filters, the opportunity exists for airborne dirt, dust, odors and particulates to be drawn into the HVAC system and be distributed to occupied areas. Aerosolized dust, particulates and odors can provide a source of eye, skin and respiratory irritation to certain individuals. In addition, these materials can accumulate on flat surfaces in occupied areas and subsequently be re-aerosolized causing further irritation.

Pleated Air Filters in Basement AHU/Heat Pump

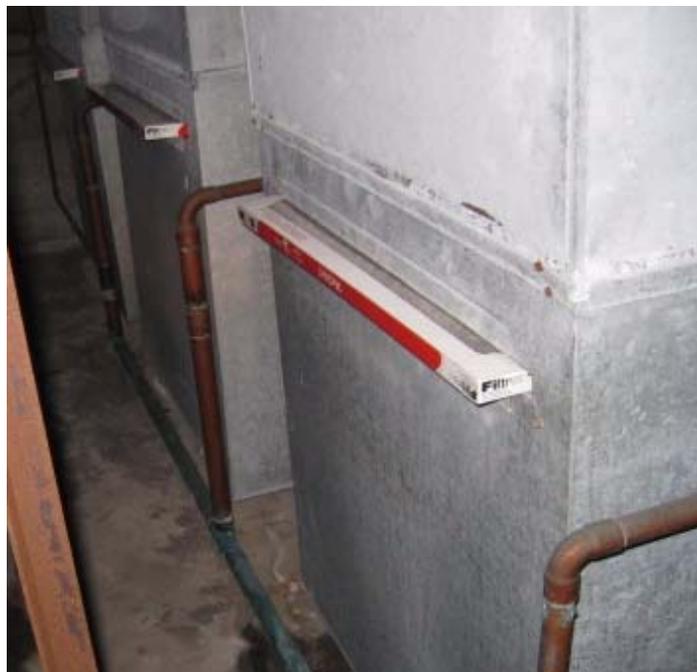
Picture 10

**Filters Protruding from Basement AHUs/Heat Pumps,
Note no Filter Access Panels are Installed**

9. Install filter access panels on basement AHUs, see Picture 12 for an example.
10. For buildings in New England, periods of low relative humidity during the winter are often unavoidable. Therefore, scrupulous cleaning practices should be adopted to minimize common indoor air contaminants whose irritant effects can be enhanced when the relative humidity is low. To control for dusts, a high efficiency particulate arrestance (HEPA) filter equipped vacuum cleaner in conjunction with wet wiping of all surfaces is recommended. Drinking water during the day can help ease some symptoms associated with a dry environment (throat and sinus irritations).

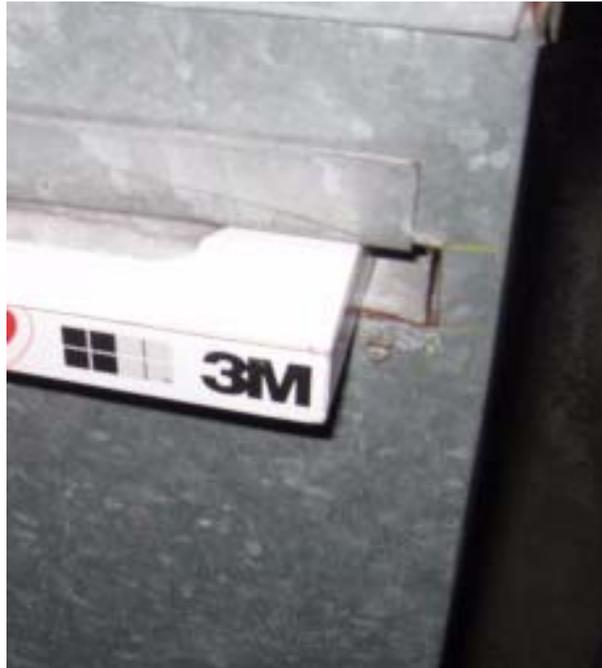
Picture 11

Close-Up of Spaces around Filter in Basement AHU/Heat Pump Indicating Filter Bypass

7. Consider balancing mechanical ventilation systems every 5 years, as recommended by ventilation industrial standards (SMACNA, 1994).
8. Ensure filters for all AHUs and heat pumps fit flush in their racks with no spaces to prevent bypass of unfiltered air.

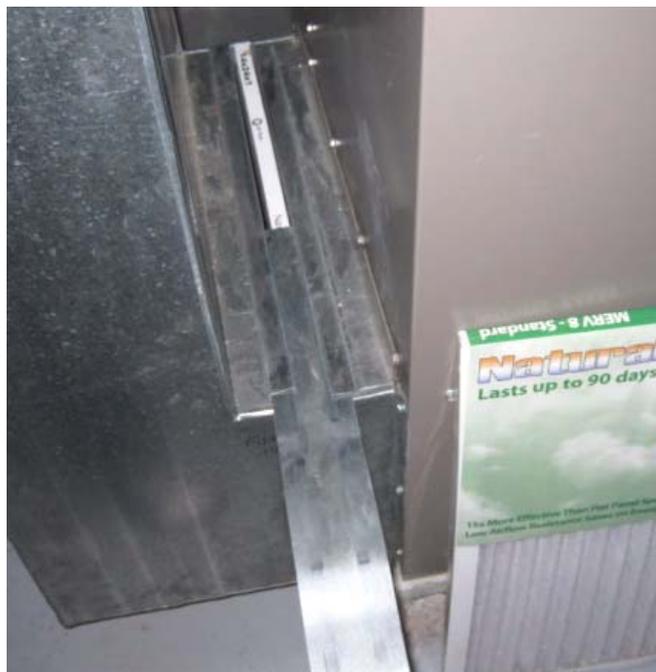
Picture 12

Example of Filter Access Panel on Residential AHU, Panel Slid Back to Reveal Interior Filter
