# **INDOOR AIR QUALITY ASSESSMENT**

**Old Hampshire Superior Court Building  
99 Main Street  
Northampton, Massachusetts**

Prepared by:  
Massachusetts Department of Public Health  
Bureau of Environmental Health  
Indoor Air Quality Program  
November 2009

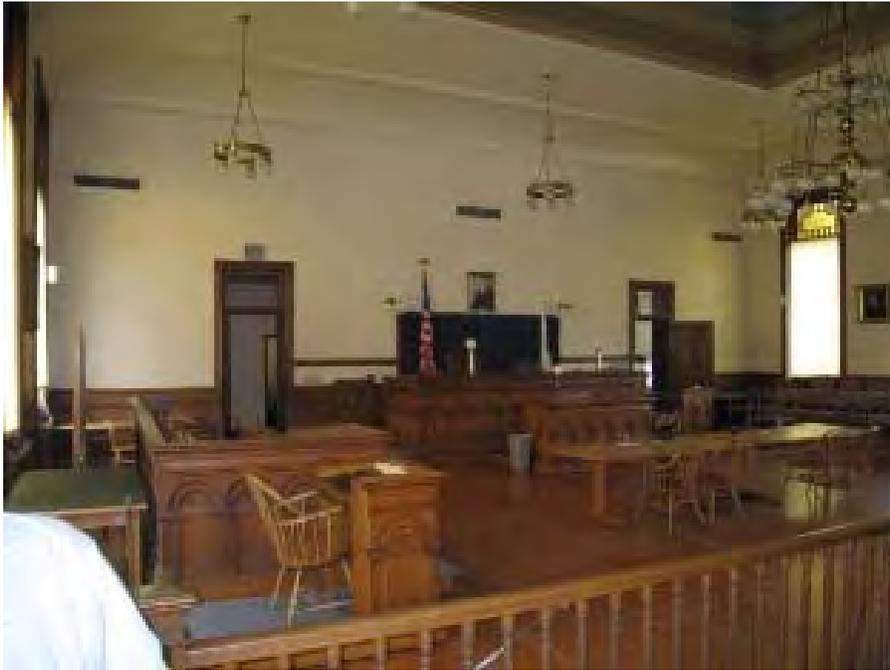
**Picture 1**

**Seldom Utilized Superior Courtroom**

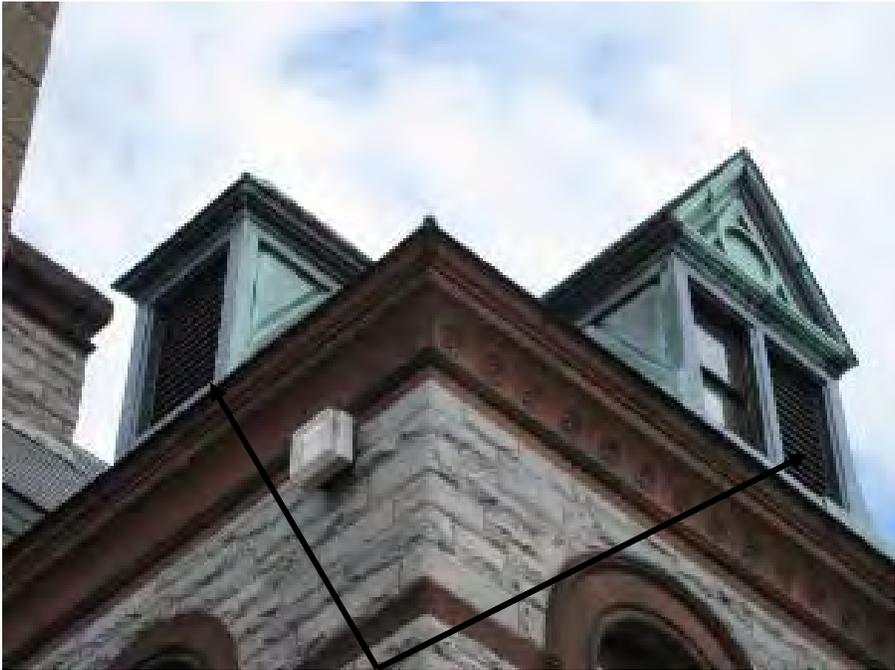
**Picture 3**

The heating, ventilating and air conditioning (HVAC) system for the upper and middle floors consists of three air-handling units (AHUs) located in the attic space of the building (Picture 2), each of which draws fresh air through an outdoor air intake located in attic dormers and distributes it to occupied areas via wall-mounted air diffusers. Return air is ducted back to the AHU via ceiling/wall-mounted grills and is ejected from the building via exhaust vents in attic dormers (Picture 3). The HVAC system for the law library has an AHU located in a

**Fresh Air Intake and Exhaust in Attic Dormers**

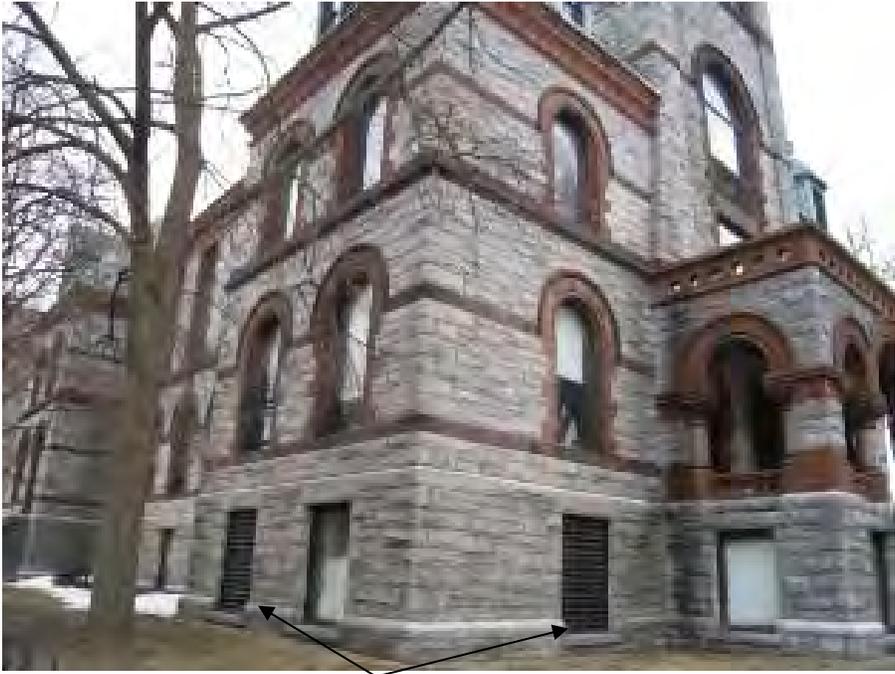
**Picture 4**

mechanical room in the lower level of the building. The fresh air intake and exhaust vent are located at ground level (Picture 4).

**Fresh Air Intake and Exhaust for Library AHU**

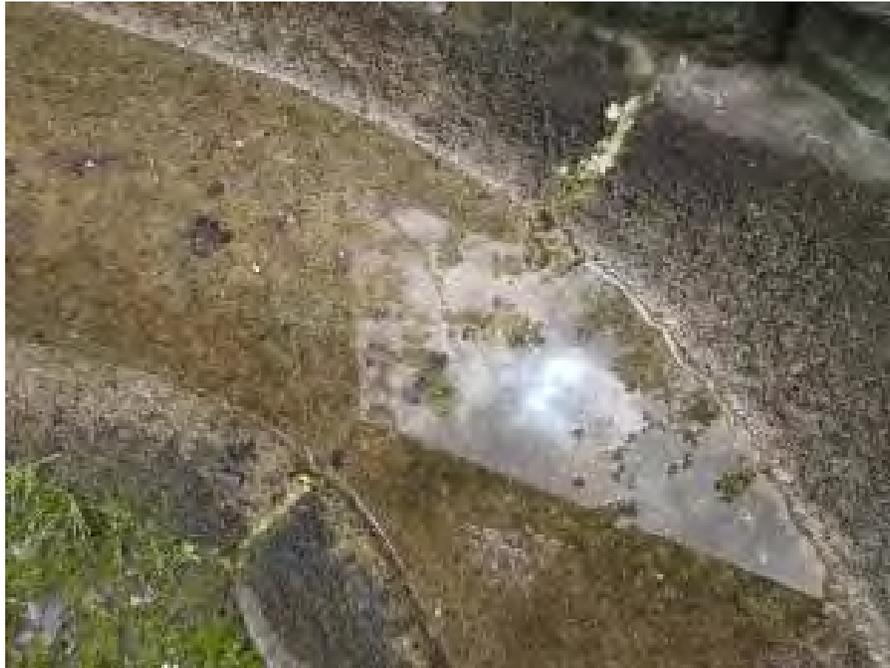
**Picture 5**

The law library has had repeated instances of flooding due to inadequate rainwater drainage along the southwest facing wall of the HSC (Picture 5). The orientation of the HSC ensures that the southwest exterior wall will be exposed to heavy rain from weather systems with

southwest winds. For this reason, the area must have adequate means to drain water from the roof and base of the exterior wall to prevent water pooling and subsequent penetration through the foundation. The roof edge does not have a gutter or downspout system. Rainwater is designed to run from the roof onto a cement trough, directing water toward a drain. This particular design is prone to creating conditions that allow for water to penetrate into the library.

1. The drain appears to be elevated above the lowest level of the cement trough. This condition can lead to chronic pooling of water which can then pass through seams in the drainage trough to keep soil against the foundation moist.
2. The roof edge does not have a gutter, which allows rainwater to accumulate in the cement trough.
3. Snow from the roof accumulates on the ground to form a dam to hold water against the building.

Each of these conditions can allow water to accumulate along the foundation, leading to penetration through the foundation via capillary action.

**Standing Water in Drainage Trough**

1. Remove snow from the base of the exterior walls after snow storms.
2. Ensure that the drain at the southwest exterior wall is functioning to readily drain rainwater without water pooling along the foundation of the building.

3. Repoint all of the seams for the drain trough with an appropriate water resistant sealant.
4. Remove the carpet from the library. Replace the carpeting with a non-absorbent floor covering (e.g. tile, carpet tile. Prior to removal, a determination should be made as to whether the surface beneath the carpeting contains asbestos. If asbestos is found, carpet removal would require compliance with state and federal asbestos remediation and hazardous materials disposal regulations.

1. Examine the feasibility of installing equipment to better regulate coolant supply to the HSC.
2. Examine the feasibility of providing better drainage along the southwest wall of the building.

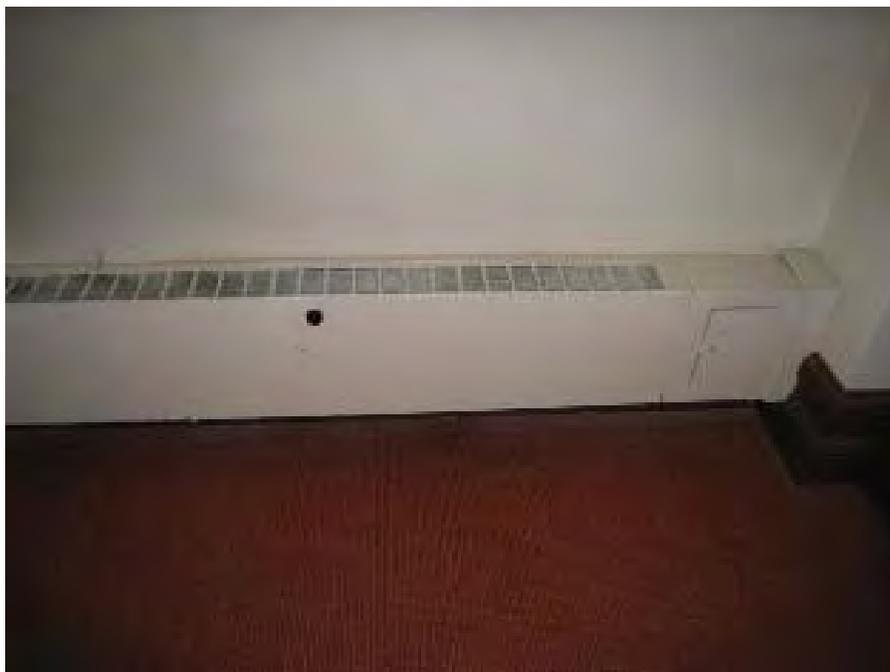
**Picture 6**

Of note is the carpeting of the library, which appears to be adhered to a tile surface (Picture 6) or to a false floor in the rear of the space (Picture 7). It is not clear whether the floor of the library was provided with a vapor barrier prior to the laying of the carpet. Without a vapor barrier, the floor of the library would be susceptible to condensation during hot, humid weather. Condensation is the collection of moisture on a surface with a temperature below the dew point. The dew point is a temperature determined by air temperature and relative humidity. A building component that is prone to the generation of condensation is the floor of a building that does not have a vapor barrier. Since the HSC was built in 1886, the basement floor does not likely have a

vapor barrier. Therefore, any surface that had a temperature below this range would be prone to generating condensation under temperatures and relative humidity conditions at the time of assessment. Carpeting adjacent to exterior wall appeared to be discolored and brittle, an indication of repeated moistening/drying. Condensation will keep the carpet moist and could then lead to musty odors and/or mold colonization, particularly during hot/humid weather. The combination of the carpeting and the false floor in the rear of the library would tend to trap moisture, resulting in the wetting of carpeting; thus, creating conditions for mold and associated odors to exist.

**Carpeting in Library Appeared to be Covering Tile Beneath**

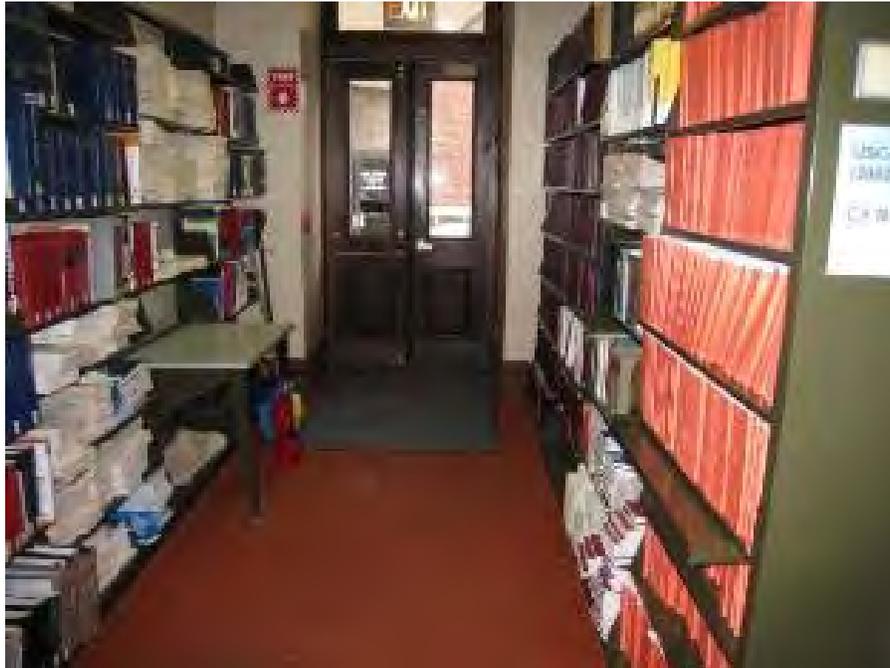
**Picture 7**

**Rear of Library May Have False Floor**

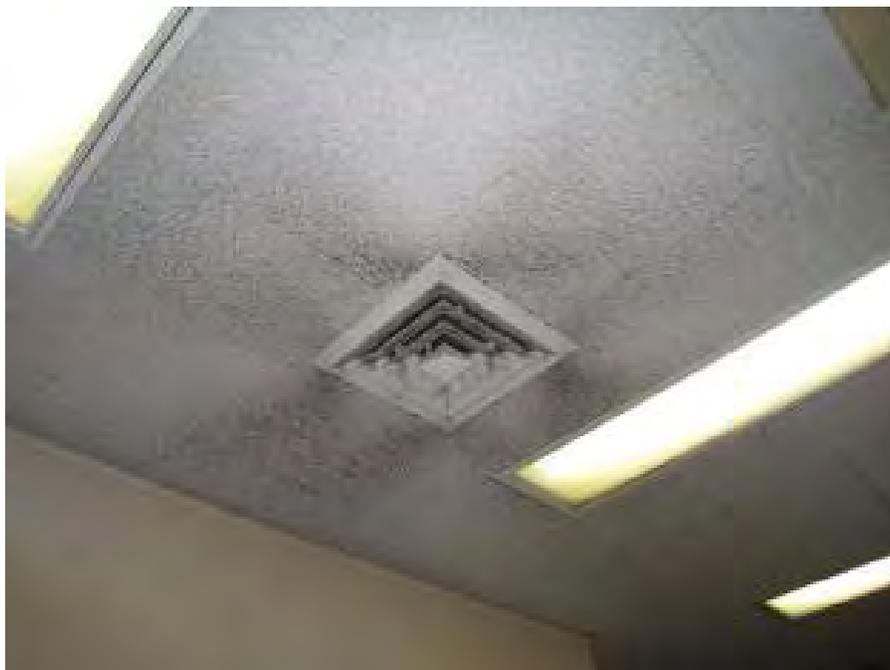
**Picture 8**

Other conditions that can affect indoor air quality were observed during the assessment. During the course of the assessment, fresh air supply vents in the library had a heavy, dark discoloration (Picture 8). This discoloration is likely due to unfiltered air drawn into the HVAC system due to an open duct clean out door located in the library level mechanical room (Picture 9). Dust, dirt and other particulate matter can be drawn in through this opening and then be distributed into the library

**Dark Stains on Air Supply Diffusers and Tiles in Library**

7. Ensure discolored air supply diffusers and exhaust vents are cleaned on a routine basis.
8. For buildings in New England, periods of low relative humidity during the winter are often unavoidable. Therefore, scrupulous cleaning practices should be adopted to minimize common indoor air contaminants whose irritant effects can be enhanced when the relative humidity is low. To control for dusts, a high efficiency particulate arrestance (HEPA) filter equipped vacuum cleaner in conjunction with wet wiping of all surfaces is recommended. Drinking water during the day can help ease some symptoms associated with a dry environment (throat and sinus irritations).

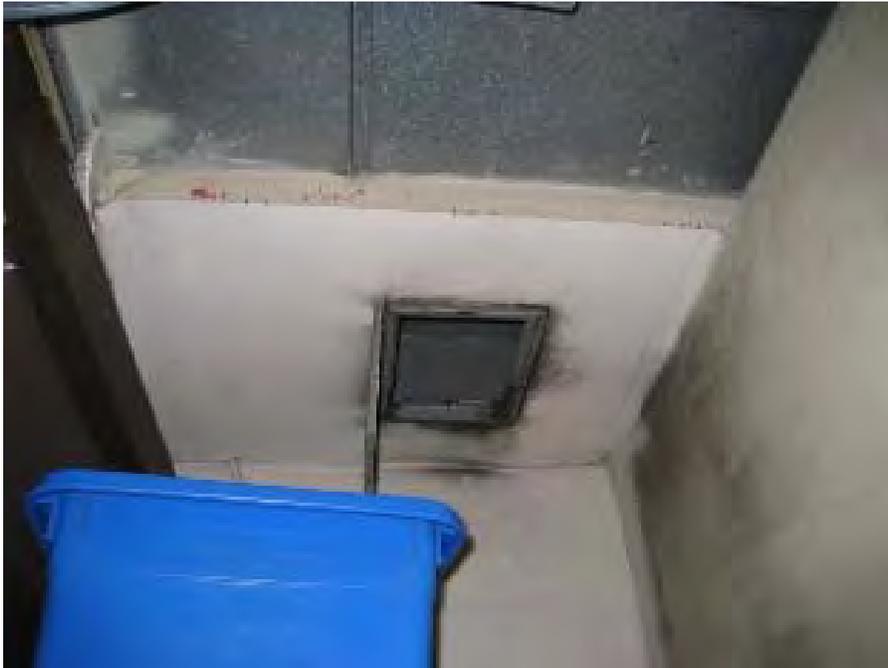
**Picture 9**

**Open Clean-Out Door**

9. Close the duct clean out door in Picture 9. Ensure that all duct doors are closed.
10. Determine composition of damaged insulating material on pipe in basement. If composed of asbestos, remediate in conformance with State and Federal asbestos abatement and hazardous materials disposal laws.

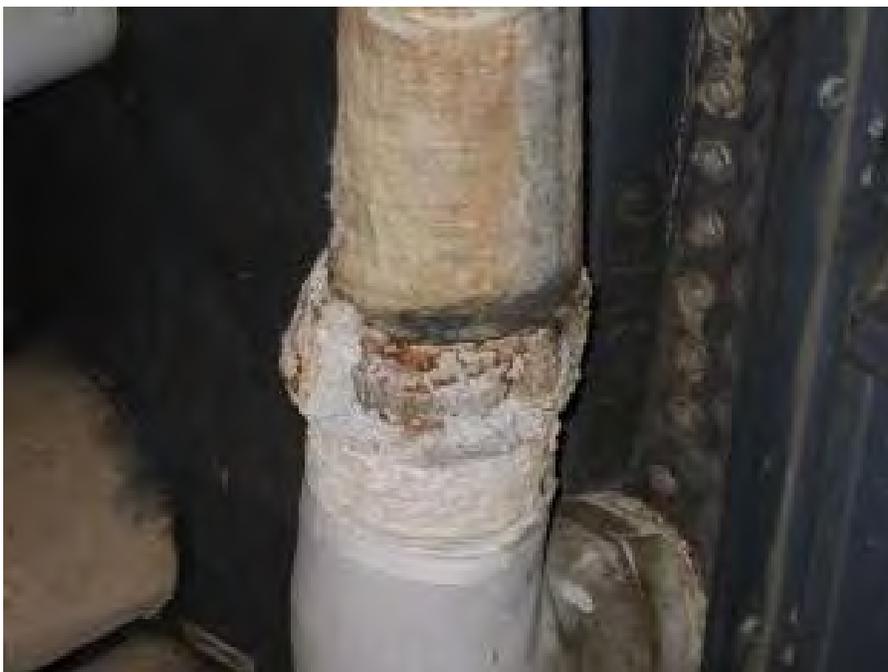
**Picture 10**

A pipe in the basement appears to have damaged insulation (Picture 10). This insulation may contain asbestos and, if so, should be remediated in conformance with all applicable State and Federal asbestos abatement and hazardous materials disposal laws.

**Pipe Insulation**
