# INDOOR AIR QUALITY ASSESSMENT

**Thomas Carroll School  
60 Northend Street  
Peabody, Massachusetts 01960**

Prepared by:  
Massachusetts Department of Public Health  
Bureau of Environmental Health  
Indoor Air Quality Program  
December 2009

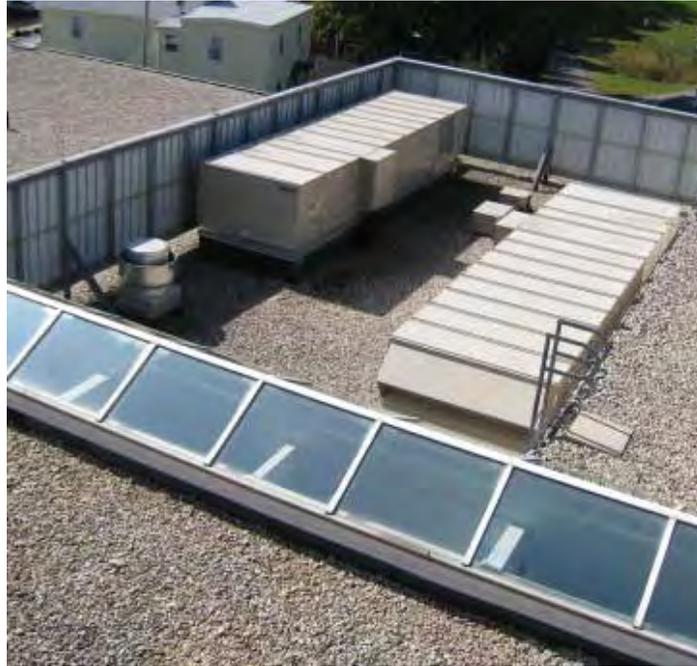
**Picture 1**

Fresh air for common areas such as the gymnasium, cafeteria, library, and administrative areas is provided by rooftop or ceiling-mounted air handling units (AHUs). These units were operating during the assessment.

**Rooftop AHUs**

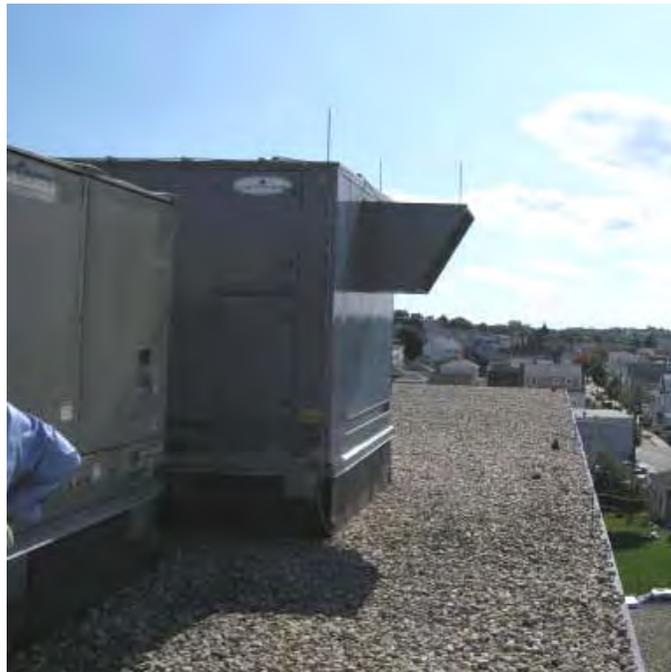
**Picture 2**

**Rooftop AHU, Note Fresh Air Intake Protruding From Side of Unit**

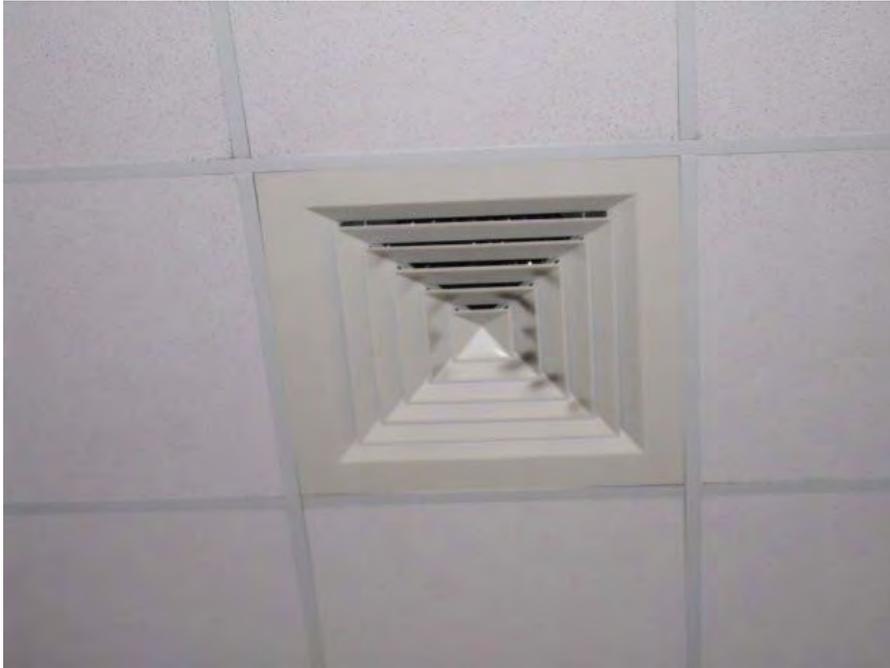
**Picture 3**

**Ceiling-Mounted Supply Diffuser**

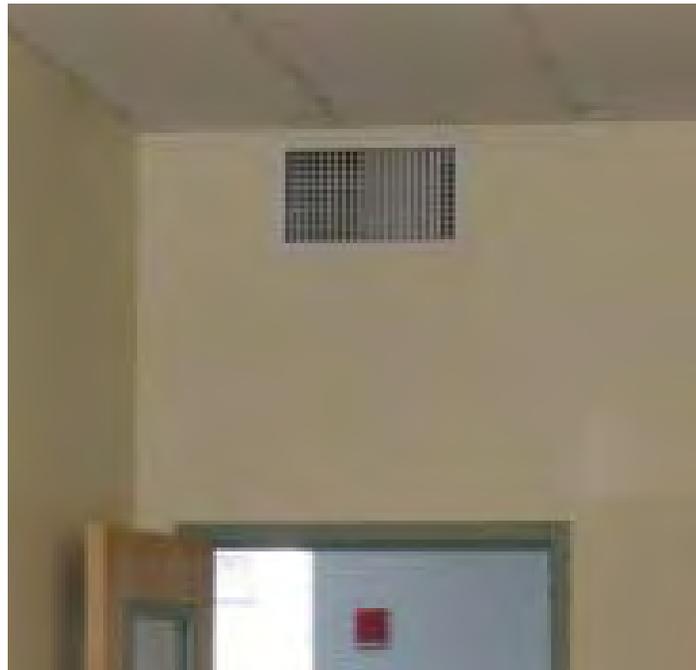
**Picture 4**

**Wall-Mounted Supply Diffuser**

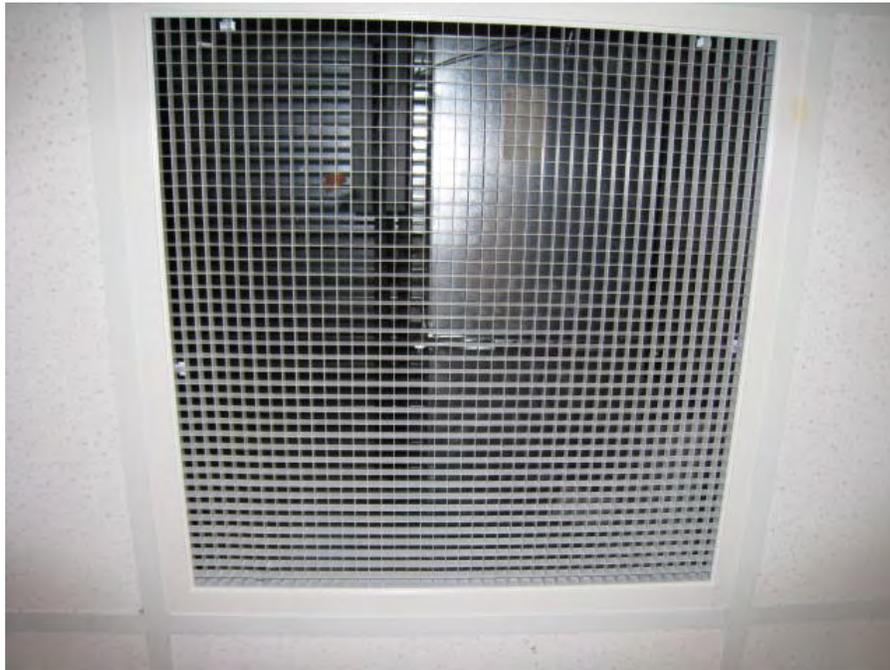
**Picture 5**

**Return Vent to an Open Ceiling Plenum, Ground floor**

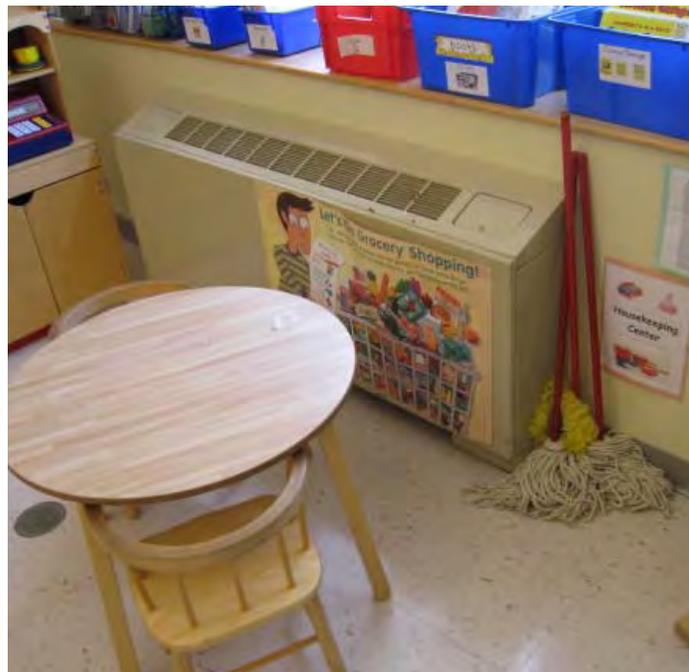
**Picture 6**

Auxiliary heating/cooling and air circulation in classrooms is supplemented by fan coil units (FCUs) ([Picture 6](#)). FCUs do not provide fresh air to rooms; rather, they re-circulate air and provide auxiliary heating or cooling as needed. A FCU draws air from the room through an intake located at the base of the unit. Air is filtered and conditioned by a coil, then distributed back to the room through an air diffuser atop the unit ([Figure 1](#)). Each FCU is controlled by a switch with settings for “low”, “medium”, “high”, and “off”. In some classrooms, FCUs were off. FCU must be allowed to operate during periods of school occupancy to aid in ventilation/air movement within classrooms.

**Classroom Fan Coil Unit Used To Facilitate Air Circulation**

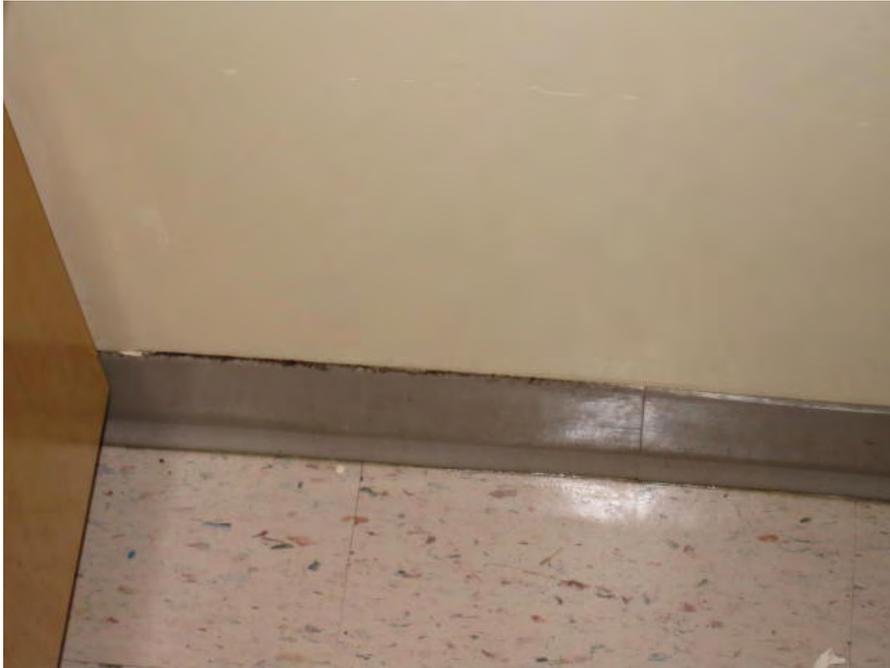
**Picture 7**

As previously mentioned, the assessment was prompted by concerns of mold growth observed on several surfaces, including walls, in below grade kindergarten classrooms. After its discovery, the surfaces with mold growth were reportedly cleaned and disinfected by school staff as well as by a professional cleaning/restoration firm (e.g., ServiceMaster). At the time of the assessment, BEH staff did not observe/detect visible mold or associated odors on these surfaces, with the exception of a small section near an aquarium ([Picture 7](#)). An interior wall cavity was also examined by BEH staff. There was no evidence of mold colonization within the wall cavity ([Picture 8](#)).

provides centralized air-conditioning (AC) during the summer months. AC systems are designed to provide cool air in part by removing moisture and reducing indoor relative humidity. It is likely that the mold growth occurred on these surfaces due to elevated relative humidity coupled with reduced activity of the HVAC system. Because these rooms are below grade, they are more susceptible to condensation due to cooling of the slab.

**Mold on Coving near Aquarium**

1. Monitor conditions in classrooms as needed to adjust the HVAC system to avoid elevated relative humidity (>70%) conditions that would be prone to condensation and/or mold growth.
2. Examine areas prone to condensation/mold growth periodically during spring/summer months and address as needed.
3. Consider supplementing the HVAC system in below grade areas with portable dehumidifiers as needed during humid, spring/summer months. Ensure dehumidifiers are cleaned and maintained as per the manufacturer's instructions to prevent standing water and mold growth.
4. Ensure classroom doors are closed for proper operation of HVAC system and to maintain comfort. Increase space beneath restroom doors, and operate the restroom exhaust fans during occupancy.

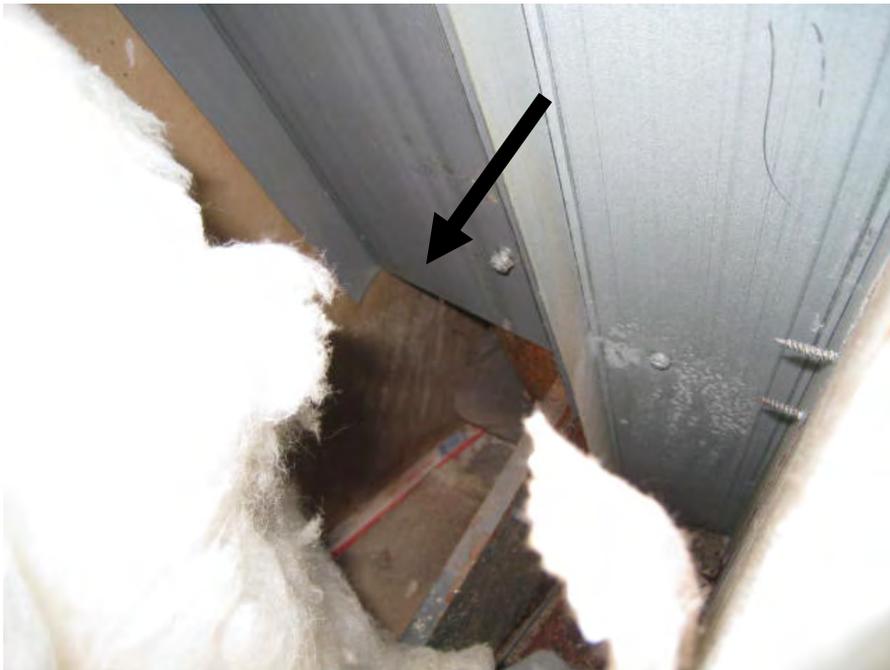
**Picture 8**

**GW Inside Wall Cavity Free Of Mold Contamination**

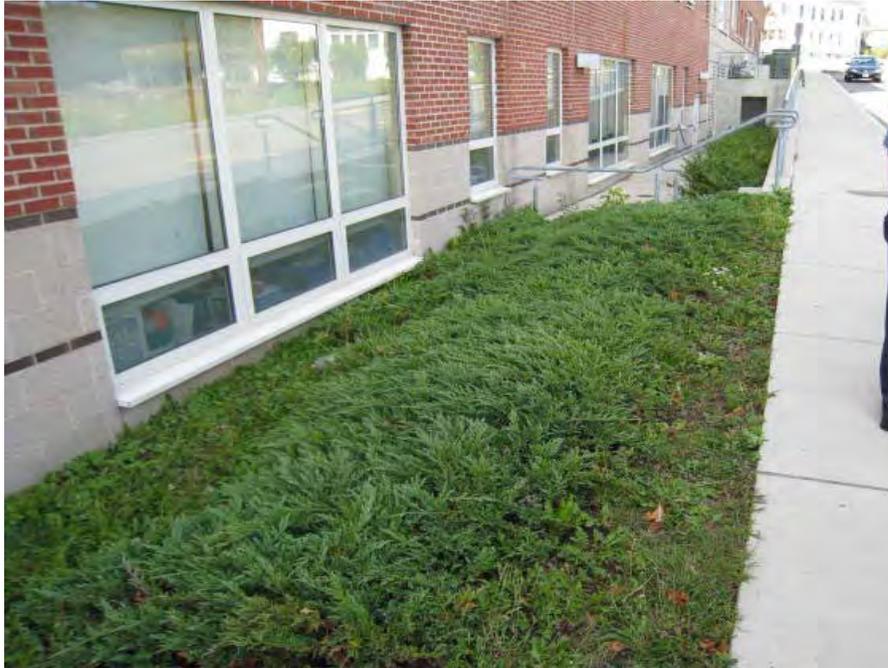
**Picture 9**

In addition, the ground directly outside the kindergarten classrooms slopes toward the building and is covered with thick vegetation, which can hold water against the exterior wall (Pictures 9 and 10). This section of shrubbery and sloped ground is framed by the building slab, the street sidewalk and an access ramp. Due to the slope of the ground, rainwater will tend to accumulate against the slab, which will lower its temperature and make the floor prone to condensation build up. While a drain exists in the ground at the south east corner of the building ([Picture 10](#)), the soil near the foundation has become compressed, leading to water pooling.

**Vegetation Directly Outside Kindergarten Classrooms**

9. Re-grade area outside of kindergarten classrooms; consider replacing vegetation with a tarmac material and/or install additional drainage to draw moisture *away* from the exterior of the building.

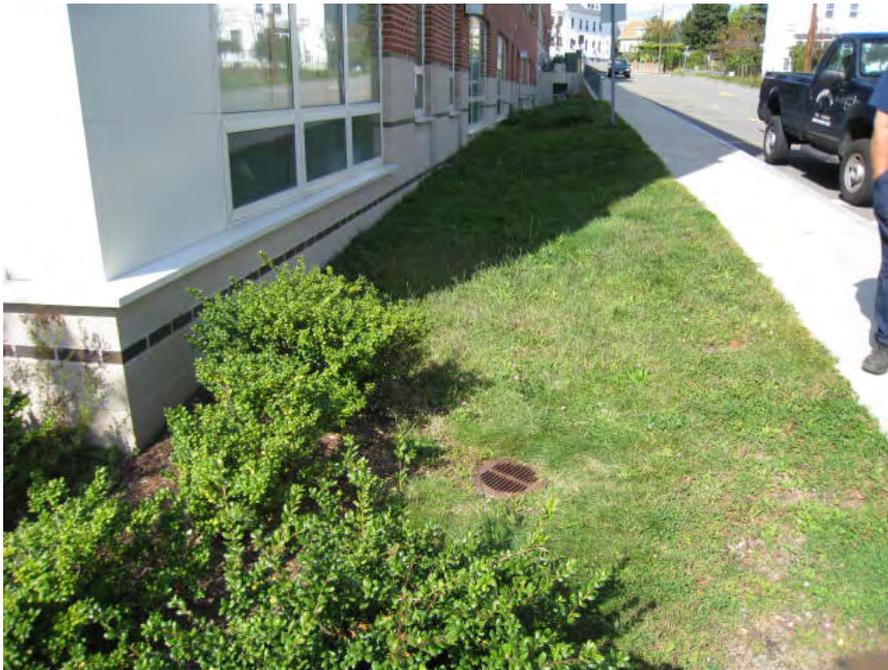
**Picture 10**

**Vegetation and Drain outside Kindergarten Classrooms,  
Note Terrain Slopes toward the Building and Drain in Foreground**

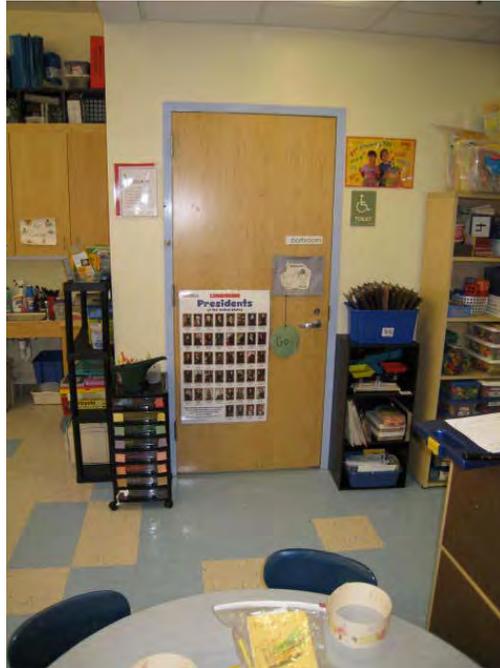
**Picture 11**

Each of the kindergarten rooms has a restroom ([Picture 11](#)). Each restroom is equipped with an exhaust vent, which is designed to draw moisture and odors. In order for exhaust vents to function properly, a source for makeup air must exist. The space between the door and the floor typically provides allows makeup air to be drawn. In this instance, the space beneath restroom doors likely needs to be increased to ease strain on the exhaust vents. In addition, if restroom exhaust vents were not activated during the summer, moisture from toilets, drains and other sources could increase the moisture load in the room, thereby increasing the relative humidity. Restroom vents should be operating continuously to remove unwanted moisture.

**Kindergarten Restroom, Note Minimum Space between Door and Floor Which Limits Draw Of Air by the Restroom Exhaust Vent**

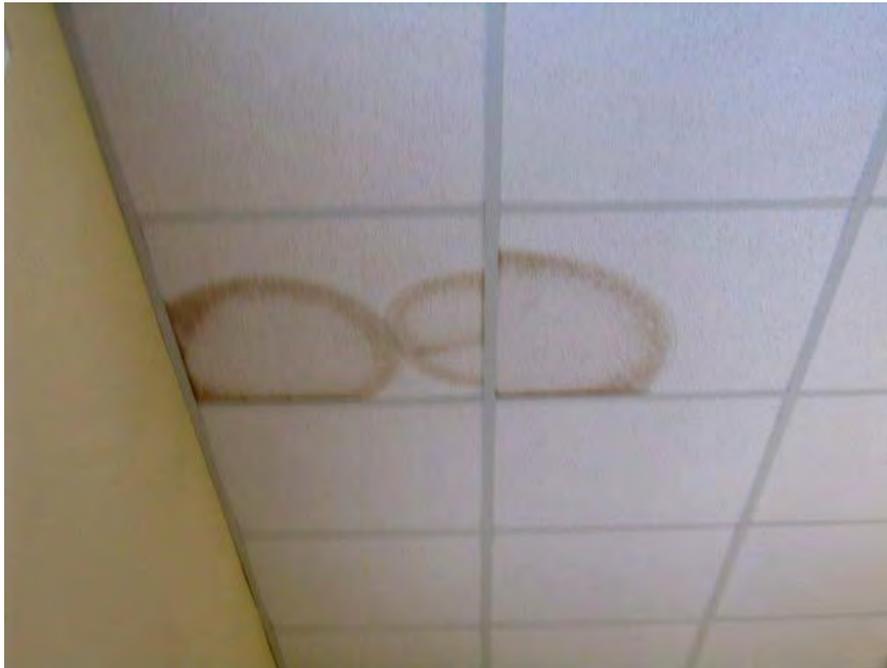
**Picture 12**

Several classrooms had water-damaged ceiling tiles which can indicate sources of water penetration from either the roof or the plumbing system ([Picture 12/Table 1](#)). Water-damaged

ceiling tiles can provide a source of mold and should be replaced after a water leak is discovered and repaired.

**Water Damaged Ceiling Tiles along Exterior Wall of Classroom**

10. Repair any remaining roof/plumbing leaks and replace water-damaged ceiling tiles.

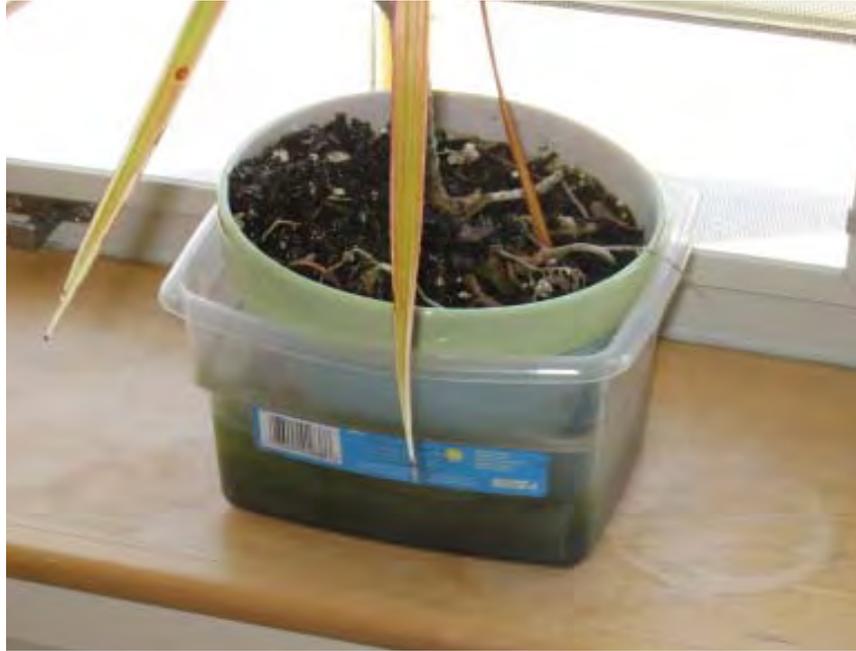
**Picture 13**

A few classrooms had plants. Plants should be equipped with drip pans; the lack of drip pans can lead to water pooling and damage to wooden windowsills (Picture 13). Moistened plant soil and drip pans, however, can be a source of mold growth and should be cleaned periodically. Plants are also a source of pollen. Plants should be located away from the air stream of ventilation sources to prevent the aerosolization of mold, pollen or particulate matter throughout the classroom. One plant was observed in several inches of green, stagnant water and located on top of a FCU, which can aerosolize mold spores and/or associated odors.

**Plant in Container of Green/Stagnant Water Located Above FCU in Classroom,  
Note Damage to Window Sill**

11. Consider providing plants with drip pans and avoid over-watering. Examine drip pans periodically for mold growth. Disinfect with an appropriate antimicrobial where necessary.

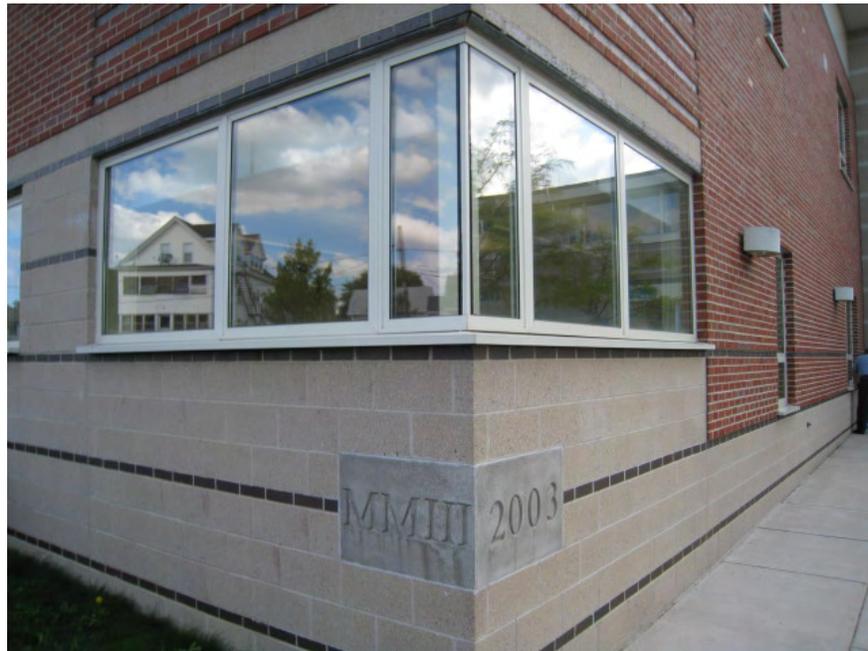
**Picture 14**

Also noted along the building's exterior were spaces and a lack of caulking/sealant between window frames and exterior brick (Pictures 14 and 15). These breaches in the building envelope can result in damage and eventually provide a pathway for moisture, drafts and pests into the building.

**Corner of Building Where Spaces Were Noted Between  
Window Frames and Exterior Brick**

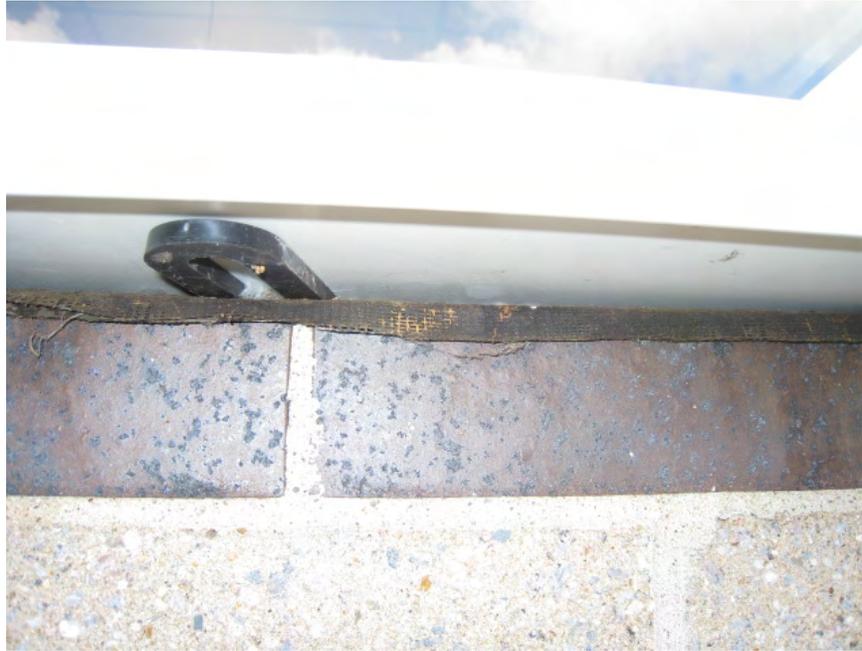
**Picture 15**

**Close-Up of Spaces Were Noted Between Window Frames and Exterior Brick**

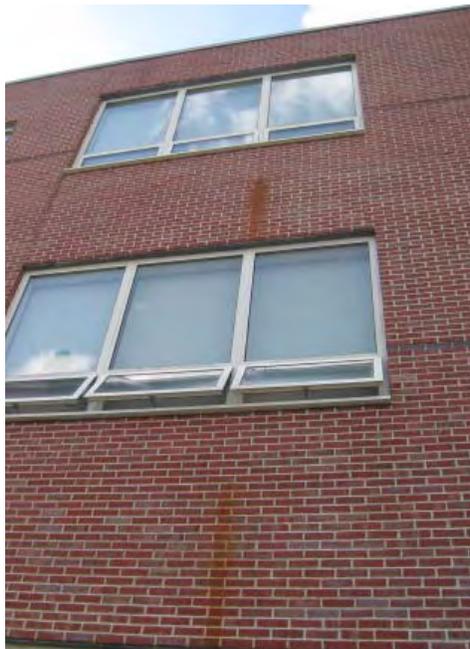
**Picture 16**

Concerns were expressed regarding rust stains on exterior brick of the building ([Picture 16](#)). The source of the rust stains is likely the condensation drains for FCUs in each classroom. The pipe or fitting for the condensation drains are probably made from a non-galvanized steel product, which corrodes when subjected to prolonged exposure to water. While not a contributing factor to the condensation issues noted in this report, over time the corroding fittings may begin to leak inside the FCUs, thereby creating a water source for moistening building components.

**Water Staining On Exterior Brick from Condensation Drains of FCUs, Note Staining In Relation Top of Window Frames**

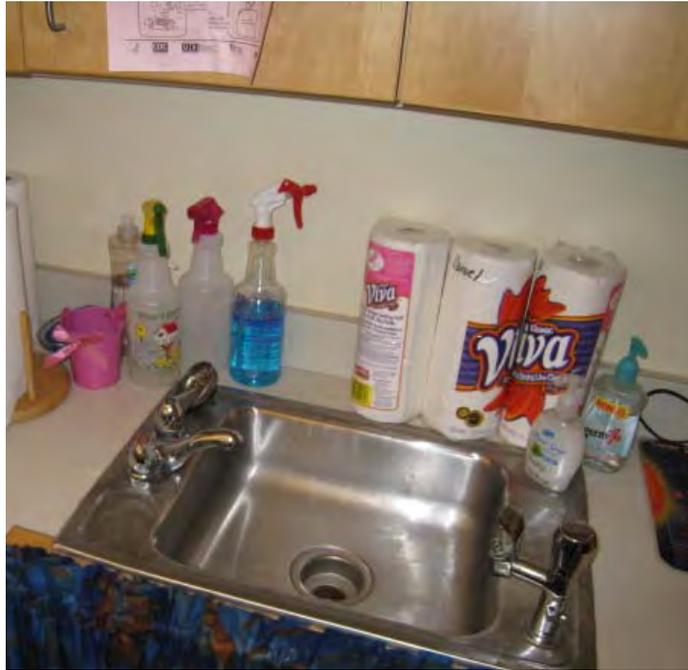
**Picture 17**

Cleaning products were observed on sink countertops in a number of classrooms ([Picture 17](#)). Cleaning products contain chemicals that can be irritating to the eyes, nose and throat of sensitive individuals. Also of concern are unlabelled bottles and containers. Products should be kept in their original containers and be clearly labeled for identification purposes, especially in the event of an emergency.

**Cleaning Products and Unlabeled Spray Bottles on Sink Countertop**

12. Consider installing local exhaust ventilation in teacher work rooms to remove excess heat and odors from lamination machines and photocopiers.
13. Store cleaning products properly and out of reach of students. Ensure spray bottles are properly labeled. Obtain Material Safety Data Sheets (MSDS) for all cleaning products used within the school and keep them in an area that is accessible to all individuals during periods of building operations as required by the Massachusetts Right-To-Know Act (MGL, 1983).

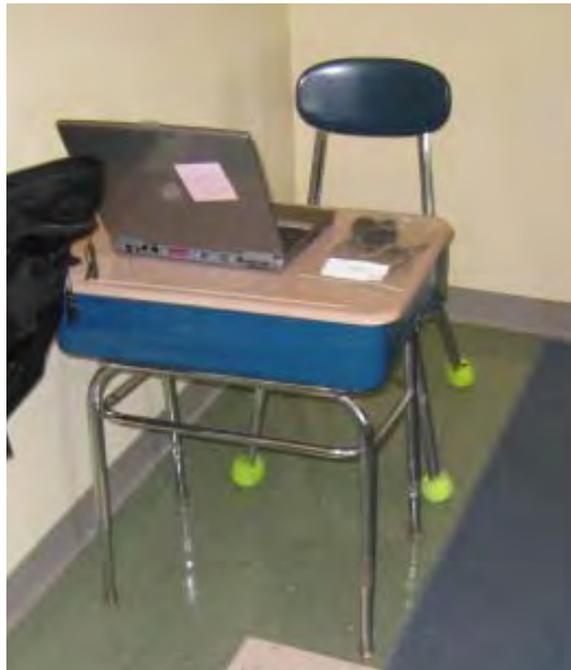
**Picture 18**

In an effort to reduce noise from sliding chairs and tables, tennis balls were sliced open and placed on chair legs in some classrooms ([Picture 18](#)). Tennis balls are made of a number of materials that are a source of respiratory irritants. Constant wearing of tennis balls can produce fibers and off-gas VOCs. Tennis balls are made with a natural rubber latex bladder, which becomes abraded when used as a chair leg pad. Use of tennis balls in this manner may introduce latex dust into the school environment. Some individuals are highly allergic to latex (e.g. spina bifida patients) (SBAA, 2001). It is recommended that the use of materials containing latex be limited in buildings to reduce the likelihood of symptoms in sensitive individuals (NIOSH, 1997). A question and answer sheet concerning latex allergy is attached as [Appendix B](#) (NIOSH, 1998).

**Tennis Balls on Chair Legs**

14. Replace latex-based tennis balls with latex-free tennis balls or alternative “glides”.
15. Professionally clean upholstered furniture annually or more frequently as needed.

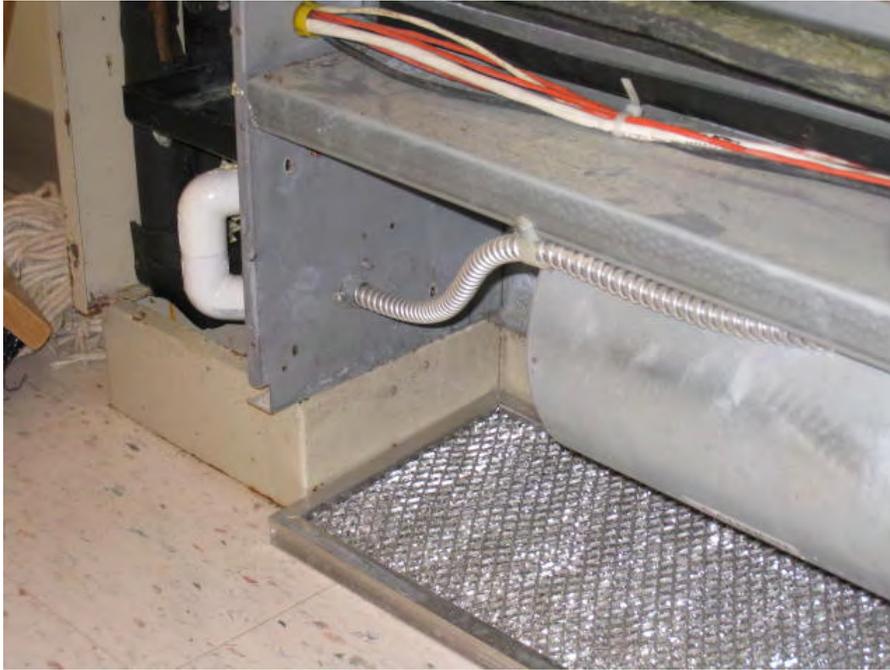
**Picture 19**

A FCU is normally equipped with a filter that strains particulates from airflow. FCUs at the TCS lack brackets necessary to hold conventional pleated filters. Due to the lack of brackets, wire mesh filters are installed in FCUs ([Picture 19](#)). Wire mesh filters do not filter respirable dust. In this condition, any airborne particles drawn into the hallway, the floor, wall cavities or other locations can be distributed via the ventilation system. Particle sources can include the FCU, photocopiers and materials stored in the mechanical rooms. In order to decrease aerosolized particulates, filters should be properly installed with correct filter brackets. The amount of airborne particles prevented from entering the air stream is determined by the dust spot efficiency. Dust spot efficiency is the ability of a filter to remove particulates of a certain diameter from air passing through the filter. Filters that have been determined by ASHRAE to meet its standard for a dust spot efficiency of a minimum of 40 percent would be sufficient to reduce airborne particulates (Thornburg, 2000; MEHRC, 1997; ASHRAE, 1992). Note that

increased filtration can reduce airflow produced by the FCU by increased resistance (called pressure drop). Prior to any increase of filtration, the FCU should be evaluated by a ventilation engineer to ascertain whether it can maintain function with more efficient filters.

**FCU Filters, Note Lack of Filter Rack to Hold Filter in Place**

5. Install filter racks in FCUs Ensure FCU filters fit securely in their racks, making modifications (e.g., install clips, alter racks) as necessary. After filter racks are installed, replace wire mesh filters with an appropriate disposable filter.

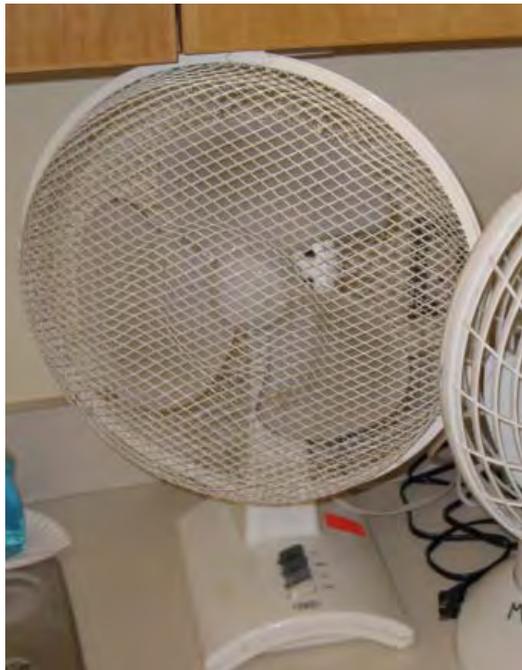
**Picture 20**

A number of personal fans, exhaust/return vent and supply diffusers were observed to have accumulated dust ([Pictures 20](#) and 21). If exhaust vents are not functioning, backdrafting can occur, which can re-aerosolize accumulated dust particles. Re-activated air diffusers and fans can also aerosolize dust accumulated on vents/fan blades.

**Accumulated Dust and Debris on Fan Blades/Screen**

16. Clean personal fans, supply air diffusers and exhaust/return vents periodically of accumulated dust.
17. For more information on mold consult “Mold Remediation in Schools and Commercial Buildings” published by the US Environmental Protection Agency (US EPA, 2001). This document can be downloaded from the US EPA website at:  
[http://www.epa.gov/iaq/molds/mold\\_remediation.html](http://www.epa.gov/iaq/molds/mold_remediation.html).

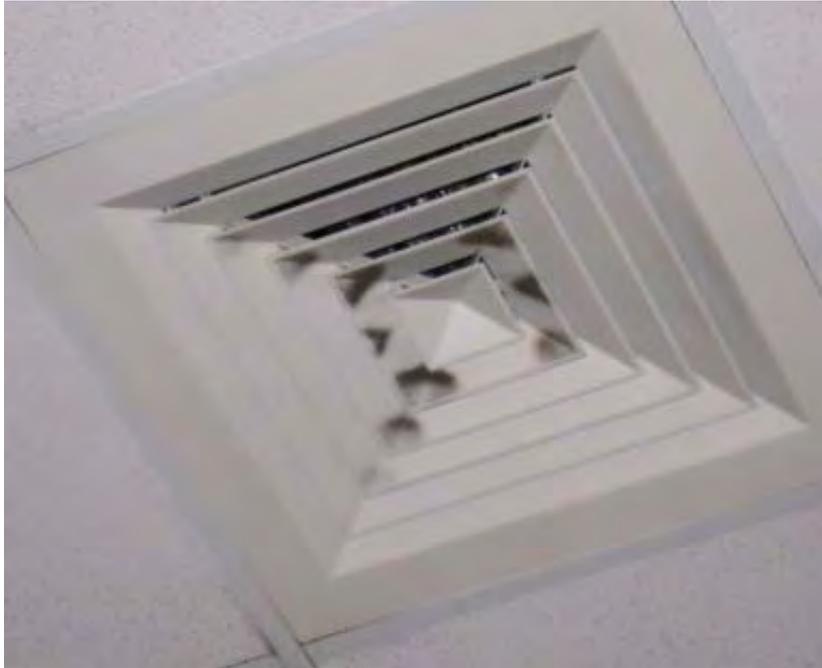
**Picture 21**

**Accumulated Dust/Debris on Supply Diffuser**
