INDOOR AIR QUALITY ASSESSMENT

**Board of Health
1 Turner Lane
Randolph, Massachusetts 02368**

Prepared by:
Massachusetts Department of Public Health
Bureau of Environmental Health
Indoor Air Quality Program
July 2009

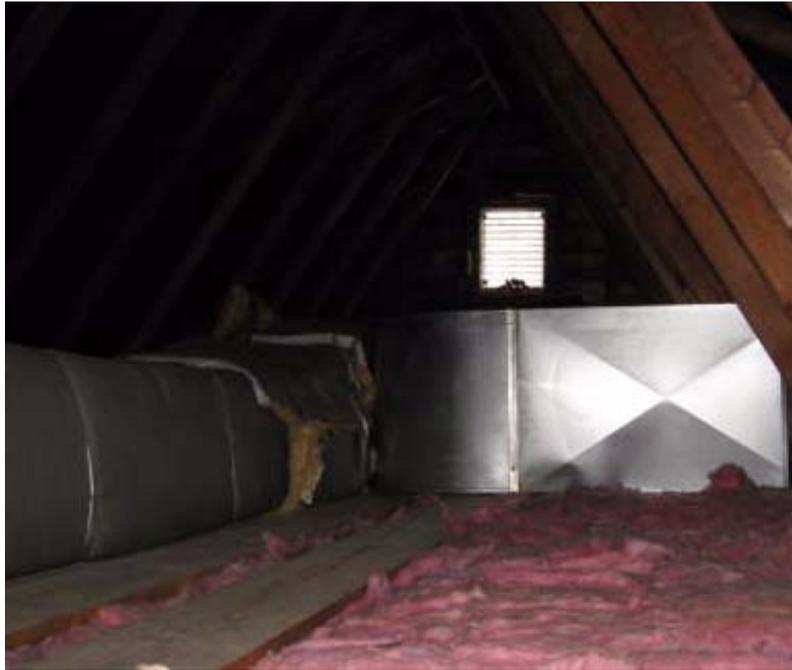
Picture 1

It can be seen from Table 1 that carbon dioxide levels were above 800 parts per million (ppm) in four of eight areas indicating poor air exchange in half of the areas surveyed the day of the assessment. It is important to note, however, that the RBOH does not have mechanical ventilation to introduce fresh air. It appears that the heating, ventilation and air conditioning (HVAC) system is limited to circulating air. The system consist of an air-handling unit (AHU) located in the attic (Picture 1). Conditioned air is distributed to ceiling-mounted air diffusers (Picture 2), and ducted back to the AHU via return vents (Picture 3). The system is controlled by a digital thermostat (Picture 4). Airflow is controlled using a fan switch that has two settings, *on* and *auto*. When the fan is set to *on*, the system provides a continuous source of air circulation and filtration. The *automatic* setting on the thermostat activates the HVAC system at a preset temperature. Once the preset temperature is reached, the HVAC system is deactivated. Therefore, no mechanical ventilation is provided until the thermostat re-activates the system.

AHU in Attic Crawlspace

2. Operate the HVAC system continuously in the fan “on” mode during periods of occupancy to maximize air circulation and filtration.
3. Work with town officials to develop a preventive maintenance program for all HVAC equipment.

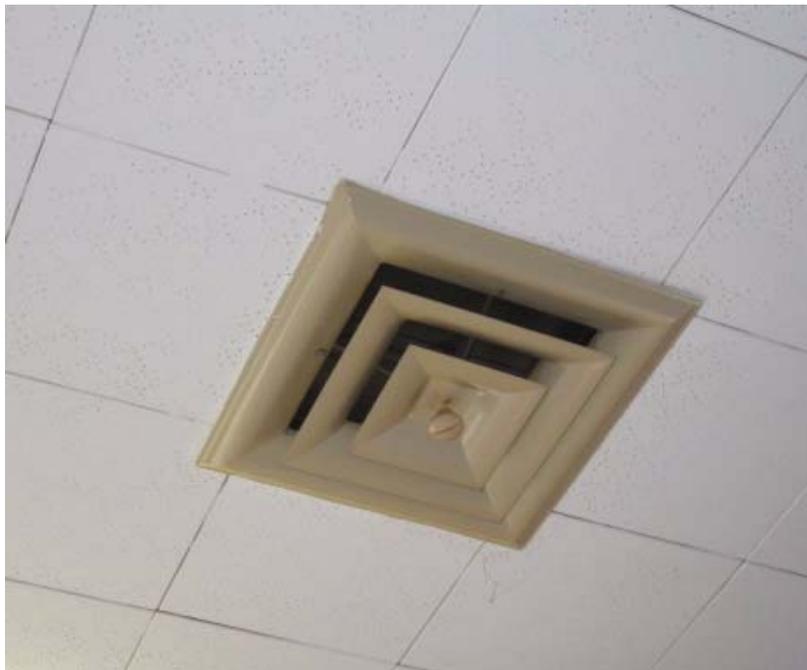
Picture 2

Ceiling-Mounted Air Diffuser

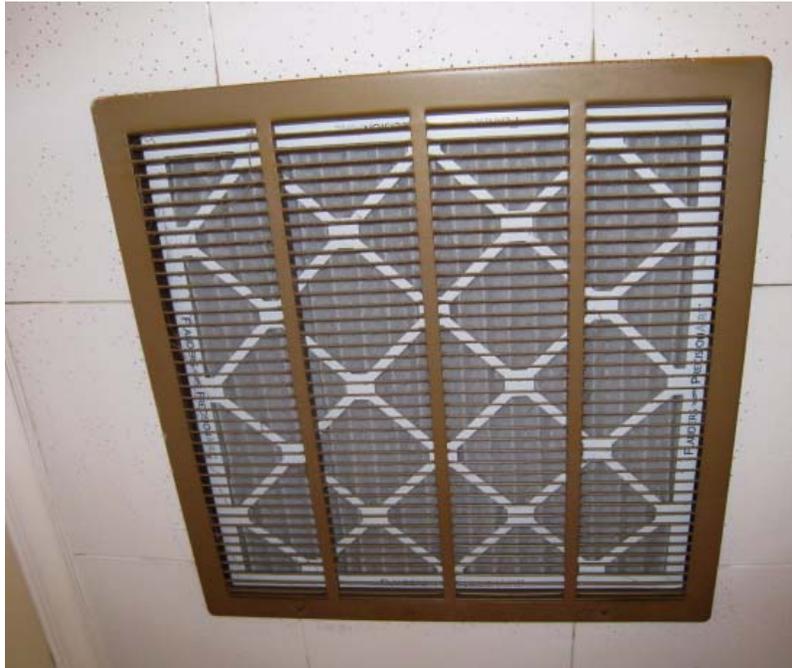
Picture 3

Ceiling-Mounted Return Vent

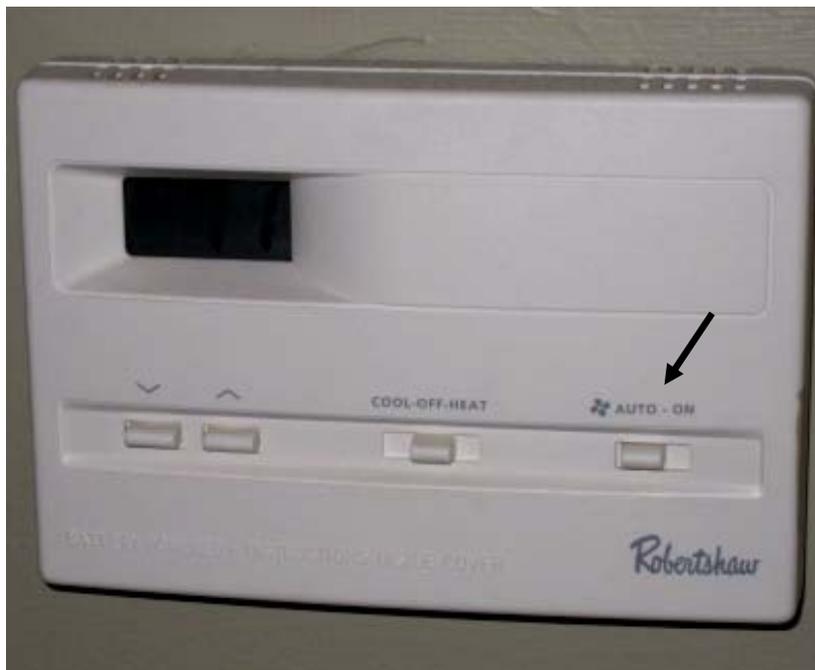
Picture 4

Digital Thermostat, Note Fan in “Auto” Position

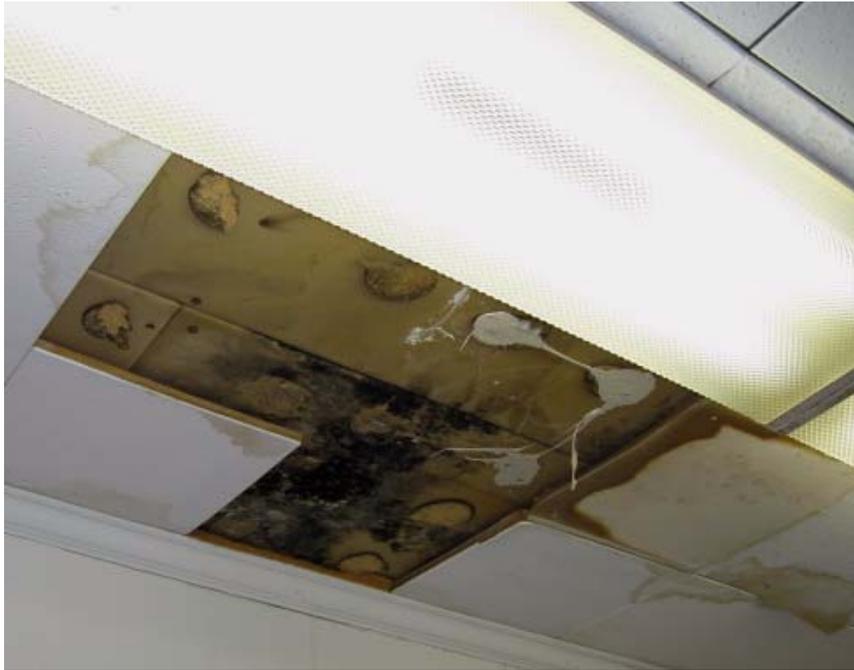
Picture 5

In order for building materials to support mold growth, a source of water exposure is necessary. IAQ staff examined the roof, exterior walls and basement of the RBOH building in an effort to identify various sources of moisture wetting building materials. Water damaged/mold colonized ceiling tiles were observed in the office formerly occupied by the RRD (Pictures 5 and 6). The US Environmental Protection Agency (US EPA) and the American Conference of Governmental Industrial Hygienists (ACGIH) recommend that porous materials be dried with fans and heating within 24 to 48 hours of becoming wet (US EPA, 2001; ACGIH, 1989). If not dried within this time frame, mold growth may occur. Once mold has colonized porous materials, they are difficult to clean and should be removed/discarded.

Water Damaged/Mold Colonized Ceiling Tiles/Panels in former RRD Office

13. Remove/replace water damaged/mold colonized ceiling tiles. Examine the area above and around these areas for mold growth. Disinfect areas of water leaks with an appropriate antimicrobial.

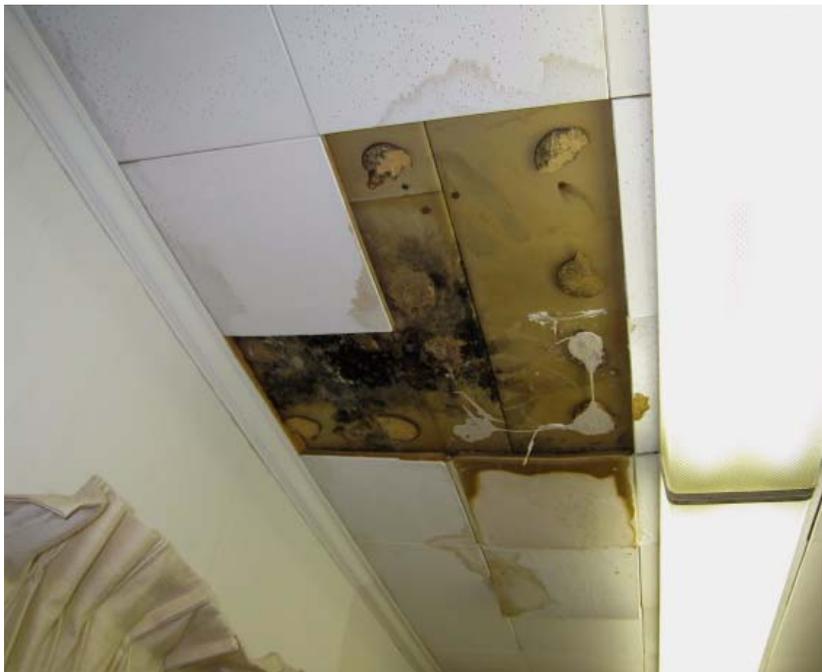
Picture 6

Water Damaged/Mold Colonized Ceiling Tiles/Panels in former RRD Office

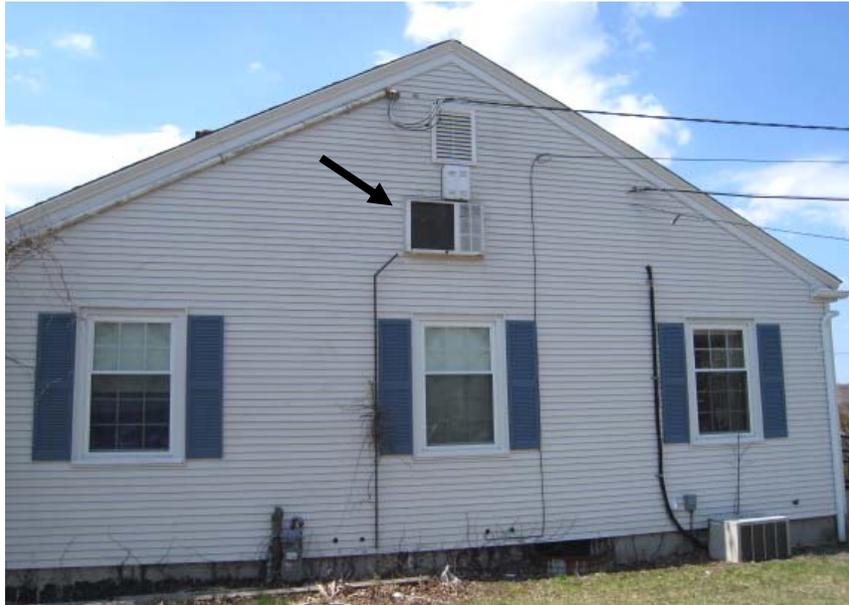
Picture 7

Water damage in the RRD office is most likely the result of water penetration through the building envelope¹ via an opening in the exterior wall for a portable AC installed directly above this office (Picture 7). The exterior portion of the AC casing projects outward through the exterior wall to form a shelf (Picture 8). Flashing to prevent water penetration around this unit appears to be absent. In easterly winds, rain may be driven through the seams around the AC to force water into the attic. Installation of flashing around ACs installed through exterior walls can prevent moisture penetration (Picture 8A).

Note Air Conditioner Installed Through Exterior Wall over Center Window of Former Randolph Recreation Department

9. Install flashing around wall-mounted air conditioners.
10. Ensure the wall-mounted AC unit drip pans drain properly and have an insulated underside.
11. Seal breaches in the building exterior to prevent further water penetration, particularly around the AC outside of former RRD area.

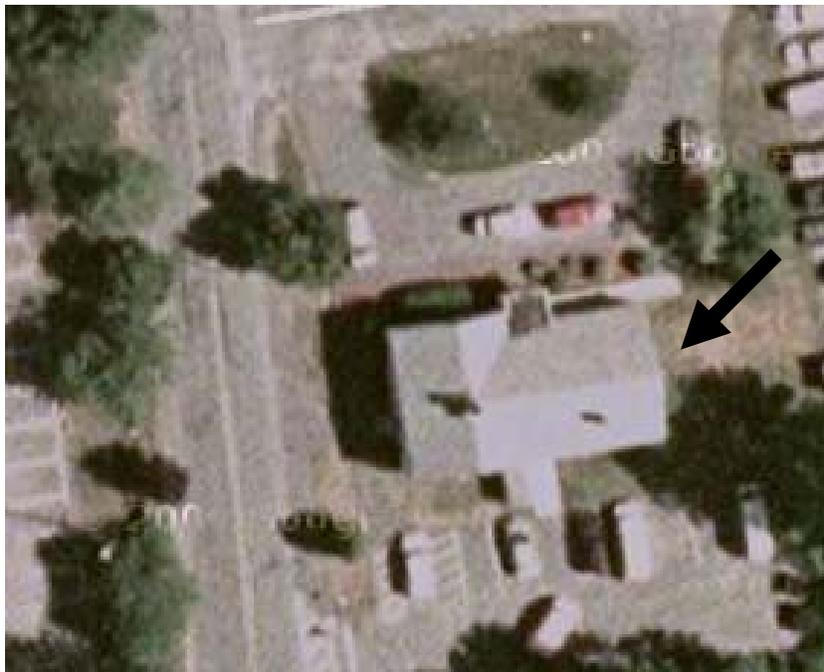
Picture 7A

Aerial View of RBOH Building, East Wall Contains Attic Wall-Mounted Air Conditioner Shown in Picture 7

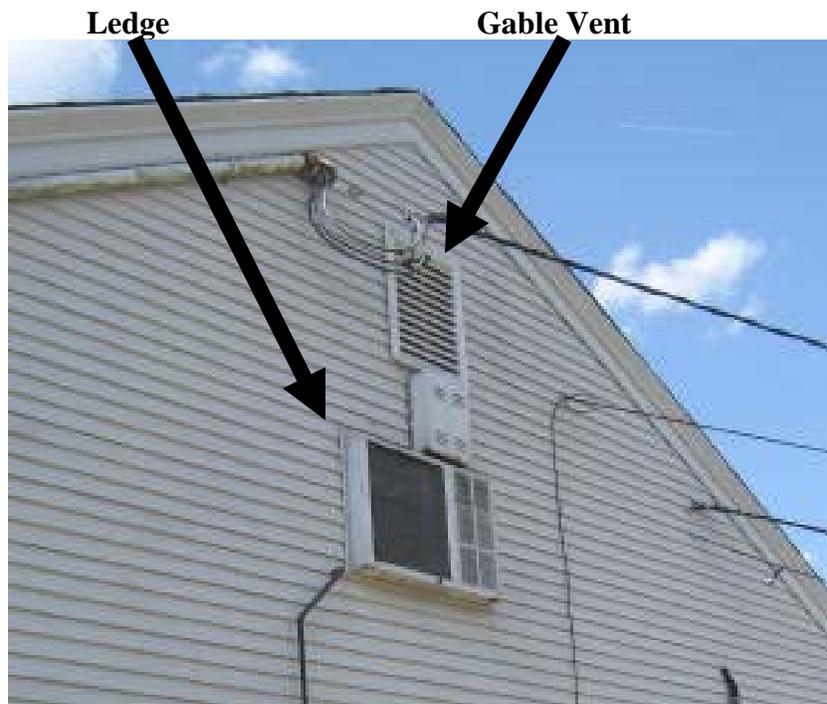
Picture 8

East Wall AC, Note Ledge

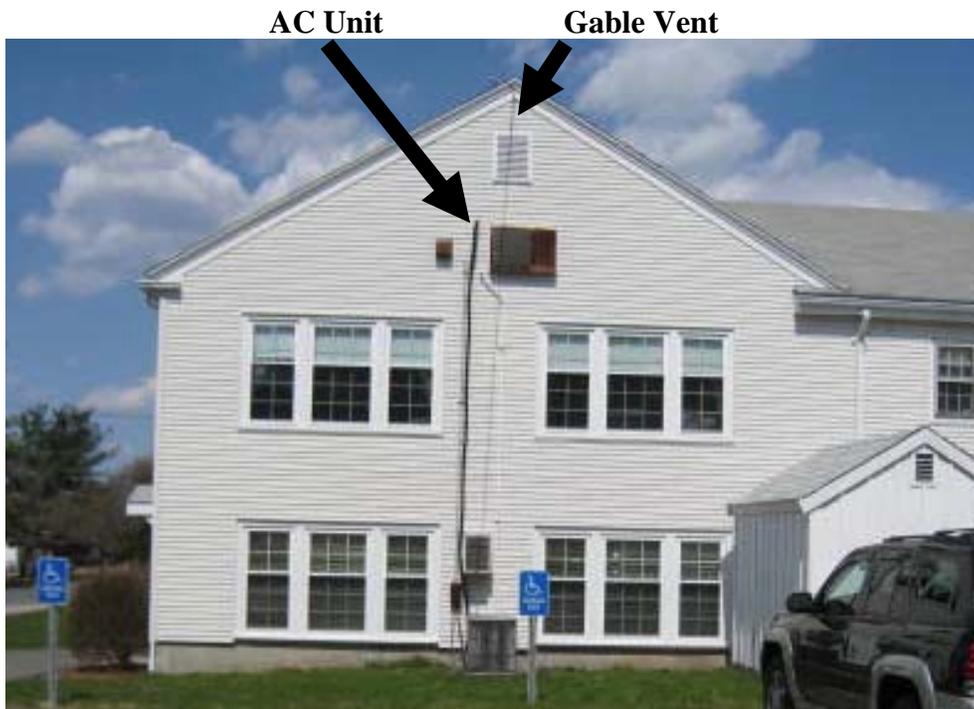
Picture 8A

Wall-mounted AC in South Exterior Wall

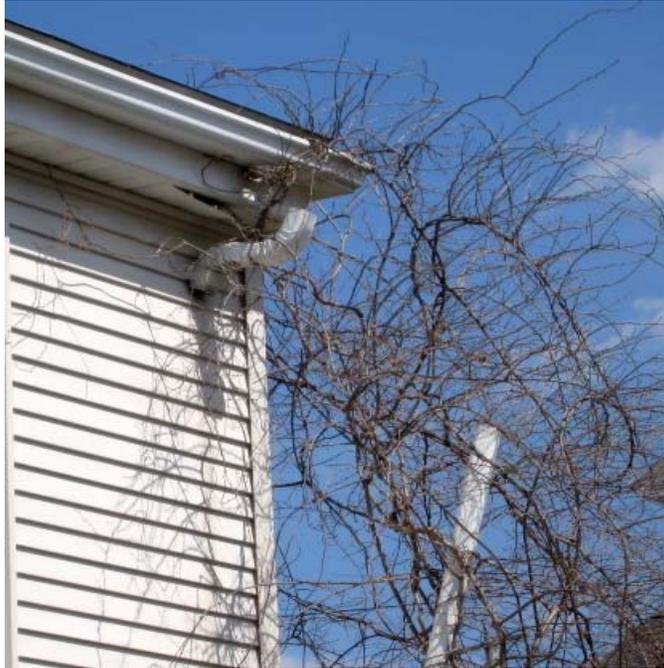
Picture 9

- Damaged/dislodged gutters and downspouts (Pictures 9 through 12);
- Clinging plants on exterior walls/foundation (Picture 13);
- Trees, vines and shrubbery growing on or in close proximity to the building's exterior (Pictures 14 through 16); and

Disconnected Gutter/Downspout

14. Repair gutters and downspouts to drain water away from the building.
15. Remove clinging plants and vegetation/overhanging branches from building exterior.

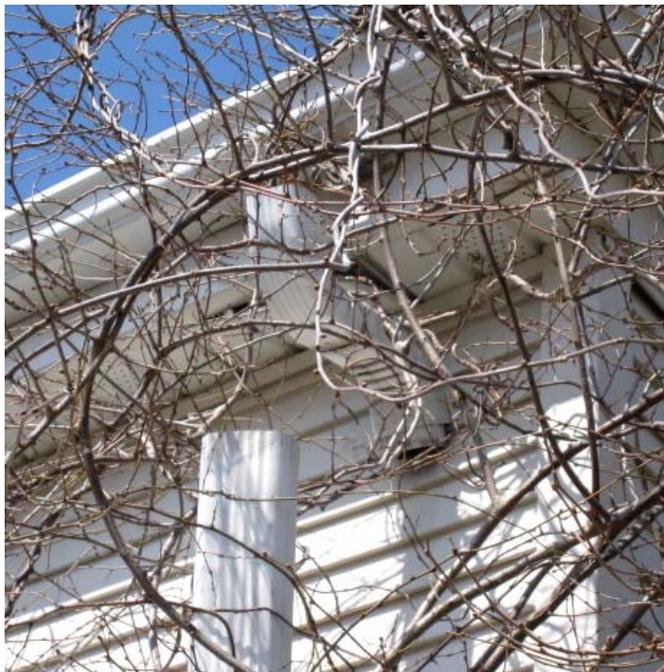
Picture 10

Disconnected Gutter/Downspout

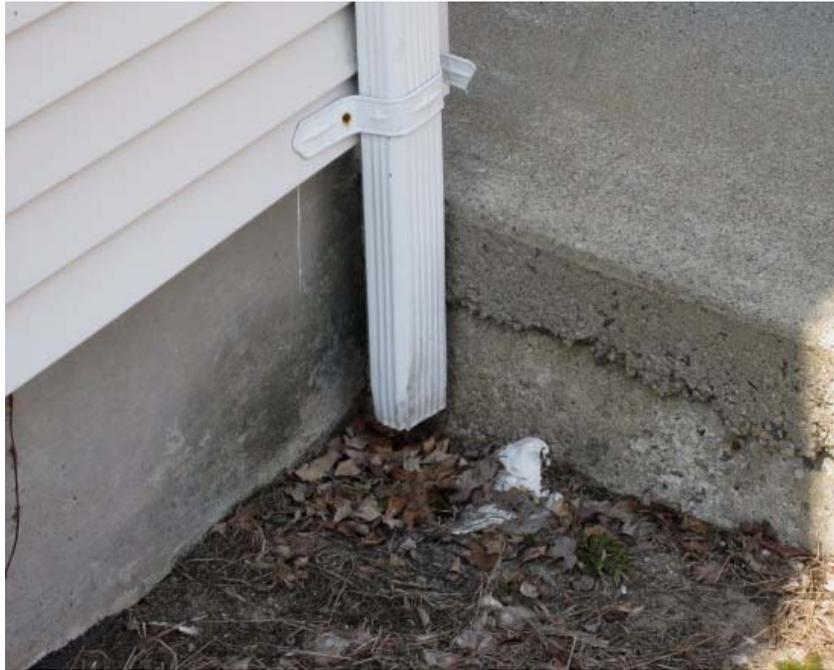
Picture 11

Missing Elbow Extension on Downspout, Which Empties against Foundation

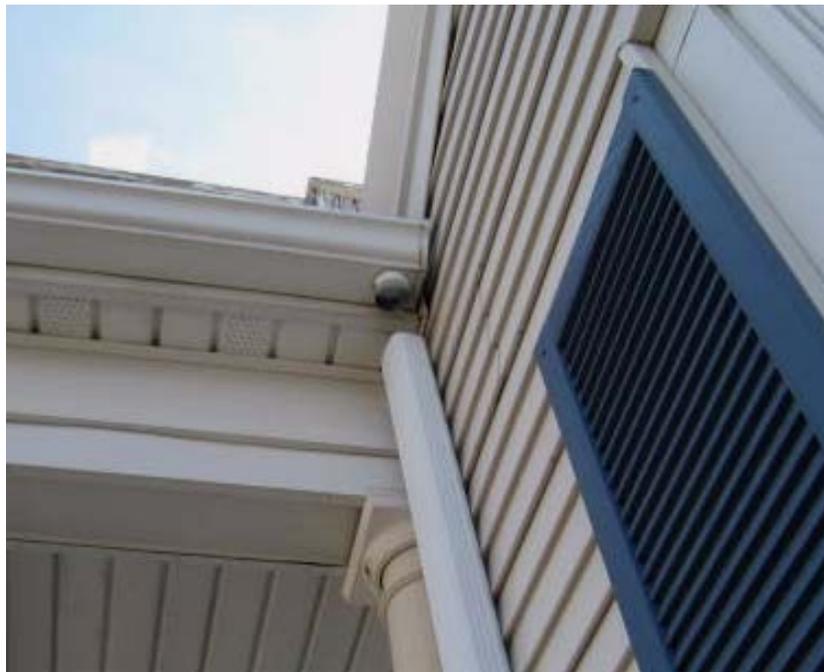
Picture 12

Disconnected Gutter/Downspout

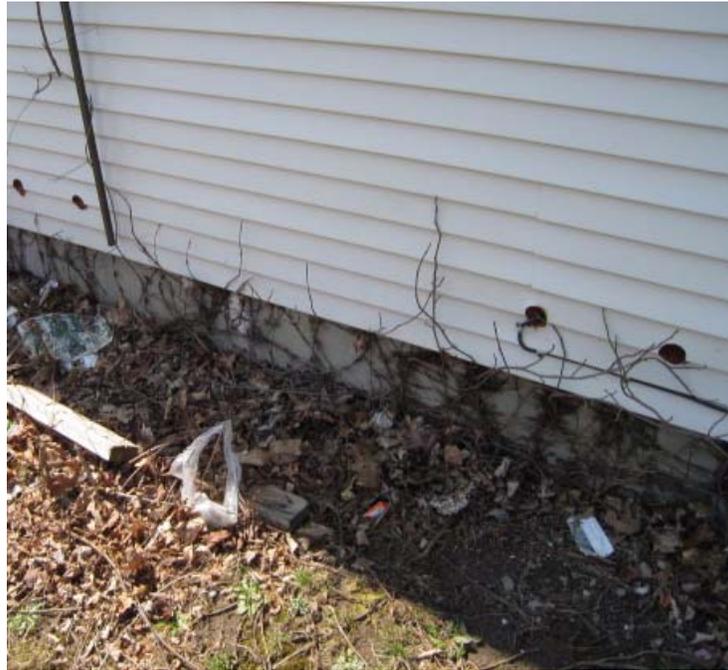
Picture 13

Clinging Plants Growing on Exterior Wall

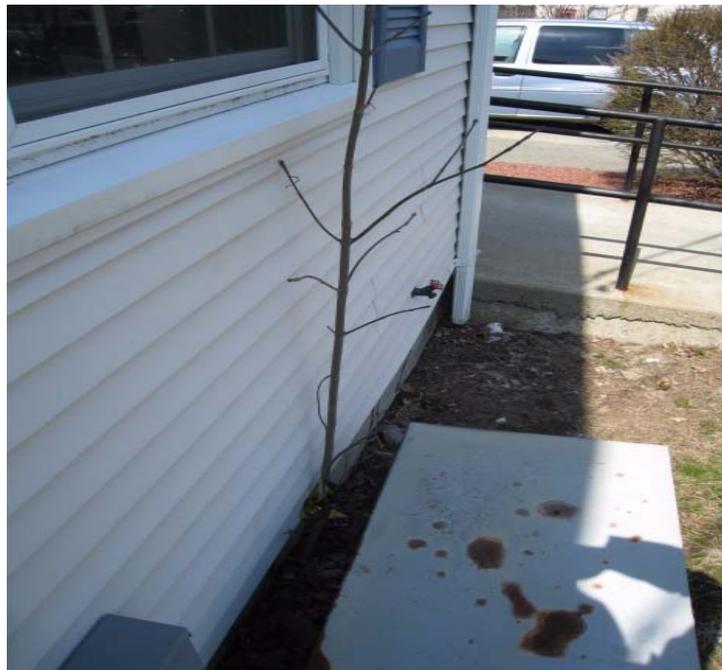
Picture 14

Small Tree Growing against Foundation

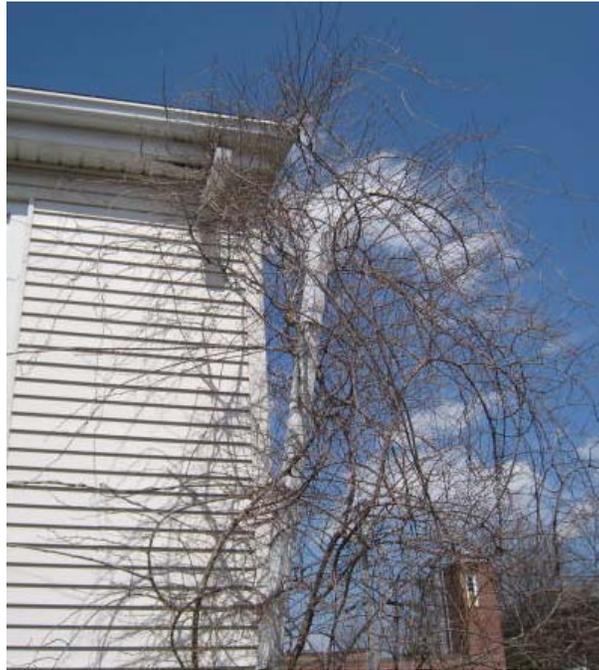
Picture 15

Tree/Vines Growing in Close Proximity to Building Exterior

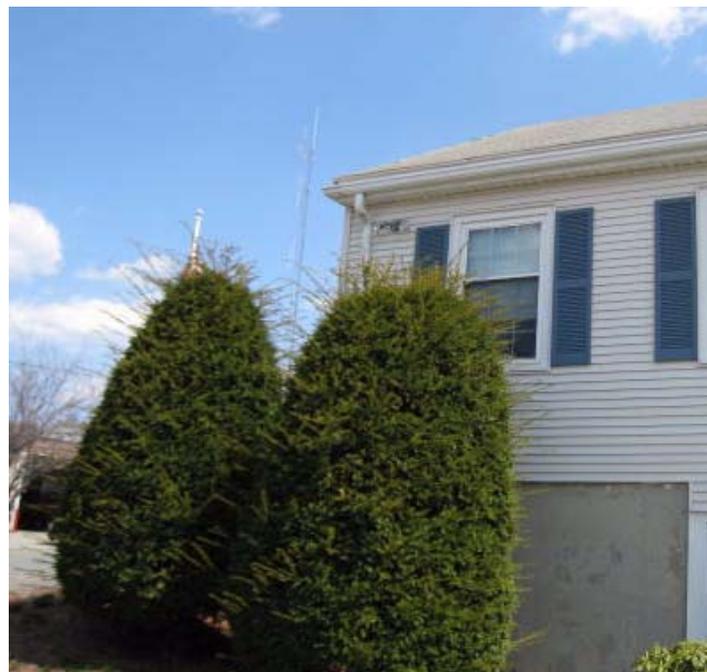
Picture 16

Shrubbery in Close Proximity to Exterior Walls

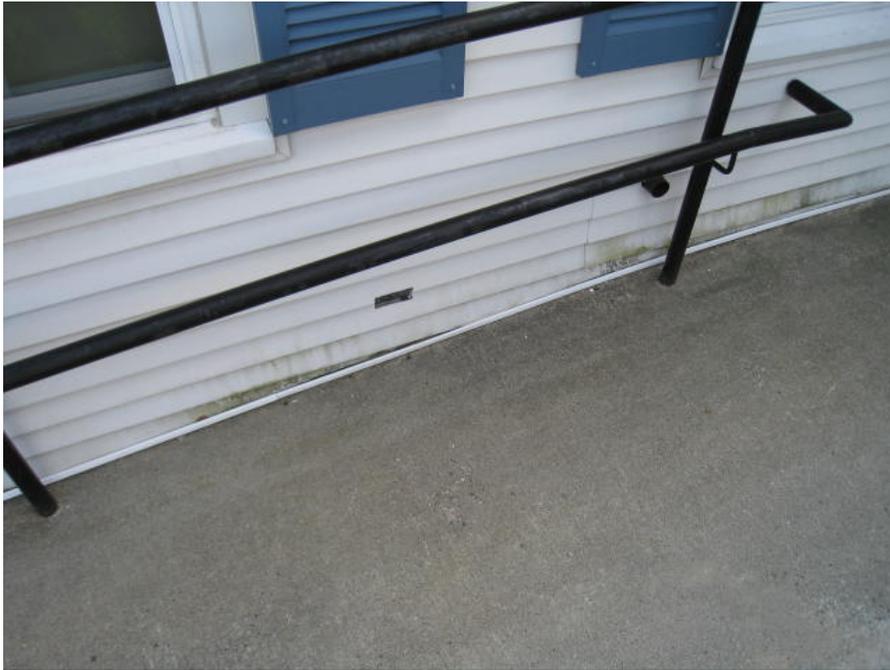
Picture 17

- Water trapped between the foundation and handicapped access ramp (Picture 17).

**Seam between Foundation and Retrofitted Access Ramp
(Note Moss Growth on Vinyl Siding)**

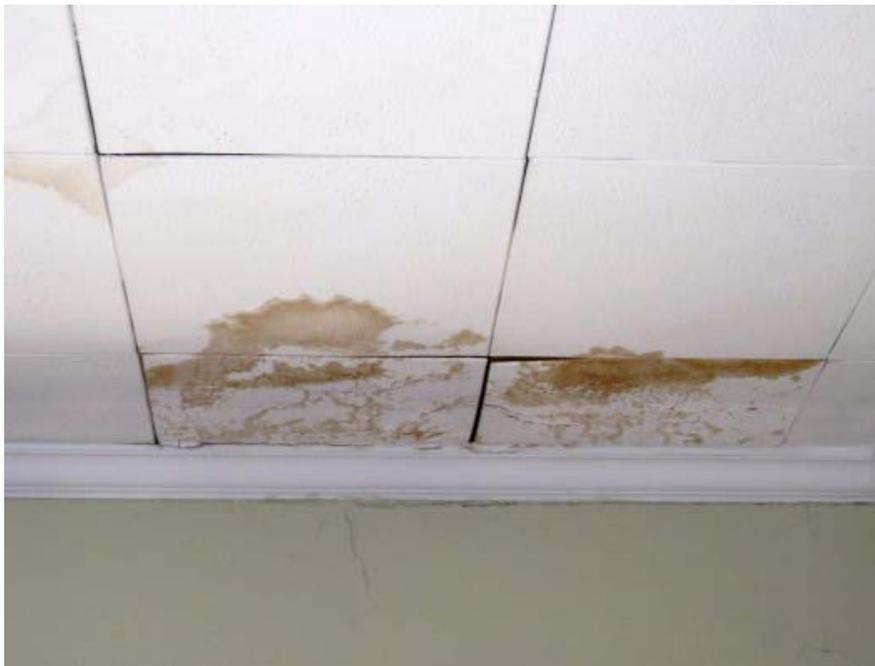
Picture 18

RBOH staff, reported the formation of large sections of icicles in the winter, indicating the building is prone to ice dams. Ice dams occur when snow (in contact with the roof) melts to form water on the upper section of the roof and refreezes on the lower portion of the roof to form ice. Heated air from occupied spaces moves upwards and gathers in the peak of the roof, warming the roofing material above water's melting point (32° F). As water rolls down the sloped roof, it freezes into ice when it comes into contact with roof materials on the lower section of the roof that is below 32° F. This ice creates a dam, which then collects and holds melting snow or rainwater against the roof shingles. Pooling water can subsequently penetrate through the roofing materials via cracks and crevices, resulting in wetting of the interior of the building, usually ceiling tiles that are located near exterior walls of the building where ice dams are occurring (Picture 18).

Water Damaged Ceiling Tiles in BOH Office

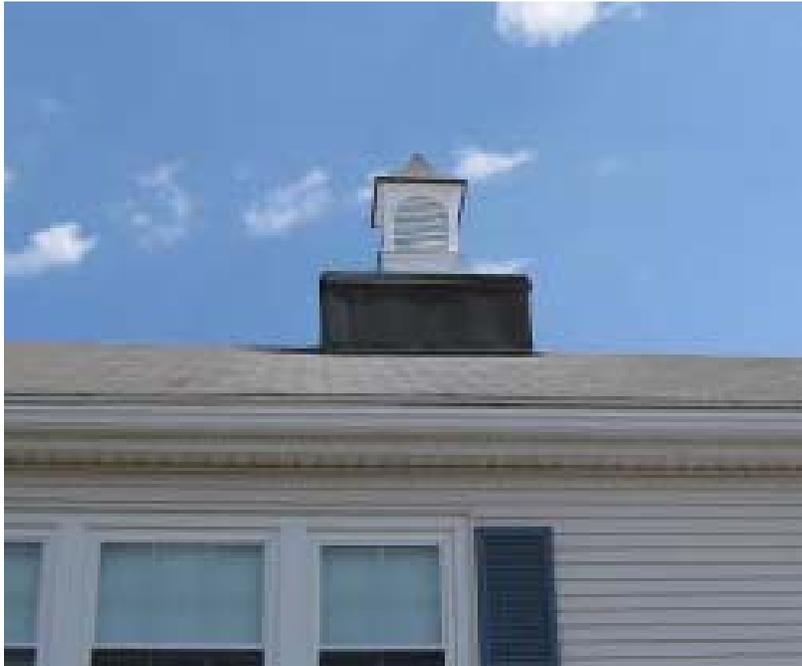
Picture 19

In order to prevent ice dams, a combination of methods are often used. At the Randolph BOH building, gable vents are located in the east and south walls (Pictures 8 and 8A). The purpose of the gable vents is to allow for cold air to enter the attic space to cool the roof. A cupola exists in the roof (Picture 19), which was likely installed to provide an opening like a ridge vent, allowing free exhaust of heat from the attic space. The floor of the attic space is insulated to prevent air movement and heat loss from the occupied space. This configuration of

Roof Cupola

5. Ensure that the cupola on the roof (Picture 19) is open in order to vent heat from the roof.
6. Consider insulating all attic ductwork.
7. Ensure that insulation in the attic floor is complete; install insulation as needed.

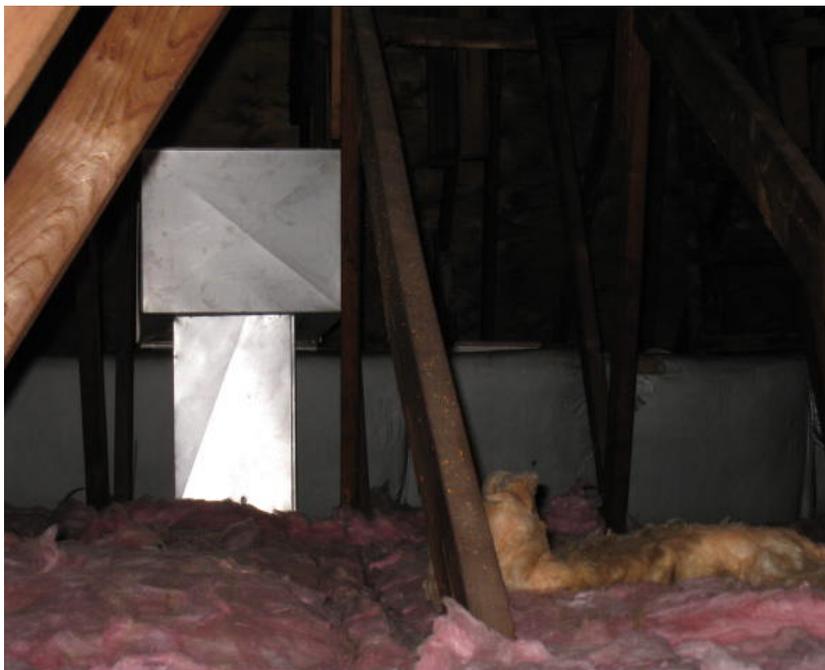
Picture 20

Uninsulated Ductwork in Attic That Would be a Source of Heat

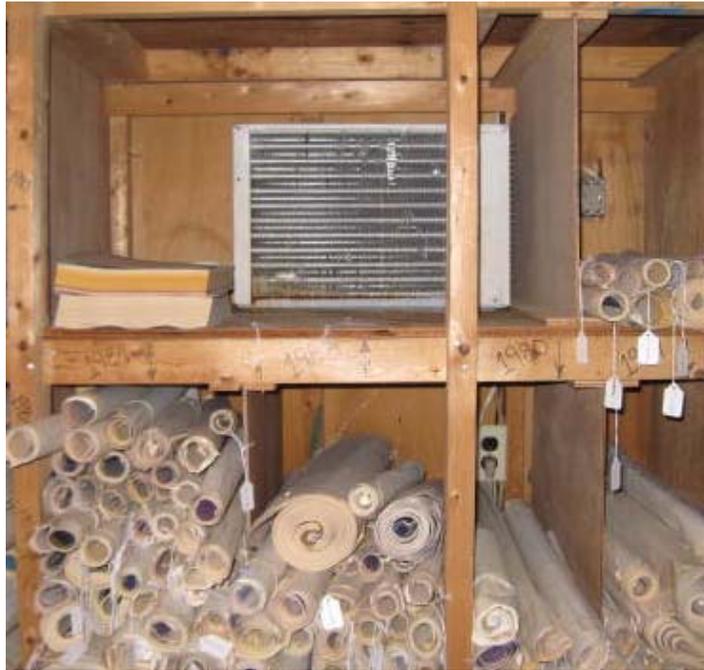
Picture 21

Another possible source of moisture in the building was from a portable AC that was installed in an interior wall in the basement (Picture 21). Normally, ACs are mounted in windows or through exterior walls, in order to drain condensate *outside* the building. No obvious signs of drainage for condensate were observed for this AC. The metal base of the AC unit was rusted from pooling water and the wooden surface around it was water damaged (Picture 22). Without proper drainage, pooling water from condensation can damage materials and create mold growth.

AC Unit Installed through Interior Wall in Basement

12. Install drainage hose/pump for portable AC in basement.

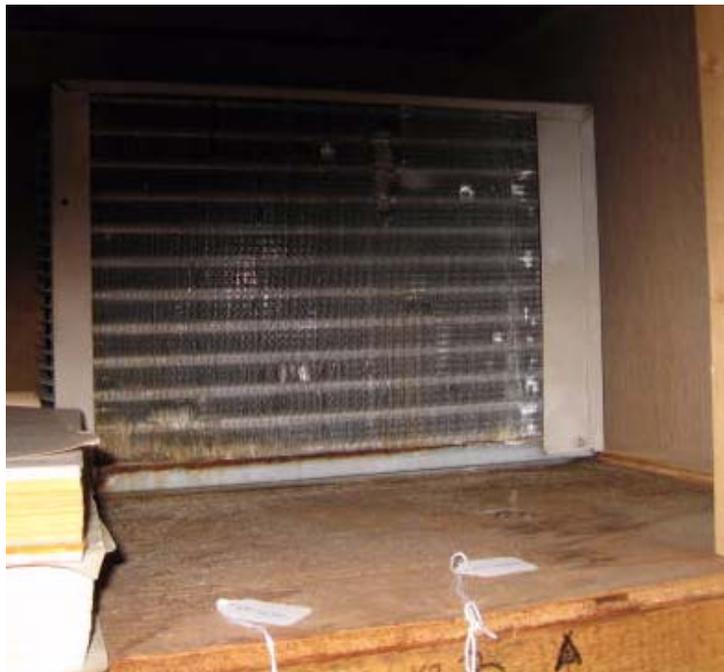
Picture 22

AC Unit, Note Rust along Bottom of Unit and Water Damaged Wood

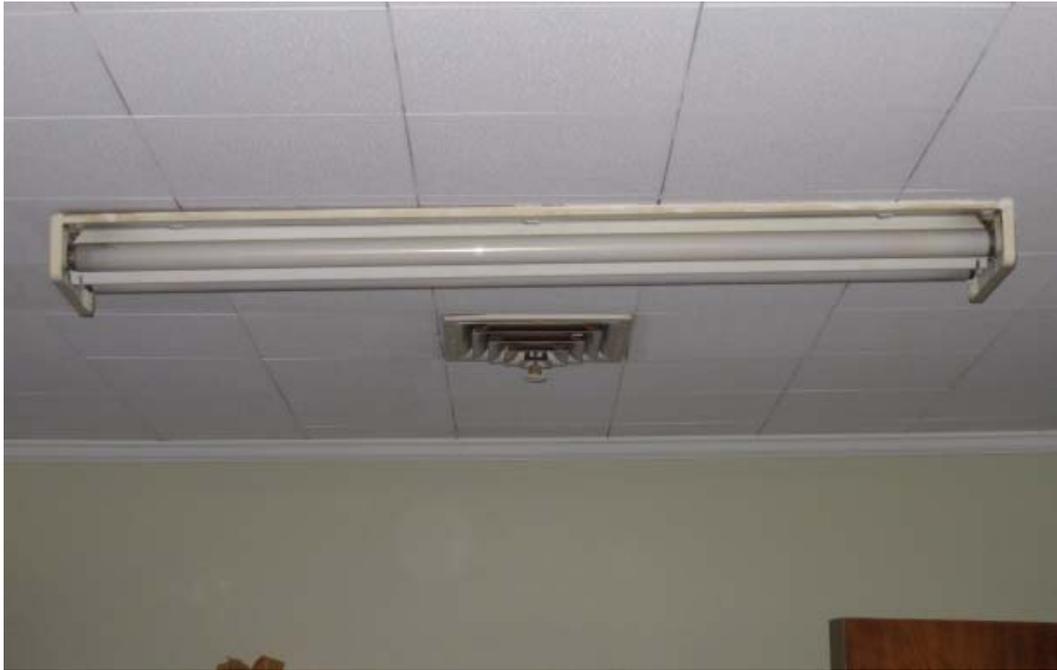
Picture 23

Finally, fluorescent light fixtures were missing covers in a number of areas (Picture 23). Fixtures should be equipped with access covers installed with bulbs fully secured in their sockets. Breakage of glass can cause injuries and may release mercury and/or other hazardous compounds.

Missing Cover on Fluorescent Light Fixture

18. Clean supply, exhaust and return vents periodically of accumulated dust.
19. Replace all covers for fluorescent light fixtures.
20. For more information on mold consult as “Mold Remediation in Schools and Commercial Buildings” published by the US Environmental Protection Agency (US EPA, 2001).
Copies of this document can be downloaded from the US EPA website at:
http://www.epa.gov/iaq/molds/mold_remediation.html
