INDOOR AIR QUALITY ASSESSMENT

**South Hadley Council on Aging
45 Dayton Street
South Hadley, Massachusetts 01075**

Prepared by:
Massachusetts Department of Public Health
Bureau of Environmental Health
Indoor Air Quality Program
February 2009

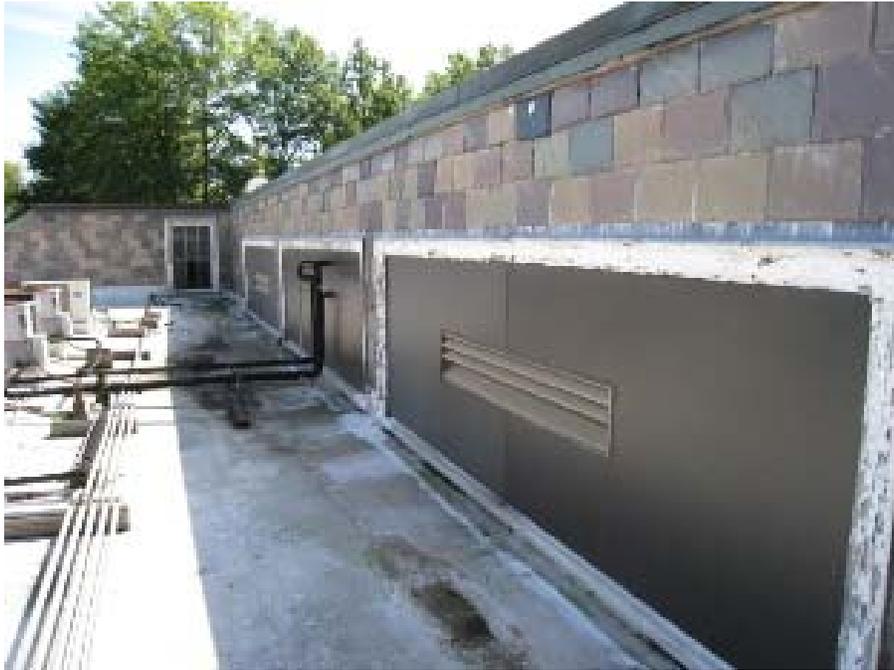
Picture 1

Fresh Air Intakes

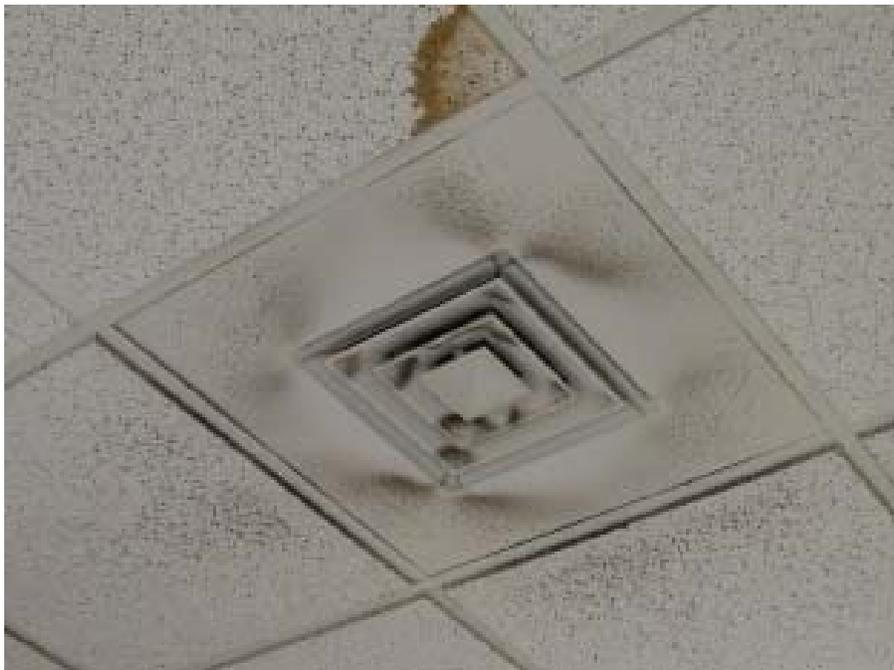
Picture 2

Fresh Air Diffuser
Note Accumulation of Dust on Diffuser and on Ceiling Tiles

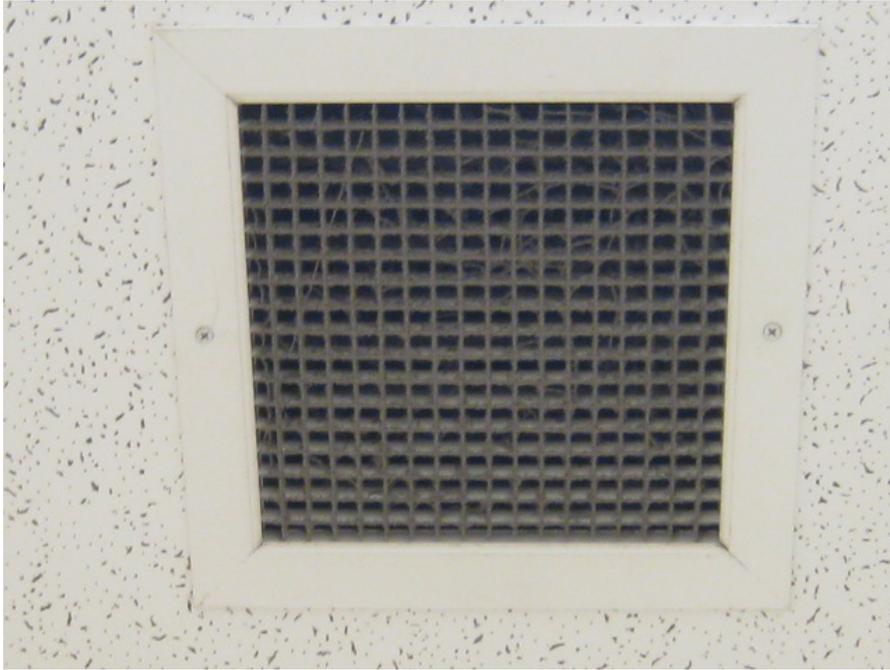
Picture 3

Ducted Exhaust Vent

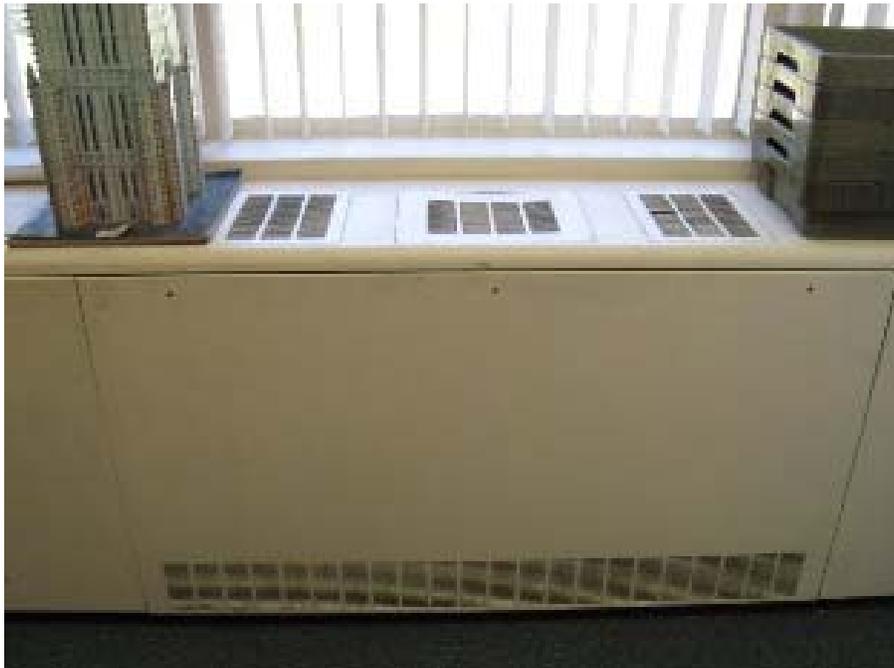
Picture 4

Ventilation is provided to the east wing by means of univents (Picture 4). Air conditioning is provided to this wing by wall-mounted air conditioners with rooftop condensers. No means of exhaust is provided for these rooms. It appears that a portion of the conference room was subdivided into three small offices utilized by the public health nurse, the foot clinic and the nurse's file room. These rooms lack a fresh air supply, exhaust ventilation, as well as windows.

Univent

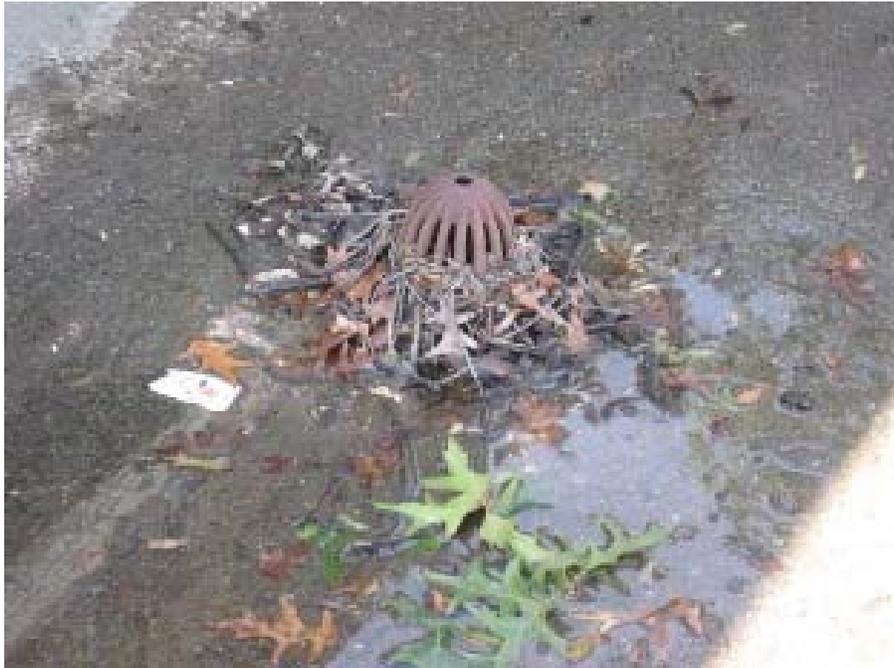
Picture 5

Several potential sources of water damage and/or mold growth were observed at SHSC. Roof drain on north wing was obstructed with debris (Picture 5). Standing water was observed on the roof of the east wing (Picture 6). Roof leaks have resulted in numerous water damaged ceiling tiles throughout the building, particularly in the conference room and its adjacent smaller rooms (Picture 7). BEH was informed that the water damaged ceiling tiles in the exercise room were a result of mechanical issues with the air conditioner rather than a roof leak. In addition to ceiling tiles and gypsum wallboard, door casings as well as carpeting in the east wing exhibited substantial water damage. Peeling paint, water damaged plaster and efflorescence was observed on the ceiling of the Meals on Wheels entrance (Picture 8). Efflorescence is a characteristic sign of water damage to plaster, but it is not mold growth. As moisture penetrates and works its way through seams in the roof membrane, water-soluble compounds in the plaster dissolve, creating a

**Obstructed Roof Drain on North Portion of Building
Note Standing Water**

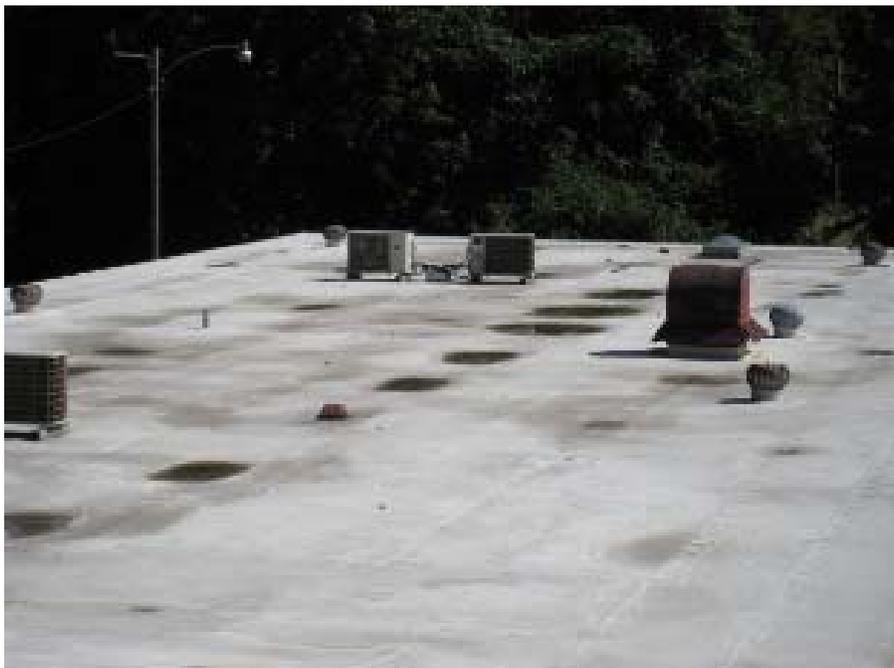
Picture 6

Standing Water on Roof of East Wing

1. Consider repair/replacement of roof areas that are leaking.
2. Consult a licensed asbestos abatement contractor to identify and remove potential asbestos insulation noted in the crawlspace, basement and under the cabinets of the east wing. Remediate damaged floor tiles in conformance with State and Federal asbestos remediation and hazardous waste disposal laws.

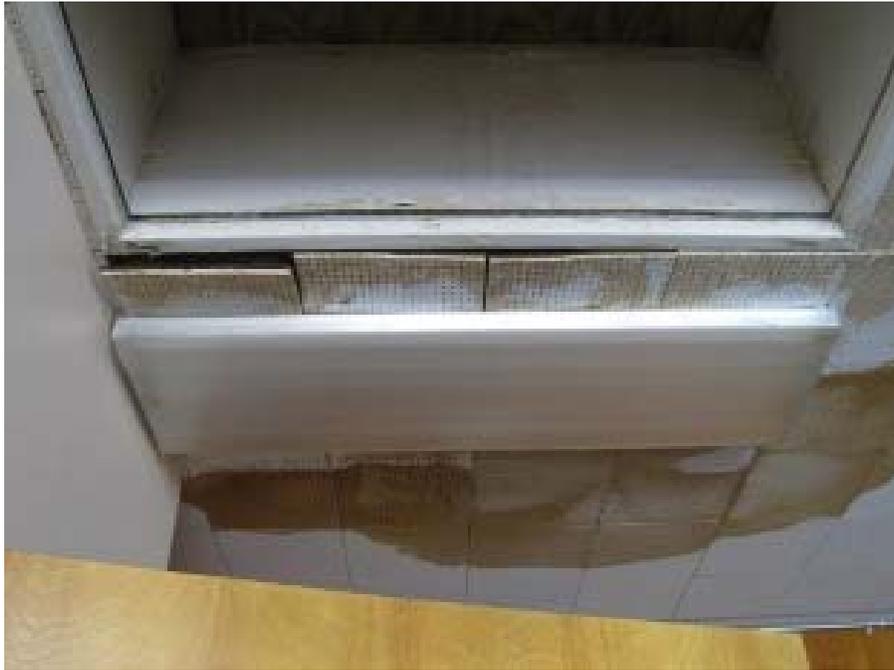
Picture 7

Buckled and Water Damaged Ceiling Tiles

3. Ensure leaks are repaired and replace water damaged ceilings tiles throughout the building. Examine the area above and around these areas for mold growth. Disinfect areas of water leaks with an appropriate antimicrobial.

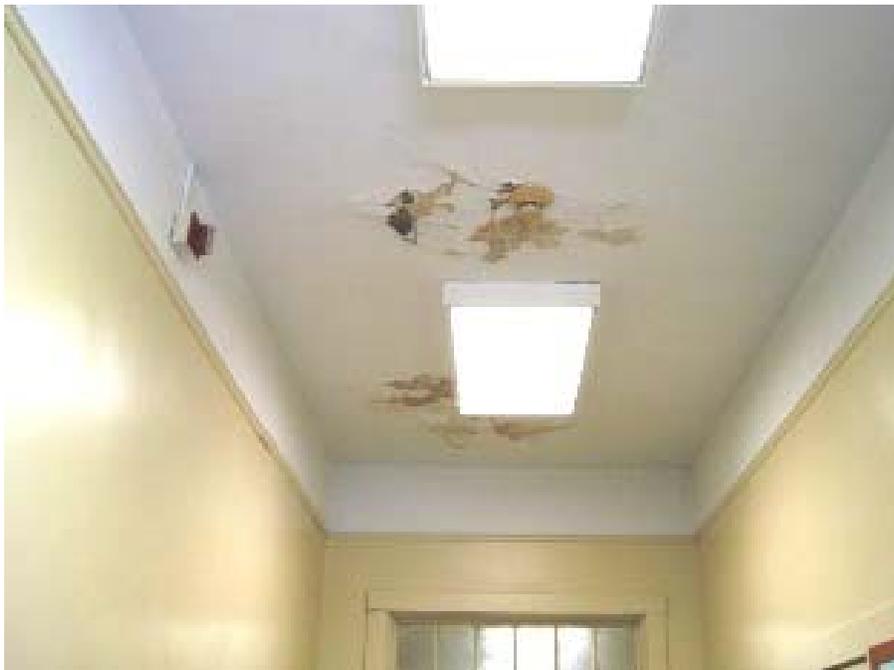
Picture 8

Water Damaged Ceiling

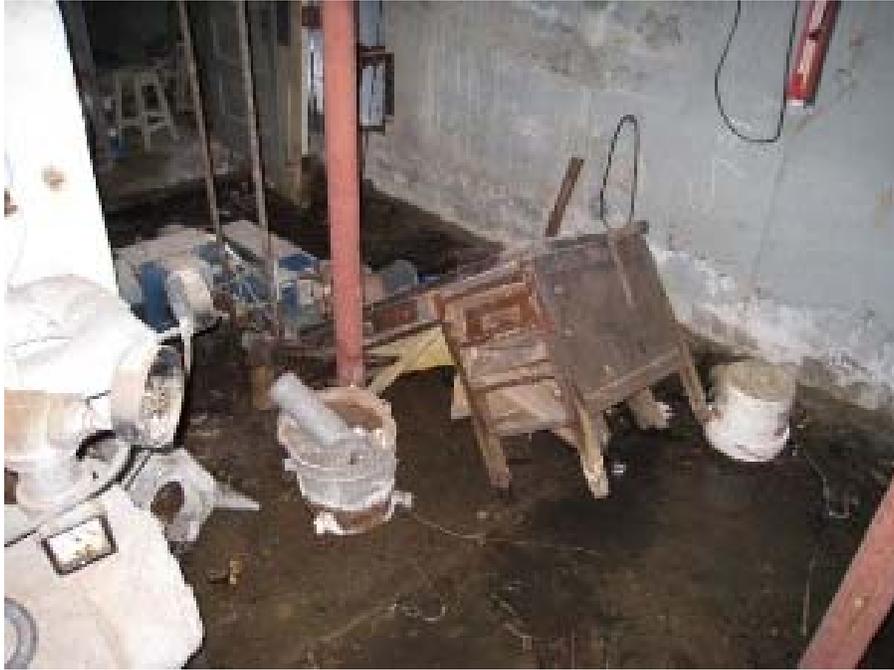
Picture 9

Debris stored on wet basement floor.

10. Remove all moistened debris from the SHCA, including but not limited to basement and crawlspace areas as well as cabinet areas in the east wing.

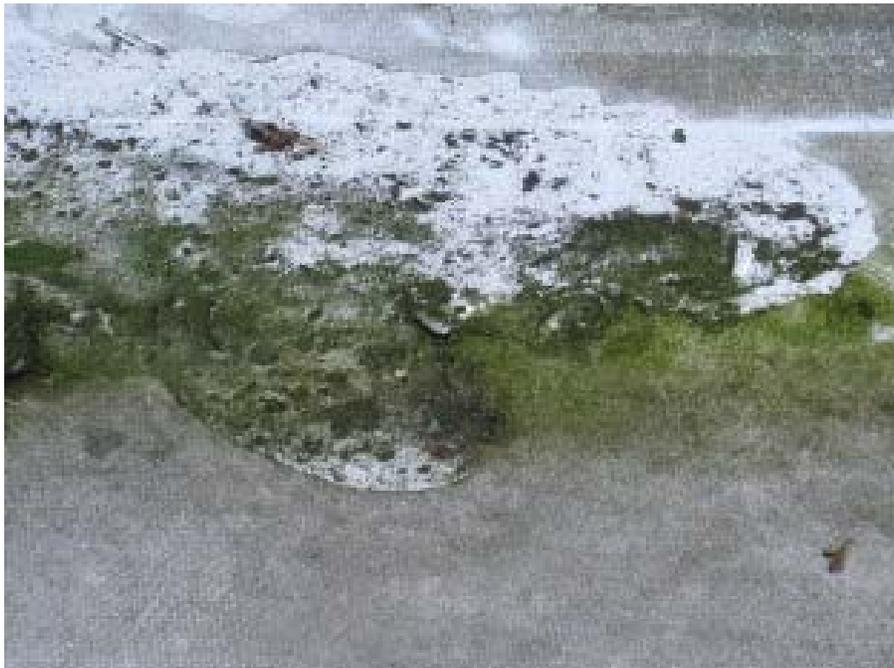
Picture 10

- Roof drains are clogged with debris. Evidence of pooled water was observed on the roof adjacent to one drain.
- Moss growth was observed on the roof (Picture 10). The two main requirements of moss are sufficient moisture and accessible nutrients. For example, the moist environment of a rooftop shaded by trees provides optimal conditions for moss growth. "Mosses will be at their best in the winter when there is plenty of water, little light, and low temperatures" (OSU, 2000). Moss is a sign of chronic dampness which holds moisture against the building.

Moss Growth on Membrane Roof

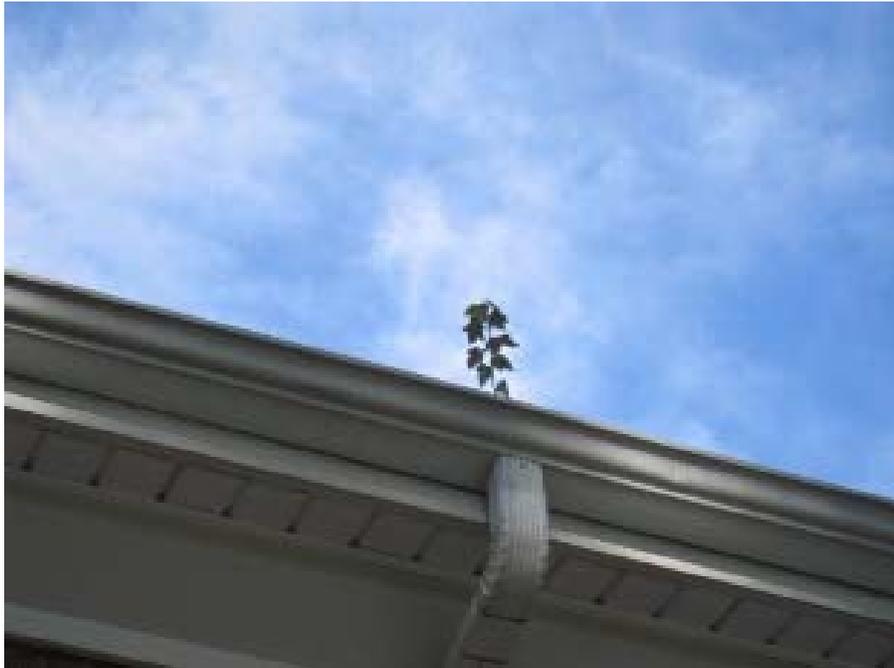
Picture 11

- Gutters are filled with debris and appear to be capable of supporting plant growth at the time of the assessment (Picture 11). Downspouts deposit rainwater at the base of the building (Picture 12). The accumulation of water adjacent to the building may allow water to penetrate the building envelope and over time, damage the foundation.

Plant Growth in Gutter

16. Establish a routine schedule to clean debris from gutters. Ensure that downspouts direct water away from the building.
17. Re-point exterior areas exhibiting loose, cracked or missing mortar.

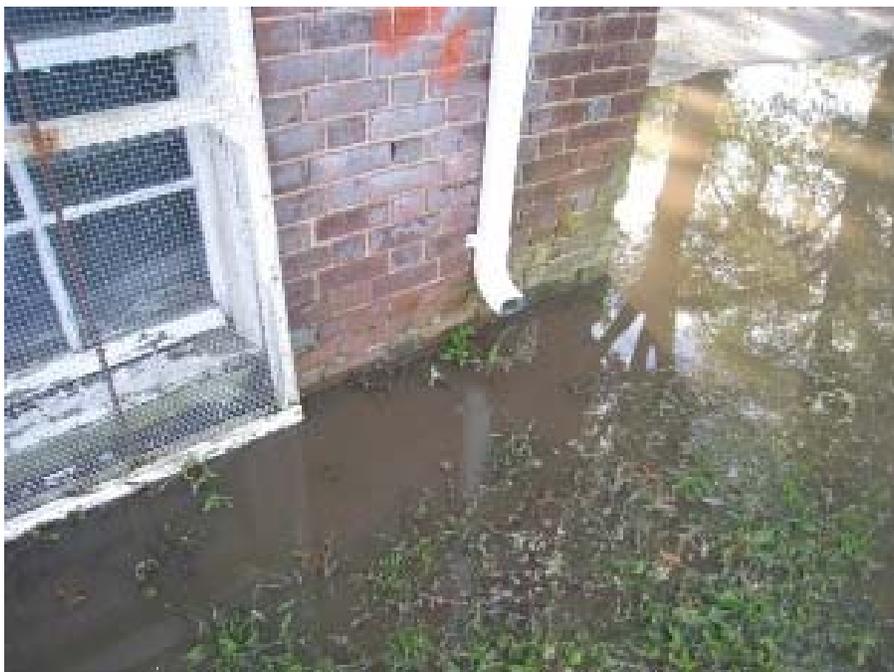
Picture 12

**Downspout Deposits Water Adjacent to the Building
Note Standing Water**

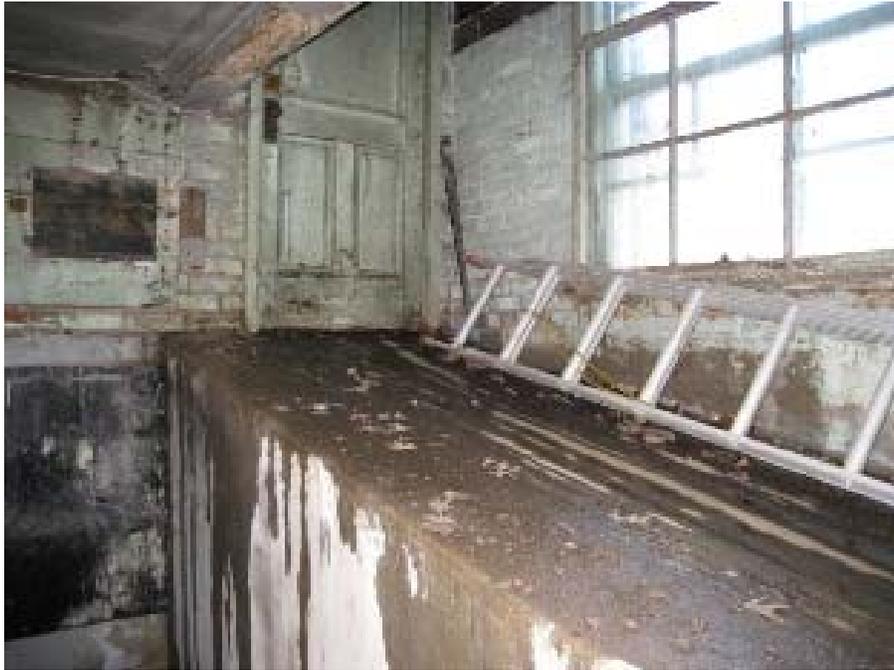
Picture 13

- Standing water was observed on the ground adjacent to the original building. This condition contributes to the water that pours into the basement (Picture 13).

Standing Water Penetrates Building Envelope and Enters Basement

7. Consider improving the grading of the ground away from the foundation at a rate of 6 inches per every 10 feet in order to eliminate water from entering basement (Lstiburek & Brennan, 2001).

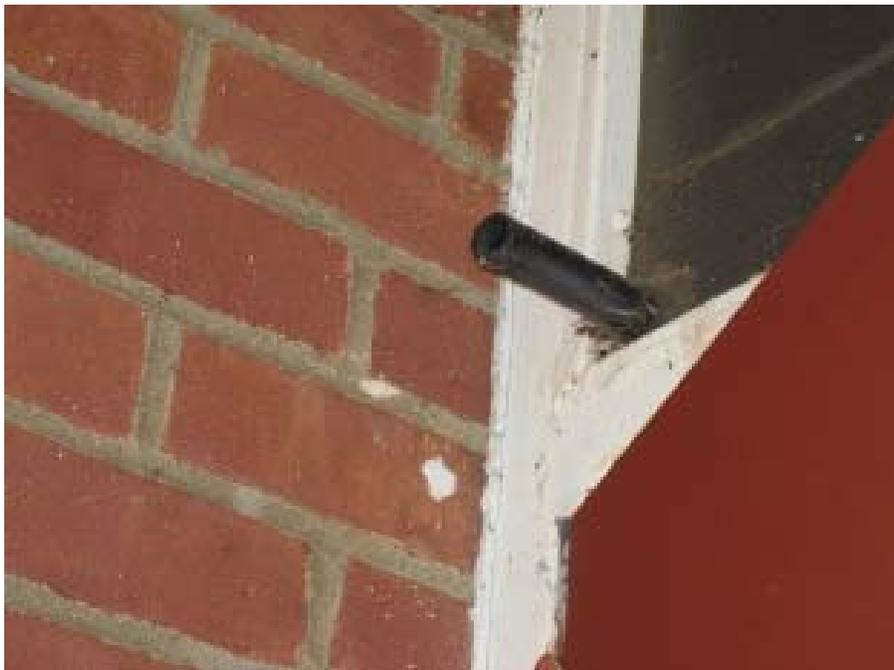
Picture 14

- Cracks in concrete were found at the base of building.
- Condensation from some of the air conditioners is collected in a tube and deposited just outside the back doors (Picture 14). The water is deposited very close to the building and appears to have resulted in some scouring of the concrete walkway. Scouring is the removal of soil by moving water during erosion. The walkway adjacent to the building is cracked and therefore, will allow water to migrate close to the building's foundation.

Condensation Line From Wall Mounted Air Conditioners

20. Ensure condensation lines for air conditioners in east wing deposit water as far away from the building as is practicable. Additionally, ensure pumps attached to some of these wall mounted air conditioners are operational and that tubing delivers condensation to desired location without leaking.

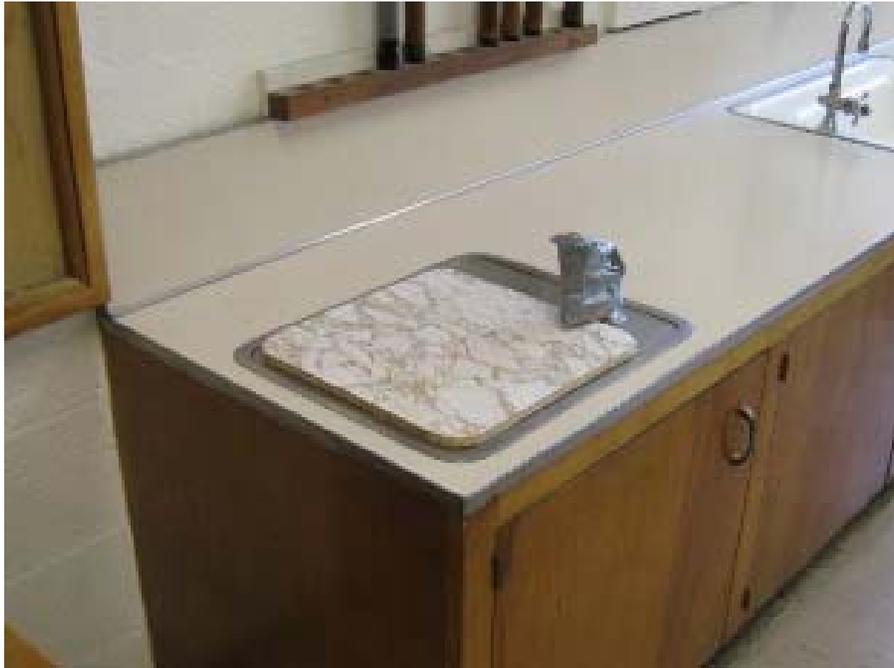
Picture 15

found abandoned utilizing a cover over the basin (Picture 15). The purpose of a drain trap is to prevent sewer system gases and odors from entering the occupied space. When water is poured into a trap, an air tight seal is created by the water in the U-bend section of the pipe. These drains must have water poured into the traps at least twice a week to maintain the integrity of the seal. Without water, the drain opens the room to the sewer system. If a mechanical device (e.g., the fan) depressurizes the room, air, gas and odors can be drawn from the sewer system into the room. The effect of this phenomenon can be enhanced if heavy rains cause an air backup in the sewer system.

Abandoned Fountain

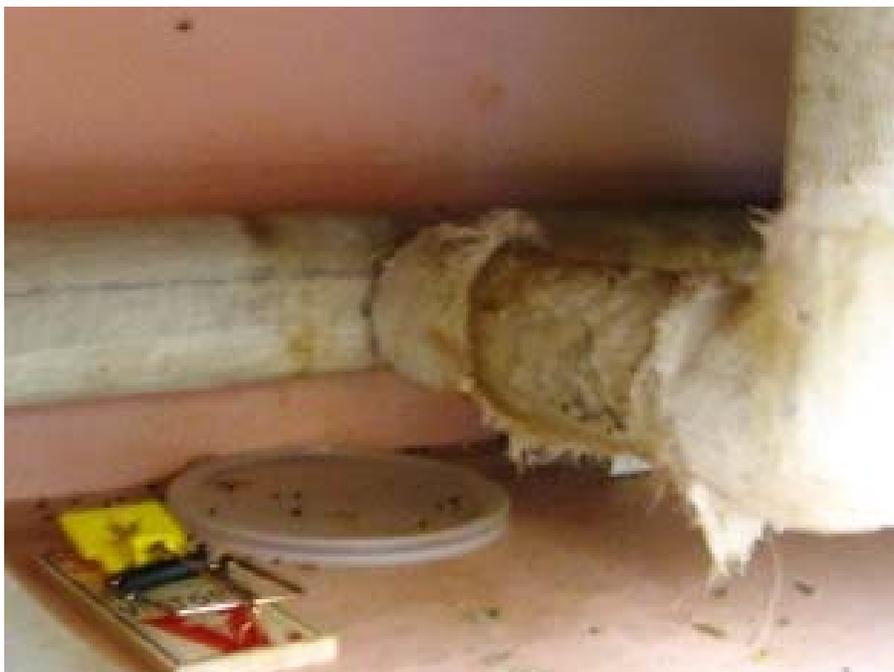
Picture 16

Rodent Droppings in Cabinet in East Wing, Note Evidence of Rodent Shredding Pipe Insulation (Potential Asbestos)

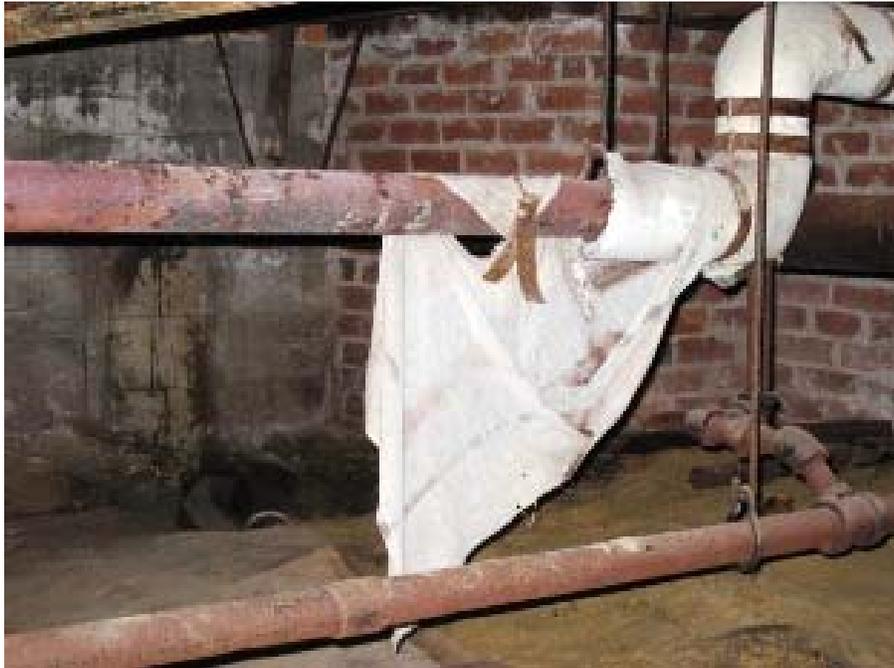
Picture 17

Friable Pipe Insulation

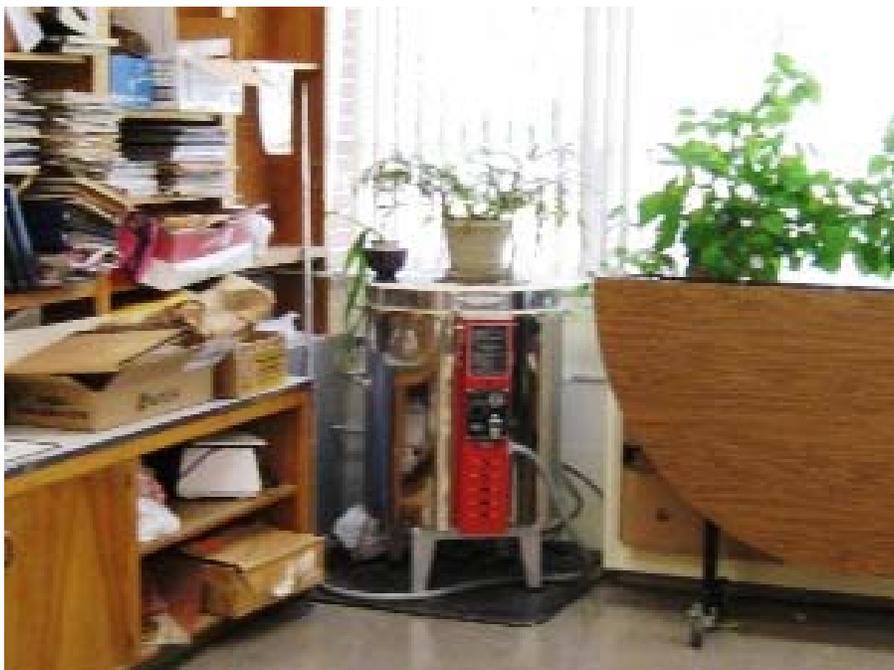
Picture 18

The ceramics room contains a kiln which was not in use at this time (Picture 18). Kiln exhaust may produce corrosive, hazardous and irritating materials including chlorine, sulfur dioxide and carbon monoxide. Pottery kilns should be provided with dedicated local exhaust ventilation (McCann, 1985) to ventilate these possible emissions from the interior of the building.

Kiln Stored in East Wing Is Not Currently In Use

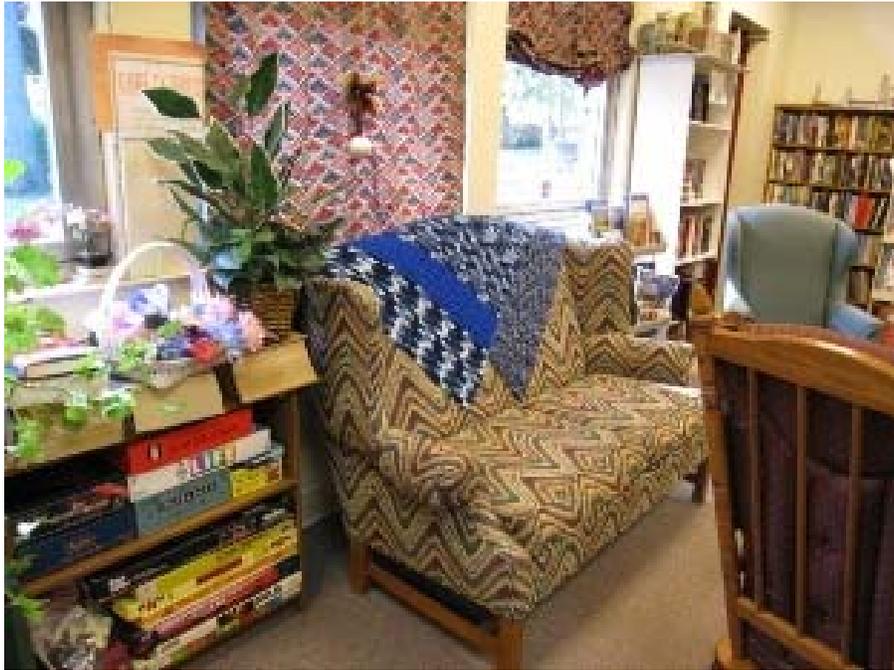
Picture 19

A number of rooms contained upholstered furniture (Picture 19). Upholstered furniture is covered with fabric that comes in contact with human skin. This type of contact can leave oils, perspiration, hair and skin cells. Dust mites feed upon human skin cells and excrete waste products that contain allergens. In addition, if relative humidity levels increase above 60 percent, dust mites tend to proliferate (US EPA, 1992). In order to remove dust mites and other pollutants, frequent vacuuming of upholstered furniture is recommended (Berry, 1994). It is also recommended that upholstered furniture (if present in schools), be professionally cleaned on an annual basis. If an excessively dusty environment exists due to outdoor conditions or indoor activities (e.g., renovations), cleaning frequency should be increased (every six months) (IICR, 2000). Elevated outdoor levels of airborne particulates can result in increased levels of indoor particulates by entering into the building through open windows, doors and filter bypass. The

Upholstered Furniture and Draperies in Library

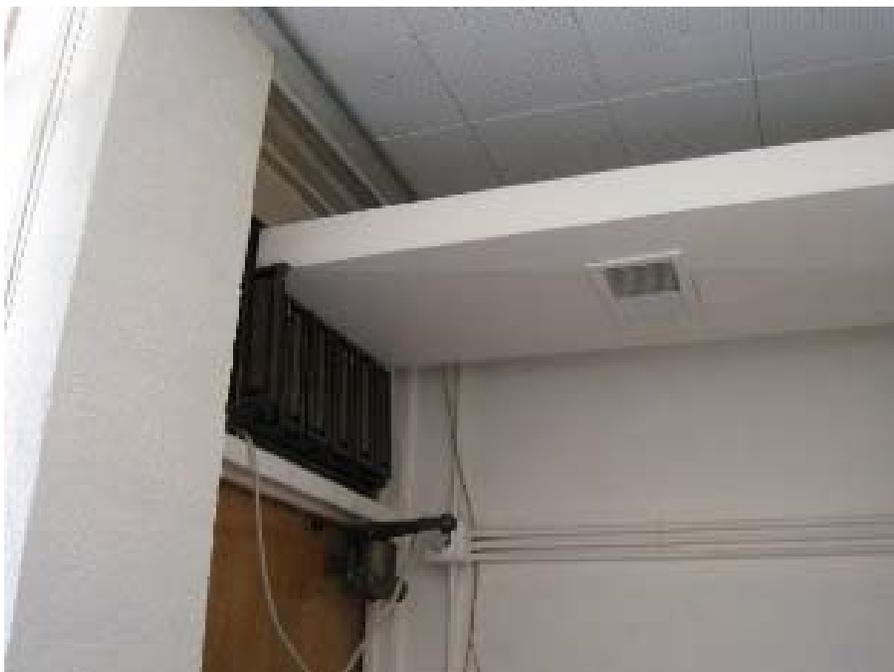
Picture 20

A number of open penetrations were observed throughout the building, particularly in the basement. Additionally, in the small rooms located within the conference room, a long duct was created and attached to a window mounted air conditioner in an attempt to provide air conditioning (Picture 20 to 21). The penetrations of these ducts through interior walls are not sealed. Open utility holes can provide a means of egress for odors, fumes, dusts and vapors between rooms and floors. In addition, these materials can migrate into the air handling chambers of unit ventilators and be distributed to occupied areas. Discontinued ducts were also observed in the basement. In addition, what appeared to be part of an old gravity heating system was observed on the wall in the kitchen above the exhaust hood. If the vent is no longer in use, it should be sealed on both ends to prevent contaminants from entering the space.

Duct Attached to Air Conditioner in Conference Room

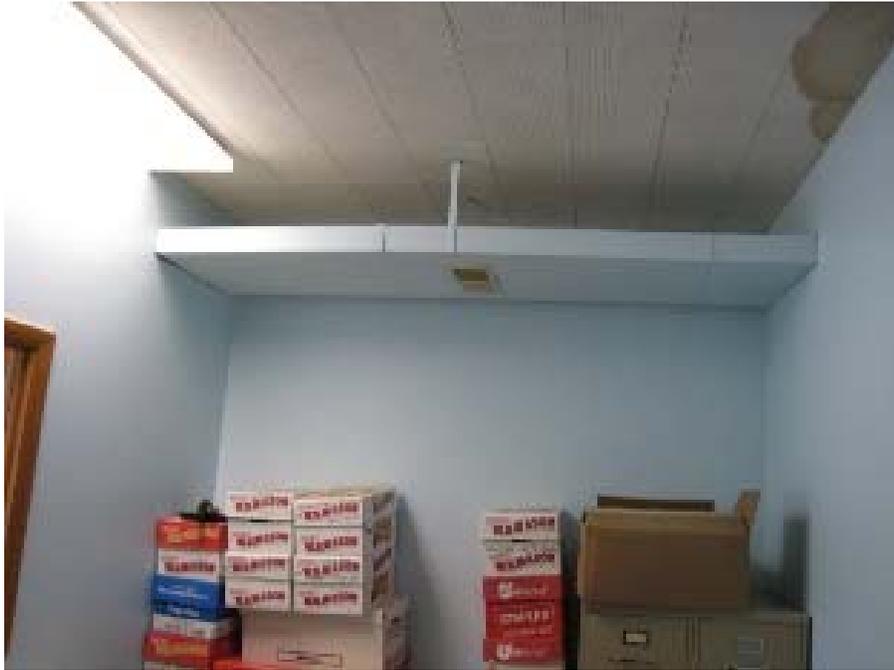
Picture 21

**Air Conditioner Duct In Storage Room
Note Open Penetrations Through Walls**
