INDOOR AIR QUALITY ASSESSMENT

**Massachusetts Department of Mental Retardation
The Fernald Center
North Nurses Building
200 Trapelo Road
Waltham, Massachusetts 02452**

Prepared by:
Massachusetts Department of Public Health
Bureau of Environmental Health
Indoor Air Quality Program
February 2009

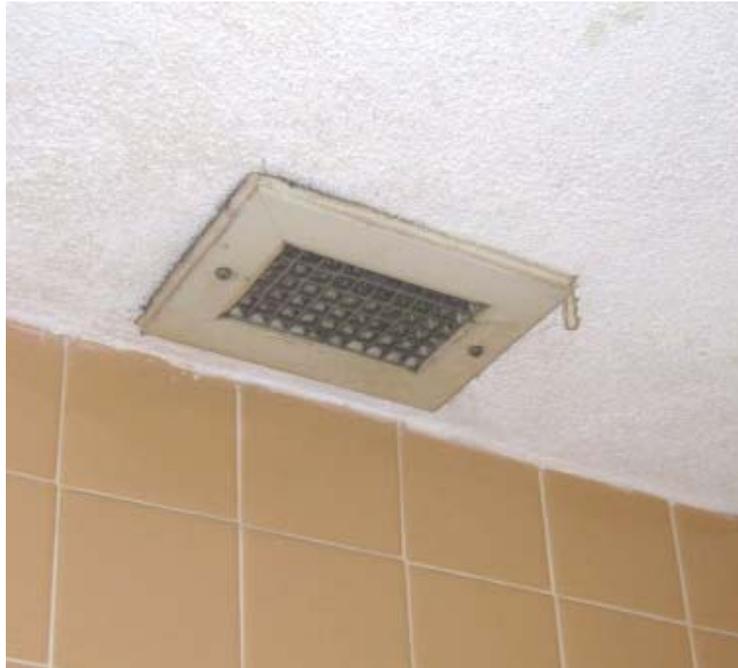
Picture 1

Restrooms, custodial closets and storage areas appear to be equipped with local exhaust ventilation (Picture 1). None of the exhaust vents were functioning during the assessment however, which can indicate they were either deactivated or inoperable. Exhaust ventilation is necessary in restrooms/custodial closets to remove excess moisture and to prevent restroom odors from penetrating into adjacent areas.

Local Exhaust Vent in Restroom

5. Restore exhaust ventilation in restrooms and custodial closets to remove odors and moisture, make repairs as necessary.
6. For buildings in New England, periods of low relative humidity during the winter are often unavoidable. Therefore, scrupulous cleaning practices should be adopted to minimize common indoor air contaminants whose irritant effects can be enhanced when the relative humidity is low. To control for dusts, a high efficiency particulate arrestance (HEPA) filter equipped vacuum cleaner in conjunction with wet wiping of all surfaces is recommended. Drinking water during the day can help ease some symptoms associated with a dry environment (e.g., throat and sinus irritations).

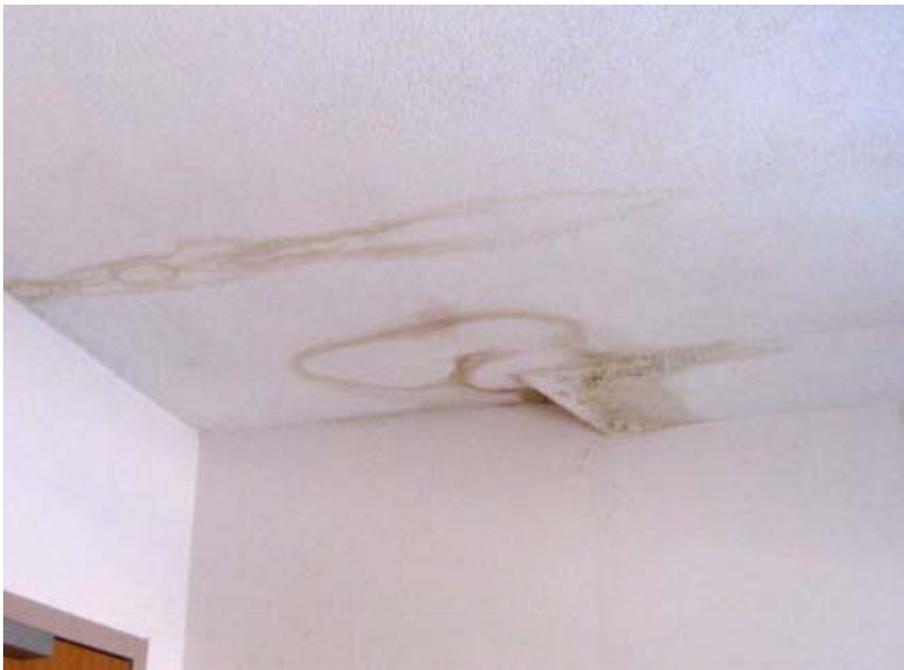
Picture 2

As discussed in detail in a previous MDPH report, visible mold growth was observed in the 1st floor hallway and conference room, which appeared to be a result of the steam leak. The earlier report provided information and supplied guidelines for remediation (MDPH, 2009). Several other potential sources of water damage and/or mold growth unrelated to the steam leak were observed. Several areas on the second floor had water-damaged ceiling plaster and stains on walls, which likely indicate leaks from either the roof or building envelope (Pictures 2 through 4/Table 1). Active roof leaks were reported in office 201 and in the environmental closet on the 1st floor (Pictures 2 and 4).

Water Damaged Ceiling Plaster, Stains on Wall/Paint Office 201

11. Seal basement windows to prevent water penetration and rodent/pest entry.
12. Ensure leaks are repaired. Scrape off efflorescence, repair/repaint water damaged plaster.

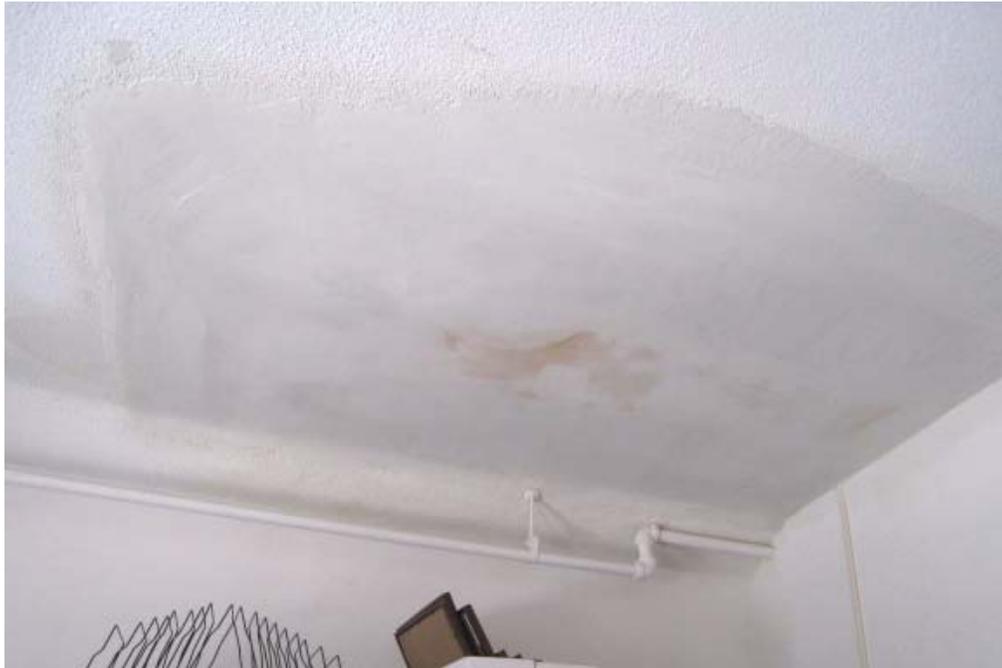
Picture 3

Repaired Section of Ceiling Plaster in 2nd Floor Office, Note new Staining in Center

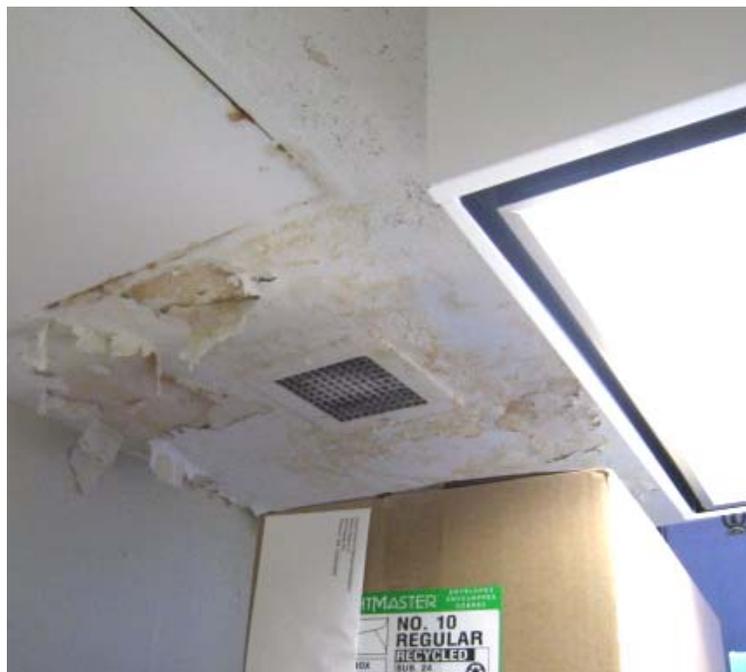
Picture 4

Water Damaged Ceiling Plaster/Peeling Paint in Environmental Closet 1st Floor

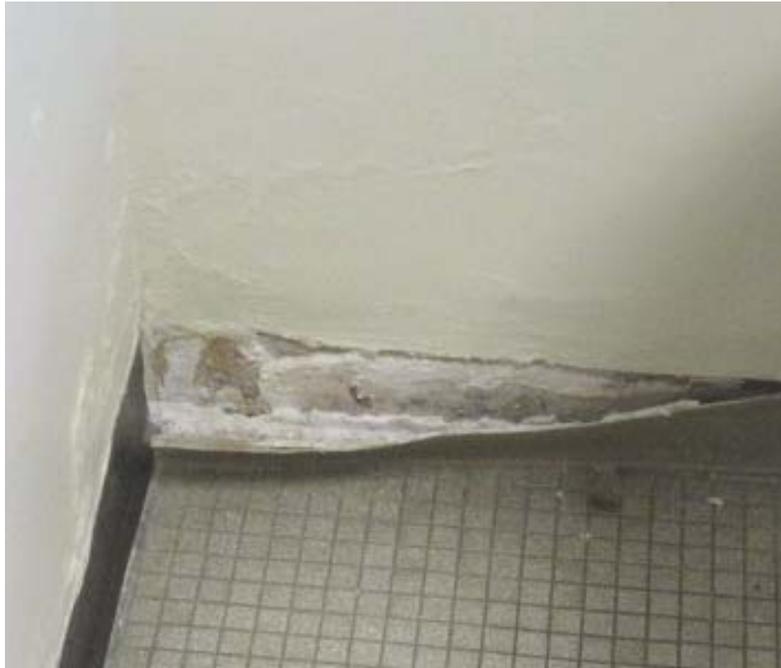
Picture 5

Efflorescence was observed on ceiling and wall plaster in a number of areas (Table 1/Picture 5). Efflorescence is a characteristic sign of water damage to brick and mortar, but it is not mold growth. As moisture penetrates and works its way through mortar and brick, water-soluble compounds in mortar and brick dissolve, creating a solution. As the solution moves to the surface of the mortar or brick, the water evaporates, leaving behind white, powdery mineral deposits.

Efflorescence on Wall Plaster in Women's Restroom

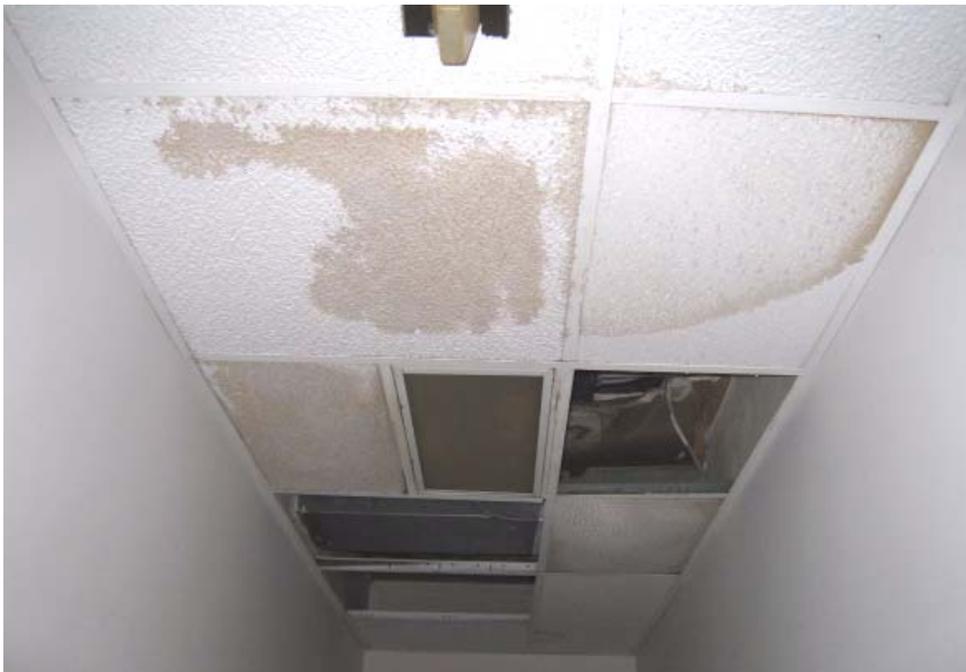
Picture 6

Water damaged/missing ceiling tiles were noted in the first floor hallway near room 105 (Picture 6). Water-damaged ceiling tiles can indicate sources of water penetration and provide a source of mold. Ceiling tiles should be replaced after a water leak is discovered and repaired. Water damaged wooden windowsills were also observed around window-mounted air conditioners in several areas (Picture 7/Table 1).

Missing/Water Damaged Ceiling Tiles 1st Floor Hallway (near Room 105)

8. Remove/replace water damaged ceiling tiles. Examine the areas above and around for mold growth. Disinfect areas of water leaks with an appropriate antimicrobial.

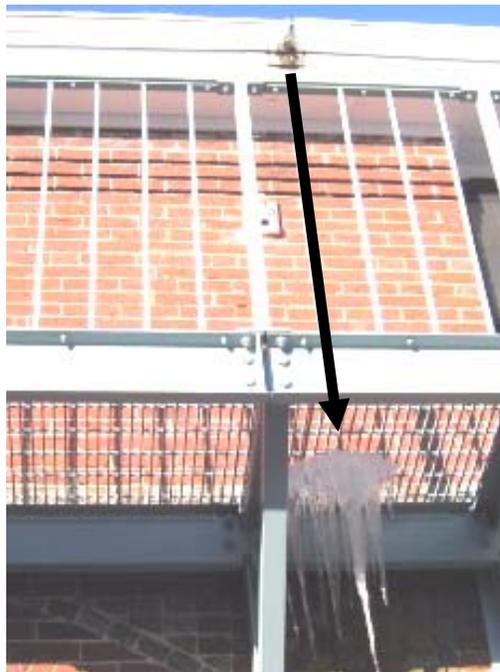
Picture 8

- Damaged/dislodged gutters and downspouts (Pictures 8 through 10);
- Gutters clogged with leaves and plant debris (Picture 11);
- Missing/damaged mortar and cracks/holes in exterior brick (Pictures 12 and 13);
- Missing/damaged basement windows sealed with plywood (Pictures 14 and 15); and
- Damage/breaches in wooden eaves along the roof edge (Pictures 16 and 17).

Hole in Gutter, Note Ice Formation Due to Leak

1. Consider consulting with an architect, masonry firm or general contractor regarding the integrity of the building envelope, primarily concerning water penetration through the roof/exterior walls.
2. Repair/replace missing/damaged sections of gutter/downspout system to direct water away from the building.

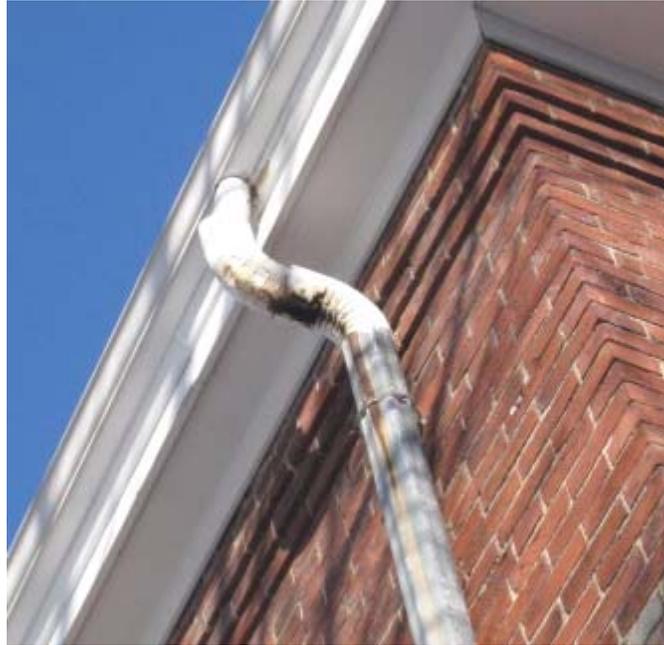
Picture 9

Hole in Downspout/Elbow

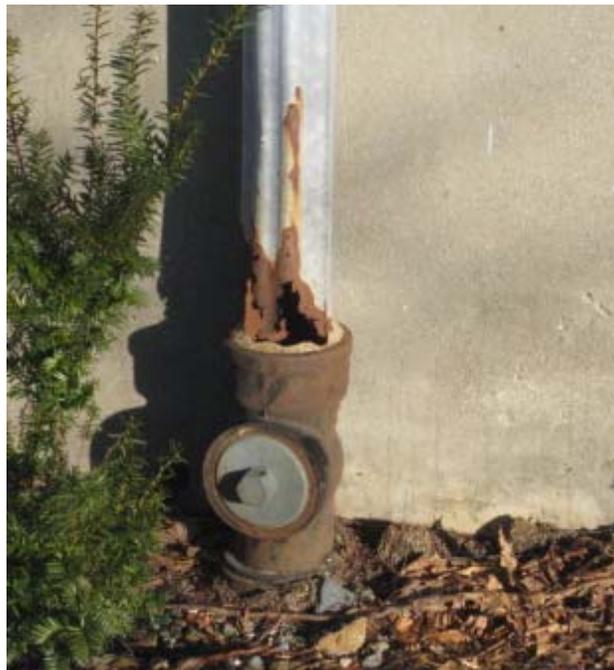
Picture 10

Hole in Downspout

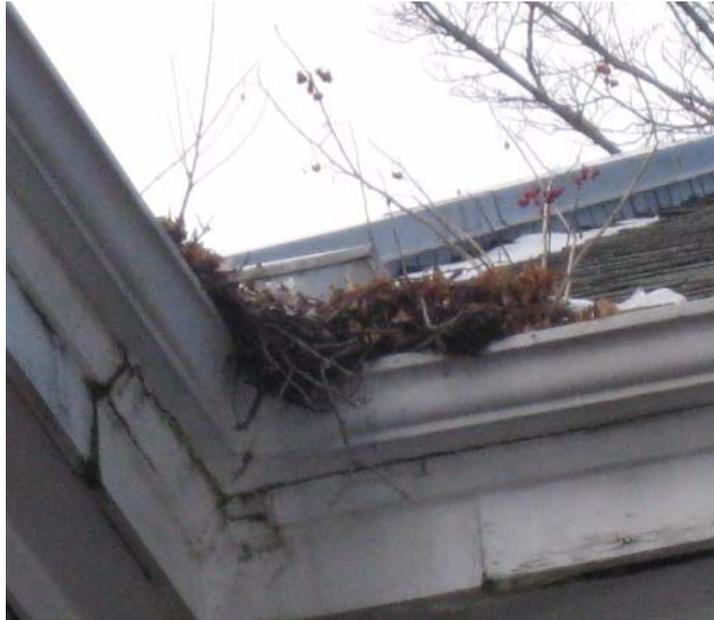
Picture 11

Gutters Clogged with Leaves and Plant Debris

9. Remove leaves and debris from gutters, examine for proper drainage.

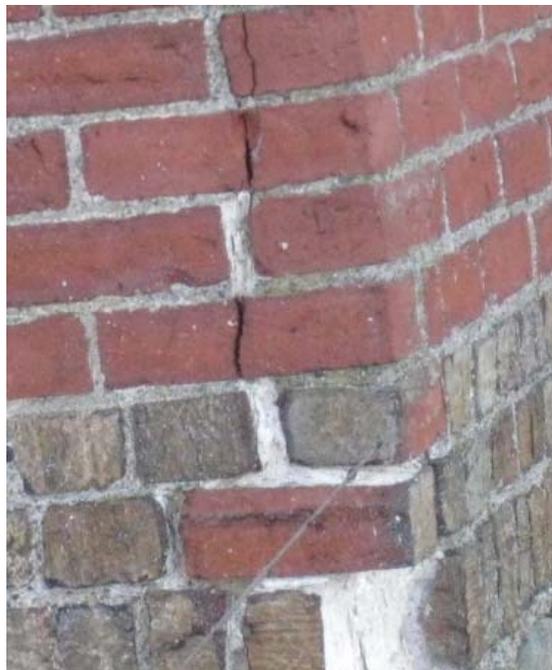
Picture 12

These conditions can undermine the integrity of the building envelope and provide a means of water entry by capillary action into the building through exterior walls, foundation concrete and masonry (Lstiburek & Brennan, 2001). In addition, these breaches in exterior areas can provide a means of drafts and pest entry into the building.

Damaged Brick, Missing/Damaged Mortar, Note Lighter Mortar Indicating Previous Repairs/Re-pointing

7. Make temporary repairs to seal breaches in building envelope (Pictures 12 through 17) to prevent drafts, access by pests/rodents and further water penetration and damage to building materials.

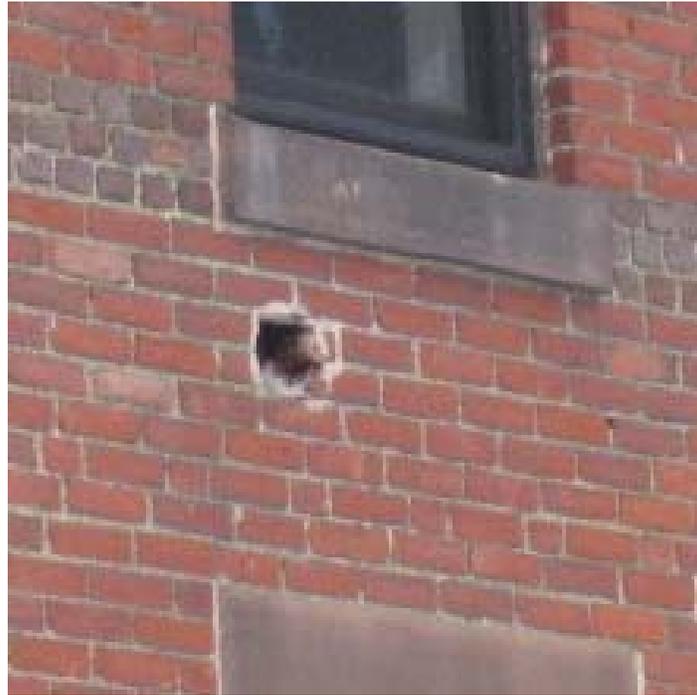
Picture 13

Hole in Building Exterior

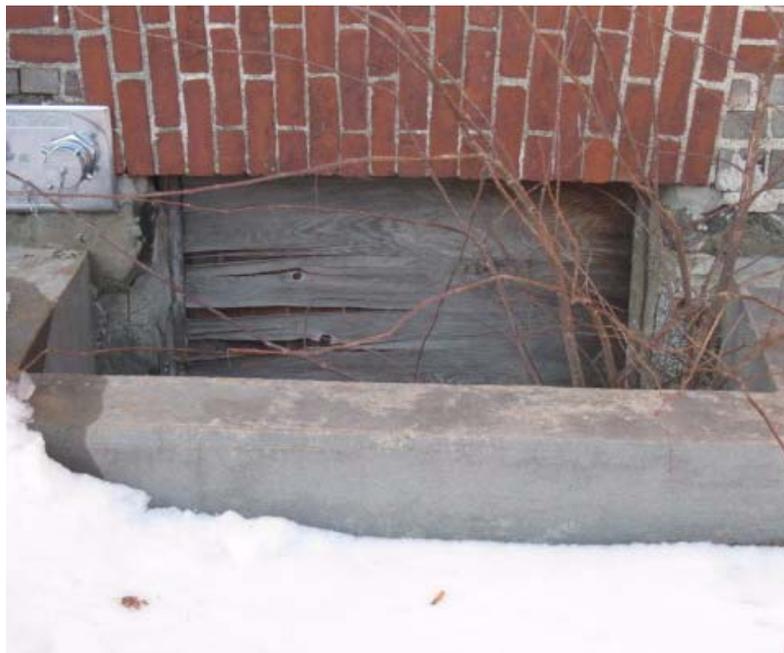
Picture 14

Basement Window Sealed With Plywood

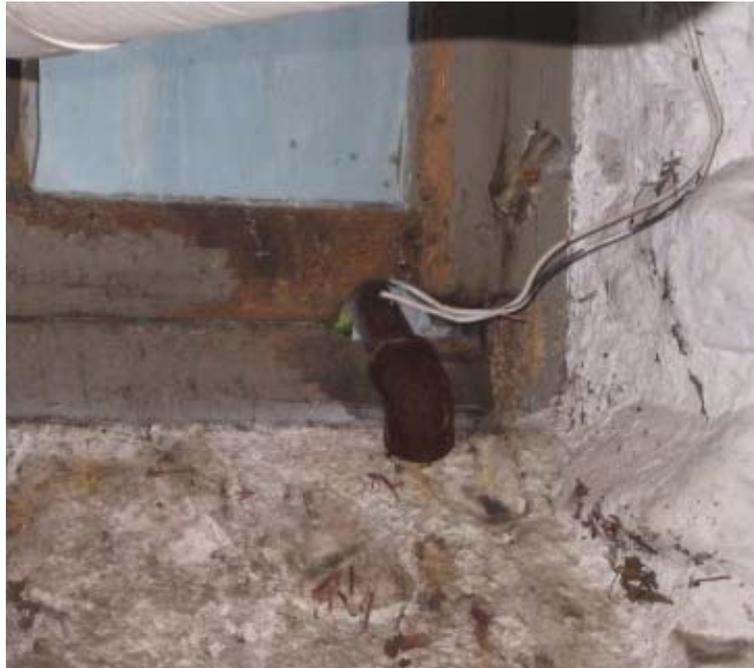
Picture 15

Hole in Window Frame for Utilities

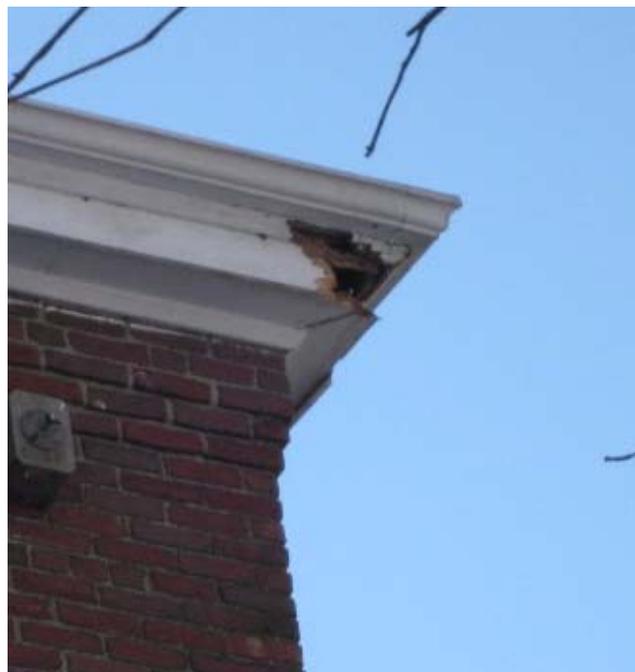
Picture 16

Damaged Wooden Cornice

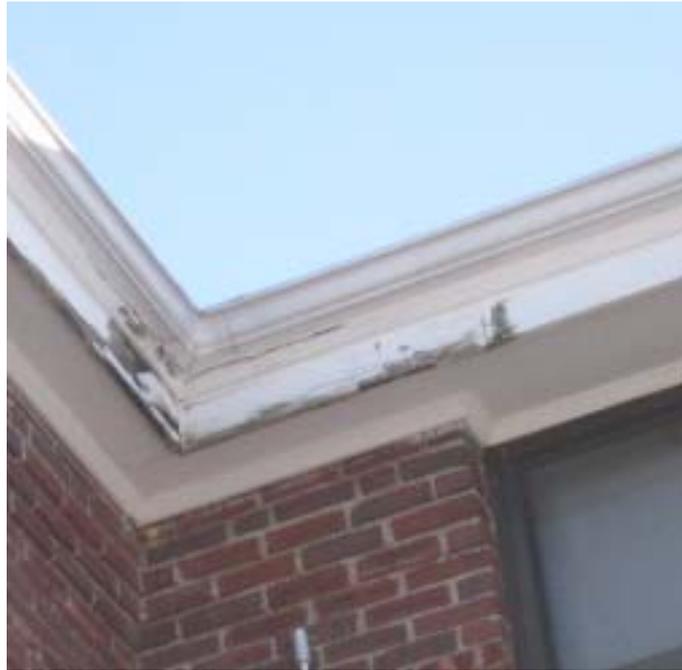
Picture 17

Damaged Wooden Cornice

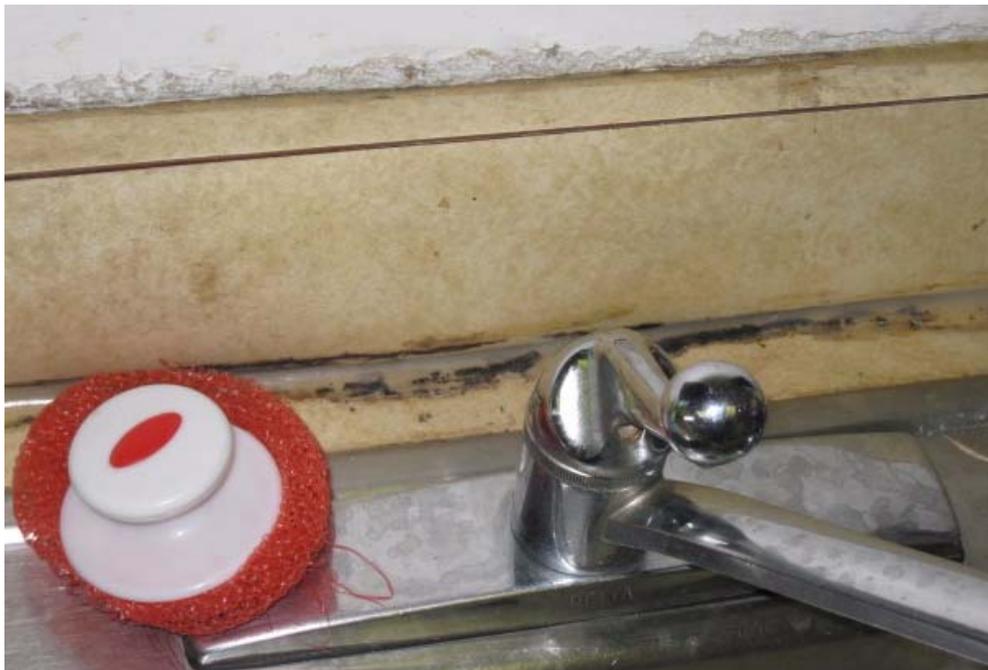
Picture 18

Visible mold growth was observed along the seam of the sink countertop and backsplash in the 1st floor kitchen (Picture 18). If not watertight, moisture can penetrate through the seam, causing water damage. Improper drainage or sink overflow can lead to water penetration into the countertop, cabinet interior and areas behind cabinets. Water

Mold (Dark Staining) along Backsplash of 1st Floor Kitchen Sink

10. Seal areas around sinks to prevent water-damage to the interior of cabinets and adjacent wallboard. Clean mold and disinfect countertop in 1st floor kitchen. Make repairs or replace if needed.

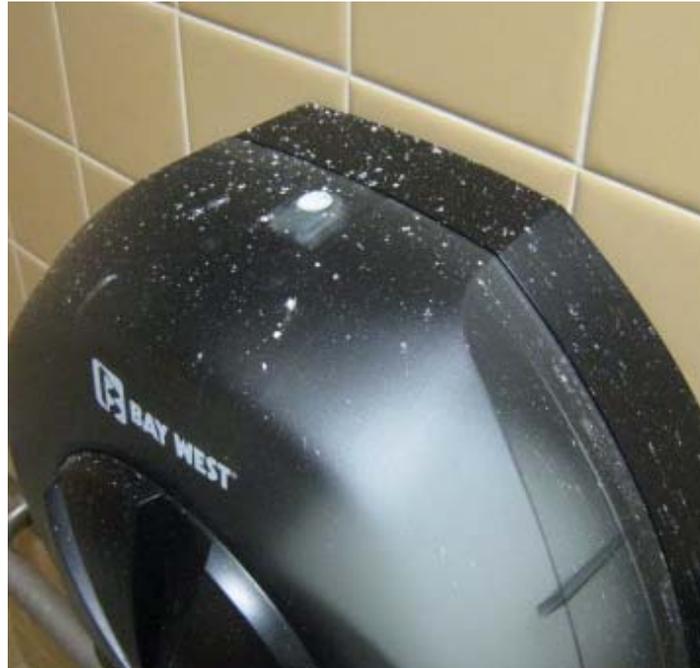
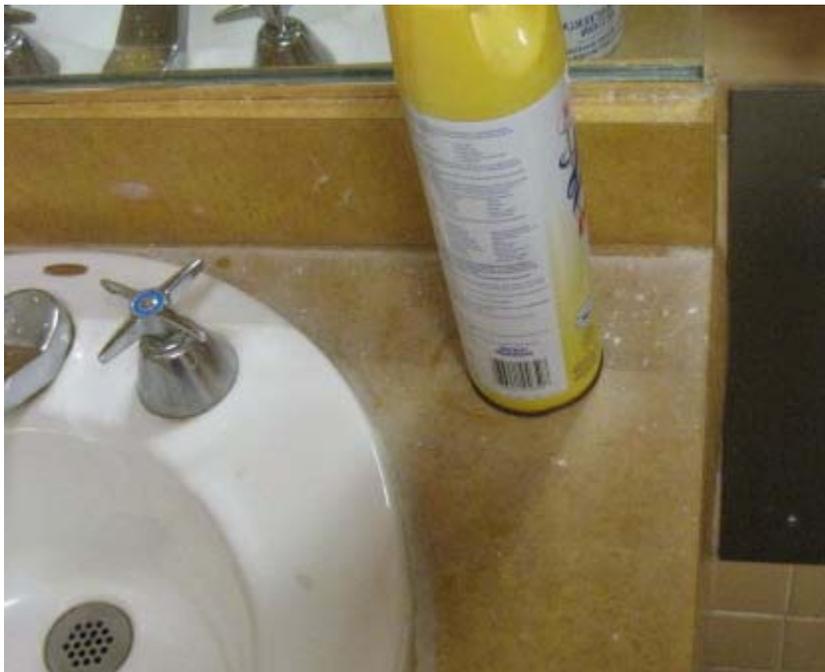
Other conditions that can affect indoor air quality were observed during the assessment. Occupants pointed out a coating of white dust on surfaces in the 1st floor men's restroom (Pictures 19 and 20). The dust appears to be sloughing off ceiling plaster and becoming aerosolized when disturbed by air currents (as observed by BEH staff), such as when the restroom door is opened/closed. Dust can be irritating to eyes, nose and respiratory tract.

White Dust/Debris on Surfaces 1st Floor Men's Restroom

14. Seal and repaint ceiling plaster in 1st floor men's restroom to prevent flaking.
15. Wrap/replace exposed fiberglass pipe insulation in conference room.

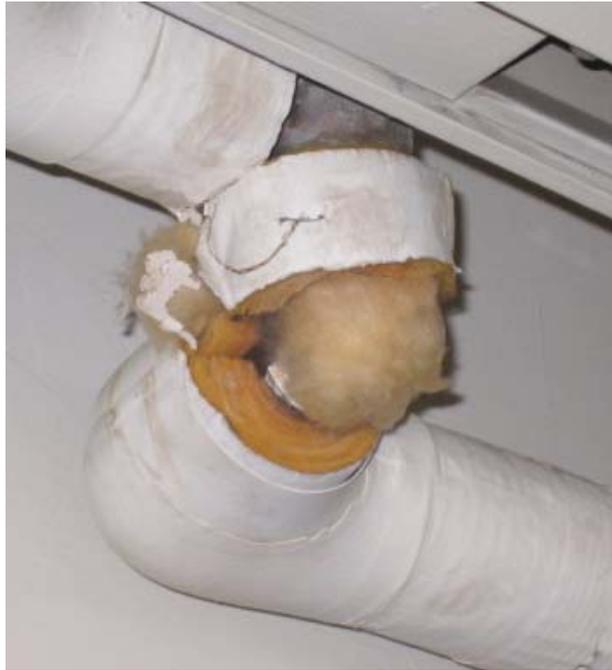
Picture 21

In some areas in the building, items were observed on windowsills, tabletops, counters, bookcases and desks. The large number of items stored provides a source for dusts to accumulate. These items (e.g., papers, folders, boxes) make it difficult for custodial staff to clean. Items should be relocated and/or be cleaned periodically to avoid excessive dust build up. Exposed fiberglass pipe insulation was observed in the 1st floor conference room. Fiberglass insulation can provide a source of skin, eye and respiratory irritation (Picture 21).

Exposed Fiberglass Insulation in 1st Floor Conference Room

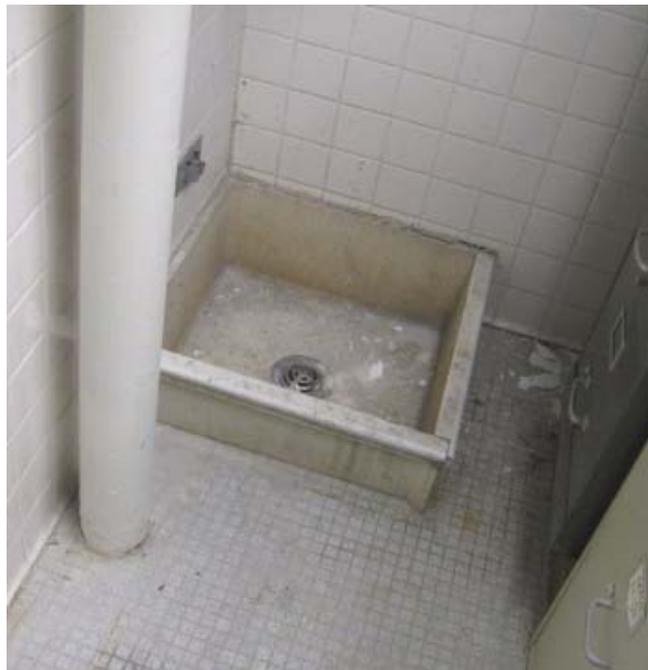
Picture 22

Finally, sewer gas-type odors were reported from the custodial sink/floor drain in the 1st floor environmental closet (Picture 22). Drains are usually designed with traps in order to prevent sewer odors/gases from penetrating into occupied spaces. When water enters a drain, the trap fills and forms a watertight seal. Without a periodic input of water (e.g., every other day), traps can dry, breaking the watertight seal. Without a watertight seal, odors or other material can travel up the drain and enter the occupied space.

Custodial Sink/Floor Drain 1st Floor Environmental Closet

16. If not in use consider sealing the floor drain in the 1st floor environmental closet, if not feasible, ensure water is poured into the drains every other day (or as needed) to maintain the integrity of the traps.
